Expertise

Protocol number: 46230783
Order No. / Reference: 26571336
Inspection date: 29 Jun 2026

Manufacturer: Ford

Model: Transit 350 L3H3 Lkw VA Trend

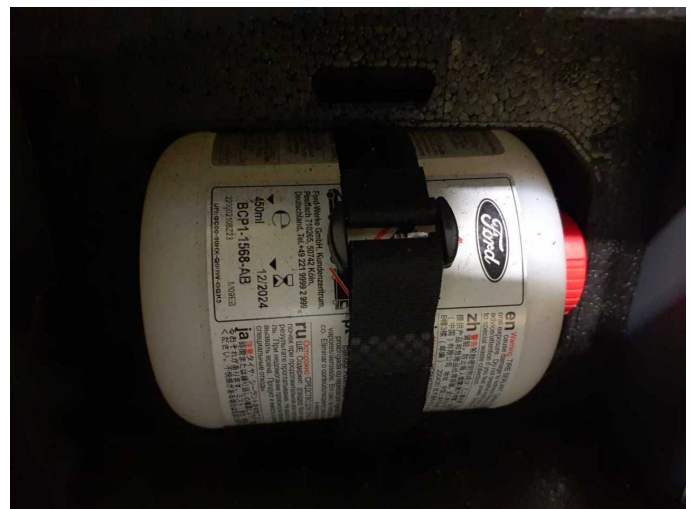
Damage 1: Equipment: Tirefit filler - Expired - Replace

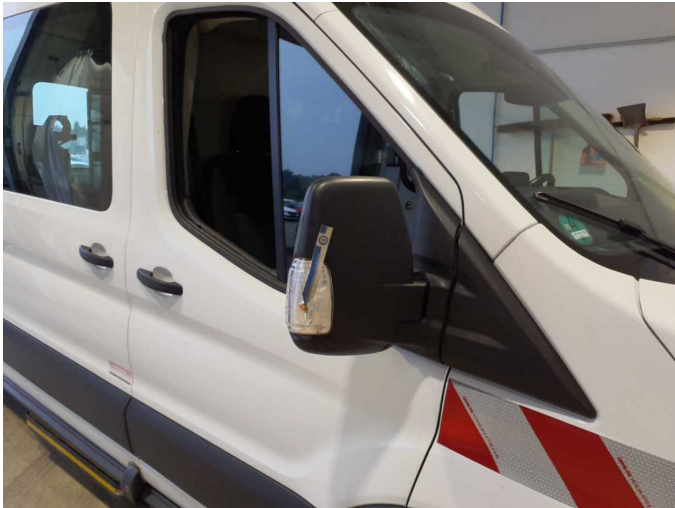
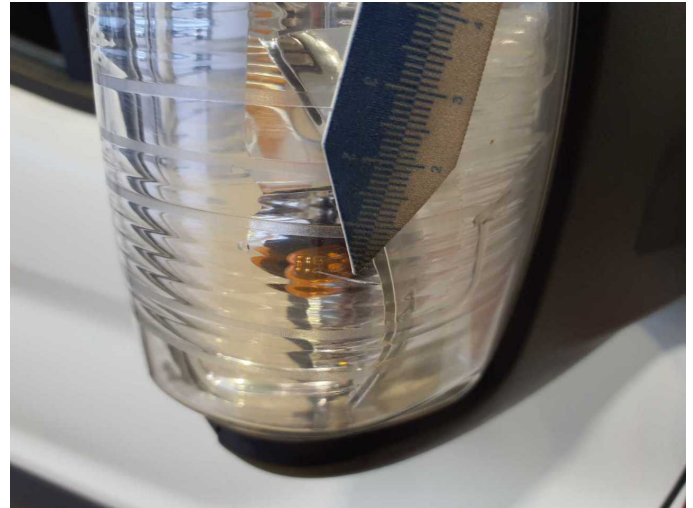
Damage 2: Indicator - front: Mirror - right side - Scratch(es) - Replace

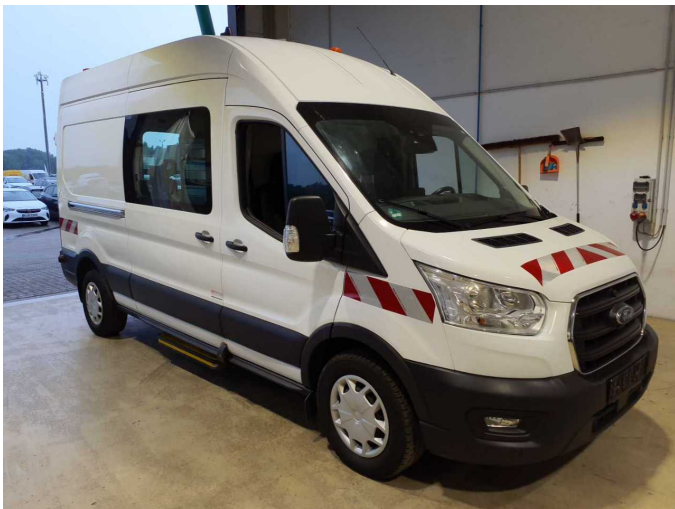
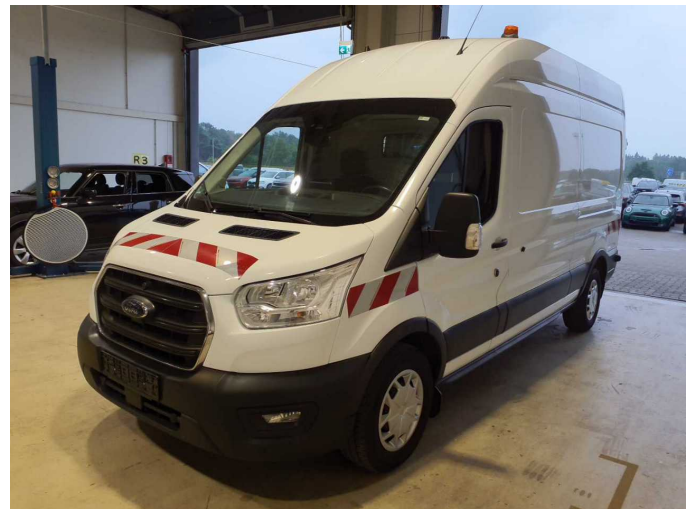
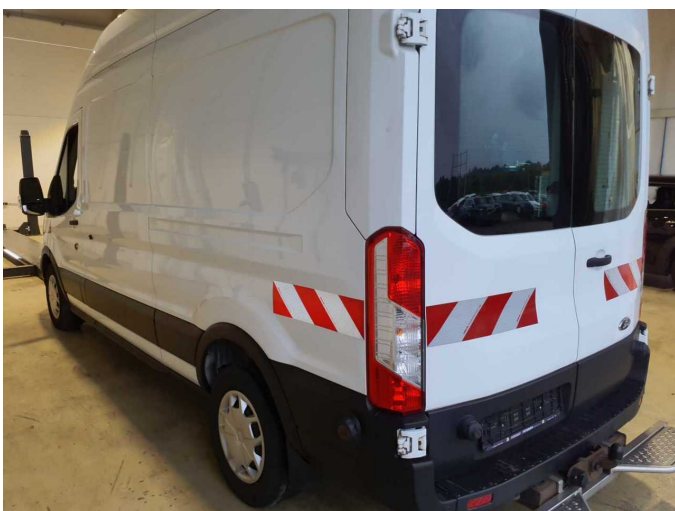
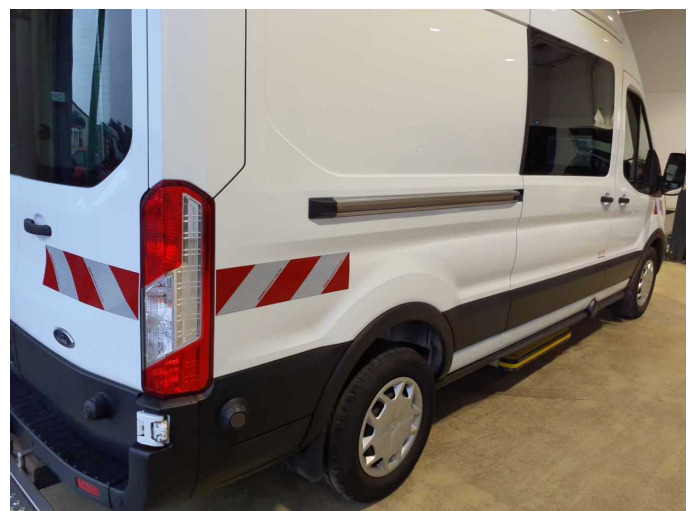
Damage 3: Body: Body - Glued / labelled - De-glue / neutralise

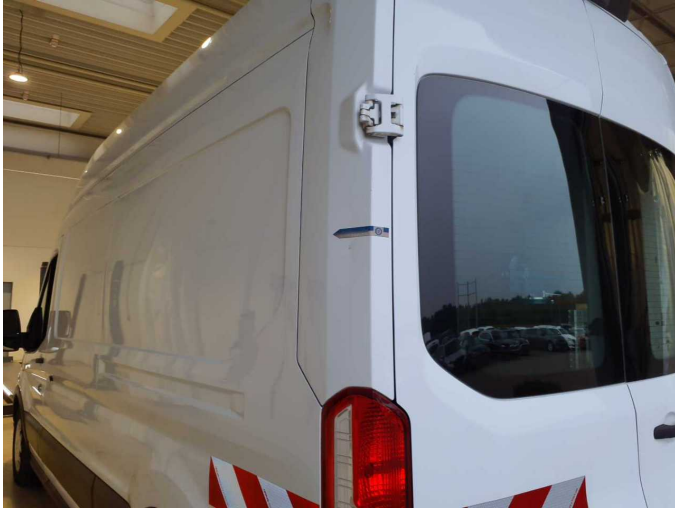
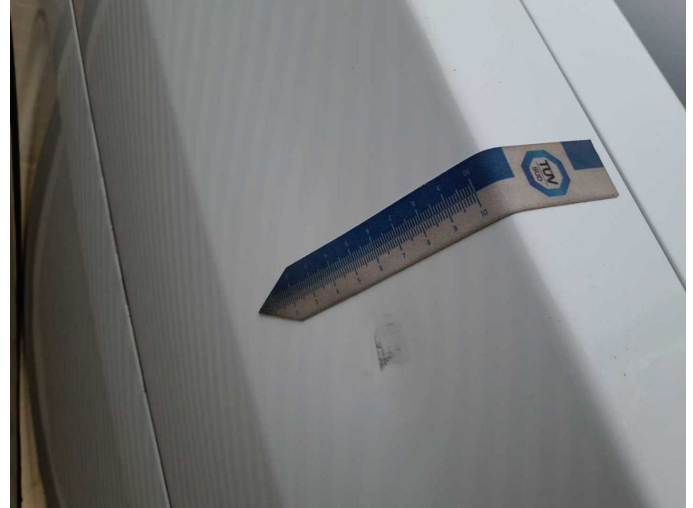
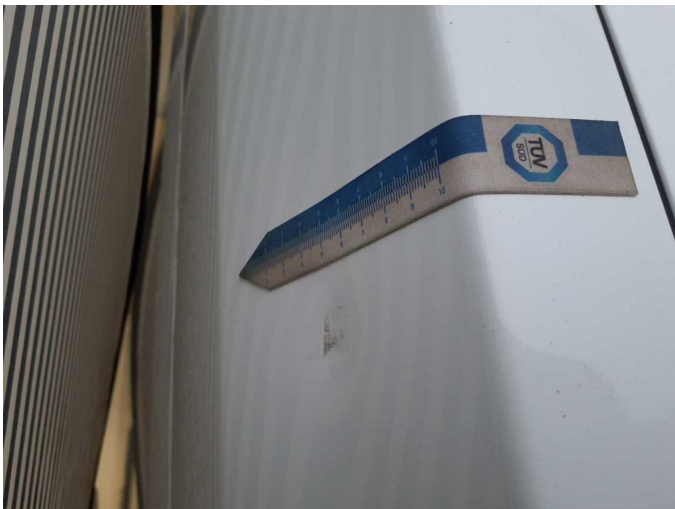
Damage 4: Side panel - rear left side: Side panel (Heckecke li.) - Dent / paintcoat damage - Smart repair

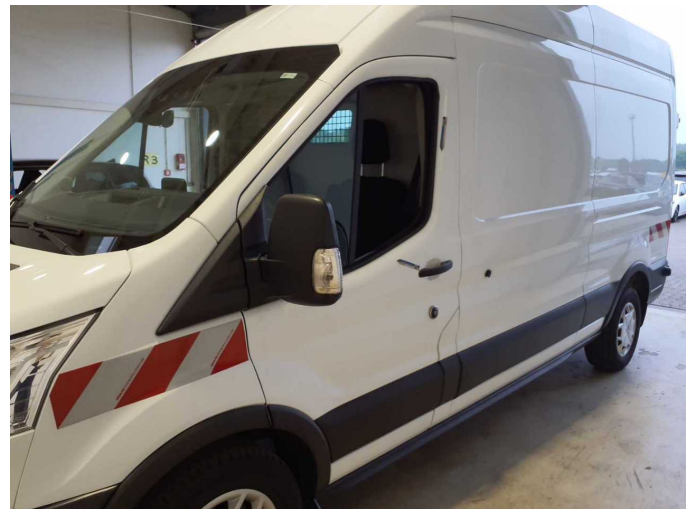
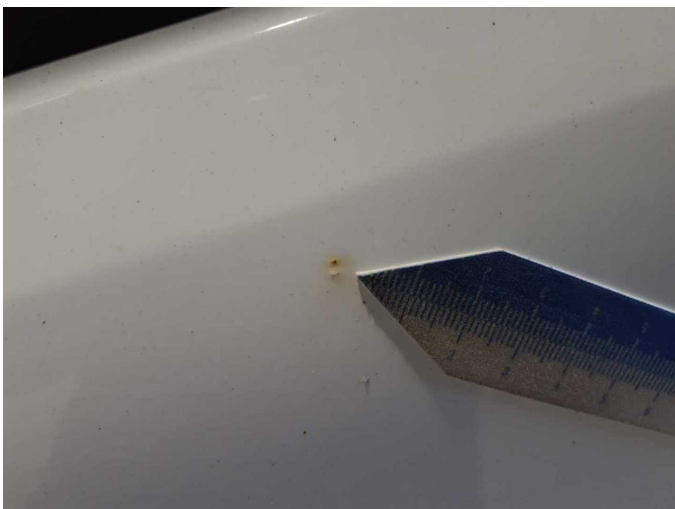
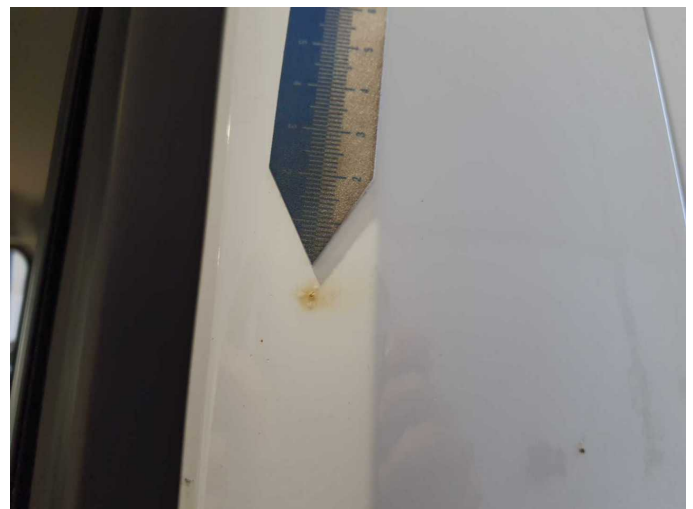
Damage 5: Door - front left side: Door - Corrosion - Smart repair

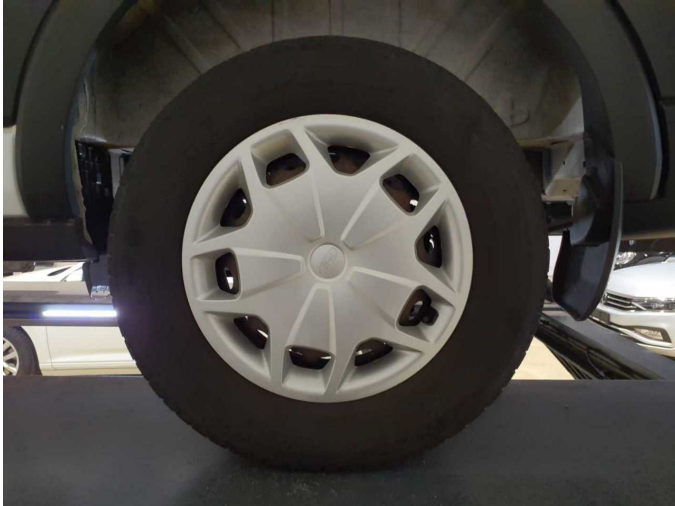
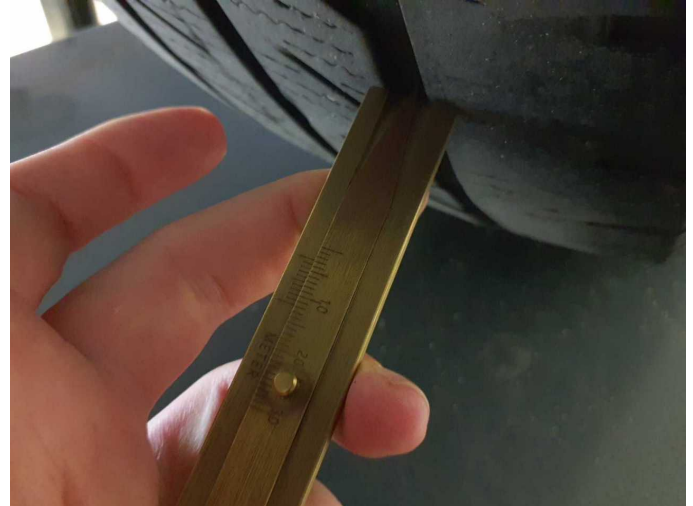
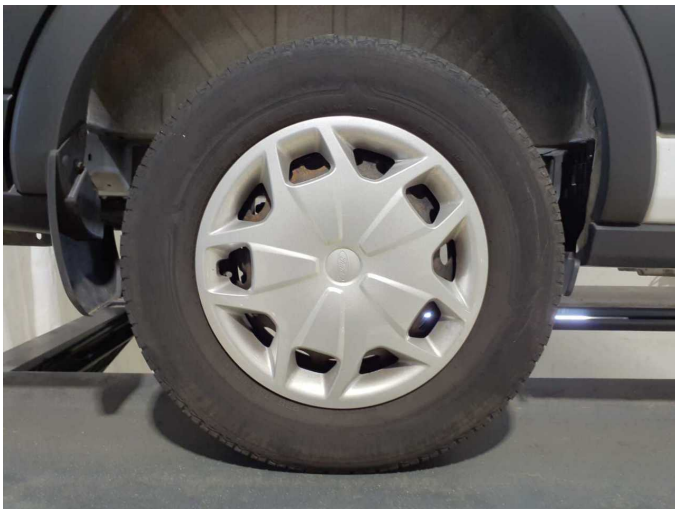
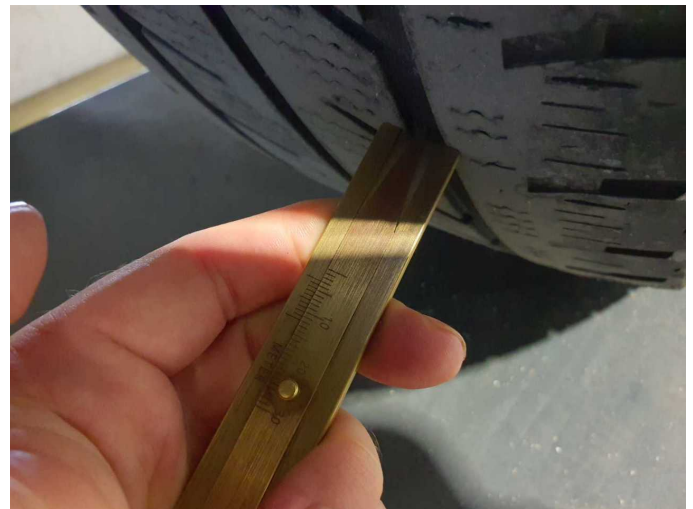
Damage 6: Wheel / tyres: Tyre - right - Does not meet the leasing specifications - Replace

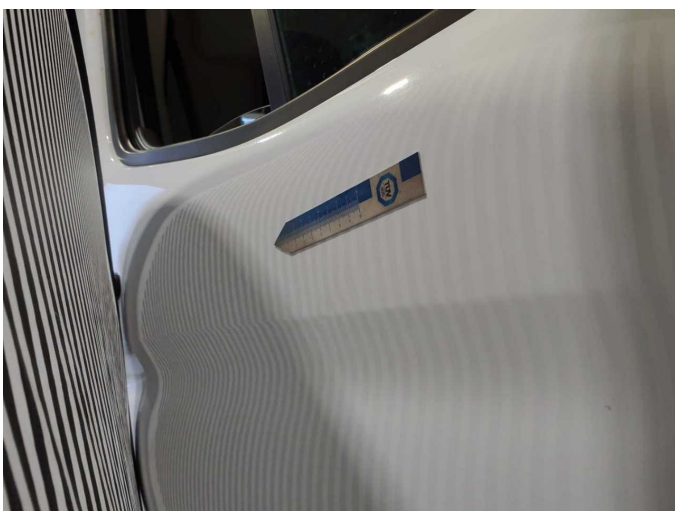
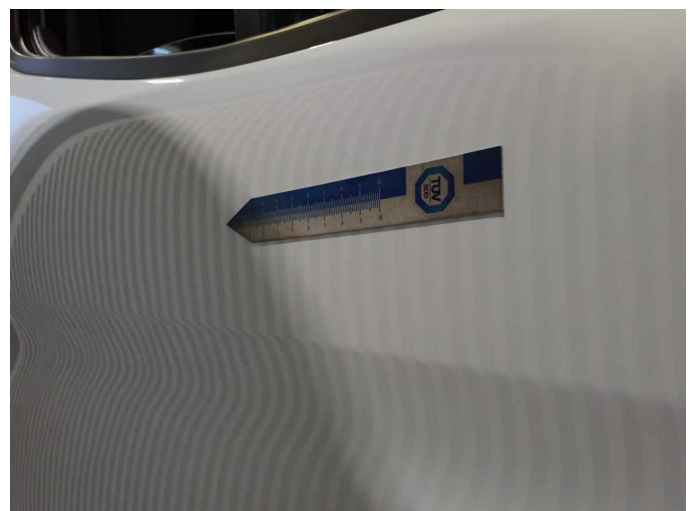
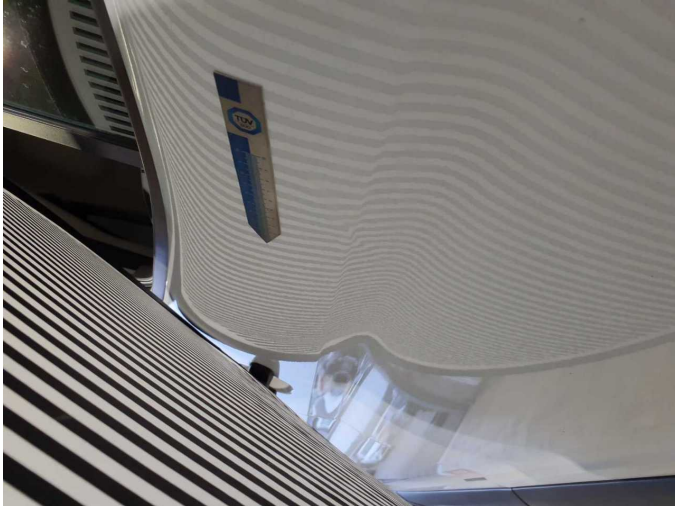
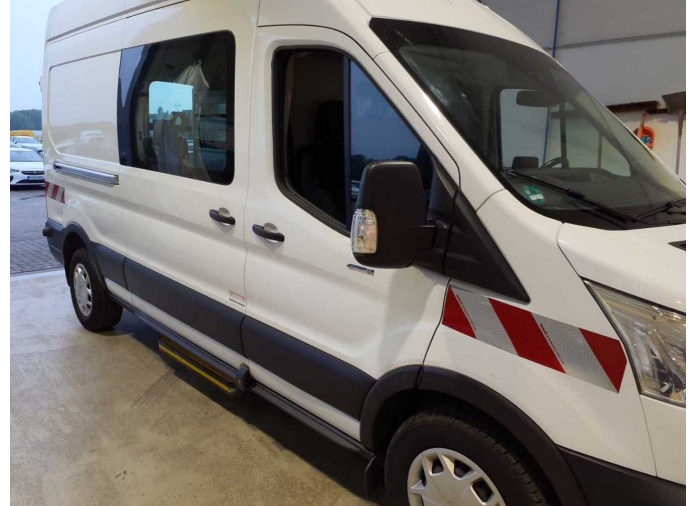
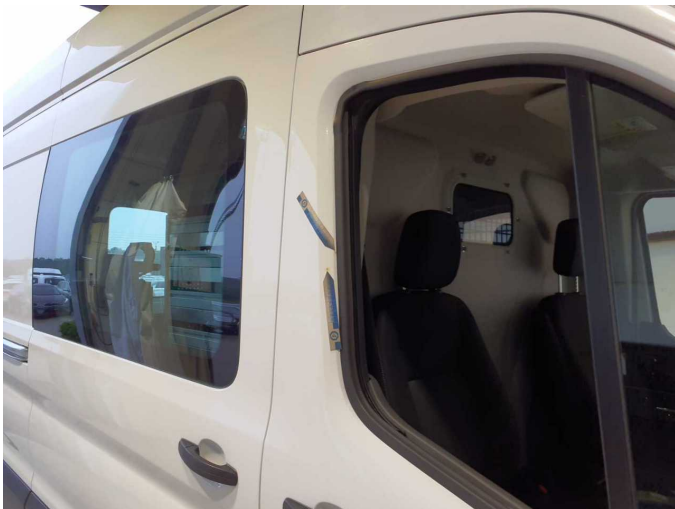
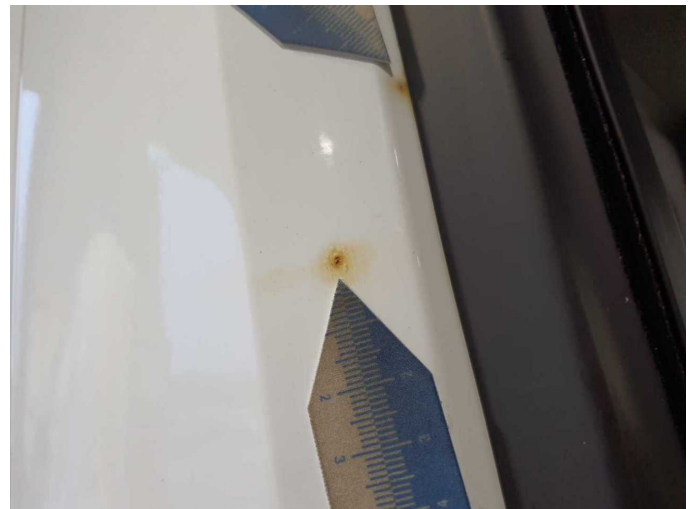
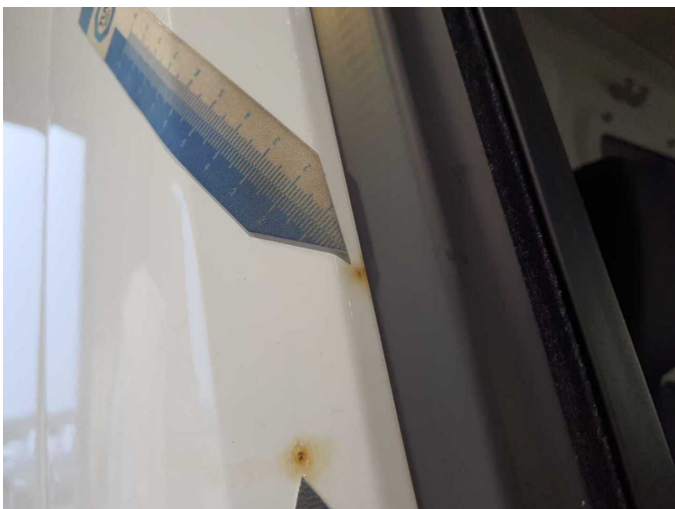
Damage 7: Door - front right side: Door - Corrosion - Repair and paint

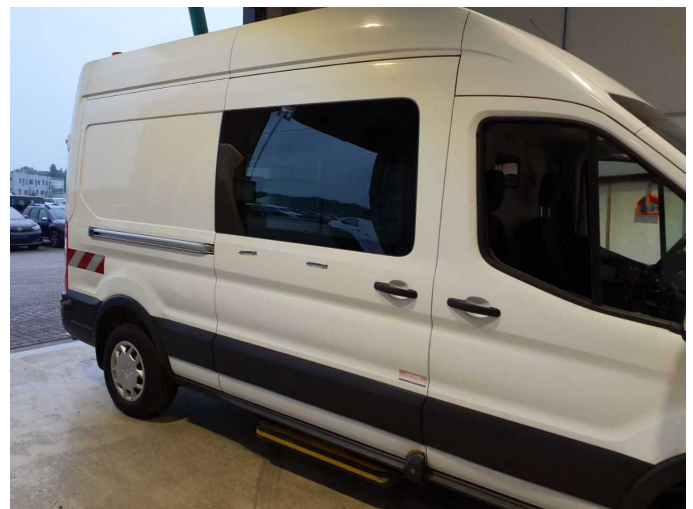
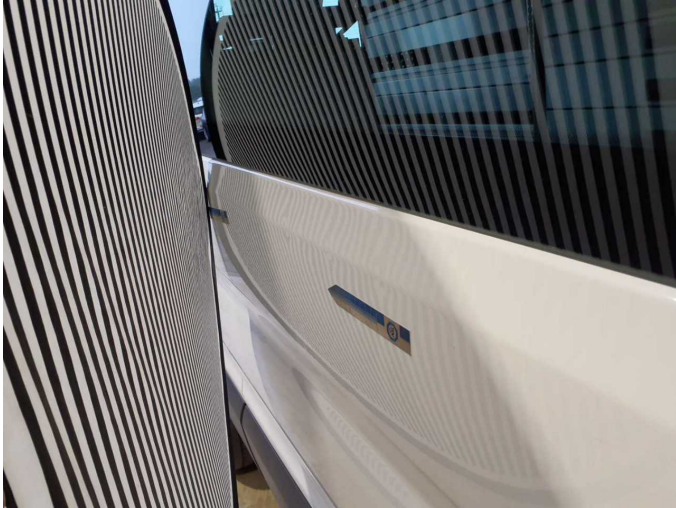
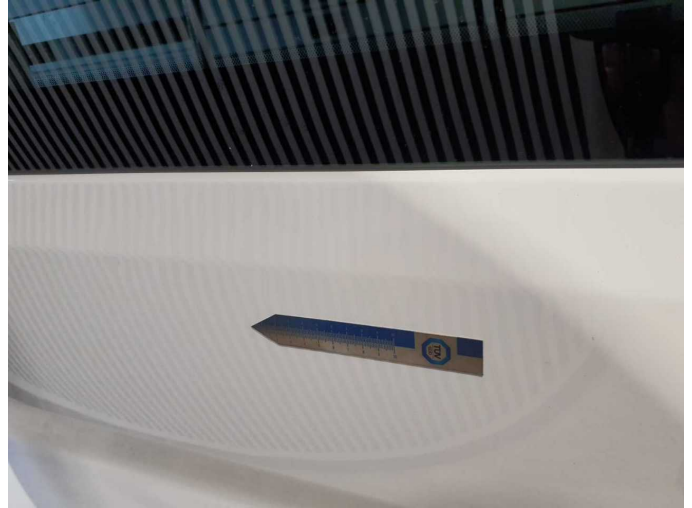
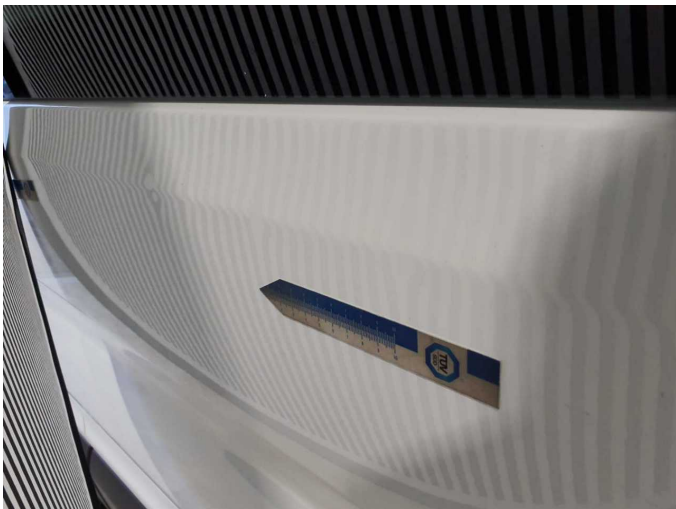
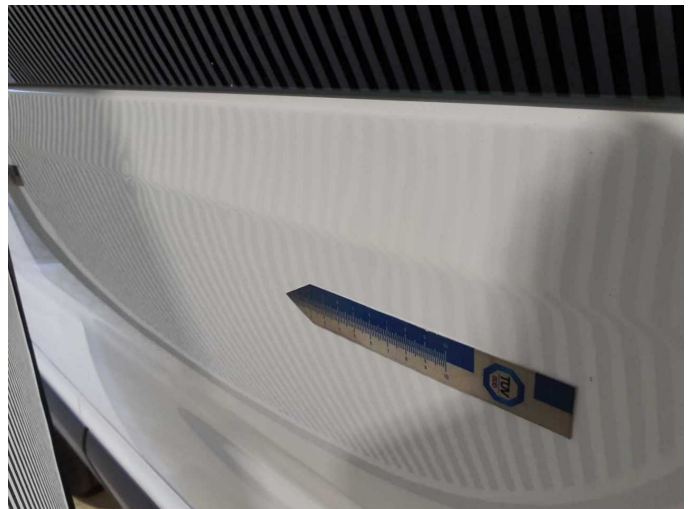
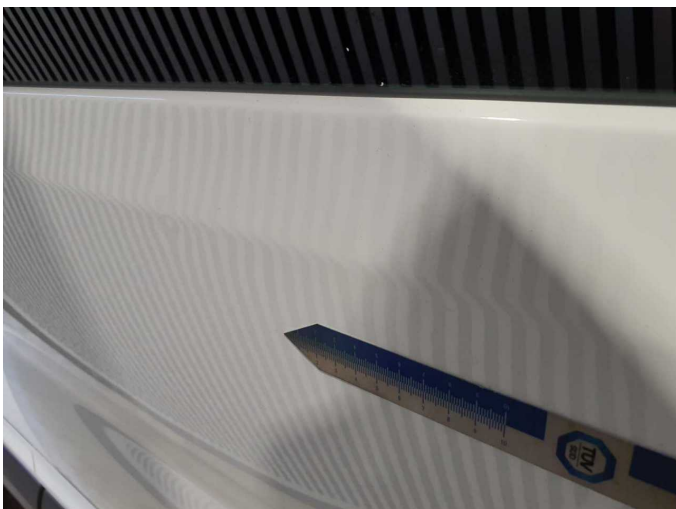
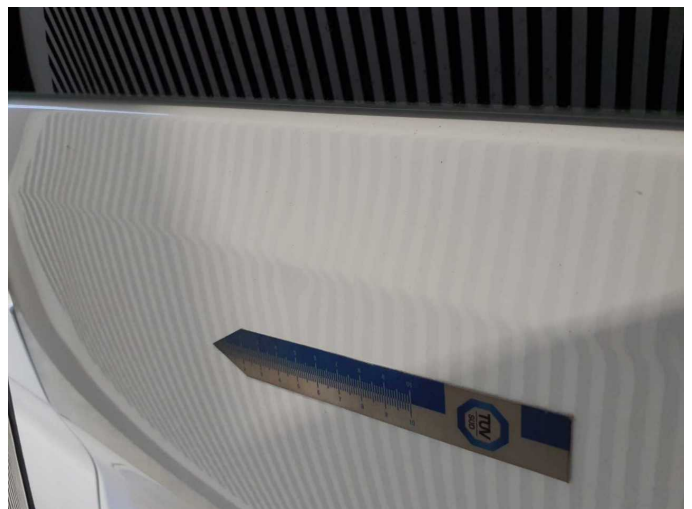
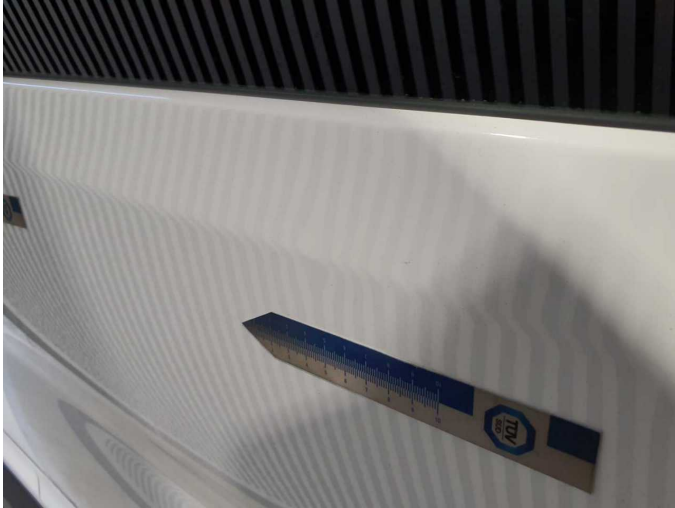
Damage 8: Sliding door, right: Sliding door - Deformed - Repair and paint

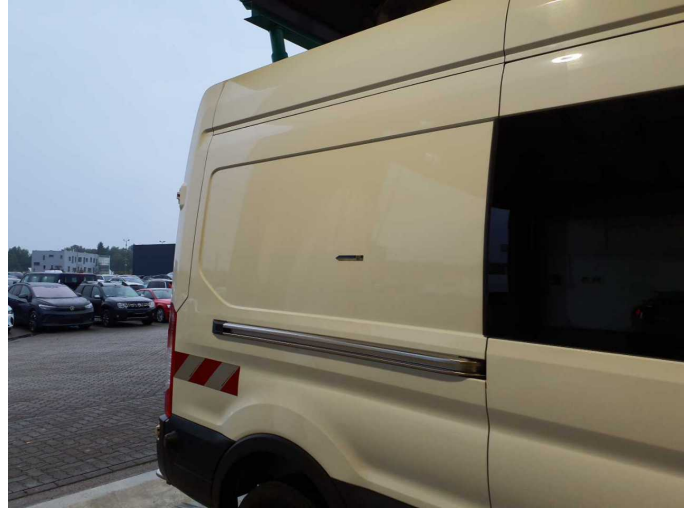
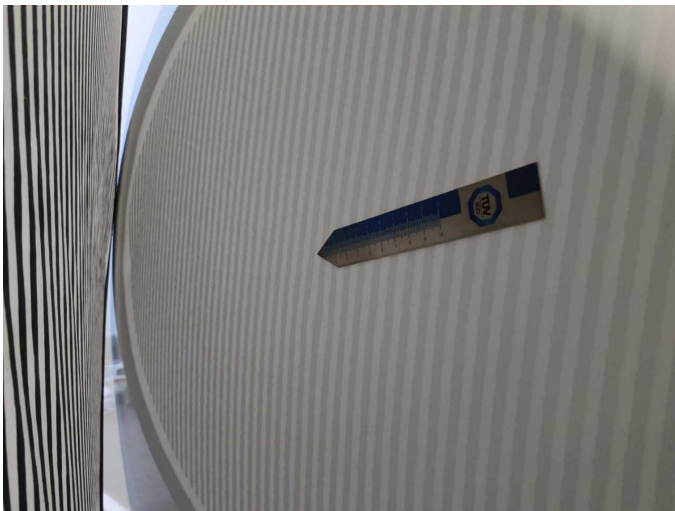
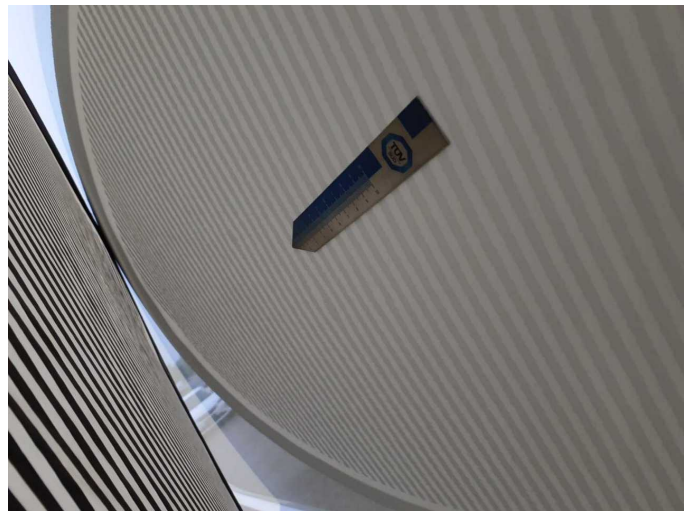
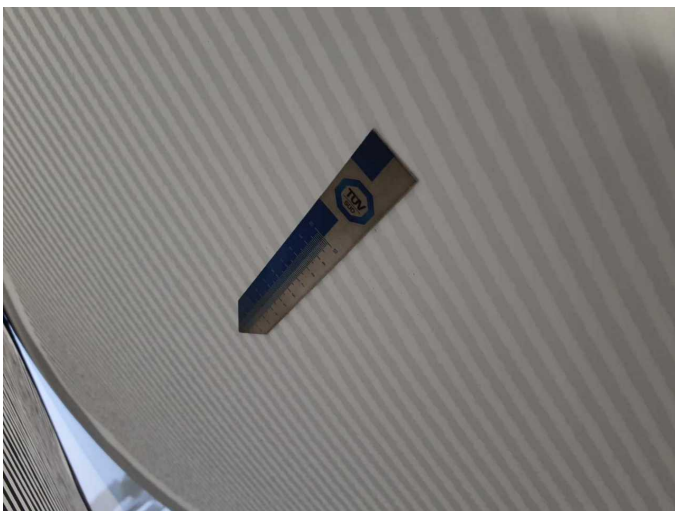
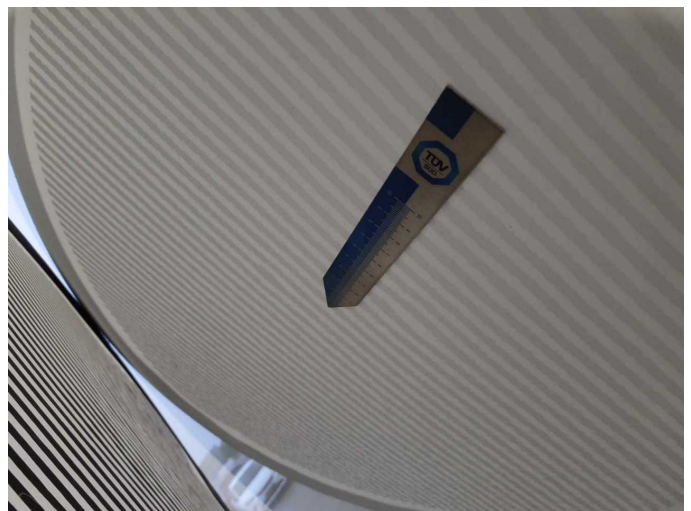
Wear and tear 7: Side panel - rear right side: Side panel - dent(s) - Smooth repair work
