# Peugeot 308 SW '21

Make:	<b>Peugeot</b>	License:	
Gearbox:	<b>Automatic</b>	Body color:	
Model:	<b>308 SW '21</b>	VIN:	<b>VR3F4DGXTNY654828</b>
Fuel type:	<b>Plug-in hybrid</b>	Power:	<b>133 kW</b>
Version:	<b>308 SW PHEV 180 All.P.Bus.Aut</b>	First registration	<b>23/02/2023</b>
Mileage:	<b>110788 km</b>	N° of doors:

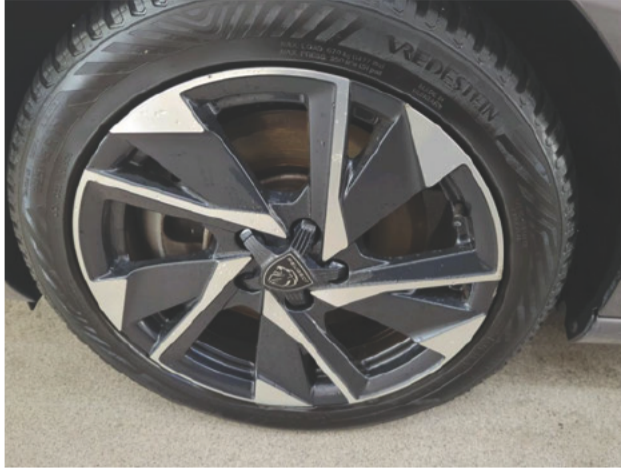
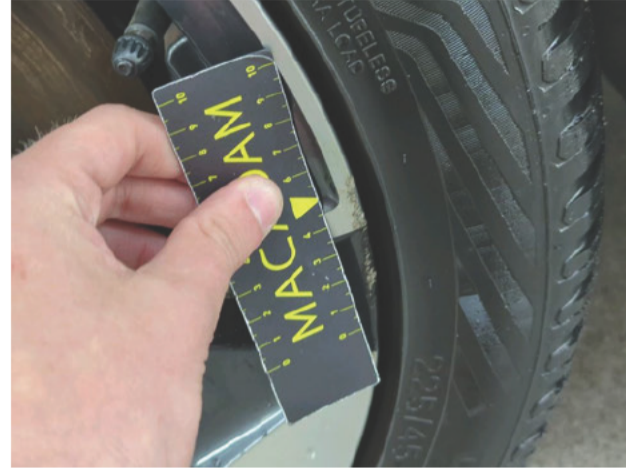
### Alloy rim FL

Scratch(es)  
Repair and paint (complete)  
Left

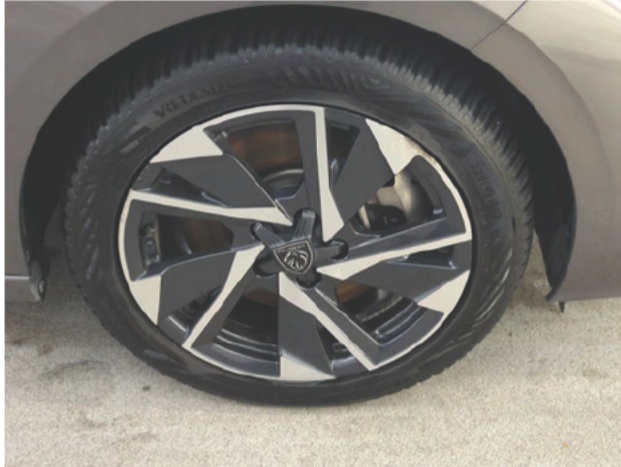
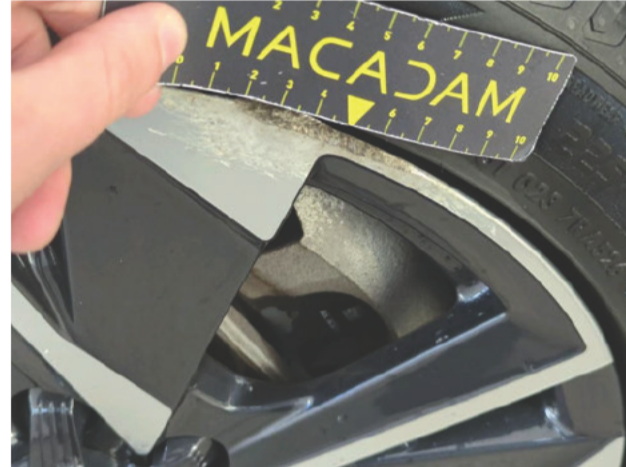
### Alloy rim FR

Scratch(es)  
Repair and paint (complete)  
Right

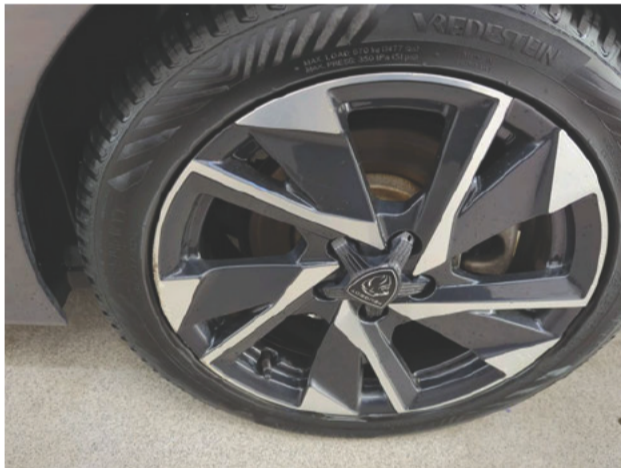
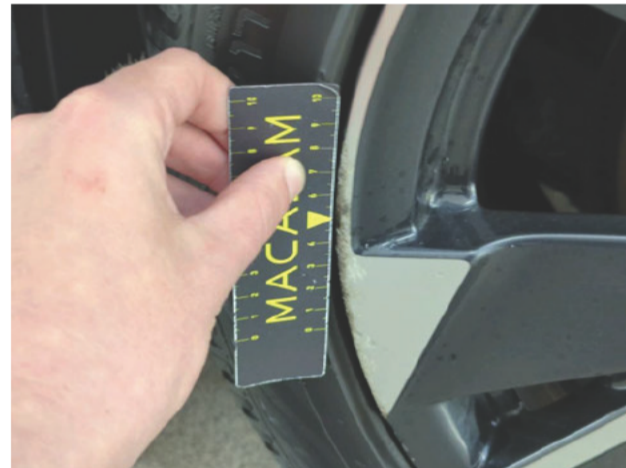
### Alloy rim RL

Scratch(es)  
Repair and paint (complete)  
Left

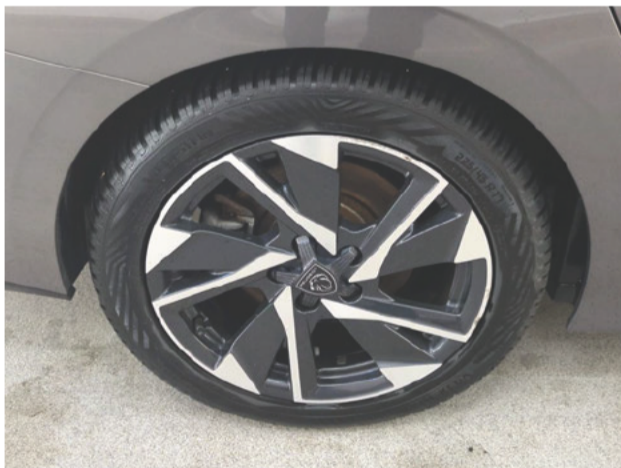
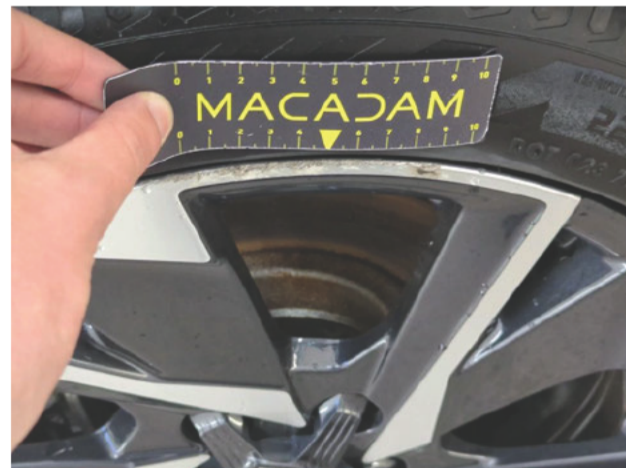
### Alloy rim RR

Scratch(es)  
Repair and paint (complete)  
Right

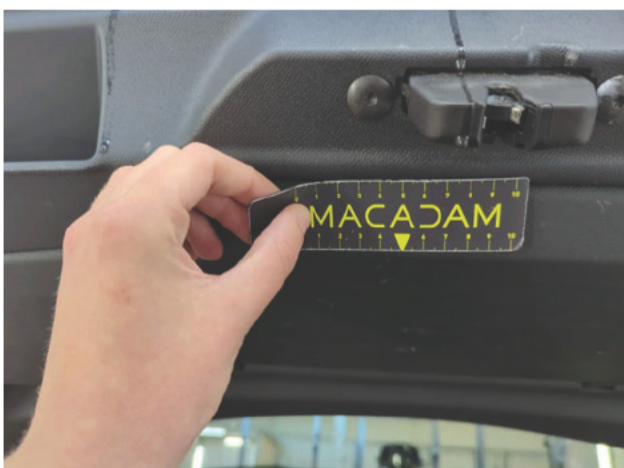
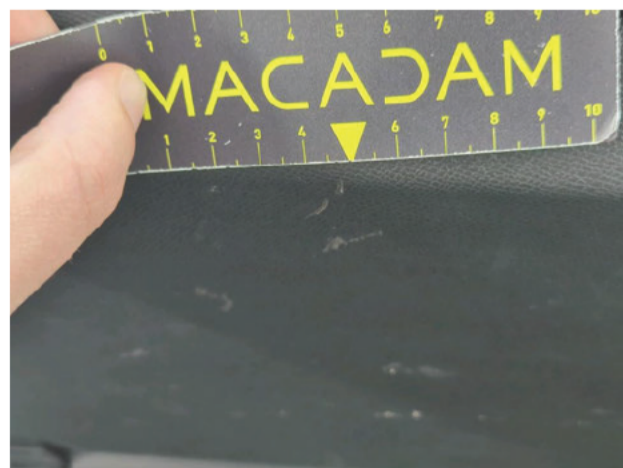
### Boot lid covering R

Scratch(es)  
Smart repair  
Rear

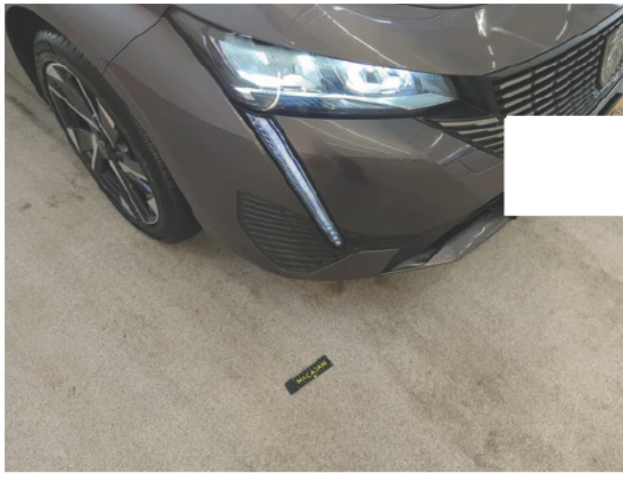
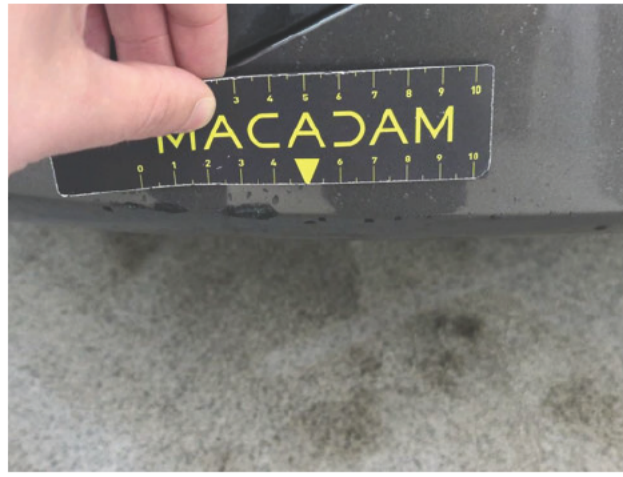
**Bumper F**

Scratch(es)  
Repair and paint (complete)  
Front

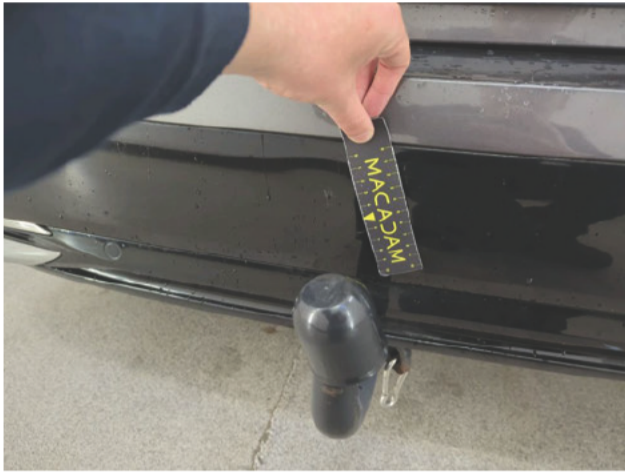
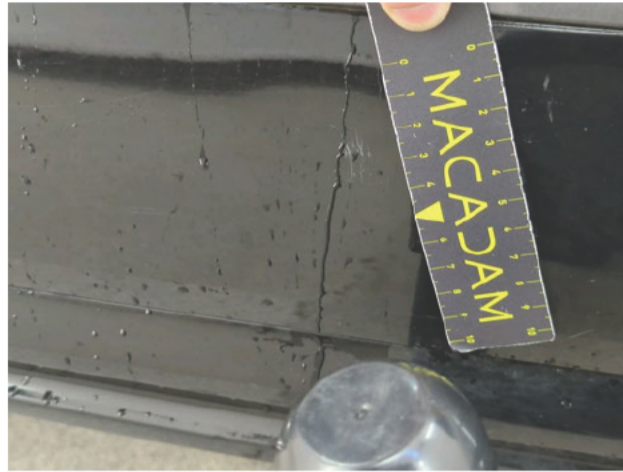
**Bumper moulding R**

Scratch(es)  
Replace and paint  
Rear

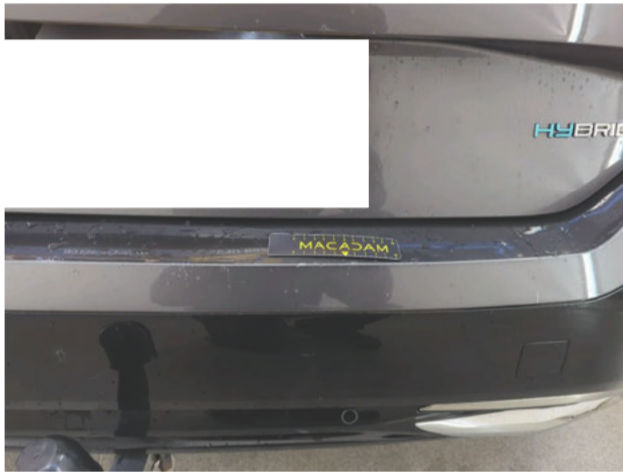
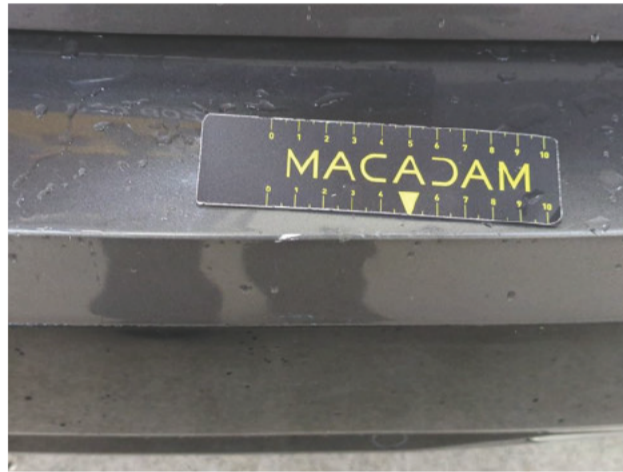
**Bumper R**

Scratch(es)  
Repair and paint (complete)  
Rear

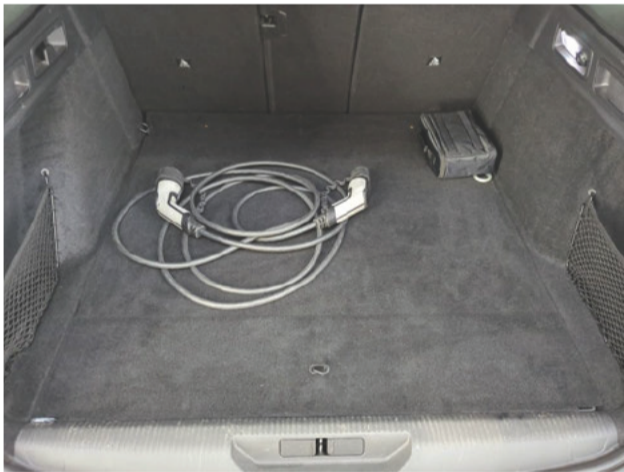
**Charging cable (normal)**

Missing  
Replace  
Rear

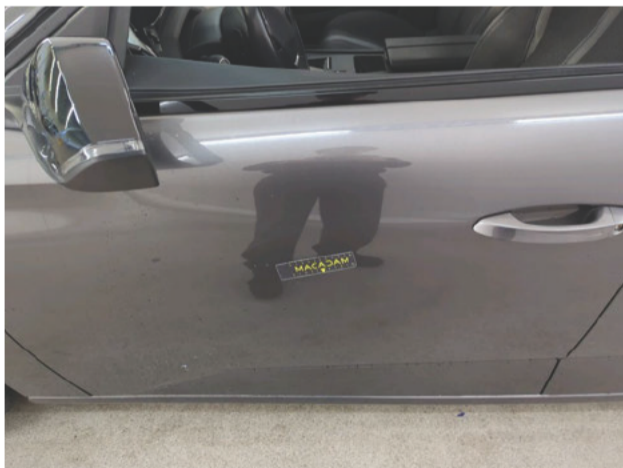
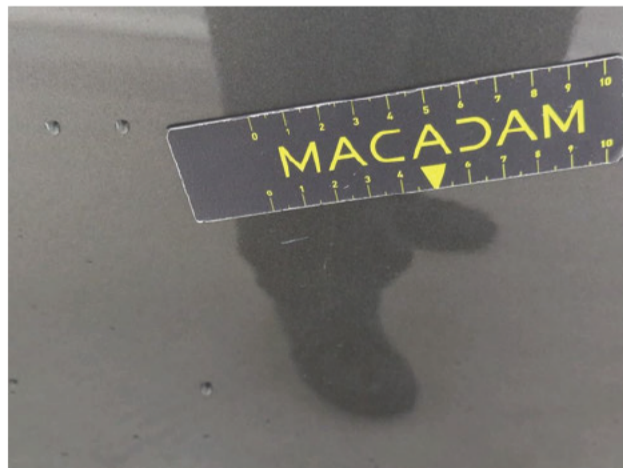
**Door FL**

Scratch(es)  
Repair and paint (complete)  
Left

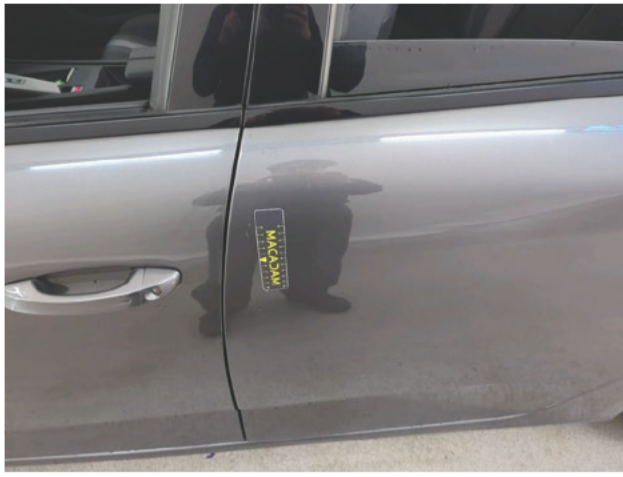
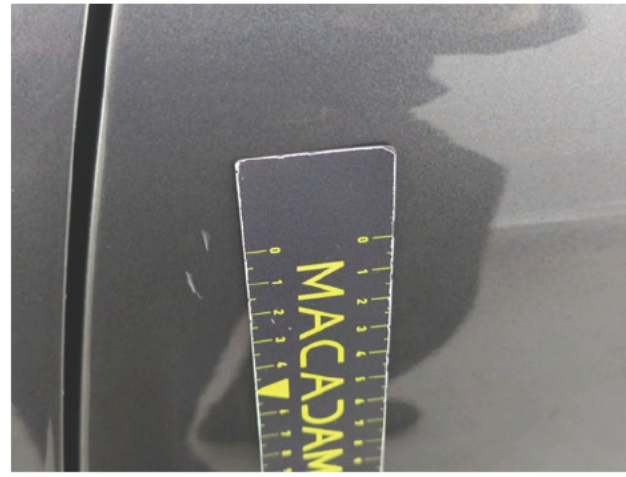
**Door RL**

Scratch(es)  
Repair and paint (complete)  
Left

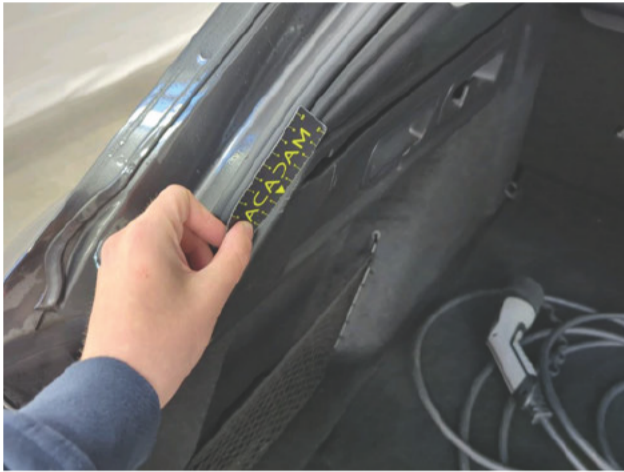
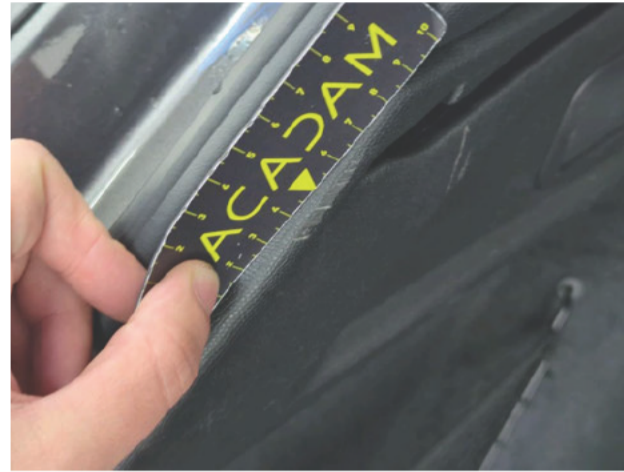
**Internal boot lining L**

Scratch(es)  
Smart repair  
Rear

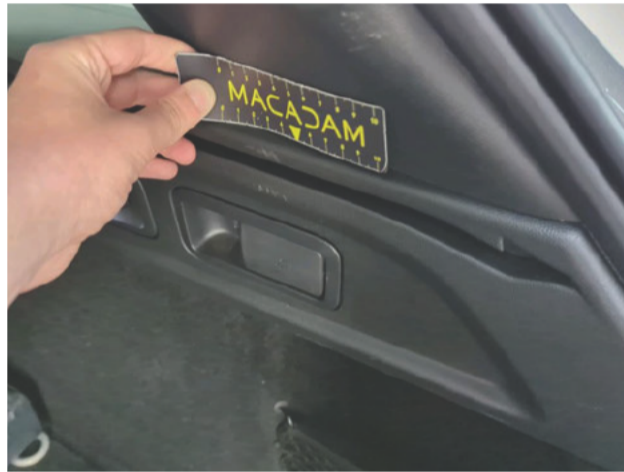
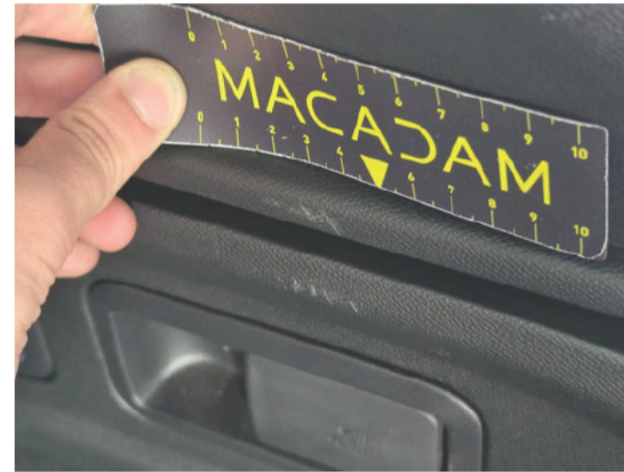
**Internal boot lining R**

Scratch(es)  
Smart repair  
Rear

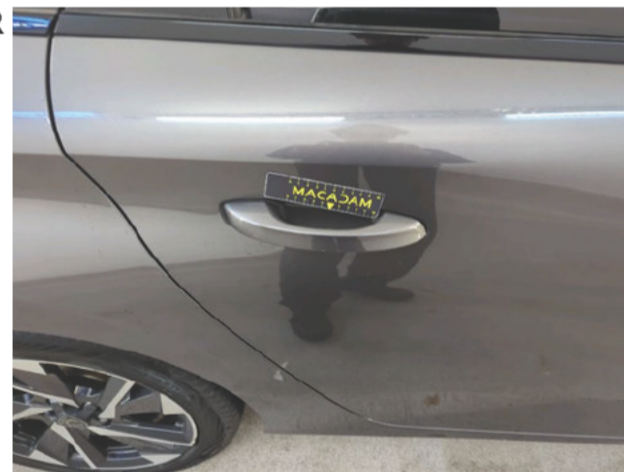
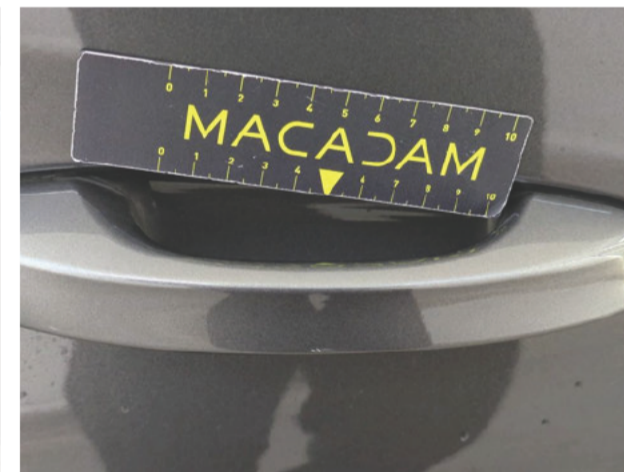
**Outer door handle RR**

Scratch(es)  
Replace and paint  
Right

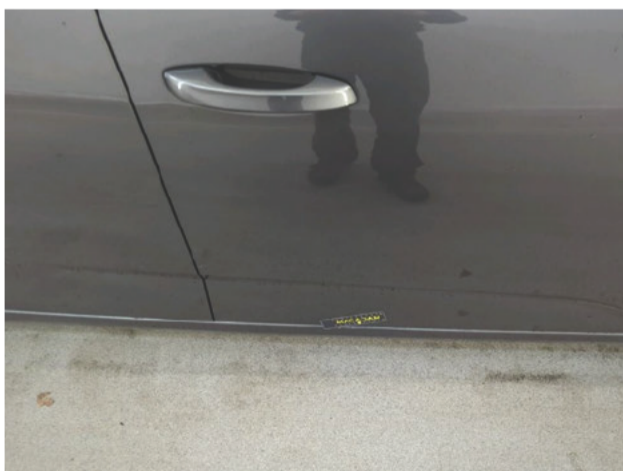
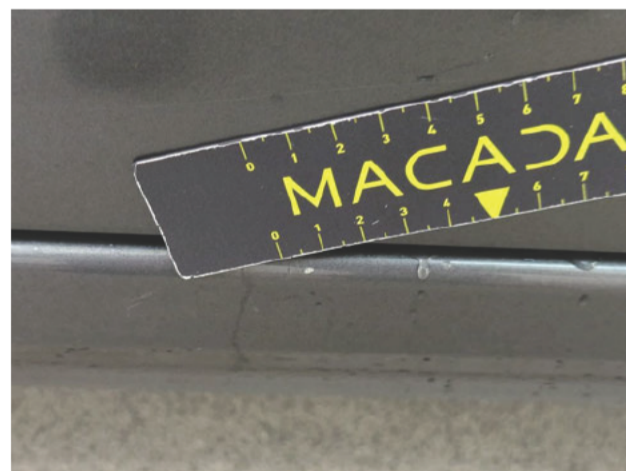
**Outer sill R**

Scratch(es)  
Repair and paint (complete)  
Right

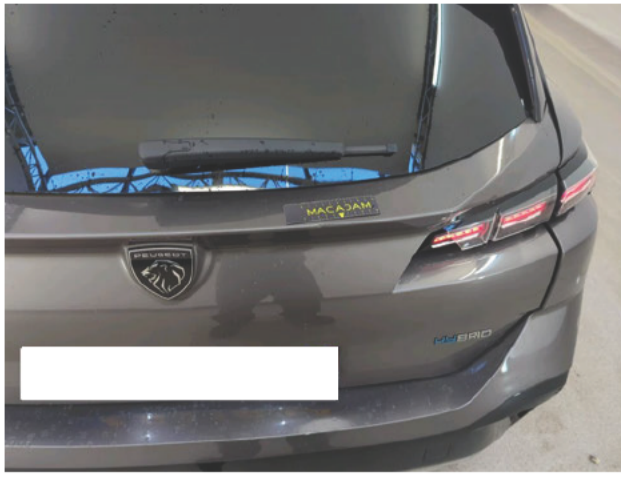
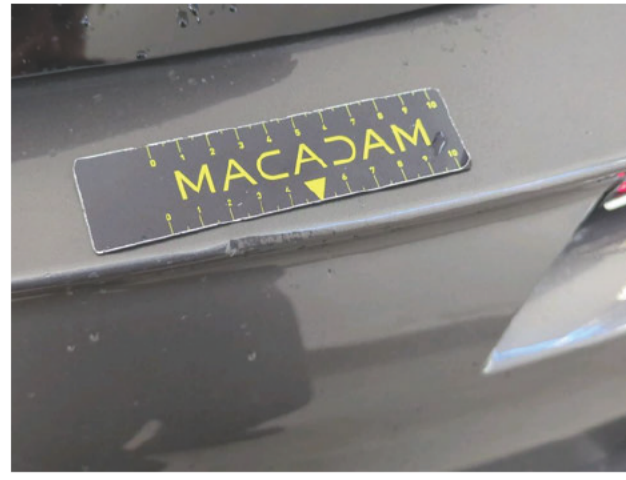
**Tailgate / Boot**

Deformed / Strained  
Repair and paint (complete)  
Rear

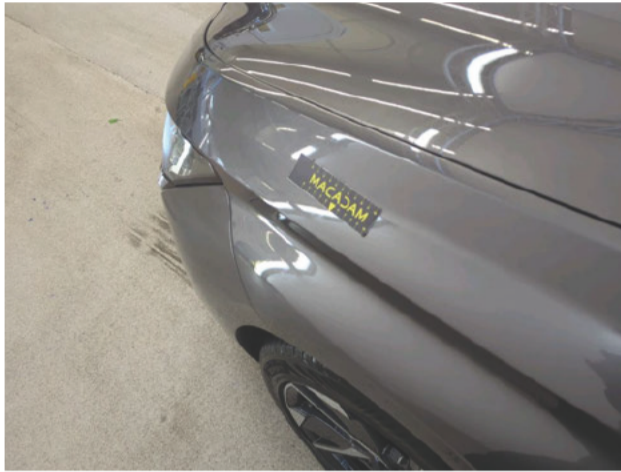
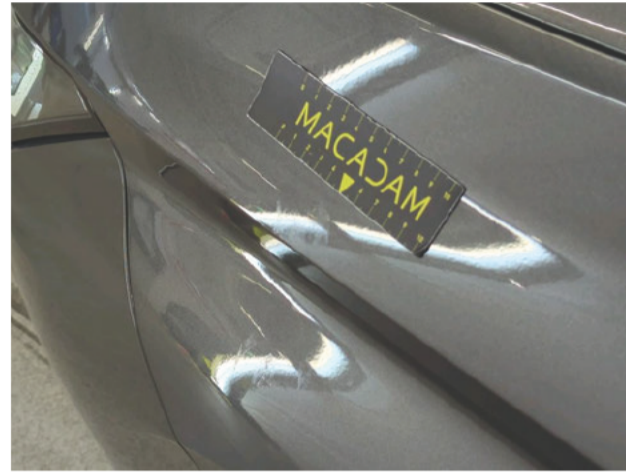
**Wing FL**

Chemical polution  
Repair and paint (complete)  
Left

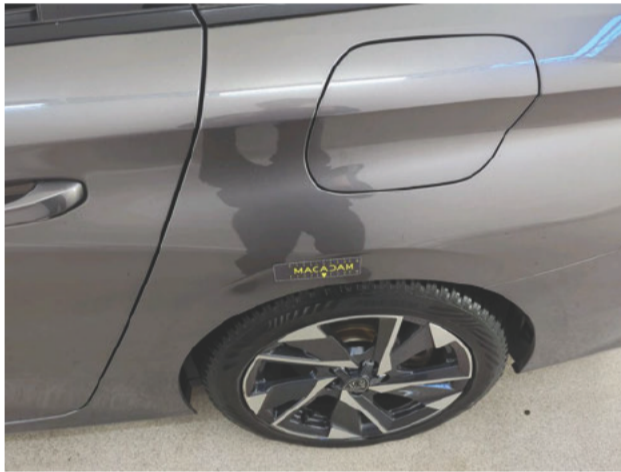
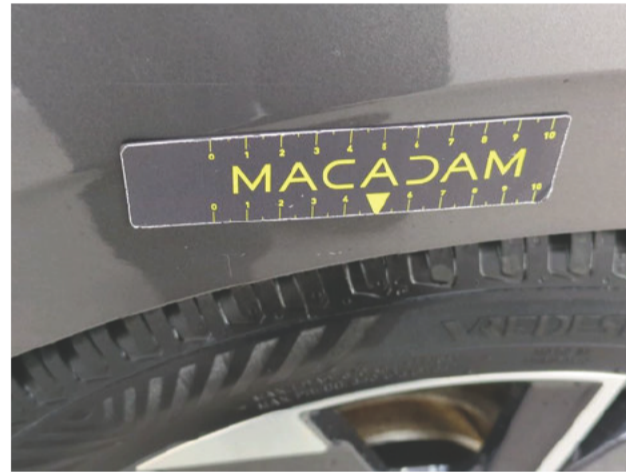
**Wing RL**

Scratch(es)  
Repair and paint (complete)  
Left

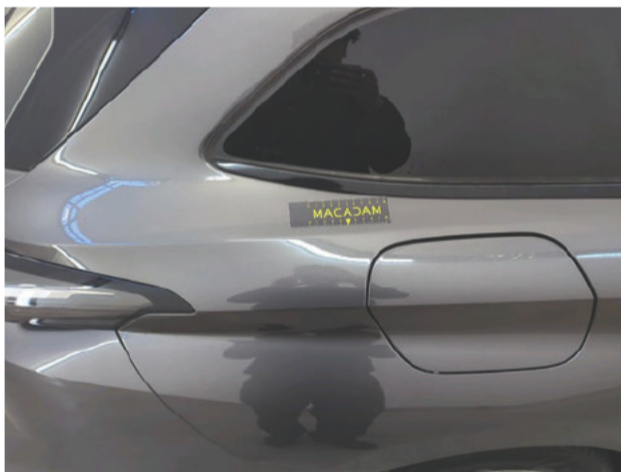
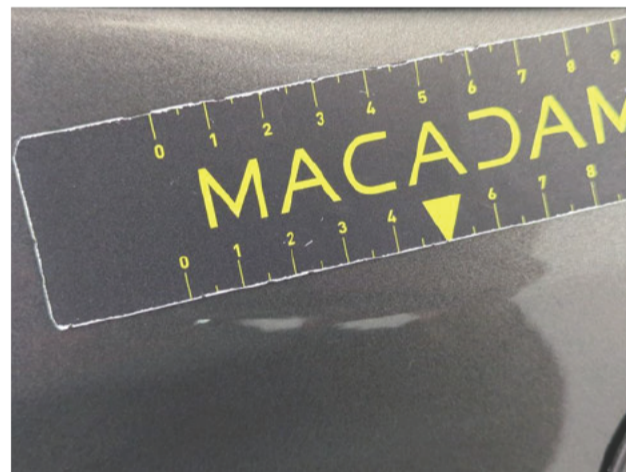
**Wing RR**

Scratch(es)  
Repair and paint (complete)  
Right
