## » Overview

**Order number:** 1002401636  
**Order completed:** 05.05.2026 14:34  
**Report number:** 10551416  
**VIN:** TMBER6NW9P3110209

## » Vehicle Data

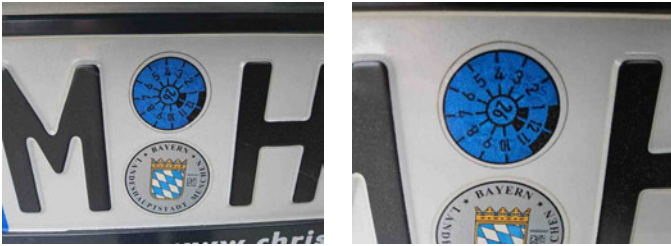
6 - MOT certificate - Expired - Renew

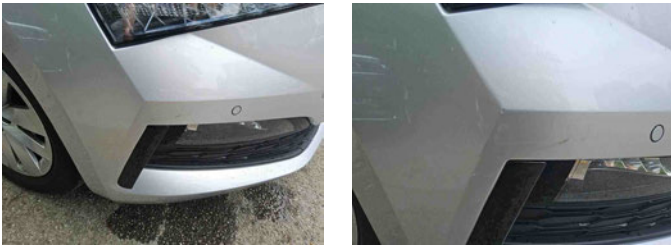
7 - Bumper FR - Scratch(es) - Smart repair

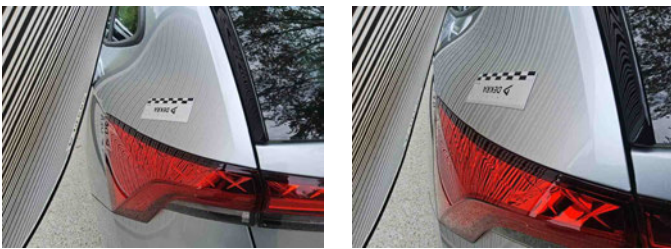
8 - Side wall RL - Dent(s) - Paintless dent repair

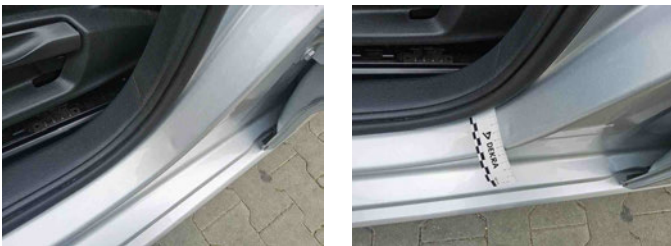
9 - Inner door sill FL - Dent(s) - Paintless dent repair

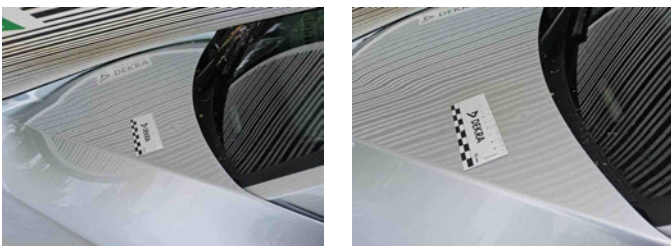
10 - Bonnet - Dent(s) - Paintless dent repair
