Expertise

Protocol number: 46434067  
Order No. / Reference: 26709914  
Inspection date: 8 Jul 2026

Manufacturer: Hyundai

Model: TUCSON 1.6 T-GDi Plug-in-Hybrid 4WD

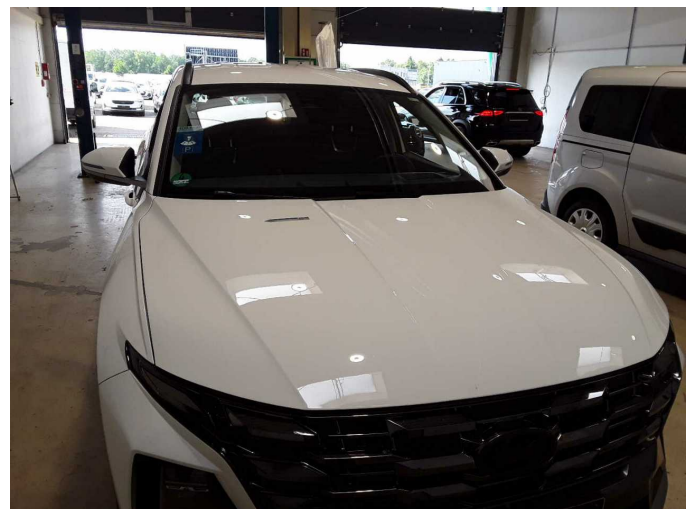
| No. | Component group | Description |
|---|---|---|
| 2 | Bonnet | Bonnet - dent(s) - Smooth repair work |

Damage 2: Bonnet: Bonnet - dent(s) - Smooth repair work

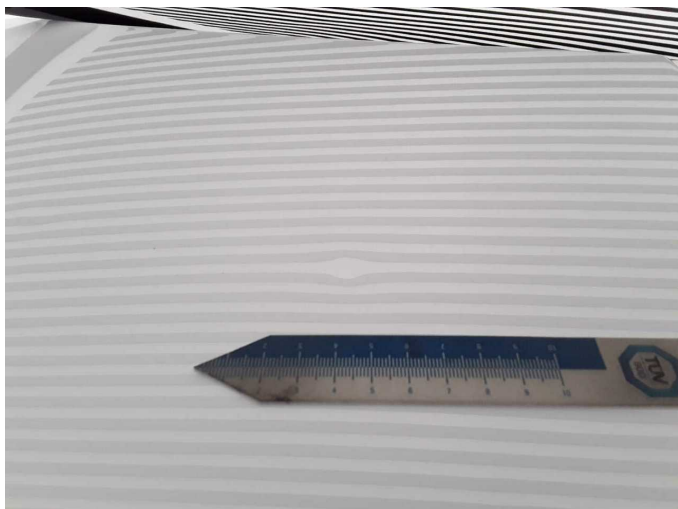
**Damage 2:** Bonnet: Bonnet - dent(s) - Smooth repair work

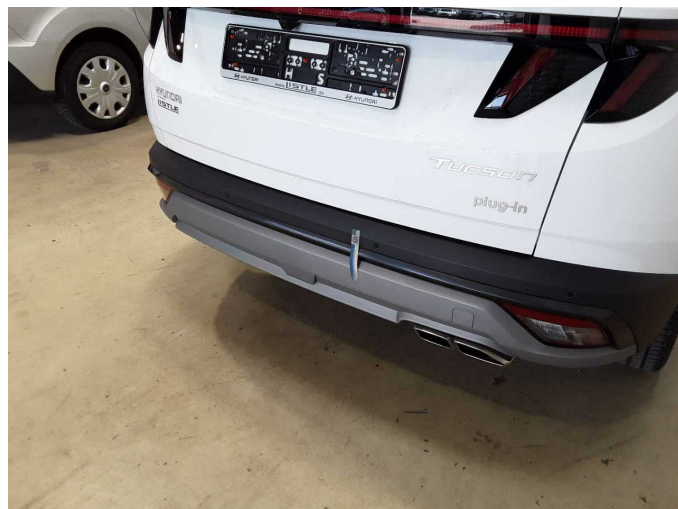
| No. | Component group | Description |
|---|---|---|
| 3 | Rear bumper | Spoiler - Scratch(es) - Replace |

**Damage 3:** Rear bumper: Spoiler - Scratch(es) - Replace

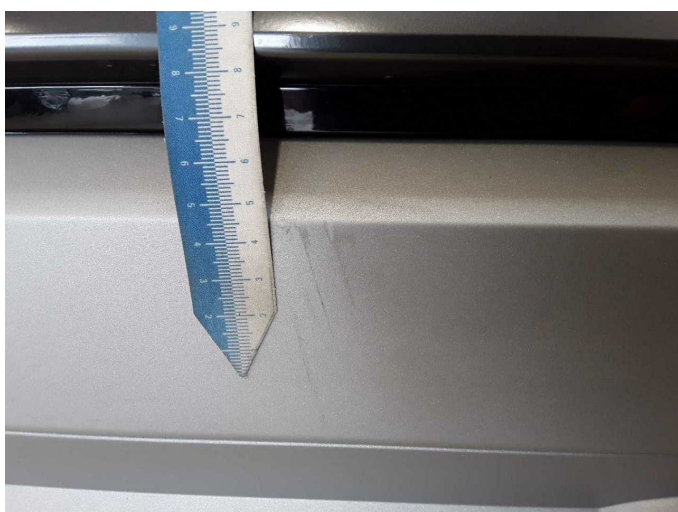
**Damage 3:** Rear bumper: Spoiler - Scratch(es) - Replace

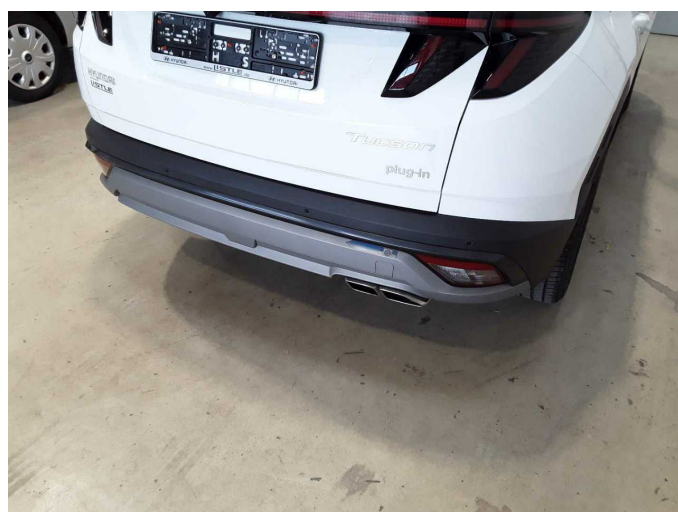
| No. | Component group | Description |
|---|---|---|
| 4 | Rear bumper | Protection strip - centre - Scratched - Replace |

**Damage 4:** Rear bumper: Protection strip - centre - Scratched - Replace

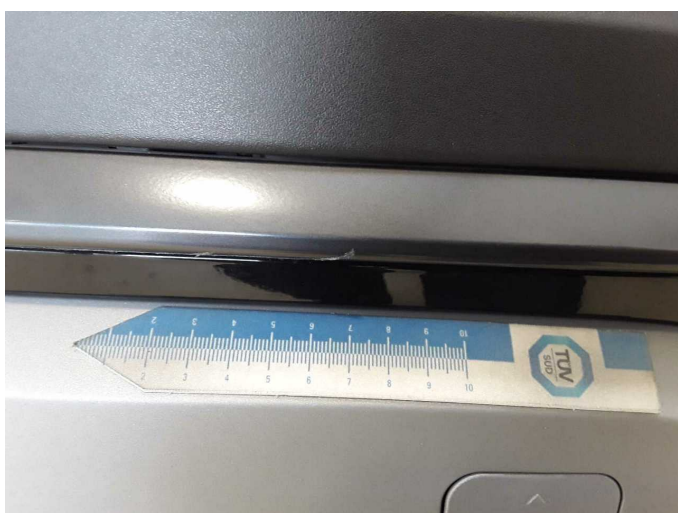
**Damage 4:** Rear bumper: Protection strip - centre - Scratched - Replace

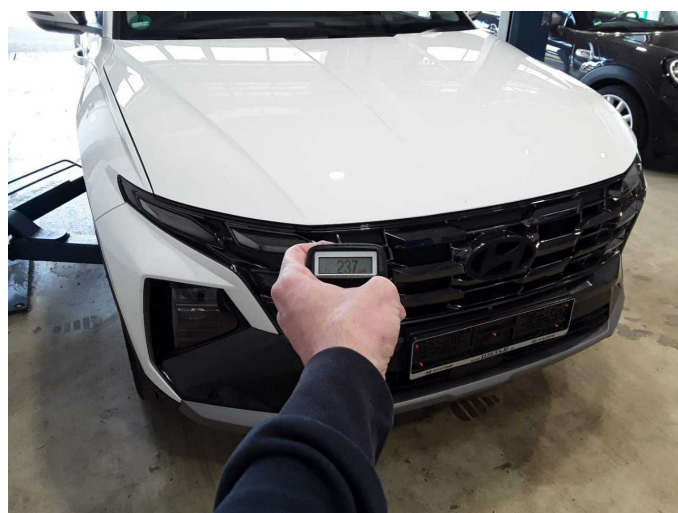
**Repainting 1:** Bonnet

| 1 | Bonnet, Professionally carried out, Invoice of repair done Non-existent |

| Bonnet | 237 µm |
