Expertise

Protocol number: 44028556
Order number / reference: 25858437
Inspection date: 20 Feb 2026

Model: Vito 116 CDI Extralang HA Aut. PRO

VIN: W1VVLCEZ6T4566515

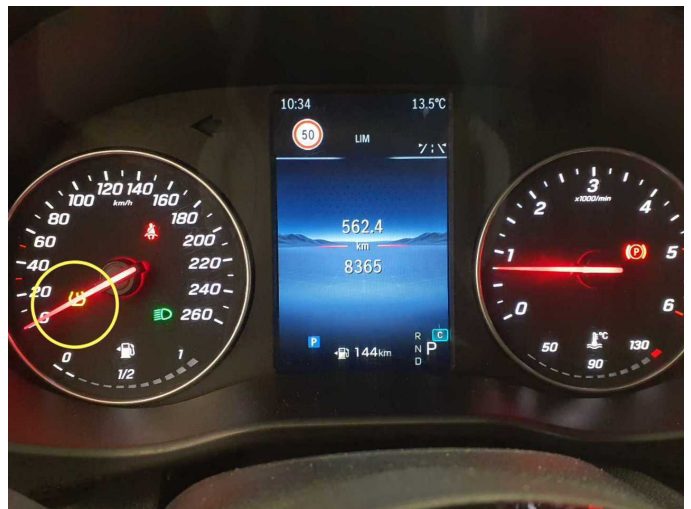
No.	Component group	Description
1	Instrument panel	Indicator light (Reifendruckkontrollsystem) - on - Perform diagnosis
2	Door - front left side	Door edge - Scratch(es) - Smart repair
3	Rear bumper	Rear bumper - Scratch(es) - Smart repair

Damage 1: Instrument panel: Indicator light (Reifendruckkontrollsystem) - on - Perform diagnosis

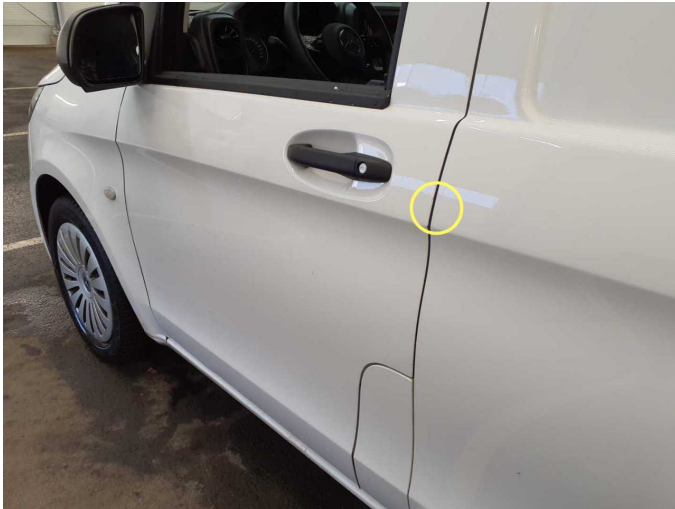
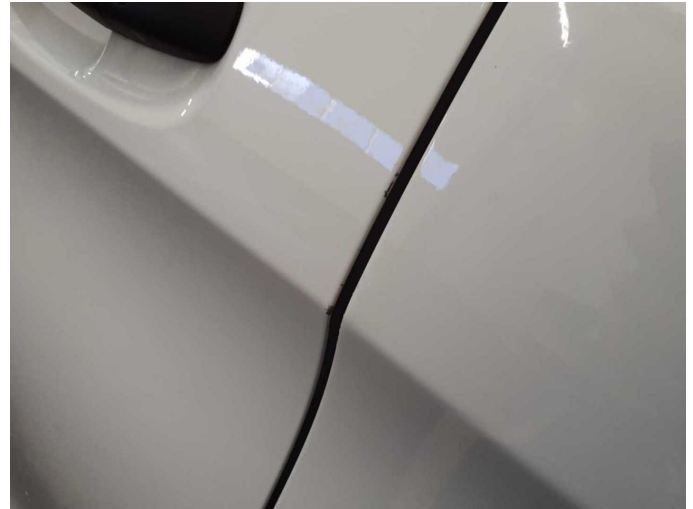
Damage 2: Door - front left side: Door edge - Scratch(es) - Smart repair

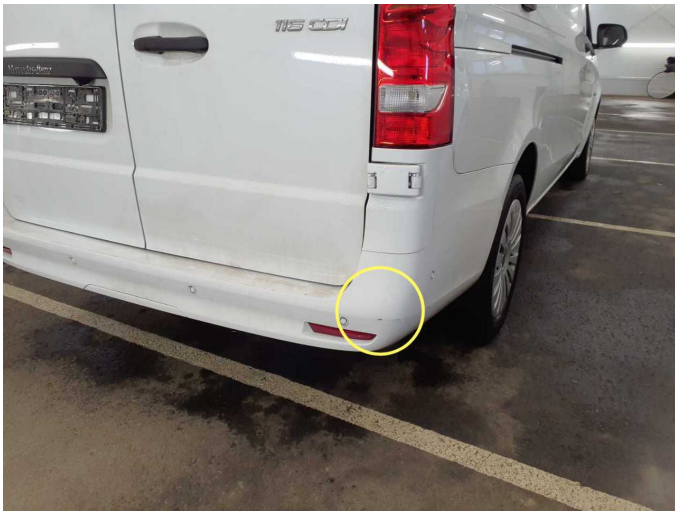
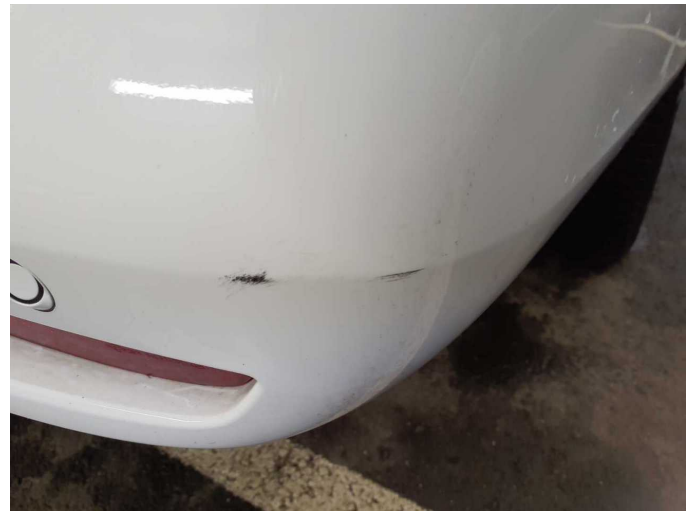
Damage 3: Rear bumper: Rear bumper - Scratch(es) - Smart repair
