Expertise

Protocol number: 46654839  
Order No. / Reference: 26660791  
Inspection date: 22 Jul 2026

Manufacturer: Opel

Model: Vivaro 1.5 D Cargo M Edition

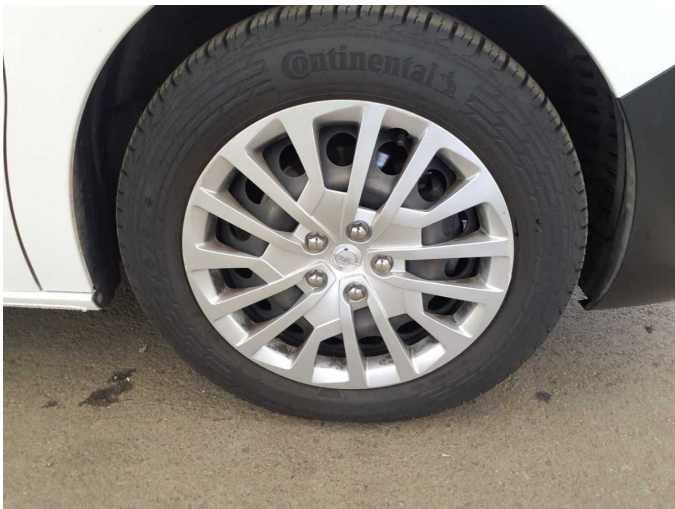
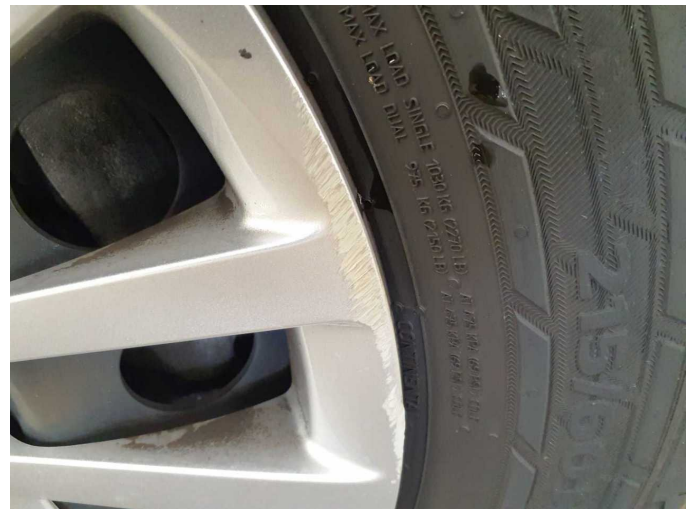
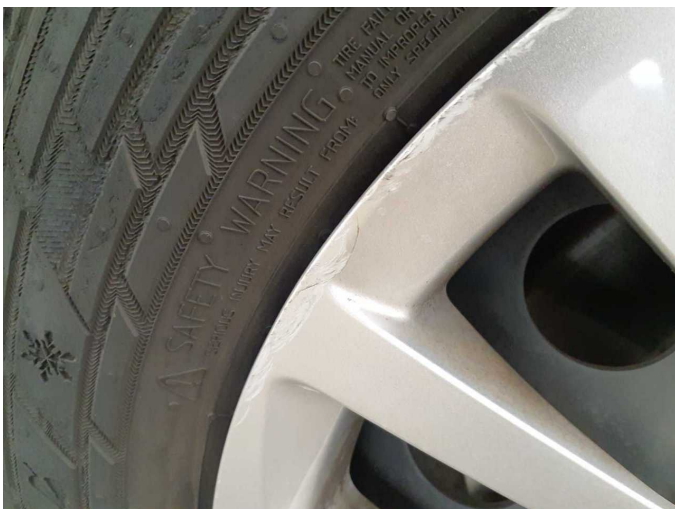
| No. | Component group | Description |
|---|---|---|
| 1 | Wheel / tyres | Wheel cover - front right side - Scratched - Replace |

**Damage 1:** Wheel / tyres: Wheel cover - front right side - Scratched - Replace

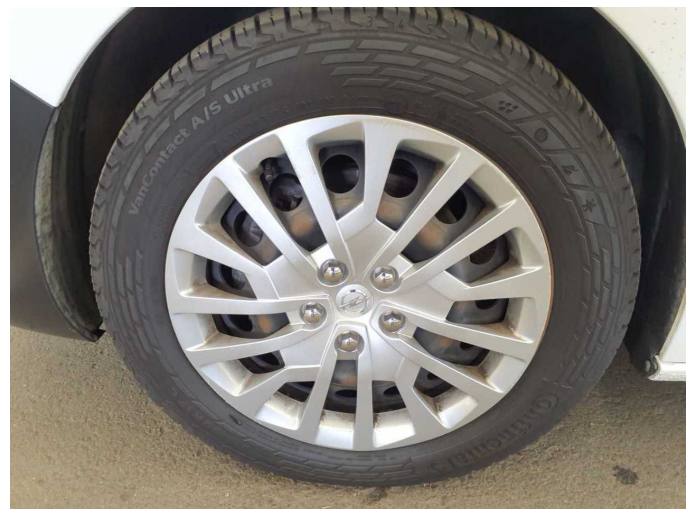
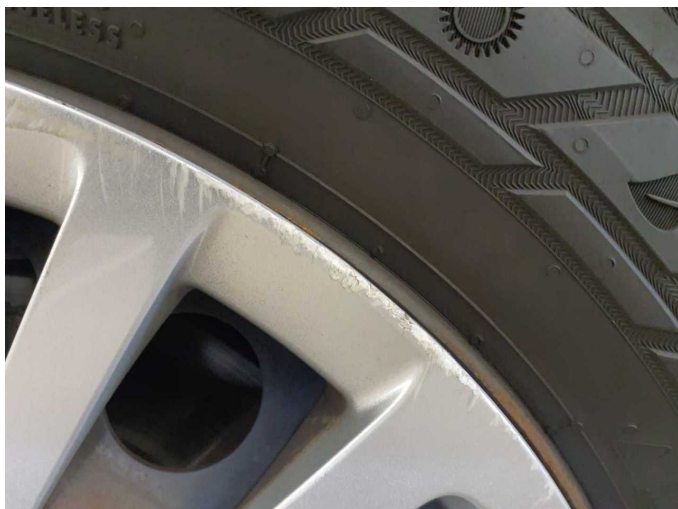
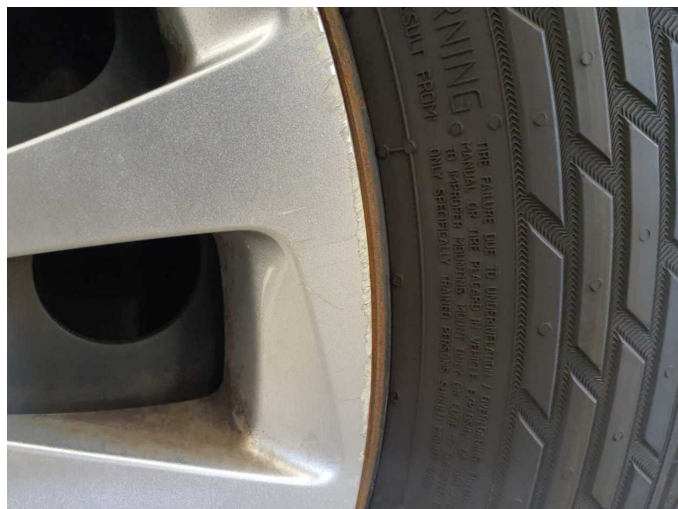
| No. | Component group | Description |
|---|---|---|
| 2 | Wheel / tyres | Wheel cover - front left side - Scratched - Replace |

**Damage 2:** Wheel / tyres: Wheel cover - front left side - Scratched - Replace

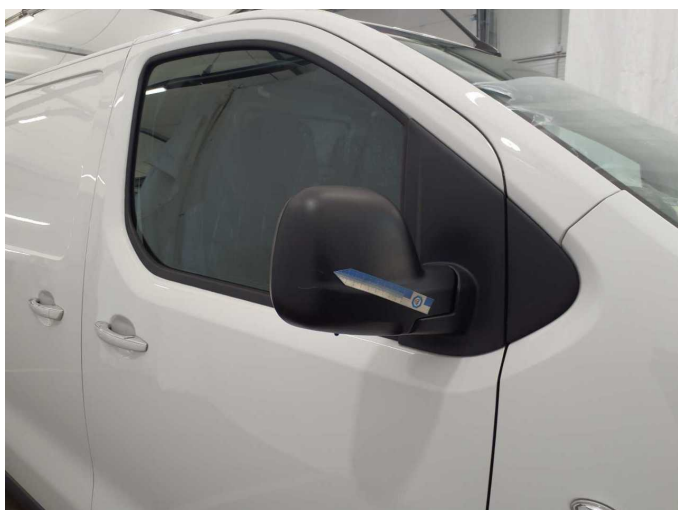
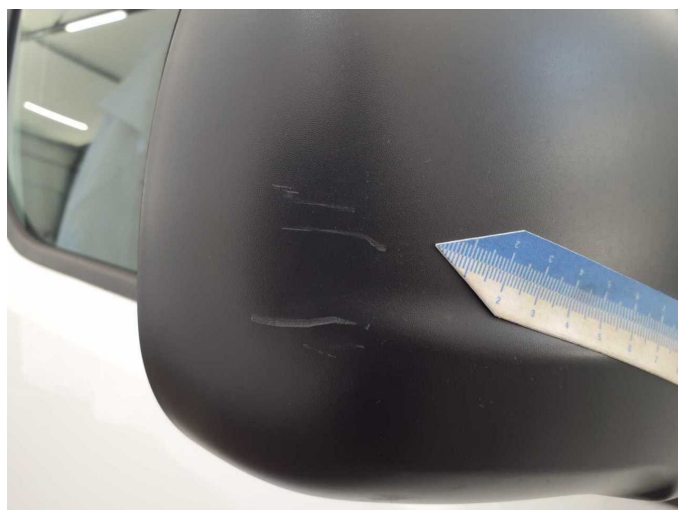
| No. | Component group | Description |
|---|---|---|
| 3 | Wing mirror - right side | Cap - Scratch(es) - Loss in value |

**Damage 3:** Wing mirror - right side: Cap - Scratch(es) - Loss in value

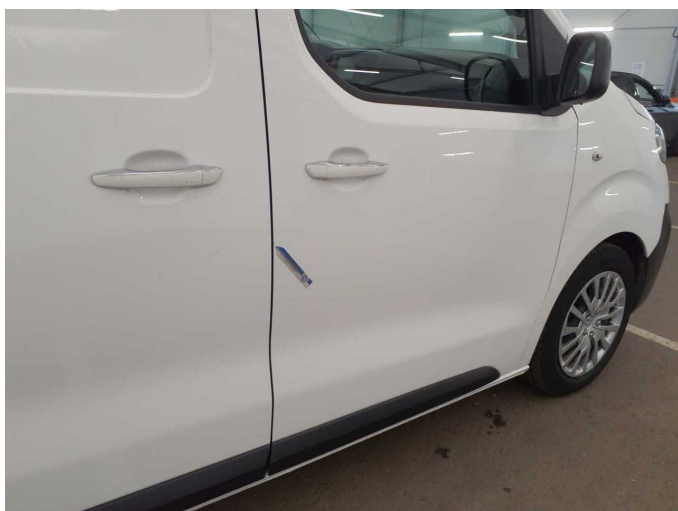
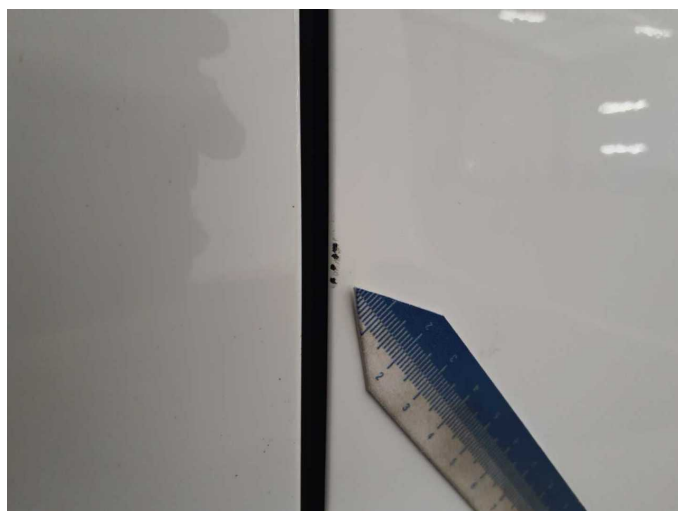
| No. | Component group | Description |
|---|---|---|
| 4 | Door - front right side | Door edge - Scratch(es) - Smart repair |

**Damage 4:** Door - front right side: Door edge - Scratch(es) - Smart repair

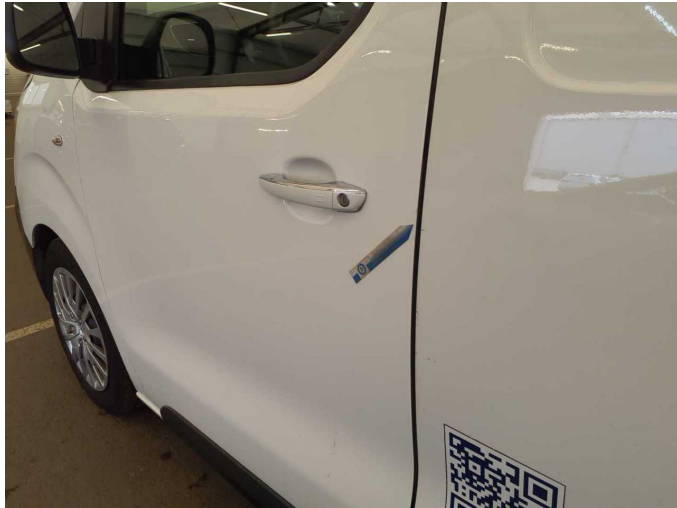
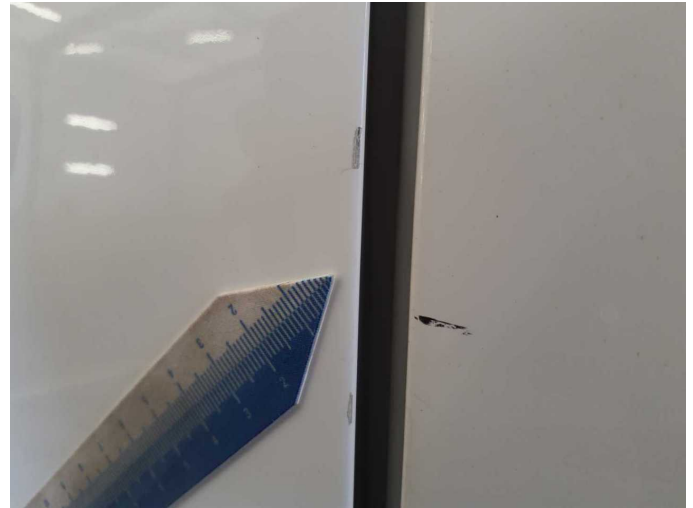
| No. | Component group | Description |
|---|---|---|
| 5 | Door - front left side | Door edge - Scratch(es) - Smart repair |

**Damage 5:** Door - front left side: Door edge - Scratch(es) - Smart repair

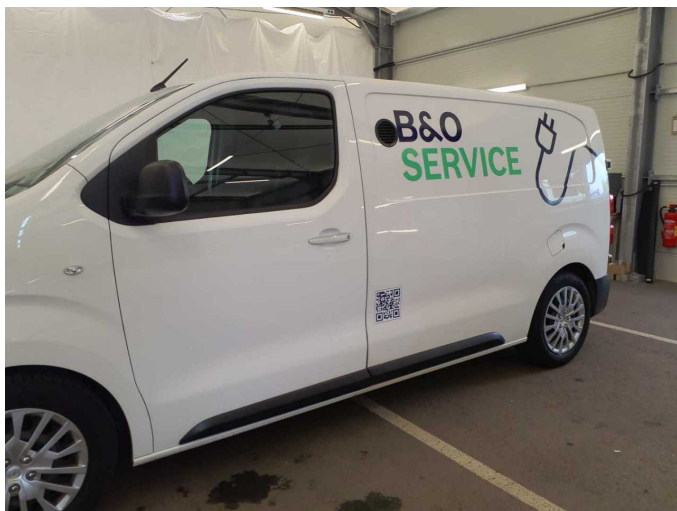
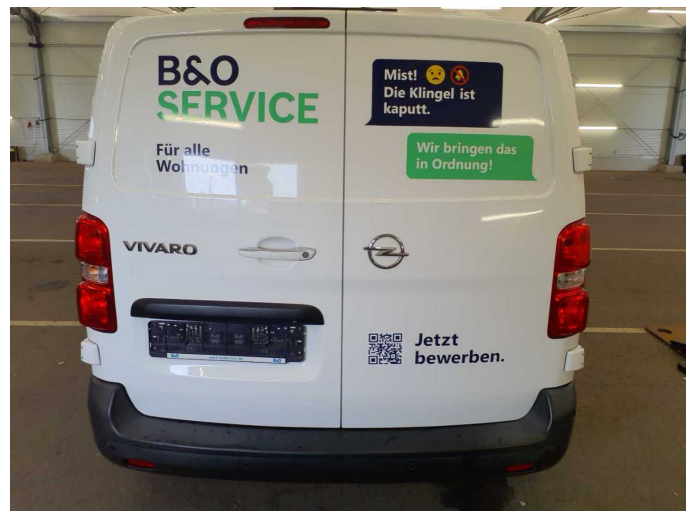
| No. | Component group | Description |
|---|---|---|
| 6 | Body | Body - Glued / labelled - De-glue / neutralise |

**Damage 6:** Body: Body - Glued / labelled - De-glue / neutralise

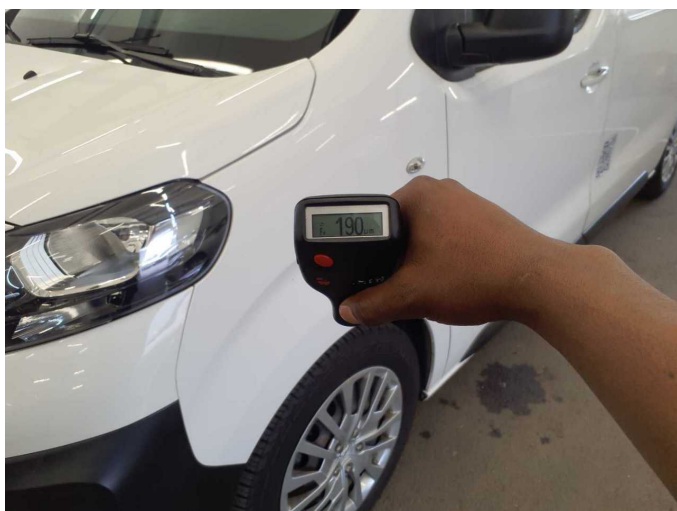
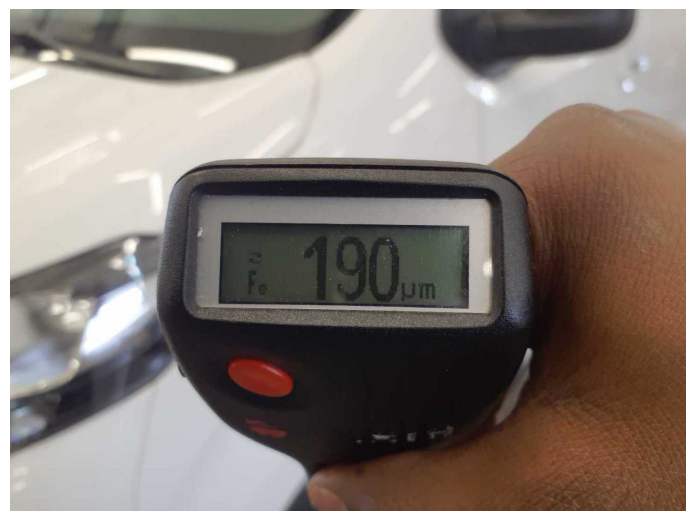
| No. | Repainting |
|---|---|
| 1 | Mudguard - left side, Professionally carried out, Invoice of repair done Non-existent |

| Mudguard - left side | 190 µm | Mudguard - right side | 246 µm |

**Repainting 1:** Mudguard - left side

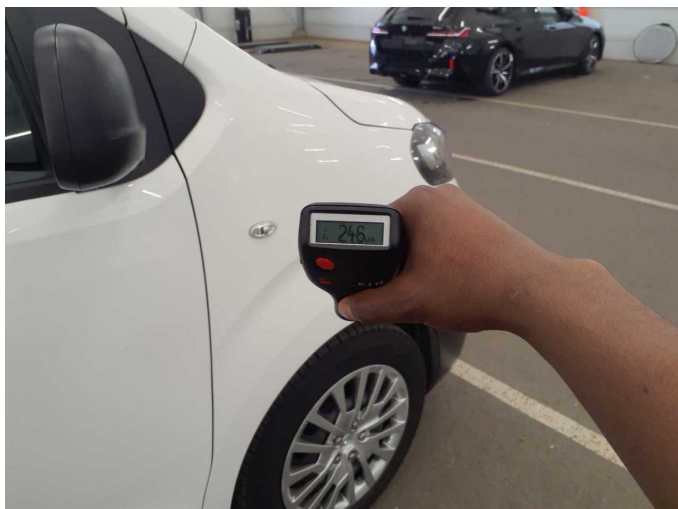
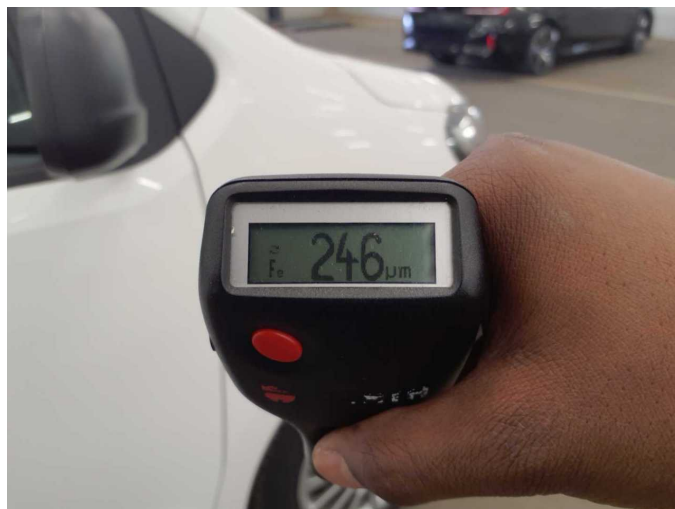
| No. | Repainting |
|---|---|
| 2 | Mudguard - right side, Professionally carried out, Invoice of repair done Non-existent |

**Repainting 2:** Mudguard - right side

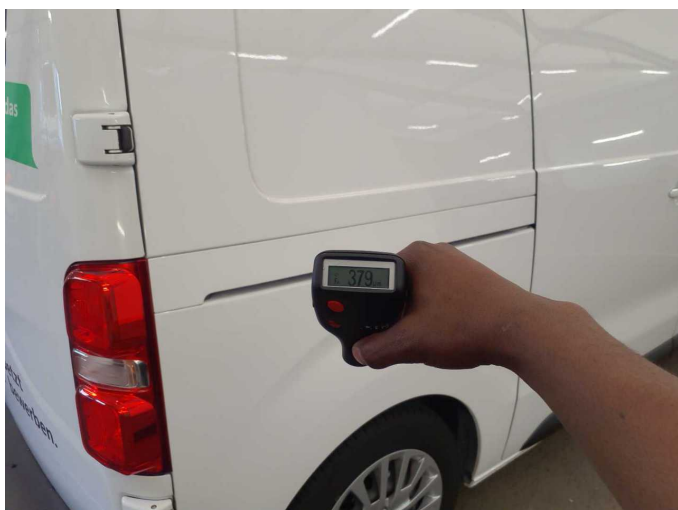
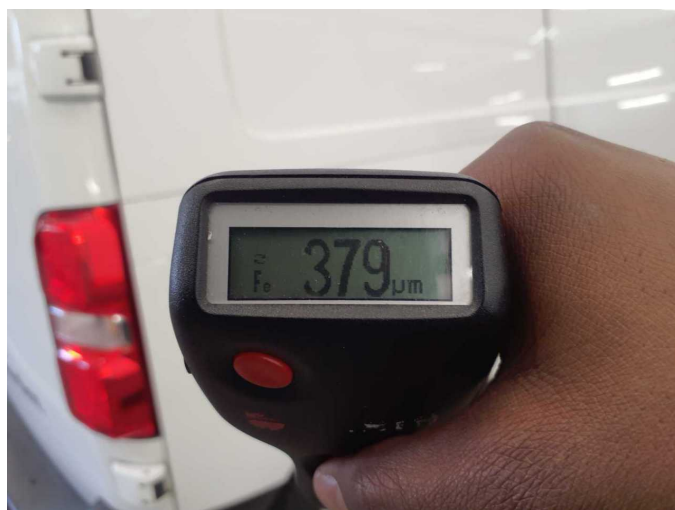
| No. | Repainting |
|---|---|
| 3 | Side panel - rear right side, Professionally carried out, Invoice of repair done Non-existent |

| Side panel - rear right side | 379 µm | Door - front left side | 228 µm |

**Repainting 3:** Side panel - rear right side

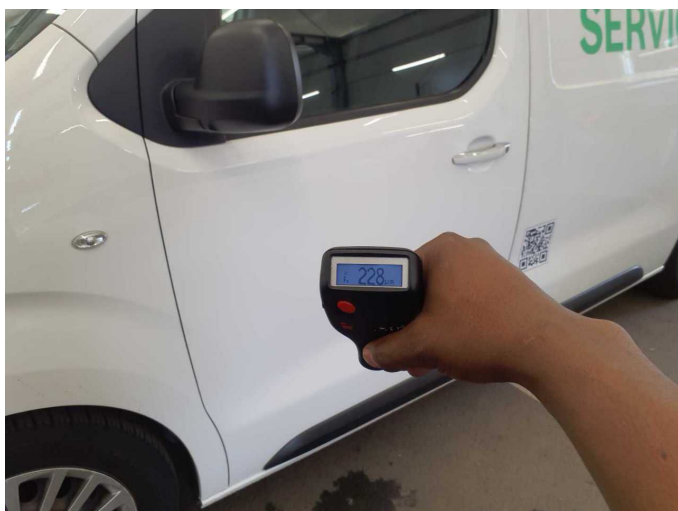
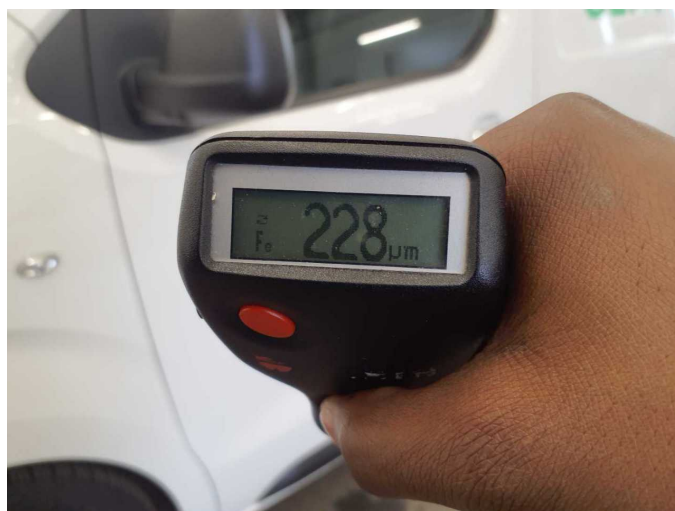
| No. | Repainting |
|---|---|
| 4 | Door - front left side, Professionally carried out, Invoice of repair done Non-existent |

**Repainting 4:** Door - front left side
