Expertise

Protocol number: 46631222  
Order No. / Reference: 26579887  
Inspection date: 17 Jul 2026

Manufacturer: Ford

Model: Kuga 1.5 EcoBlue Aut. COOL&CONNECT

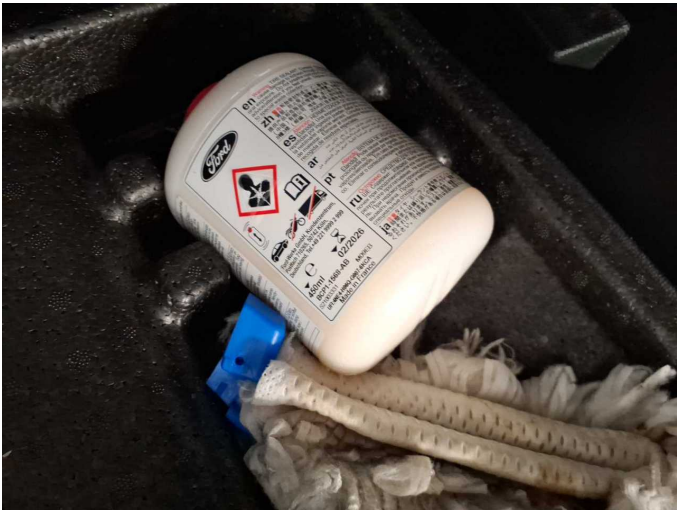
| No. | Component group | Description |
|---|---|---|
| 1 | Equipment | Tirefit filler - Expired - Replace |

Damage 1: Equipment: Tirefit filler - Expired - Replace

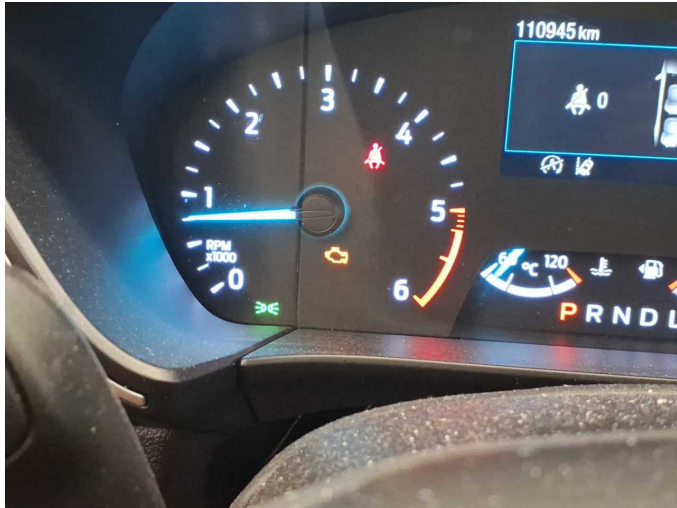
| Engine function test | An engine test run was performed, problem has been detected<br>This is due to the following reason.:<br>Motorkontrolleuchte aktiv, Fehlerursache ohne Diagnose nicht genau identifizierbar |

| No. | Component group | Description |
|---|---|---|
| 2 | Instrument panel | Indicator light (Motor) - on - Perform diagnosis |

**Damage 2:** Instrument panel: Indicator light (Motor) - on - Perform diagnosis

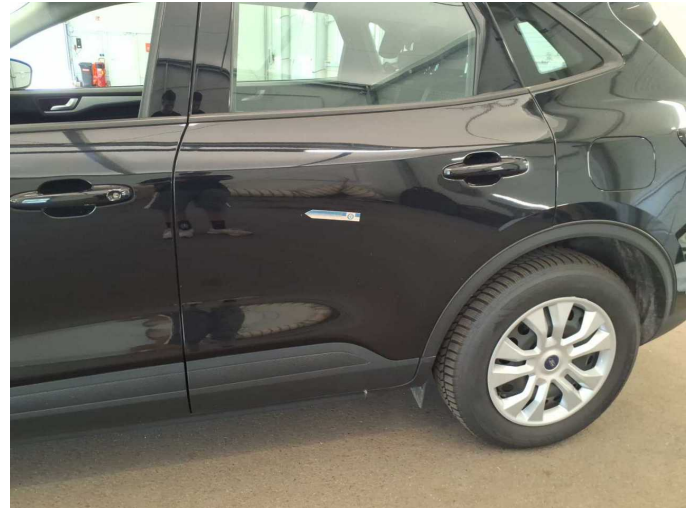
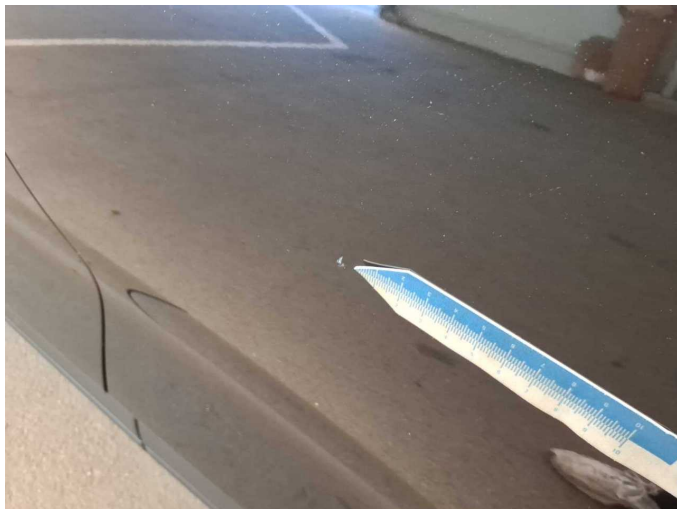
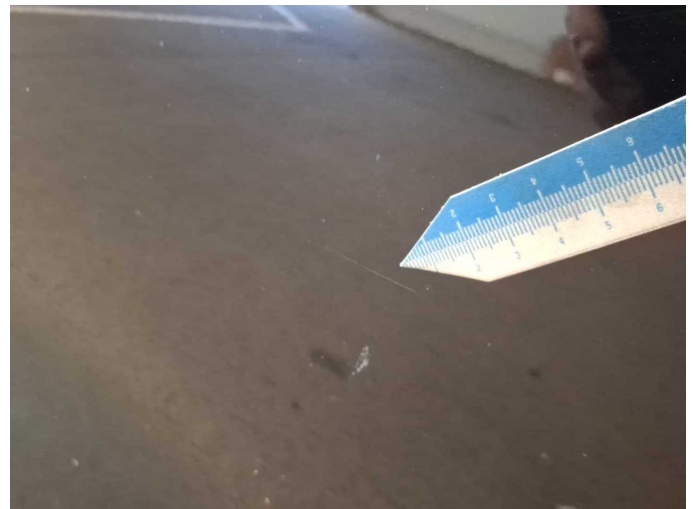
| No. | Component group | Description |
|---|---|---|
| 3 | Door - rear left side | Door - Scratch(es) - Paint |

**Damage 3:** Door - rear left side: Door - Scratch(es) - Paint

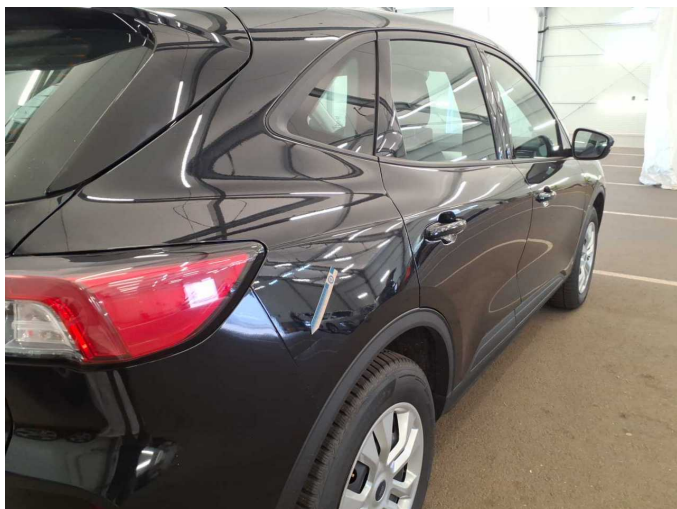
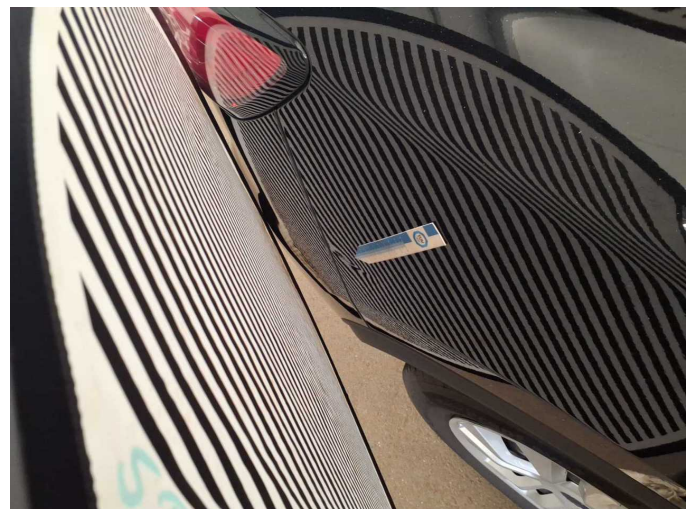
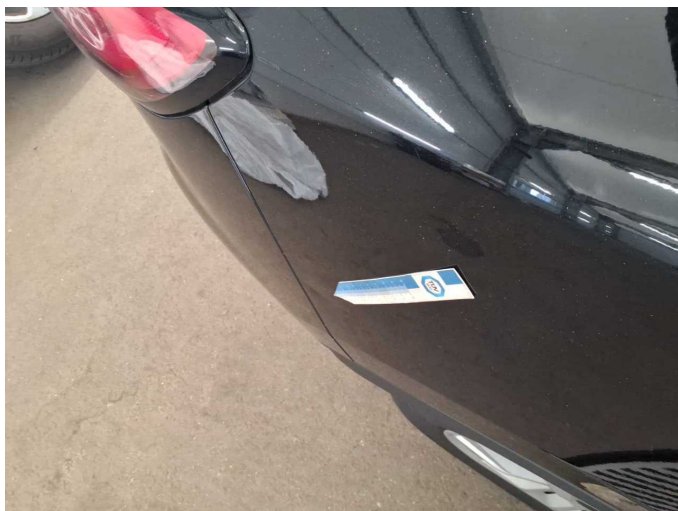
| No. | Component group | Description |
|---|---|---|
| 4 | Side panel - rear right side | Side panel - Deformed - Repair and paint |

**Damage 4:** Side panel - rear right side: Side panel - Deformed - Repair and paint

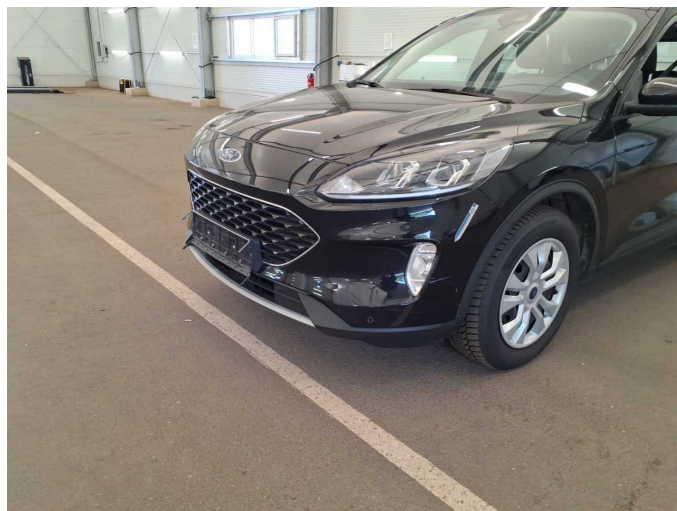
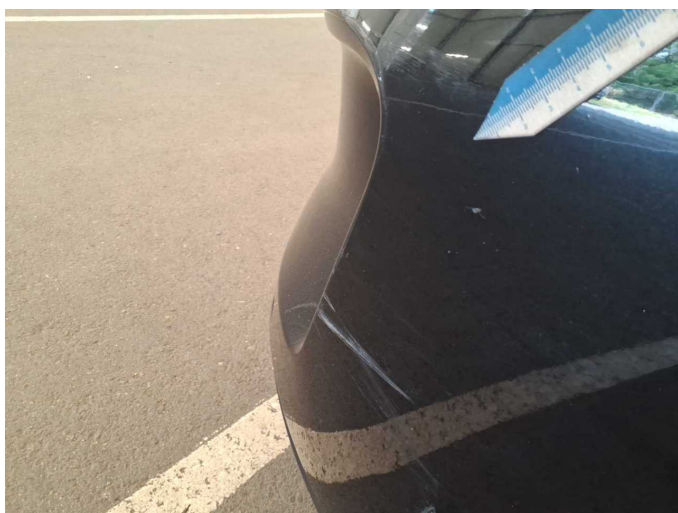
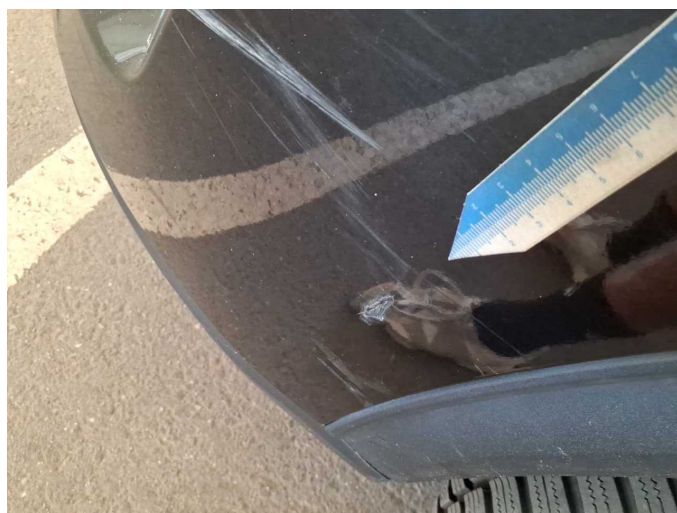
| No. | Component group | Description |
|---|---|---|
| 5 | Front bumper | Front bumper - Scratched - Paint |

**Damage 5:** Front bumper: Front bumper - Scratched - Paint

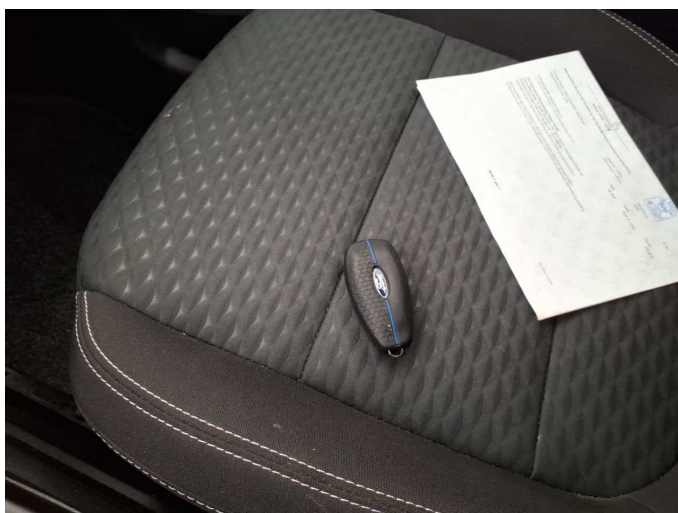
Equipment - Vehicle key

**Missing part 1:** Equipment: Vehicle key - Missing - Replace
