## Expertise

Protocol number: 45869219  
Order No. / Reference: 26325580  
Inspection date: 10 Jun 2026

Model: C 220 d T 9G-TRONIC Avantgarde Advanced

VIN: W1KAH0EB2RF147315

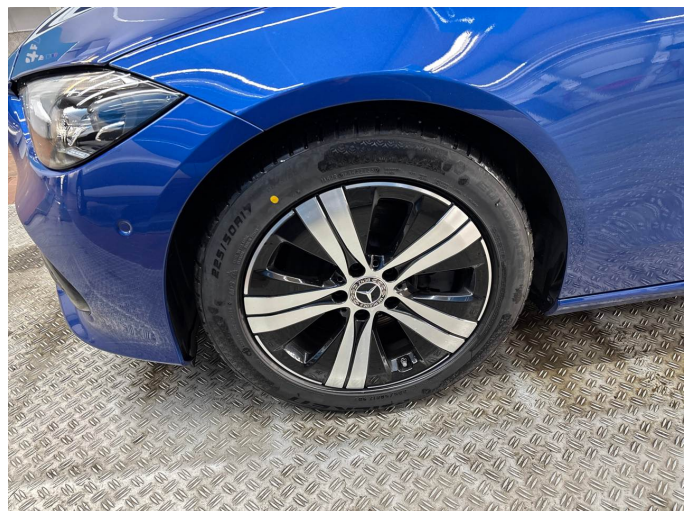
Figure 12: Mounted tyres

#	Tyre size	Type of tyre	Manufacturer	Tread depth
1)	225/50 R17 98V	Winter tyres on Light alloy	Falken	5mm / 5mm
2)	225/50 R17 98V	Winter tyres on Light alloy	Falken	5mm / 5mm

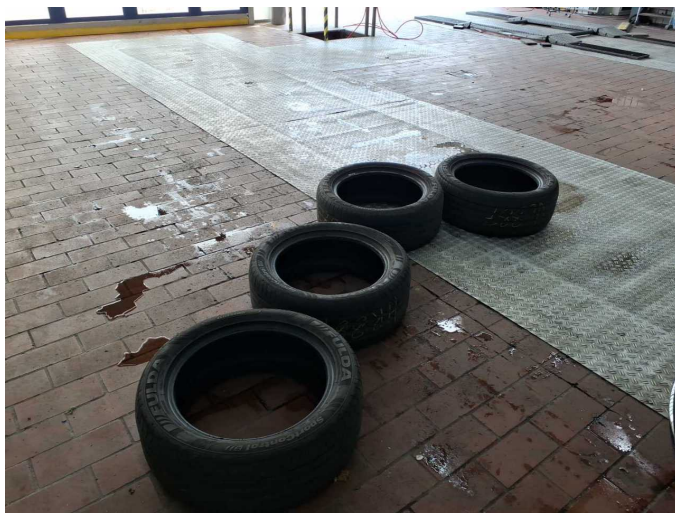
Figure 15: Additional tyres

#	Tyre size	Type of tyre	Manufacturer	Tread depth
1)	225/50 R17 98Y	Summer tyres (Without wheel rim)	Fulda	4mm / 4mm
2)	225/50 R17 98Y	Summer tyres (Without wheel rim)	Fulda	4mm / 4mm

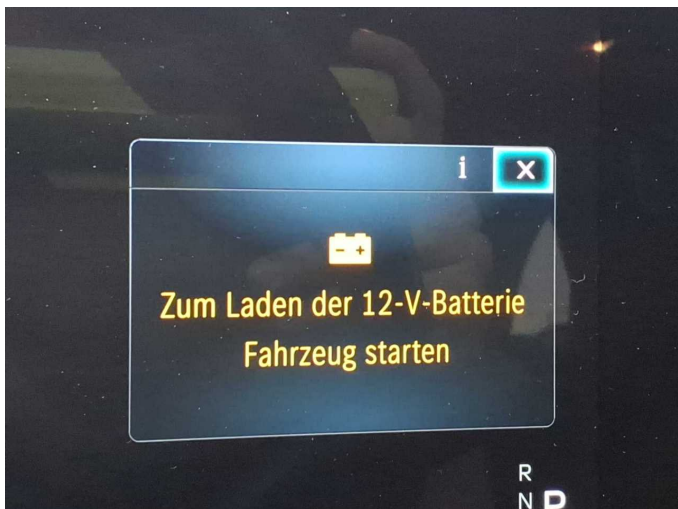
**Damage 1:** Electrical system: Battery - Empty - Perform diagnosis

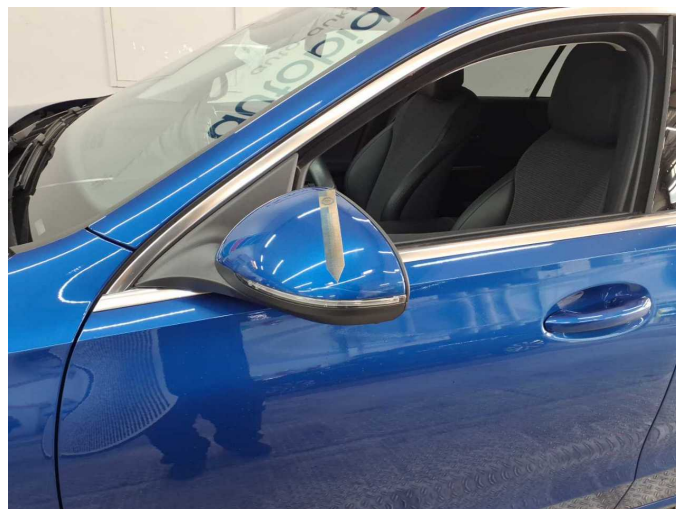
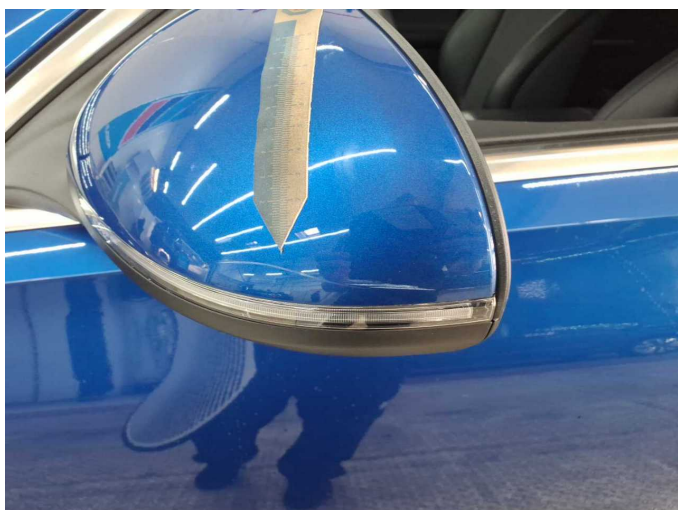
**Damage 3:** Wing mirror - left side: Cap - Scratch(es) - Smart repair
