Expertise

Protocol number: 46201181
Order No. / Reference: 26154565
Inspection date: 17 Jun 2026

Model: 317 CDI Sprinter Lang HA 9G-TRONIC PRO

VIN: W1V3KCFZ5TP845171

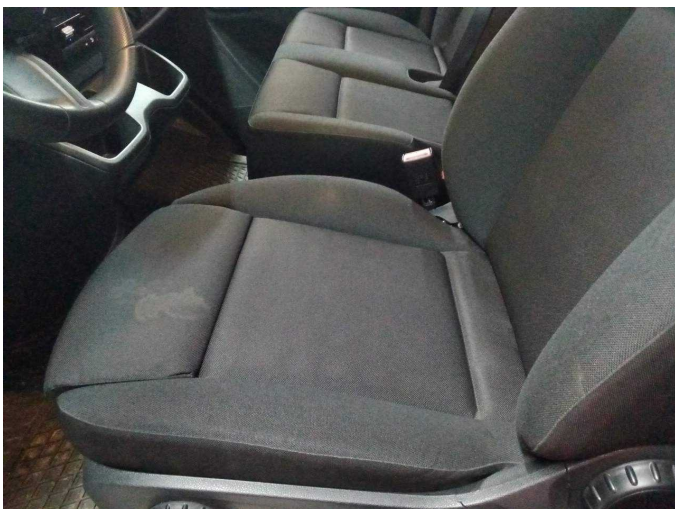
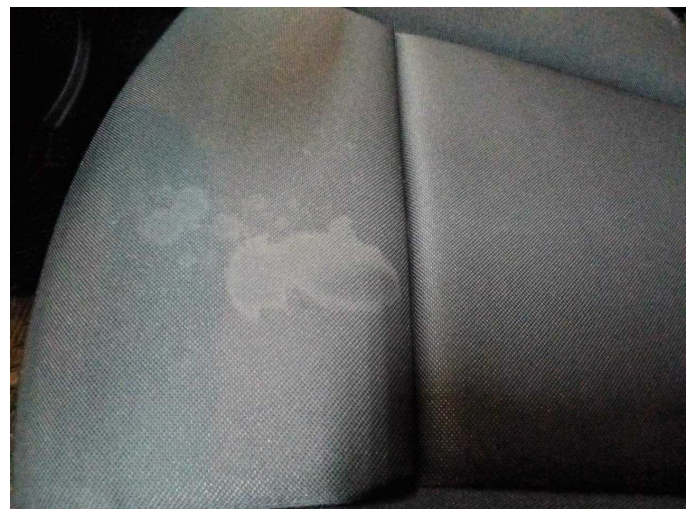
Damage 1: Seat - front: Seat cover - left side - Clean

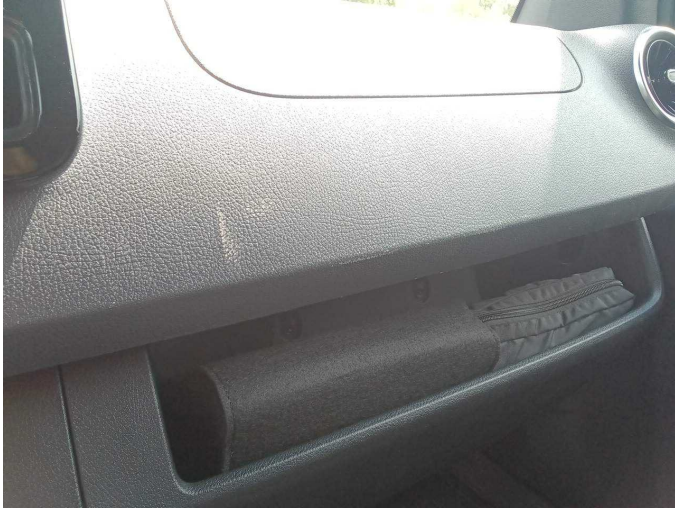
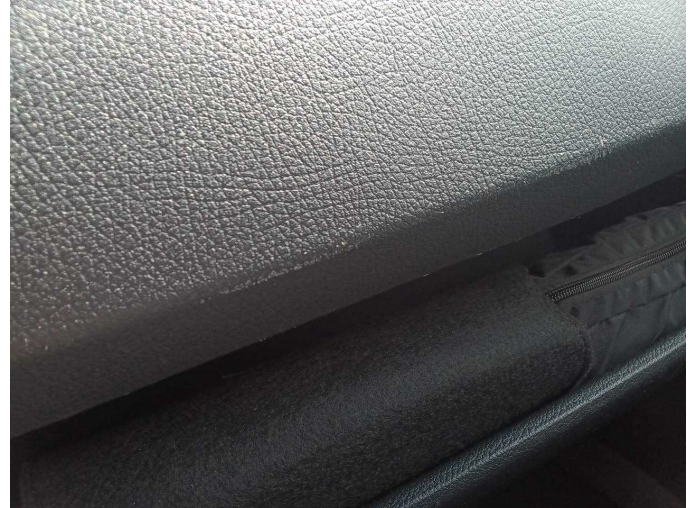
Damage 2: Instrument panel: Glove box - Scratch(es) - Loss in value

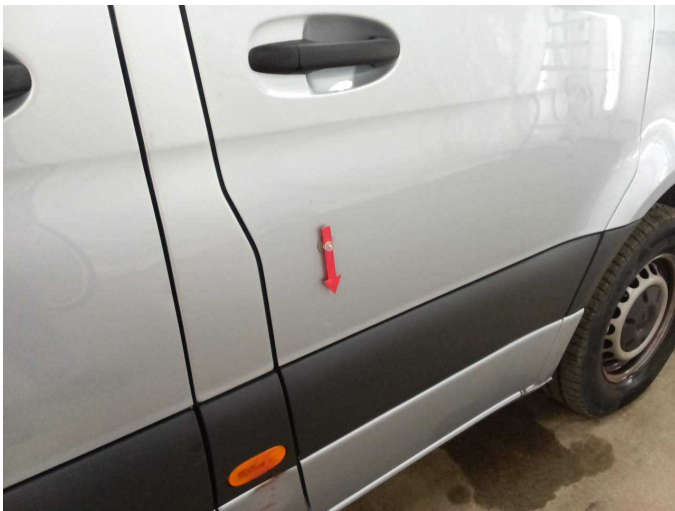
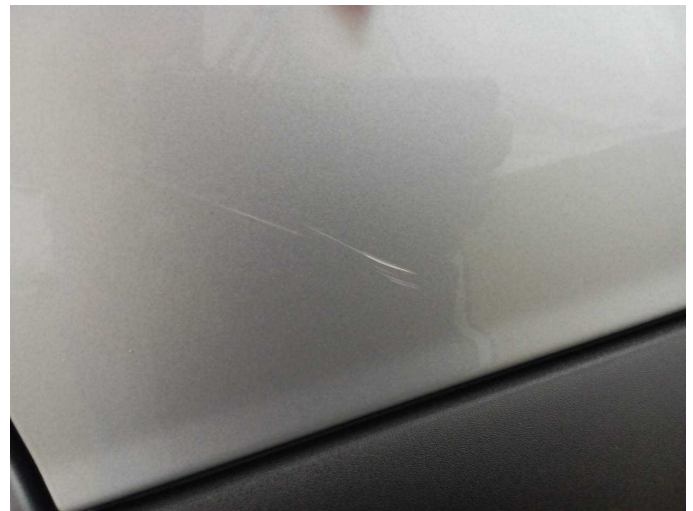
Damage 3: Door - front right side: Door - Scratch(es) - Smart repair

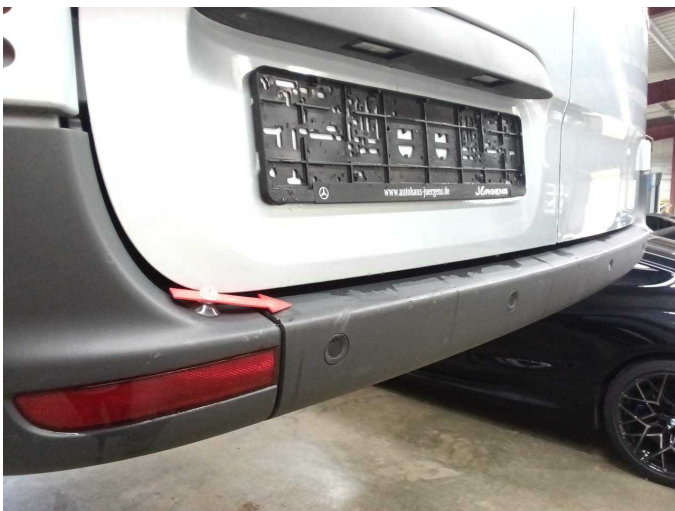
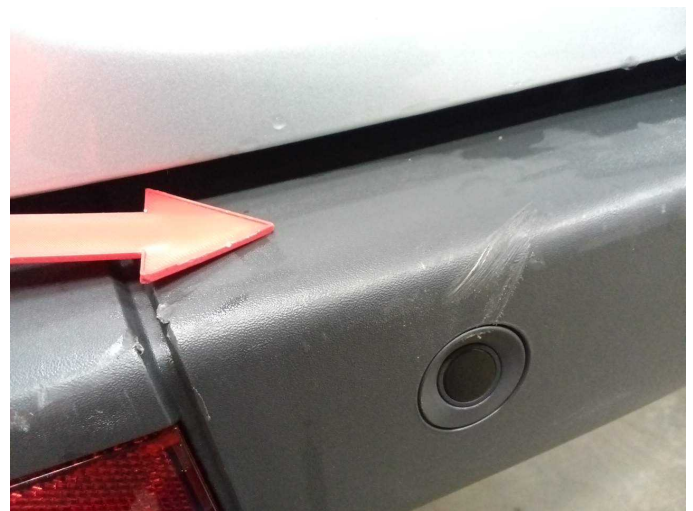
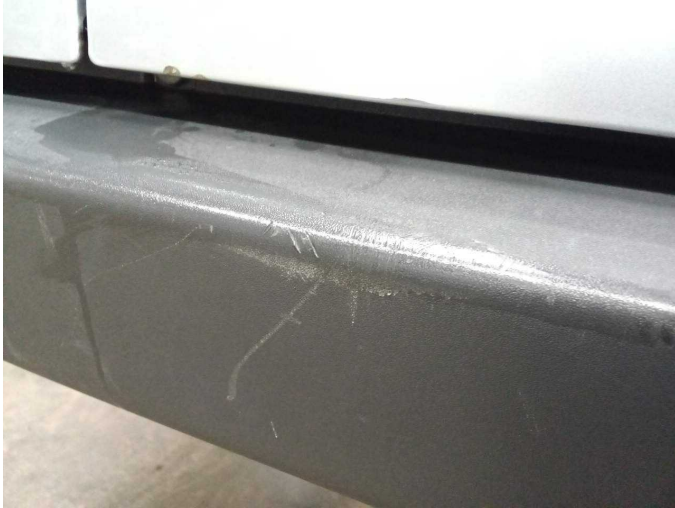
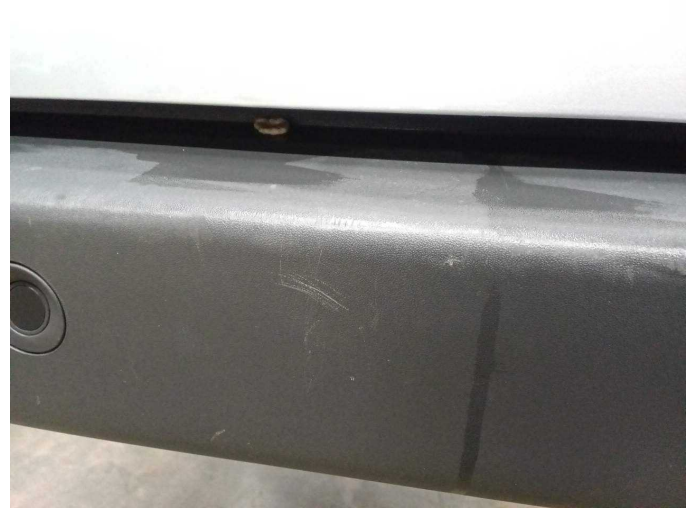
Damage 4: Rear bumper: Rear bumper - Scratched - Loss in value

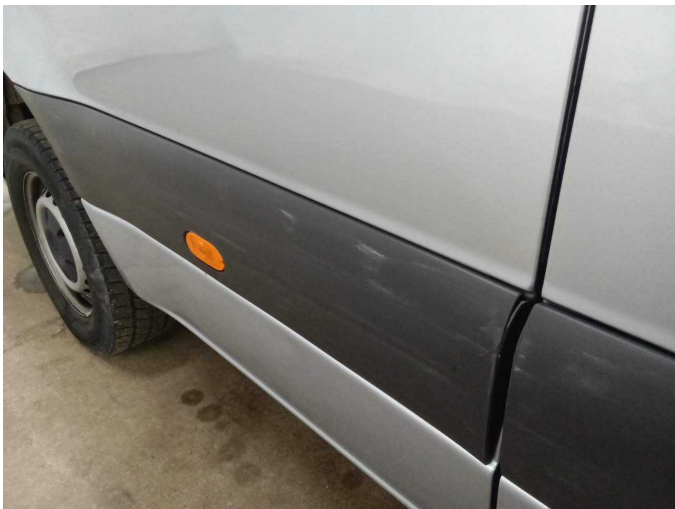
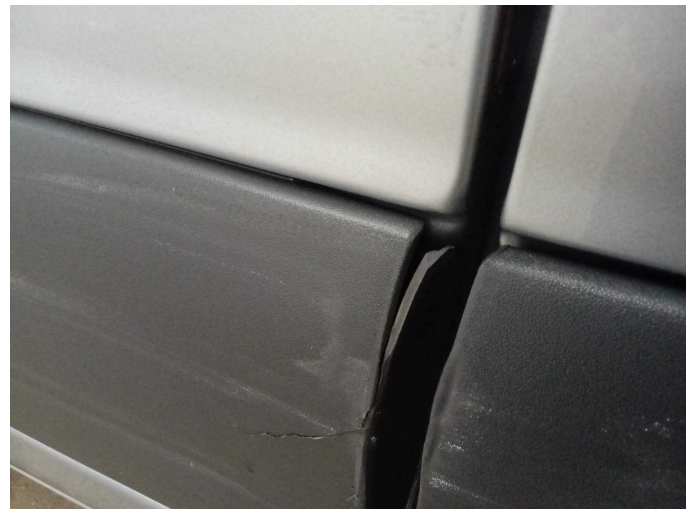
Damage 5: Side panel - rear right side: Protection strip - Broken / torn - Replace

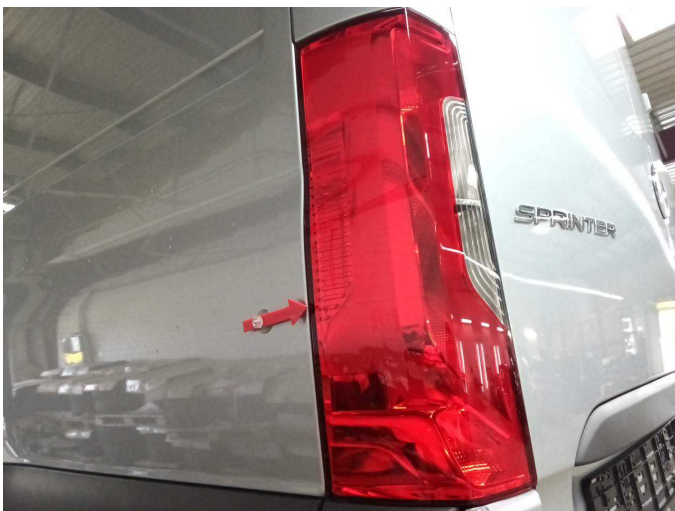
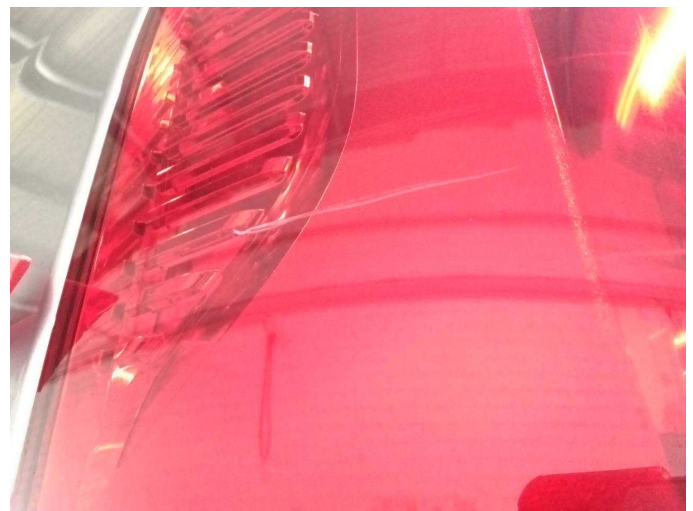
Damage 6: Tail light: Tail lamp - left side - Scratch(es) - Replace

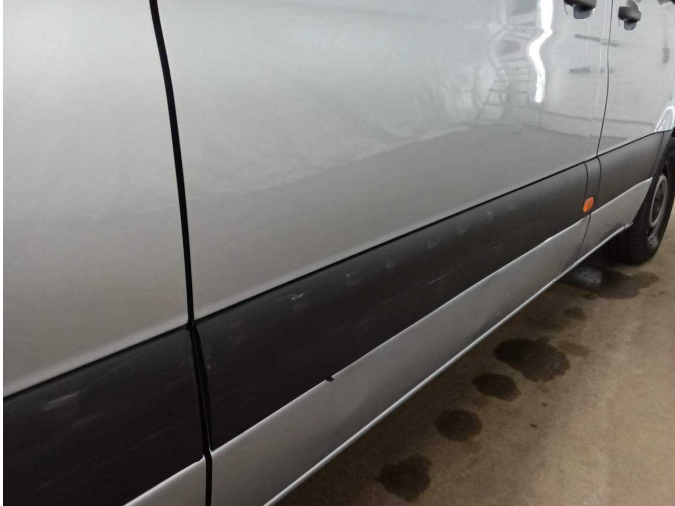
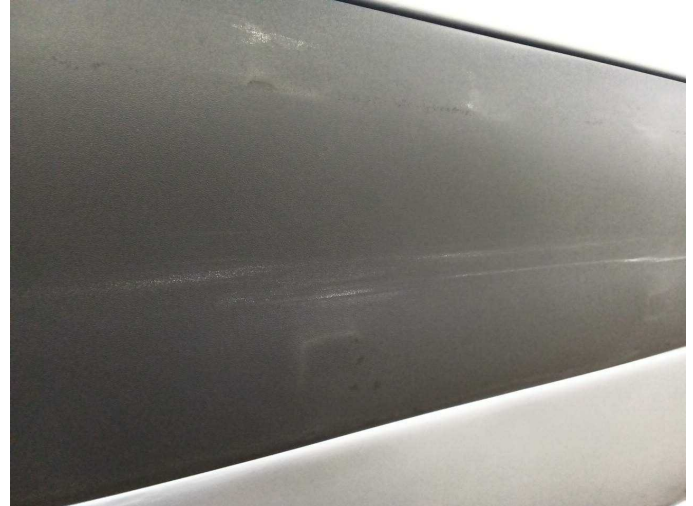
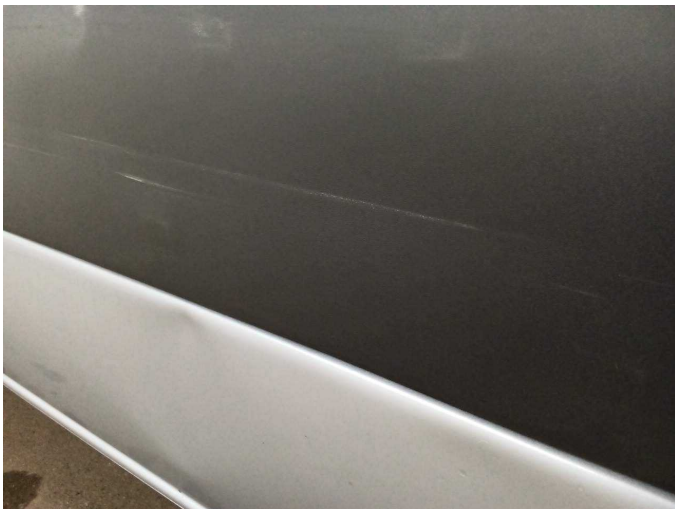
Damage 7: Sliding door, right: Protection strip - Scratched - Replace

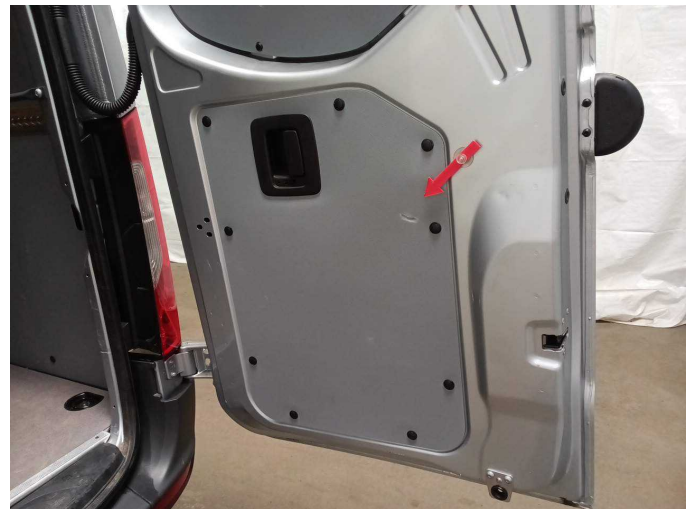
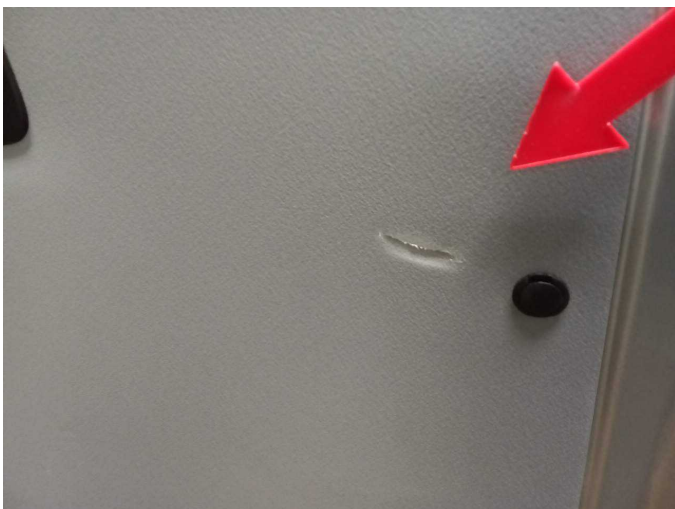
Damage 8: Trim / covers: Boot lid - interior trim - Scratched - Replace

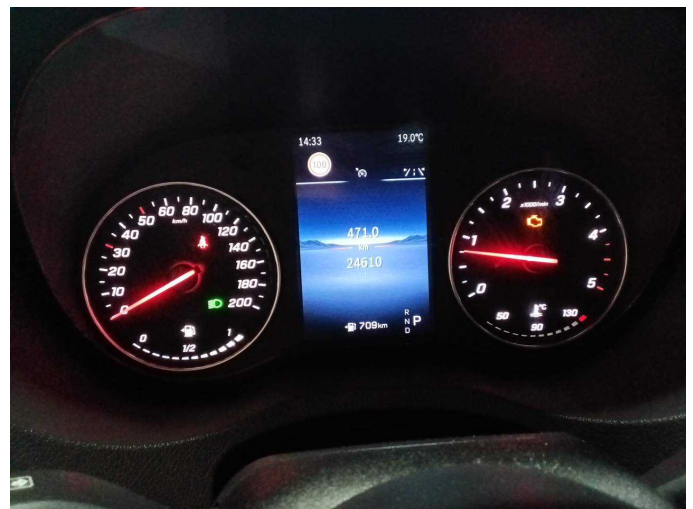
Documents submitted	At the time of the inspection, the vehicle registration certificate Part 2 (title) was available, but the vehicle registration certificate Part 1 (document) was not. (Copy)
VIN comparison	The vehicle identification number (VIN) was read from the vehicle and its conformity with the submitted documents was confirmed by the undersigned during the inspection.
Inspection	The inspection conditions were sufficient for the assessment of the vehicle. Lifting equipment and/or a pit were available for examining the vehicle.
Test drive	No test drive/shunting maneuver was carried out during the inspection of the vehicle.
Engine function test	An engine test run was performed, problem has been detected This is due to the following reason.: Motorkontrolleuchte aktiv

Damage 9: Instrument panel: Indicator light (Motorkontrolle) - on - Perform diagnosis

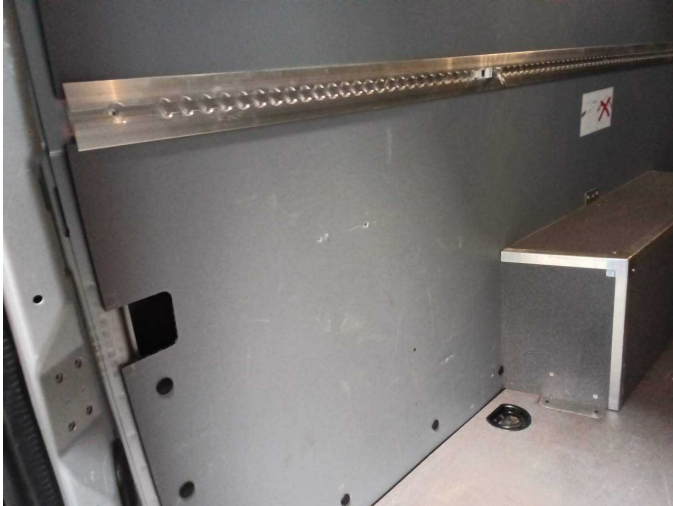
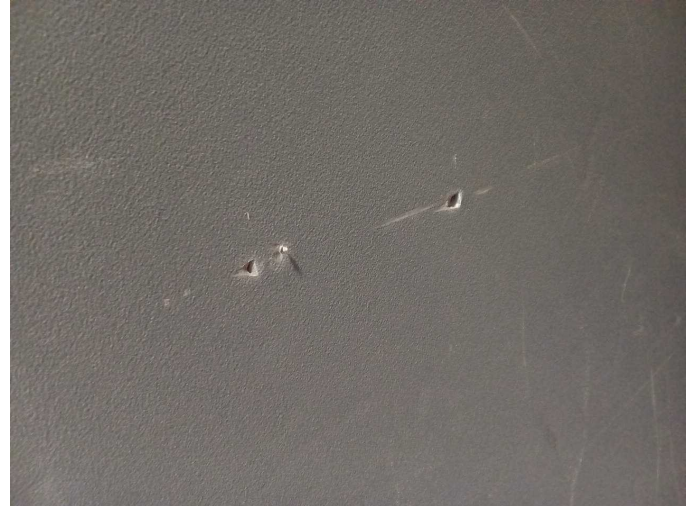
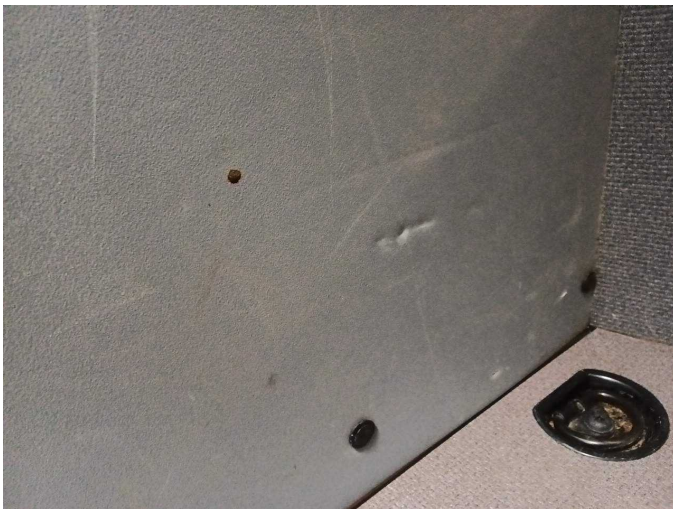
Damage 10: Side panel - rear left side: Interior trim - Holes - Replace

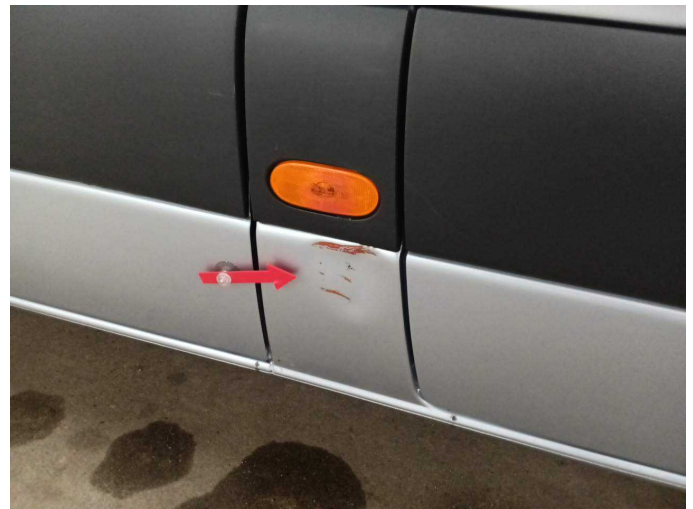
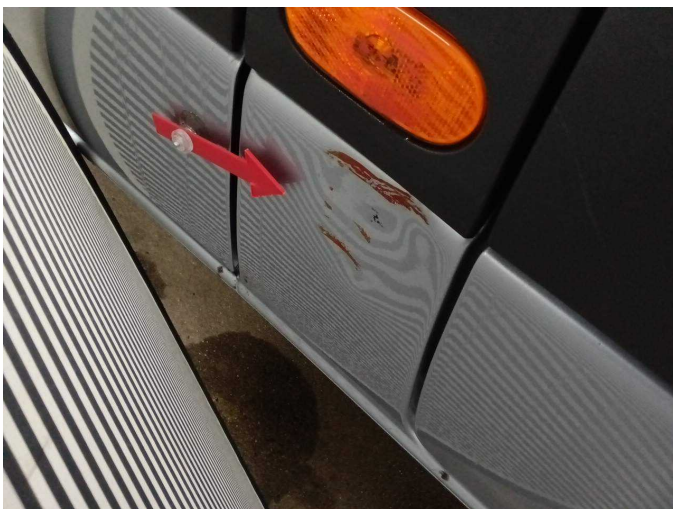
Damage 11: Side panel - rear right side: Sill - Dent / paintcoat damage - Repair and paint

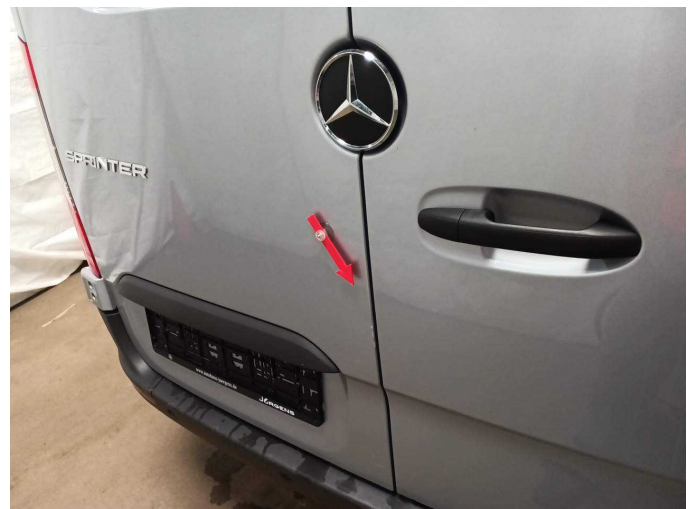
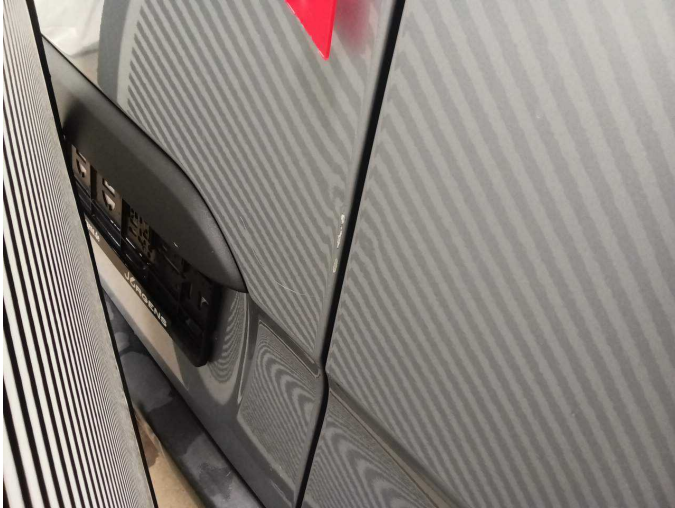
Damage 12: Boot lid / rear door: Boot lid - Dent / paintcoat damage - Repair and paint

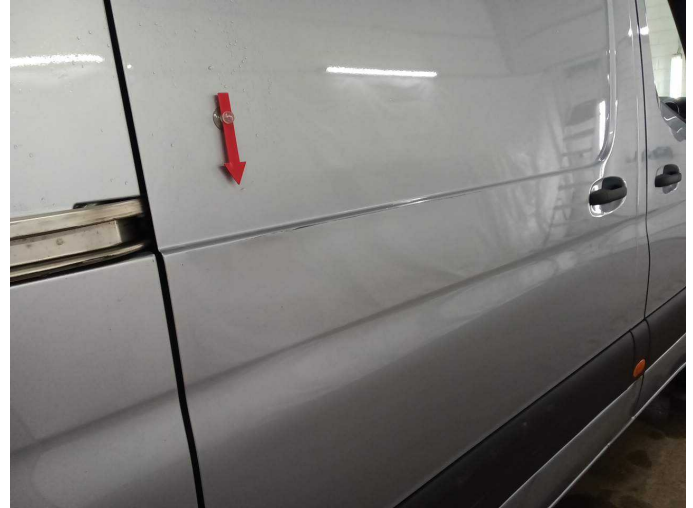
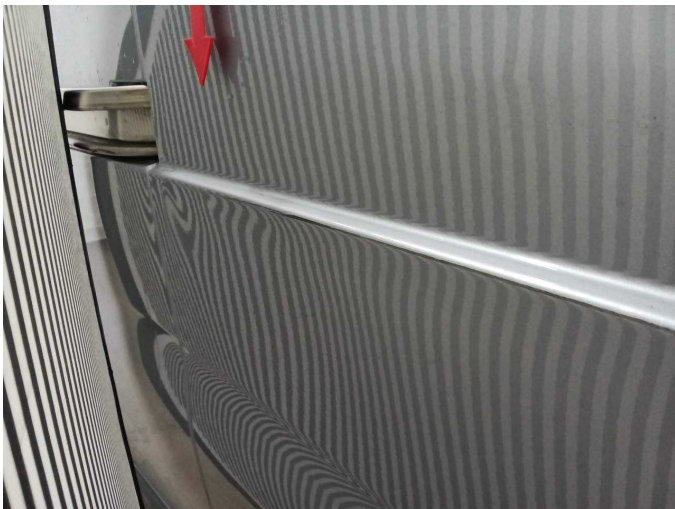
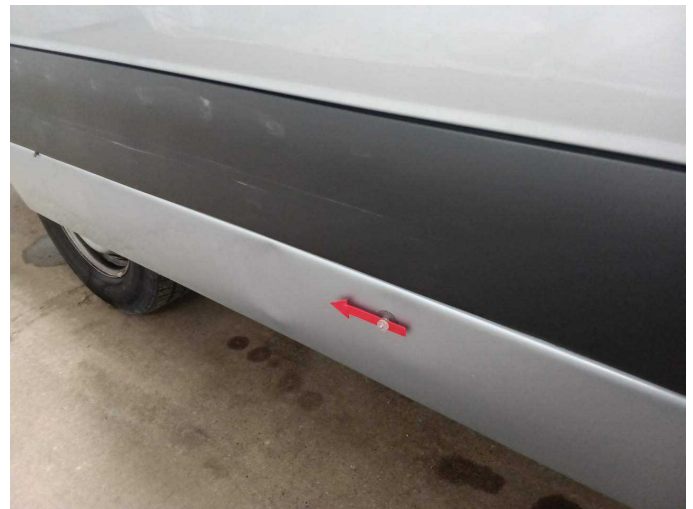
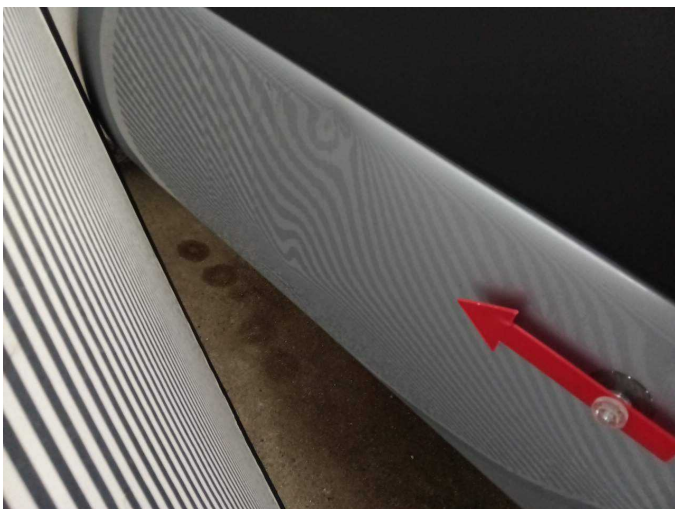
Damage 13: Sliding door, right: Sliding door - Dent / paintcoat damage - Repair and paint
