Protocol number: 45664434
Order No. / Reference: 26172947
Inspection date: 27 May 2026

Manufacturer: Peugeot

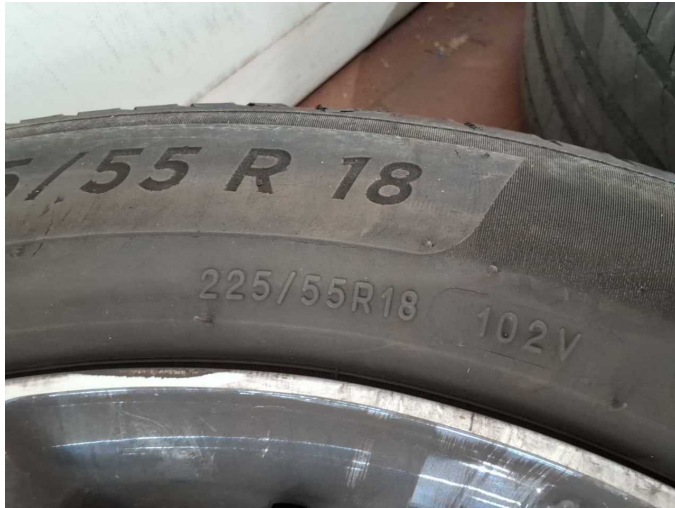
Damage 1: 2nd wheel set: 1 tyre - Broken / torn - Replace

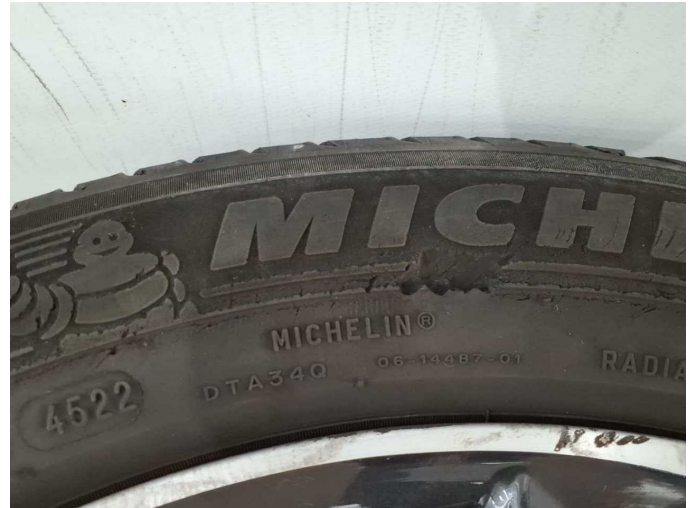
Damage 1: 2nd wheel set: 1 tyre - Broken / torn - Replace

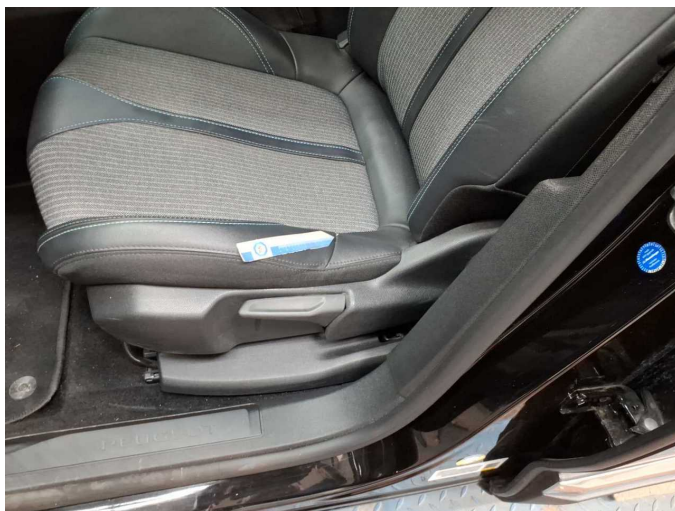
Damage 2: Seat - front: Seat cover - left side - Broken / torn - Loss in value

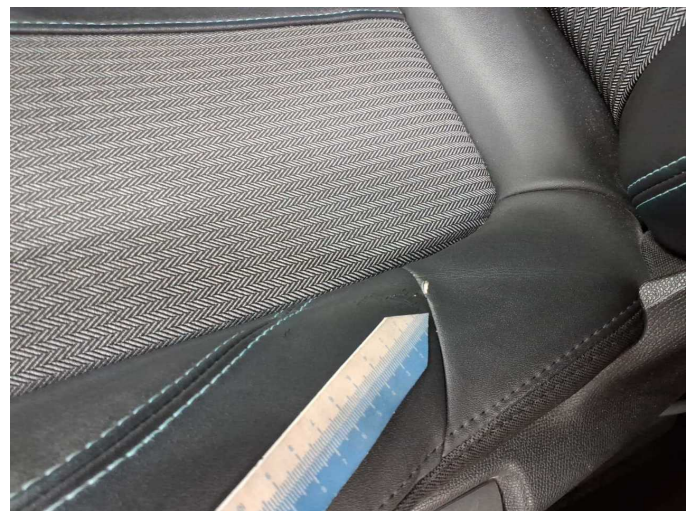
Damage 2: Seat - front: Seat cover - left side - Broken / torn - Loss in value

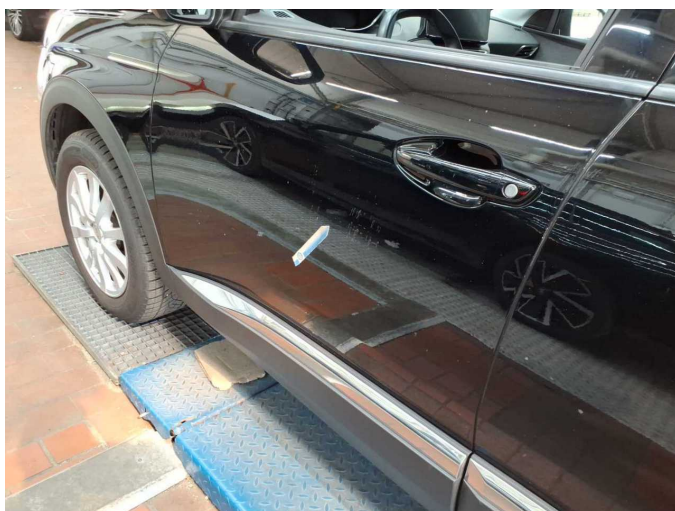
Damage 3: Door - front left side: Door - Dent / paintcoat damage - Paint

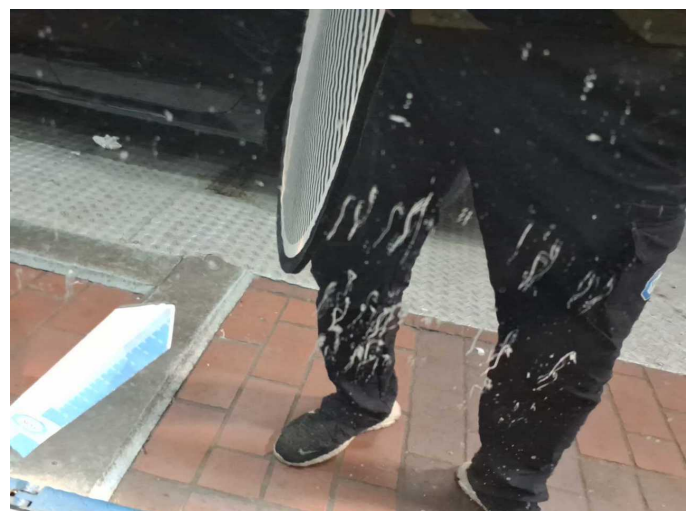
Damage 3: Door - front left side: Door - Dent / paintcoat damage - Paint

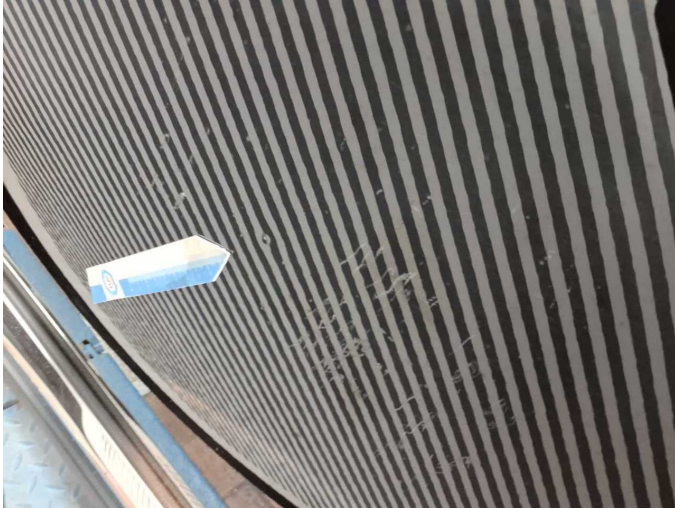
Damage 3: Door - front left side: Door - Dent / paintcoat damage - Paint

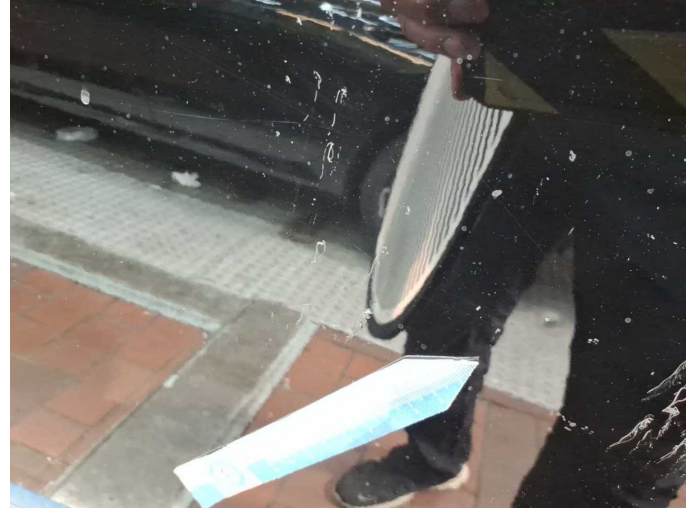
Damage 3: Door - front left side: Door - Dent / paintcoat damage - Paint

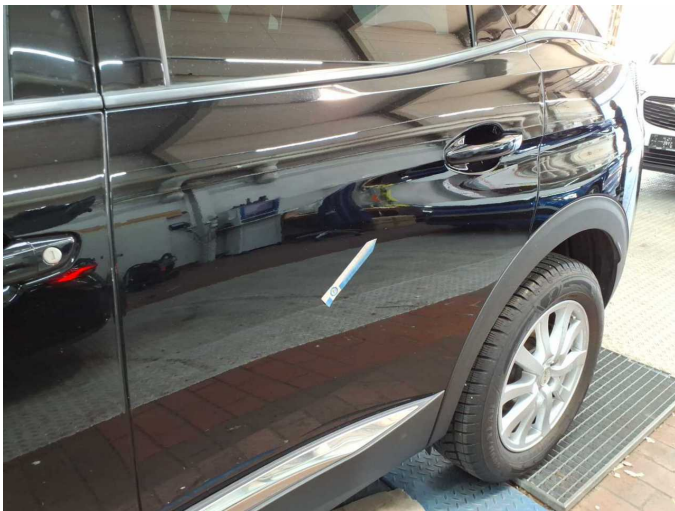
Wear and tear 3: Door - rear left side: Door - dent(s) - No deduction

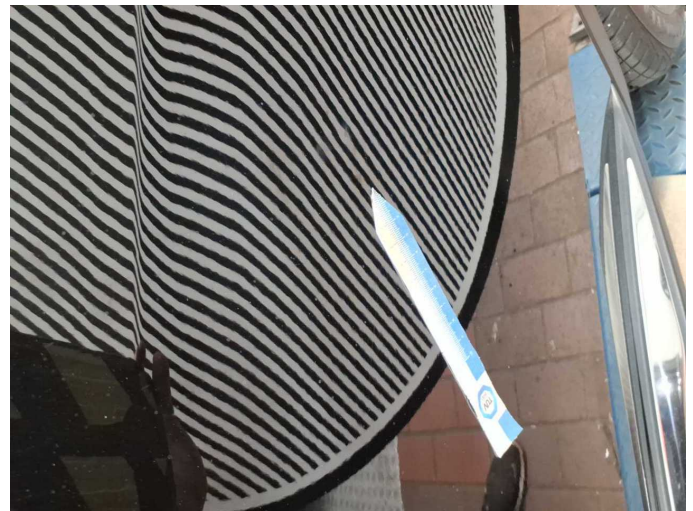
Wear and tear 3: Door - rear left side: Door - dent(s) - No deduction

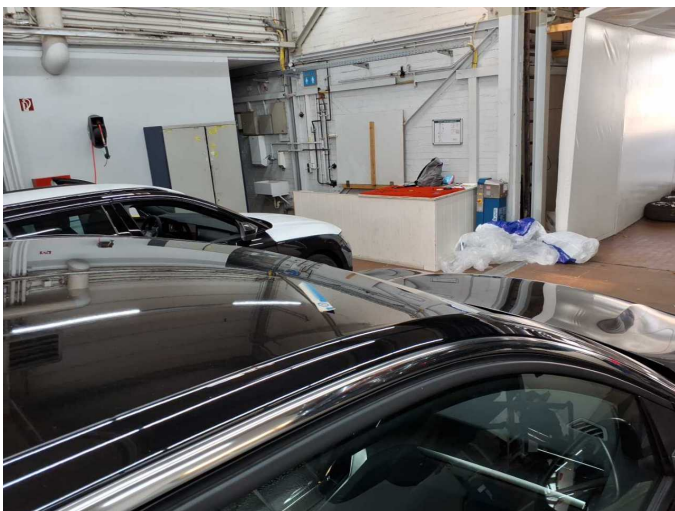
Wear and tear 4: Roof: Roof - dent(s) - No deduction

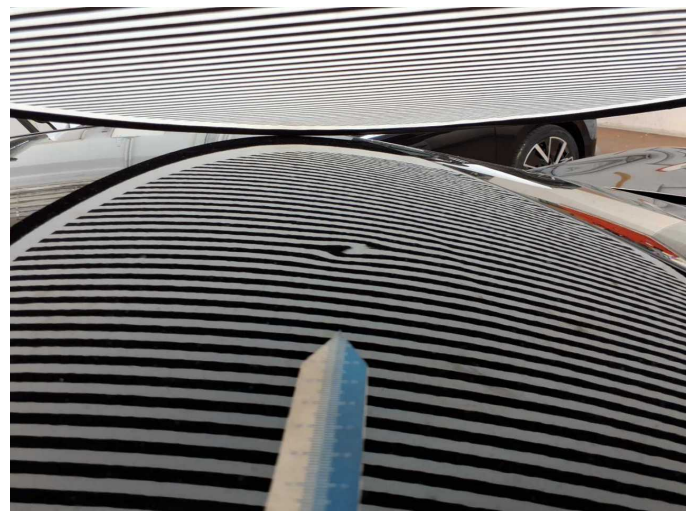
Wear and tear 4: Roof: Roof - dent(s) - No deduction

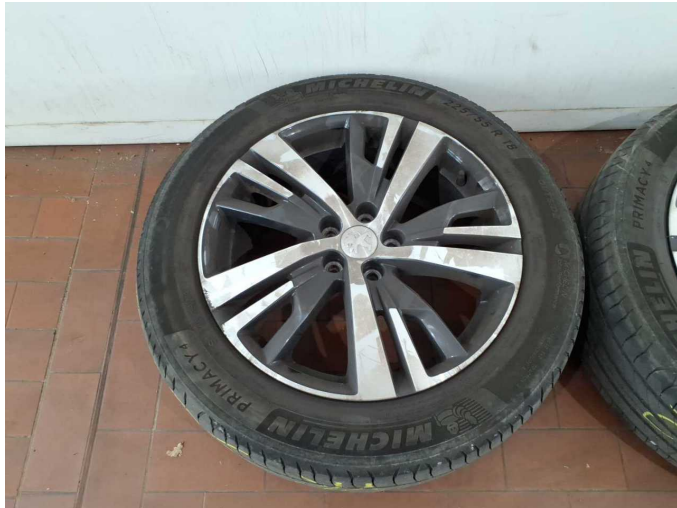
Wear and tear 5: 2nd wheel set: 1 alloy rim - Scratch(es) - No deduction

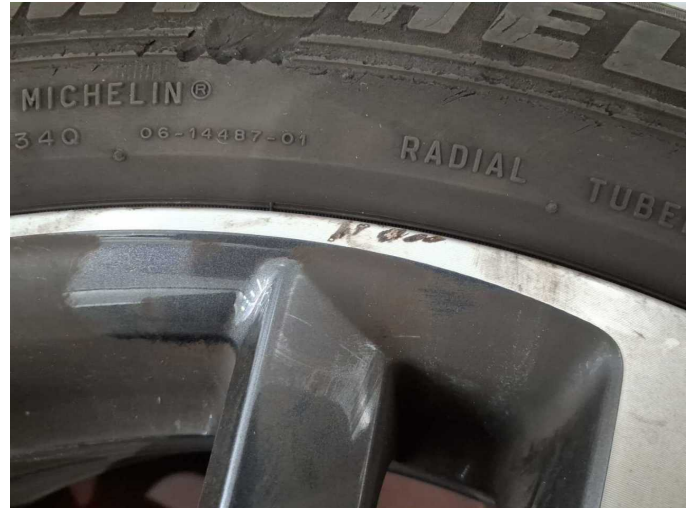
Wear and tear 5: 2nd wheel set: 1 alloy rim - Scratch(es) - No deduction

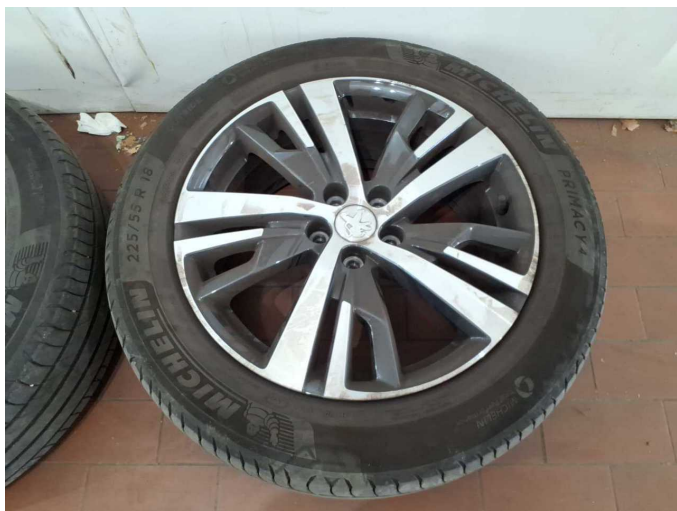
Wear and tear 6: 2nd wheel set: 1 alloy rim - Scratch(es) - No deduction

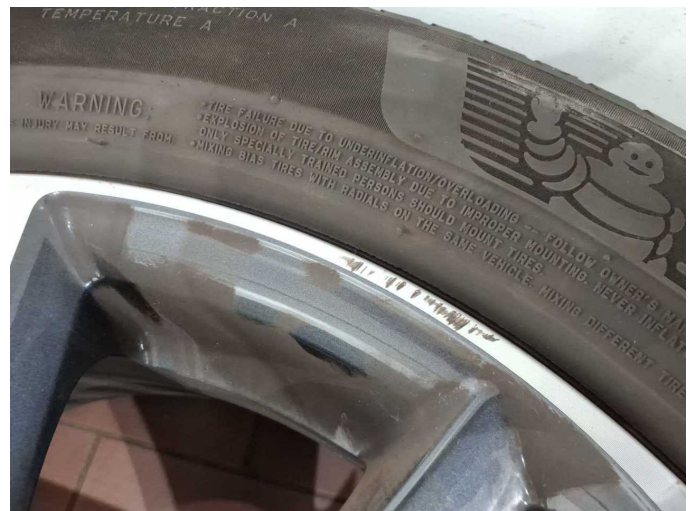
Wear and tear 6: 2nd wheel set: 1 alloy rim - Scratch(es) - No deduction

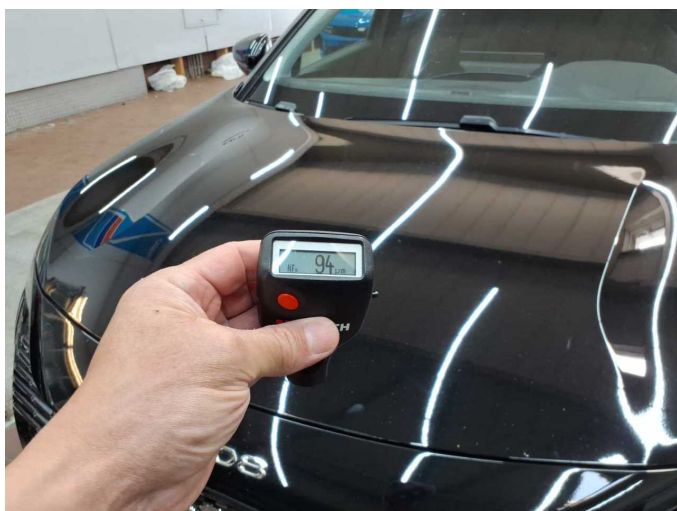
Repainting 1: Mudguard - left side, Mudguard - right side, Bonnet, Side panel - rear left side, Side panel - rear right side, Door - rear left side, Door - rear right side, Door - front left side, Door - front right side
