## Expertise

Protocol number: 45868850  
Order No. / Reference: 26460976  
Inspection date: 10 Jun 2026

Model: S-Max 2.0 EcoBlue Aut. TITANIUM

VIN: WF0JXXWPCJNM84700

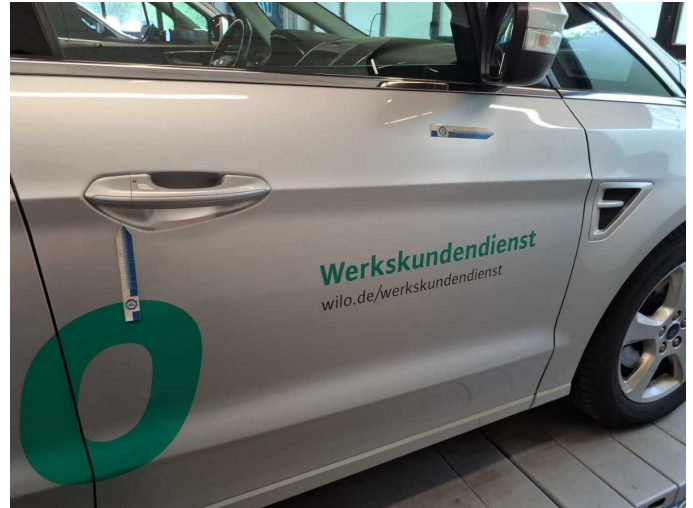
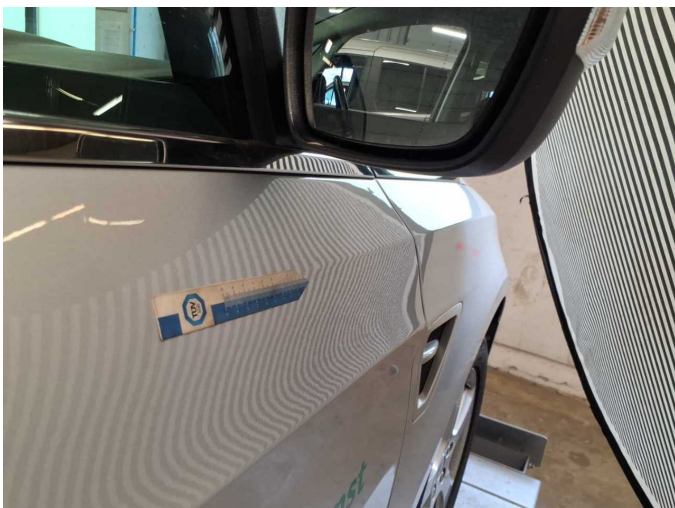
Damage 1: Door - front right side: Door - dent(s) - Smooth repair work

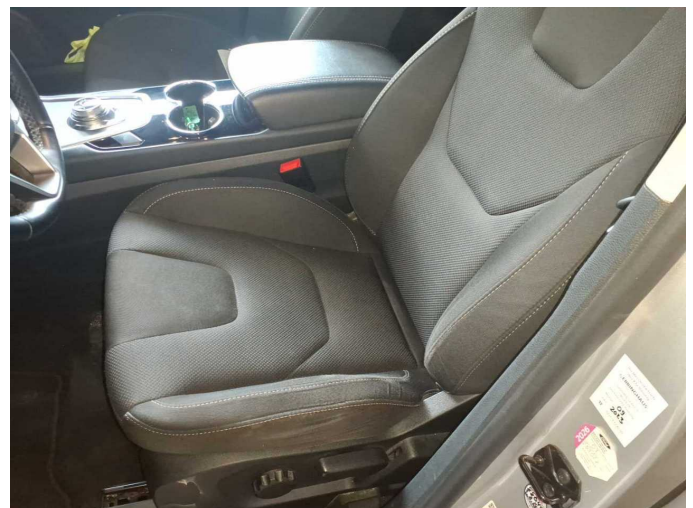
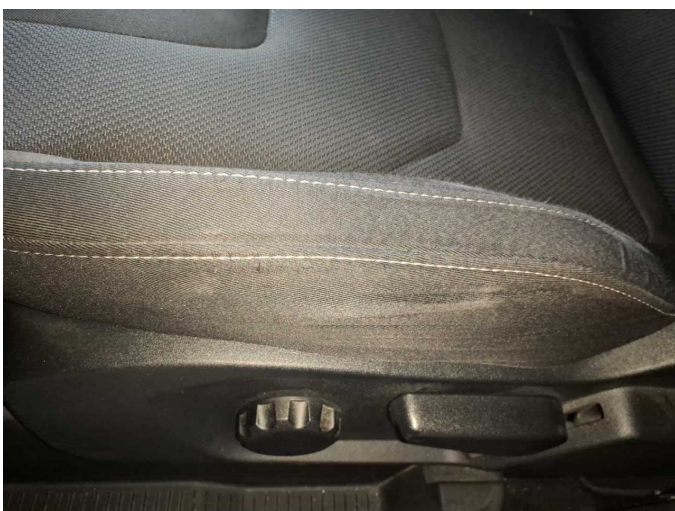
Damage 2: Seat - front: Seat cover - left side - Scratched - Smart repair

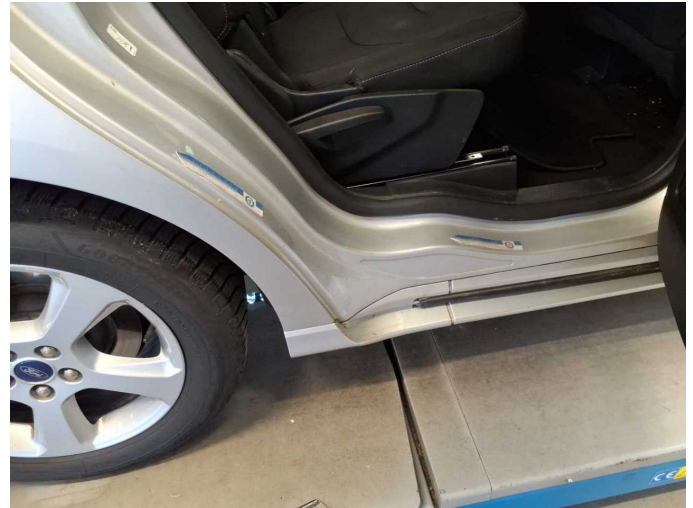
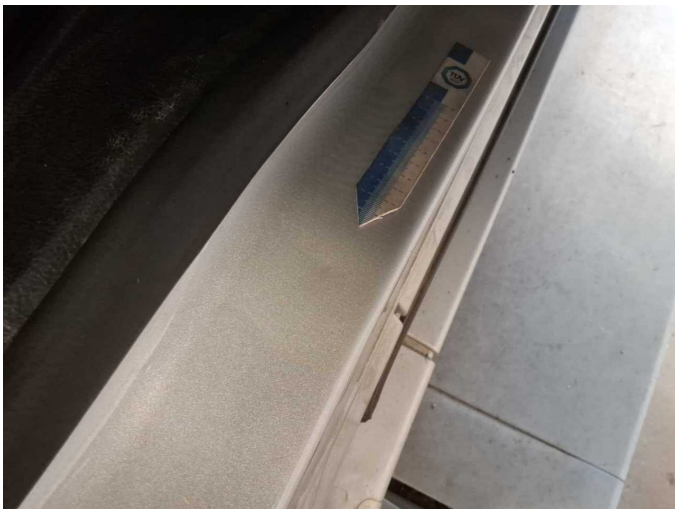
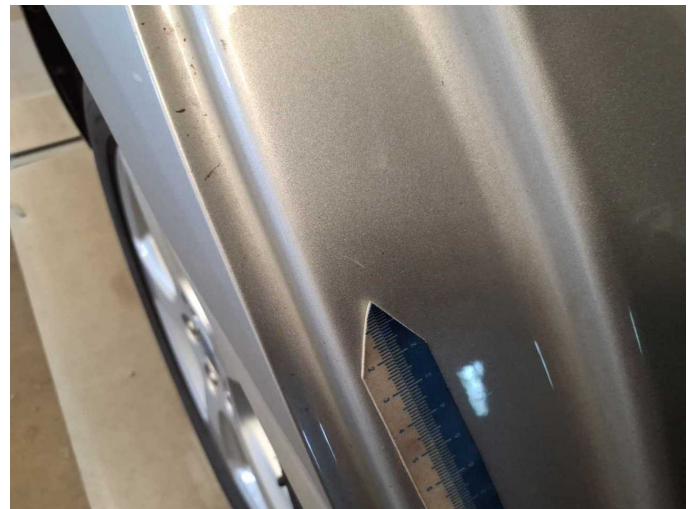
**Damage 4:** Side panel - rear right side: Sill - Dent / paintcoat damage - Smart repair

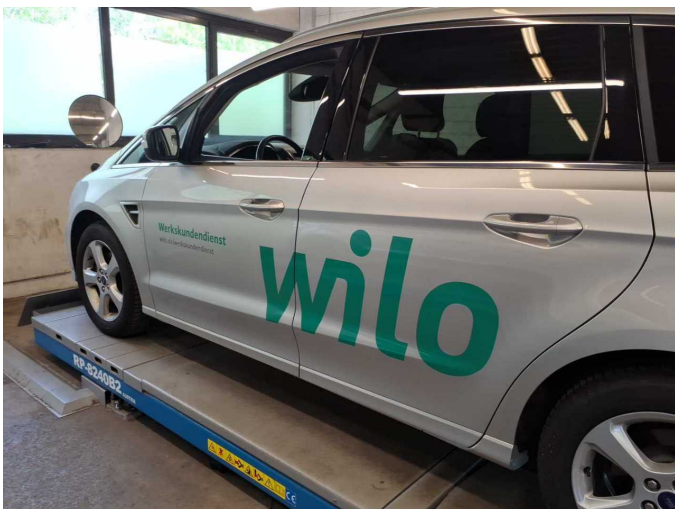
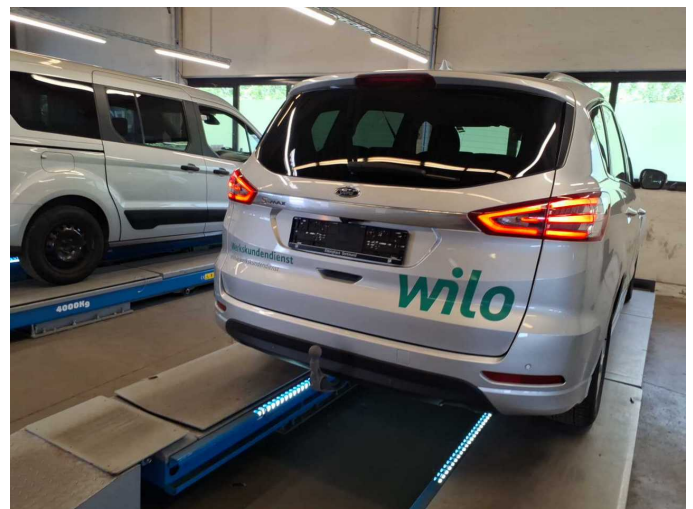
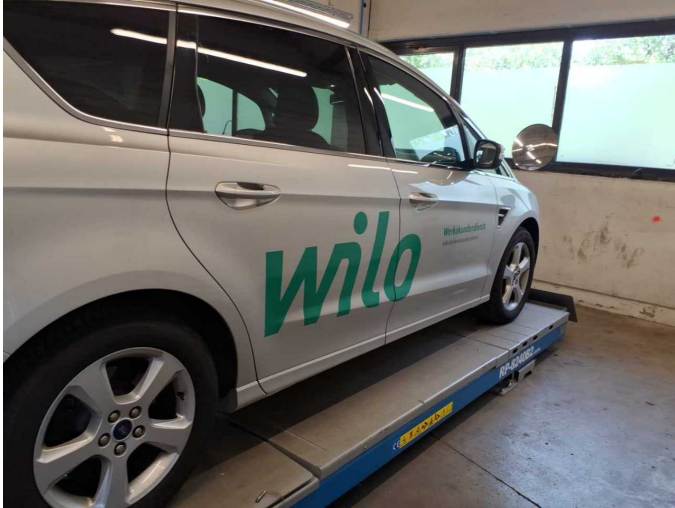
**Damage 5:** Body: Body - Glued / labelled - De-glue / neutralise

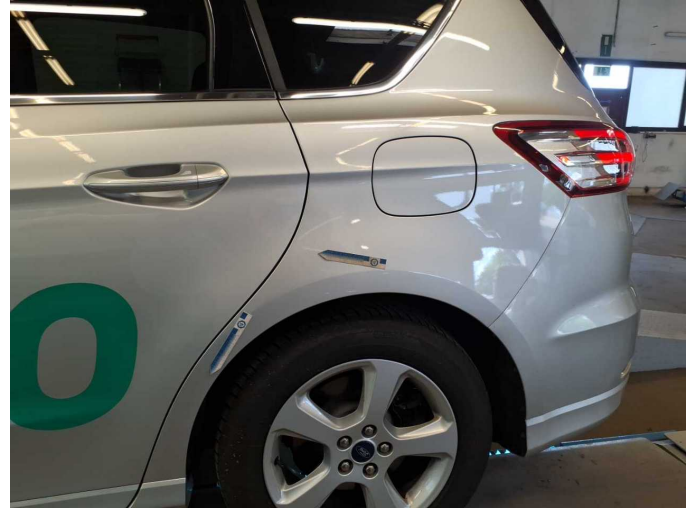
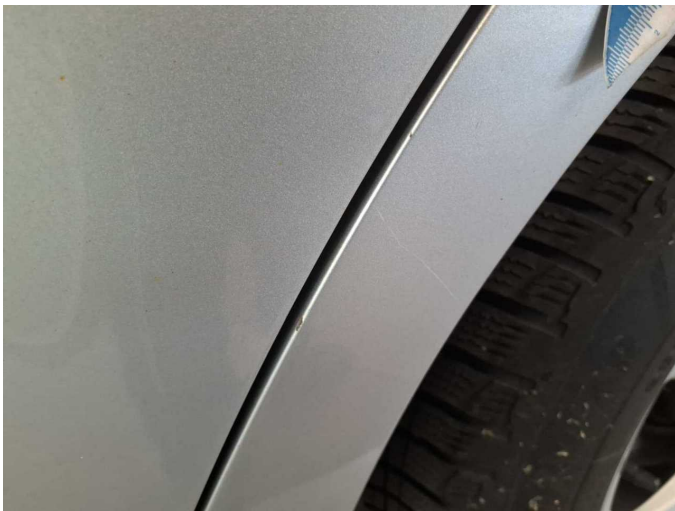
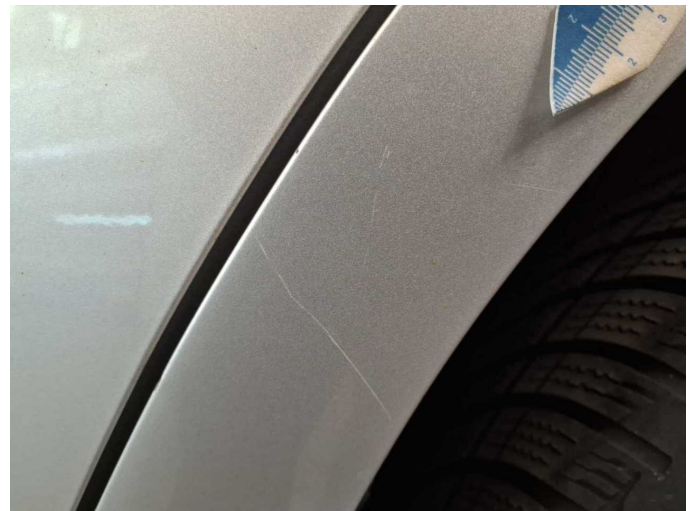
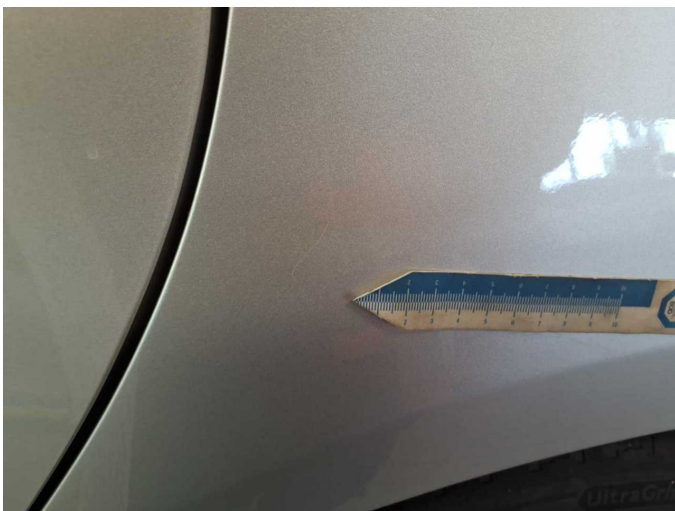
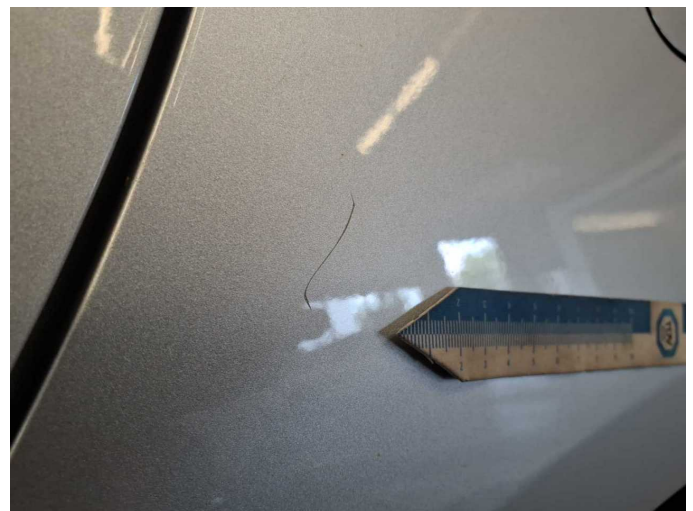
**Damage 6:** Side panel - rear left side: Side panel - Scratched - Paint

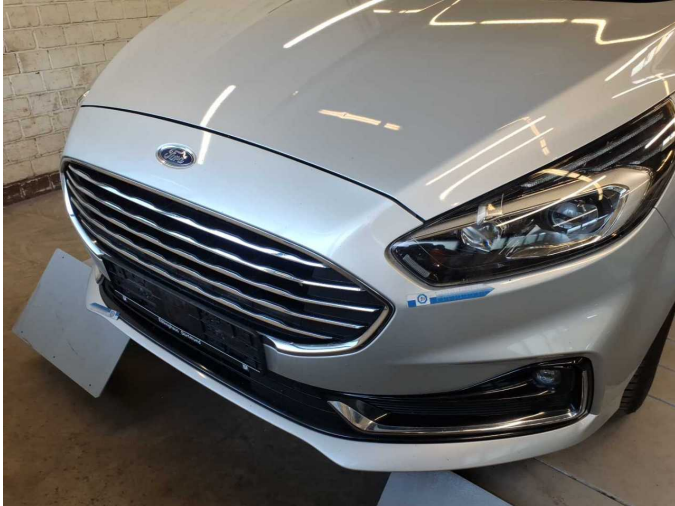
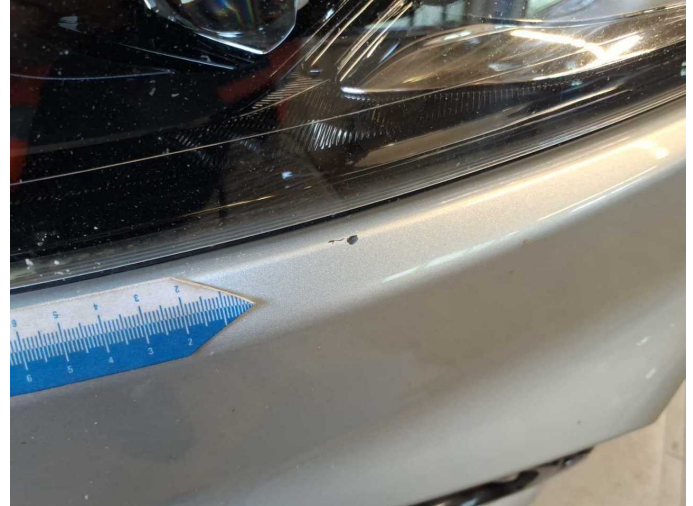
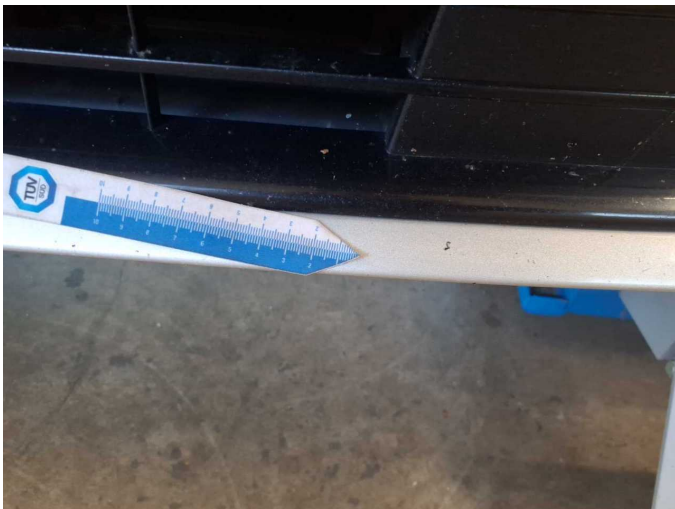
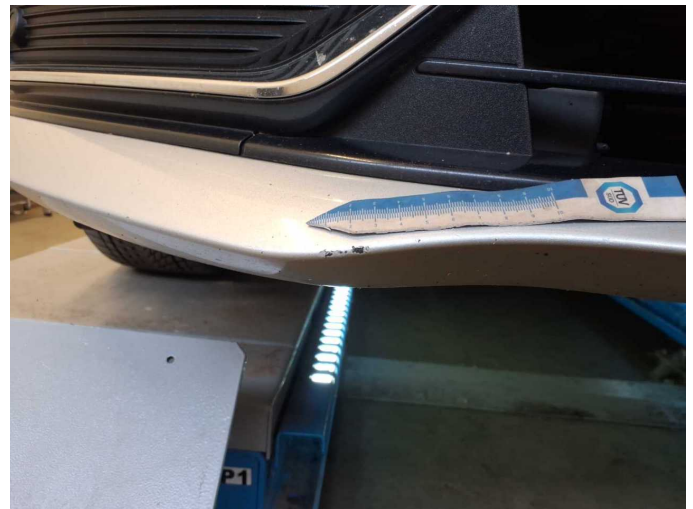
**Damage 7:** Front bumper: Front bumper - Scratched - Paint

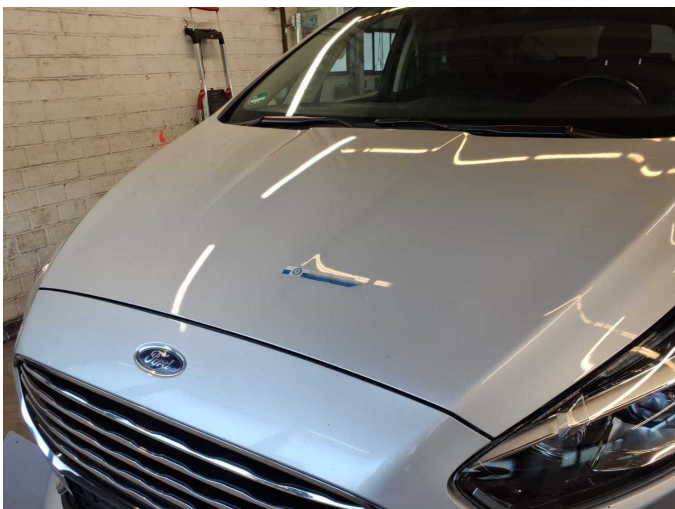
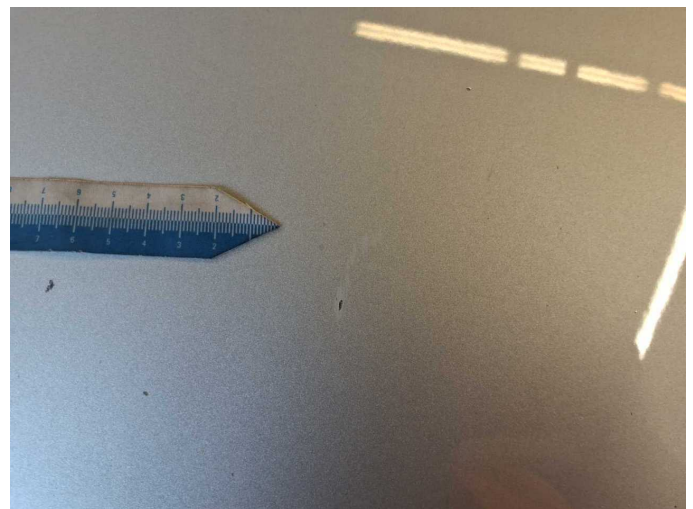
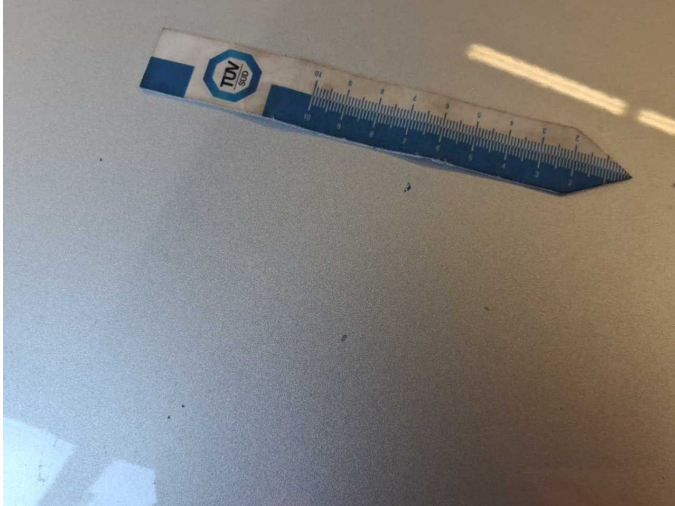
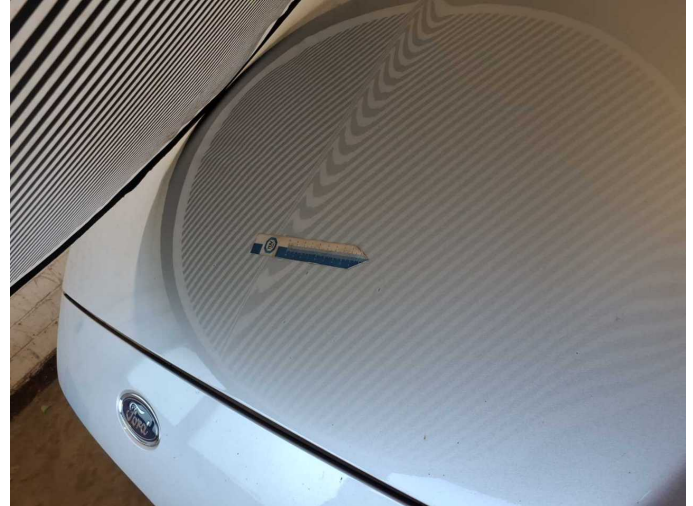
**Damage 8:** Bonnet: Bonnet - Dent / paintcoat damage - Repair and paint

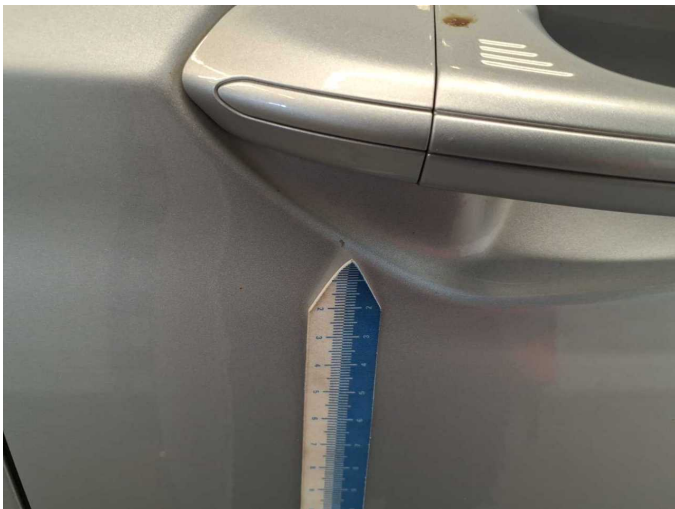
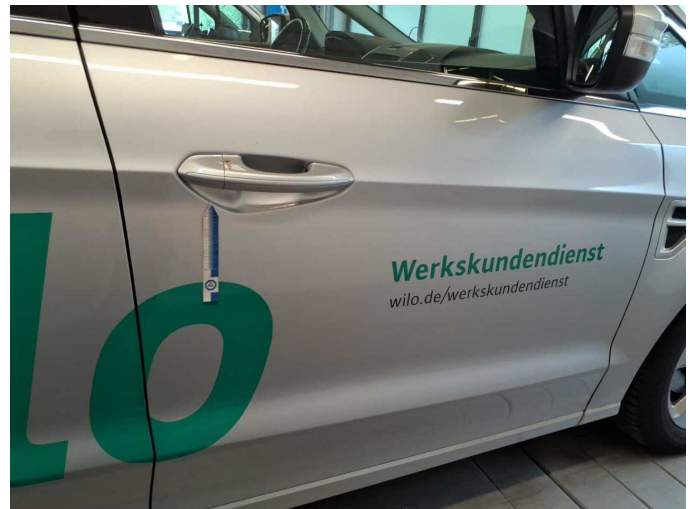
**Wear and tear 1:** Door - front right side: Door - Stone chips - No deduction
