Expertise

Protocol number: 46046168  
Order No. / Reference: 26461424  
Inspection date: 19 Jun 2026

| Manufacturer: Ford | Model: Focus Turnier 1.5 EcoBlue Start-Stopp-System Aut. ST-LINE |
| VIN: WF0PXXGCHPMG56519 | |

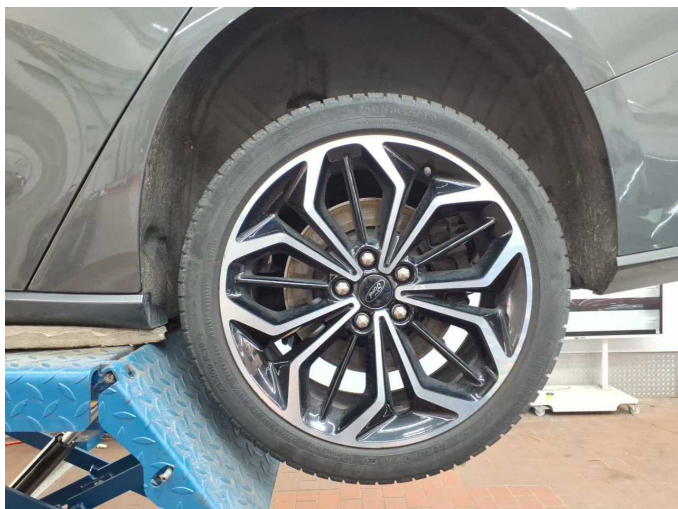
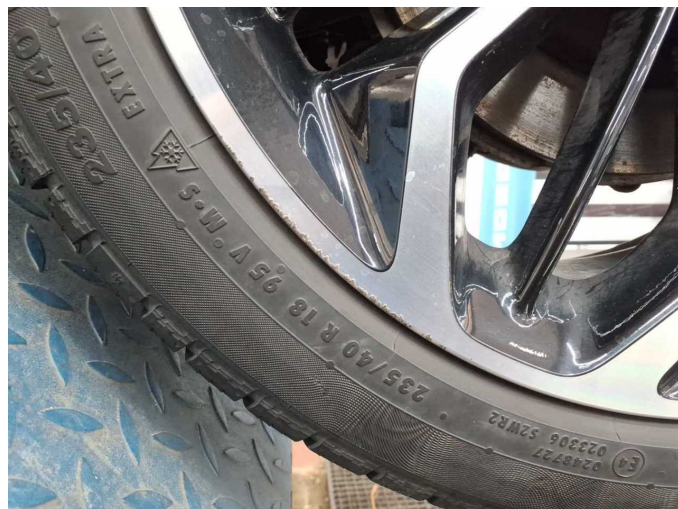
| No. | Component group | Description |
|---|---|---|
| 1 | Wheel / tyres | Alloy rim - rear left side - Scratch(es) - Loss in value |

**Damage 1:** Wheel / tyres: Alloy rim - rear left side - Scratch(es) - Loss in value

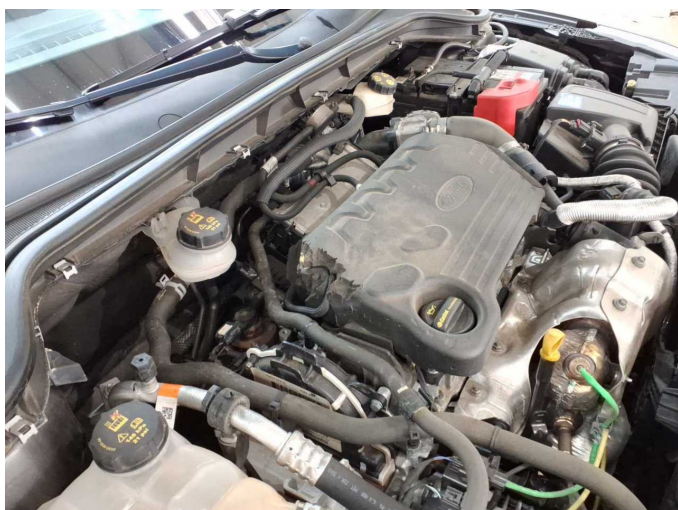
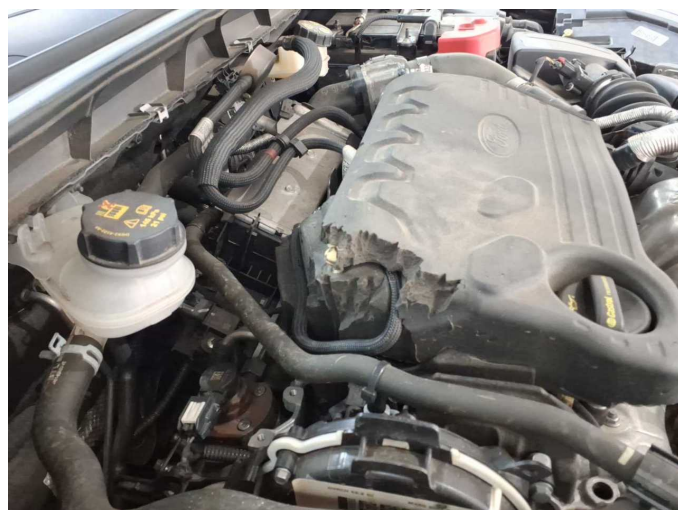
| No. | Component group | Description |
|---|---|---|
| 2 | Engine | Engine cover - Damage caused by marten / rodent - Replace |

Marder Spuren sind im Motorraum, weitere Schäden sind möglich.

**Damage 2:** Engine: Engine cover - Damage caused by marten / rodent - Replace

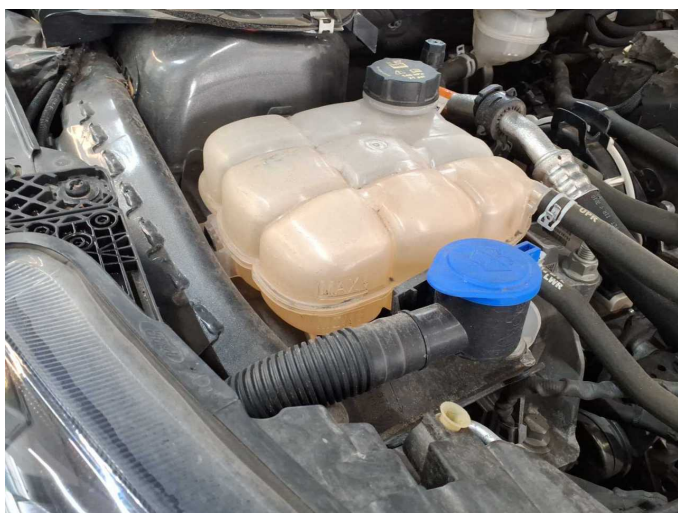
| No. | Component group | Description |
|---|---|---|
| 3 | Engine cooling | Coolant (Behälter - Mehrkosten möglich) - Leaking - Perform diagnosis |

**Damage 3:** Engine cooling: Coolant (Behälter - Mehrkosten möglich) - Leaking - Perform diagnosis

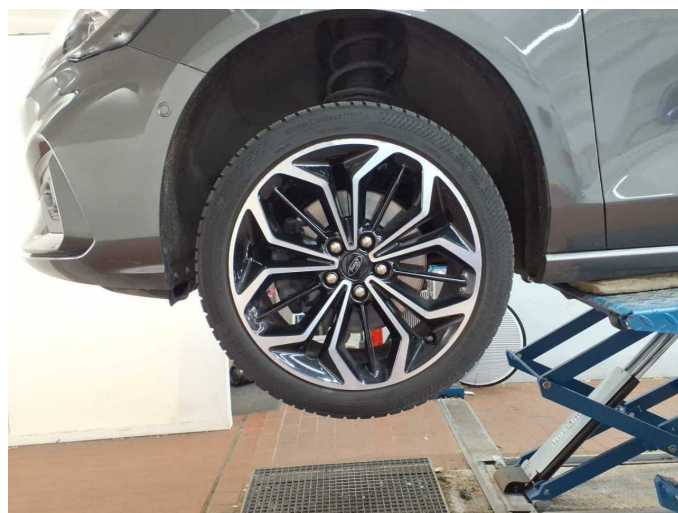
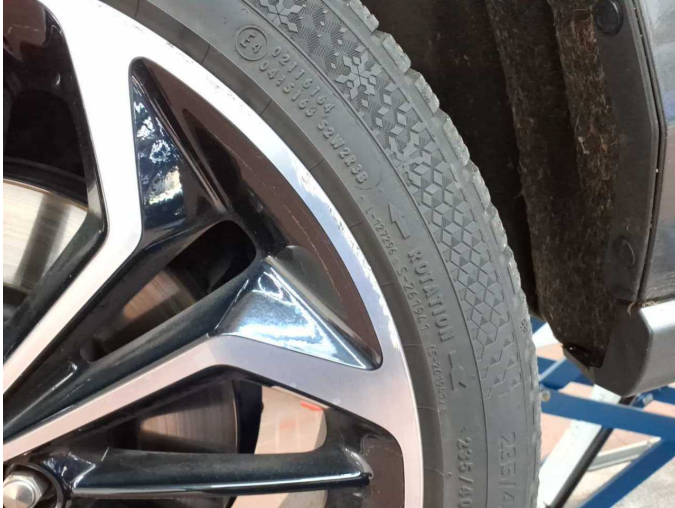
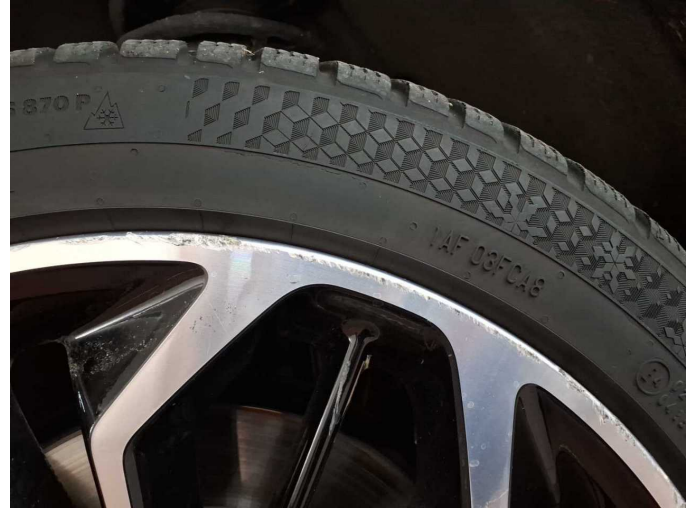
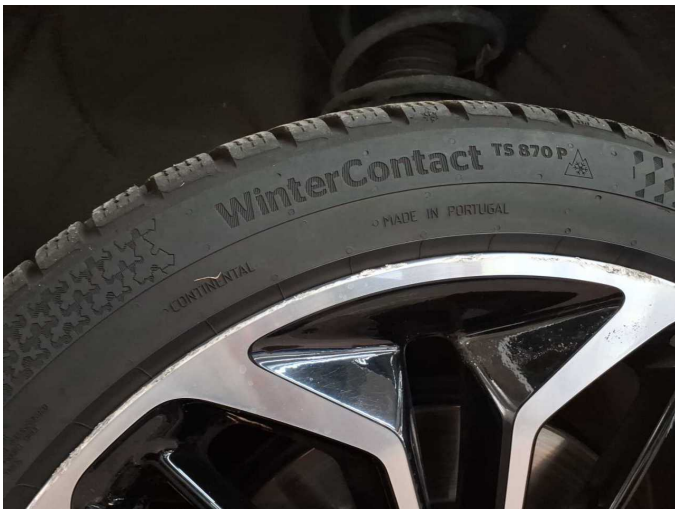
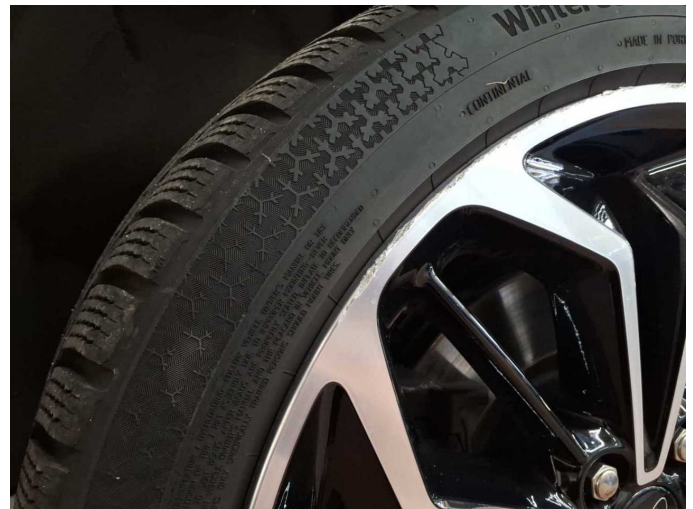
| No. | Component group | Description |
|---|---|---|
| 4 | Wheel / tyres | Alloy rim - front left side - Scratch(es) - Loss in value |

**Damage 4:** Wheel / tyres: Alloy rim - front left side - Scratch(es) - Loss in value

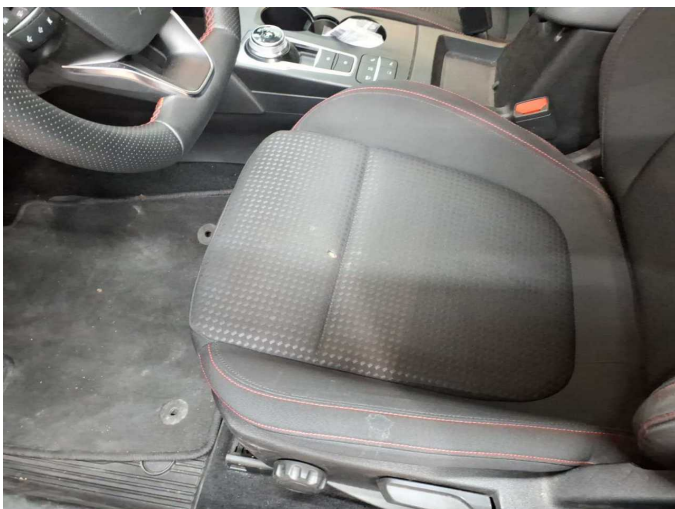
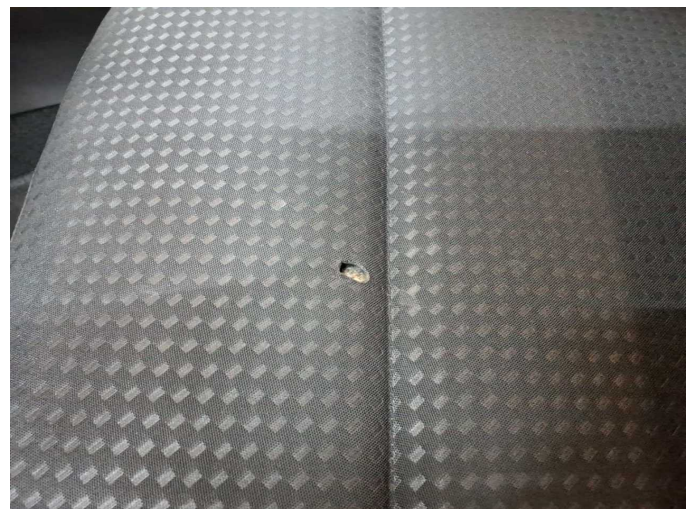
| No. | Component group | Description |
|---|---|---|
| 5 | Seat - front | Seat cover - left side - Burn hole (cigarettes) - Replace |

**Damage 5:** Seat - front: Seat cover - left side - Burn hole (cigarettes) - Replace

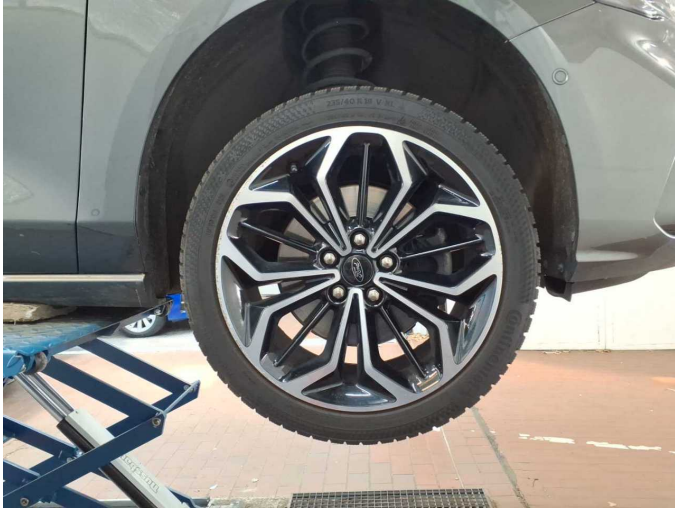
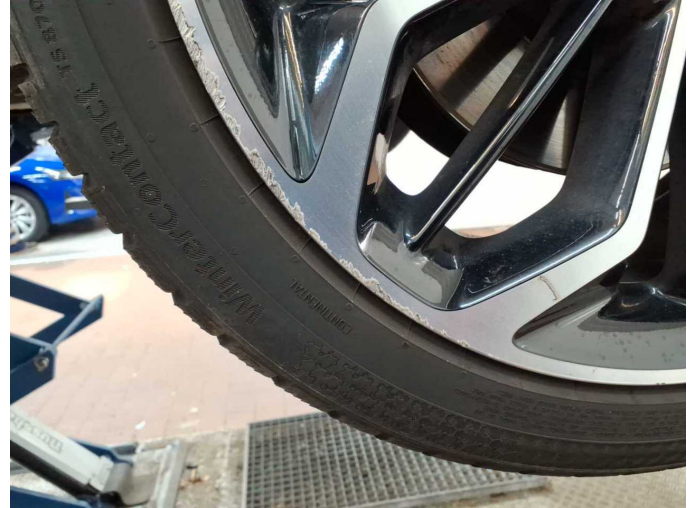
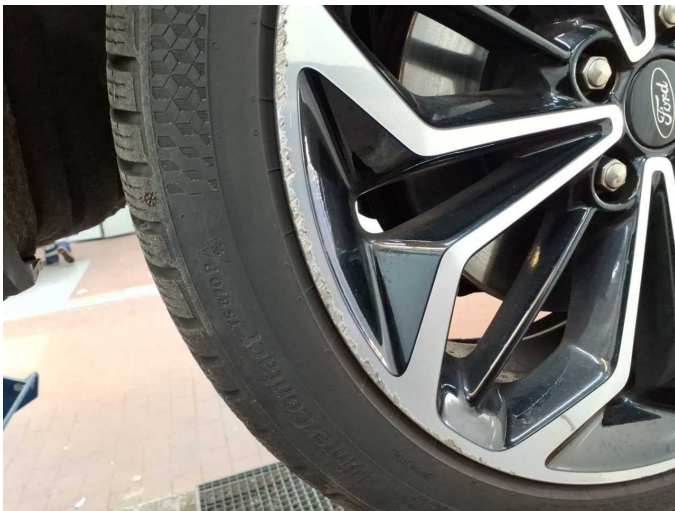
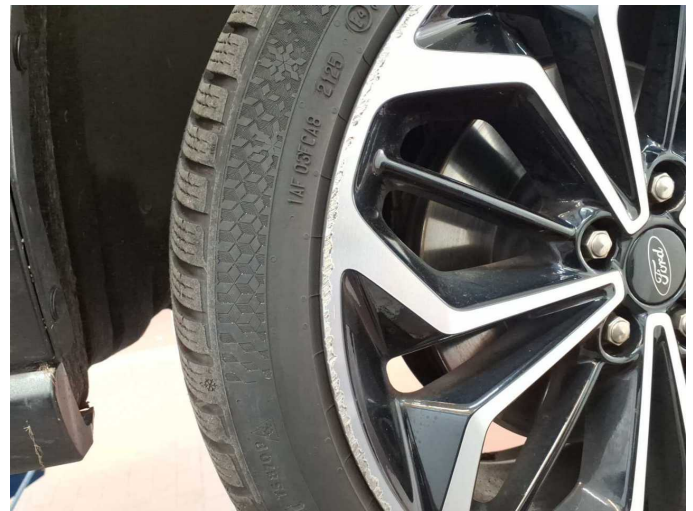
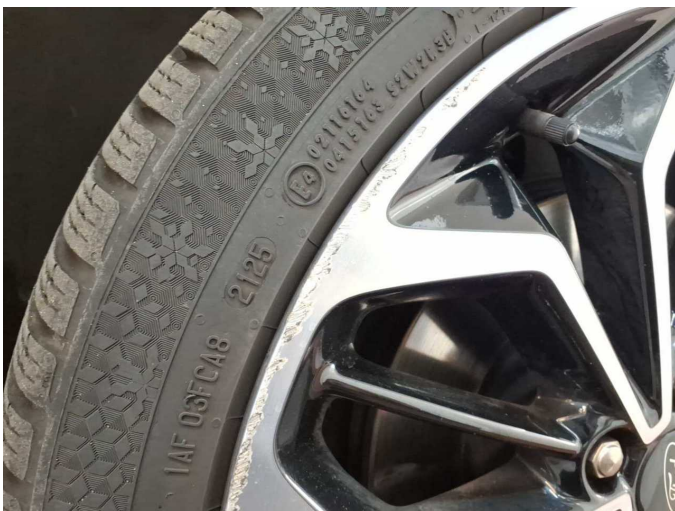
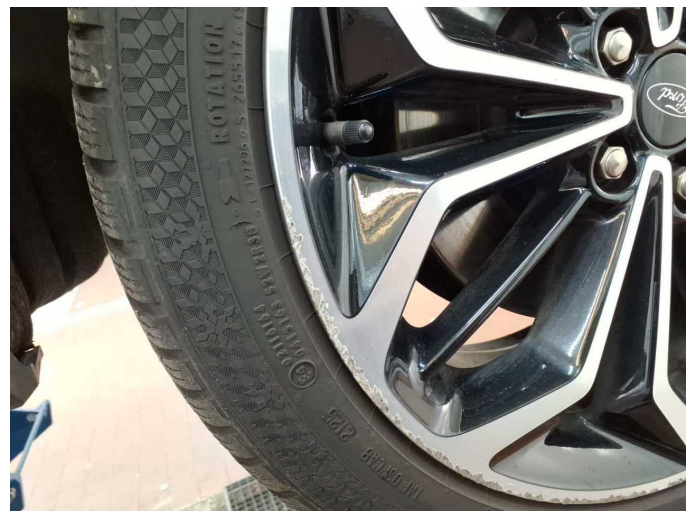
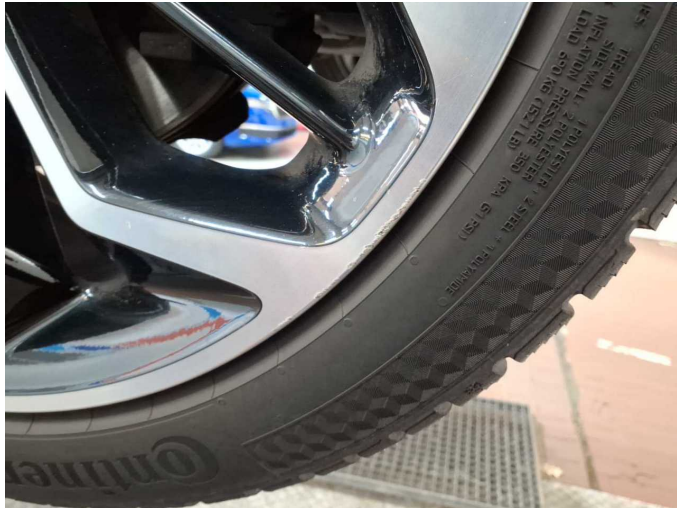
| No. | Component group | Description |
|---|---|---|
| 6 | Wheel / tyres | Alloy rim - front right side - Scratched - Replace |

**Damage 6:** Wheel / tyres: Alloy rim - front right side - Scratched - Replace
