Expertise

Protocol number: 46910136  
Order No. / Reference: 26776851  
Inspection date: 4 Aug 2026

| Manufacturer: Opel | Model: Astra 1.5 D Start/Stop Sports Tourer Automatik Edition |
| VIN: W0VBD8EV8M8013074 | |

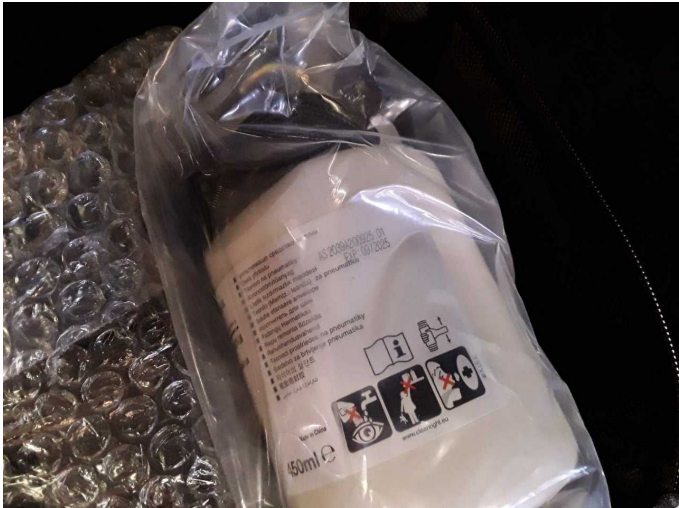
| No. | Component group | Description |
|---|---|---|
| 1 | Equipment | Tirefit filler - Expired - Replace |

Damage 1: Equipment: Tirefit filler - Expired - Replace

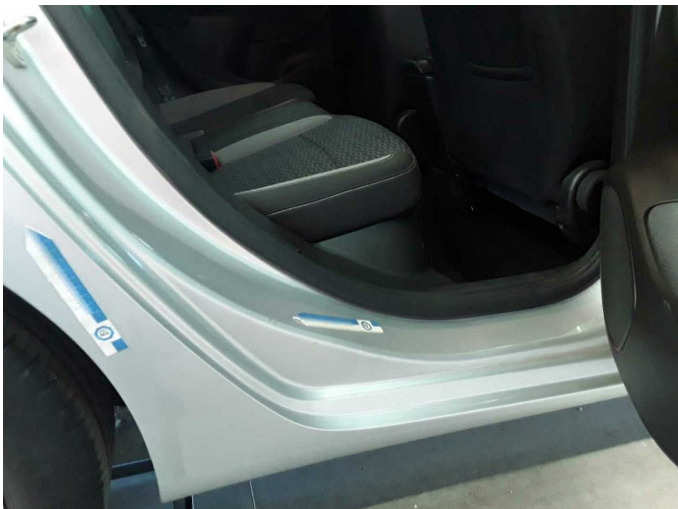
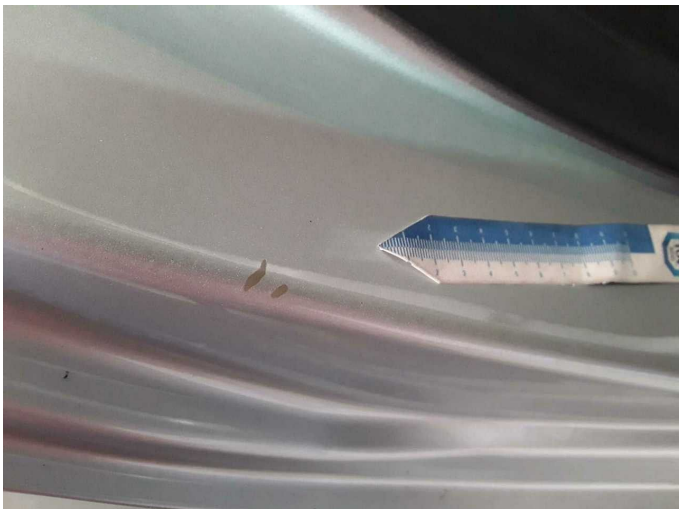
| No. | Component group | Description |
|---|---|---|
| 2 | Side panel - rear right side | Sill - Scratched - Smart repair |

Damage 2: Side panel - rear right side: Sill - Scratched - Smart repair

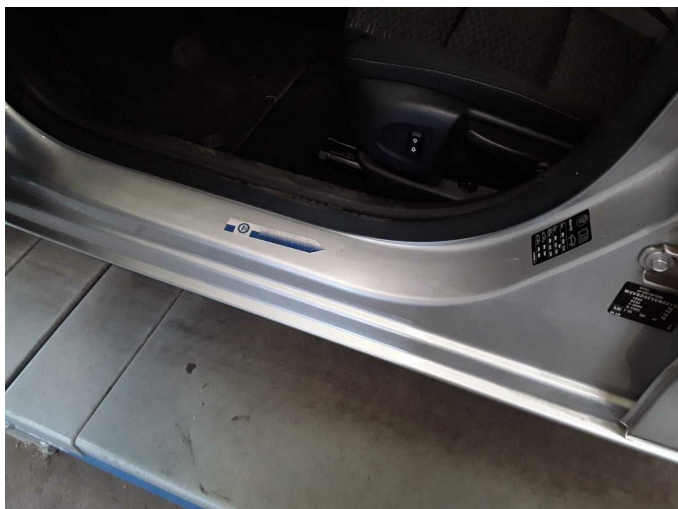
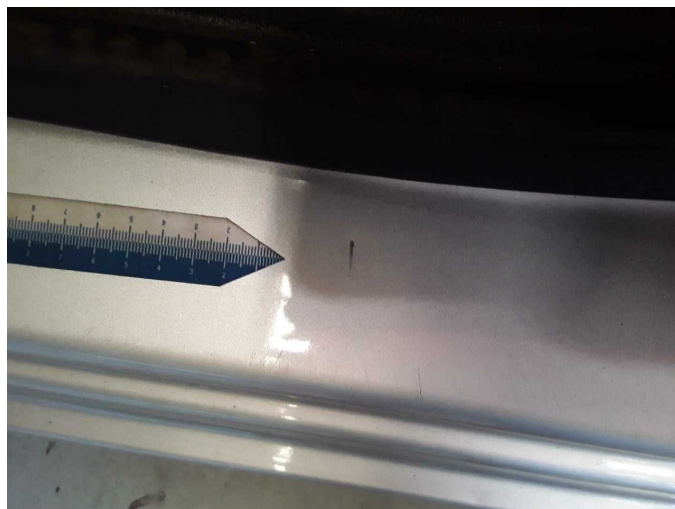
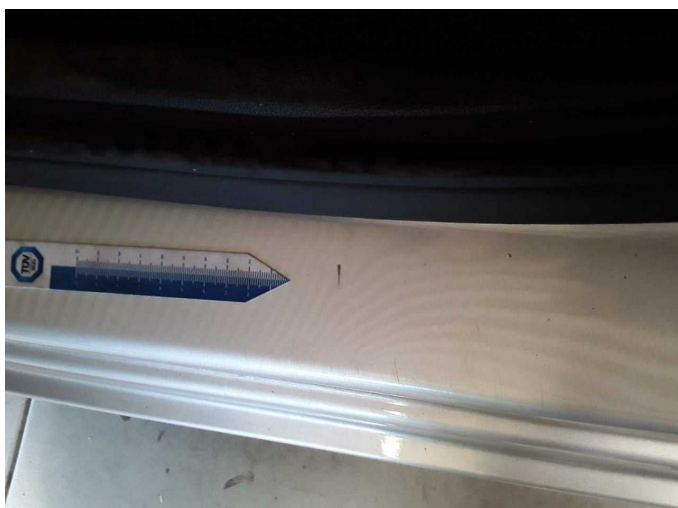
| No. | Component group | Description |
|---|---|---|
| 3 | Sill - left side | Sill - Dent / paintcoat damage - Smart repair |

**Damage 3:** Sill - left side: Sill - Dent / paintcoat damage - Smart repair

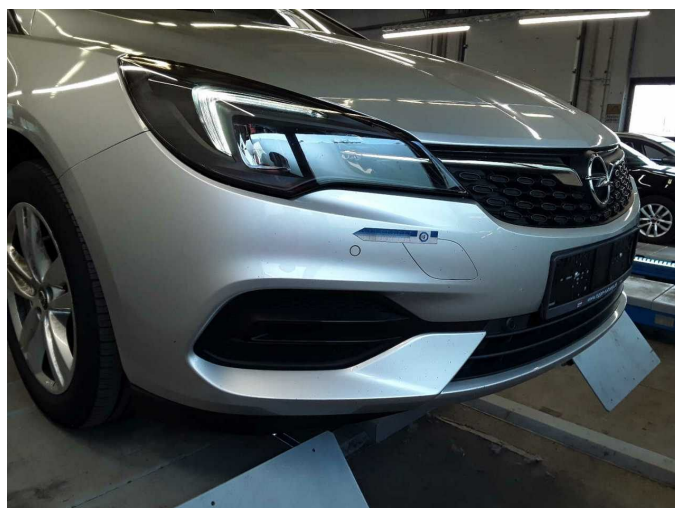
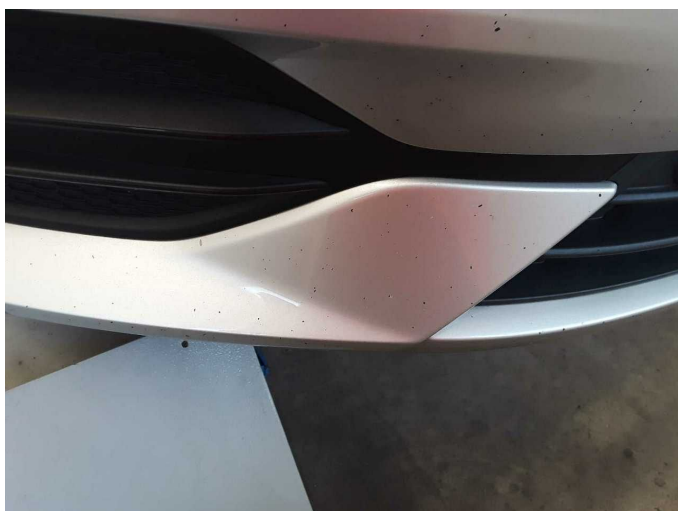
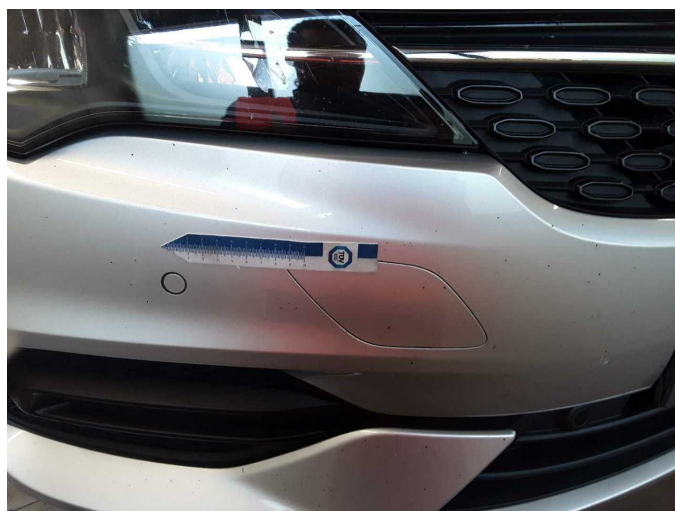
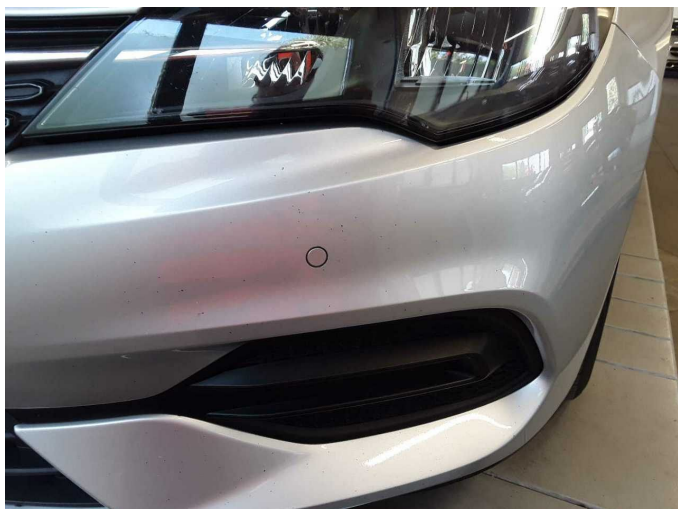
| No. | Component group | Description |
|---|---|---|
| 4 | Front bumper | Front bumper - Stone chips - Paint |

**Damage 4:** Front bumper: Front bumper - Stone chips - Paint

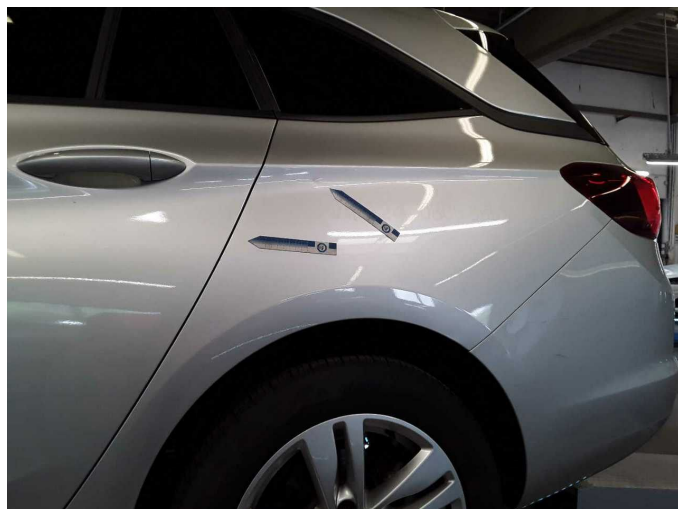
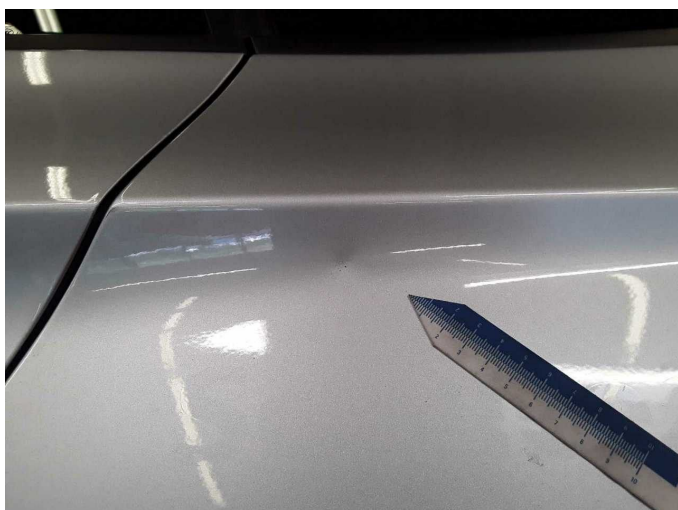
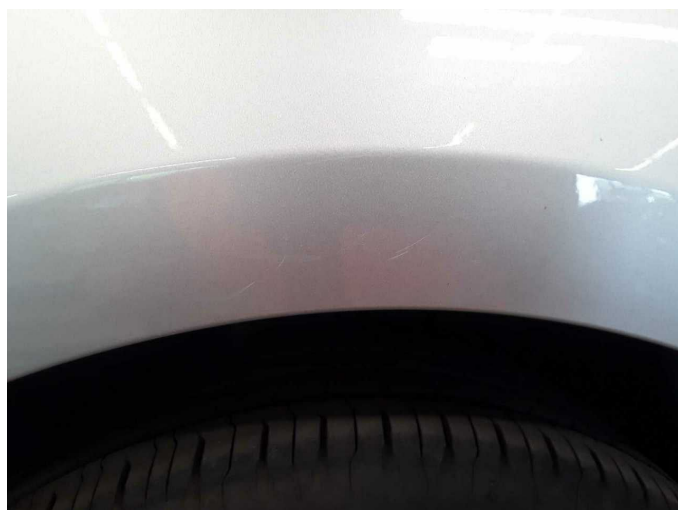
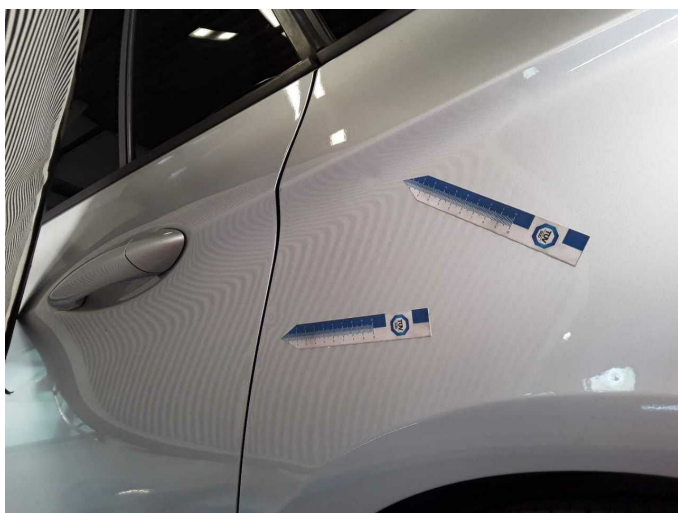
| No. | Component group | Description |
|---|---|---|
| 5 | Side panel - rear left side | Side panel - Dent / paintcoat damage - Repair and paint |

**Damage 5:** Side panel - rear left side: Side panel - Dent / paintcoat damage - Repair and paint

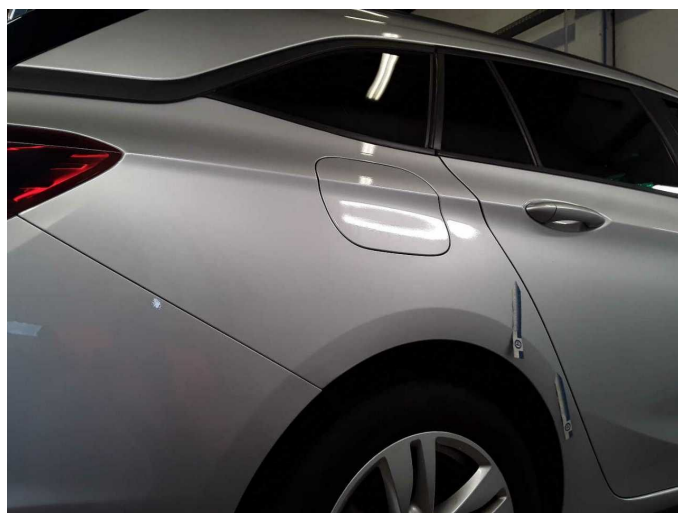
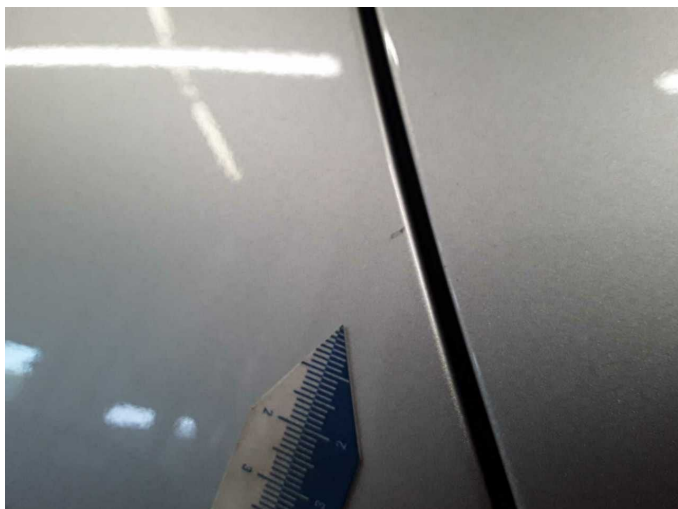
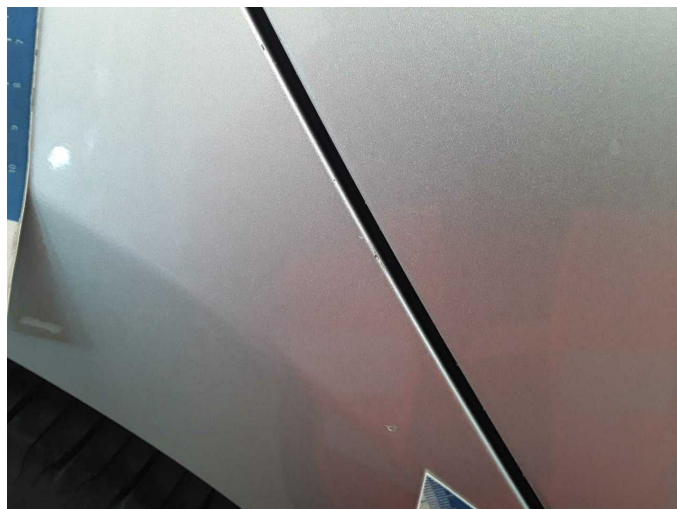
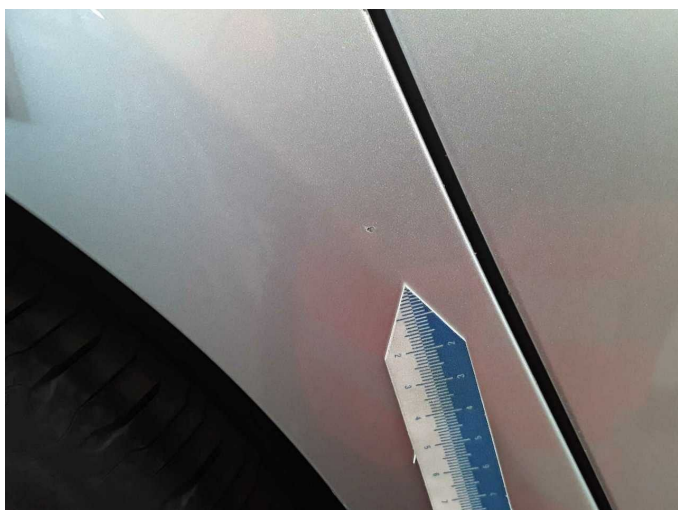
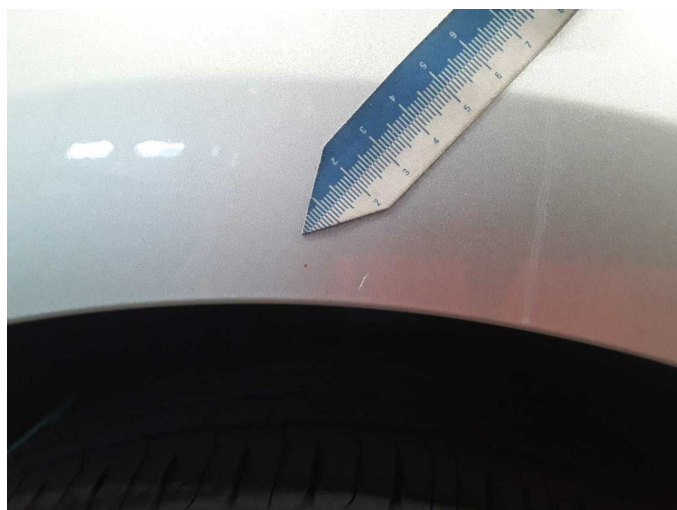
| No. | Component group | Description |
|---|---|---|
| 6 | Side panel - rear right side | Side panel - Scratch(es) - Paint |

**Damage 6:** Side panel - rear right side: Side panel - Scratch(es) - Paint

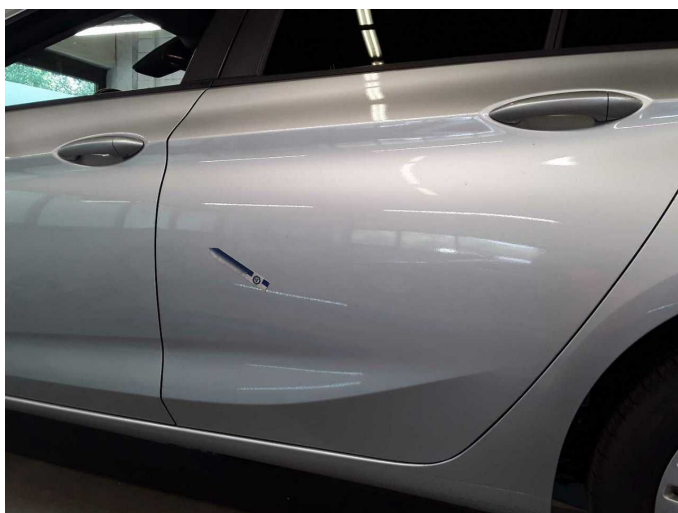
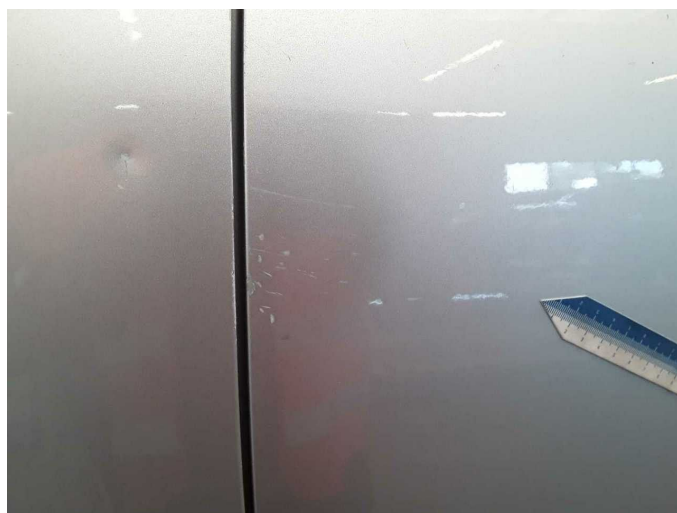
| No. | Component group | Description |
|---|---|---|
| 7 | Door - rear left side | Door - Scratch(es) - Paint |

**Damage 7:** Door - rear left side: Door - Scratch(es) - Paint

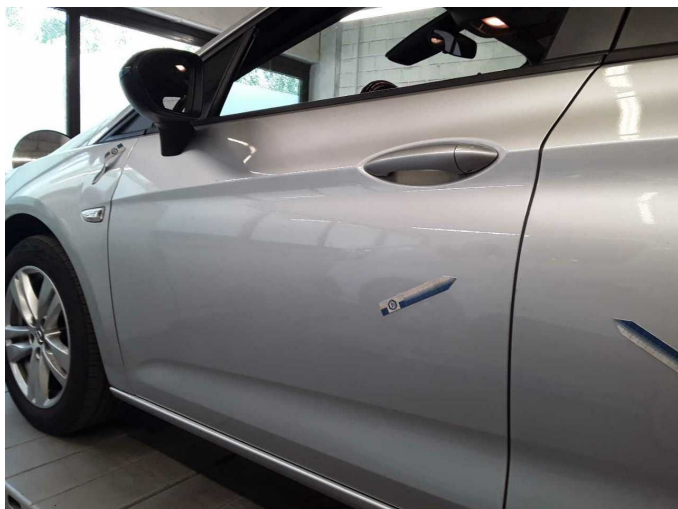
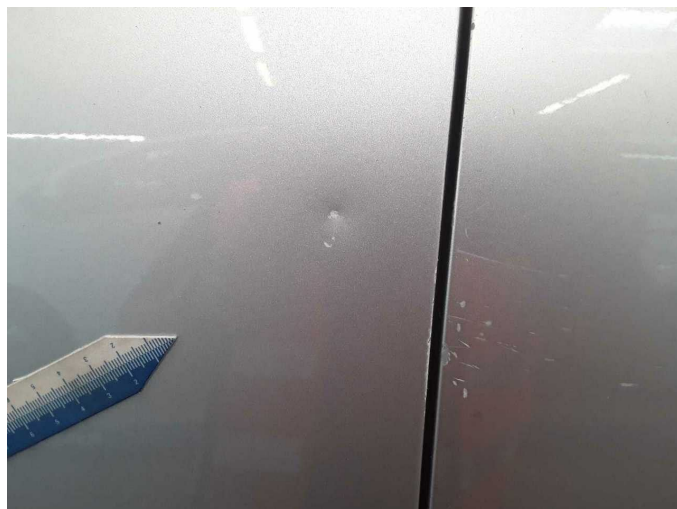
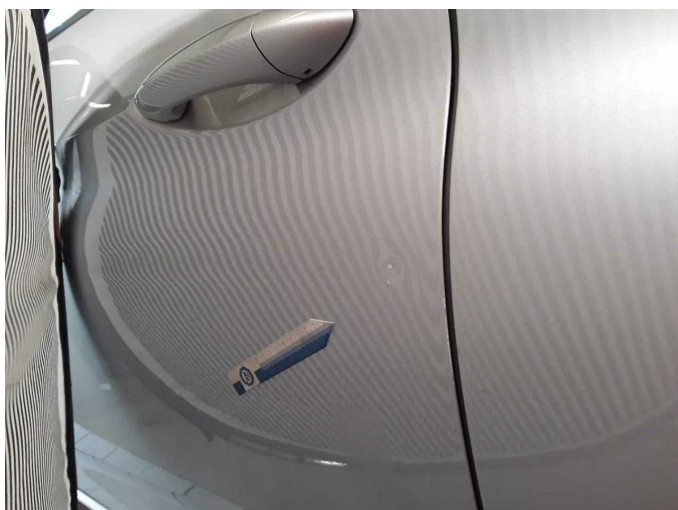
| No. | Component group | Description |
|---|---|---|
| 8 | Door - front left side | Door - Dent / paintcoat damage - Repair and paint |

**Damage 8:** Door - front left side: Door - Dent / paintcoat damage - Repair and paint

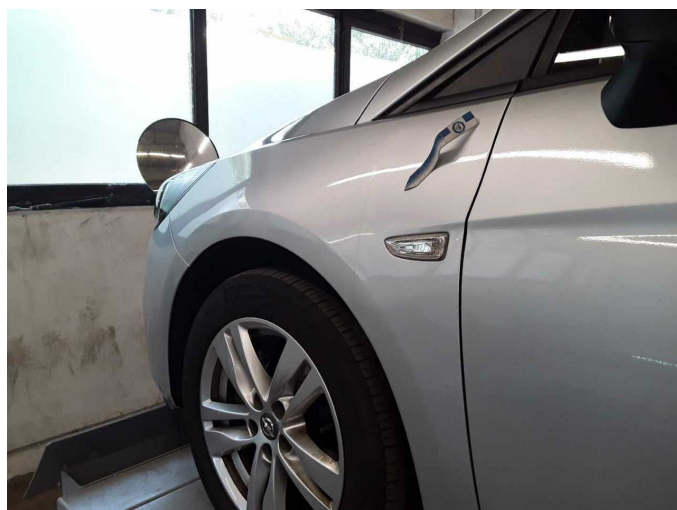
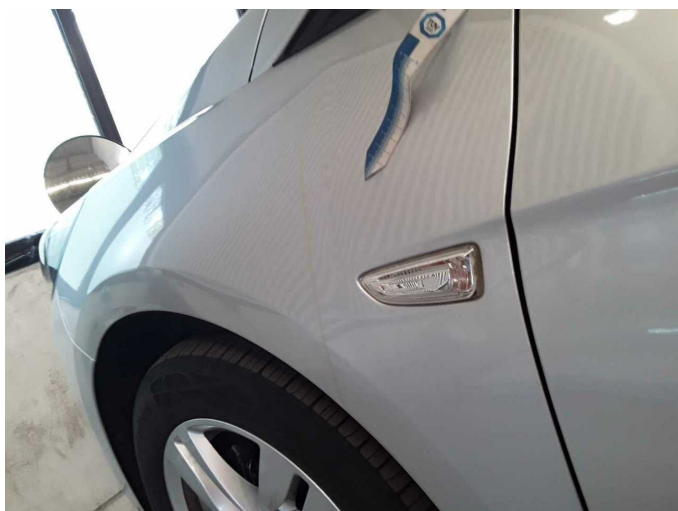
| No. | Component group | Description |
|---|---|---|
| 9 | Mudguard - left side | Mudguard - left side - Deformed - Replace |

**Damage 9:** Mudguard - left side: Mudguard - left side - Deformed - Replace

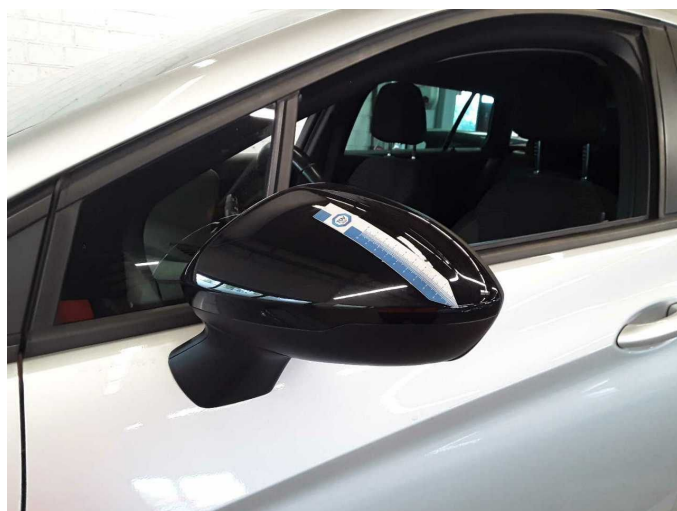
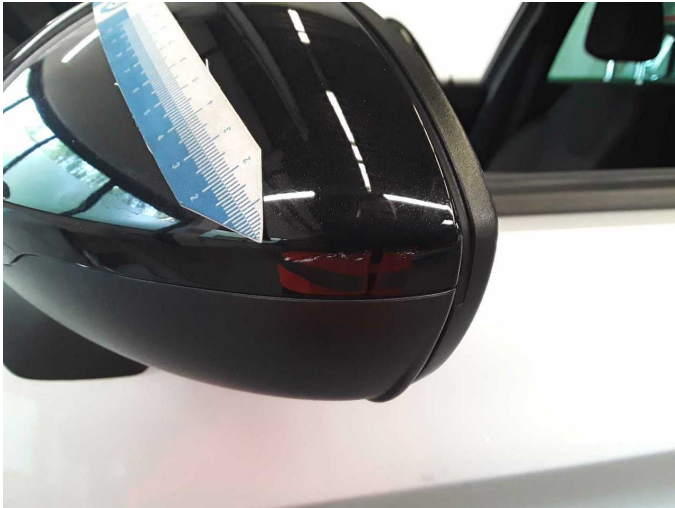
| No. | Component group | Description |
|---|---|---|
| 1 | Wing mirror - left side | Cap - Soiled - No deduction |

**Wear and tear 1:** Wing mirror - left side: Cap - Soiled - No deduction

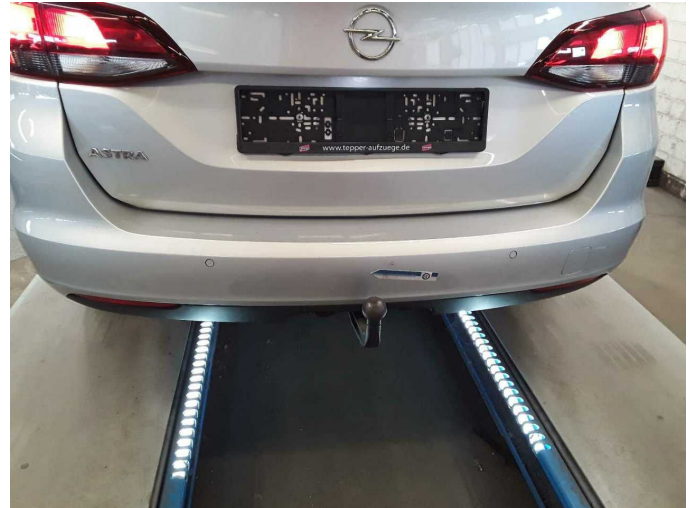
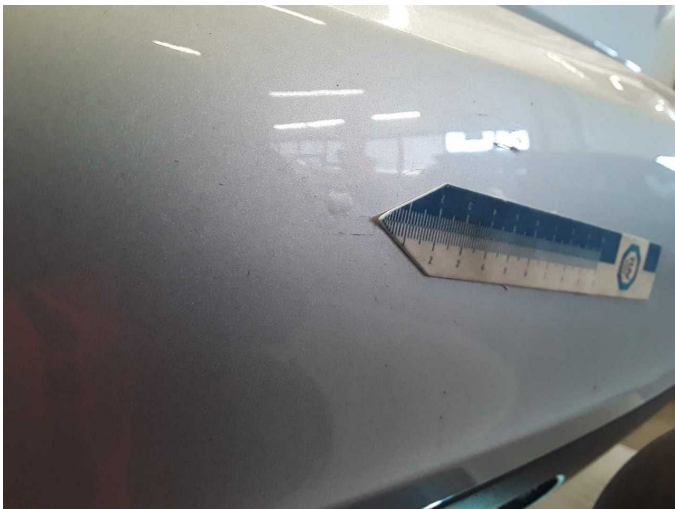
| No. | Component group | Description |
|---|---|---|
| 2 | Rear bumper | Rear bumper - Scratch(es) - No deduction |

**Wear and tear 2:** Rear bumper: Rear bumper - Scratch(es) - No deduction
