## Expertise

Protocol number: 46162124  
Order No. / Reference: 26479714  
Inspection date: 23 Jun 2026

Model: Touran 2.0 TDI SCR DSG Comfortline

VIN: WVGZZZ1T9PW005050

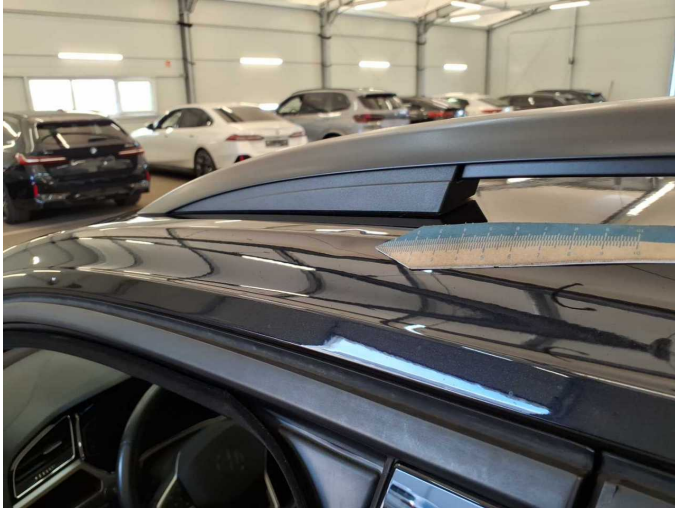
**Damage 1:** Roof: Roof rail - left side - dent(s) - Smooth repair work

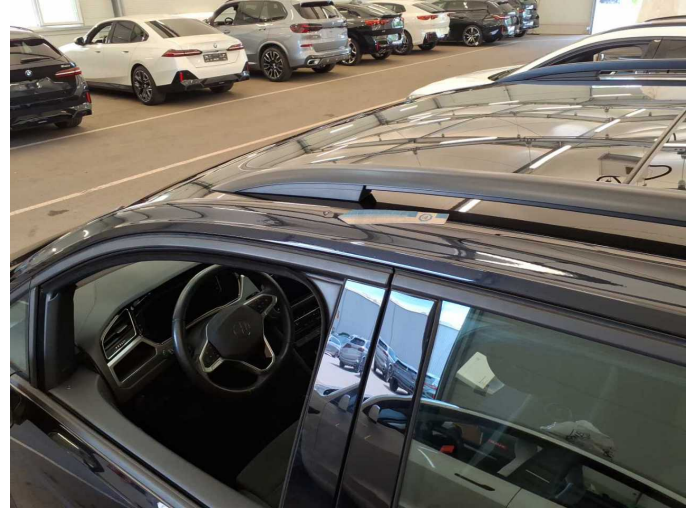
**Damage 1:** Roof: Roof rail - left side - dent(s) - Smooth repair work

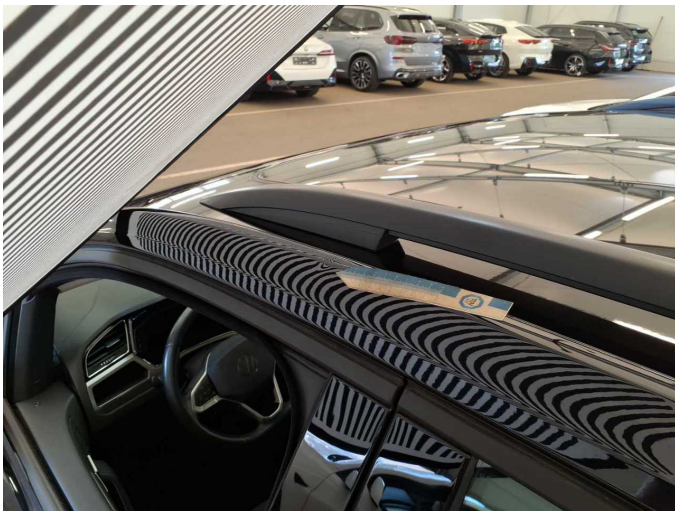
**Damage 1:** Roof: Roof rail - left side - dent(s) - Smooth repair work

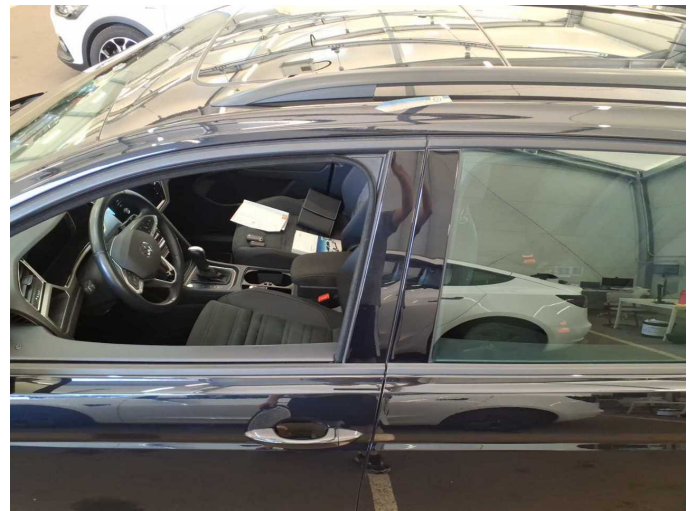
**Damage 1:** Roof: Roof rail - left side - dent(s) - Smooth repair work

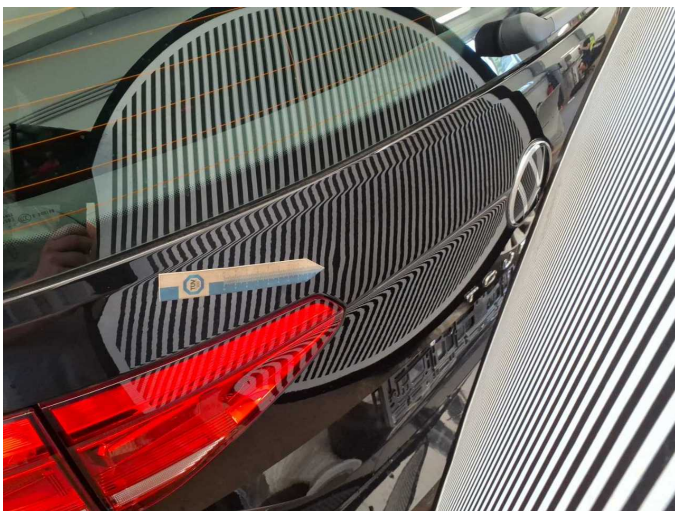
**Damage 2:** Boot lid / rear door: Boot lid - dent(s) - Smooth repair work

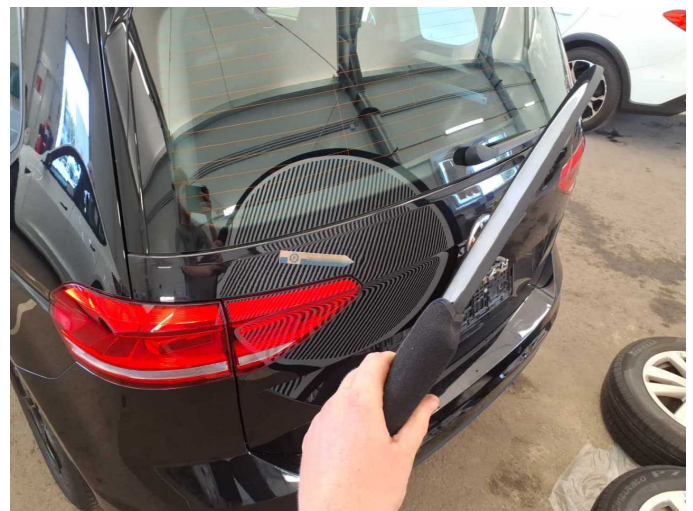
**Damage 2:** Boot lid / rear door: Boot lid - dent(s) - Smooth repair work

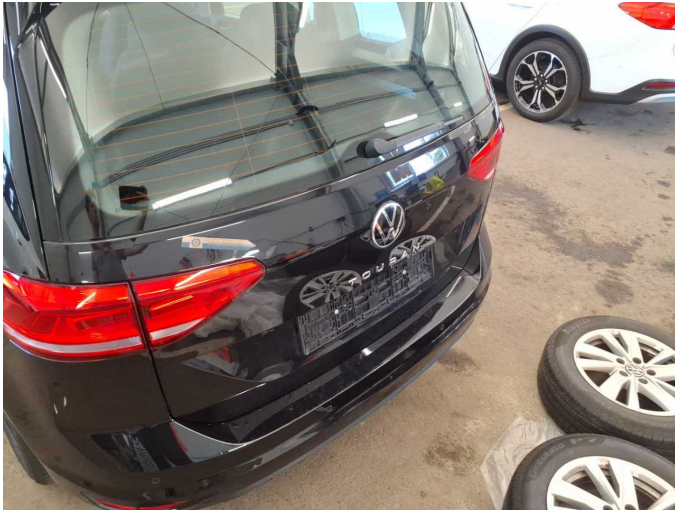
**Damage 2:** Boot lid / rear door: Boot lid - dent(s) - Smooth repair work

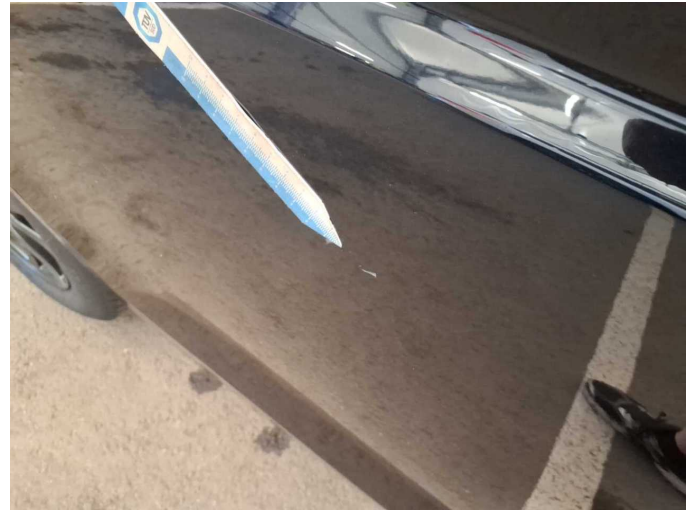
**Damage 3:** Door - rear right side: Door - Scratch(es) - Paint

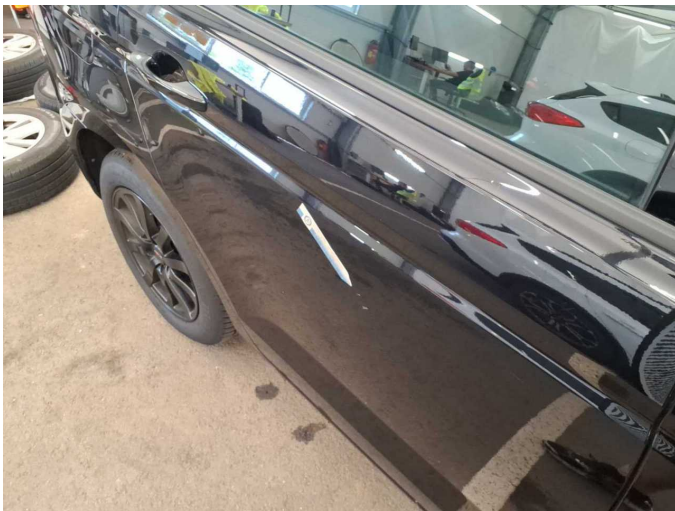
**Damage 3:** Door - rear right side: Door - Scratch(es) - Paint

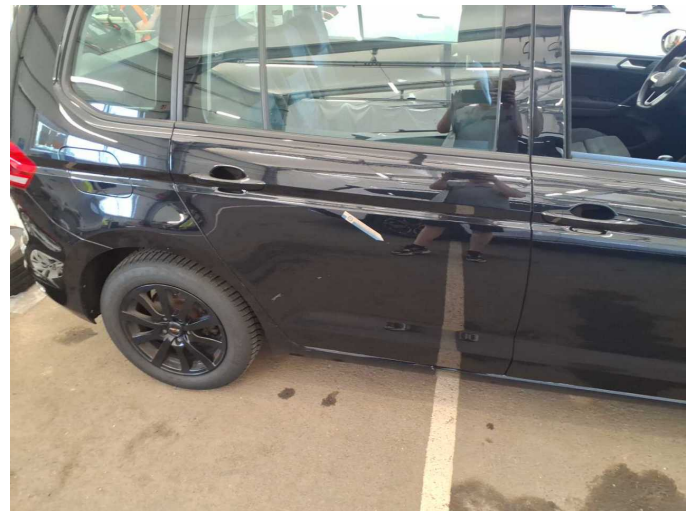
**Damage 3:** Door - rear right side: Door - Scratch(es) - Paint

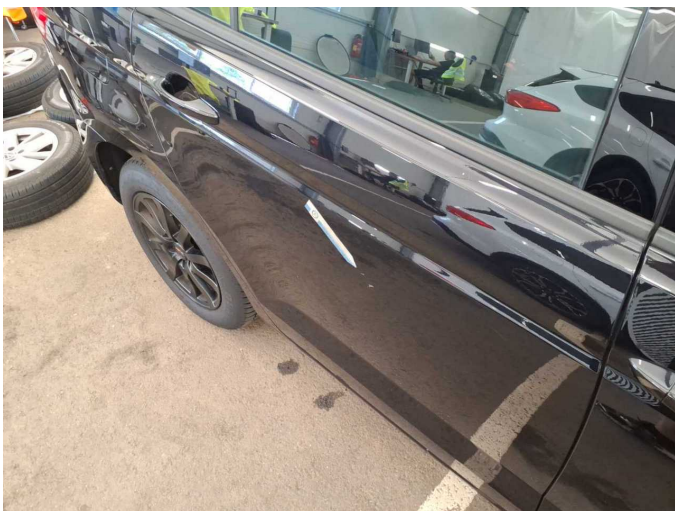
**Damage 3:** Door - rear right side: Door - Scratch(es) - Paint

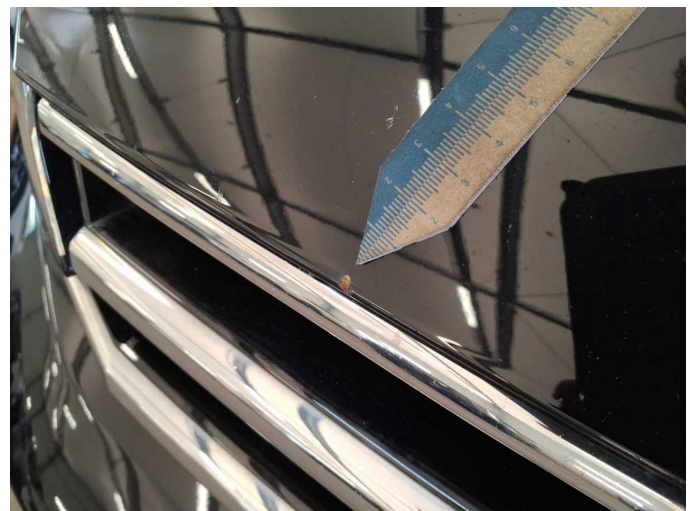
**Damage 4:** Bonnet: Bonnet (Korrosion durch Steinschlag) - Stone chips - Repair and paint

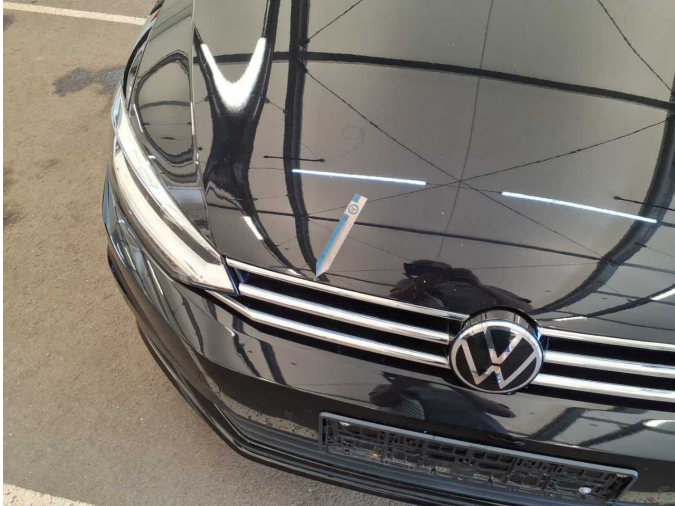
**Damage 4:** Bonnet: Bonnet (Korrosion durch Steinschlag) - Stone chips - Repair and paint

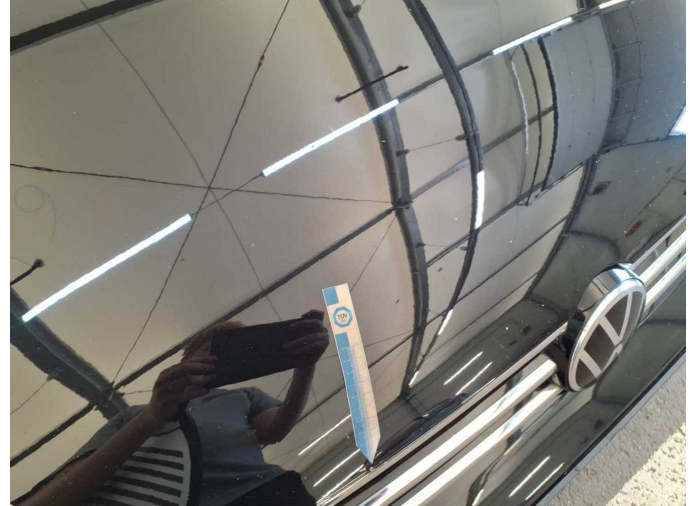
**Damage 4:** Bonnet: Bonnet (Korrosion durch Steinschlag) - Stone chips - Repair and paint

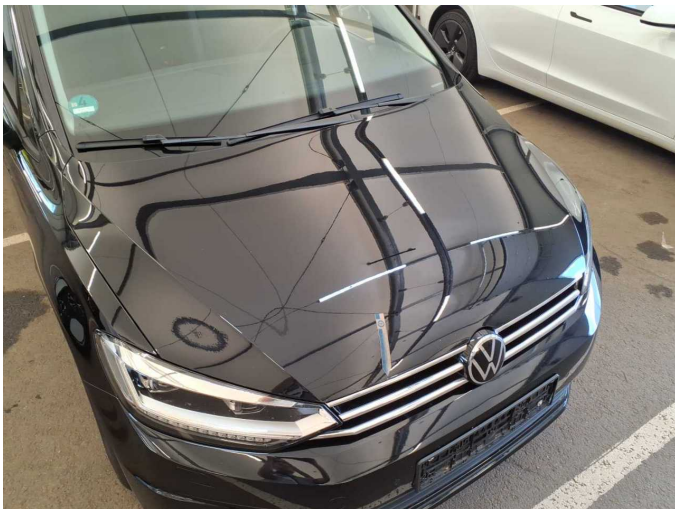
**Damage 4:** Bonnet: Bonnet (Korrosion durch Steinschlag) - Stone chips - Repair and paint

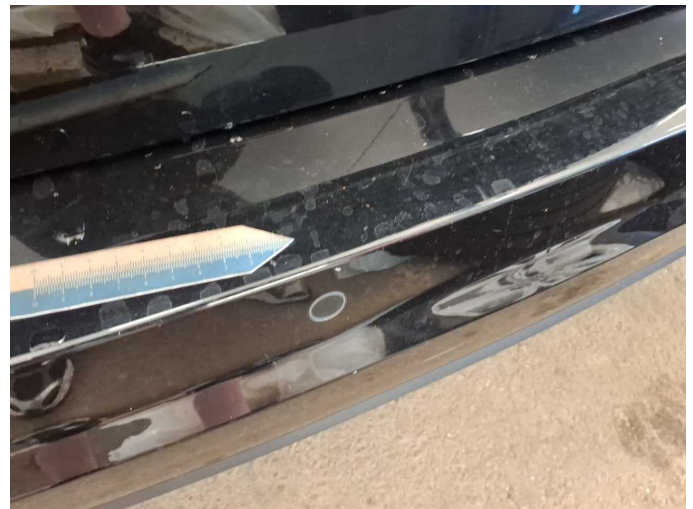
**Damage 5:** Rear bumper: Rear bumper - Scratch(es) - Paint

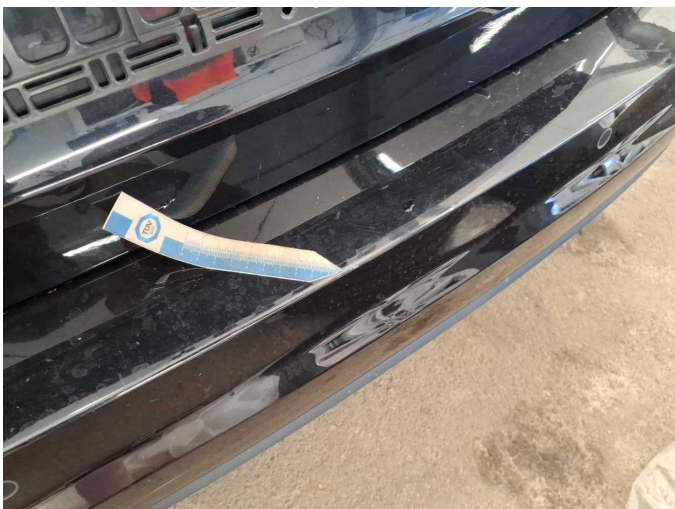
**Damage 5:** Rear bumper: Rear bumper - Scratch(es) - Paint

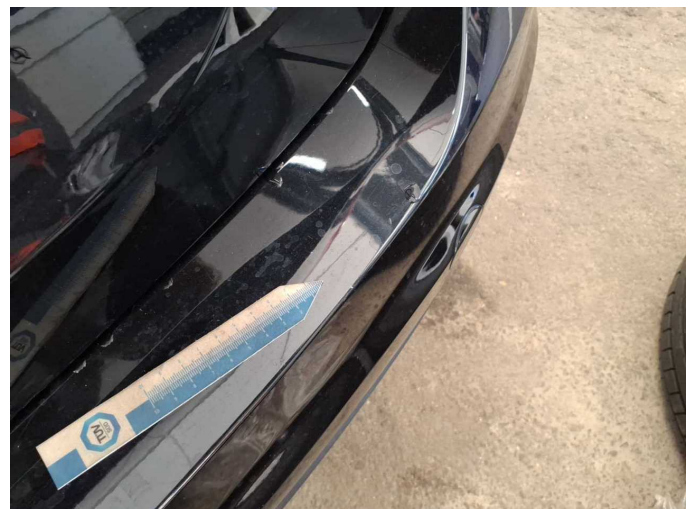
**Damage 5:** Rear bumper: Rear bumper - Scratch(es) - Paint

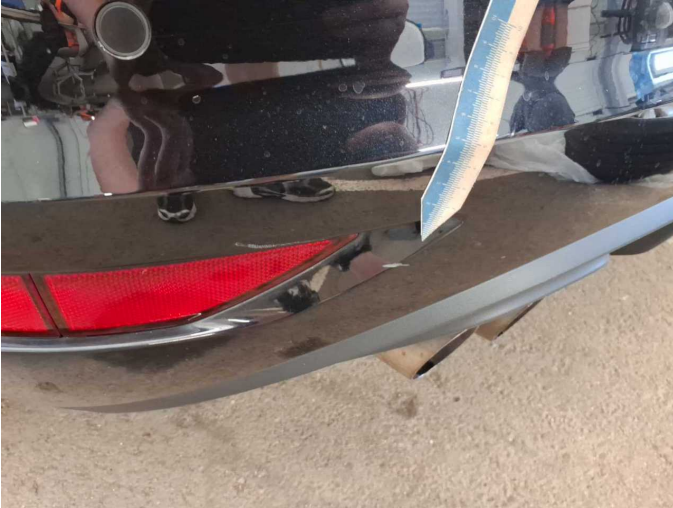
**Damage 5:** Rear bumper: Rear bumper - Scratch(es) - Paint

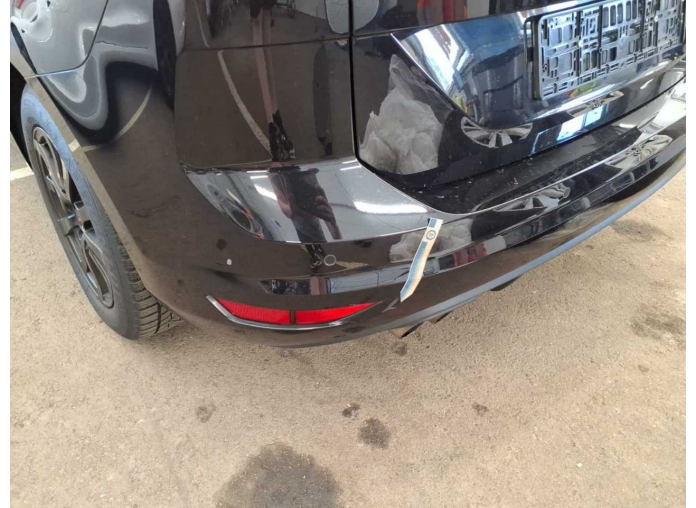
**Damage 5:** Rear bumper: Rear bumper - Scratch(es) - Paint

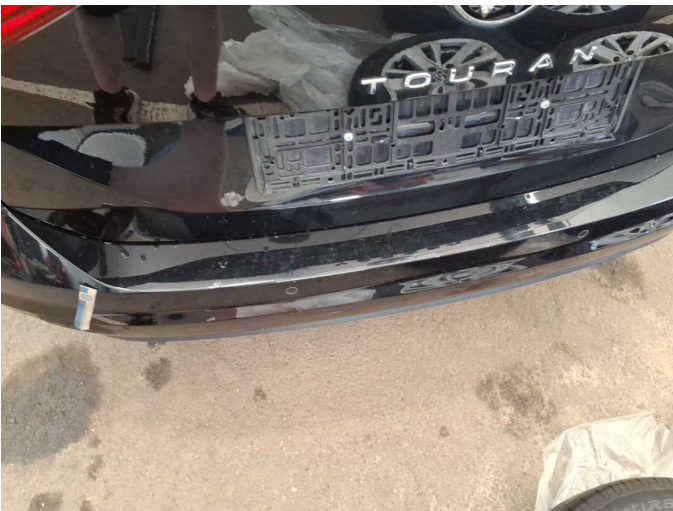
**Damage 5:** Rear bumper: Rear bumper - Scratch(es) - Paint

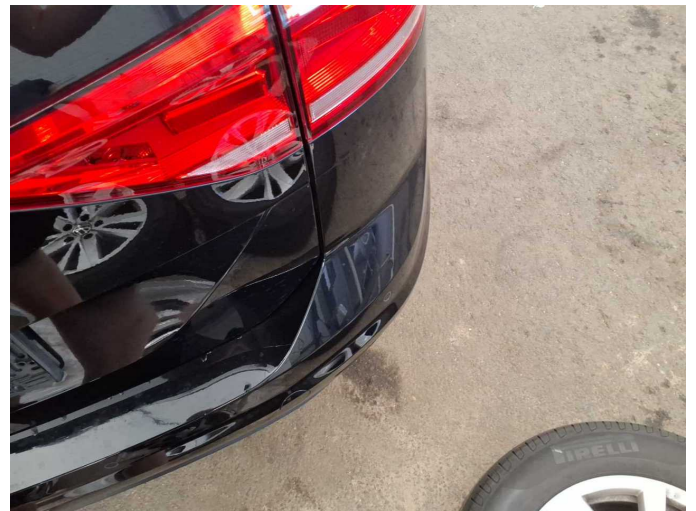
**Damage 5:** Rear bumper: Rear bumper - Scratch(es) - Paint

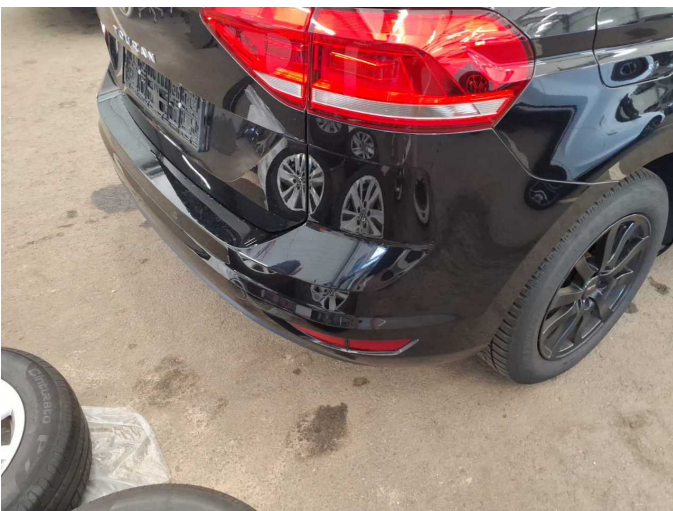
**Damage 5:** Rear bumper: Rear bumper - Scratch(es) - Paint

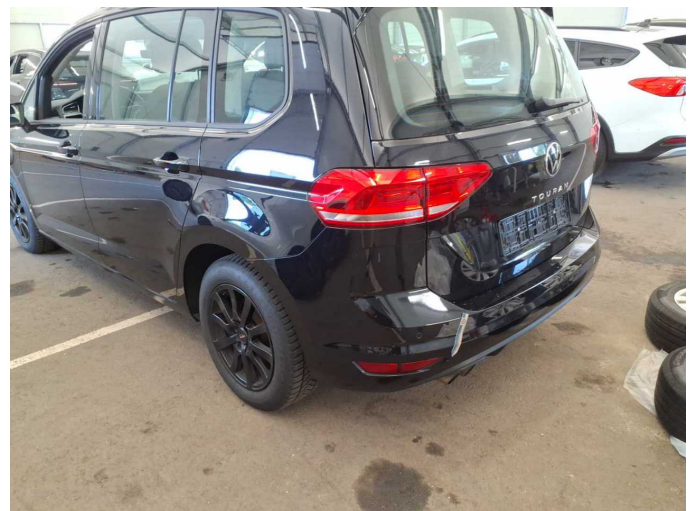
**Damage 5:** Rear bumper: Rear bumper - Scratch(es) - Paint

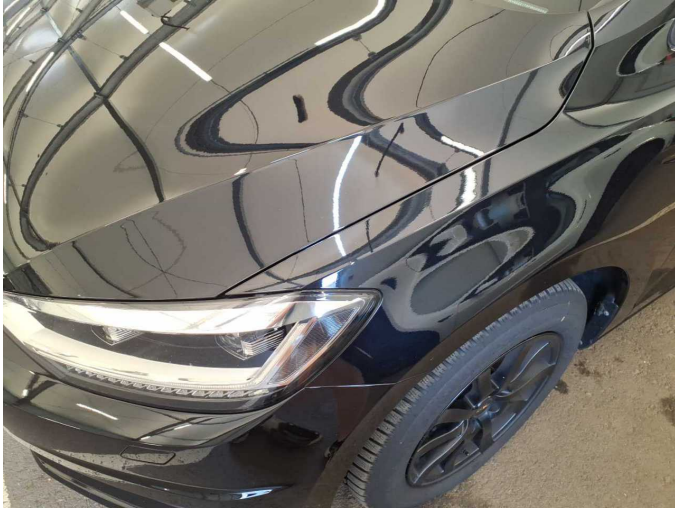
**Wear and tear 1:** Mudguard - left side: Mudguard - left side - Stone chips - No deduction

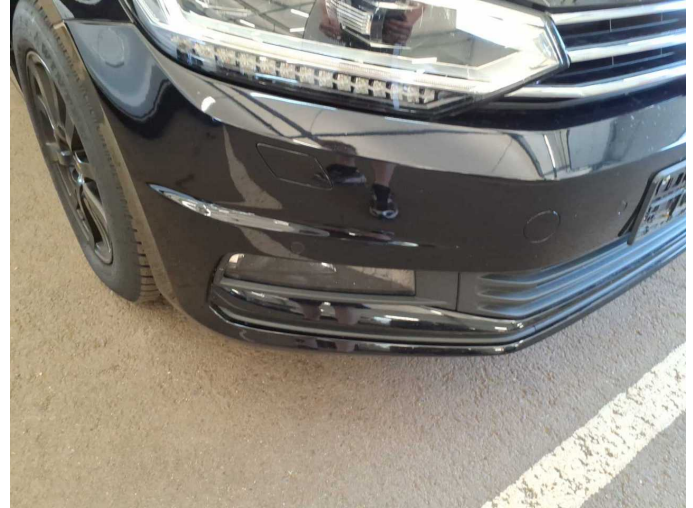
**Wear and tear 2:** Front bumper: Front bumper - Stone chips - No deduction

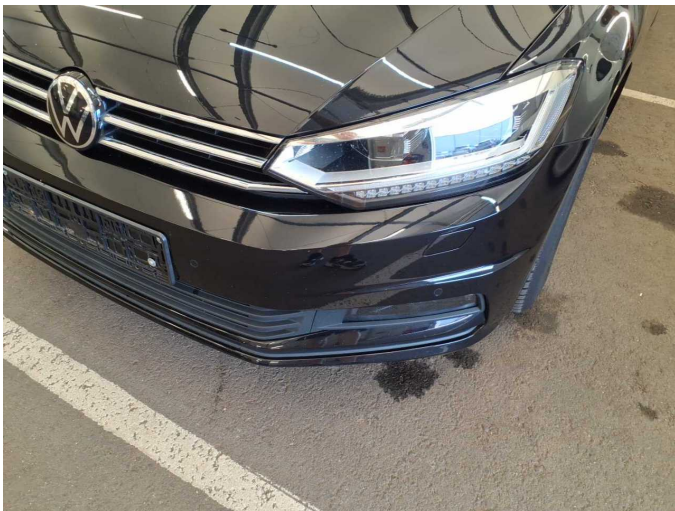
**Wear and tear 2:** Front bumper: Front bumper - Stone chips - No deduction

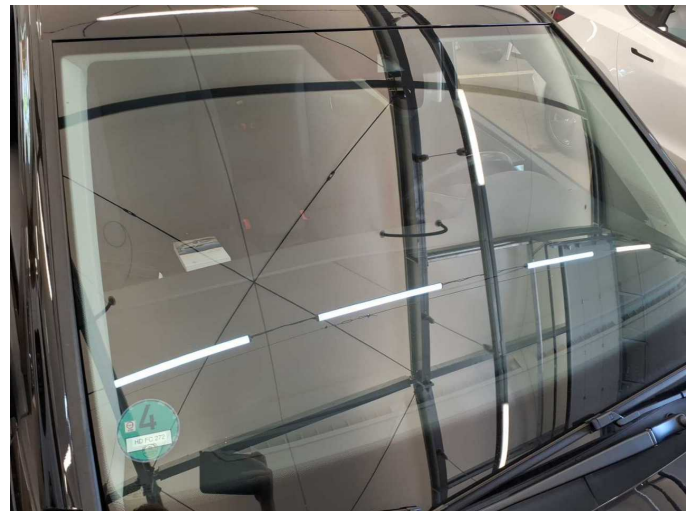
**Wear and tear 3:** Vehicle glazing: Windscreen - Stone chips - No deduction

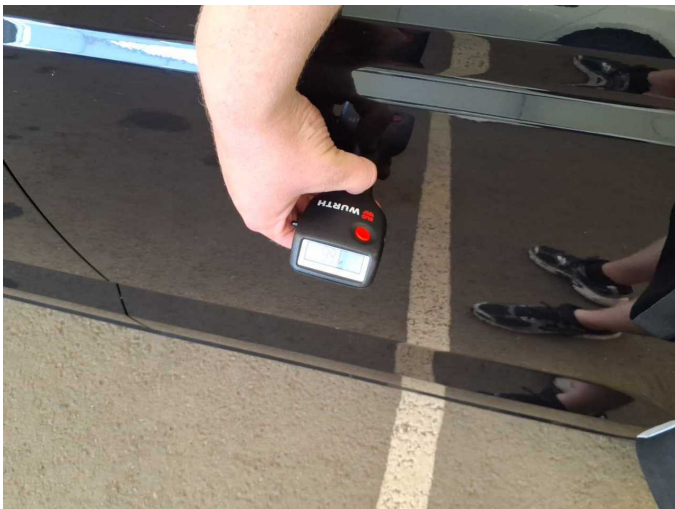
Door - rear left side	186 µm
-----------------------	--------

**Repainting 1:** Door - rear left side

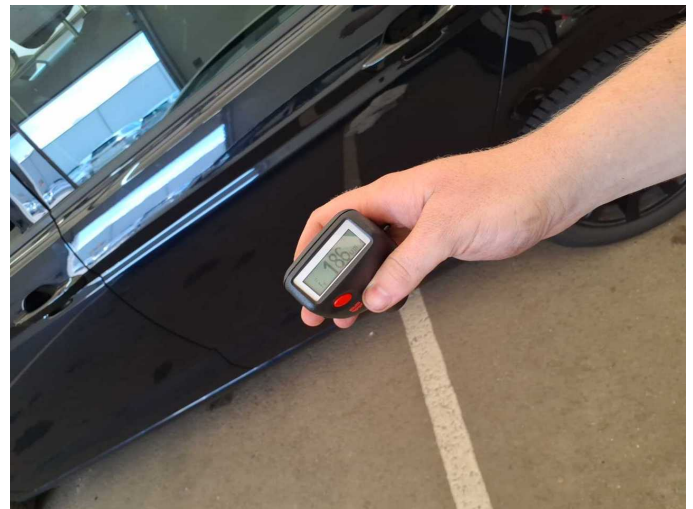
**Repainting 1:** Door - rear left side
