## Expertise

Protocol number: 46078650  
Order No. / Reference: 26529694  
Inspection date: 22 Jun 2026

Manufacturer: Peugeot

Model: 308 SW BlueHDi 130 EAT8 Allure Pack

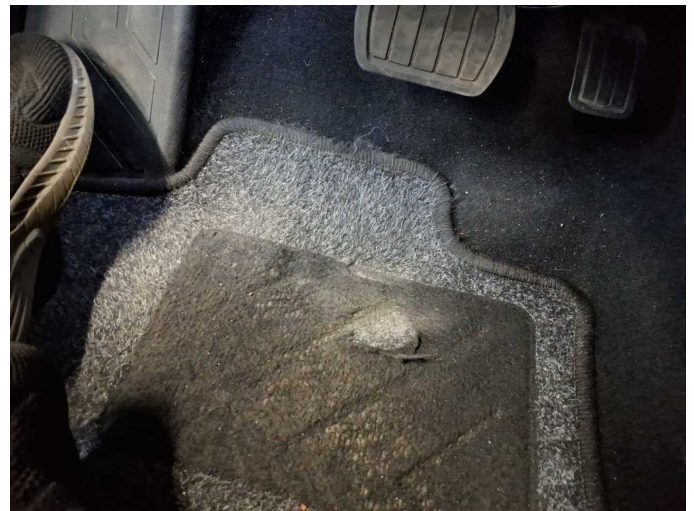
Damage 1: Trim / covers: Floor mats - Broken / torn - Replace

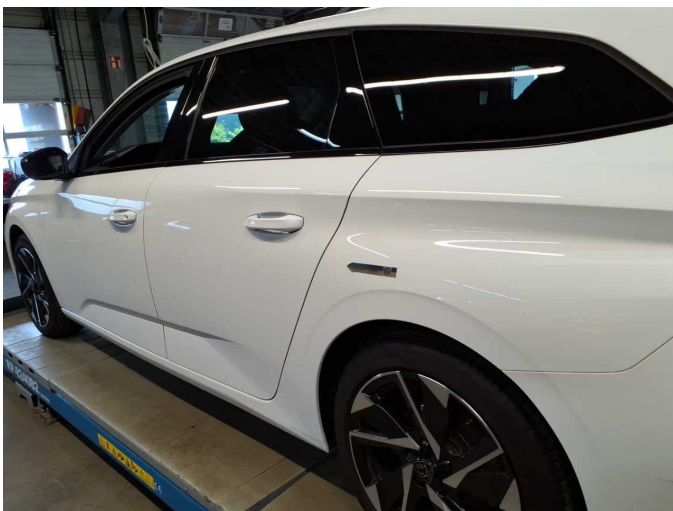
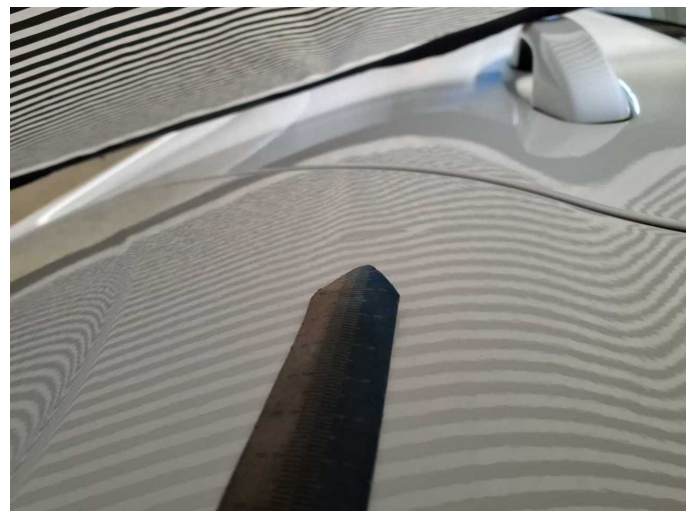
Damage 2: Side panel - rear left side: Side panel - dent(s) - Smooth repair work

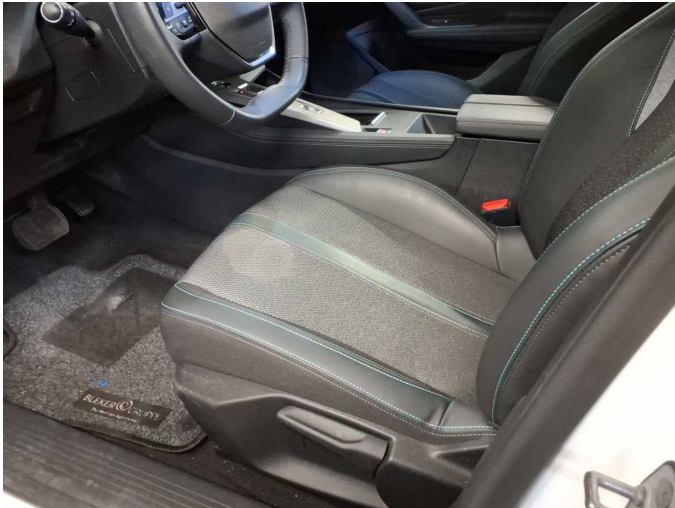
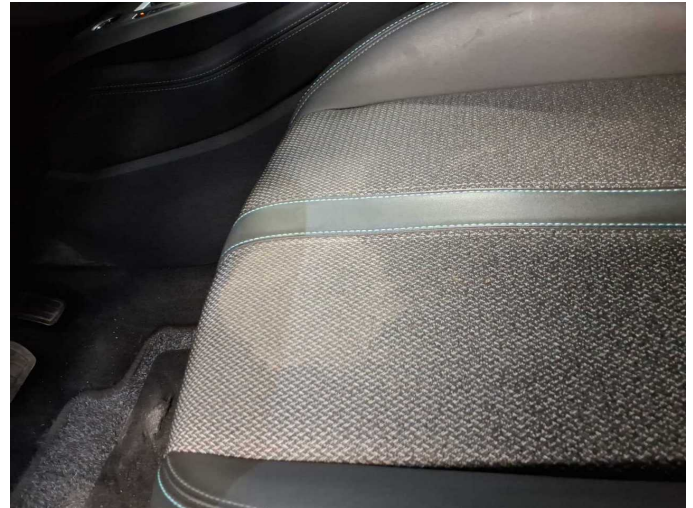
**Damage 3:** Seat - front: Seat cover - left side - Soiled - Clean

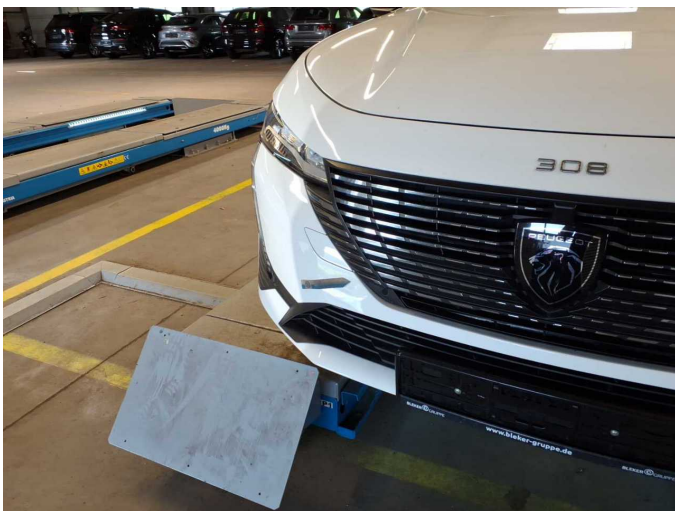
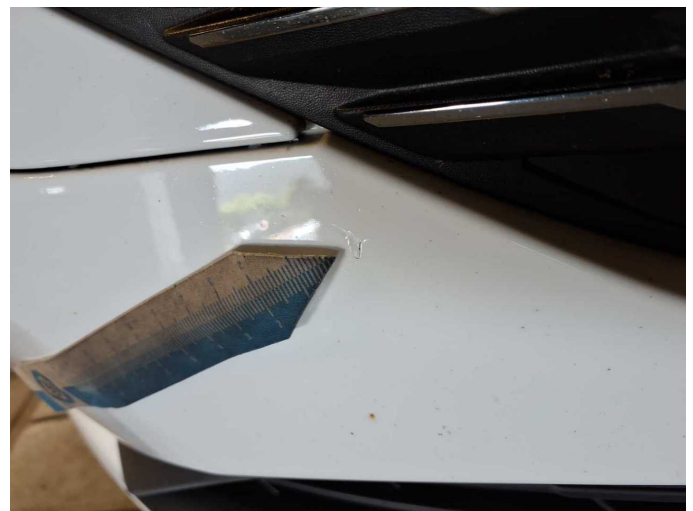
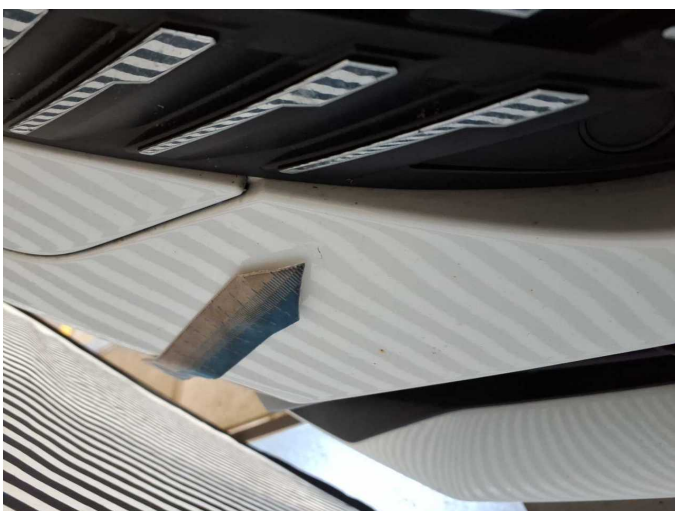
**Damage 4:** Front bumper: Front bumper - Stone chips - Smart repair

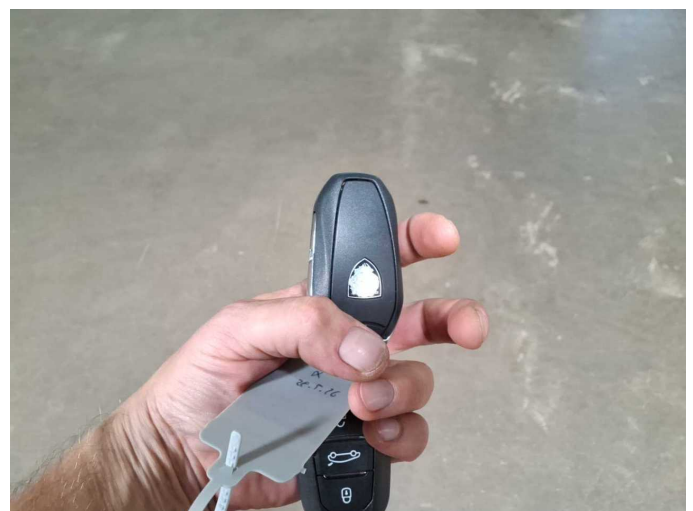
**Damage 5:** Equipment: Vehicle key with remote control - Scratched - Loss in value

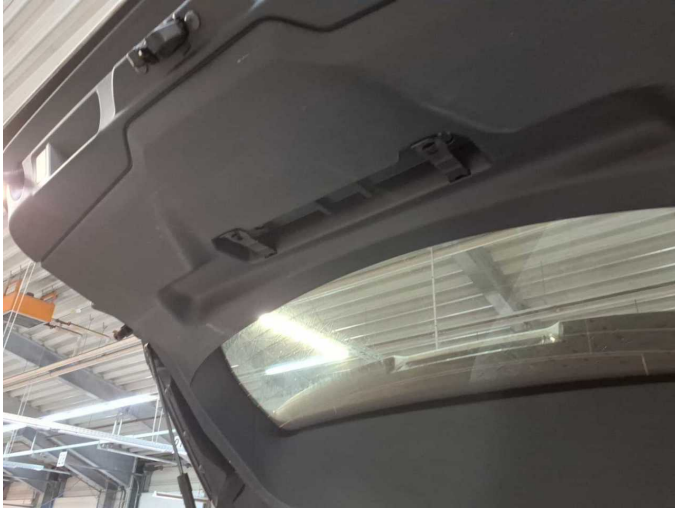
**Missing part 1:** Equipment: Warning triangle - Missing - Replace
