Expertise

Protocol number: 46142391  
Order No. / Reference: 26559148  
Inspection date: 25 Jun 2026

Manufacturer: Skoda  
VIN: TMBJJ7NS3P8019027

Model: Kodiahq 2.0 TDI DSG Tour

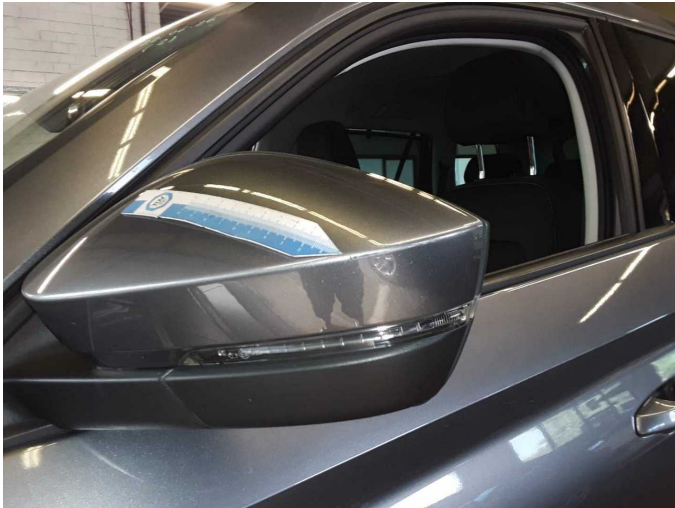
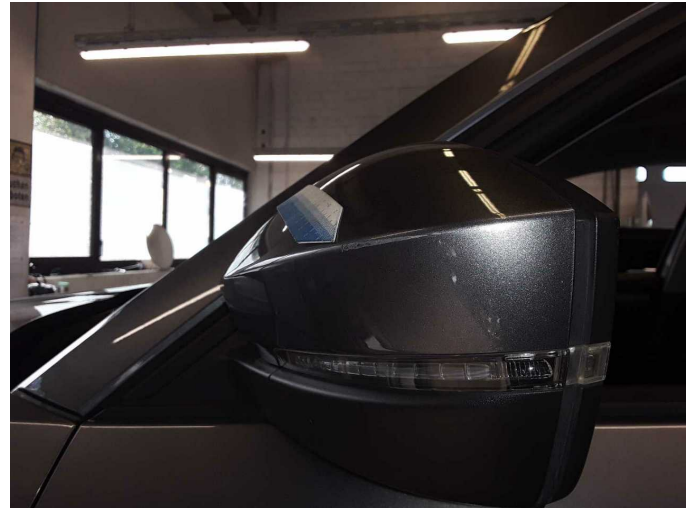
| No. | Component group | Description |
|---|---|---|
| 1 | Wing mirror - left side | Cap - Scratch(es) - Smart repair |

**Damage 1:** Wing mirror - left side: Cap - Scratch(es) - Smart repair

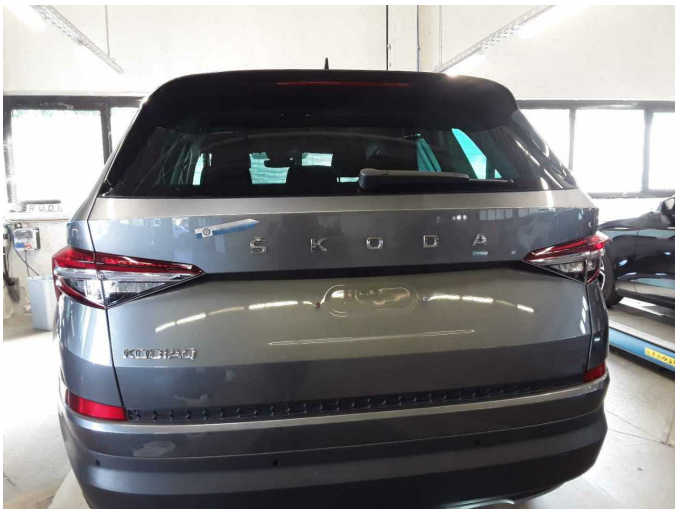
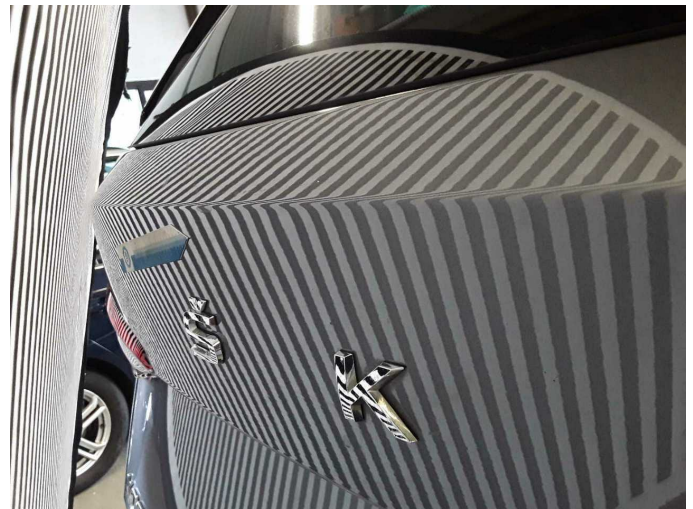
| No. | Component group | Description |
|---|---|---|
| 2 | Boot lid / rear door | Boot lid - dent(s) - Smooth repair work |

**Damage 2:** Boot lid / rear door: Boot lid - dent(s) - Smooth repair work

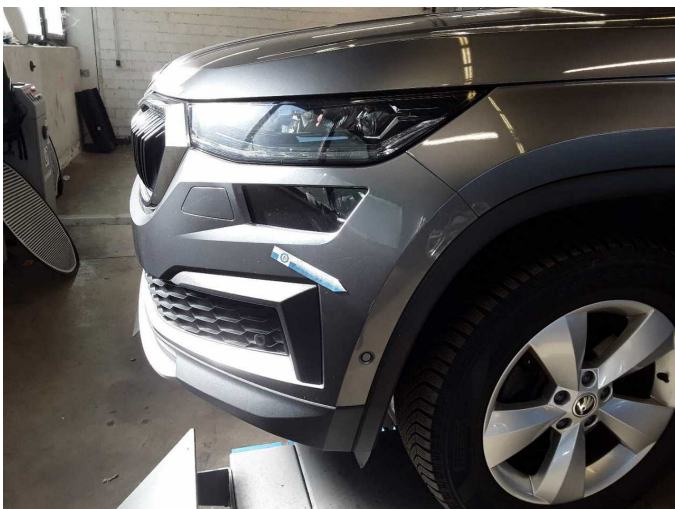
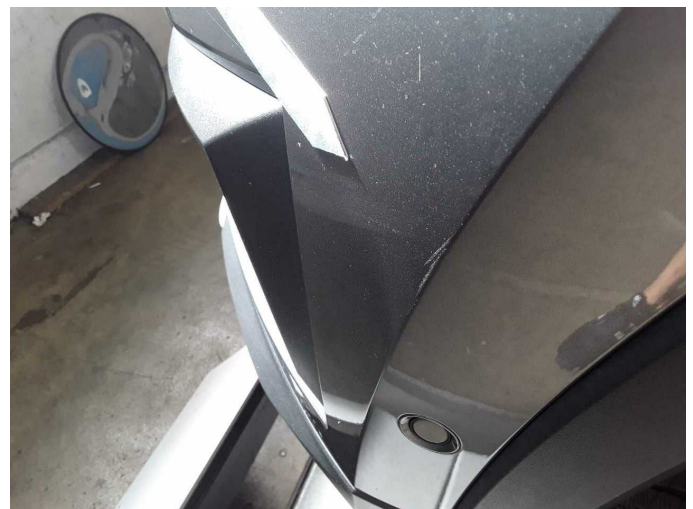
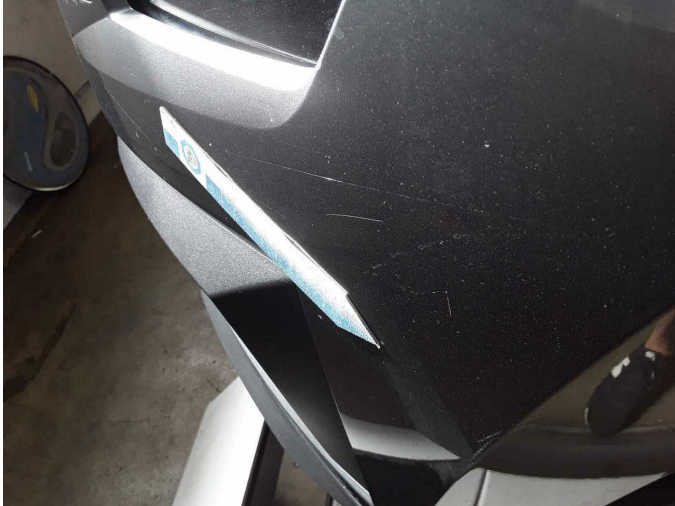
| No. | Component group | Description |
|---|---|---|
| 3 | Front bumper | Front bumper - Scratch(es) - Smart repair |

**Damage 3:** Front bumper: Front bumper - Scratch(es) - Smart repair

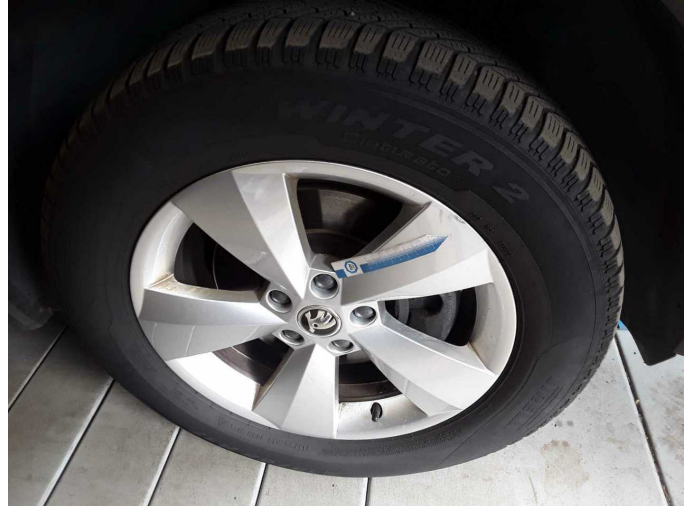
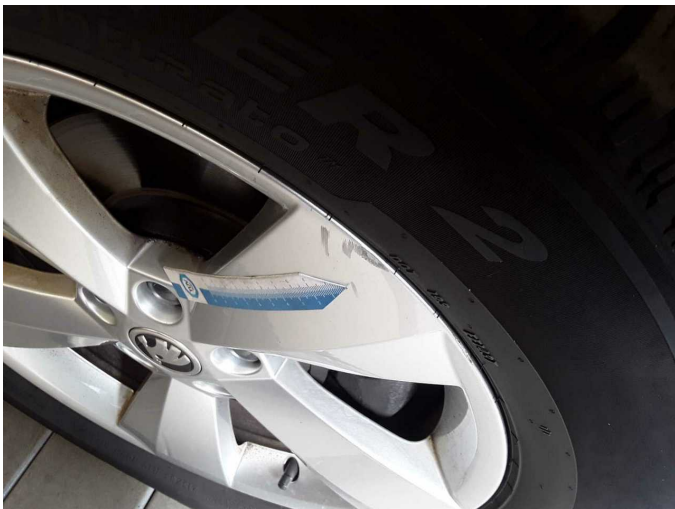
| No. | Component group | Description |
|---|---|---|
| 4 | Wheel / tyres | Alloy rim - front right side - Scratched - Smart repair |

**Damage 4:** Wheel / tyres: Alloy rim - front right side - Scratched - Smart repair

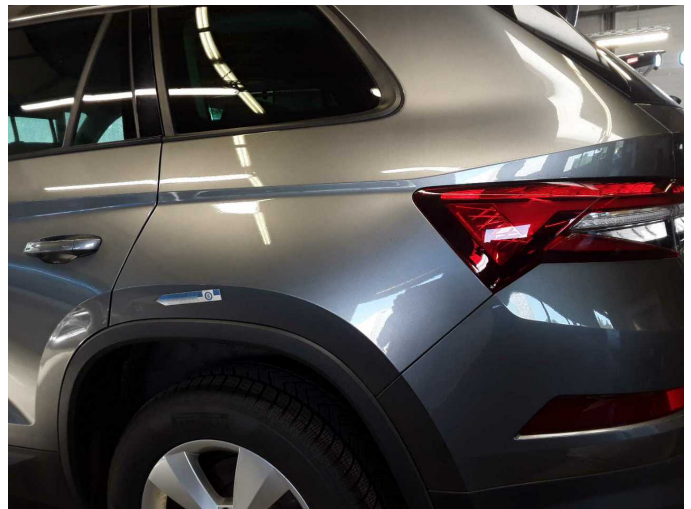
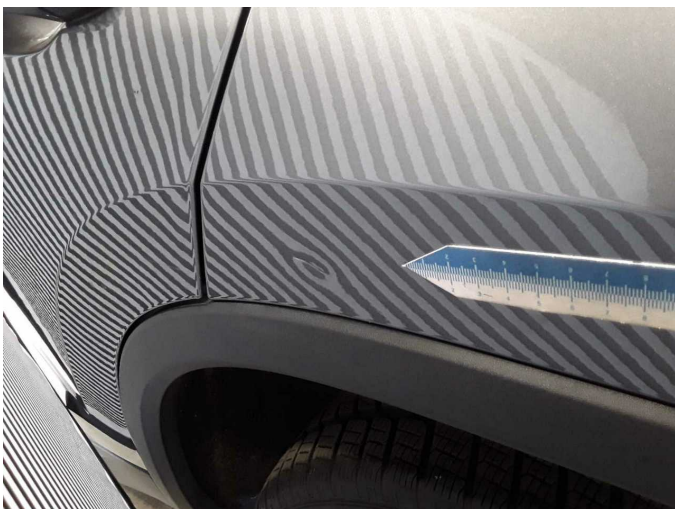
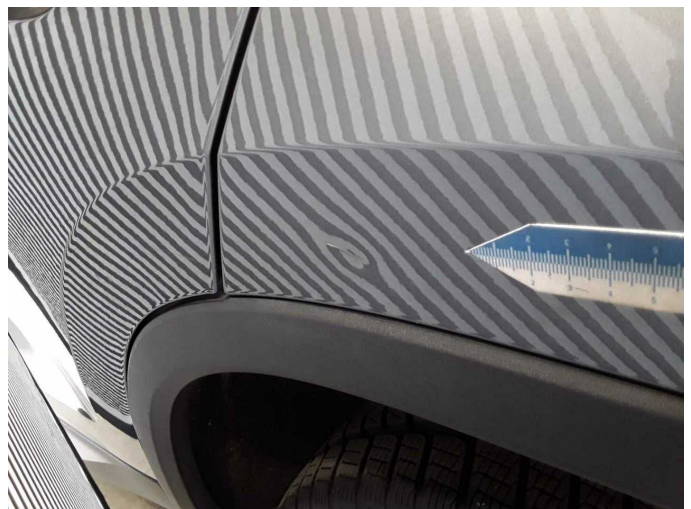
| No. | Component group | Description |
|---|---|---|
| 5 | Side panel - rear left side | Side panel - Dent / paintcoat damage - Repair and paint |

**Damage 5:** Side panel - rear left side: Side panel - Dent / paintcoat damage - Repair and paint

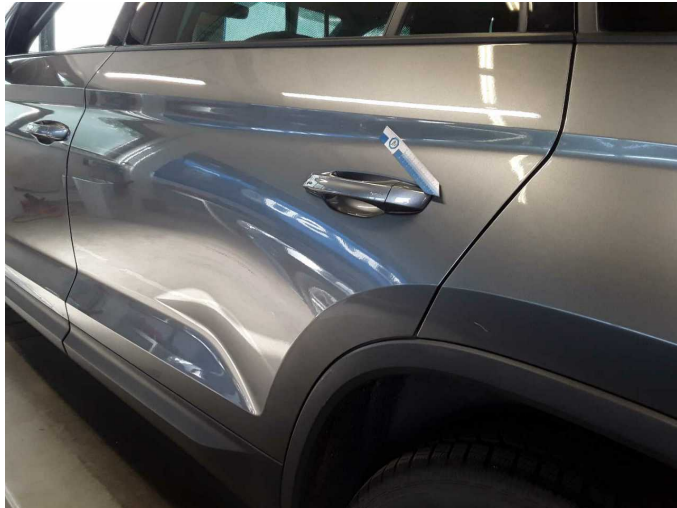
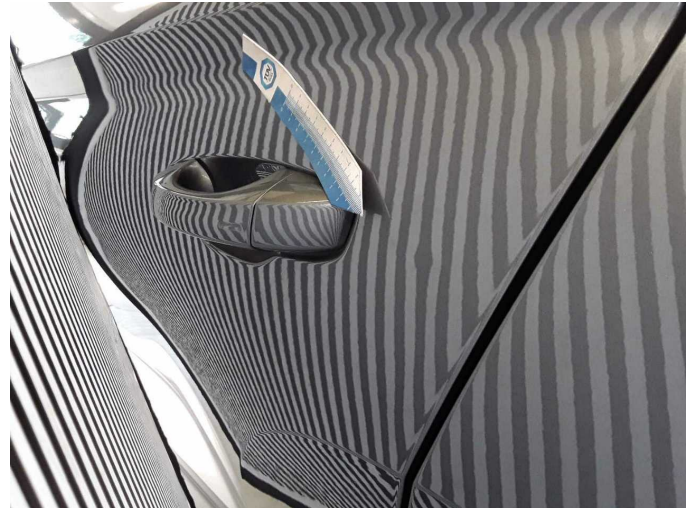
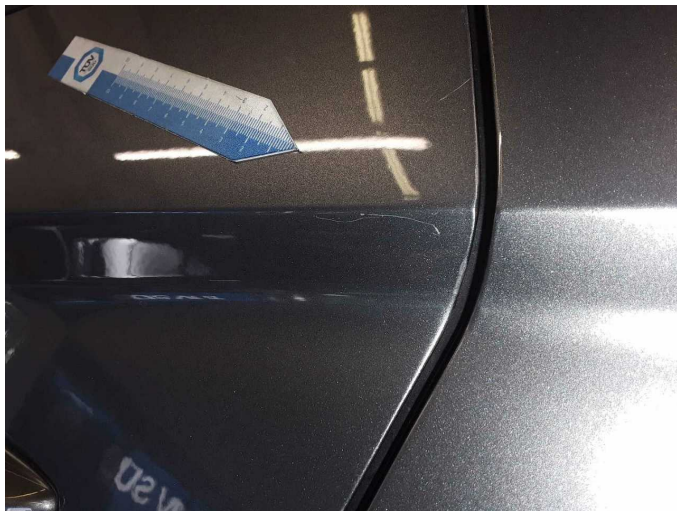
| No. | Component group | Description |
|---|---|---|
| 6 | Door - rear left side | Door - Dent / paintcoat damage - Repair and paint |

**Damage 6:** Door - rear left side: Door - Dent / paintcoat damage - Repair and paint

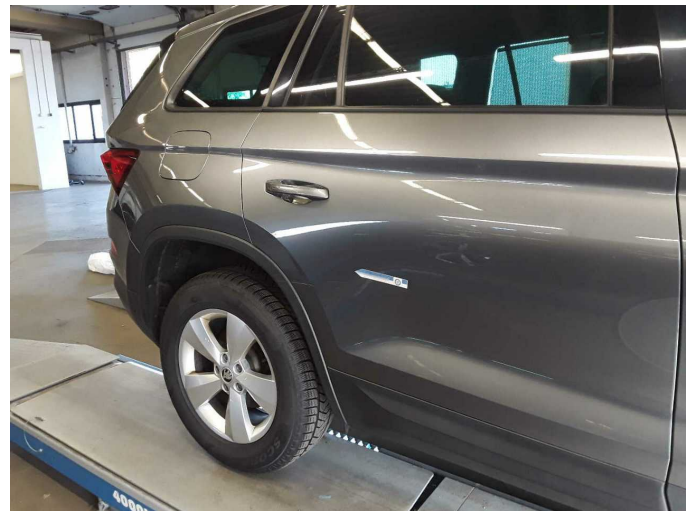
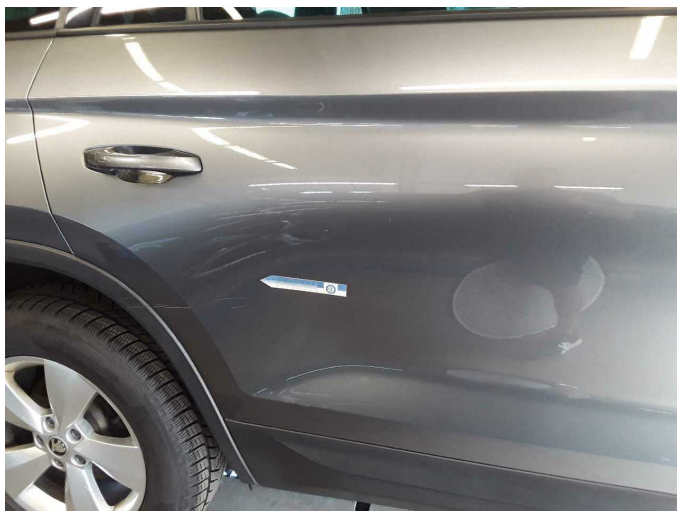
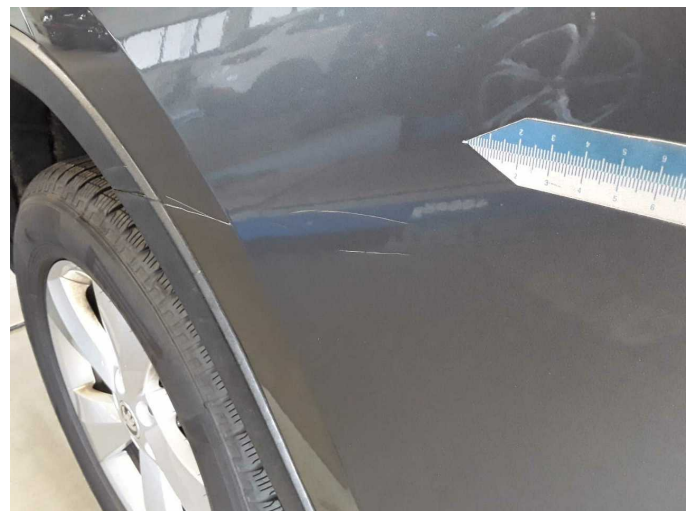
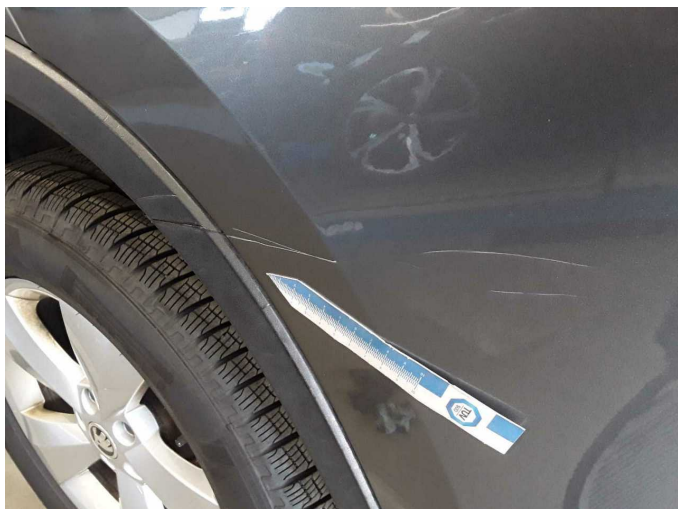
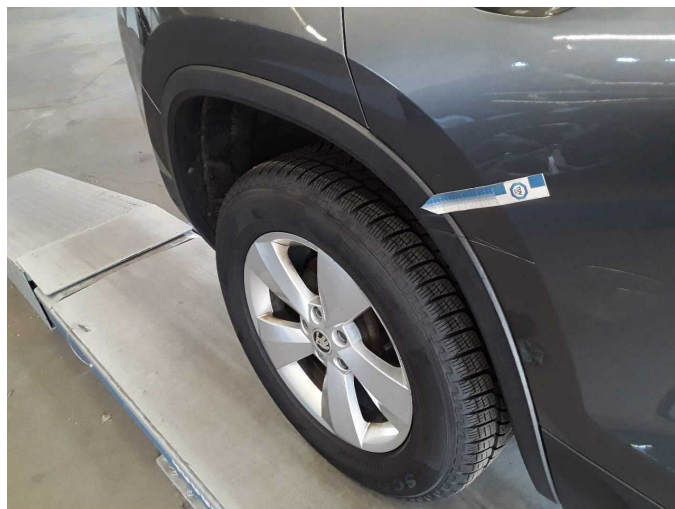
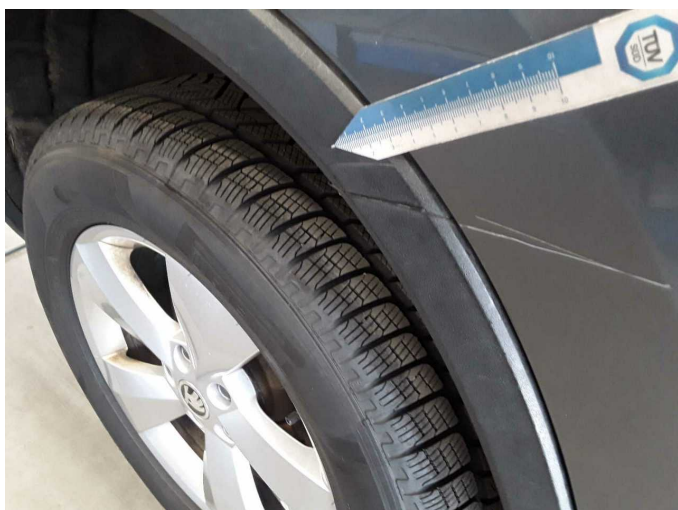
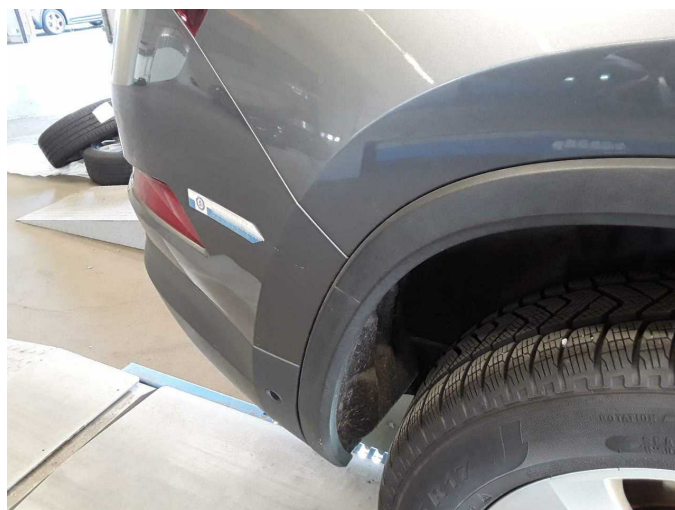
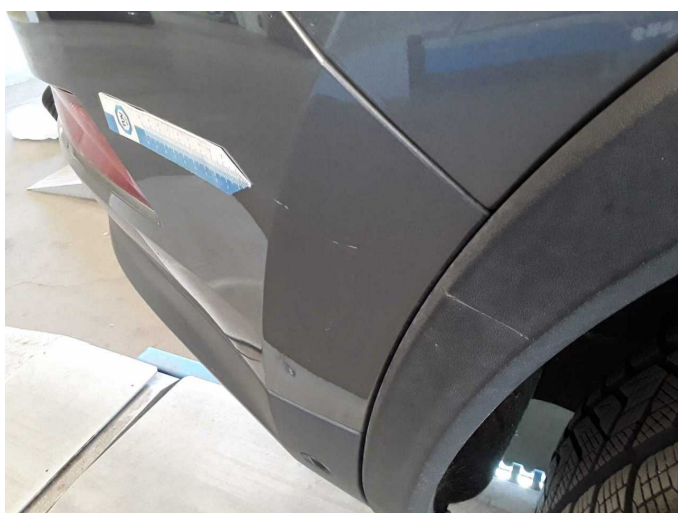
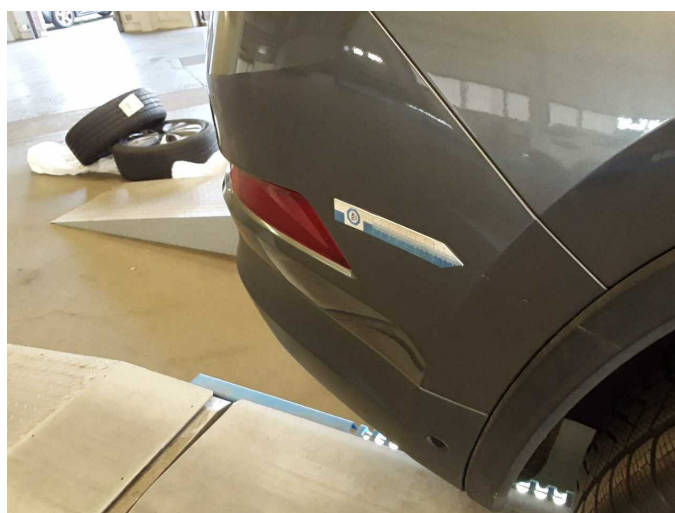
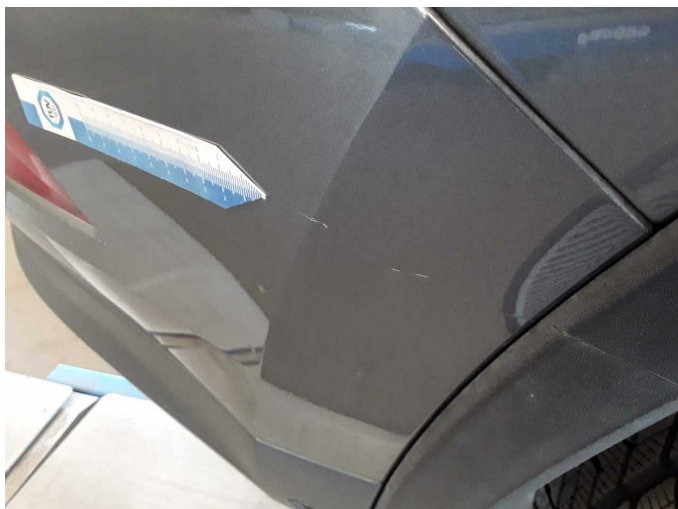
- 1 Side right

**Accident 1:** Side right

**Accident 1: Side right**
