Expertise

Protocol number: 46641427  
Order No. / Reference: 26716594  
Inspection date: 21 Jul 2026

Manufacturer: Mercedes-Benz

Model: E 220 d T 9G-TRONIC

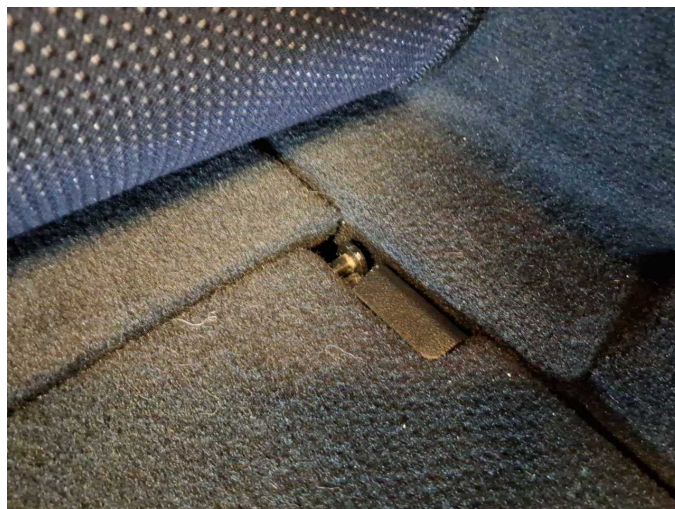
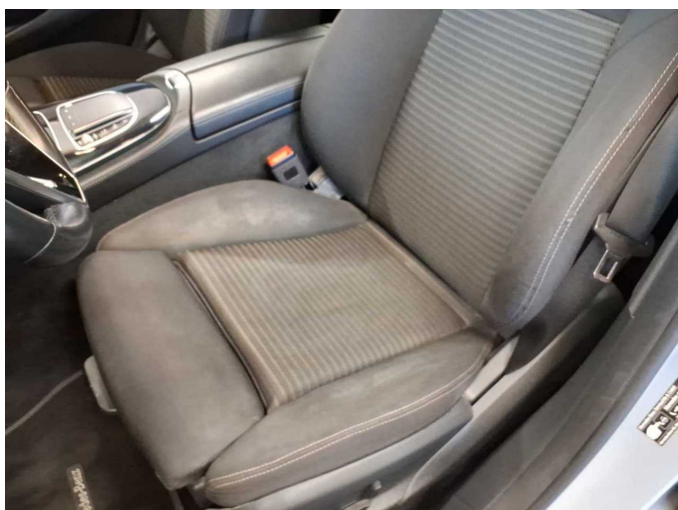
| No. | Component group | Description |
|---|---|---|
| 1 | Rear of vehicle | Boot floor (Verkleidung) - Broken / torn - Replace |

**Damage 1:** Rear of vehicle: Boot floor (Verkleidung) - Broken / torn - Replace

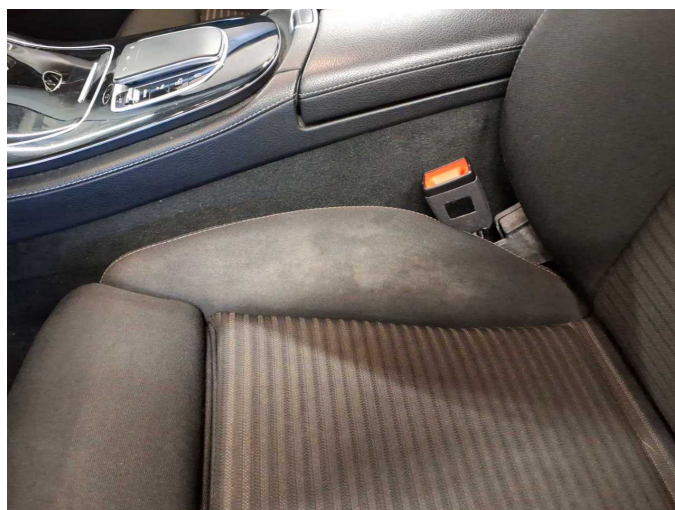
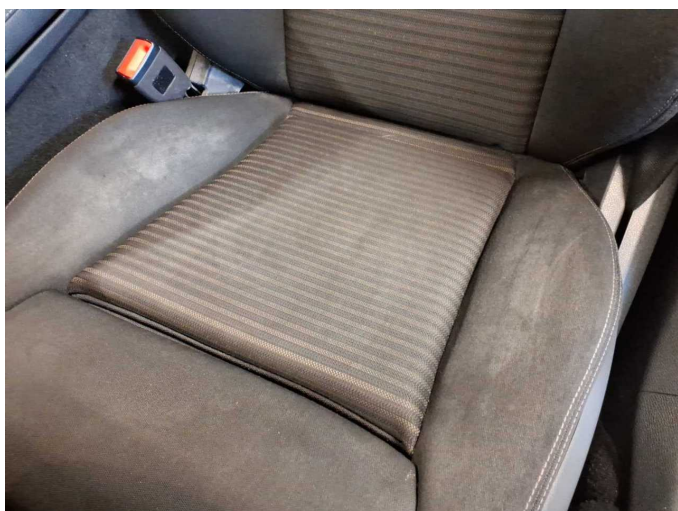
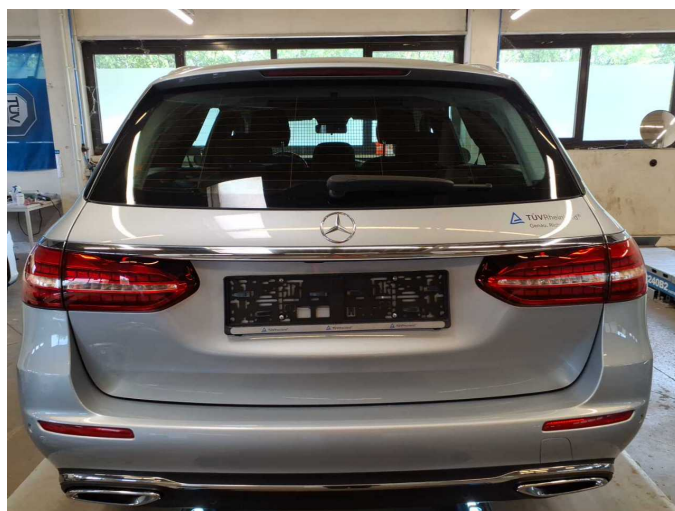
| No. | Component group | Description |
|---|---|---|
| 2 | Seat - front | Seat cover - left side - Soiled - Clean |

**Damage 2:** Seat - front: Seat cover - left side - Soiled - Clean

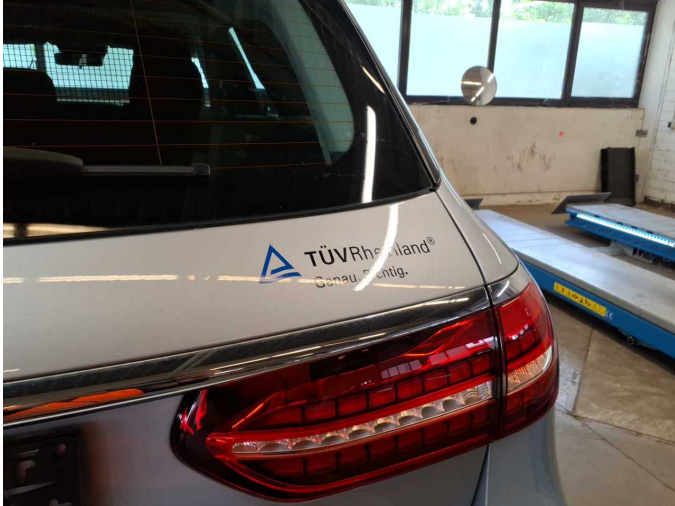
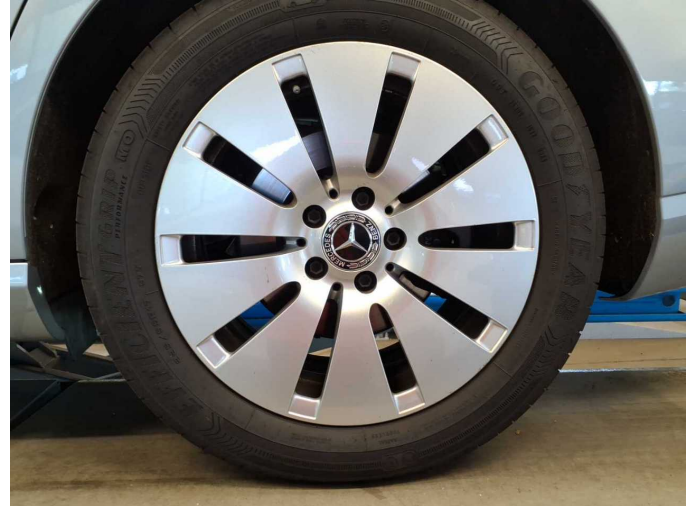
| No. | Component group | Description |
|---|---|---|
| 3 | Boot lid / rear door | Boot lid - Glued / labelled - De-glue / neutralise |

**Damage 3:** Boot lid / rear door: Boot lid - Glued / labelled - De-glue / neutralise

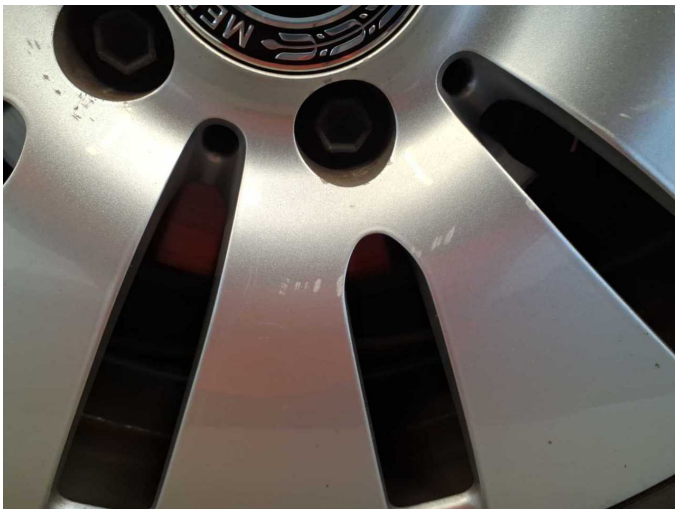
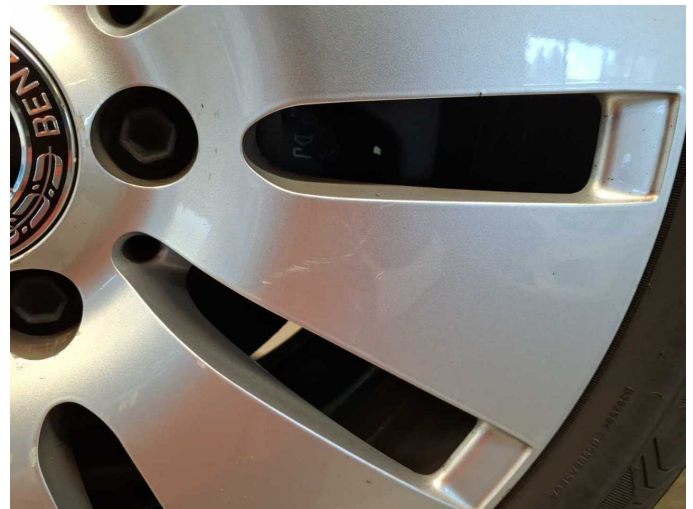
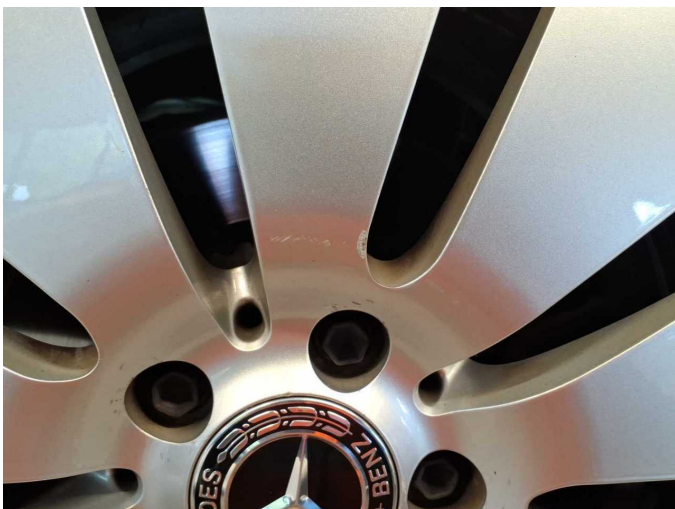
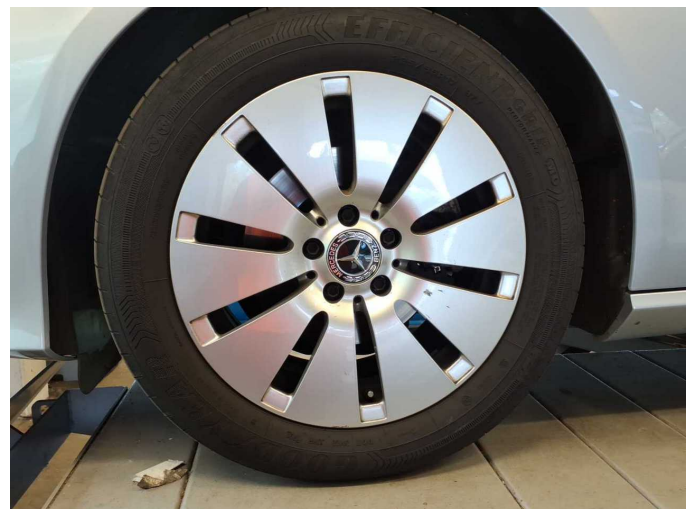
| No. | Component group | Description |
|---|---|---|
| 4 | Wheel / tyres | Alloy rim - rear left side - Scratch(es) - Loss in value |

**Damage 4:** Wheel / tyres: Alloy rim - rear left side - Scratch(es) - Loss in value

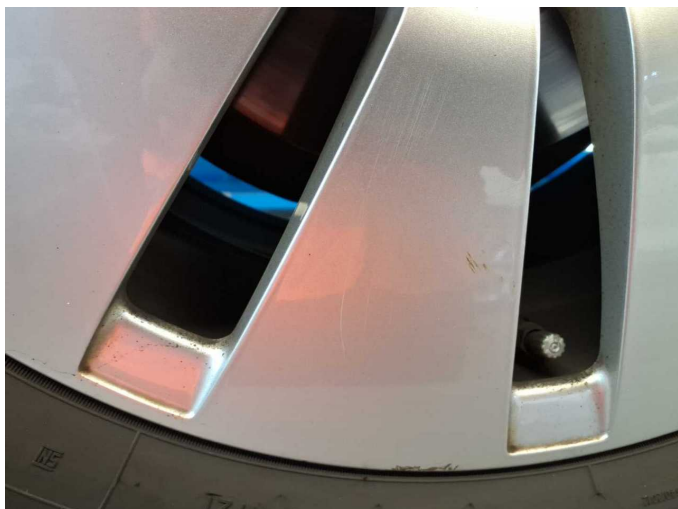
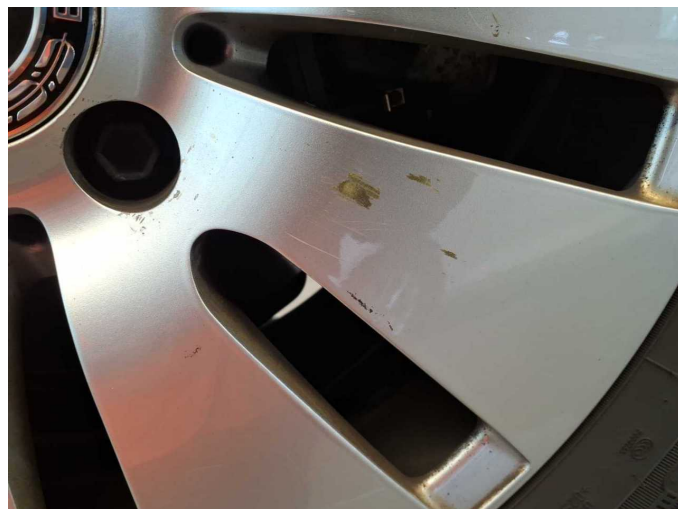
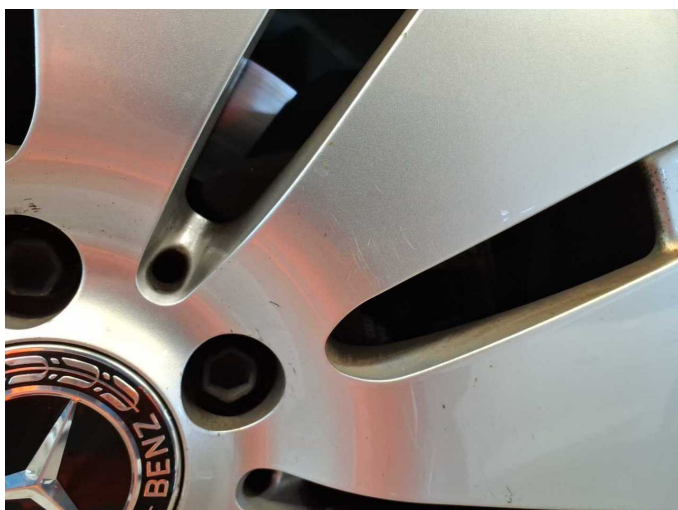
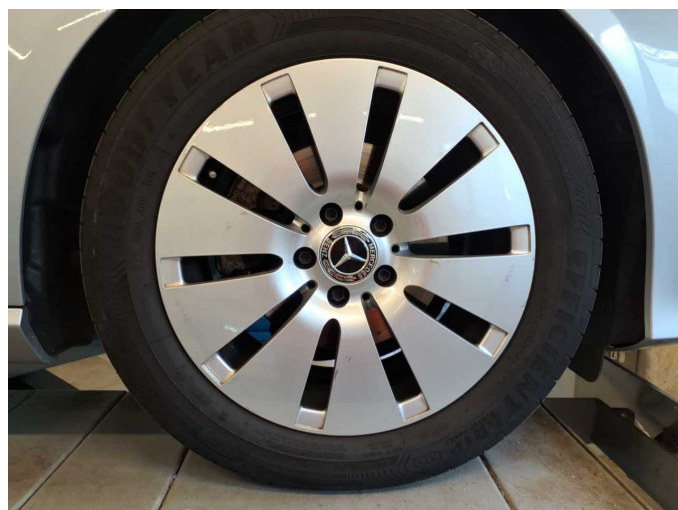
| No. | Component group | Description |
|---|---|---|
| 5 | Wheel / tyres | Alloy rim - front left side - Scratch(es) - Loss in value |

**Damage 5:** Wheel / tyres: Alloy rim - front left side - Scratch(es) - Loss in value

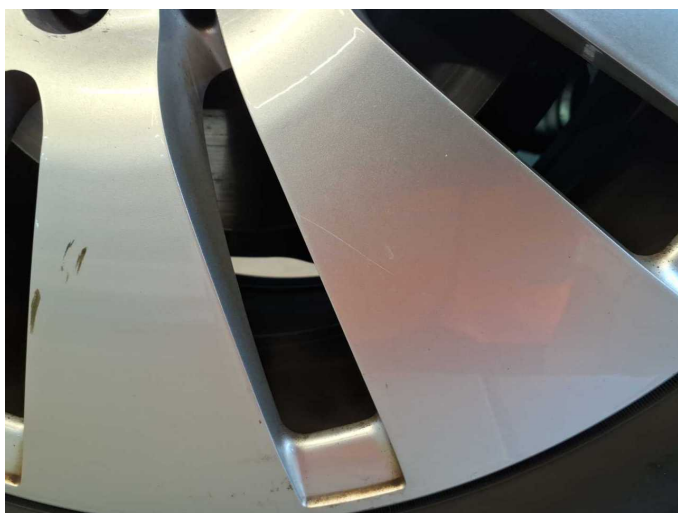
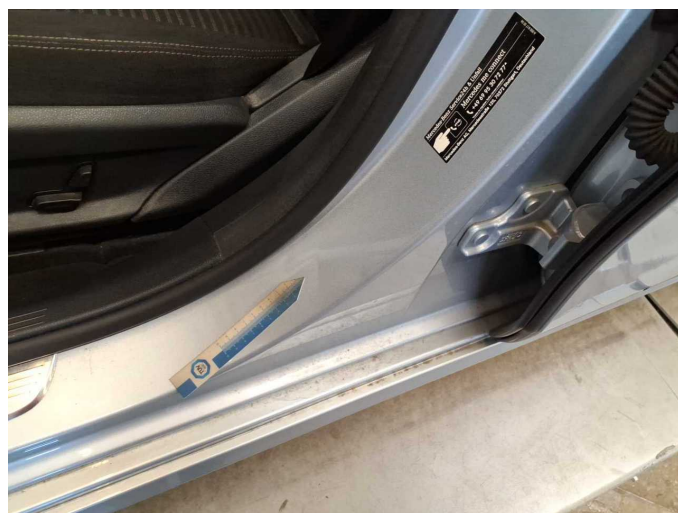
| No. | Component group | Description |
|---|---|---|
| 6 | Wheel / tyres | Alloy rim - front right side - Scratch(es) - Loss in value |

**Damage 6:** Wheel / tyres: Alloy rim - front right side - Scratch(es) - Loss in value

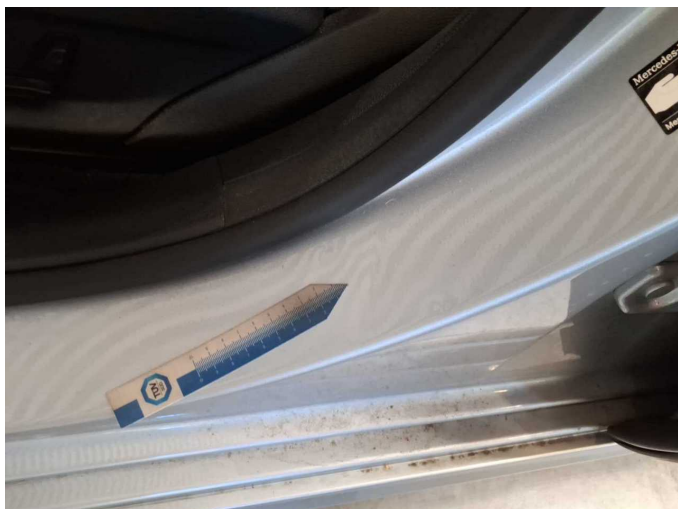
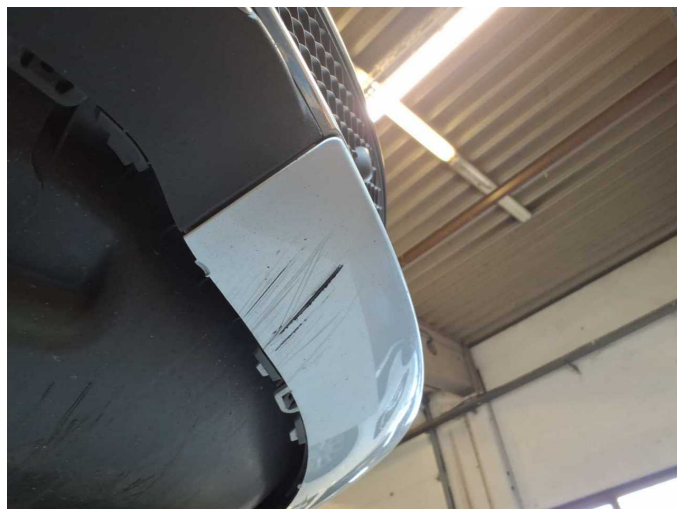
| No. | Component group | Description |
|---|---|---|
| 7 | Sill - left side | Sill - dent(s) - Smooth repair work |

**Damage 7:** Sill - left side: Sill - dent(s) - Smooth repair work

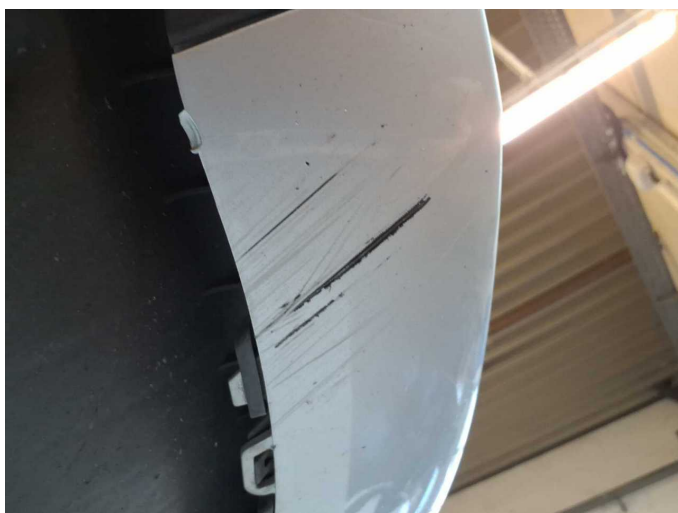
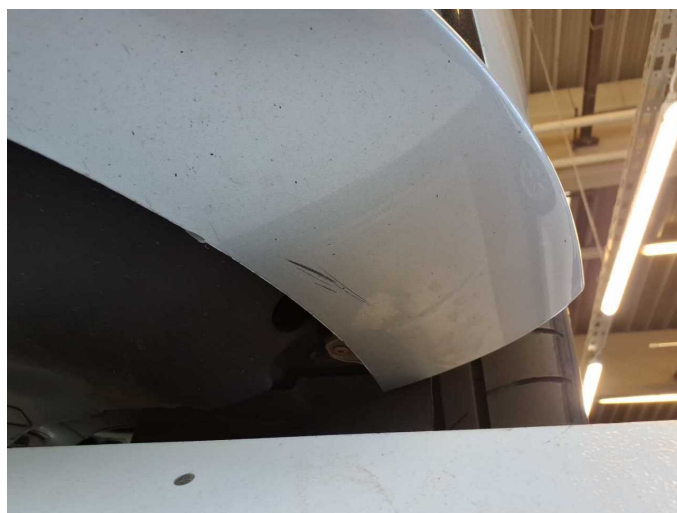
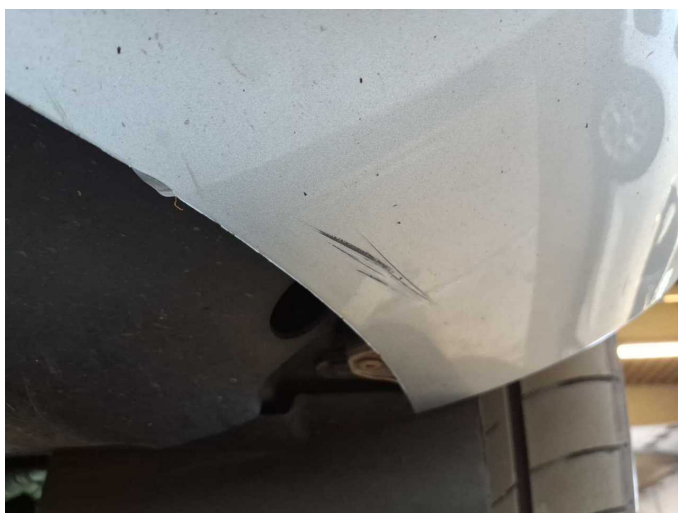
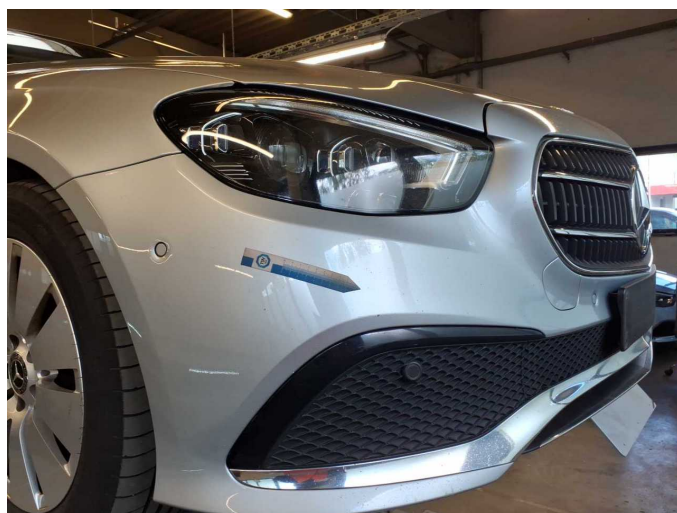
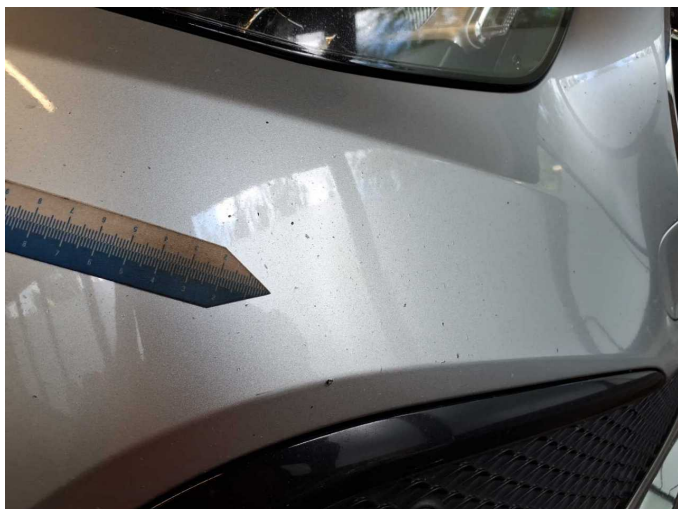
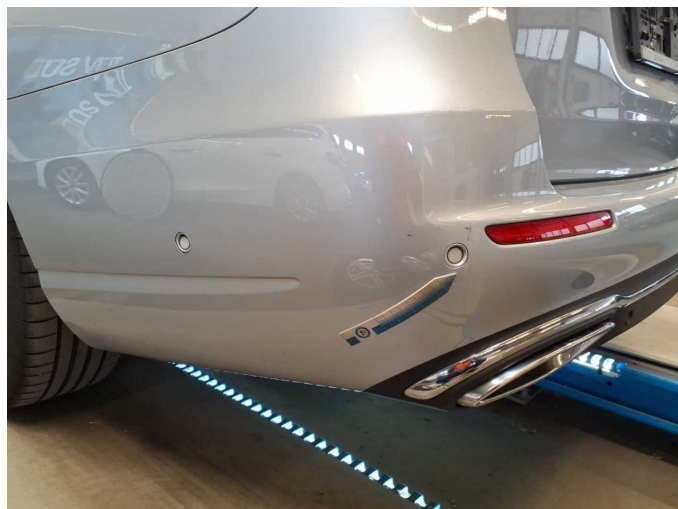
| No. | Component group | Description |
|---|---|---|
| 8 | Front bumper | Front bumper (+ Steinschläge) - Scratch(es) - Paint |

**Damage 8:** Front bumper: Front bumper (+ Steinschläge) - Scratch(es) - Paint

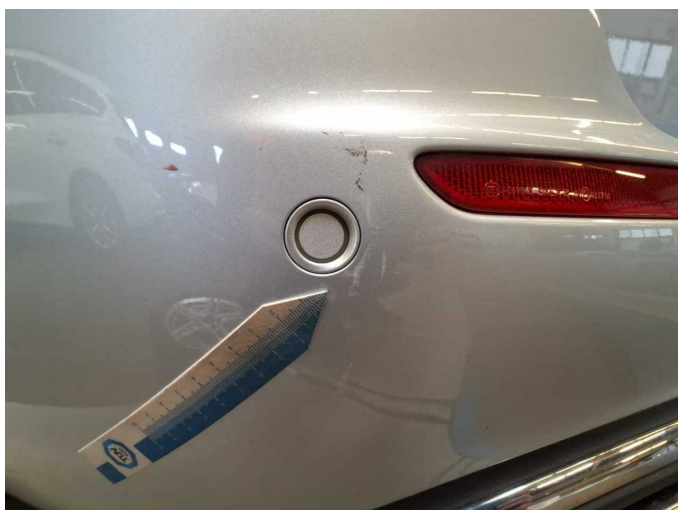
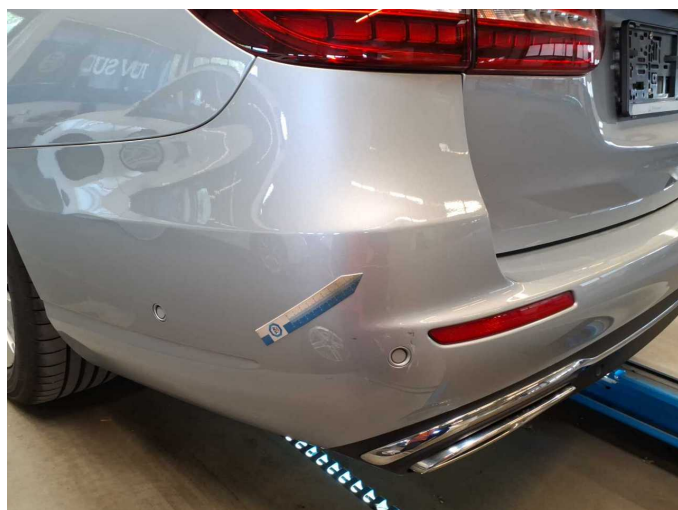
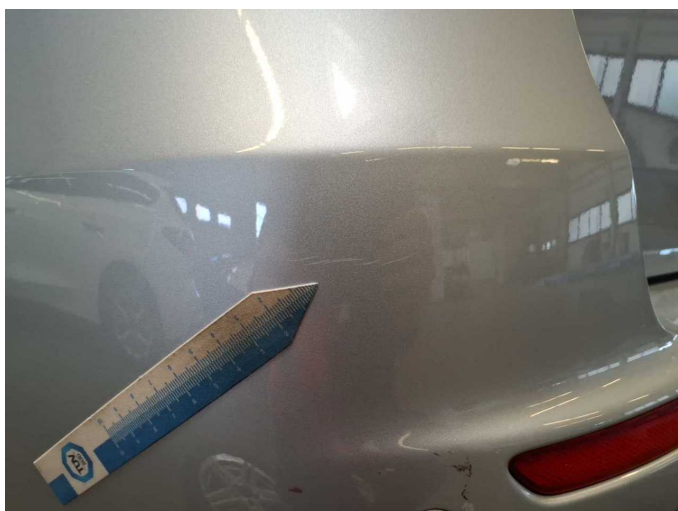
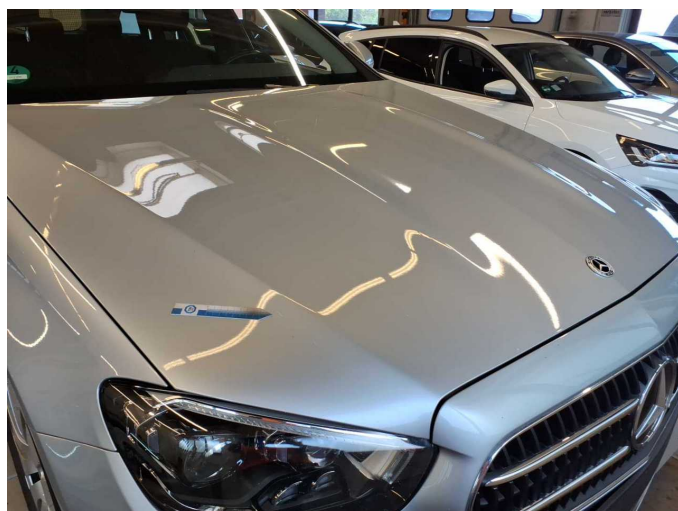
| No. | Component group | Description |
|---|---|---|
| 9 | Rear bumper | Rear bumper - Scratch(es) - Paint |

**Damage 9:** Rear bumper: Rear bumper - Scratch(es) - Paint

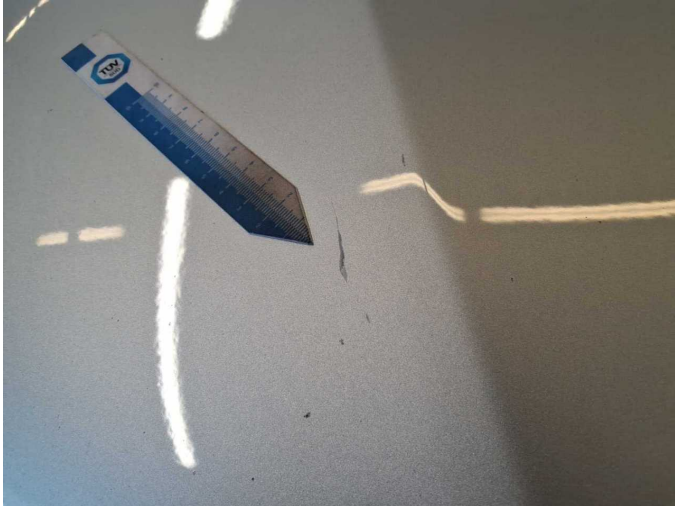
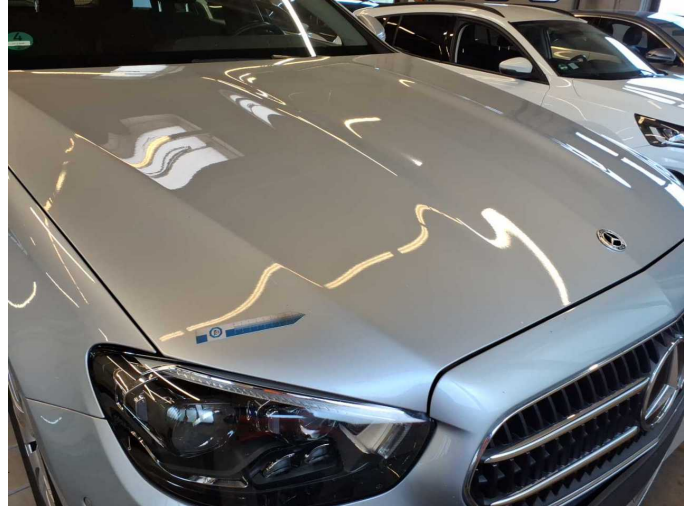
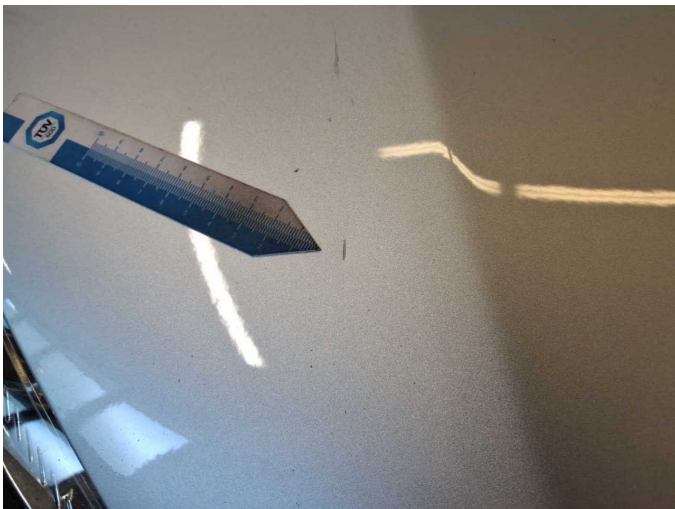
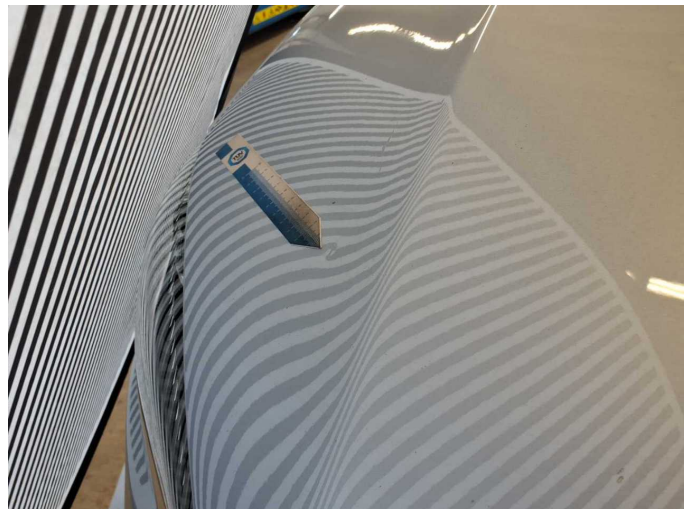
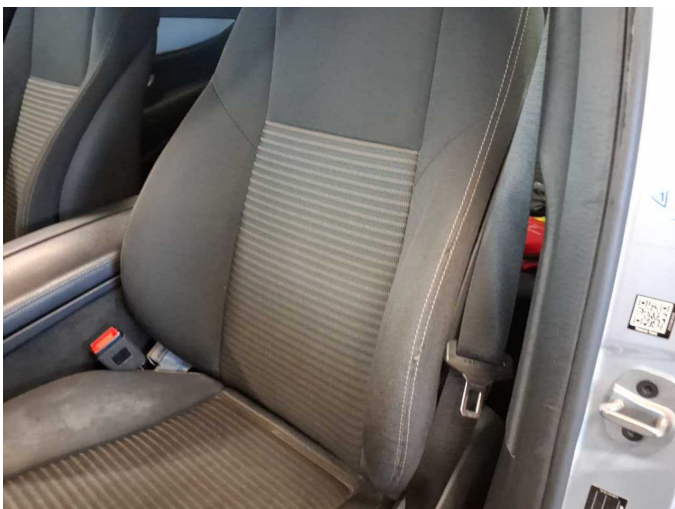
| No. | Component group | Description |
|---|---|---|
| 10 | Bonnet | Bonnet (+ Delle) - Scratch(es) - Repair and paint |

**Damage 10:** Bonnet: Bonnet (+ Delle) - Scratch(es) - Repair and paint

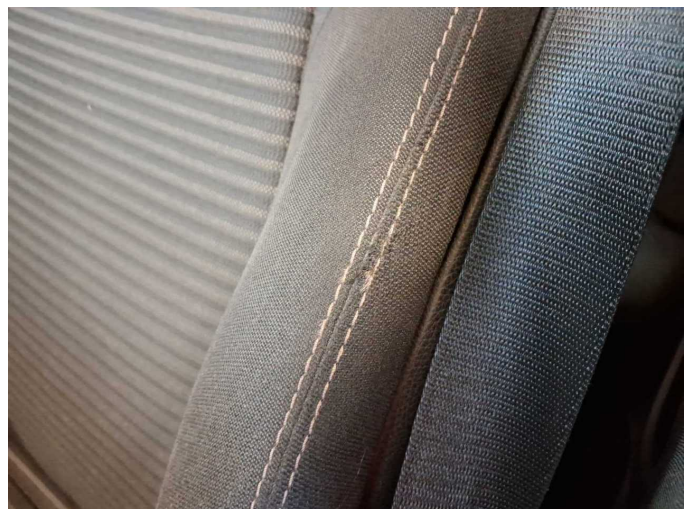
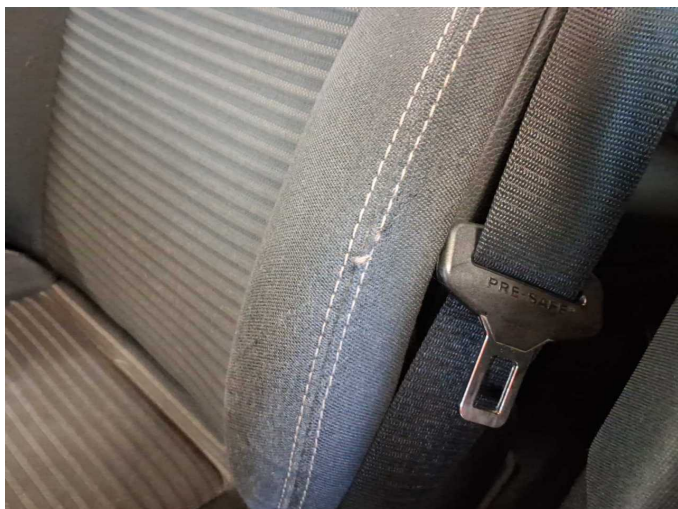
| No. | Component group | Description |
|---|---|---|
| 2 | Seat - front | Seat cover - left side - Scratched - No deduction |

**Wear and tear 2:** Seat - front: Seat cover - left side - Scratched - No deduction
