Expertise

Protocol number: 46583987  
Order No. / Reference: 26701496  
Inspection date: 16 Jul 2026

Manufacturer: Skoda  
VIN: TMBJH7NP0M7072616

Model: Superb Combi 2.0 TDI Style

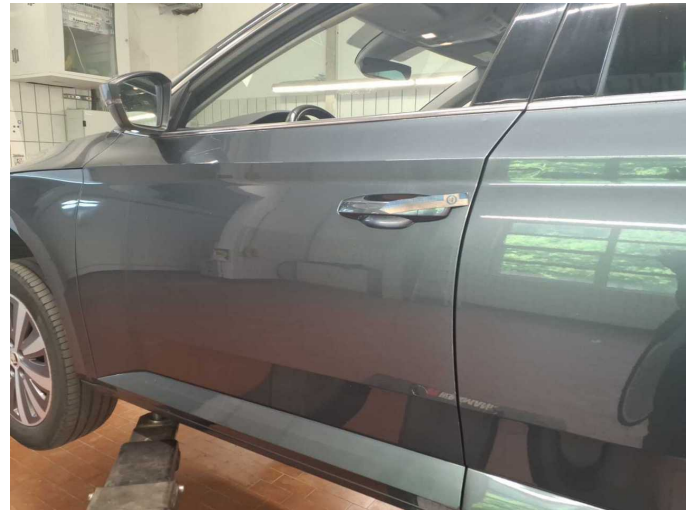
| No. | Component group | Description |
|---|---|---|
| 5 | Door - front left side | Door handle - outside - Scratch(es) - Smart repair |

Damage 5: Door - front left side: Door handle - outside - Scratch(es) - Smart repair

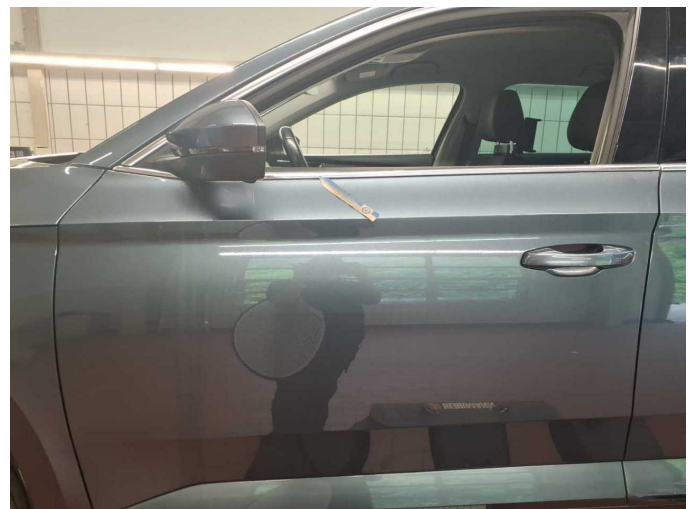
| No. | Component group | Description |
|---|---|---|
| 6 | Door - front left side | Strip - outer - Scratch(es) - Replace |

Damage 6: Door - front left side: Strip - outer - Scratch(es) - Replace

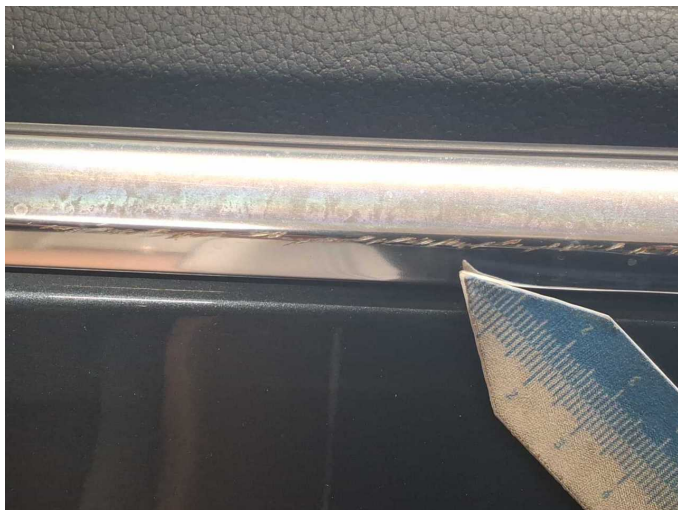
**Damage 6:** Door - front left side: Strip - outer - Scratch(es) - Replace

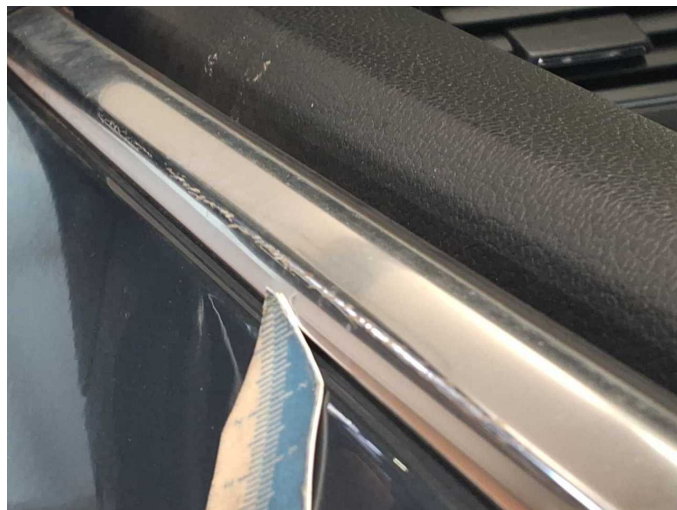
**Damage 6:** Door - front left side: Strip - outer - Scratch(es) - Replace

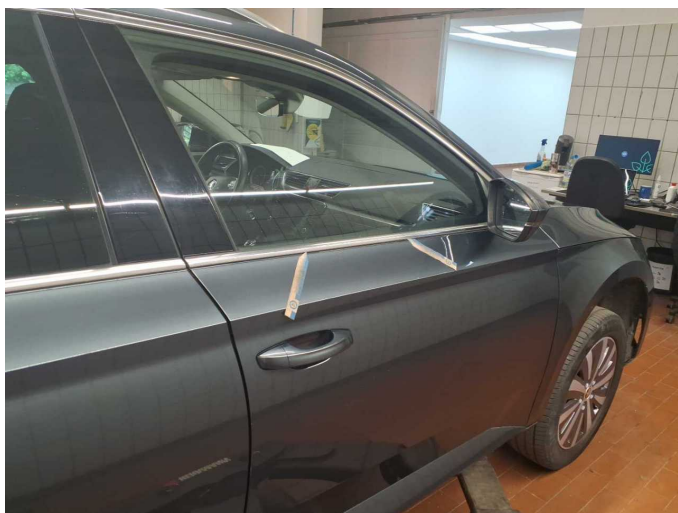
| No. | Component group | Description |
|---|---|---|
| 7 | Door - front right side | Strip - outer - Scratch(es) - Replace |

**Damage 7:** Door - front right side: Strip - outer - Scratch(es) - Replace

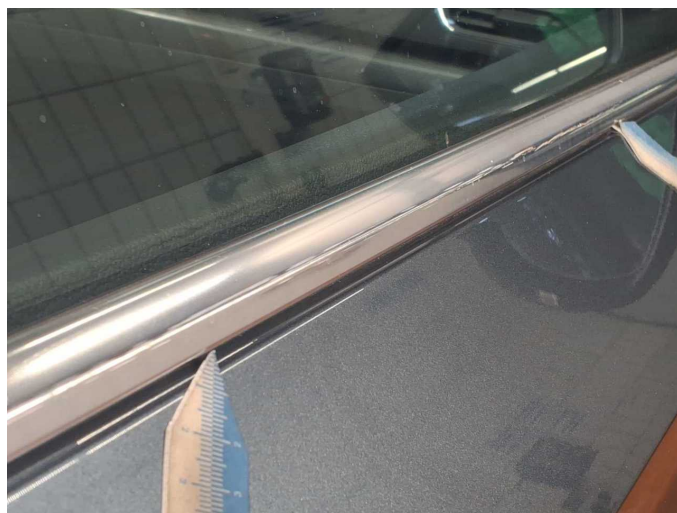
**Damage 7:** Door - front right side: Strip - outer - Scratch(es) - Replace

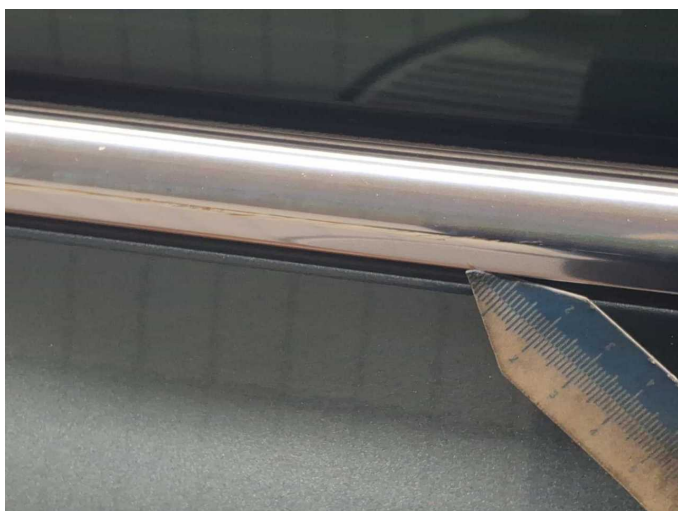
**Damage 7:** Door - front right side: Strip - outer - Scratch(es) - Replace

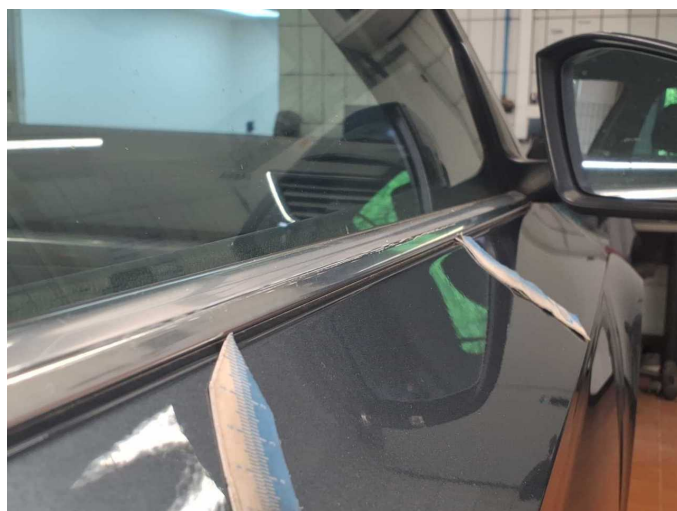
**Damage 7:** Door - front right side: Strip - outer - Scratch(es) - Replace

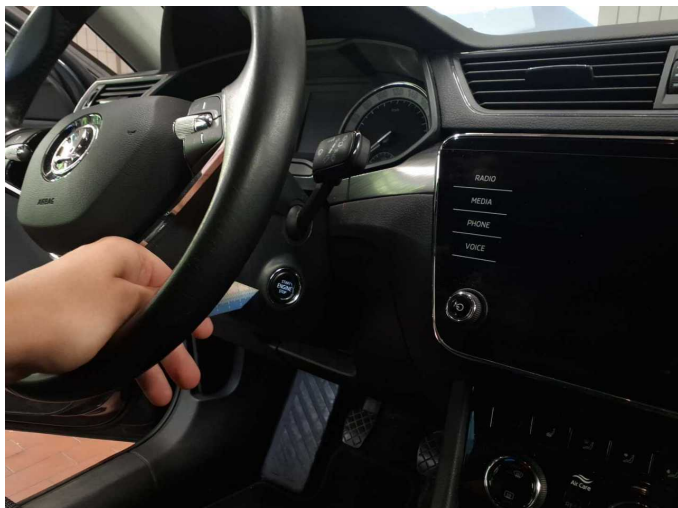
| No. | Component group | Description |
|---|---|---|
| 8 | Steering system | Steering column (Taster Startknopf) - Broken / torn - Loss in value |

**Damage 8:** Steering system: Steering column (Taster Startknopf) - Broken / torn - Loss in value

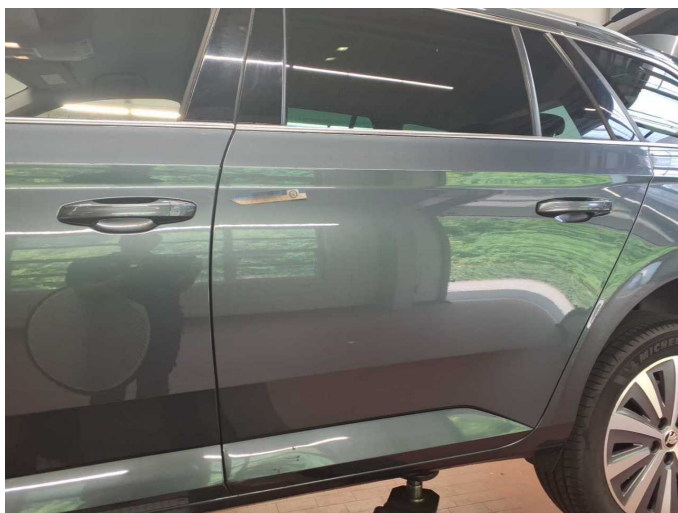
| No. | Component group | Description |
|---|---|---|
| 9 | Door - rear left side | Door - dent(s) - Smart repair |

**Damage 9:** Door - rear left side: Door - dent(s) - Smart repair

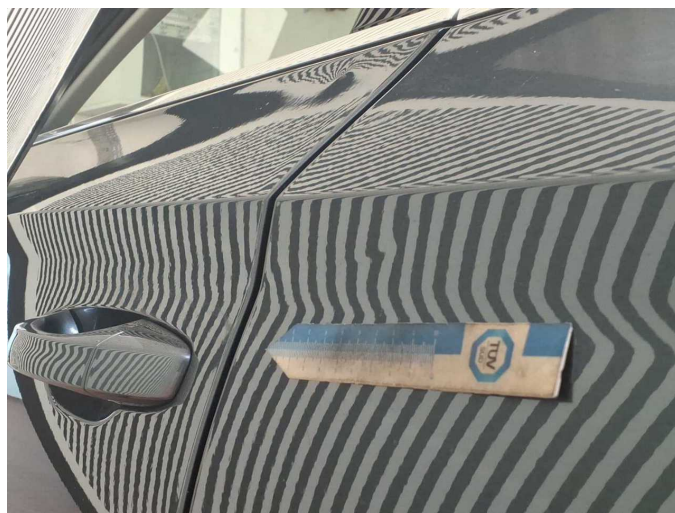
**Damage 9:** Door - rear left side: Door - dent(s) - Smart repair

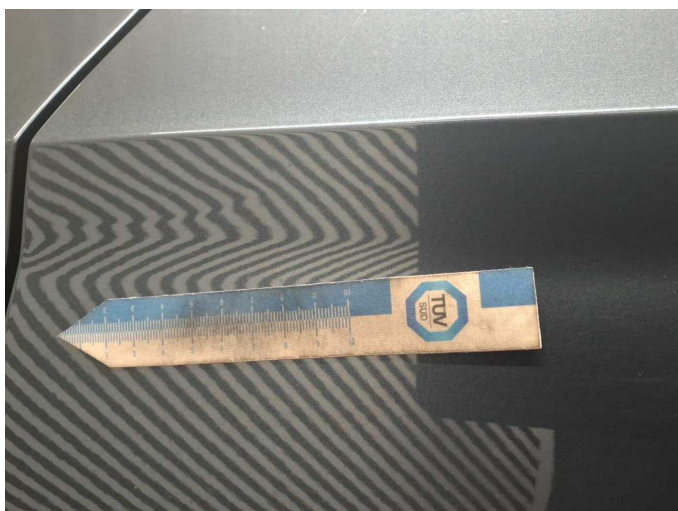
**Damage 9:** Door - rear left side: Door - dent(s) - Smart repair

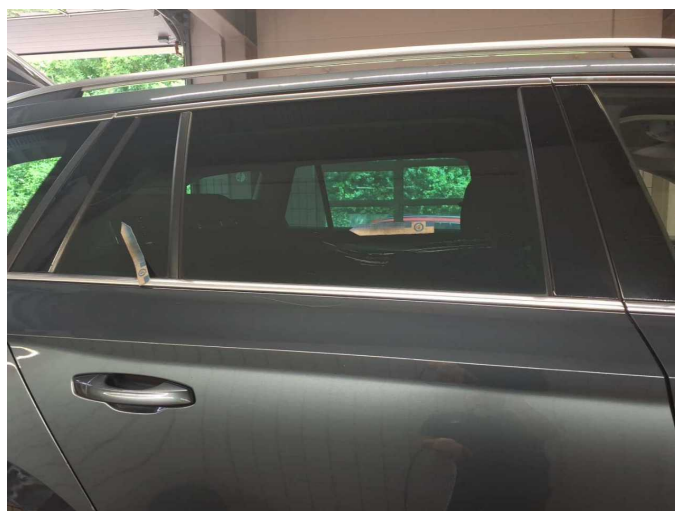
| No. | Component group | Description |
|---|---|---|
| 10 | Vehicle glazing | Door glass - rear right side - Scratch(es) - Loss in value |

**Damage 10:** Vehicle glazing: Door glass - rear right side - Scratch(es) - Loss in value

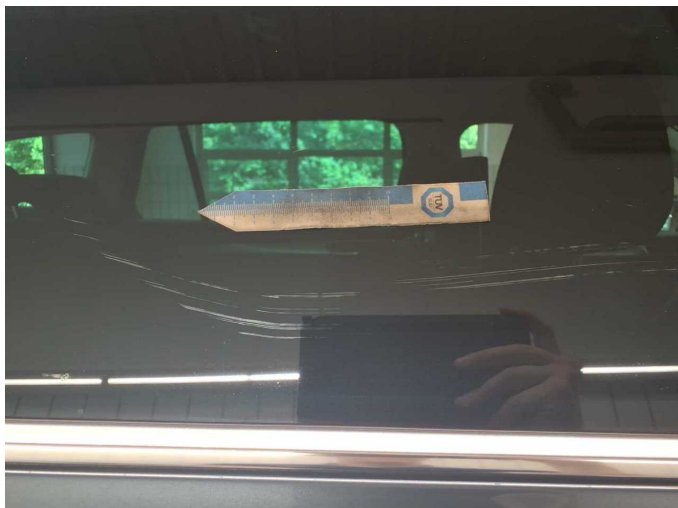
**Damage 10:** Vehicle glazing: Door glass - rear right side - Scratch(es) - Loss in value

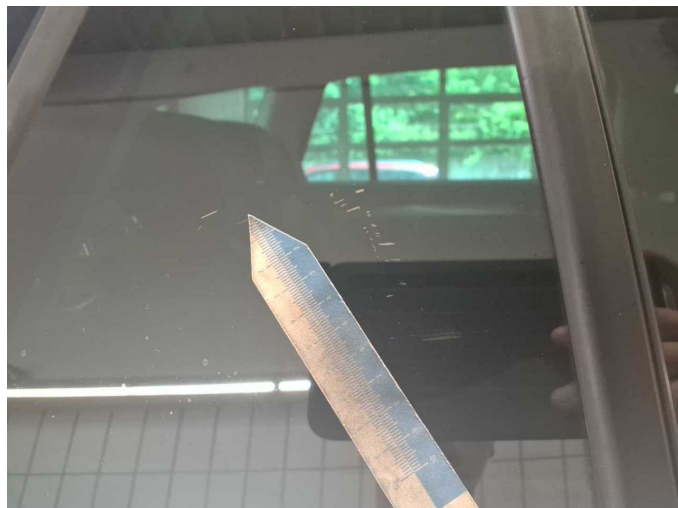
**Damage 10:** Vehicle glazing: Door glass - rear right side - Scratch(es) - Loss in value

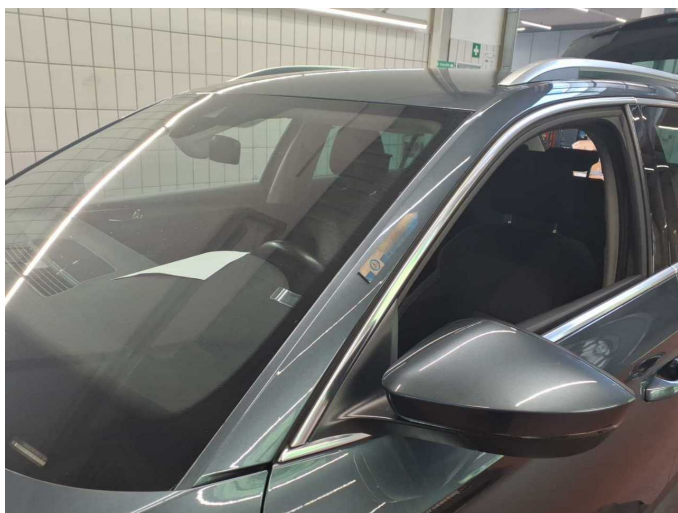
| No. | Component group | Description |
|---|---|---|
| 11 | Body | A-pillar - left side - Scratch(es) - Smart repair |

**Damage 11:** Body: A-pillar - left side - Scratch(es) - Smart repair

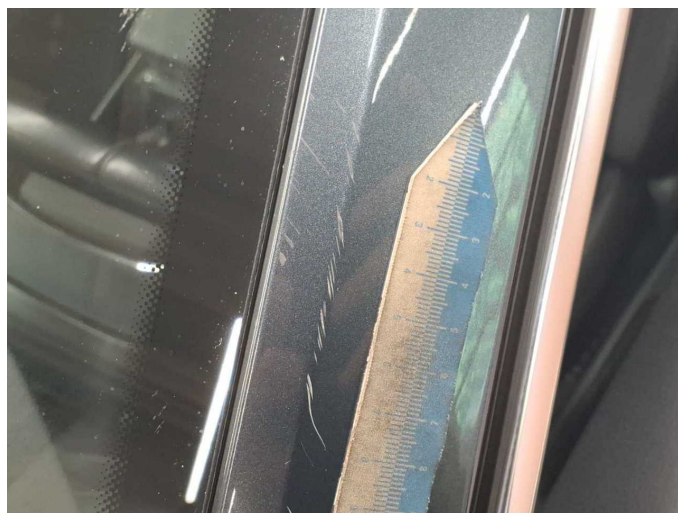
**Damage 11:** Body: A-pillar - left side - Scratch(es) - Smart repair

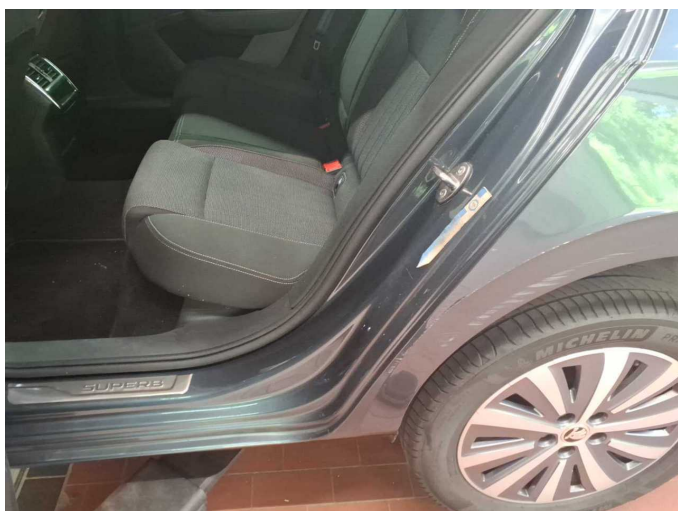
| No. | Component group | Description |
|---|---|---|
| 12 | Side panel - rear left side | Sill - Scratch(es) - Smart repair |

**Damage 12:** Side panel - rear left side: Sill - Scratch(es) - Smart repair

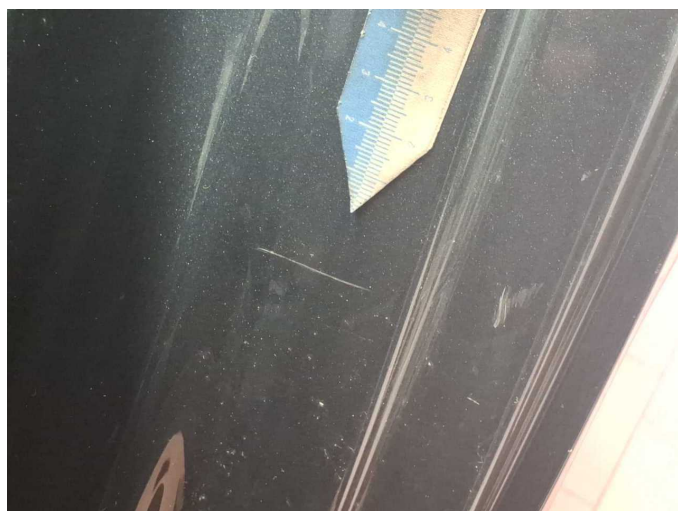
**Damage 12:** Side panel - rear left side: Sill - Scratch(es) - Smart repair

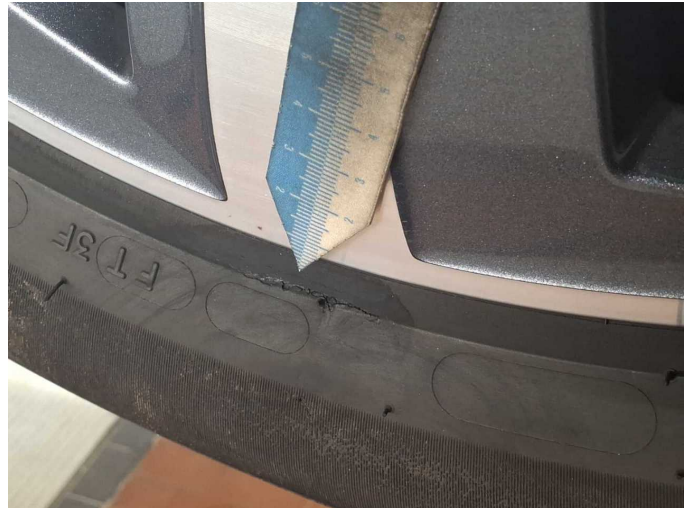
| No. | Component group | Description |
|---|---|---|
| 14 | Wheel / tyres | Tyre - front right side (nicht fahrbereit) - Broken / torn - Replace |

**Damage 14:** Wheel / tyres: Tyre - front right side (nicht fahrbereit) - Broken / torn - Replace

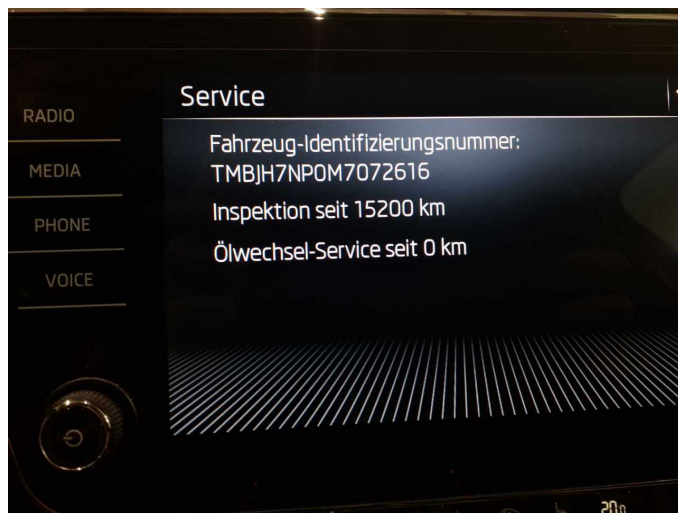
| No. | Component group | Description |
|---|---|---|
| 15 | Misc. | Inspection / maintenance (seit 15200 km) - Due - Perform |

**Damage 15:** Misc.: Inspection / maintenance (seit 15200 km) - Due - Perform

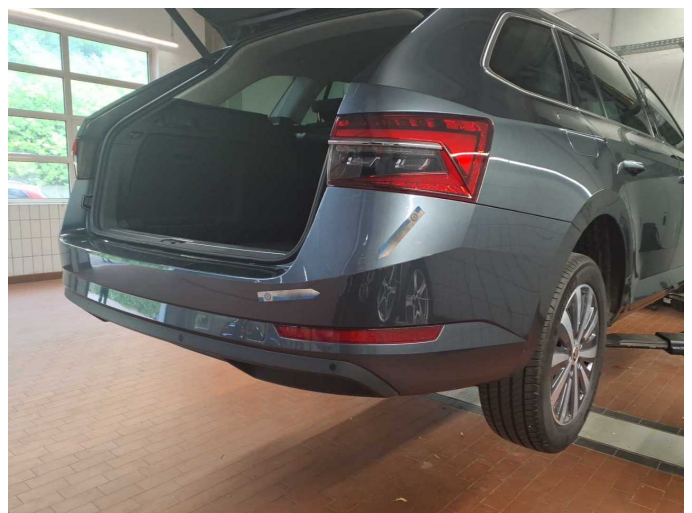
| No. | Component group | Description |
|---|---|---|
| 16 | Rear bumper | Rear bumper - Scratched - Paint |

**Damage 16:** Rear bumper: Rear bumper - Scratched - Paint

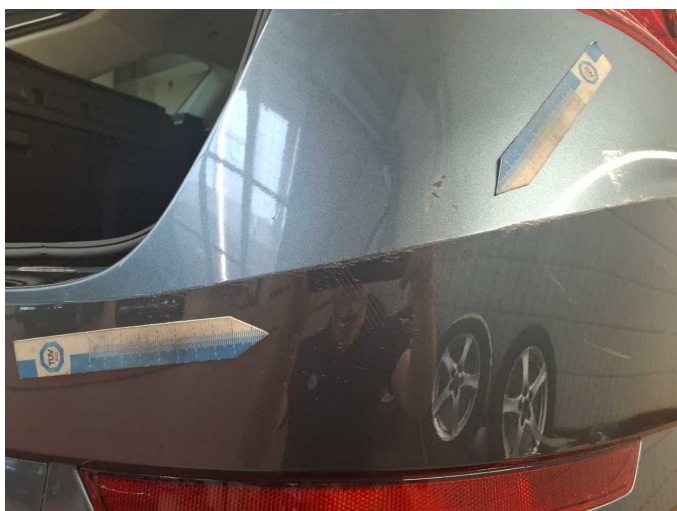
**Damage 16:** Rear bumper: Rear bumper - Scratched - Paint

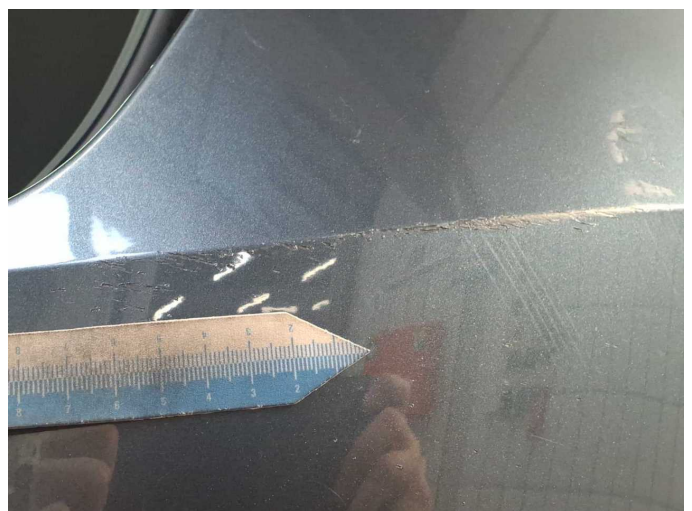
**Damage 16:** Rear bumper: Rear bumper - Scratched - Paint

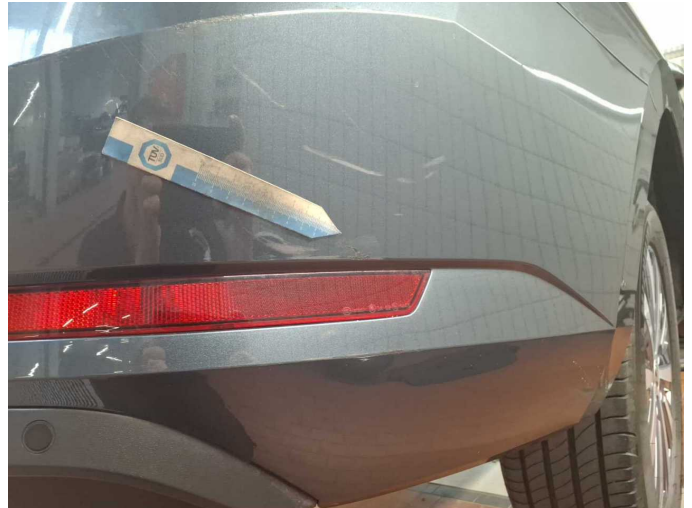
**Damage 16:** Rear bumper: Rear bumper - Scratched - Paint

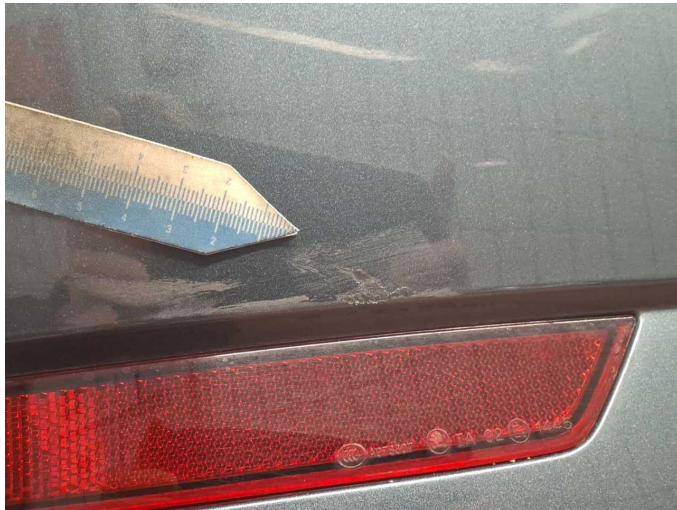
**Damage 16:** Rear bumper: Rear bumper - Scratched - Paint

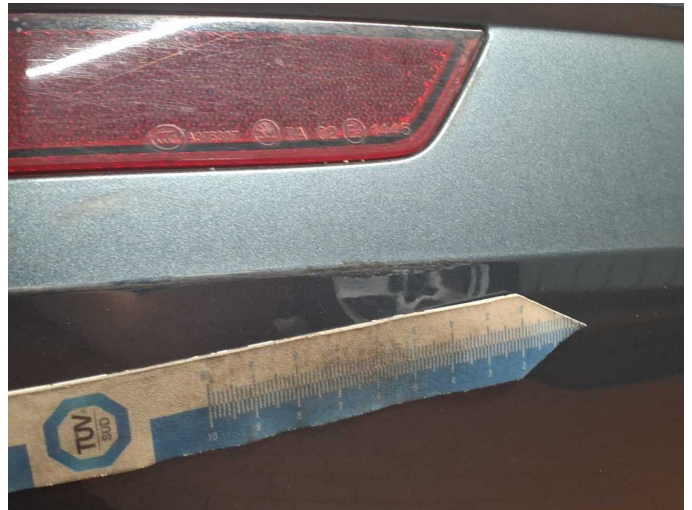
**Damage 16:** Rear bumper: Rear bumper - Scratched - Paint

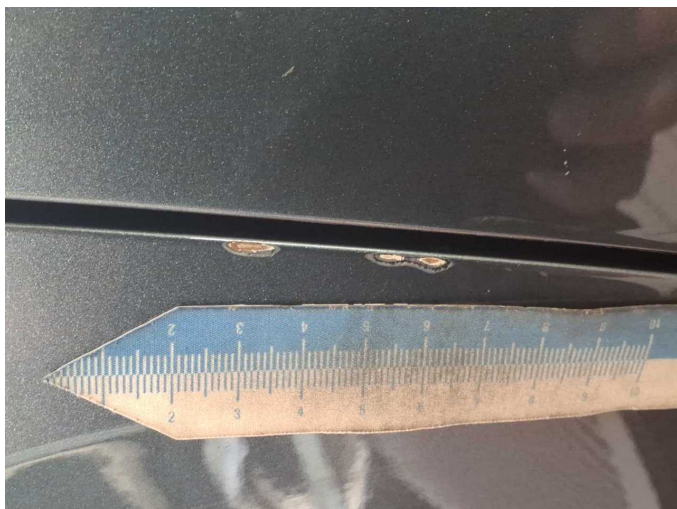
| No. | Component group | Description |
|---|---|---|
| 17 | Side panel - rear right side | Side panel - Scratch(es) - Paint |

**Damage 17:** Side panel - rear right side: Side panel - Scratch(es) - Paint

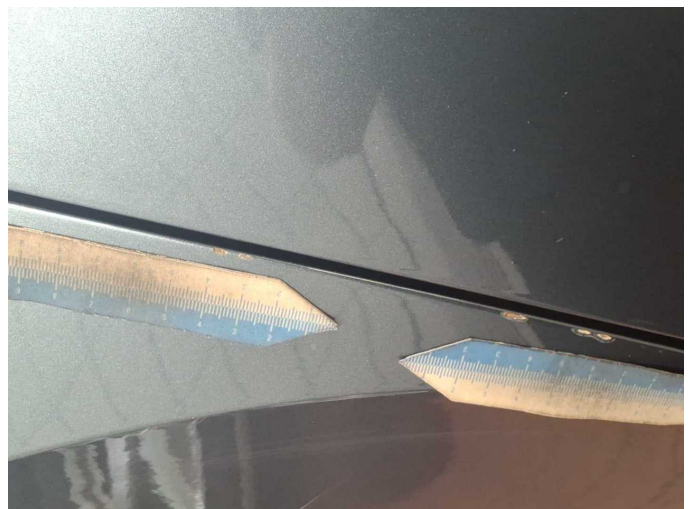
**Damage 17:** Side panel - rear right side: Side panel - Scratch(es) - Paint

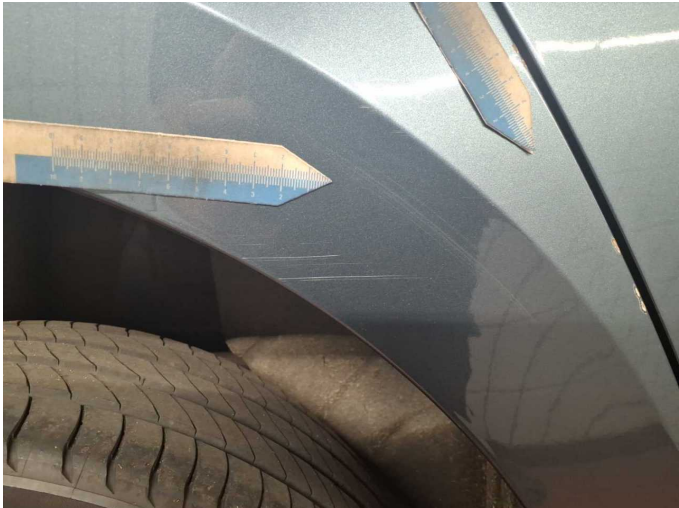
Damage 17: Side panel - rear right side: Side panel - Scratch(es) - Paint

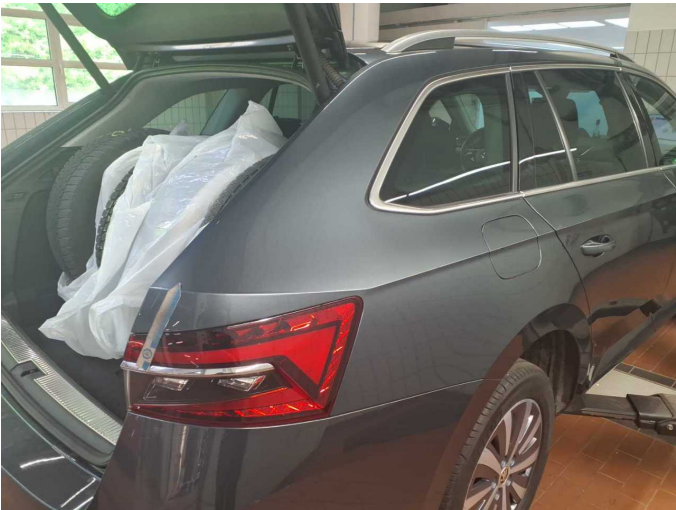
Damage 17: Side panel - rear right side: Side panel - Scratch(es) - Paint

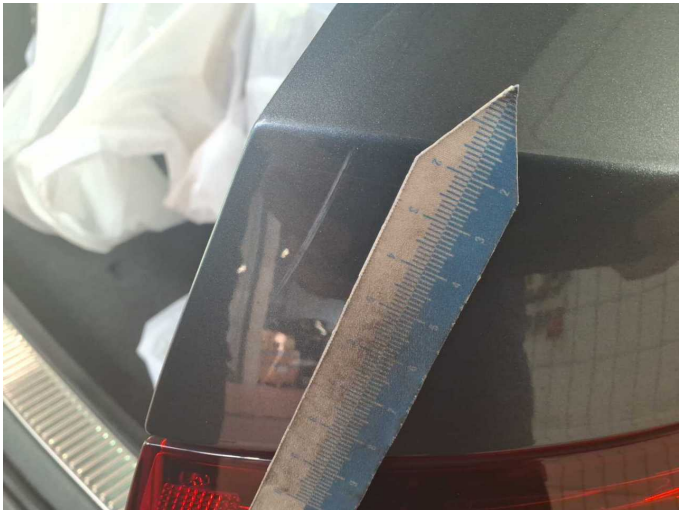
Damage 17: Side panel - rear right side: Side panel - Scratch(es) - Paint

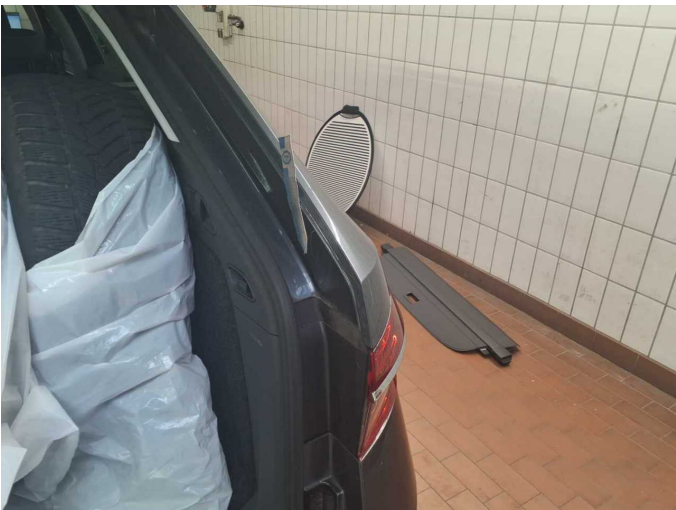
Damage 17: Side panel - rear right side: Side panel - Scratch(es) - Paint

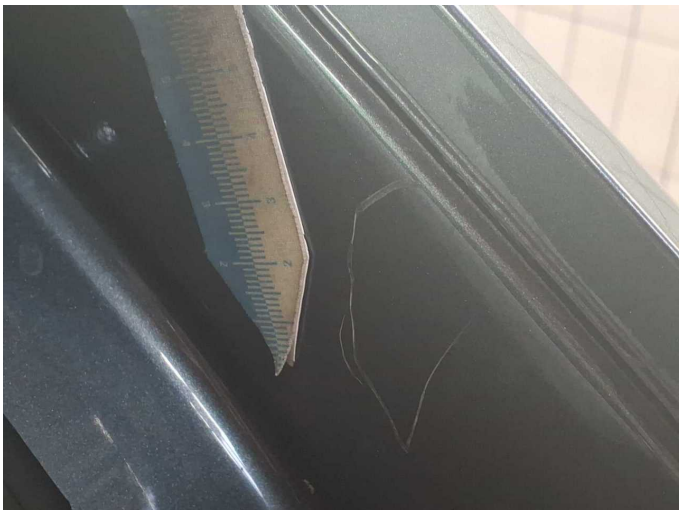
Damage 17: Side panel - rear right side: Side panel - Scratch(es) - Paint

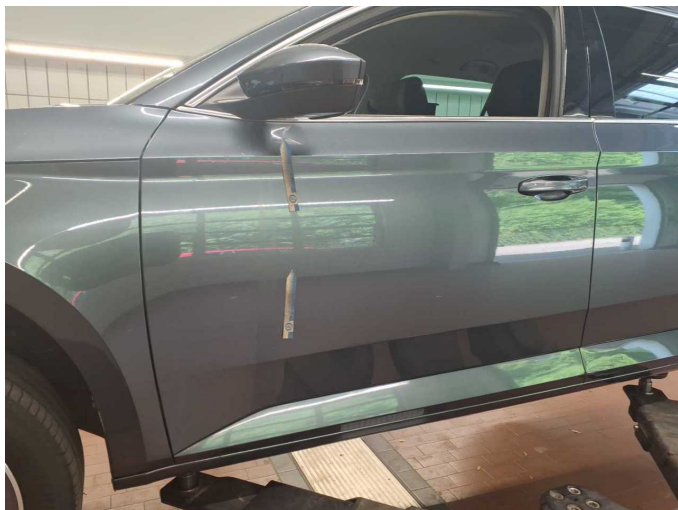
| No. | Component group | Description |
|---|---|---|
| 18 | Door - front left side | Door (+ verschmutzt) - Dent / paintcoat damage - Repair and paint |

**Damage 18:** Door - front left side: Door (+ verschmutzt) - Dent / paintcoat damage - Repair and paint

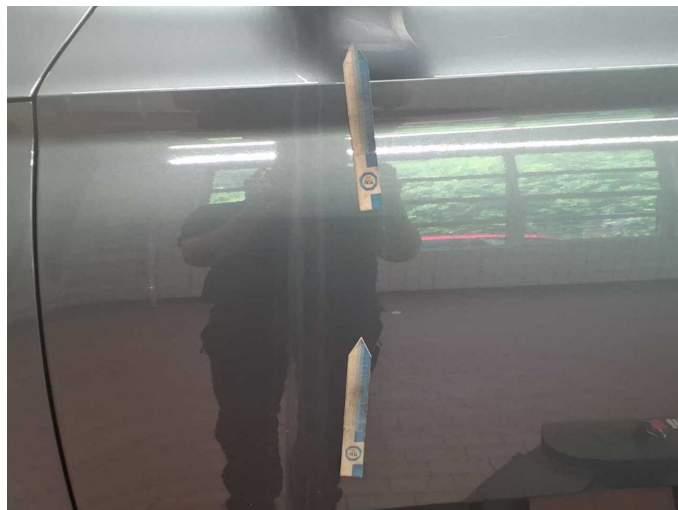
**Damage 18:** Door - front left side: Door (+ verschmutzt) - Dent / paintcoat damage - Repair and paint

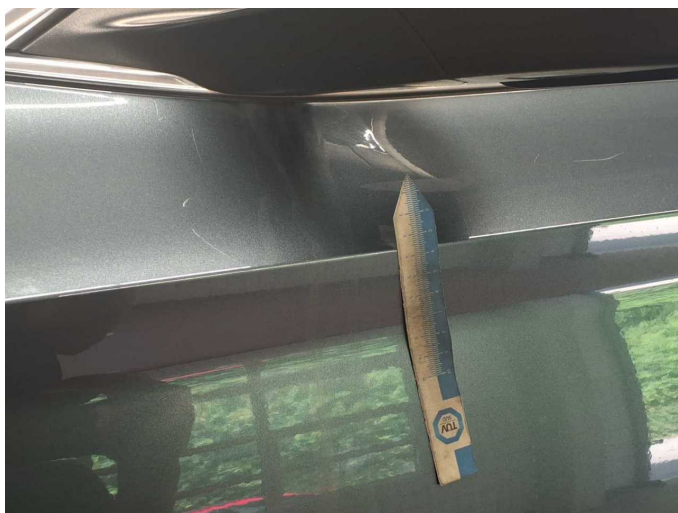
**Damage 18:** Door - front left side: Door (+ verschmutzt) - Dent / paintcoat damage - Repair and paint

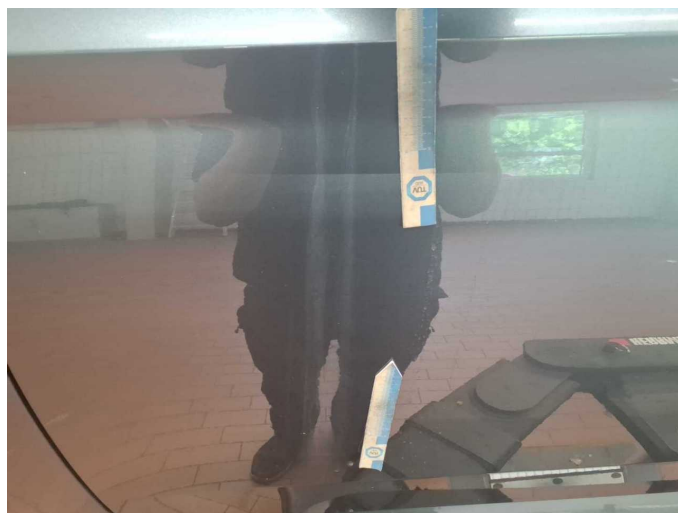
**Damage 18:** Door - front left side: Door (+ verschmutzt) - Dent / paintcoat damage - Repair and paint

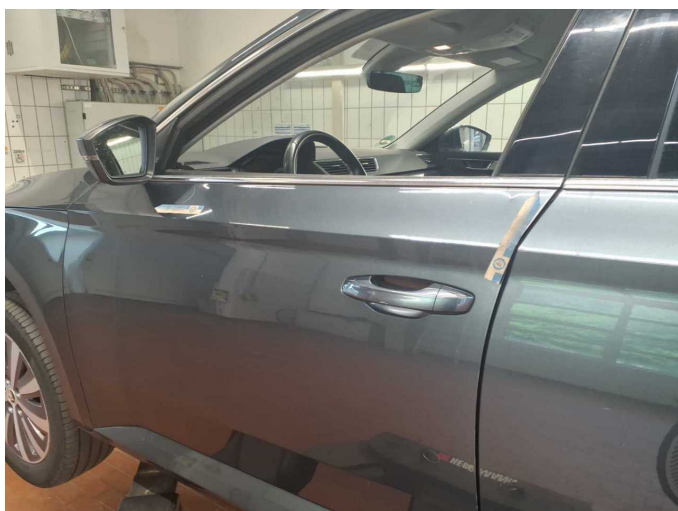
**Damage 18:** Door - front left side: Door (+ verschmutzt) - Dent / paintcoat damage - Repair and paint

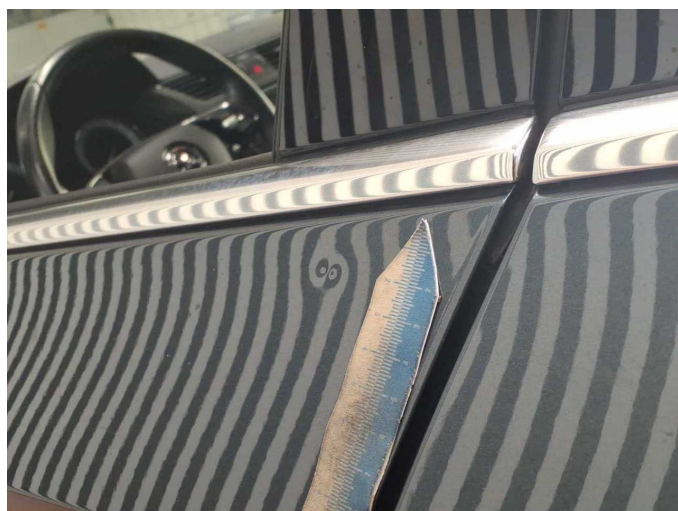
**Damage 18:** Door - front left side: Door (+ verschmutzt) - Dent / paintcoat damage - Repair and paint

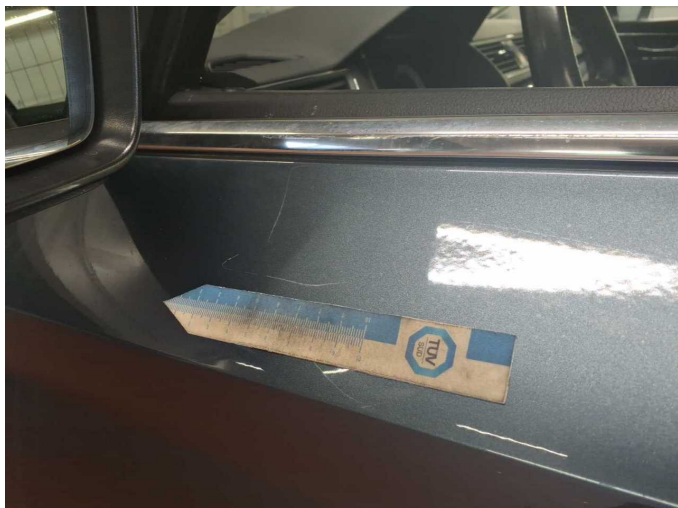
**Damage 18:** Door - front left side: Door (+ verschmutzt) - Dent / paintcoat damage - Repair and paint

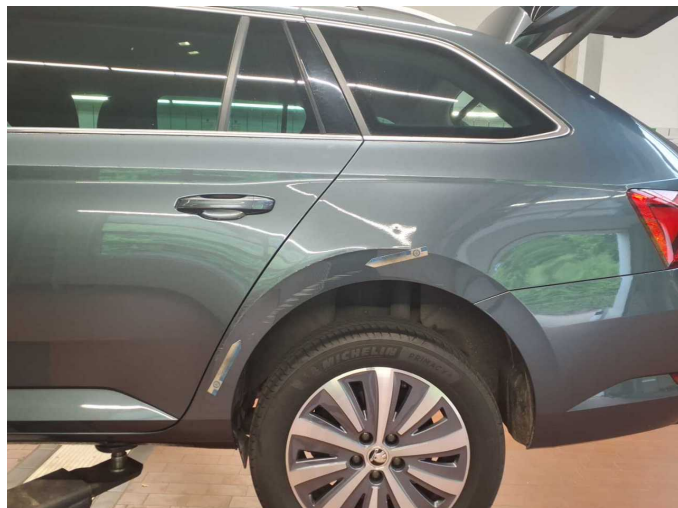
| No. | Component group | Description |
|---|---|---|
| 19 | Side panel - rear left side | Side panel - Dent / paintcoat damage - Repair and paint |

**Damage 19:** Side panel - rear left side: Side panel - Dent / paintcoat damage - Repair and paint

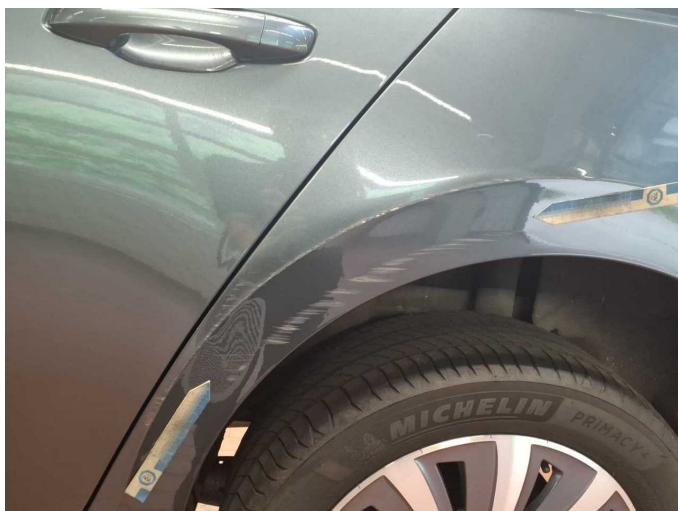
**Damage 19:** Side panel - rear left side: Side panel - Dent / paintcoat damage - Repair and paint

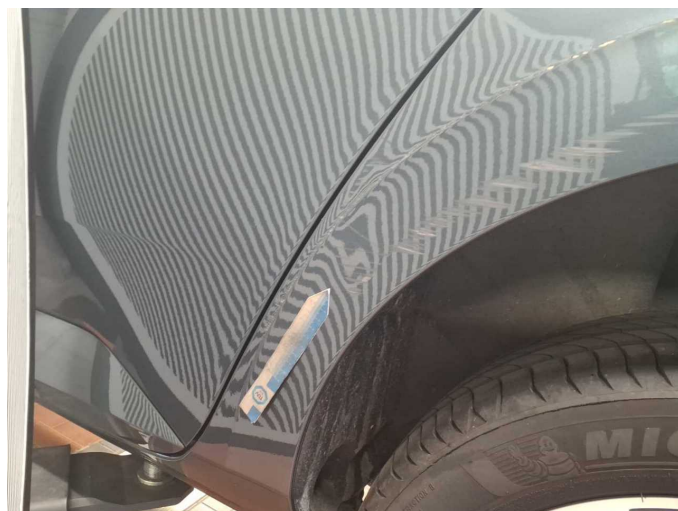
**Damage 19:** Side panel - rear left side: Side panel - Dent / paintcoat damage - Repair and paint

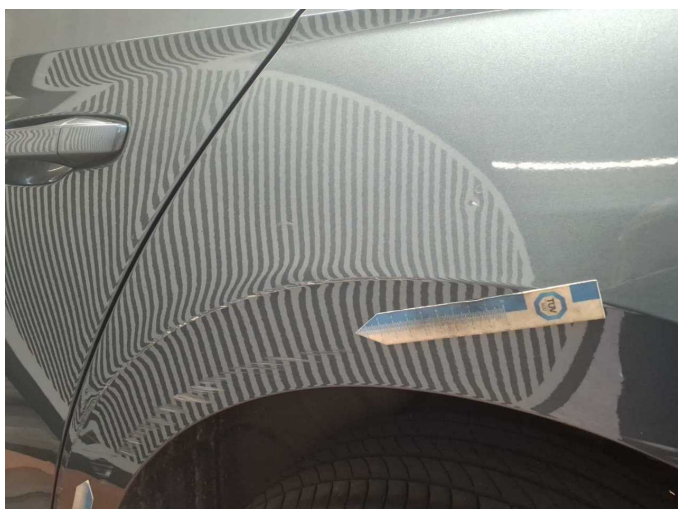
**Damage 19:** Side panel - rear left side: Side panel - Dent / paintcoat damage - Repair and paint

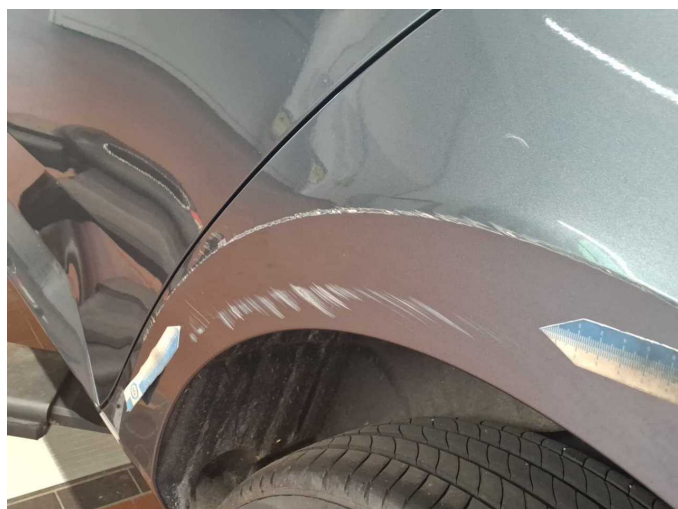
**Damage 19:** Side panel - rear left side: Side panel - Dent / paintcoat damage - Repair and paint

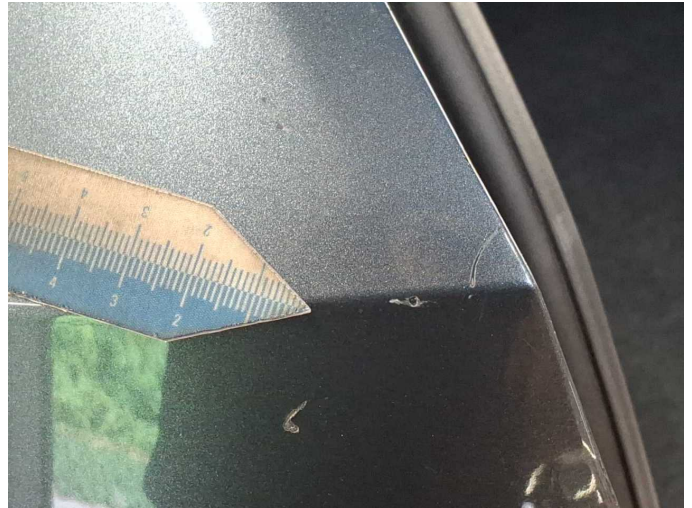
**Damage 19:** Side panel - rear left side: Side panel - Dent / paintcoat damage - Repair and paint

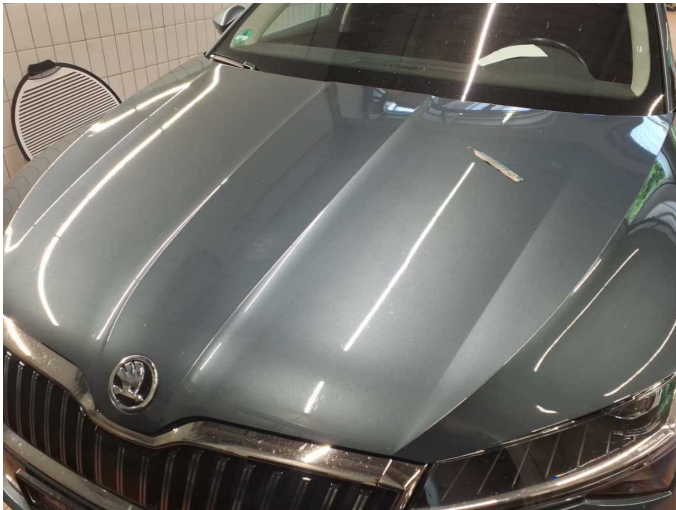
| No. | Component group | Description |
|---|---|---|
| 20 | Bonnet | Bonnet (+ Steinschläge) - Paint defect - Paint |

**Damage 20:** Bonnet: Bonnet (+ Steinschläge) - Paint defect - Paint

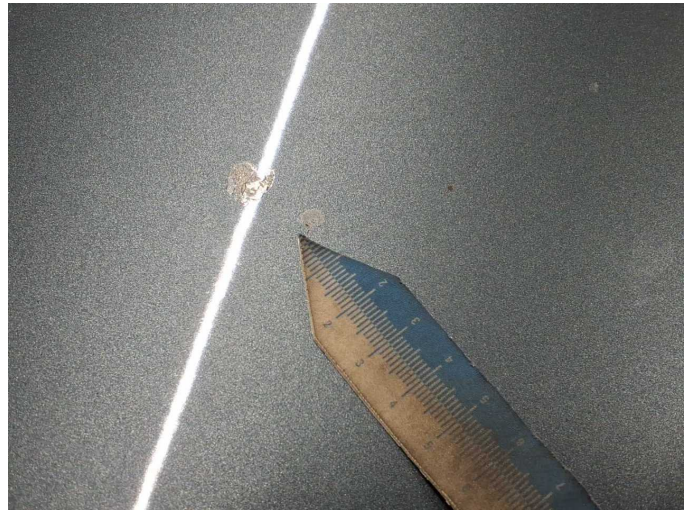
**Damage 20:** Bonnet: Bonnet (+ Steinschläge) - Paint defect - Paint

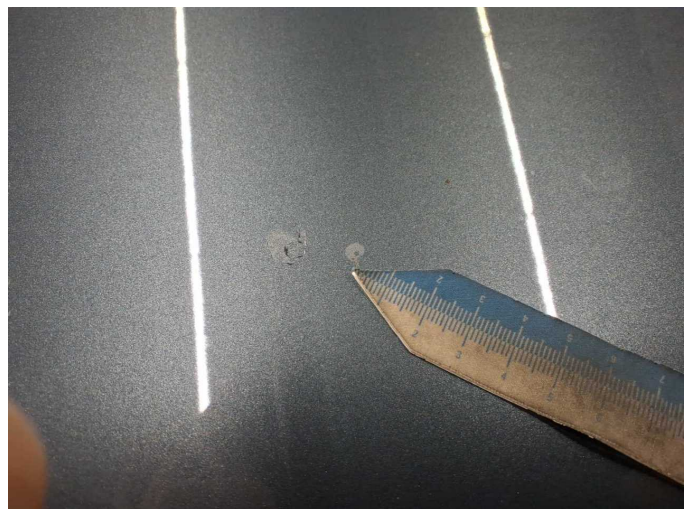
**Damage 20:** Bonnet: Bonnet (+ Steinschläge) - Paint defect - Paint

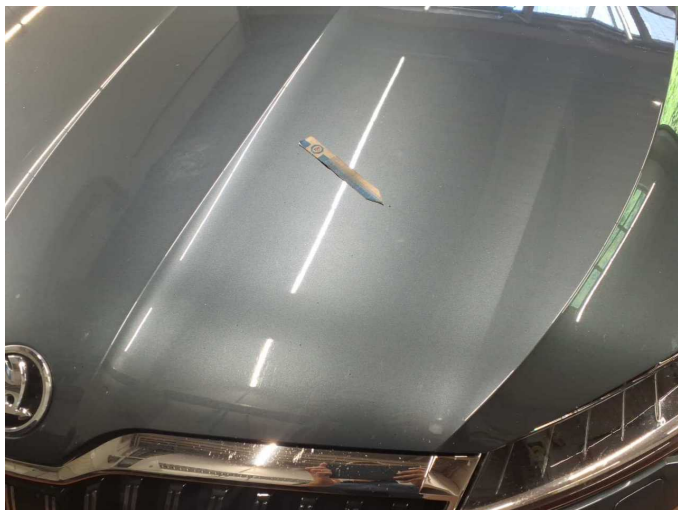
**Damage 20:** Bonnet: Bonnet (+ Steinschläge) - Paint defect - Paint

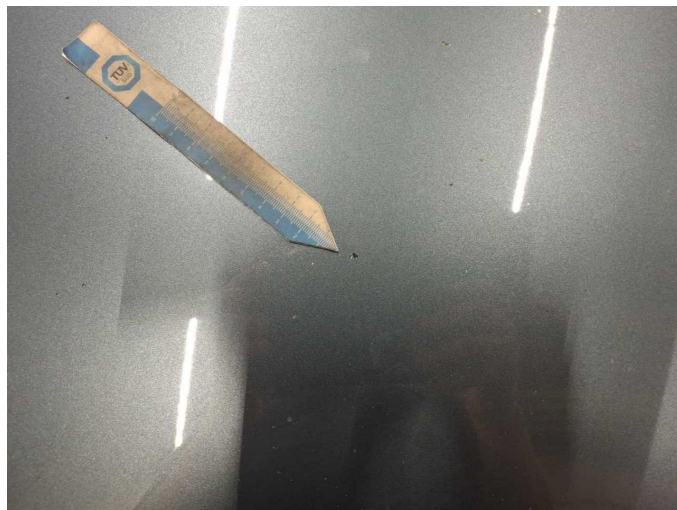
**Damage 20:** Bonnet: Bonnet (+ Steinschläge) - Paint defect - Paint

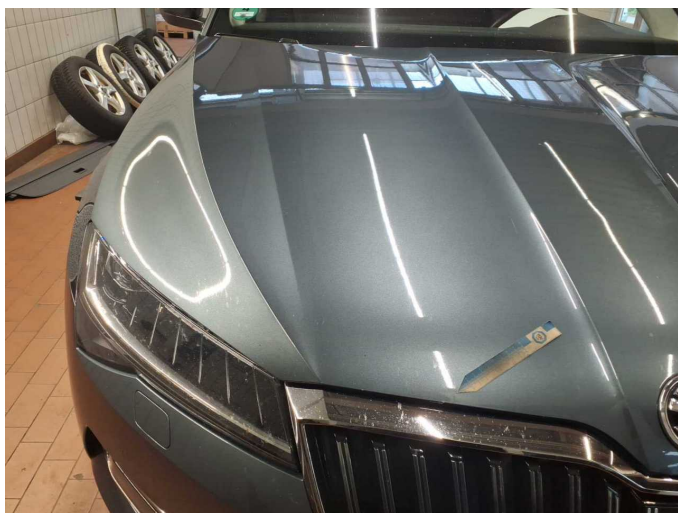
**Damage 20:** Bonnet: Bonnet (+ Steinschläge) - Paint defect - Paint

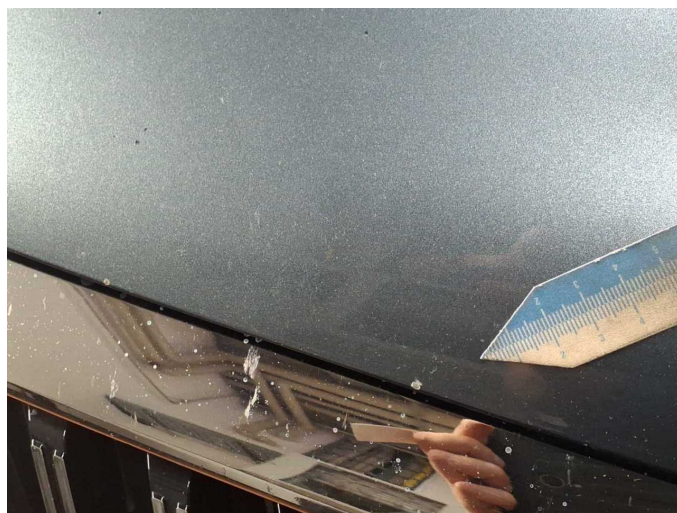
**Damage 20:** Bonnet: Bonnet (+ Steinschläge) - Paint defect - Paint

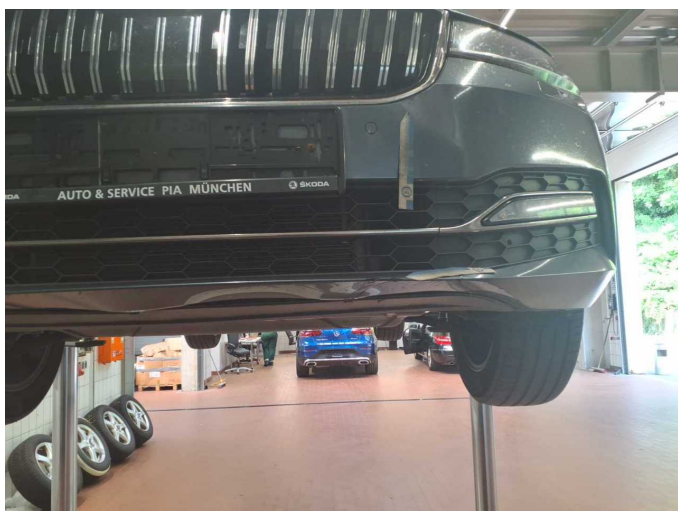
| No. | Component group | Description |
|---|---|---|
| 21 | Front bumper | Front bumper (+ Fehlstellung) - Scratched - Repair and paint |

**Damage 21:** Front bumper: Front bumper (+ Fehlstellung) - Scratched - Repair and paint

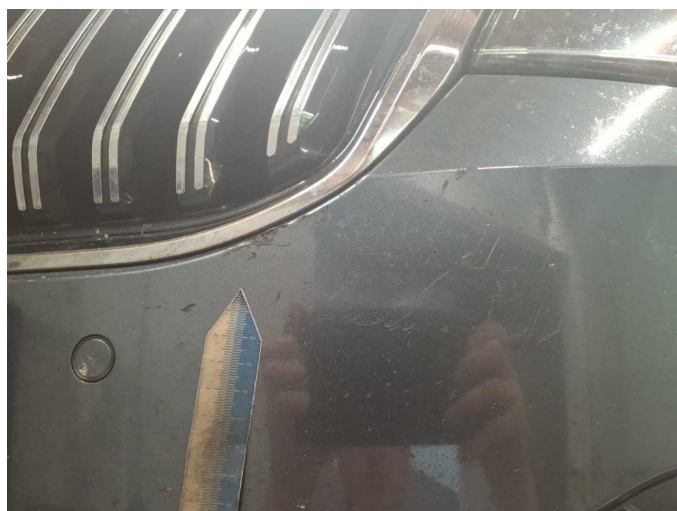
**Damage 21:** Front bumper: Front bumper (+ Fehlstellung) - Scratched - Repair and paint

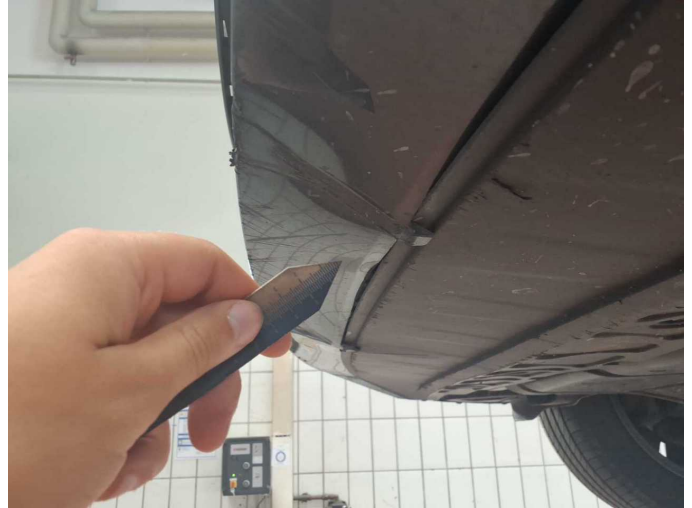
**Damage 21:** Front bumper: Front bumper (+ Fehlstellung) - Scratched - Repair and paint

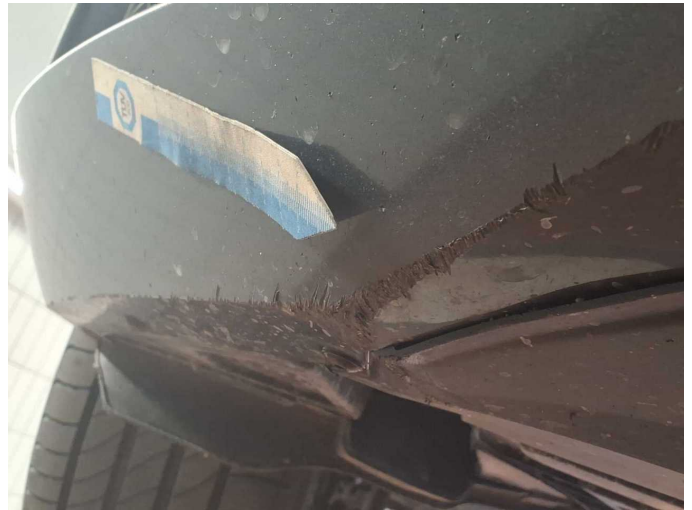
**Damage 21:** Front bumper: Front bumper (+ Fehlstellung) - Scratched - Repair and paint

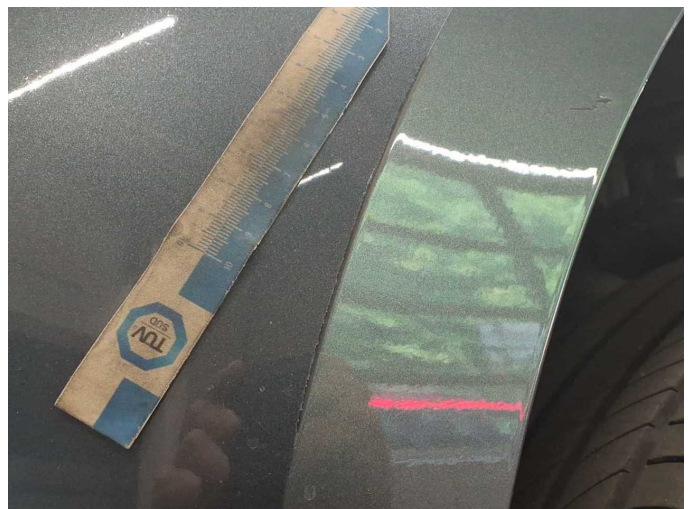
**Damage 21:** Front bumper: Front bumper (+ Fehlstellung) - Scratched - Repair and paint

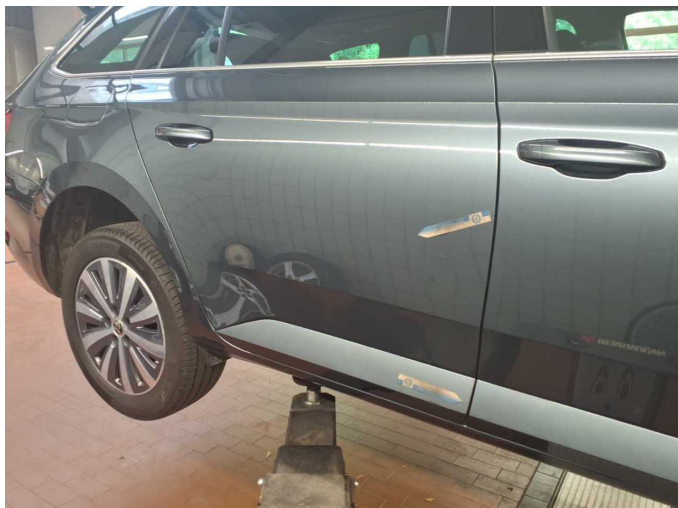
| No. | Component group | Description |
|---|---|---|
| 22 | Door - rear right side | Door (+ Zierleiste verschürft - lackieren) - Dent / paintcoat damage - Repair and paint |

**Damage 22:** Door - rear right side: Door (+ Zierleiste verschürft - lackieren) - Dent / paintcoat damage - Repair and paint
