Expertise

Protocol number: 46583987  
Order No. / Reference: 26701496  
Inspection date: 16 Jul 2026

Manufacturer: Skoda  
VIN: TMBJH7NP0M7072616

Model: Superb Combi 2.0 TDI Style

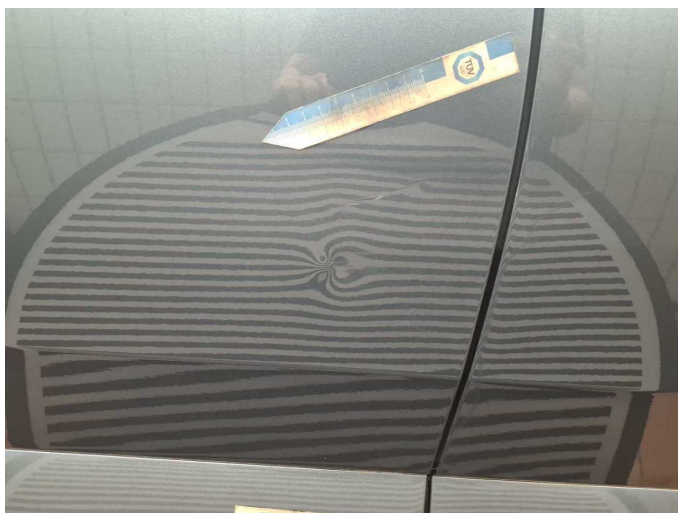
**Damage 22:** Door - rear right side: Door (+ Zierleiste verschürft - lackieren) - Dent / paintcoat damage - Repair and paint

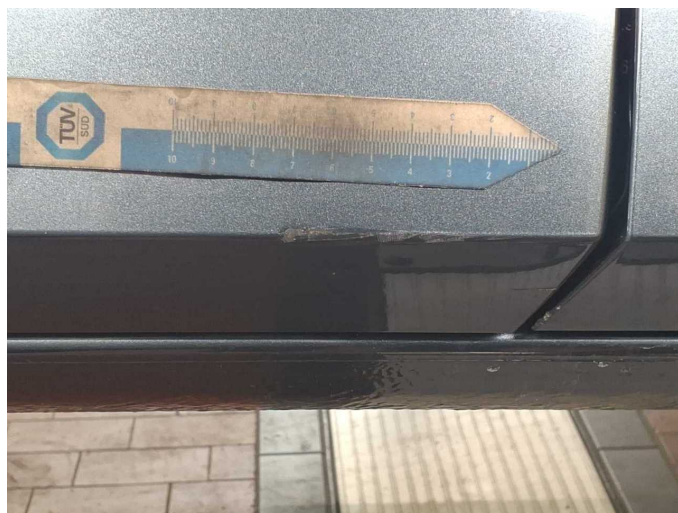
**Damage 22:** Door - rear right side: Door (+ Zierleiste verschürft - lackieren) - Dent / paintcoat damage - Repair and paint

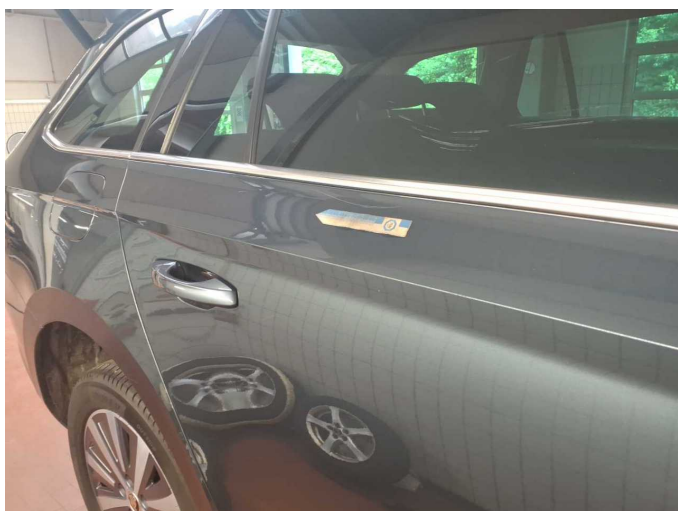
**Damage 22:** Door - rear right side: Door (+ Zierleiste verschürft - lackieren) - Dent / paintcoat damage - Repair and paint

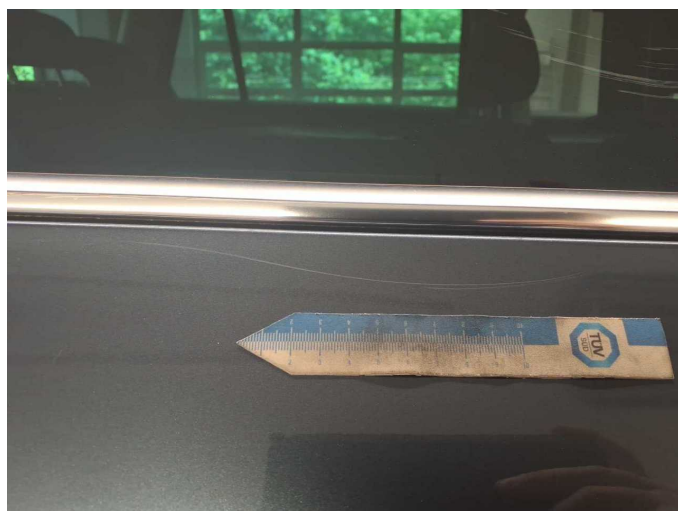
**Damage 22:** Door - rear right side: Door (+ Zierleiste verschürft - lackieren) - Dent / paintcoat damage - Repair and paint

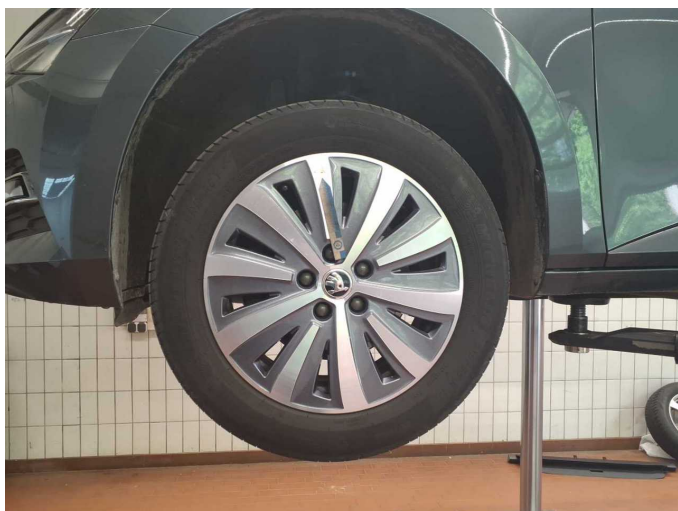
| No. | Component group | Description |
|---|---|---|
| 2 | Wheel / tyres | Alloy rim - front left side - Scratch(es) - No deduction |

**Wear and tear 2:** Wheel / tyres: Alloy rim - front left side - Scratch(es) - No deduction

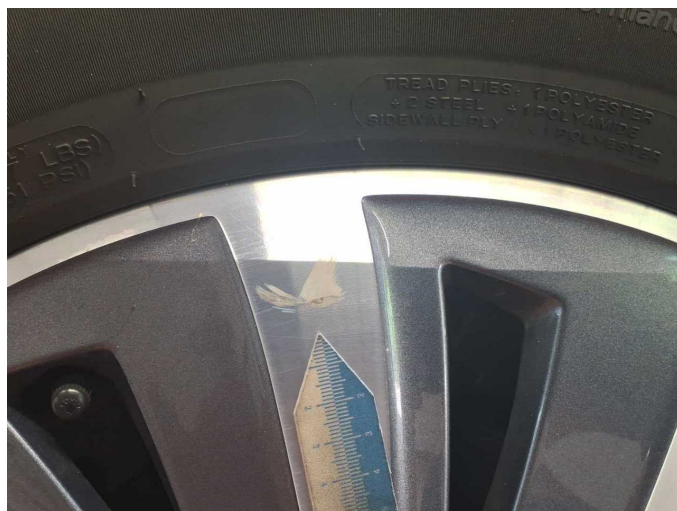
**Wear and tear 2:** Wheel / tyres: Alloy rim - front left side - Scratch(es) - No deduction

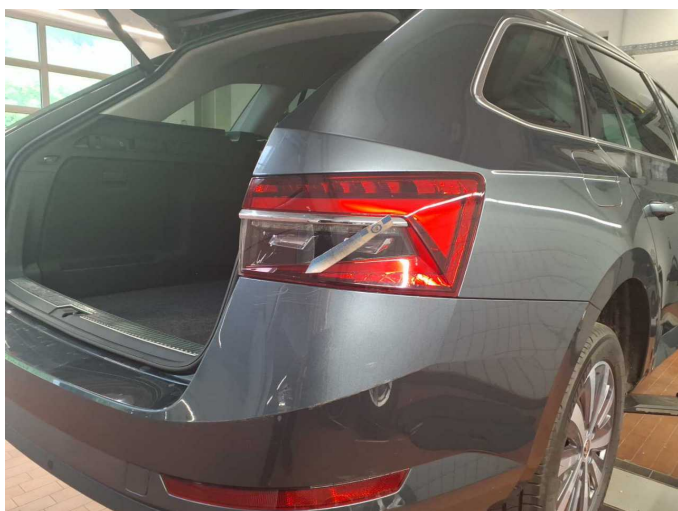
| No. | Component group | Description |
|---|---|---|
| 4 | Tail light | Tail lamp - right side - Scratch(es) - No deduction |

**Wear and tear 4:** Tail light: Tail lamp - right side - Scratch(es) - No deduction

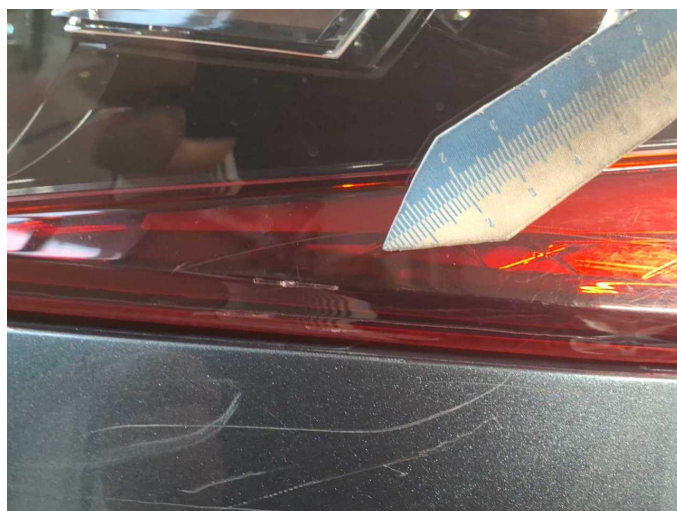
**Wear and tear 4:** Tail light: Tail lamp - right side - Scratch(es) - No deduction

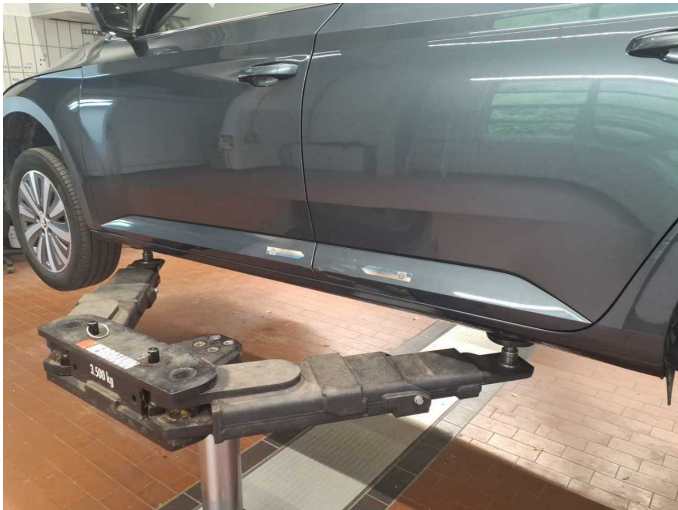
| No. | Accident |
|---|---|
| 1 | Side - left |

**Accident 1:** Side - left
