Expertise

Protocol number: 46599191  
Order No. / Reference: 26626460  
Inspection date: 20 Jul 2026

Manufacturer: Ford

Model: Transit Connect 230 L2 S&S Autm. Trend

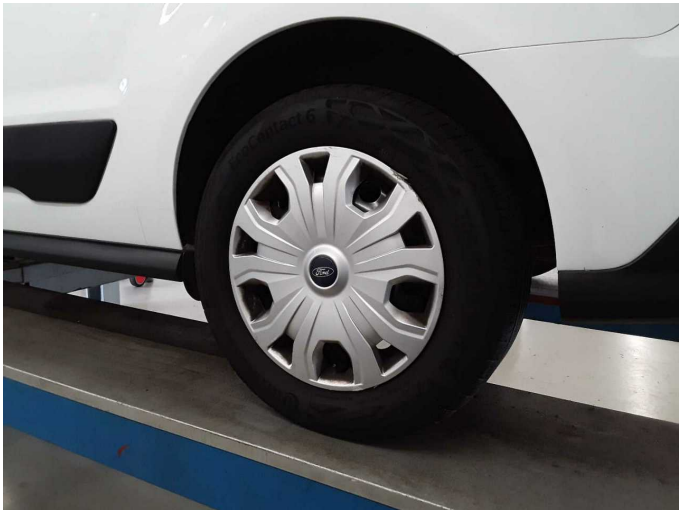
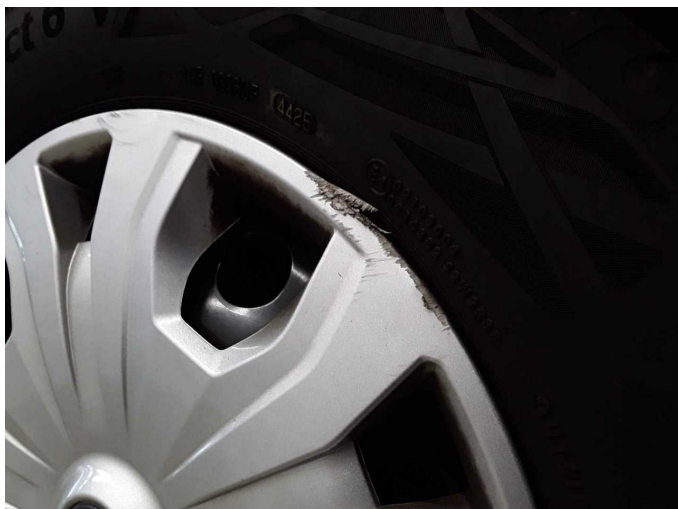
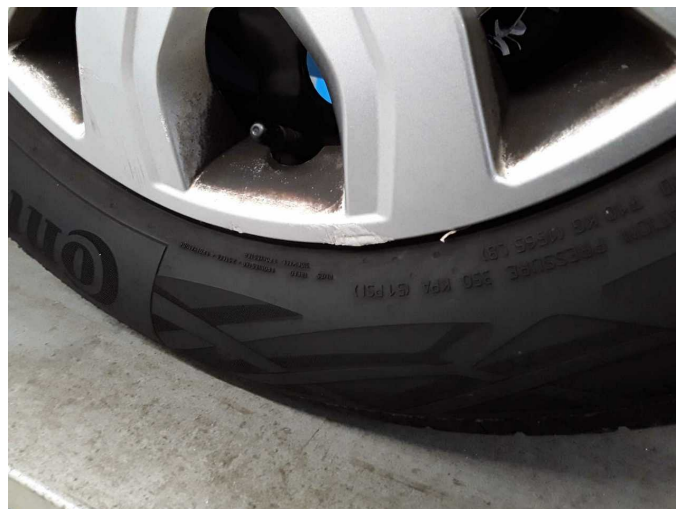
| No. | Component group | Description |
|---|---|---|
| 1 | Wheel / tyres | Wheel cover - rear left side - Broken / torn - Replace |

Damage 1: Wheel / tyres: Wheel cover - rear left side - Broken / torn - Replace

**Damage 1:** Wheel / tyres: Wheel cover - rear left side - Broken / torn - Replace

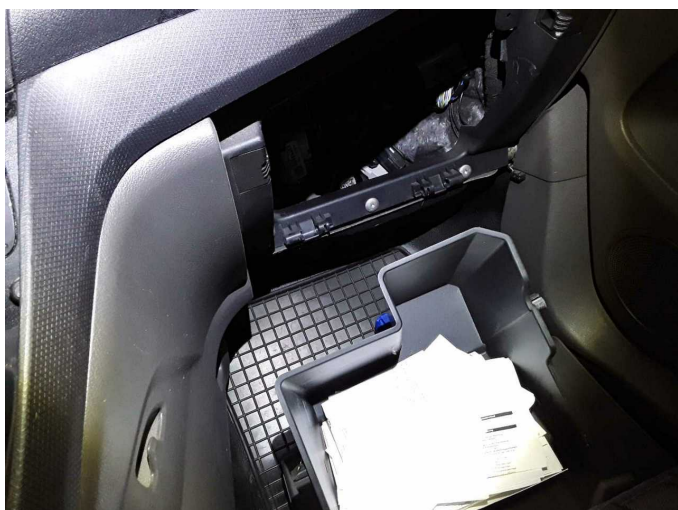
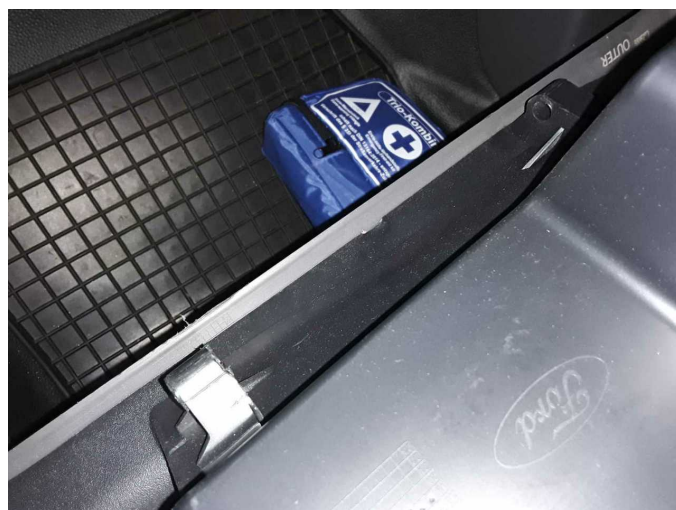
| No. | Component group | Description |
|---|---|---|
| 2 | Instrument panel | Glove box - Loose - Repair |

**Damage 2:** Instrument panel: Glove box - Loose - Repair

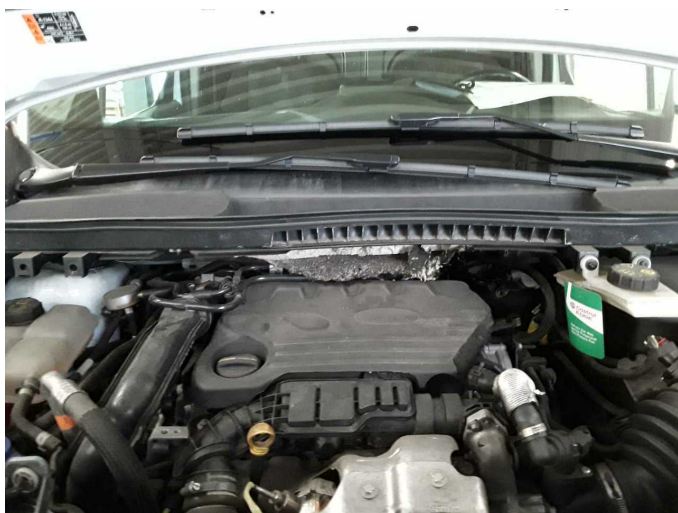
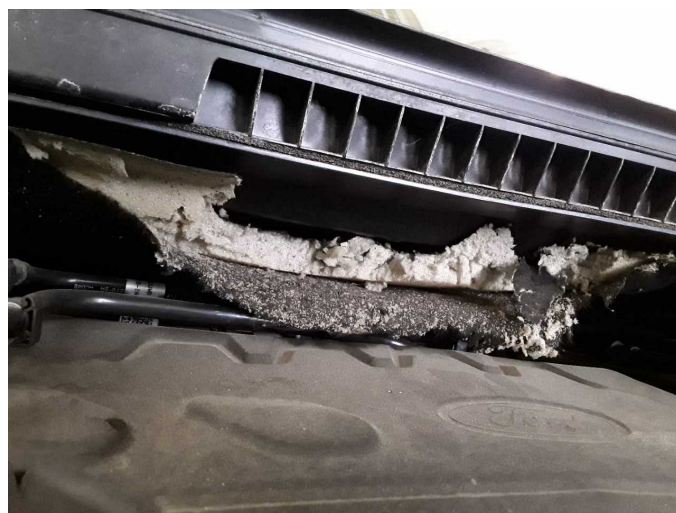
| No. | Component group | Description |
|---|---|---|
| 3 | Cab | Insulation lining (Stirnwand) - Damage caused by marten / rodent - Replace |

**Damage 3:** Cab: Insulation lining (Stirnband) - Damage caused by marten / rodent - Replace

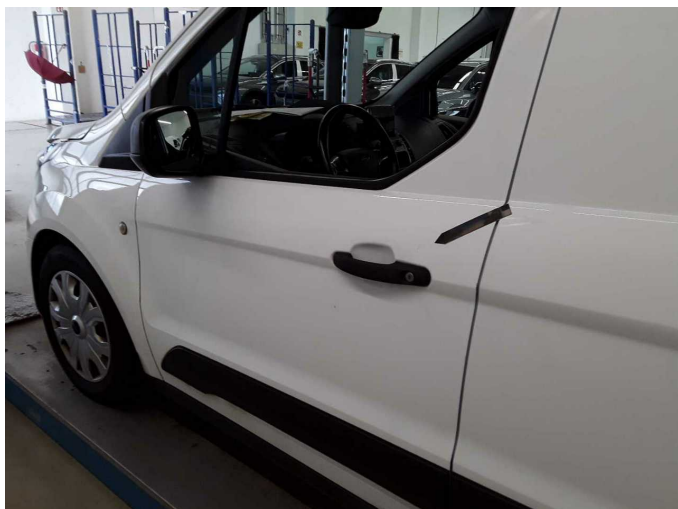
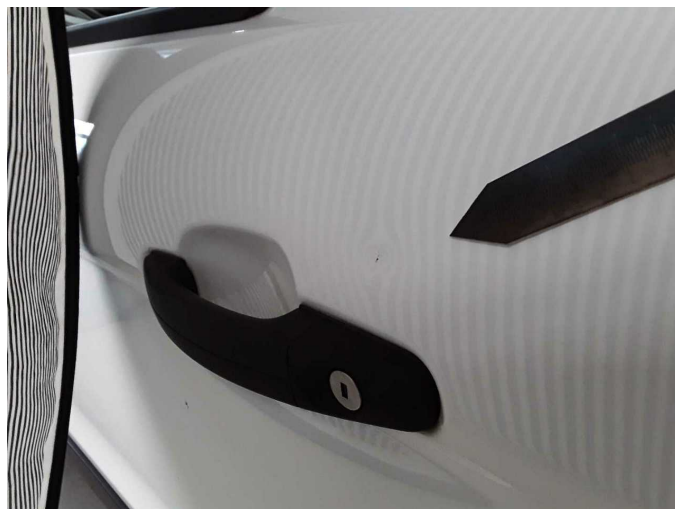
| No. | Component group | Description |
|---|---|---|
| 4 | Door - front left side | Door - dent(s) - Smart repair |

**Damage 4:** Door - front left side: Door - dent(s) - Smart repair

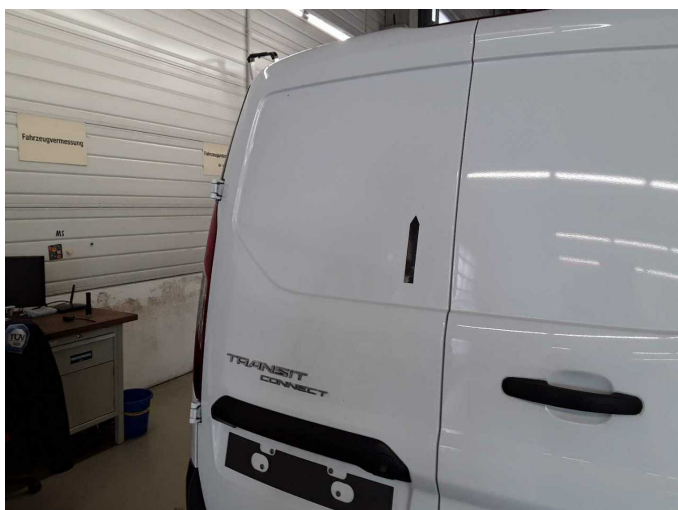
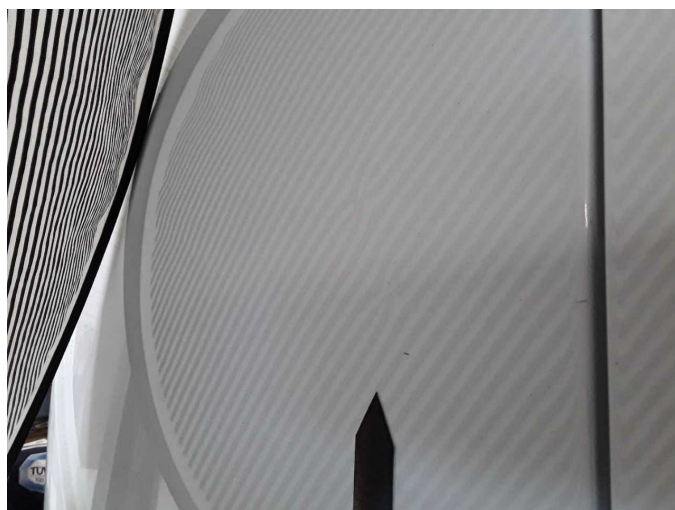
| No. | Component group | Description |
|---|---|---|
| 5 | Boot lid / rear door | Rear door - left side - dent(s) - Smart repair |

**Damage 5:** Boot lid / rear door: Rear door - left side - dent(s) - Smart repair

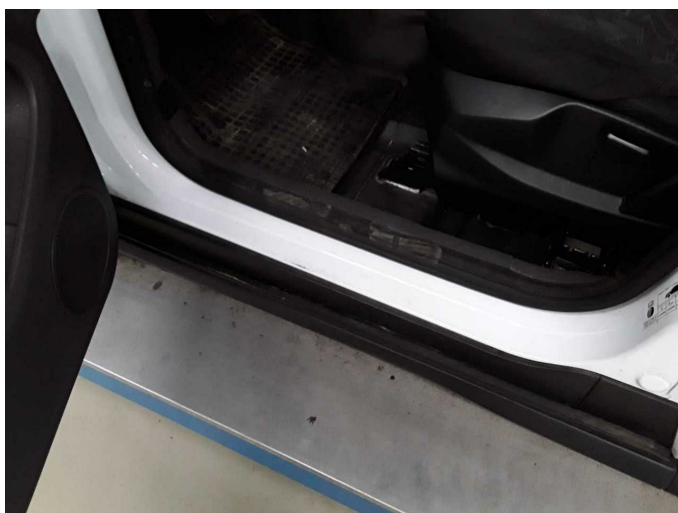
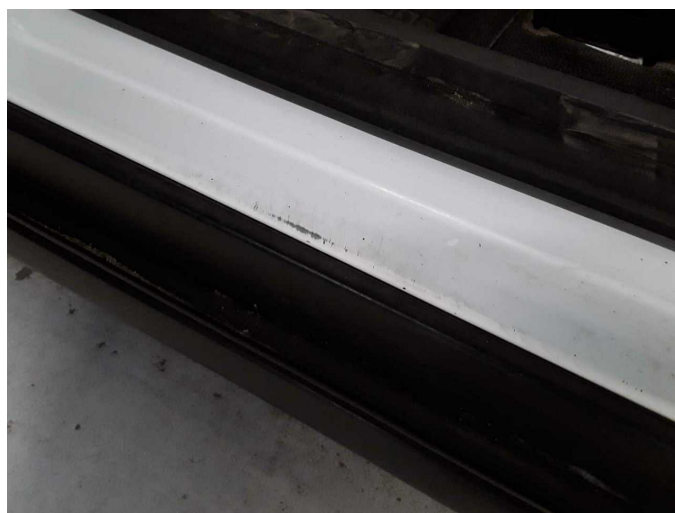
| No. | Component group | Description |
|---|---|---|
| 6 | Sill - left side | Sill - Scratch(es) - Smart repair |

**Damage 6:** Sill - left side: Sill - Scratch(es) - Smart repair

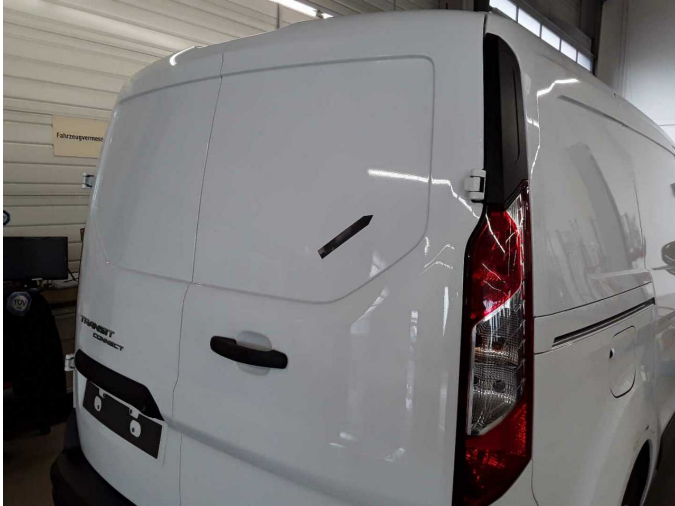
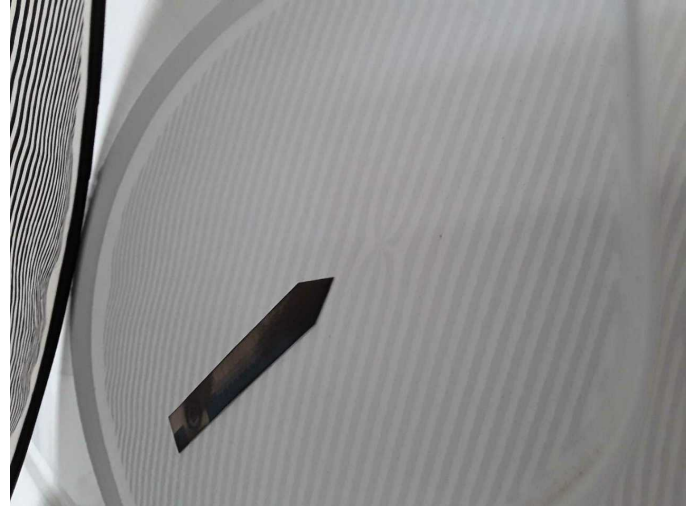
| No. | Component group | Description |
|---|---|---|
| 7 | Boot lid / rear door | Rear door - right side - dent(s) - Smart repair |

**Damage 7:** Boot lid / rear door: Rear door - right side - dent(s) - Smart repair

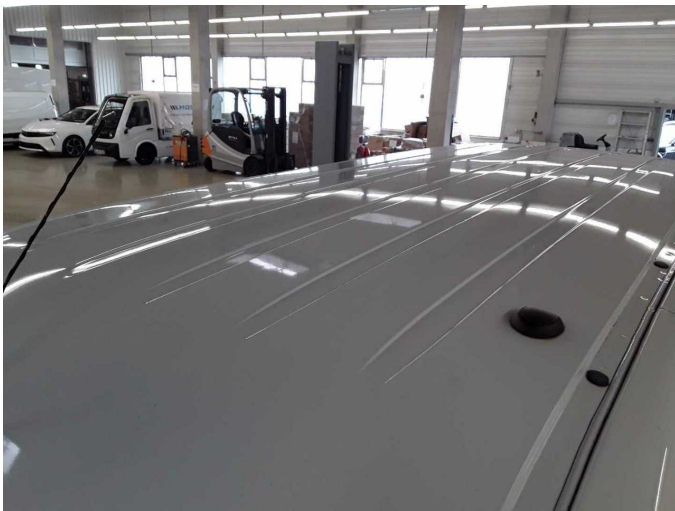
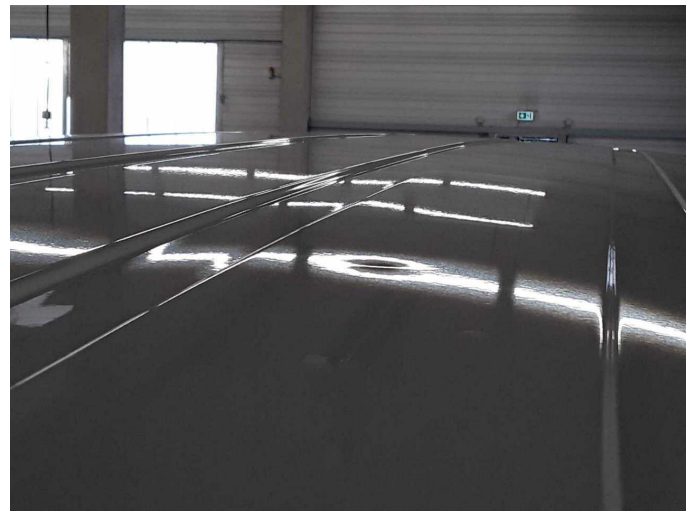
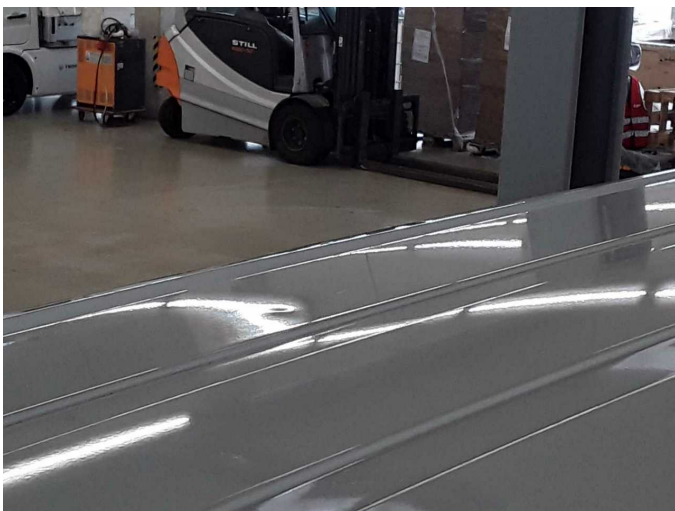
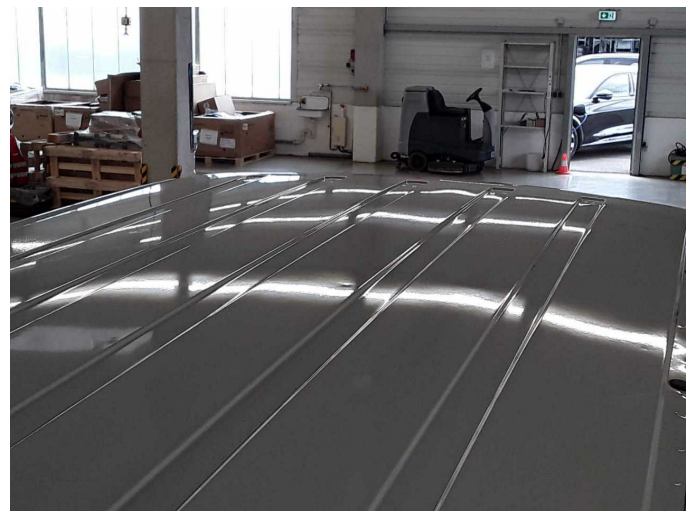
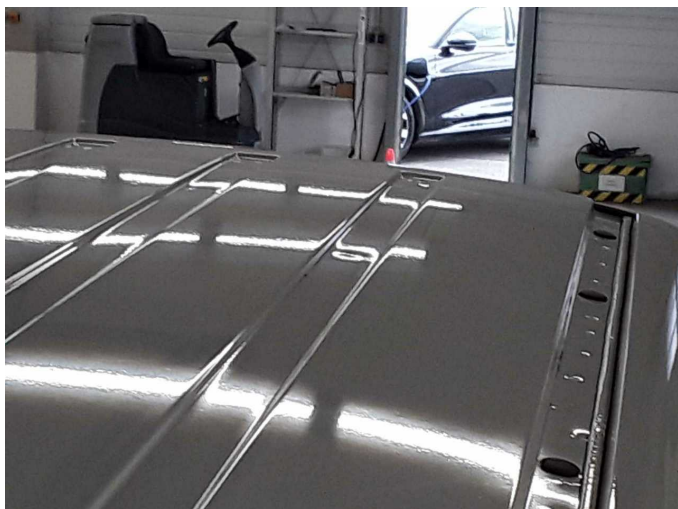
| No. | Component group | Description |
|---|---|---|
| 8 | Roof | Roof - dent(s) - Smart repair |

**Damage 8:** Roof: Roof - dent(s) - Smart repair

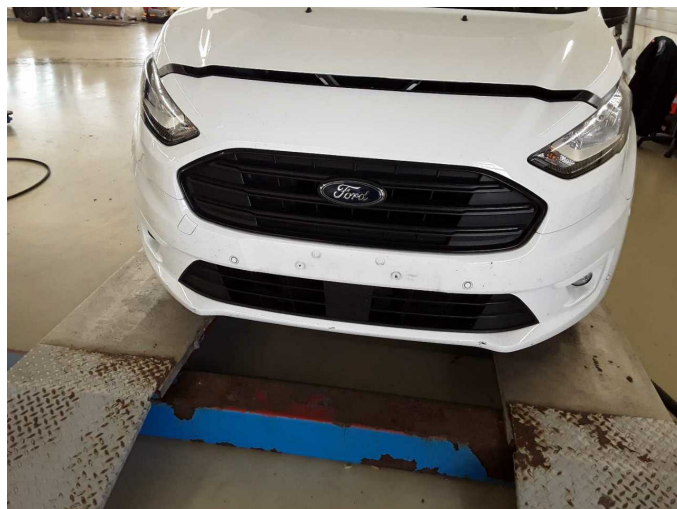
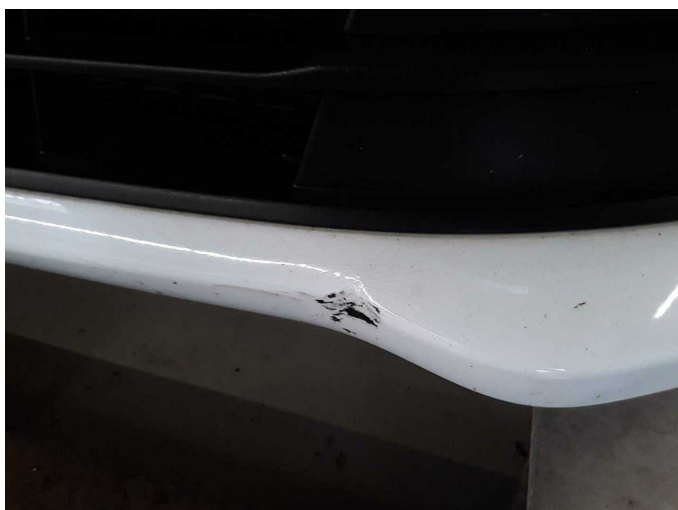
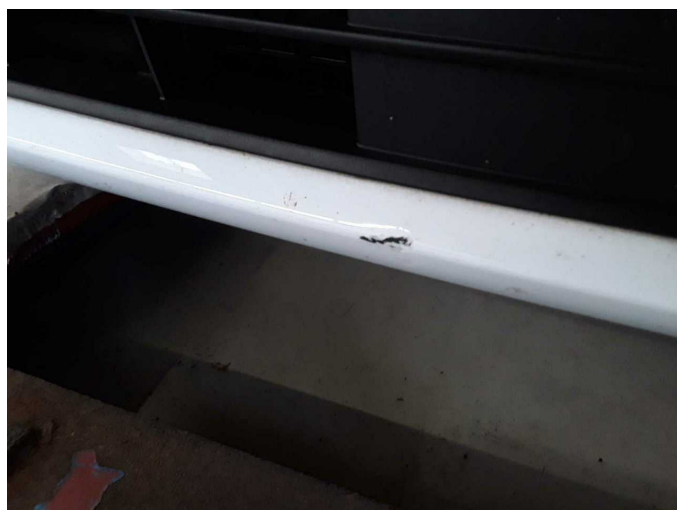
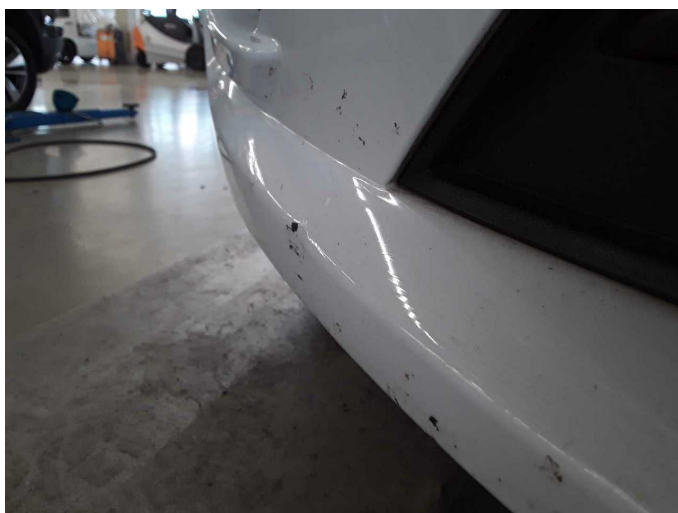
| No. | Component group | Description |
|---|---|---|
| 9 | Front bumper | Bumper with Parktronic (Unterteil) - Deformed - Replace |

**Damage 9:** Front bumper: Bumper with Parktronic (Unterteil) - Deformed - Replace

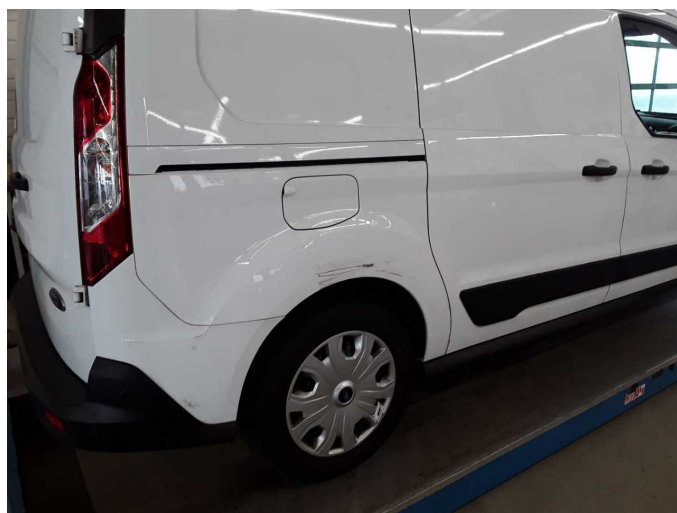
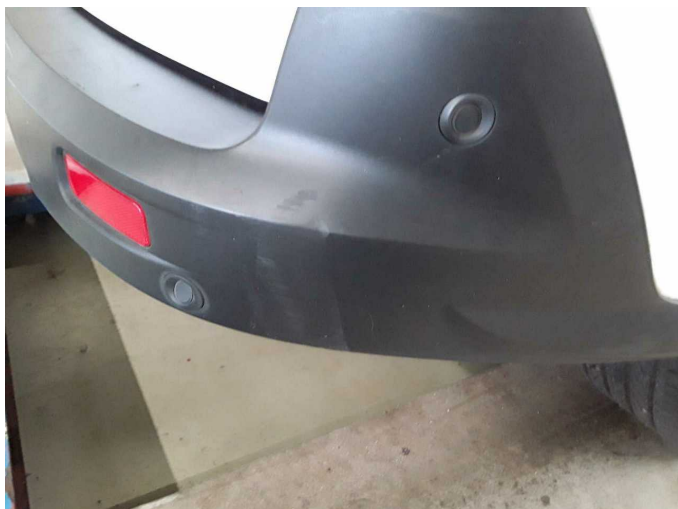
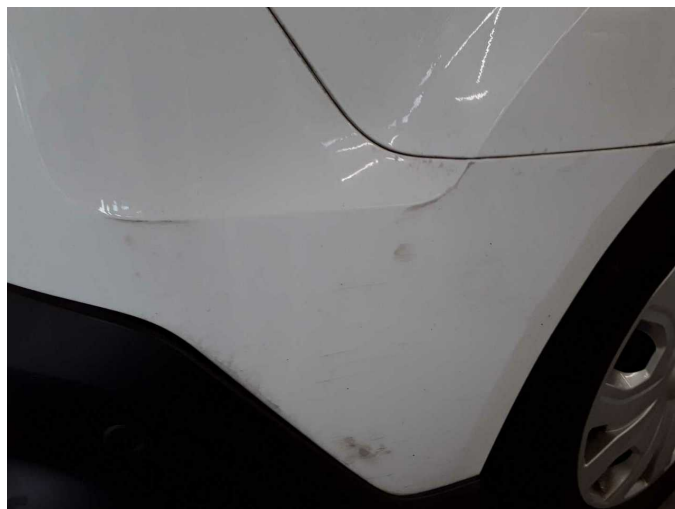
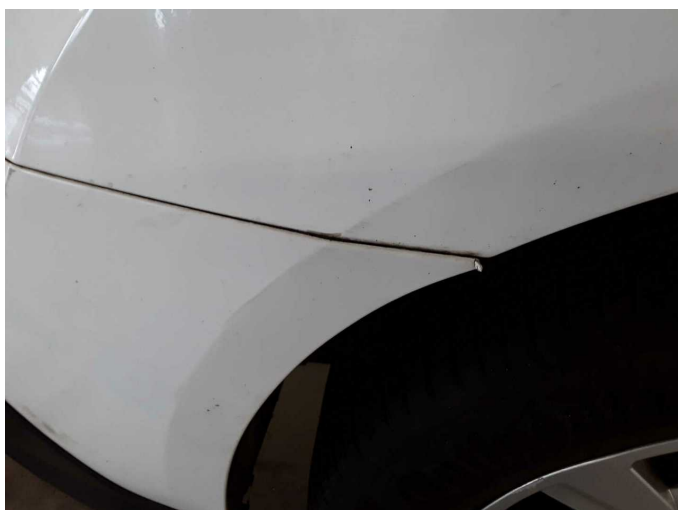
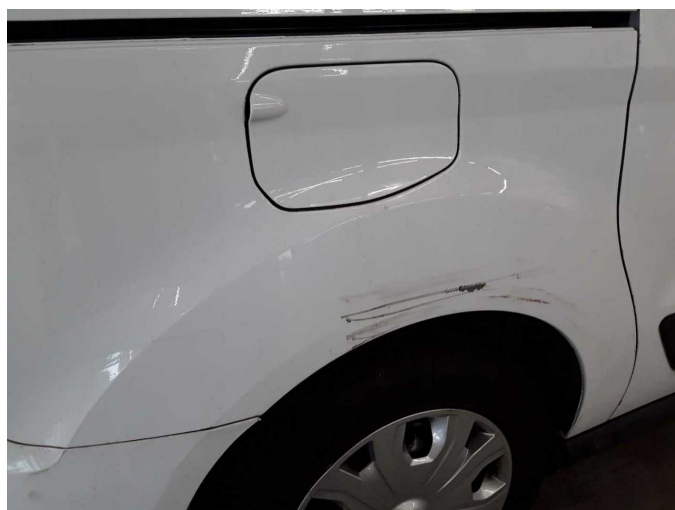
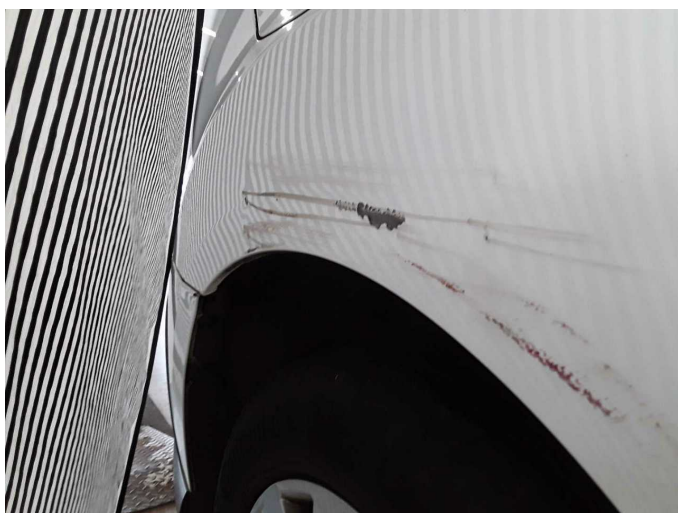
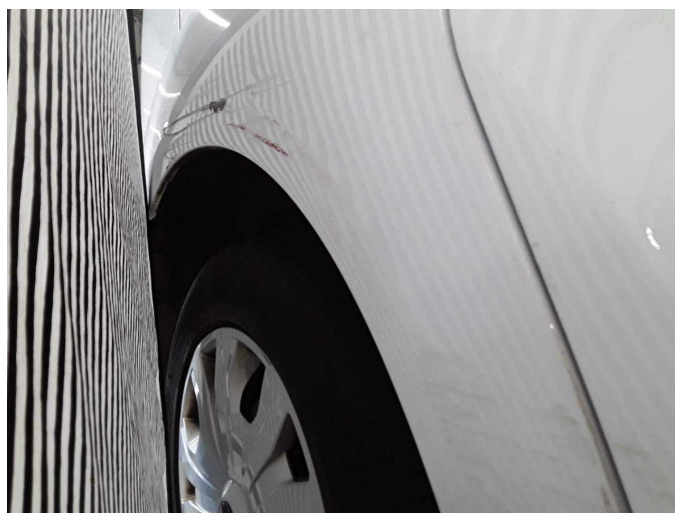
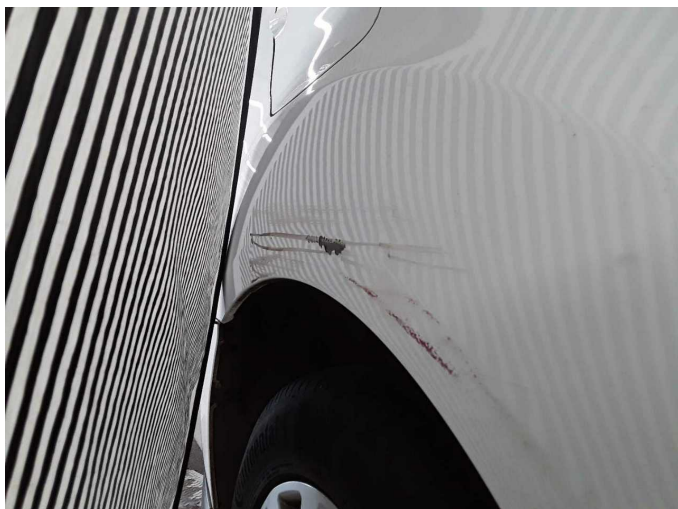
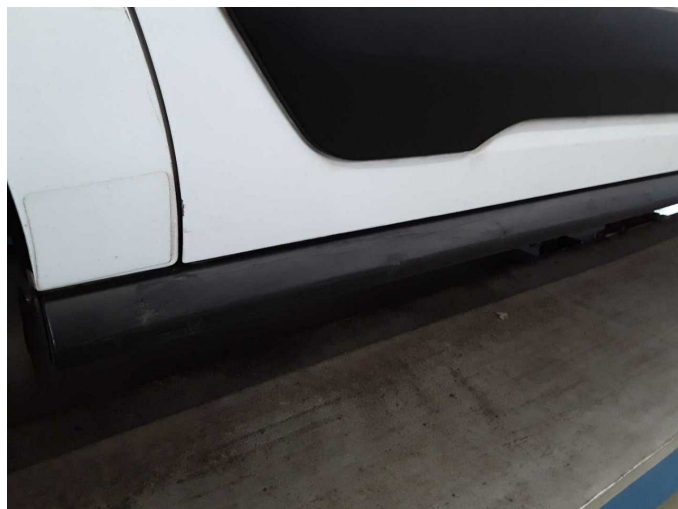
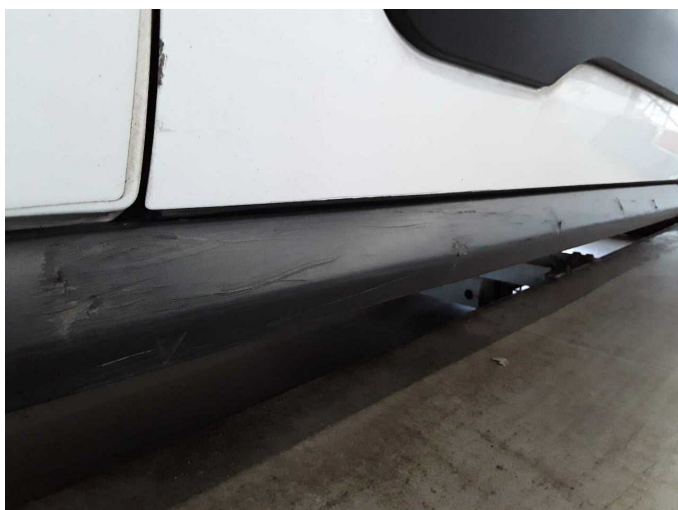
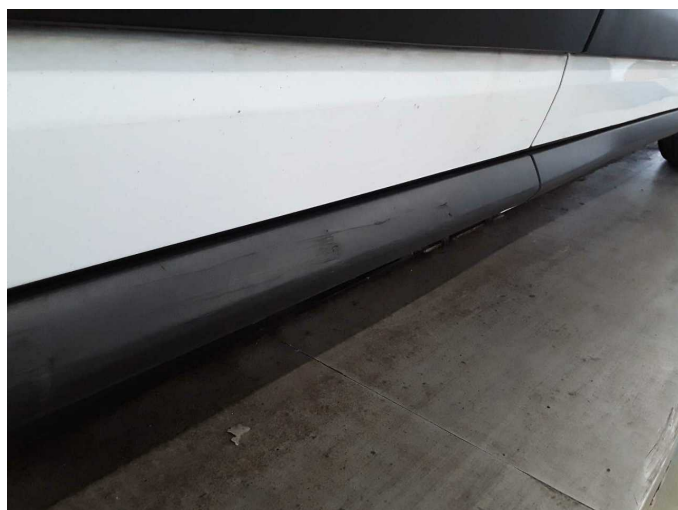
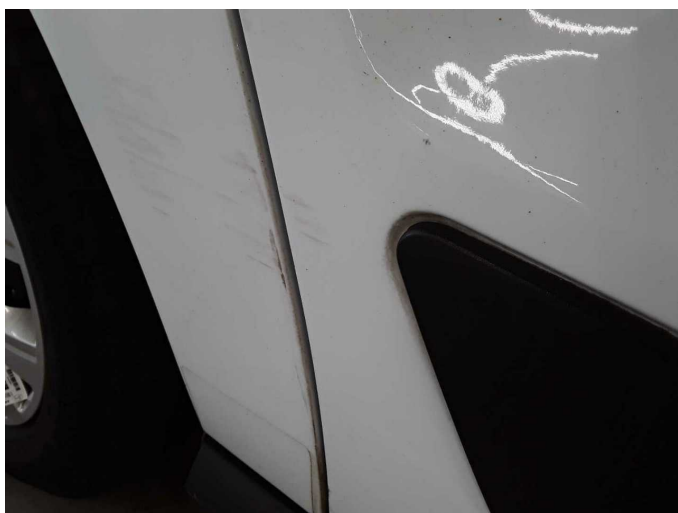
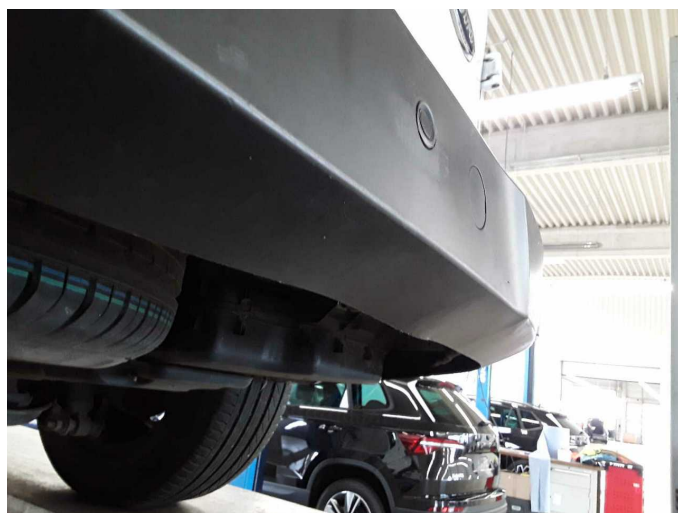
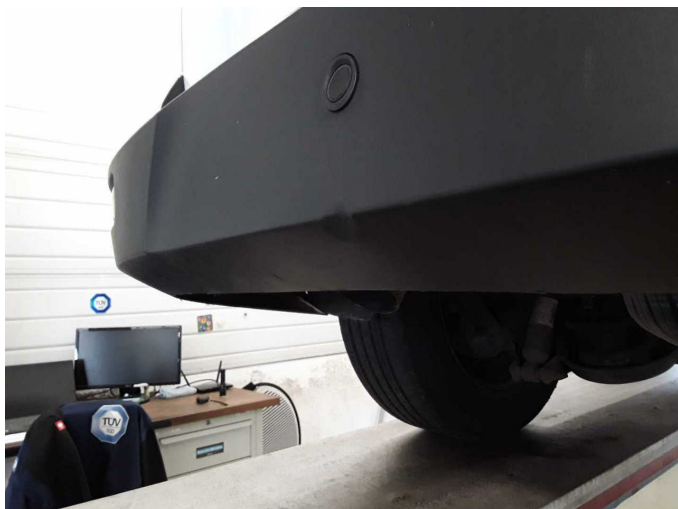
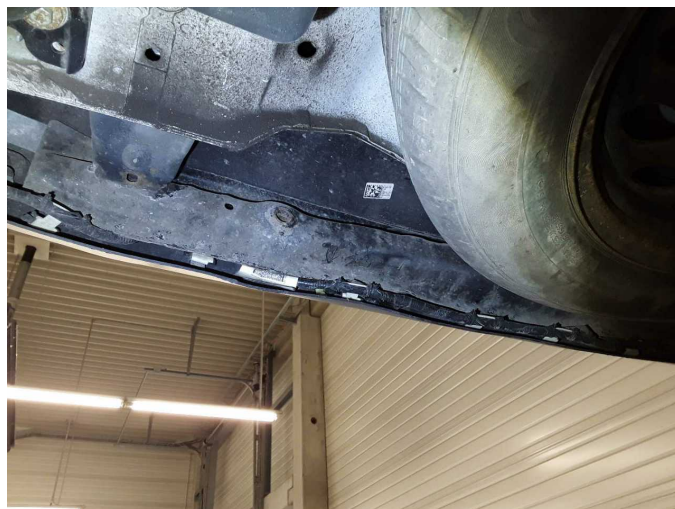
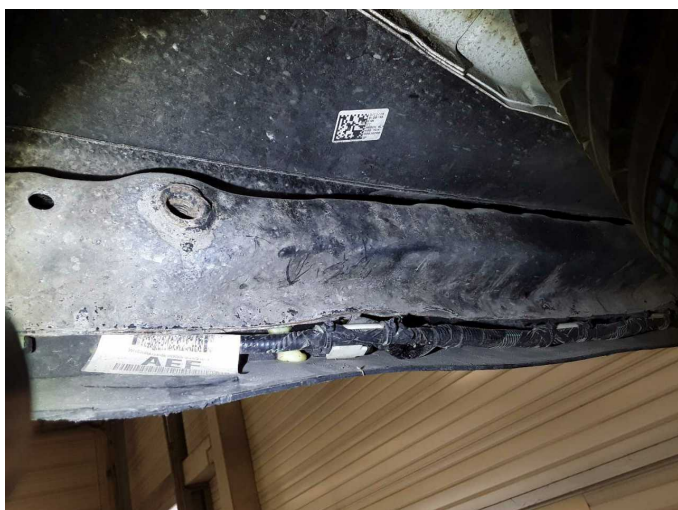
| No. | Accident |
|---|---|
| 1 | Rear, Side right |

**Accident 1:** Rear, Side right

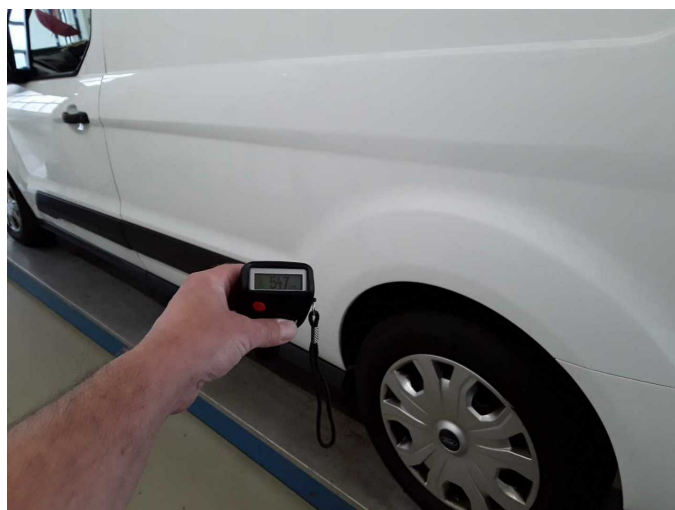
| Side panel - rear left side | 547 µm | Side panel - rear right side | 610 µm |

**Side panel - rear left side: 547 µm**

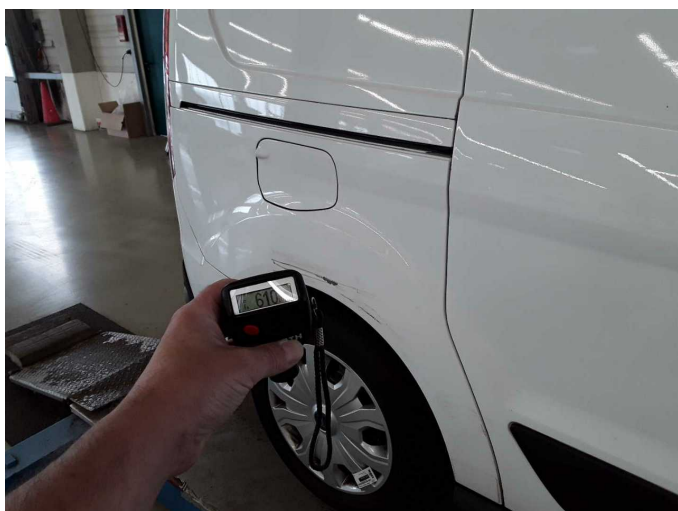
**Side panel - rear right side: 610 µm**

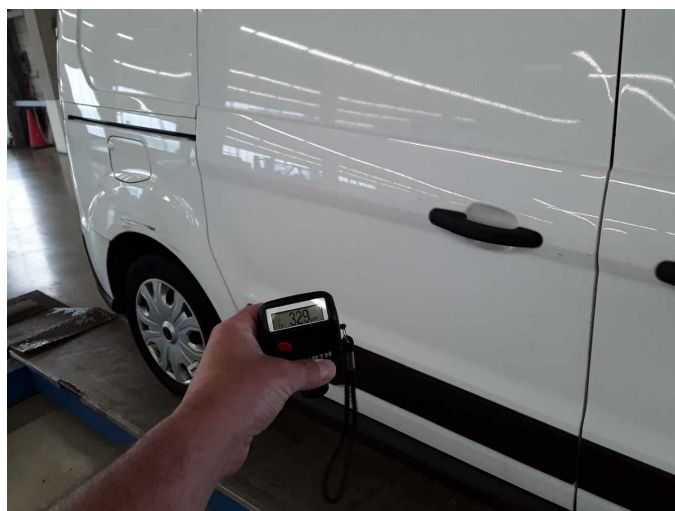
| Door - rear right side | 329 µm | | |

**Door - rear right side: 329 µm**
