Expertise

Protocol number: 46407362  
Order No. / Reference: 26594233  
Inspection date: 9 Jul 2026

Manufacturer: Opel

Model: Insignia Sports Tourer 1.5 Diesel Automatik Business

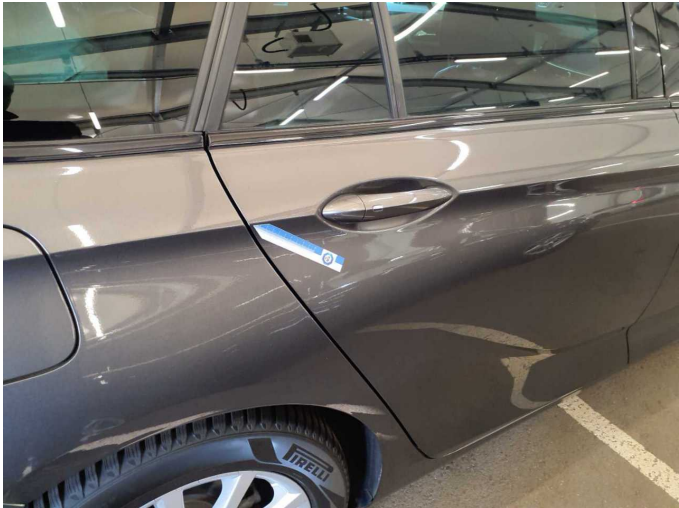
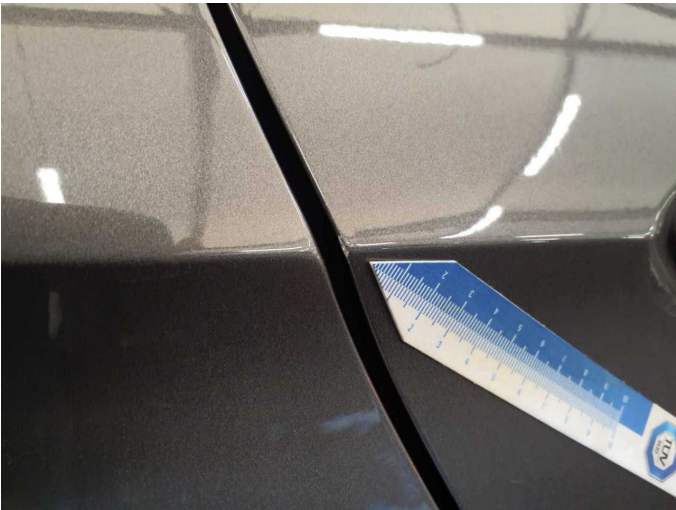
| No. | Component group | Description |
|---|---|---|
| 1 | Door - rear right side | Door edge - Scratch(es) - Smart repair |

Damage 1: Door - rear right side: Door edge - Scratch(es) - Smart repair

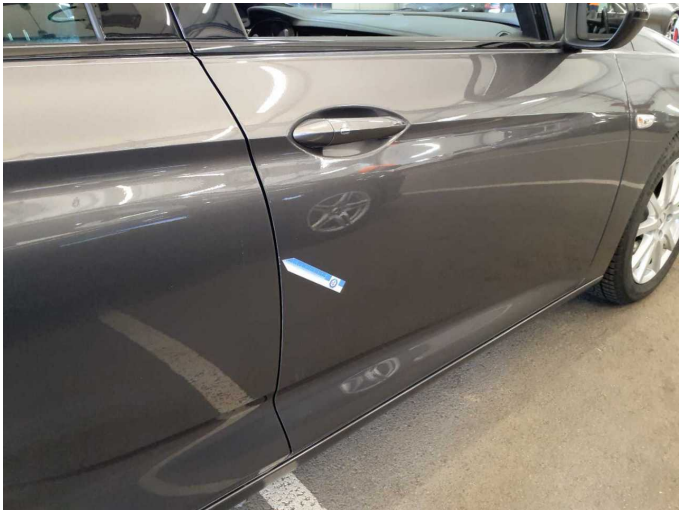
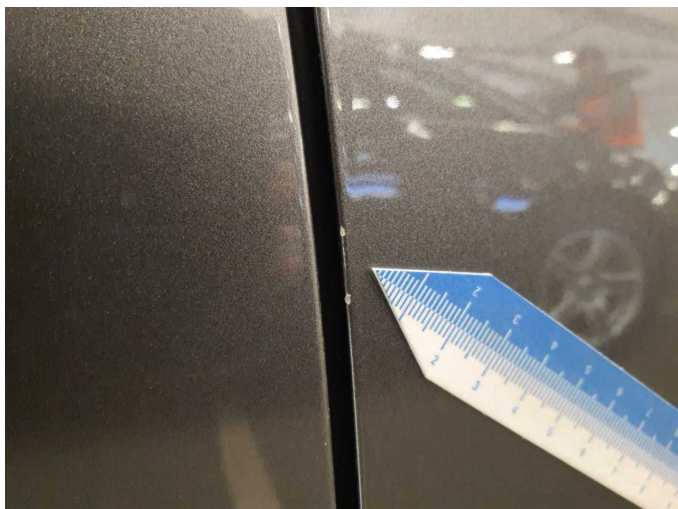
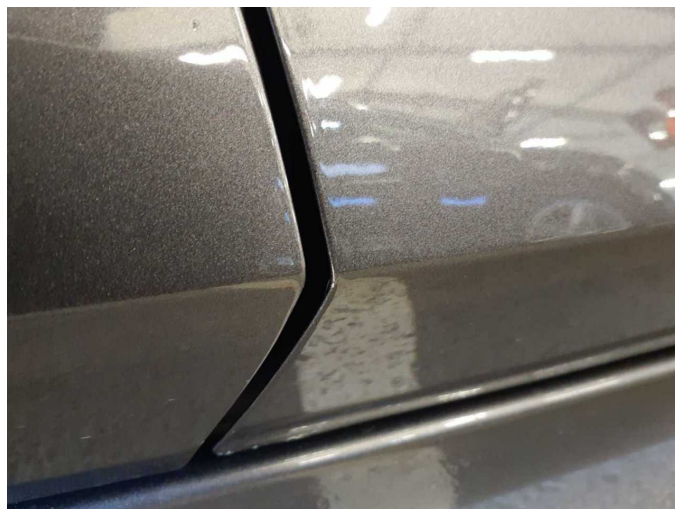
| No. | Component group | Description |
|---|---|---|
| 2 | Door - front right side | Door edge - Scratch(es) - Smart repair |

Damage 2: Door - front right side: Door edge - Scratch(es) - Smart repair

**Damage 2:** Door - front right side: Door edge - Scratch(es) - Smart repair

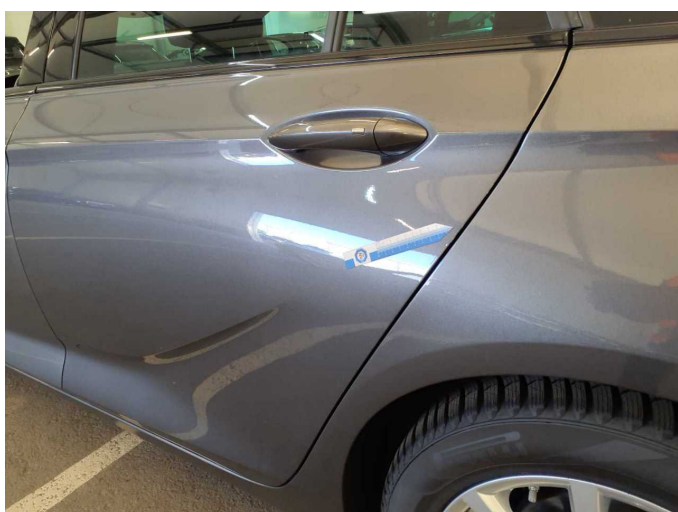
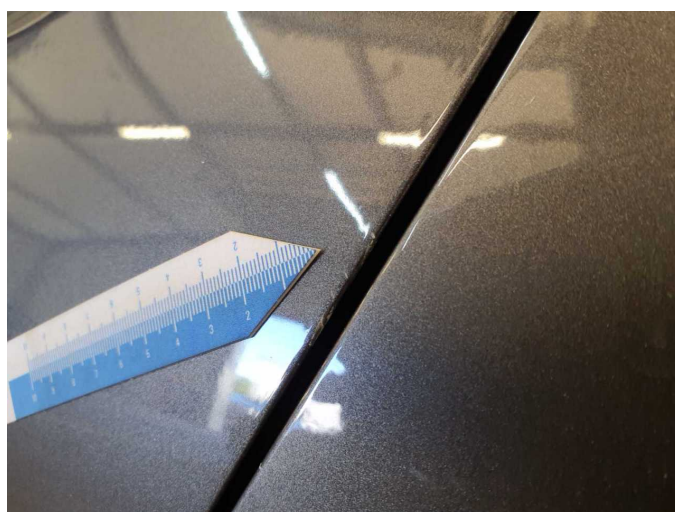
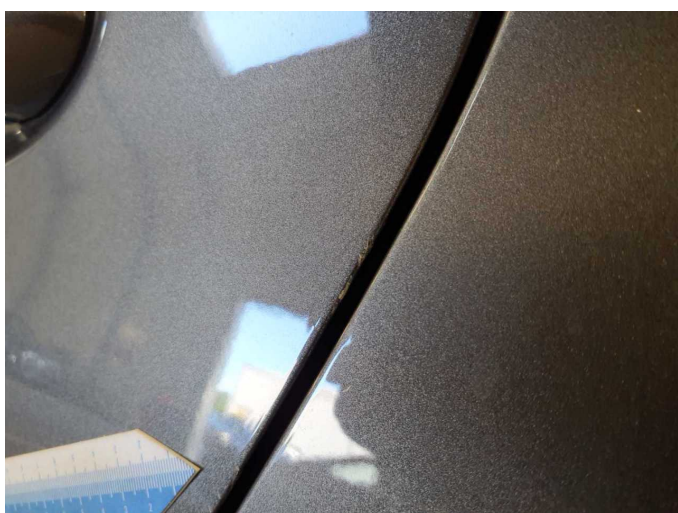
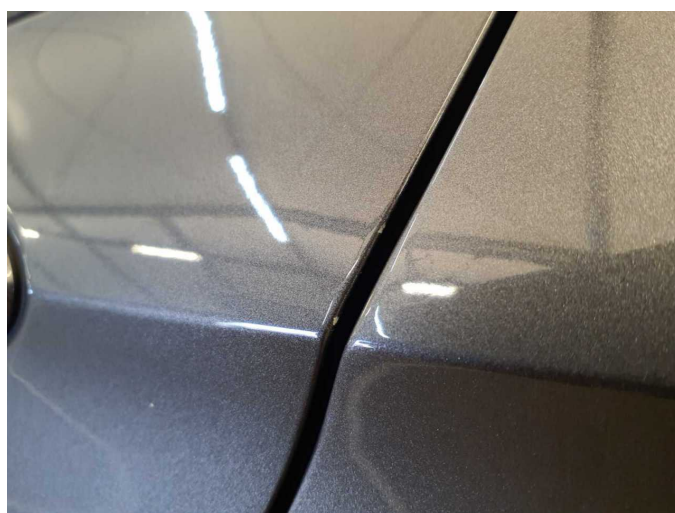
| No. | Component group | Description |
|---|---|---|
| 3 | Door - rear left side | Door edge - Scratch(es) - Smart repair |

**Damage 3:** Door - rear left side: Door edge - Scratch(es) - Smart repair

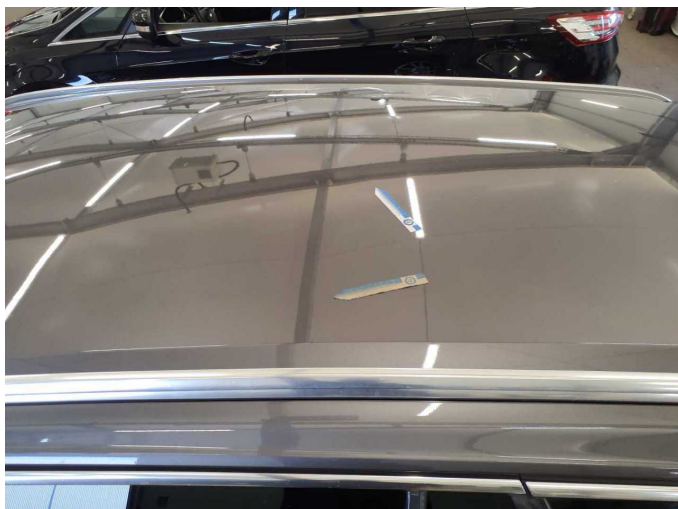
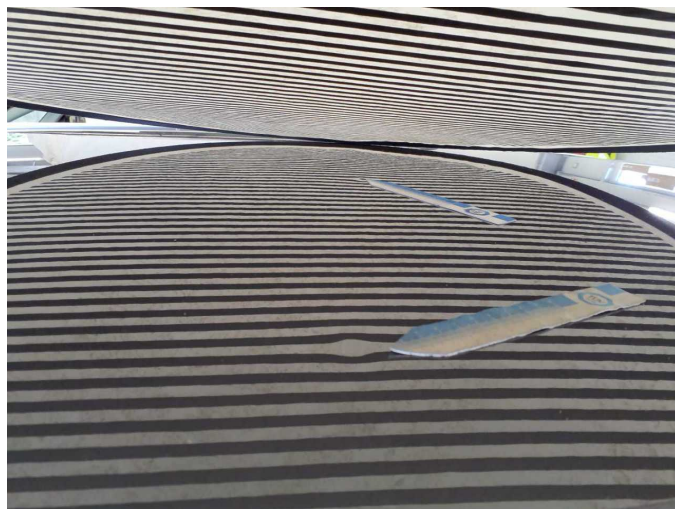
| No. | Component group | Description |
|---|---|---|
| 4 | Roof | Roof - dent(s) - Smart repair |

**Damage 4:** Roof: Roof - dent(s) - Smart repair

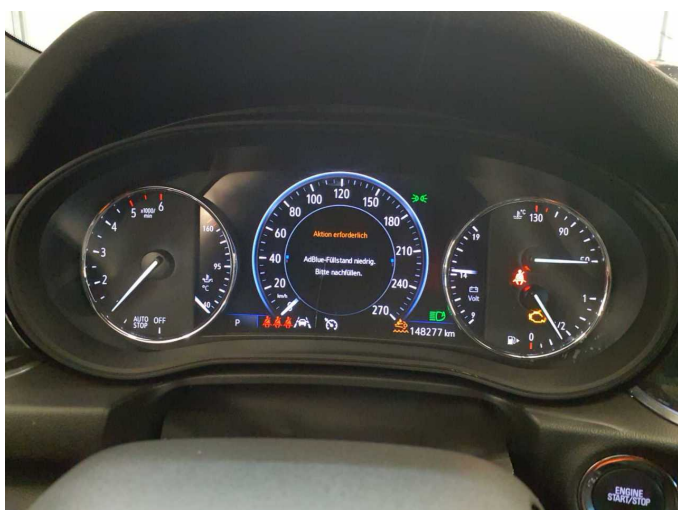
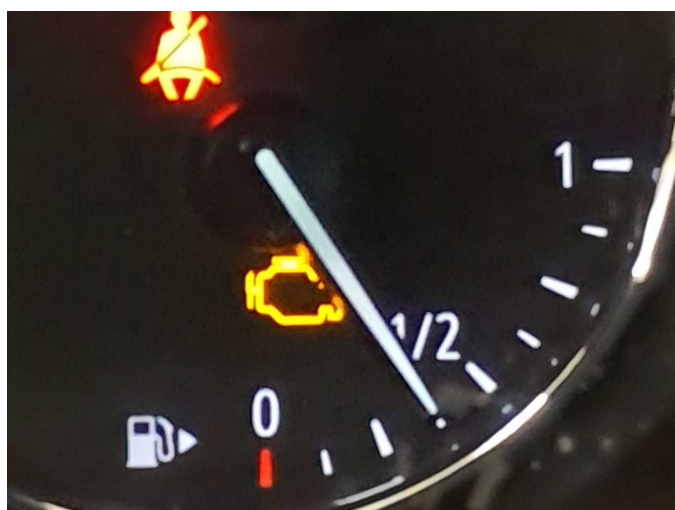
| Engine function test | An engine test run was performed, problem has been detected<br>This is due to the following reason.:<br>Motorkontrollleuchte |

| No. | Component group | Description |
|---|---|---|
| 5 | Instrument panel | Indicator light (Motorkontrollleuchte) - on - Perform diagnosis |

**Damage 5:** Instrument panel: Indicator light (Motorkontrollleuchte) - on - Perform diagnosis

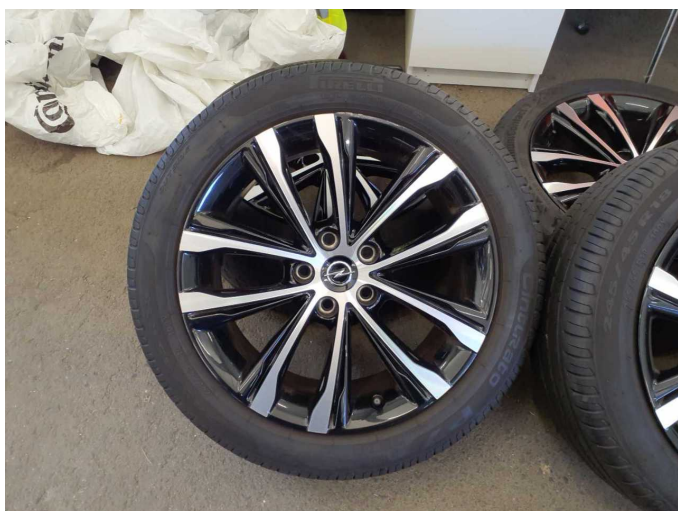
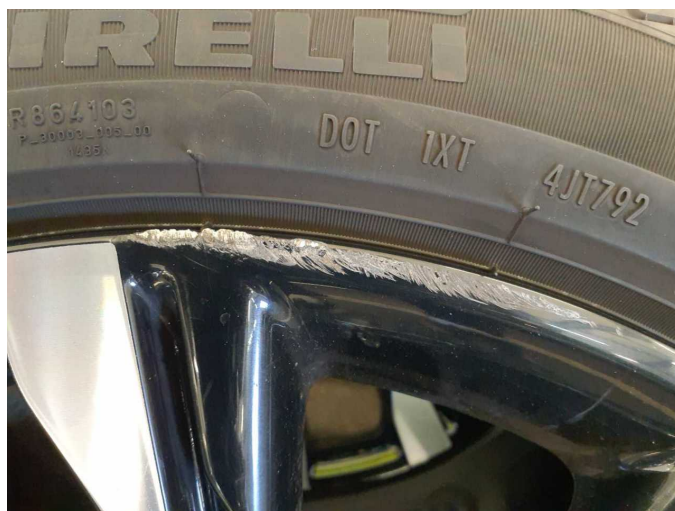
| No. | Component group | Description |
|---|---|---|
| 6 | 2nd wheel set | 1 alloy rim - Scratched - Replace |

**Damage 6:** 2nd wheel set: 1 alloy rim - Scratched - Replace

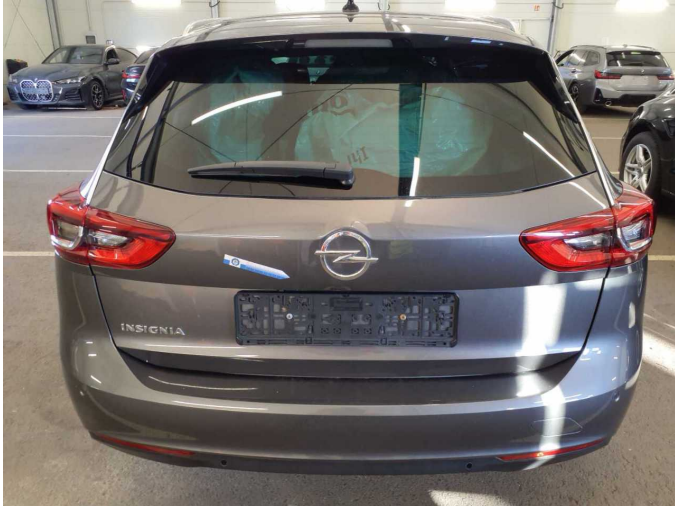
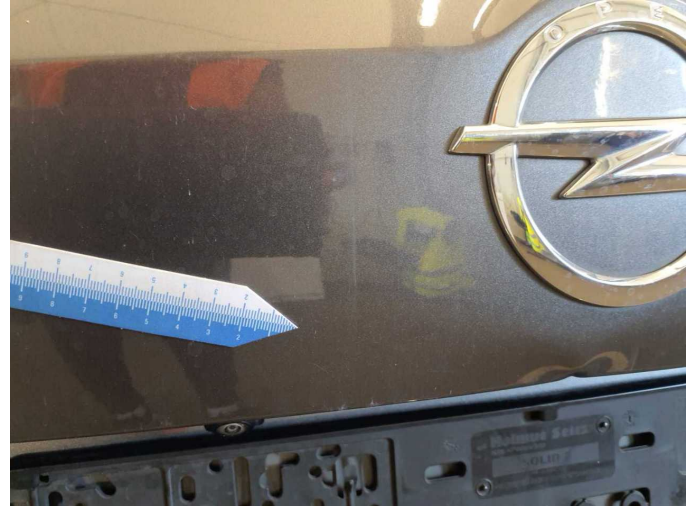
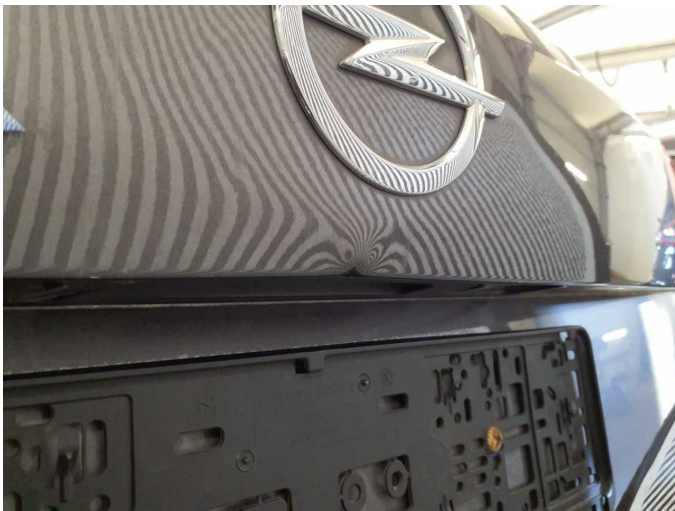
| No. | Component group | Description |
|---|---|---|
| 7 | Boot lid / rear door | Boot lid - Dent / paintcoat damage - Repair and paint |

**Damage 7:** Boot lid / rear door: Boot lid - Dent / paintcoat damage - Repair and paint

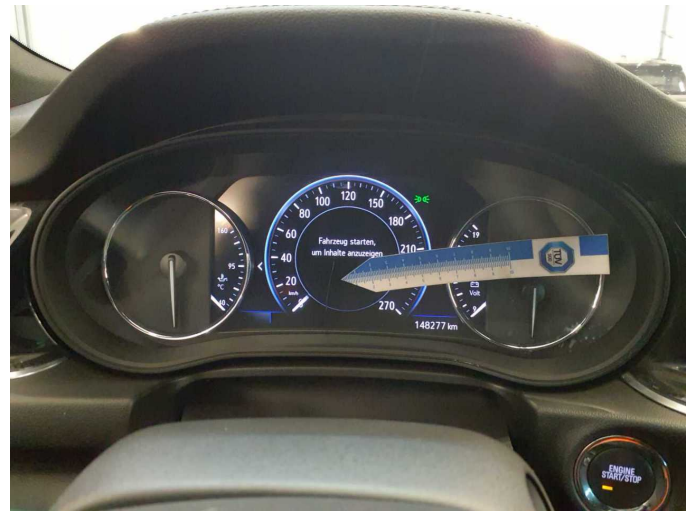
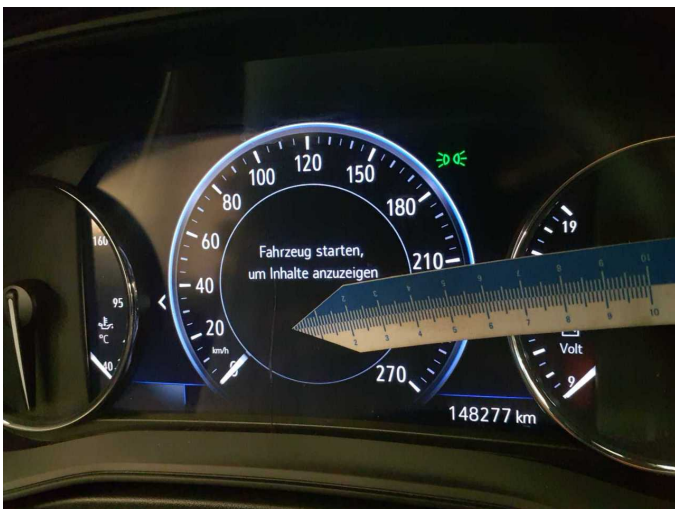
| No. | Component group | Description |
|---|---|---|
| 8 | Instrument panel | Instrument cluster (Glas) - Broken / torn - Replace |

**Damage 8:** Instrument panel: Instrument cluster (Glas) - Broken / torn - Replace

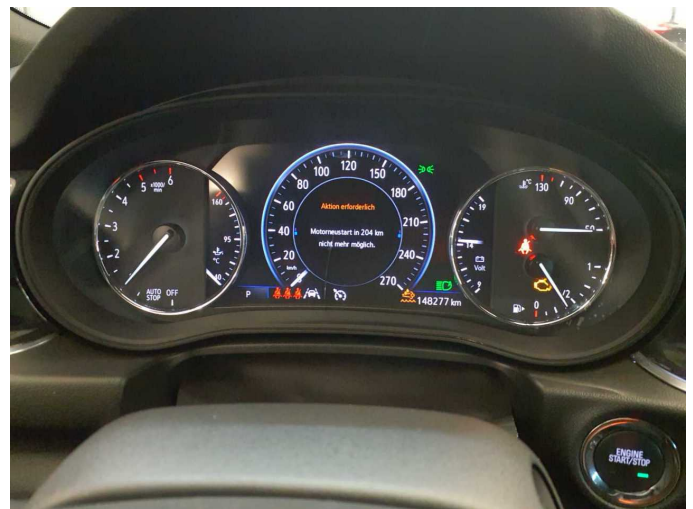
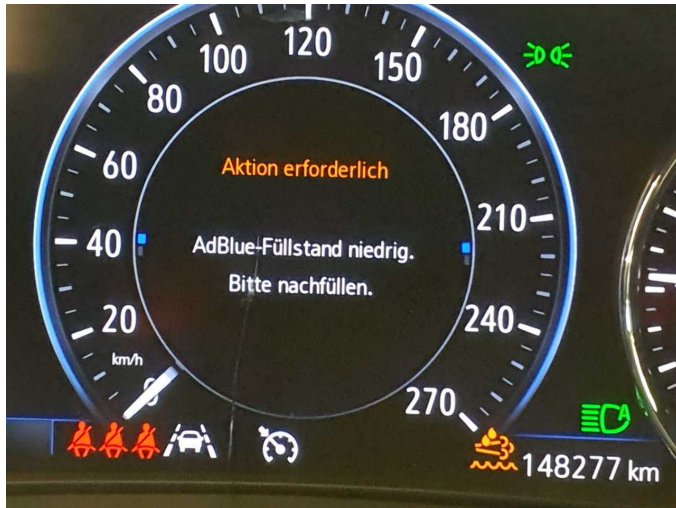
| No. | Component group | Description |
|---|---|---|
| 2 | Instrument panel | Indicator light (Ad Blue Nachfüllen!) - on - No deduction |

**Wear and tear 2:** Instrument panel: Indicator light (Ad Blue Nachfüllen!) - on - No deduction
