Expertise

Protocol number: 46680249  
Order No. / Reference: 26585299  
Inspection date: 15 Jul 2026

Manufacturer: Volkswagen

Model: Crafter 35 TDI 4MOTION Trendline

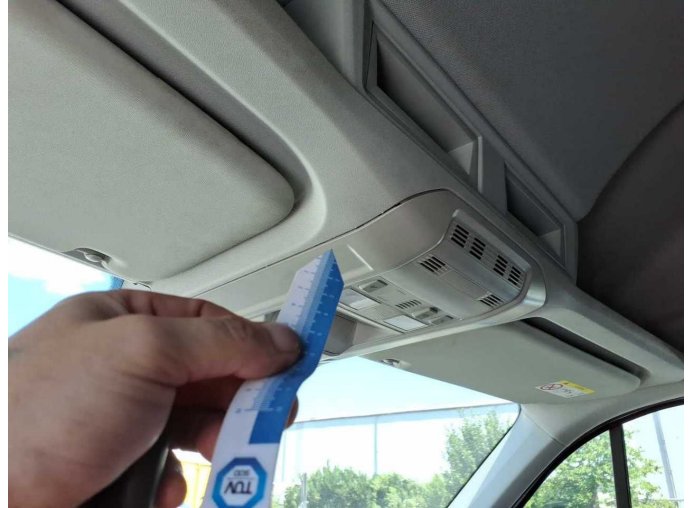
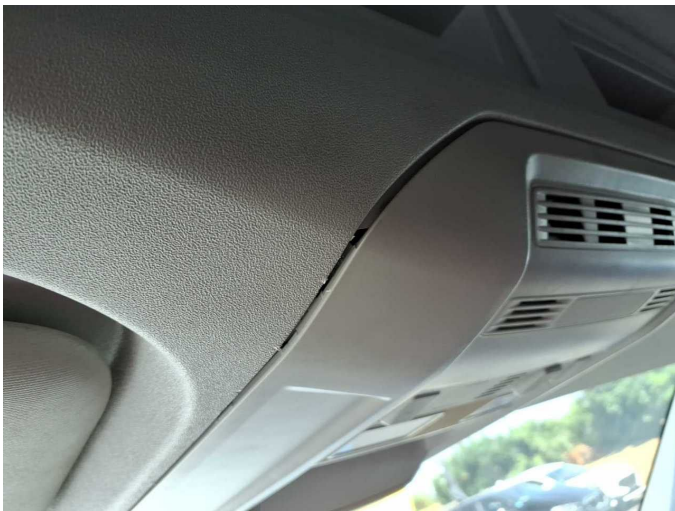
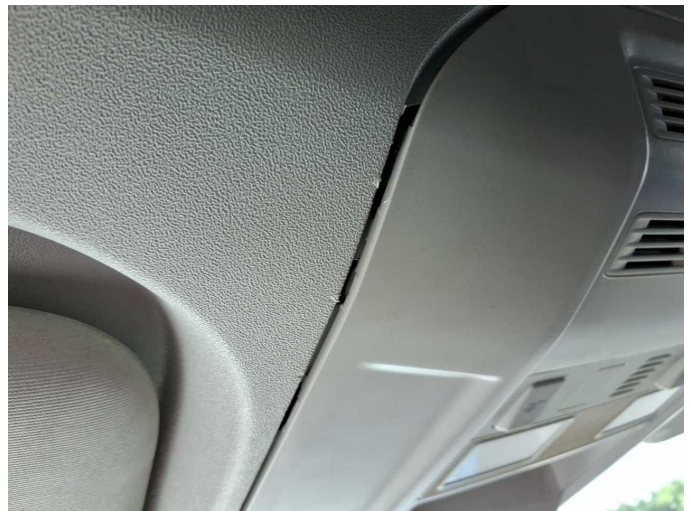
| No. | Component group | Description |
|---|---|---|
| 2 | Trim / covers | Roof lining (Beleuchtung mitte, Abdeckung ggf, erneuern) - Loose - Perform diagnosis |

**Damage 2:** Trim / covers: Roof lining (Beleuchtung mitte, Abdeckung ggf, erneuern) - Loose - Perform diagnosis

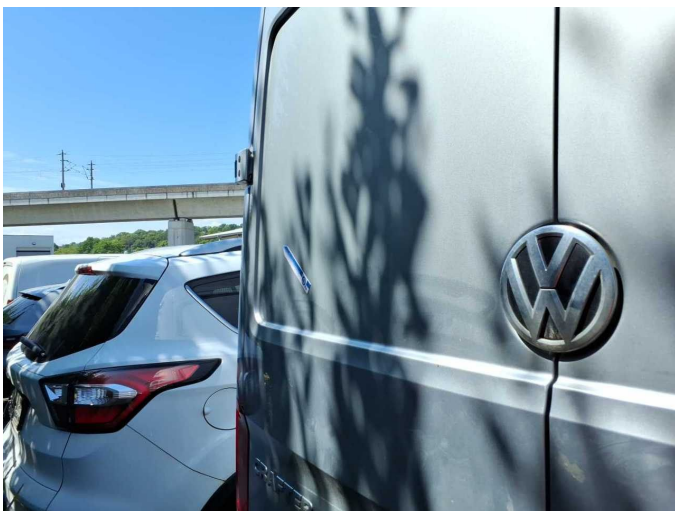
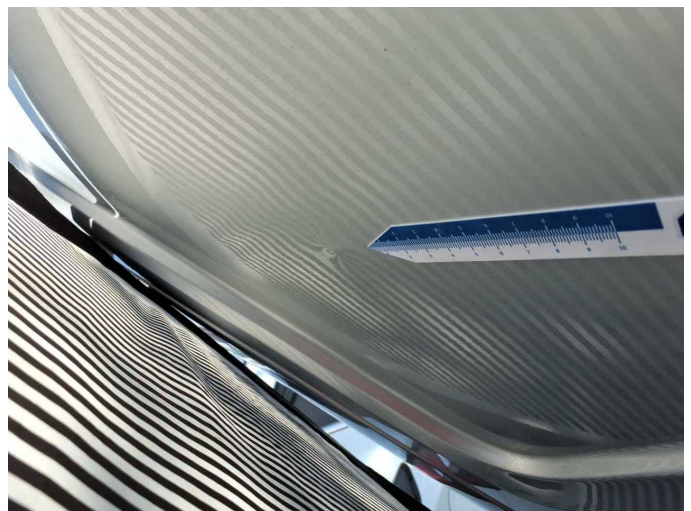
| No. | Component group | Description |
|---|---|---|
| 3 | Boot lid / rear door | Rear door - left side - dent(s) - Smooth repair work |

**Damage 3:** Boot lid / rear door: Rear door - left side - dent(s) - Smooth repair work

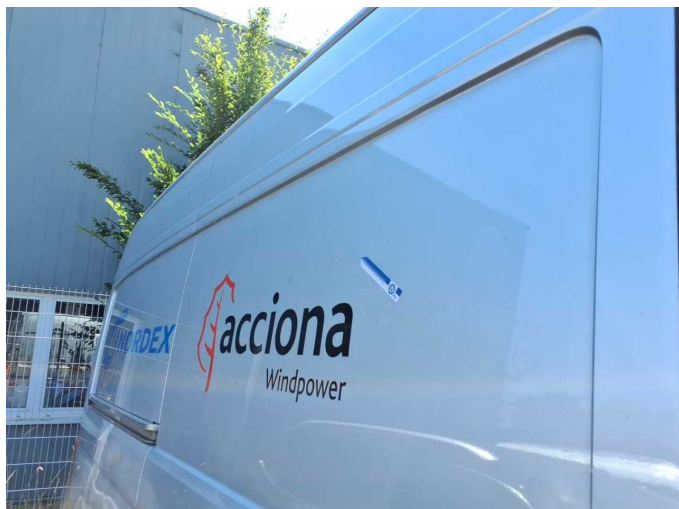
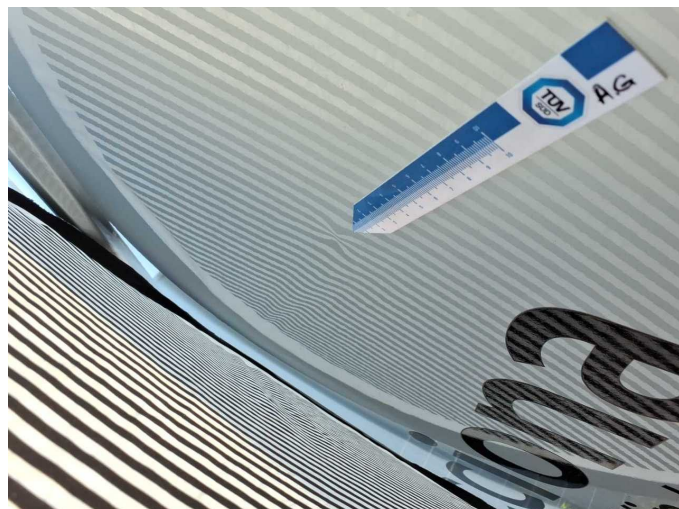
| No. | Component group | Description |
|---|---|---|
| 4 | Sliding door, right | Sliding door - dent(s) - Smooth repair work |

**Damage 4:** Sliding door, right: Sliding door - dent(s) - Smooth repair work

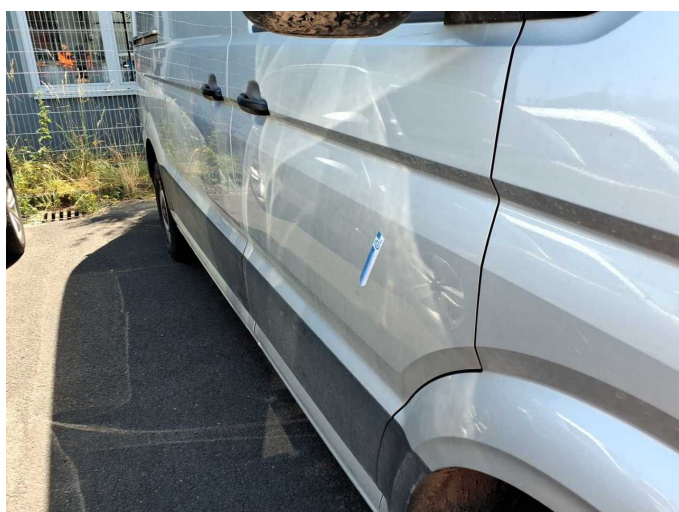
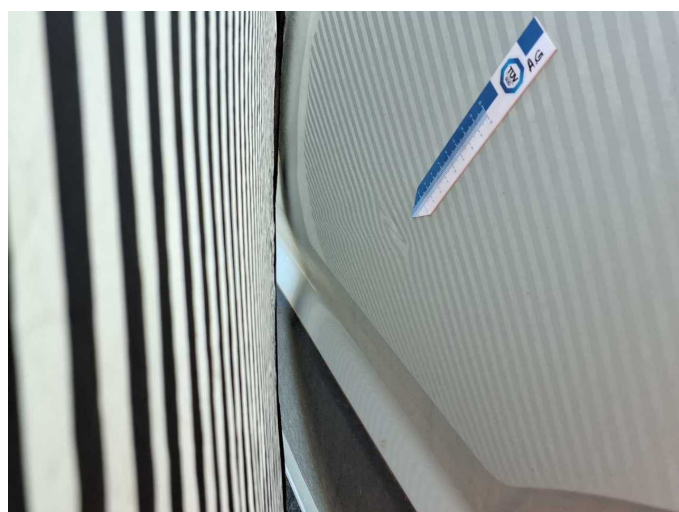
| No. | Component group | Description |
|---|---|---|
| 5 | Door - front right side | Door - dent(s) - Smooth repair work |

**Damage 5:** Door - front right side: Door - dent(s) - Smooth repair work

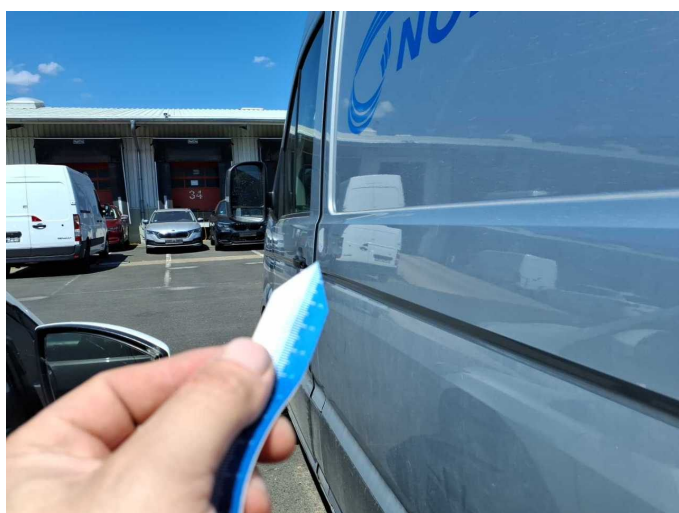
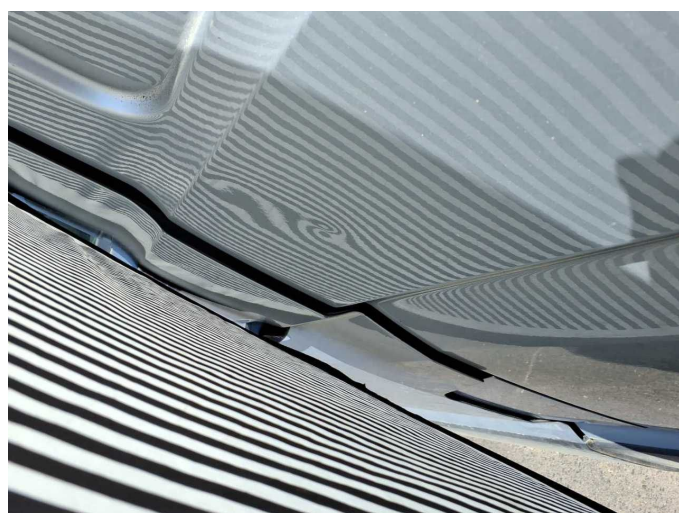
| No. | Component group | Description |
|---|---|---|
| 6 | Side panel - rear left side | Side panel (Mitte) - dent(s) - Smooth repair work |

**Damage 6:** Side panel - rear left side: Side panel (Mitte) - dent(s) - Smooth repair work

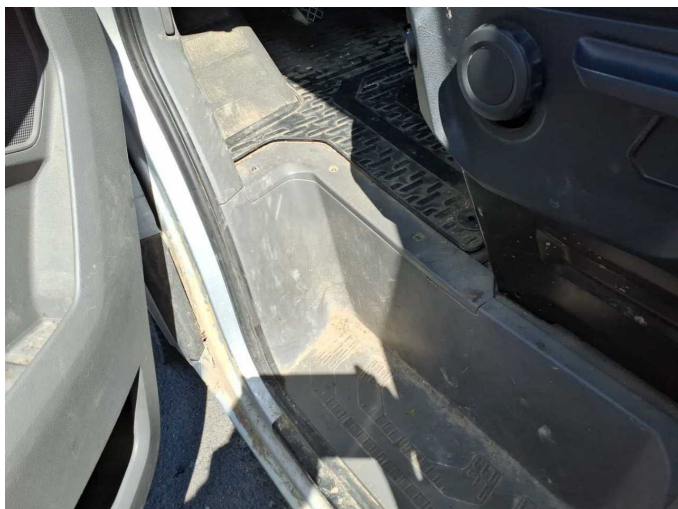
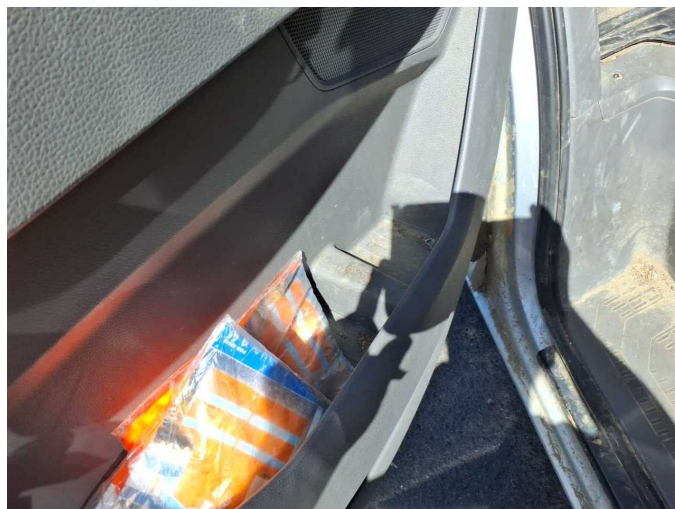
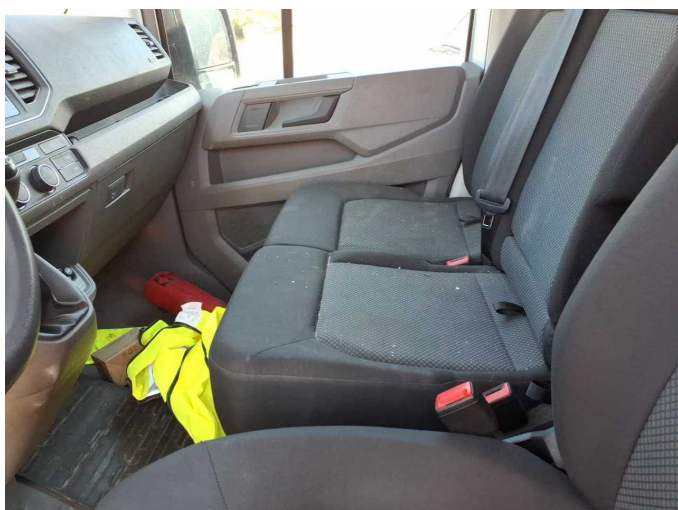
| No. | Component group | Description |
|---|---|---|
| 7 | Interior | Interior - Soiled - Clean |

**Damage 7:** Interior: Interior - Soiled - Clean

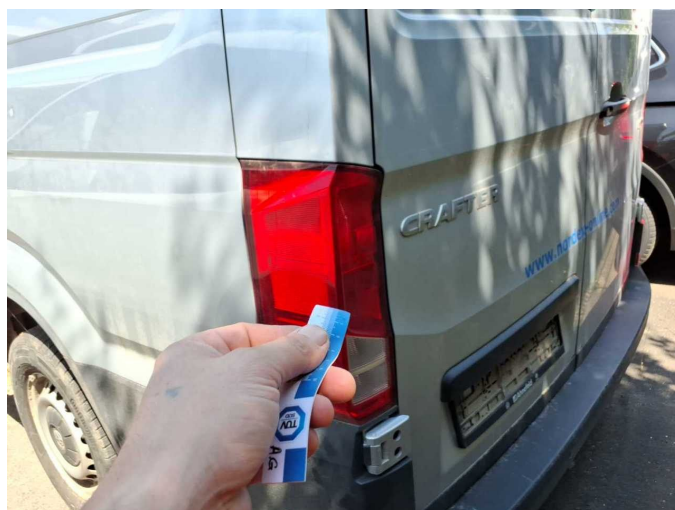
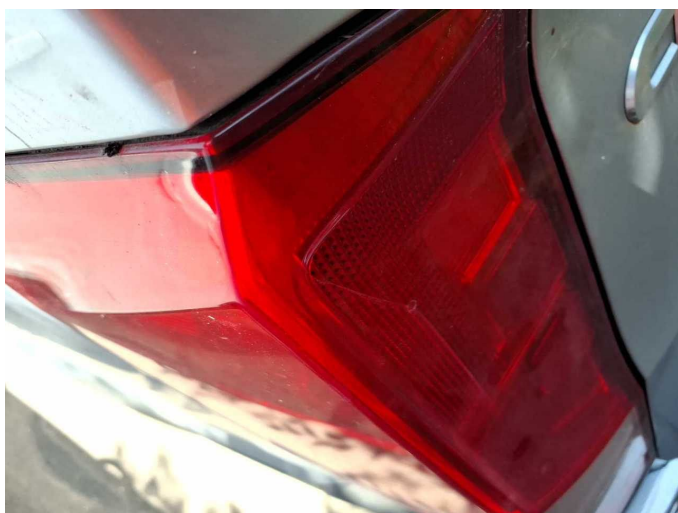
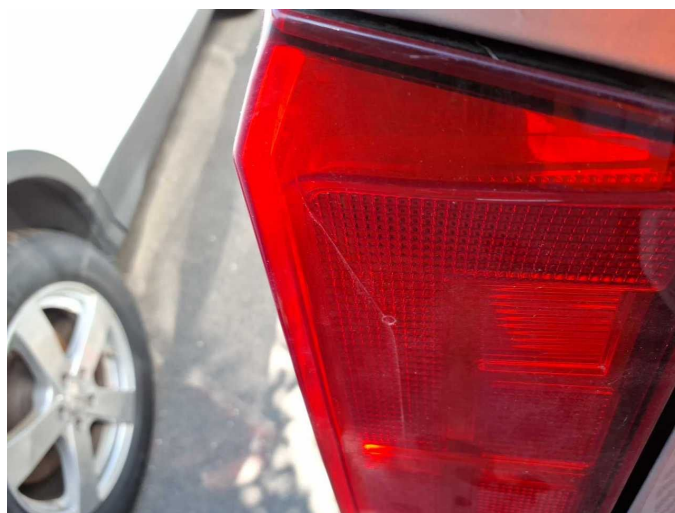
| No. | Component group | Description |
|---|---|---|
| 8 | Tail light | Tail lamp - left side - Broken / torn - Replace |

**Damage 8:** Tail light: Tail lamp - left side - Broken / torn - Replace

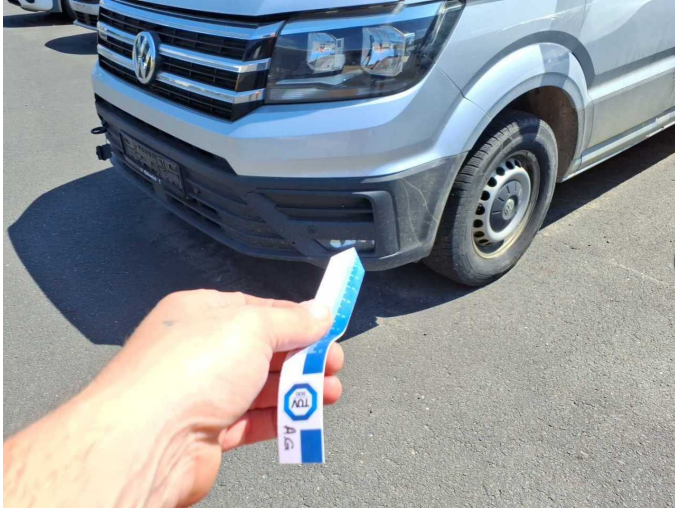
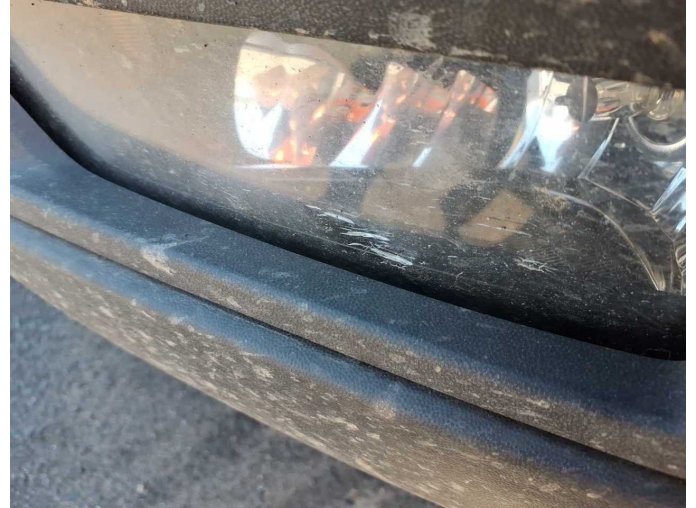
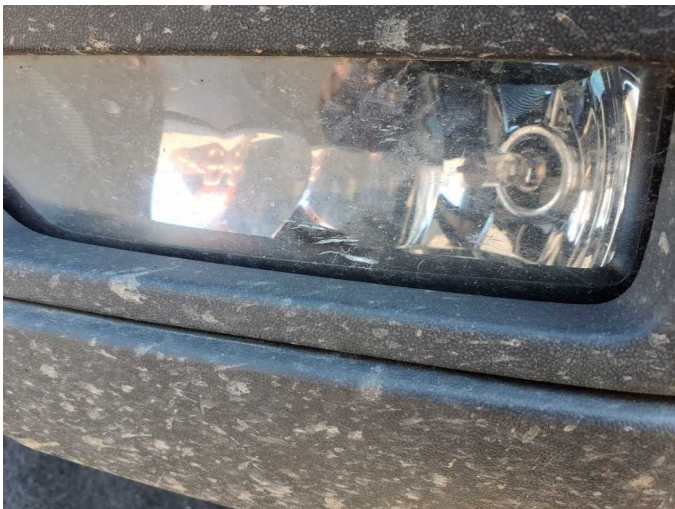
| No. | Component group | Description |
|---|---|---|
| 9 | Fog lamp | Fog lamp - front left side - Broken / torn - Replace |

**Damage 9:** Fog lamp: Fog lamp - front left side - Broken / torn - Replace

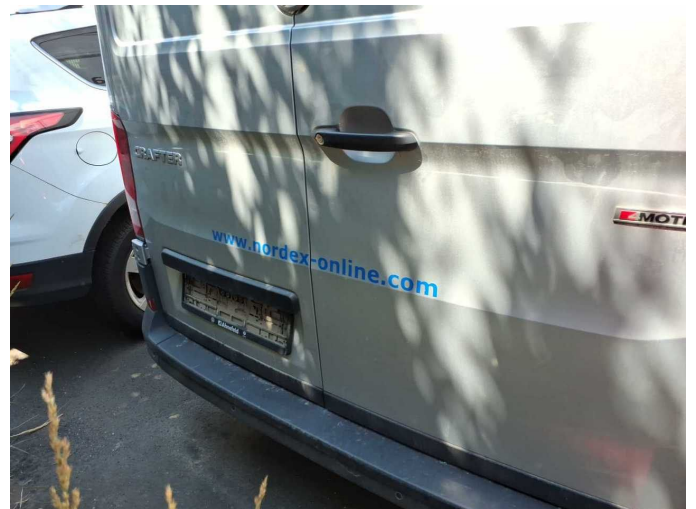
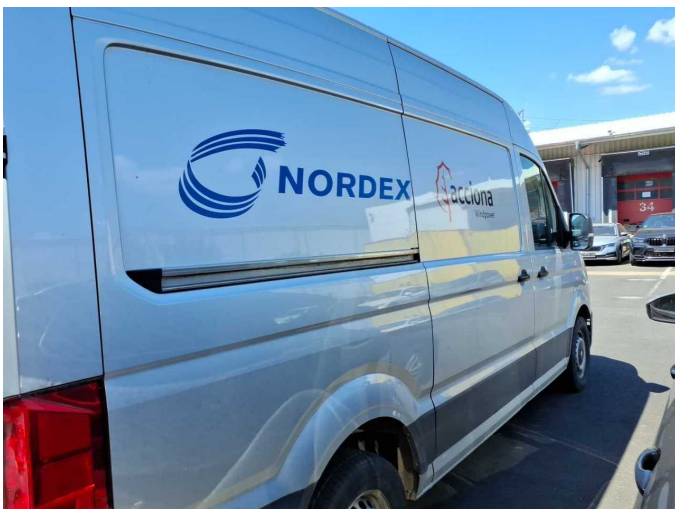
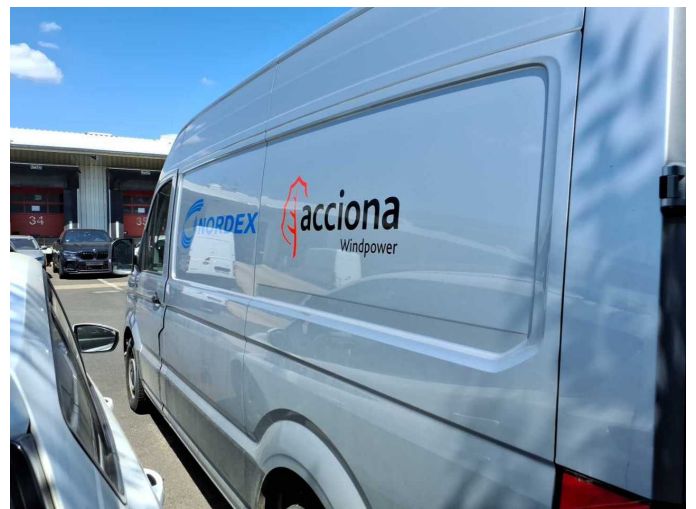
| No. | Component group | Description |
|---|---|---|
| 10 | Body | Body - Glued / labelled - De-glue / neutralise |

**Damage 10:** Body: Body - Glued / labelled - De-glue / neutralise

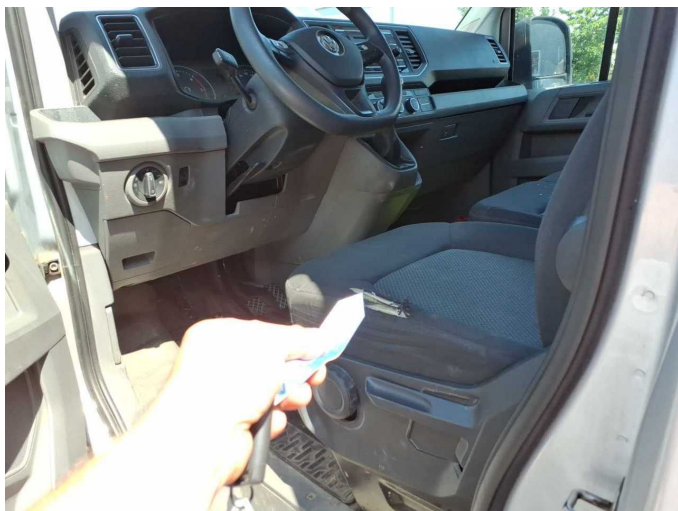
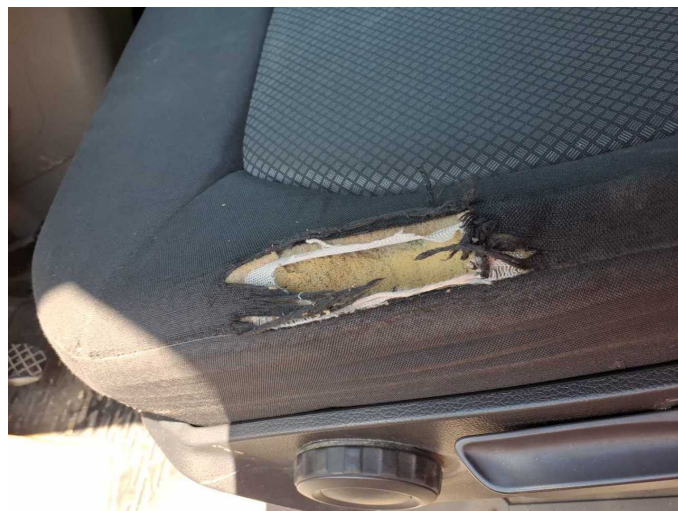
| No. | Component group | Description |
|---|---|---|
| 11 | Seat - front | Seat cover - left side (+ Polster) - Broken / torn - Replace |

**Damage 11:** Seat - front: Seat cover - left side (+ Polster) - Broken / torn - Replace

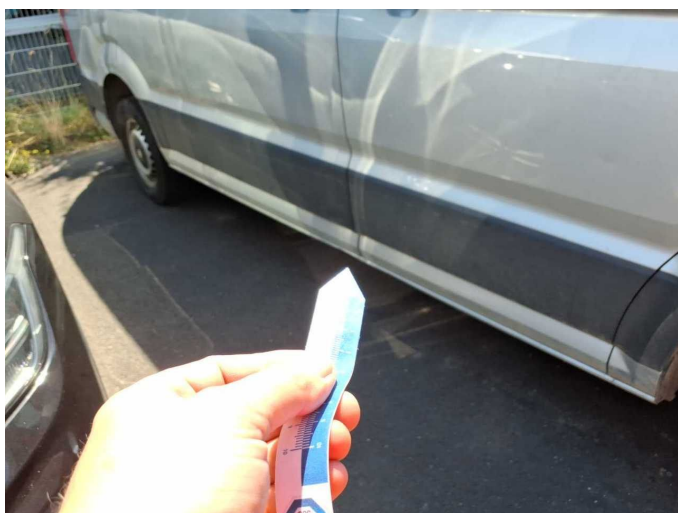
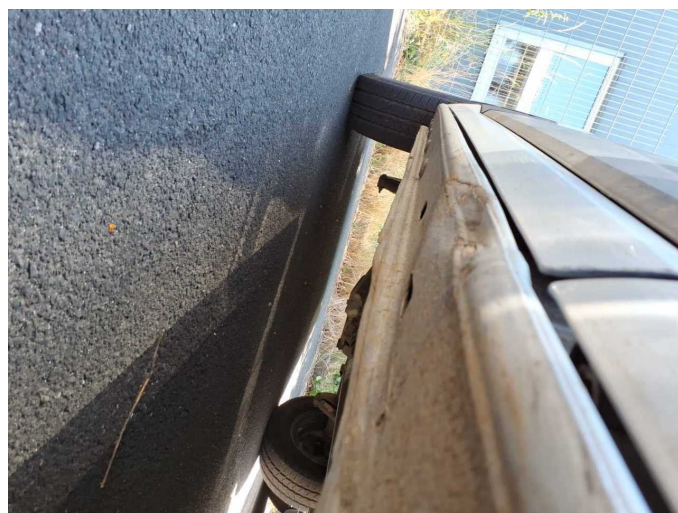
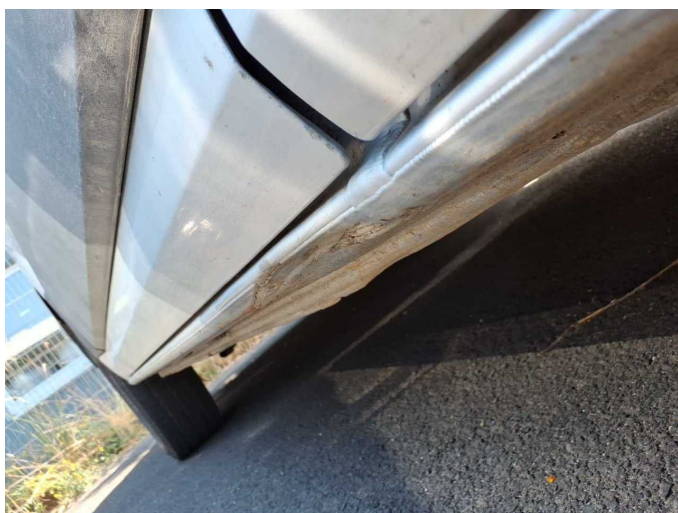
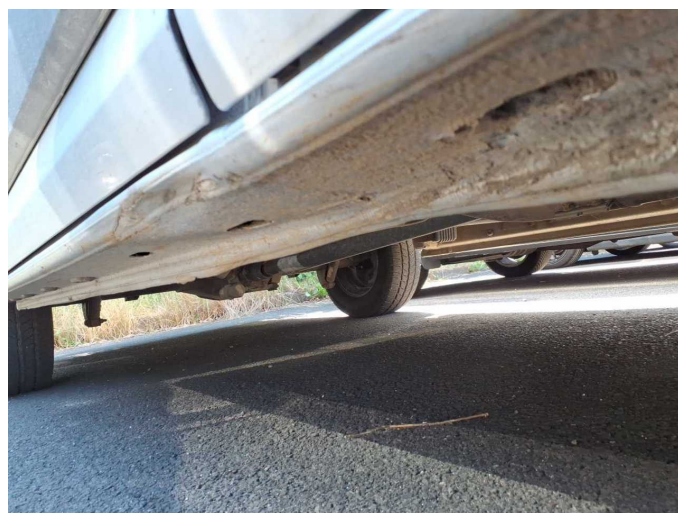
| No. | Component group | Description |
|---|---|---|
| 12 | Sill - right side | Sill - Deformed - Repair and paint |

**Damage 12:** Sill - right side: Sill - Deformed - Repair and paint

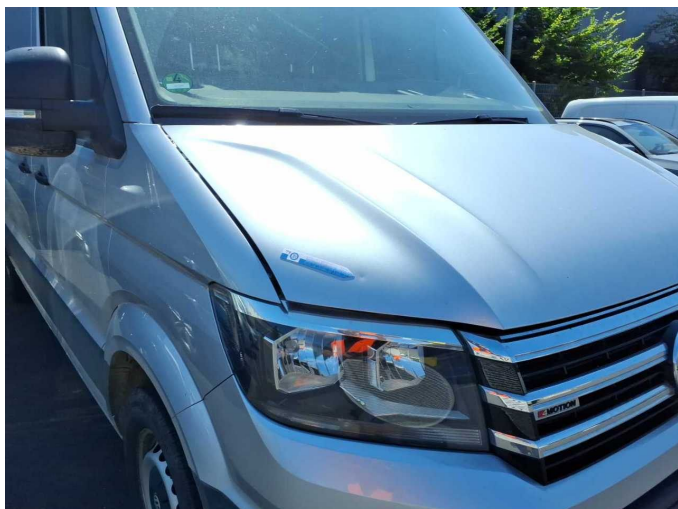
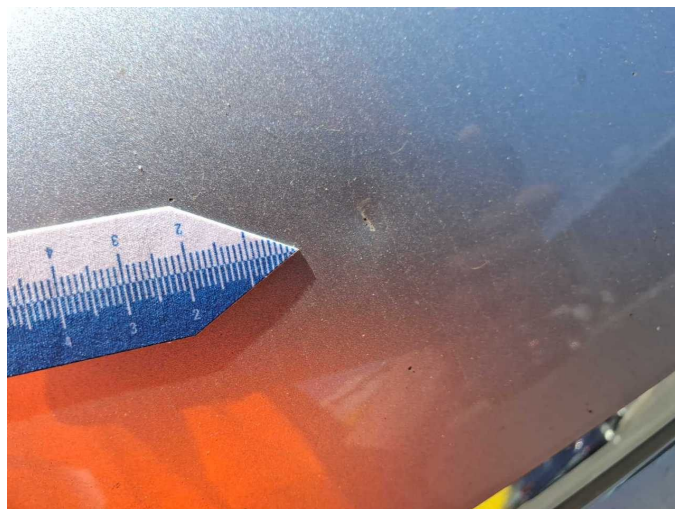
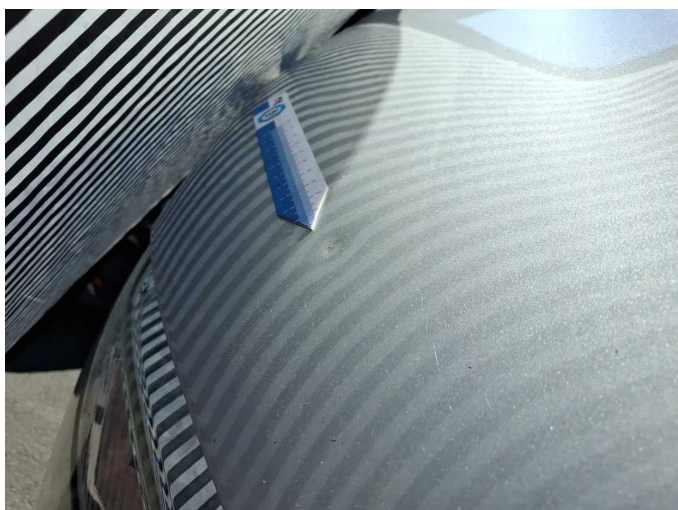
| No. | Component group | Description |
|---|---|---|
| 13 | Bonnet | Bonnet - Dent / paintcoat damage - Repair and paint |

**Damage 13:** Bonnet: Bonnet - Dent / paintcoat damage - Repair and paint

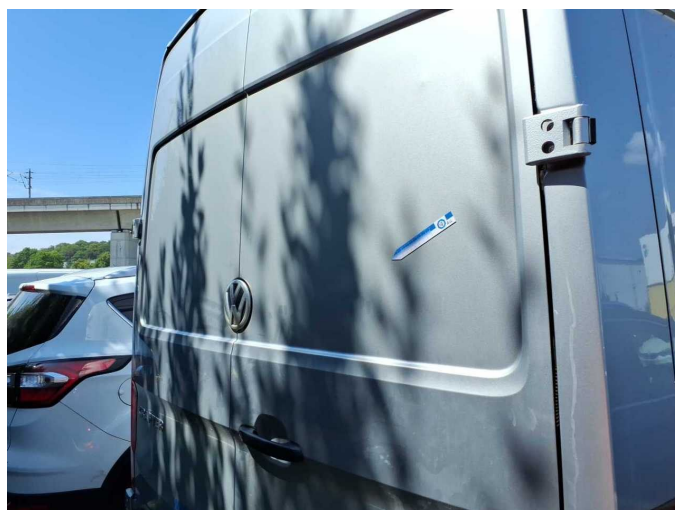
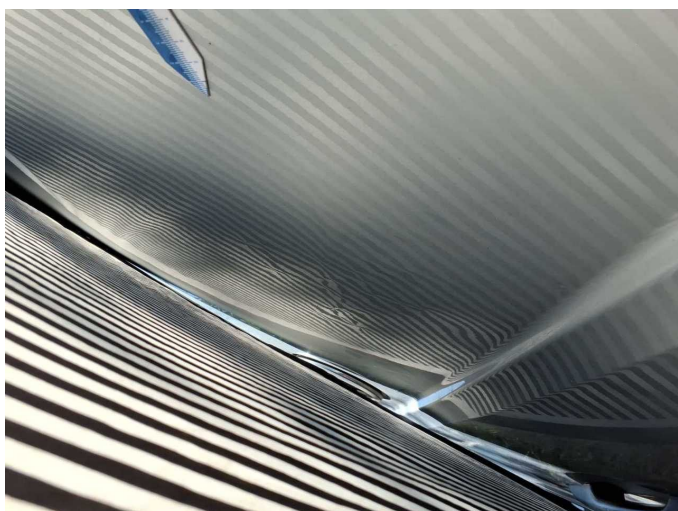
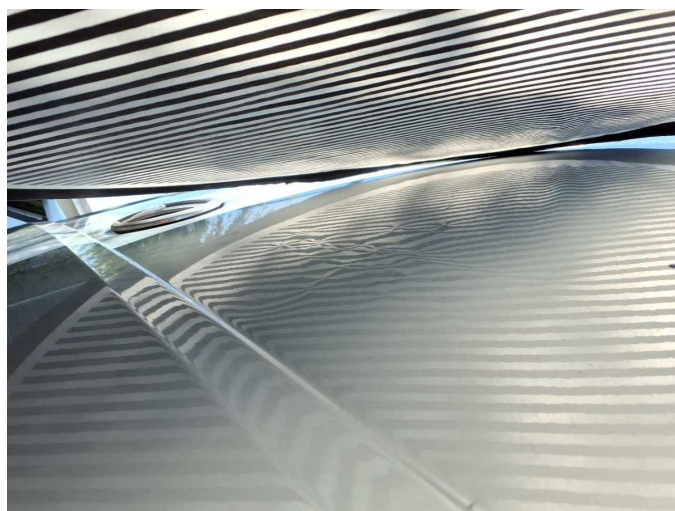
| No. | Component group | Description |
|---|---|---|
| 14 | Boot lid / rear door | Rear door - right side - Deformed - Repair and paint |

**Damage 14:** Boot lid / rear door: Rear door - right side - Deformed - Repair and paint

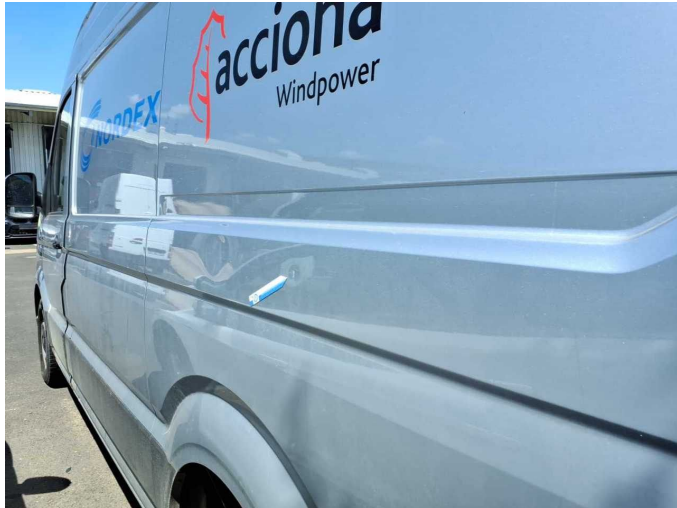
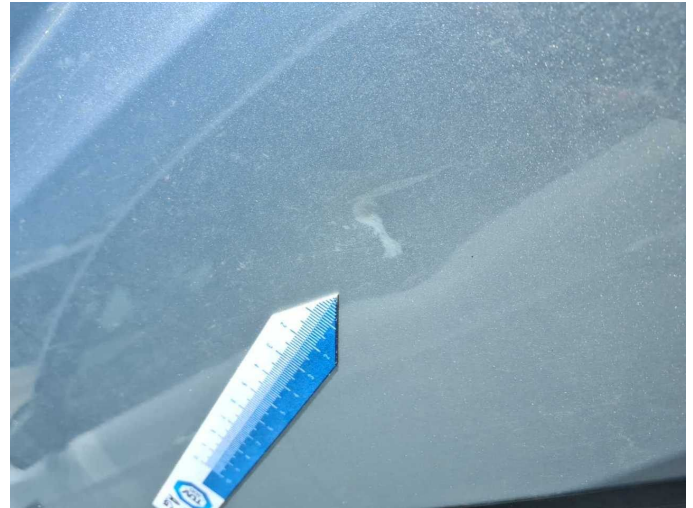
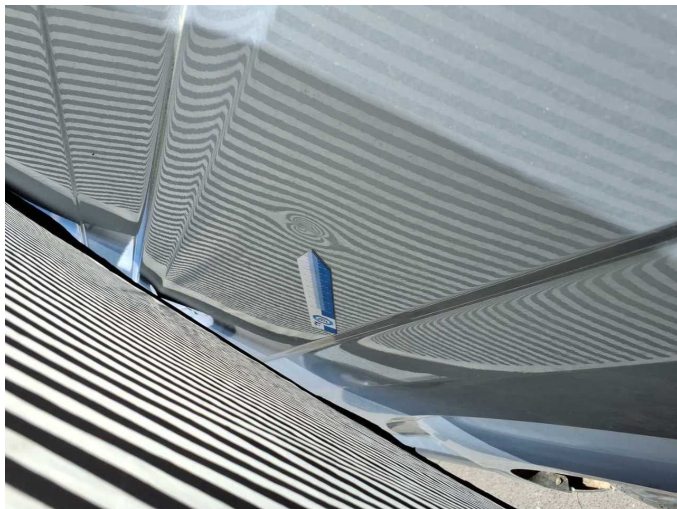
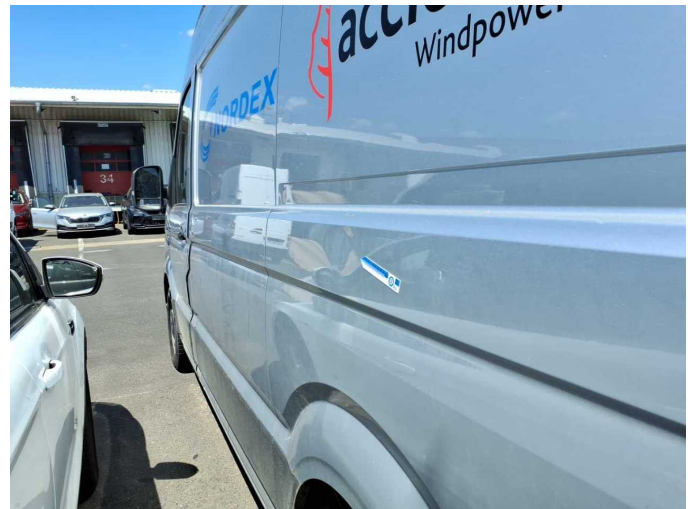
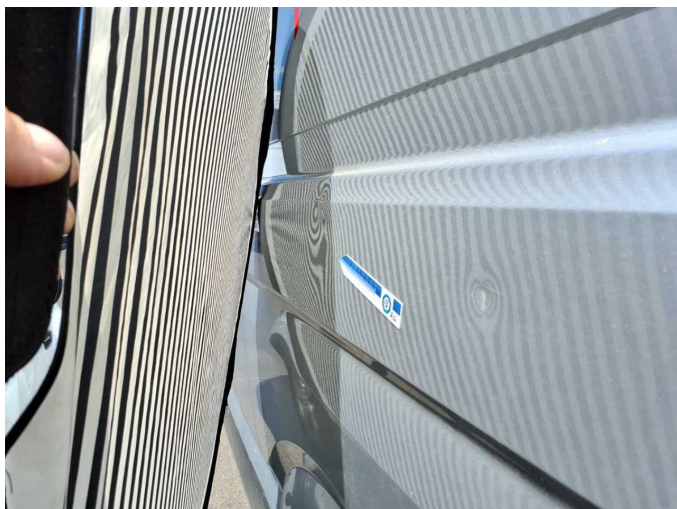
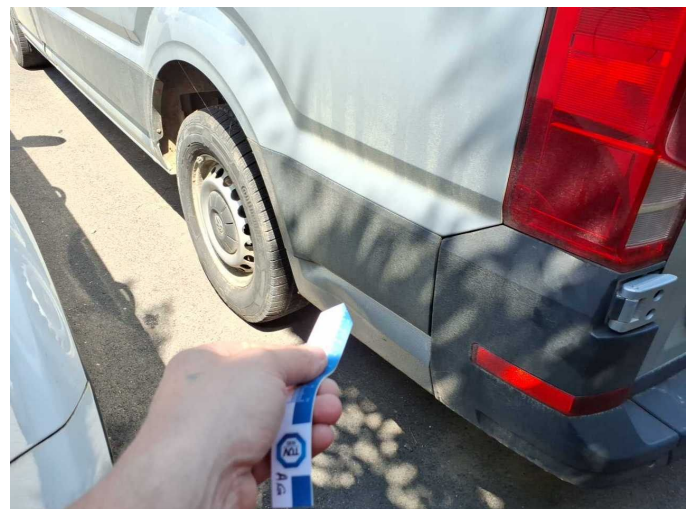
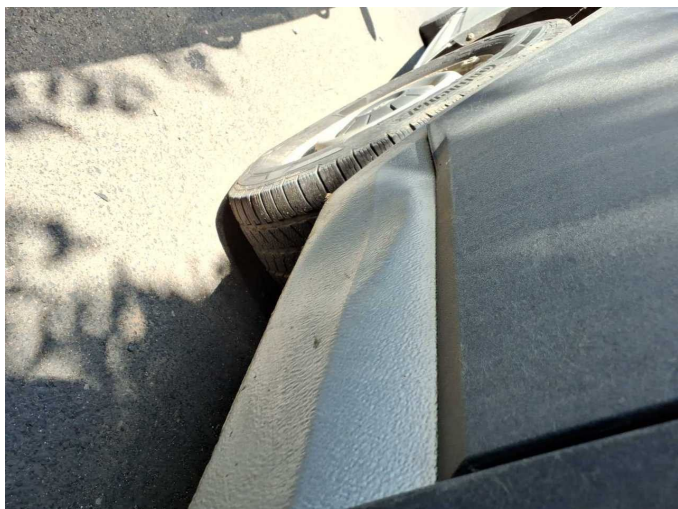
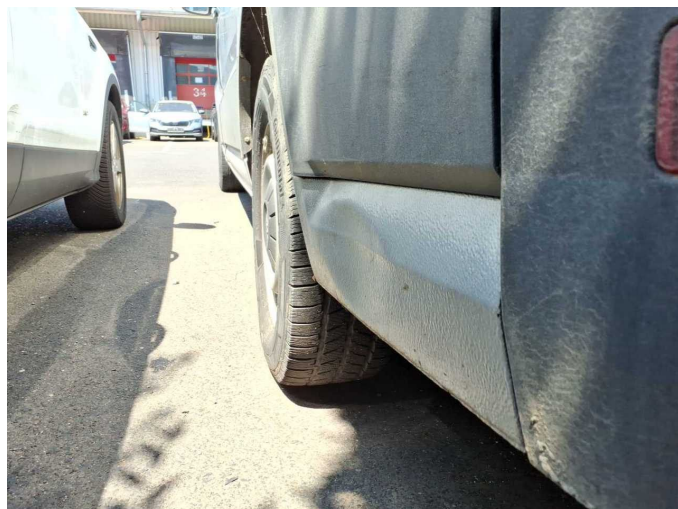
| No. | Component group | Description |
|---|---|---|
| 15 | Side panel - rear left side | Side panel (Hinten) - Deformed - Repair and paint |

**Damage 15:** Side panel - rear left side: Side panel (Hinten) - Deformed - Repair and paint

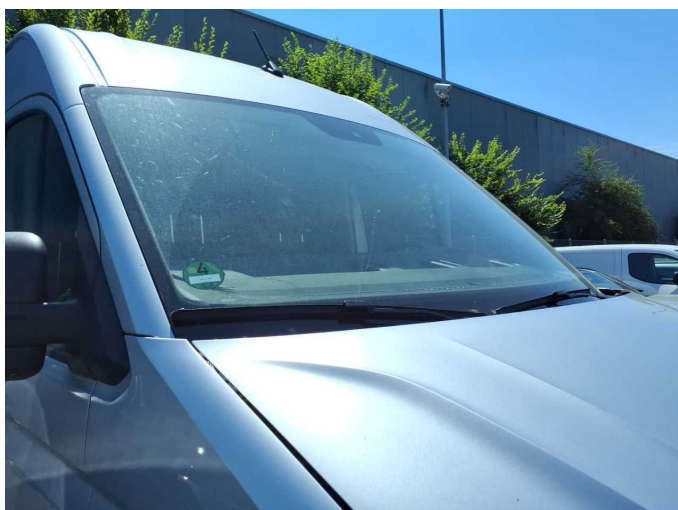
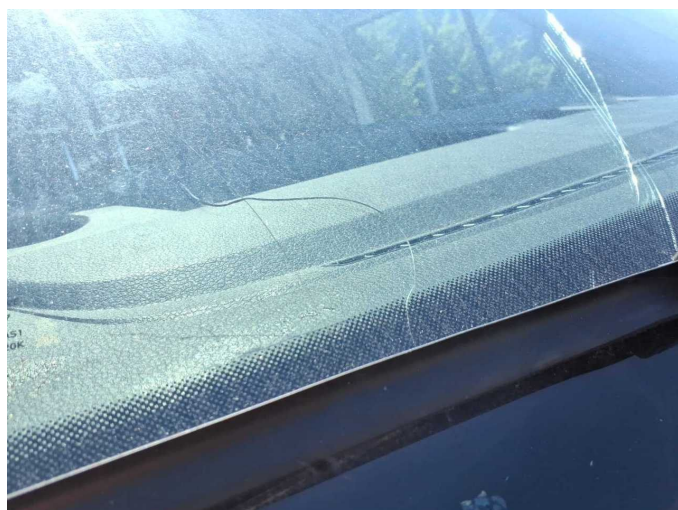
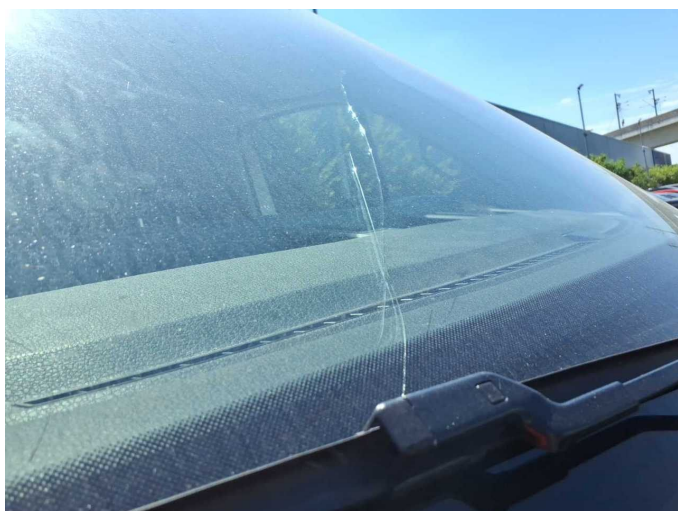
| No. | Component group | Description |
|---|---|---|
| 16 | Vehicle glazing | Windscreen - Broken / torn - repair according to calculation |

**Damage 16:** Vehicle glazing: Windscreen - Broken / torn - repair according to calculation

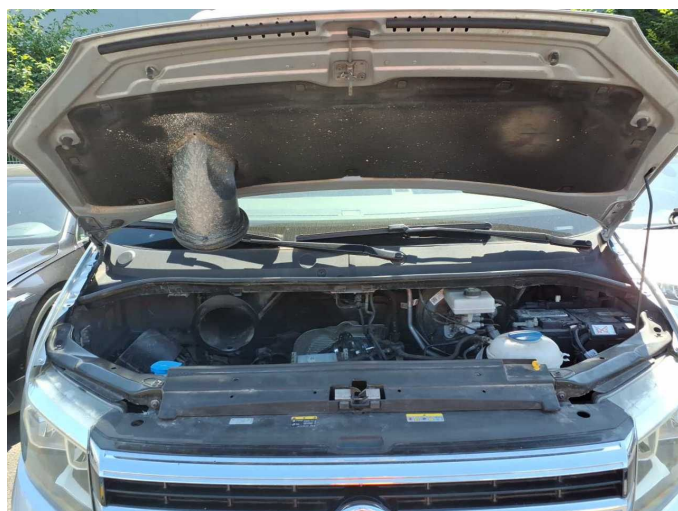
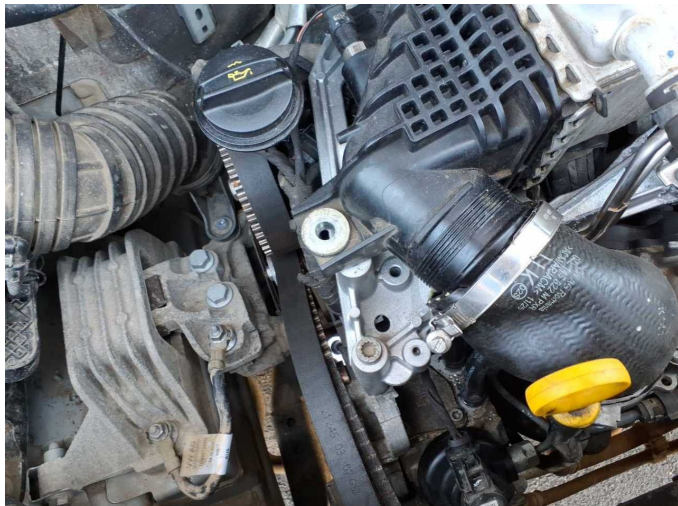
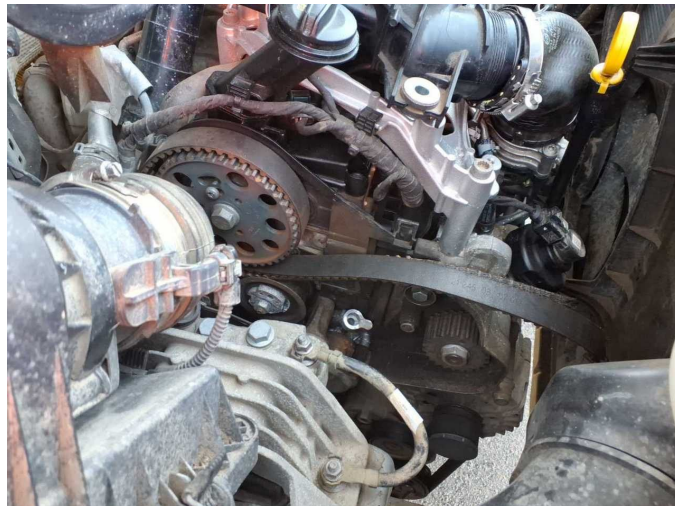
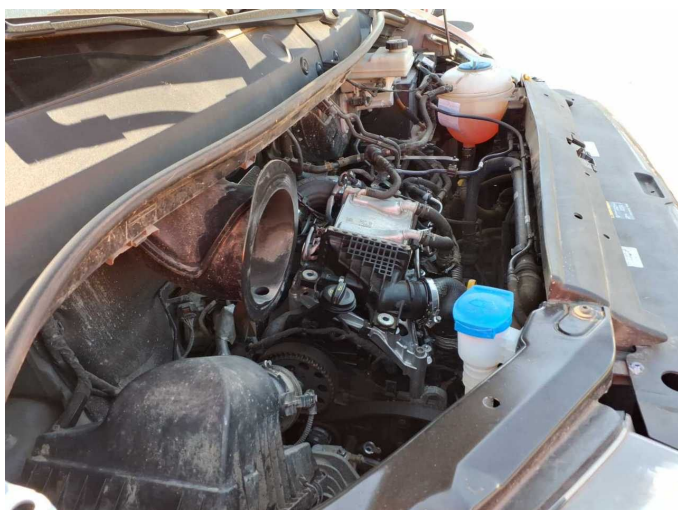
| Engine function test | An engine test run was performed.<br>This is due to the following reason.:<br>Motorschaden |

| No. | Component group | Description |
|---|---|---|
| 17 | Engine | Engine - Non-operational - repair according to calculation |

**Damage 17:** Engine: Engine - Non-operational - repair according to calculation

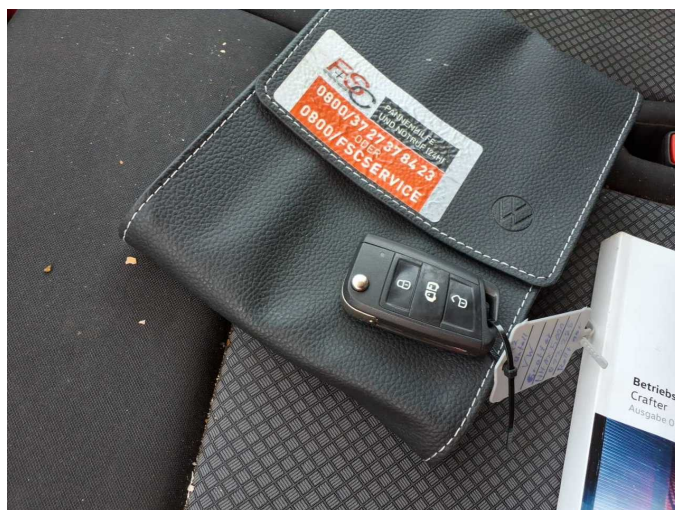
Equipment - Vehicle key with remote control

**Missing part 1:** Equipment: Vehicle key with remote control - Missing - Replace

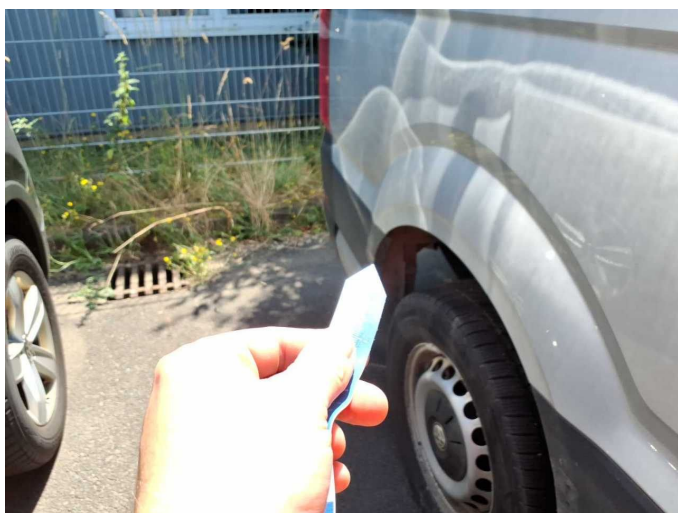
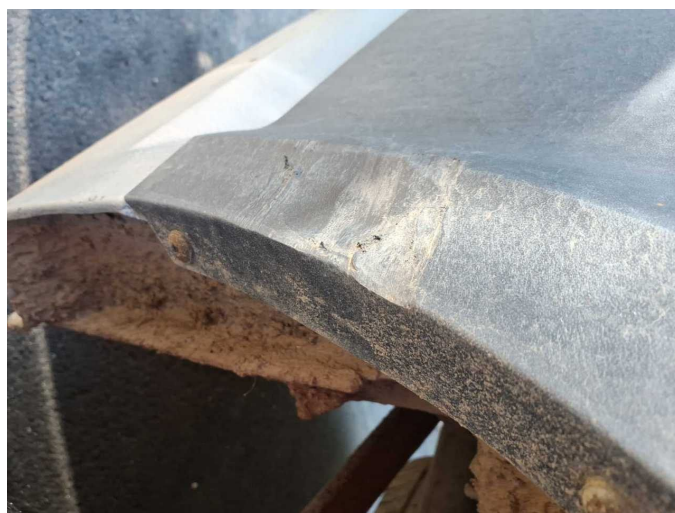
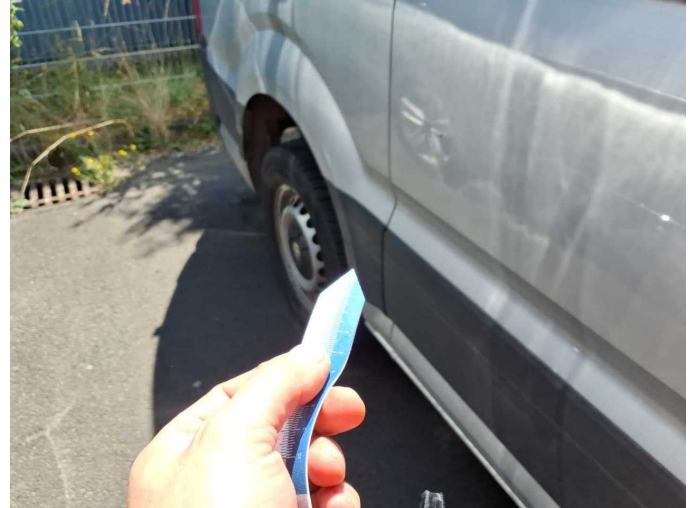
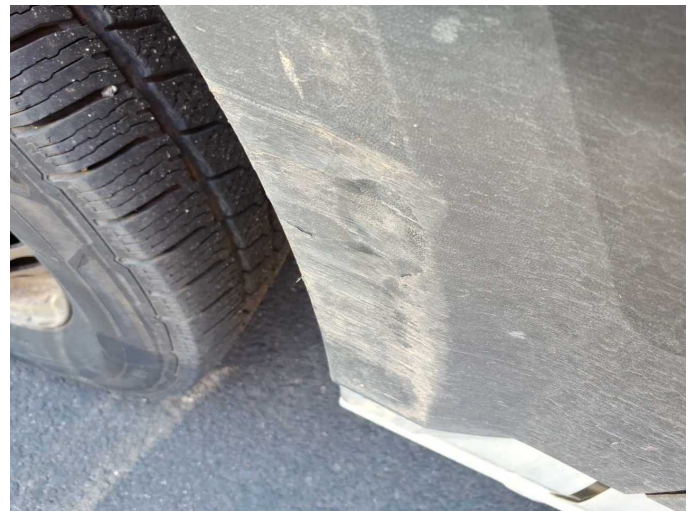
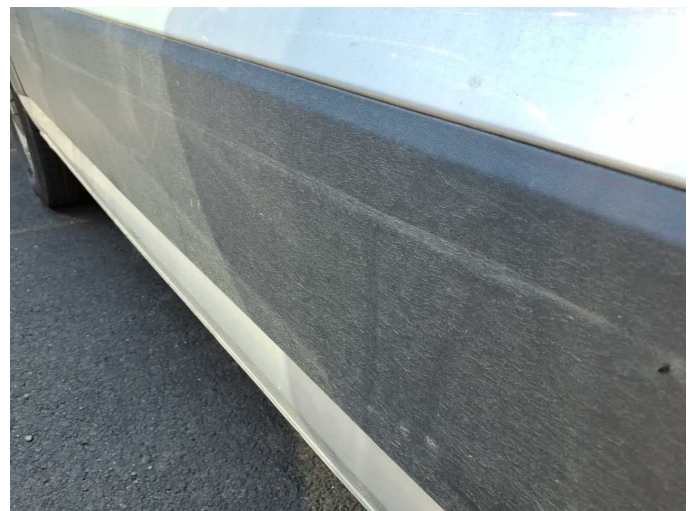
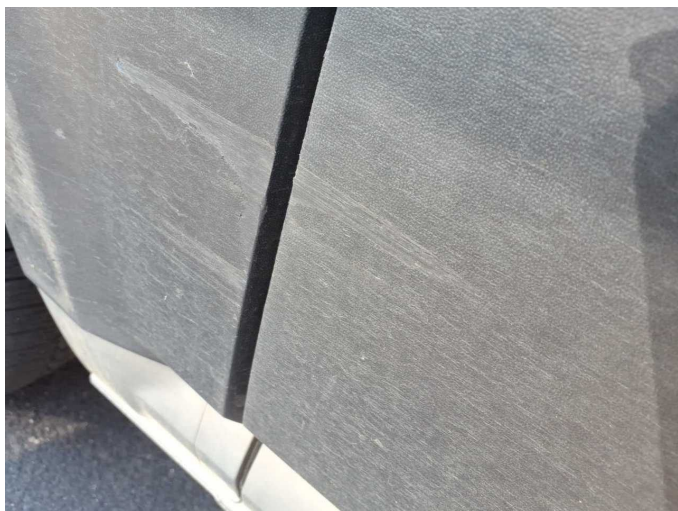
1 Side right

**Accident 1:** Side right

**Accident 1: Side right**
