- Vehicle Inspection Report -

Number: 10197629
From: 10.03.2026

Vehicle category:	Passenger Car
Vehicle type:	SUV
Make:	Volkswagen
Model:	Tiguan
Manufacturers and type code:	0603 / CIR
Date of first registration:	08.12.2023
Mileage:	41,756 km
Proof of mileage:	ReadOff
Exterior colour:	Deep Black Perleffekt
Roof colour:	Deep Black Perleffekt
Propulsion:	Front
Fuel:	Petrol
Engine size (cc):	1,500 ccm
Performance:	110 kW (150 PS)
Length:	
Height:	
Width:	
Permitted total weight:	
Wheelbase:	
Number of powered axles:	2
Cylinders:	4
Euronorm:	Euro 6
Number of doors:	4
Number of seats:	5
Gearbox:	Automatic 7-speed
Upholstery type:	Lining fabrics
Interior colour:	Anthrazit - Titanschwarz/Titanschwarz/ Schwarz/Storm Grey
Number of keys:	2

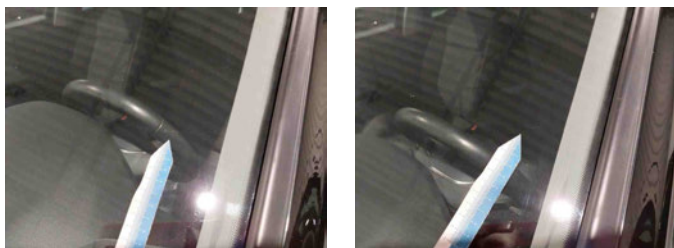
1 - Windscreen - Scratch(es) - Acceptable

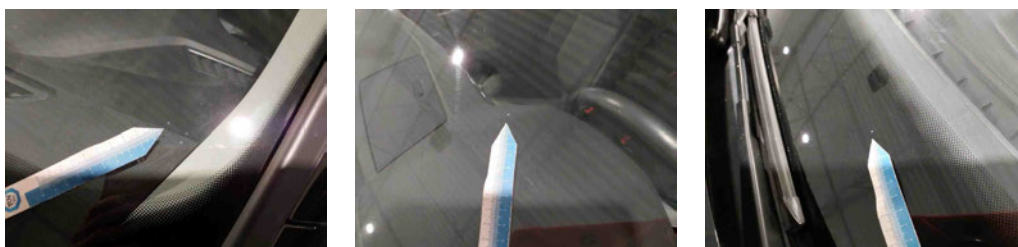
2 - Windscreen - Stone chip(s) - Acceptable

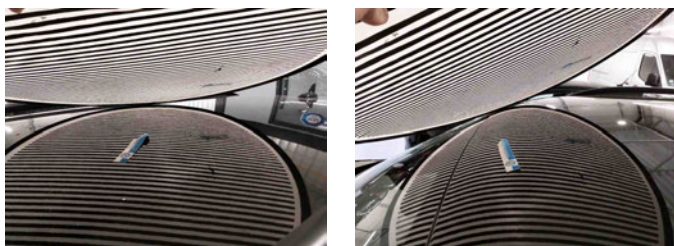
3 - Roof - Dent(s) - Acceptable

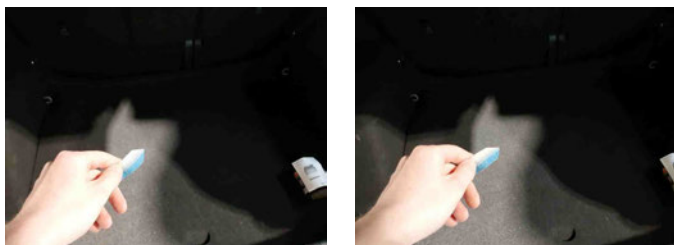
1 - Floor covering - Missing - Replace
