Expertise

Protocol number: 46897549  
Order No. / Reference: 26830806  
Inspection date: 4 Aug 2026

Manufacturer: Opel

Model: Astra Sports Tourer 1.5 D Automatik Elegance

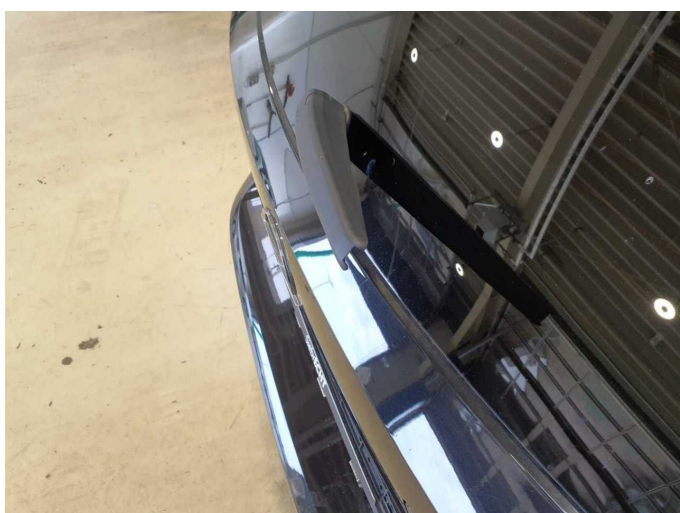
| No. | Component group | Description |
|---|---|---|
| 1 | Screen cleaning | Wiper blades - rear - Missing - Replace |

Damage 1: Screen cleaning: Wiper blades - rear - Missing - Replace

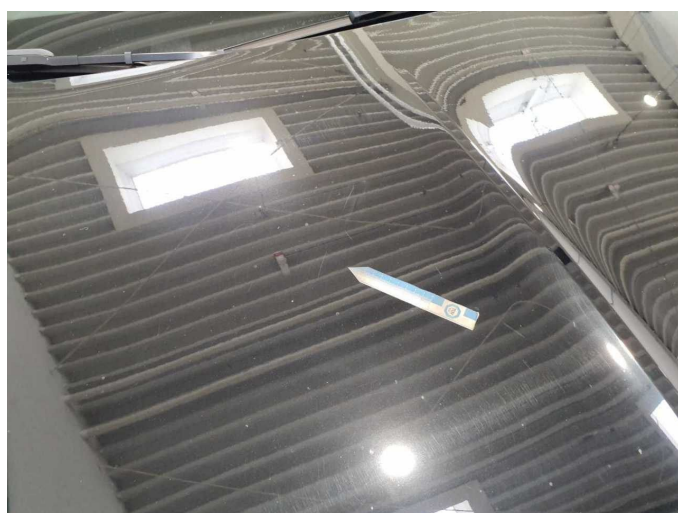
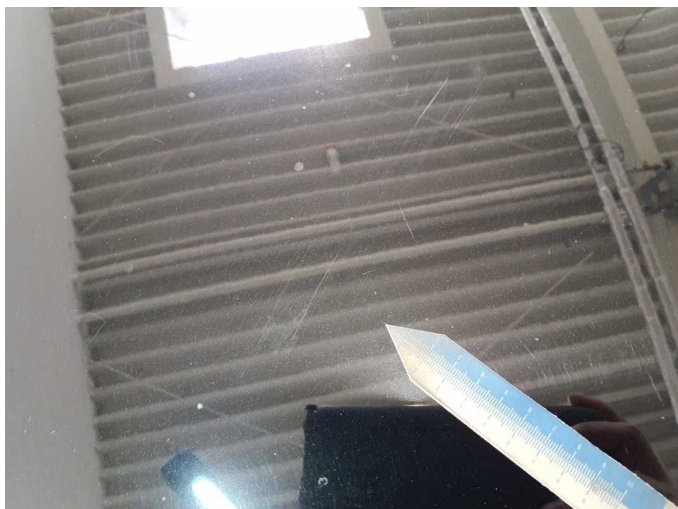
| No. | Component group | Description |
|---|---|---|
| 2 | Bonnet | Bonnet - Scratch(es) - Smart repair |

Damage 2: Bonnet: Bonnet - Scratch(es) - Smart repair

**Damage 2:** Bonnet: Bonnet - Scratch(es) - Smart repair

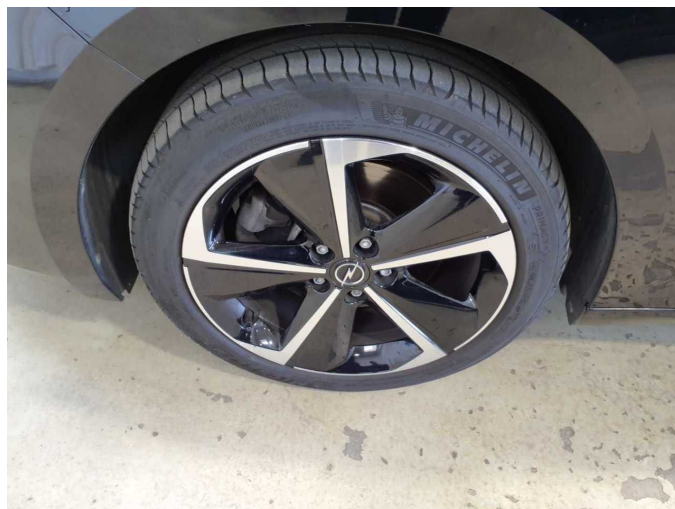
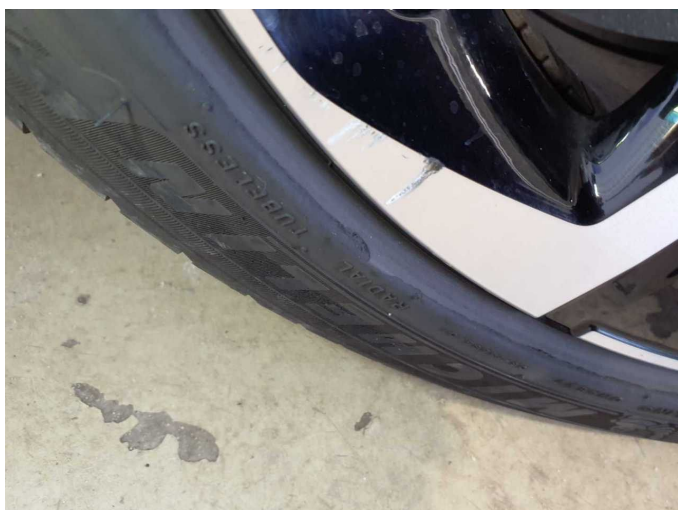
| No. | Component group | Description |
|---|---|---|
| 3 | Wheel / tyres | Tyre - front left side - Broken / torn - Replace |

**Damage 3:** Wheel / tyres: Tyre - front left side - Broken / torn - Replace

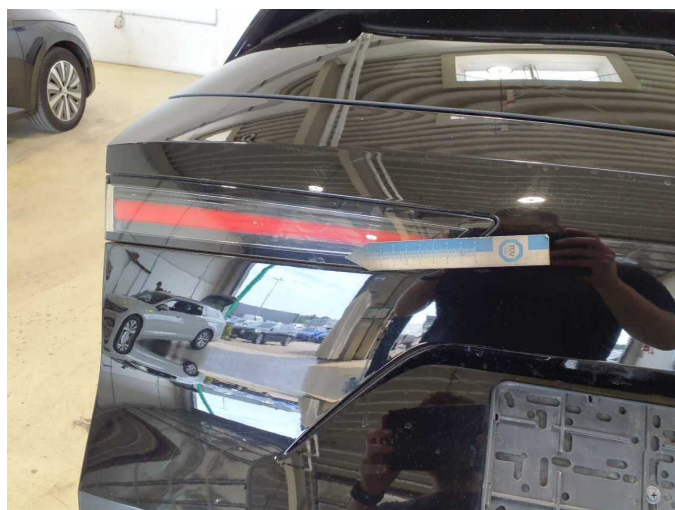
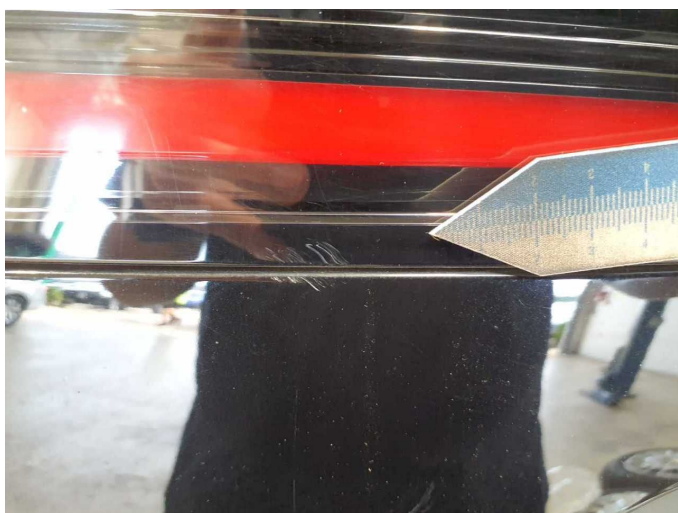
| No. | Component group | Description |
|---|---|---|
| 4 | Tail light | Tail lamp - left side - Scratch(es) - Replace |

**Damage 4:** Tail light: Tail lamp - left side - Scratch(es) - Replace

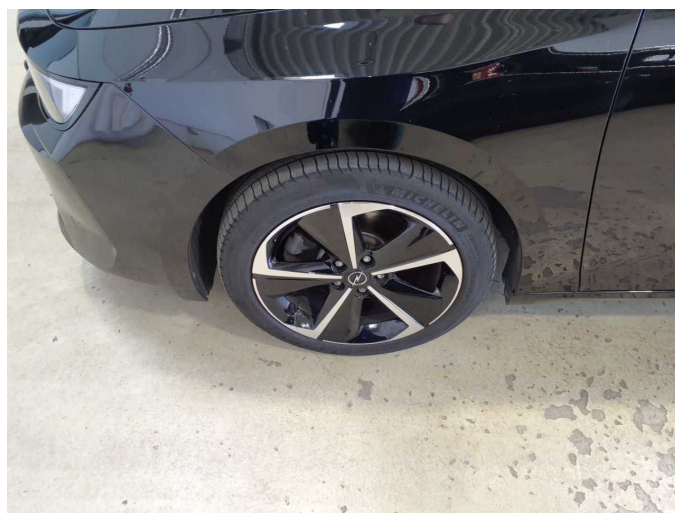
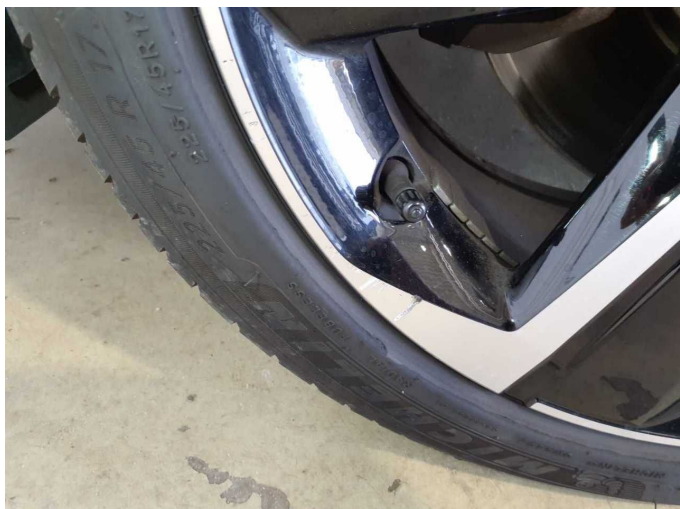
| No. | Component group | Description |
|---|---|---|
| 5 | Wheel / tyres | Alloy rim - front left side - Scratched - Replace |

**Damage 5:** Wheel / tyres: Alloy rim - front left side - Scratched - Replace

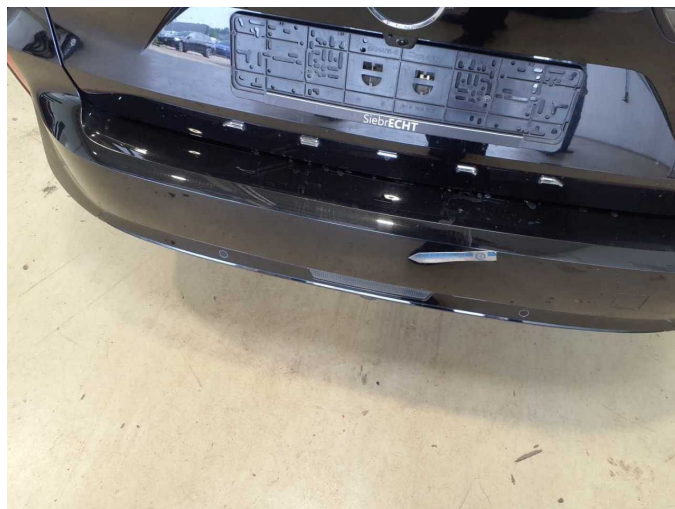
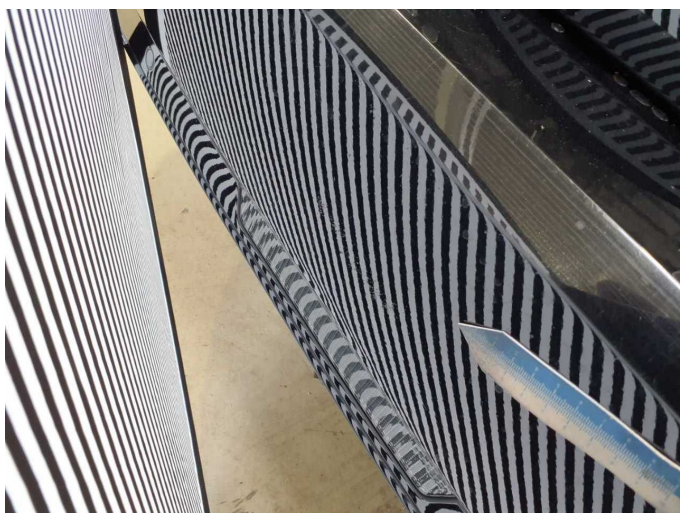
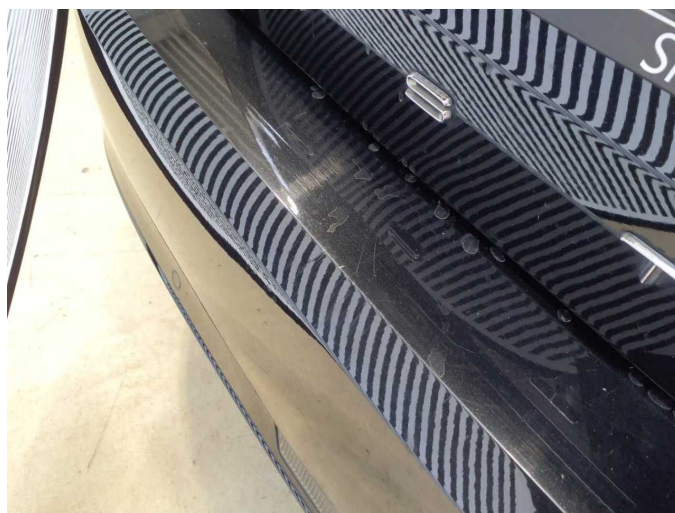
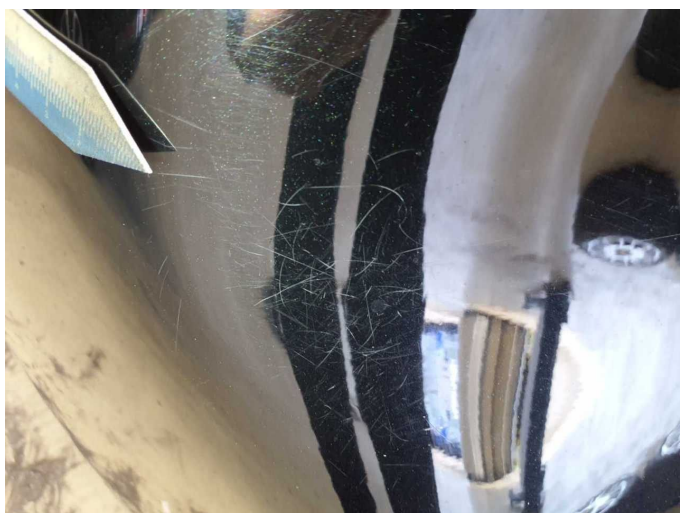
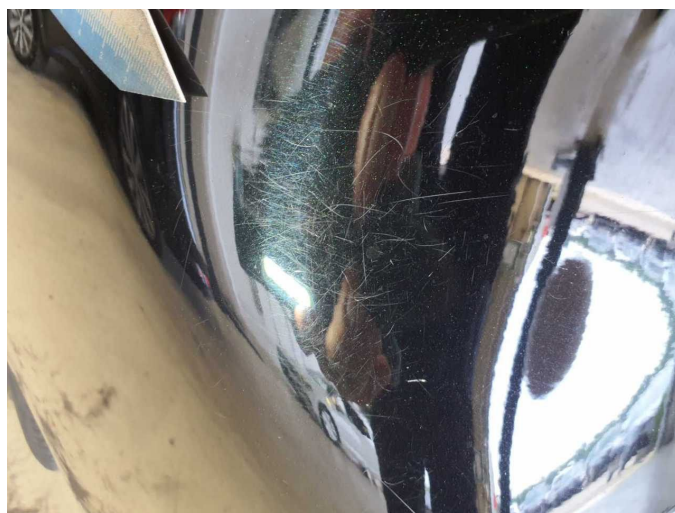
| No. | Component group | Description |
|---|---|---|
| 6 | Rear bumper | Rear bumper - Scratch(es) - Paint |

**Damage 6:** Rear bumper: Rear bumper - Scratch(es) - Paint

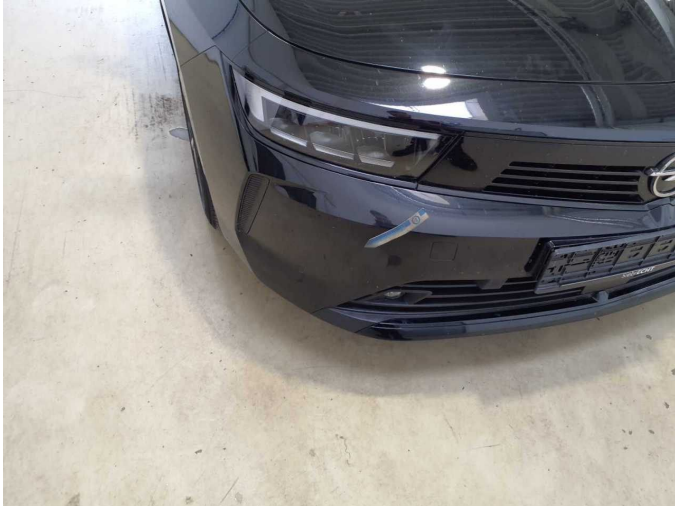
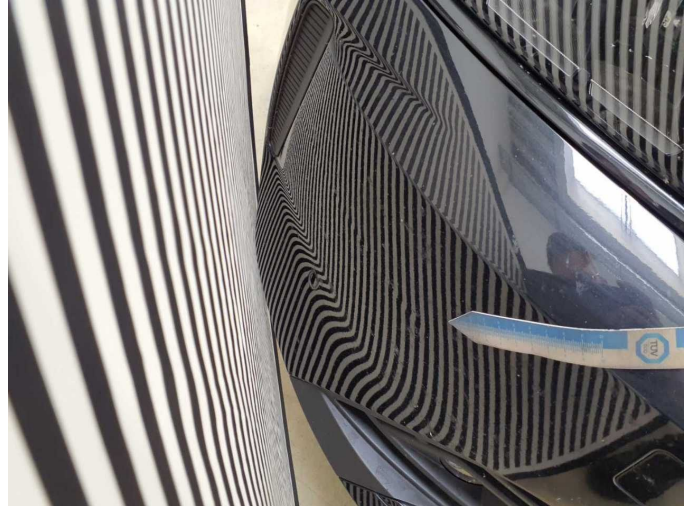
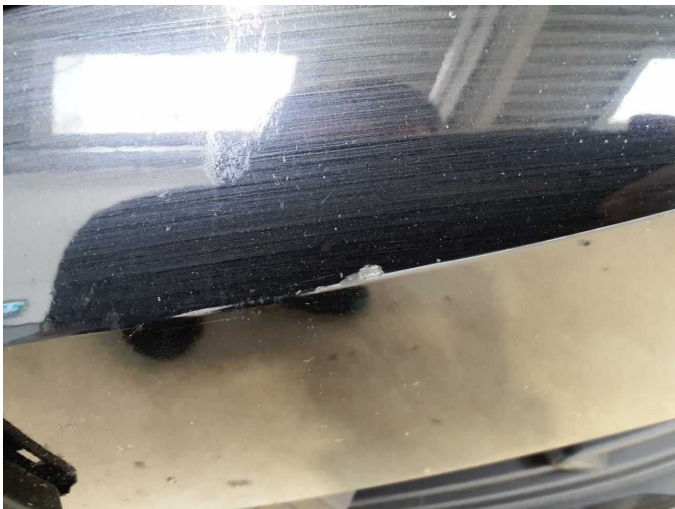
| No. | Component group | Description |
|---|---|---|
| 7 | Front bumper | Front bumper - Dent / paintcoat damage - Repair and paint |

**Damage 7:** Front bumper: Front bumper - Dent / paintcoat damage - Repair and paint

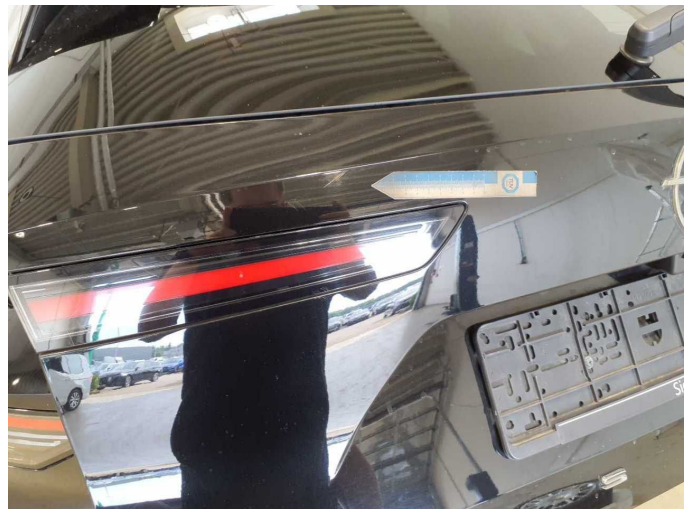
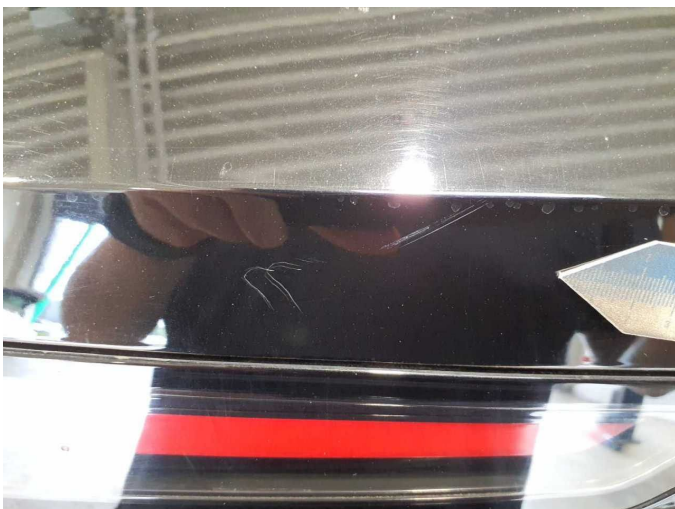
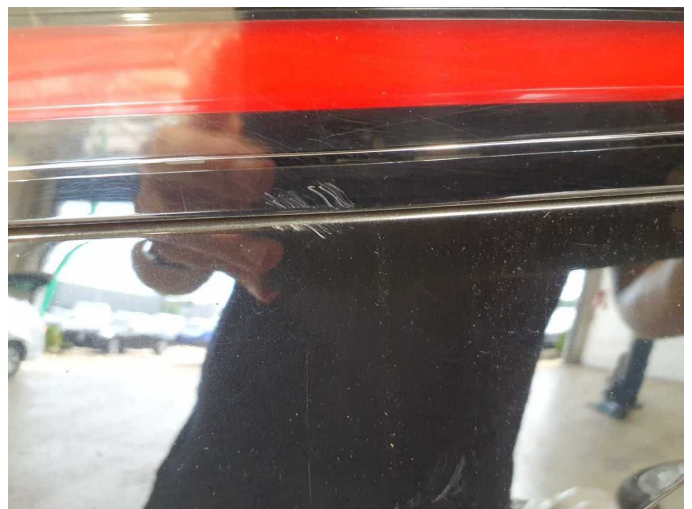
| No. | Component group | Description |
|---|---|---|
| 8 | Boot lid / rear door | Boot lid - Scratch(es) - Paint |

**Damage 8:** Boot lid / rear door: Boot lid - Scratch(es) - Paint

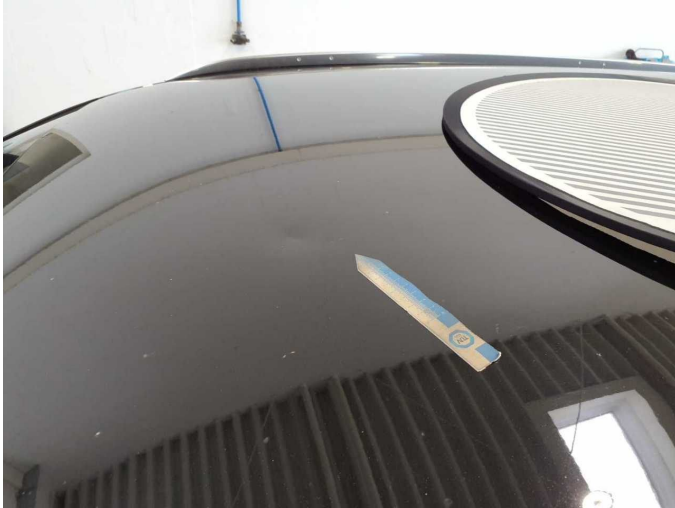
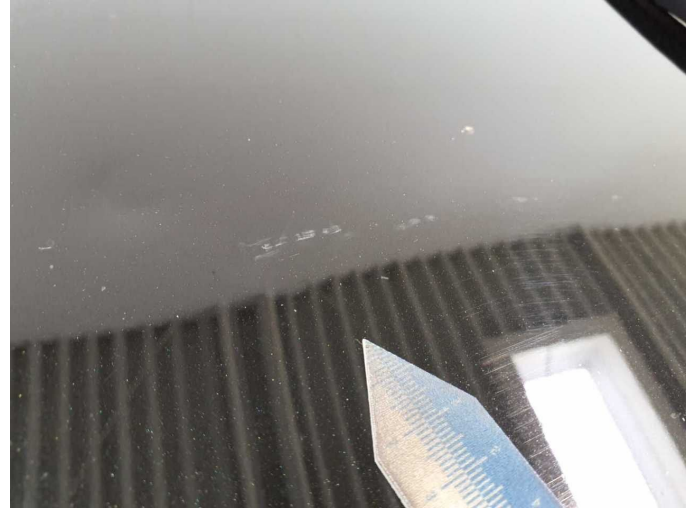
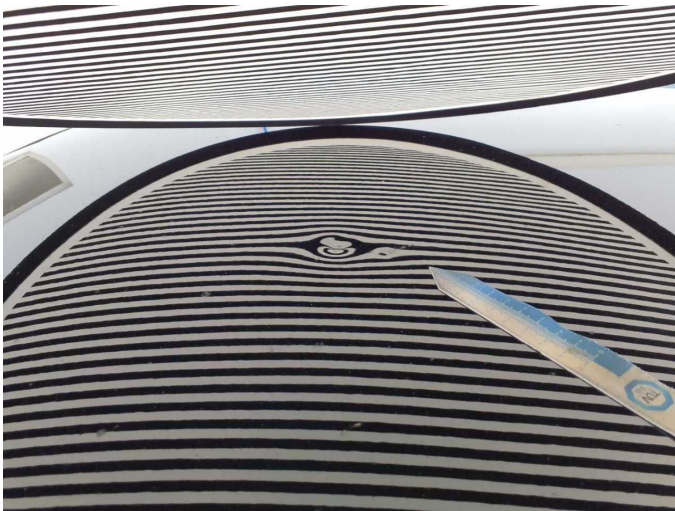
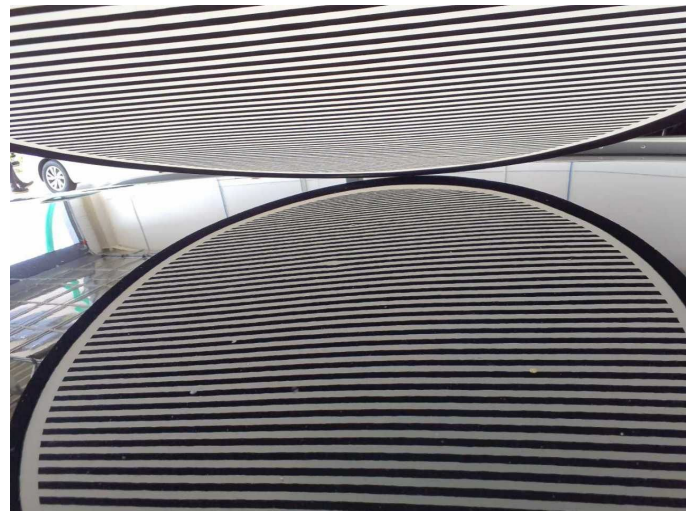
| No. | Component group | Description |
|---|---|---|
| 9 | Roof | Roof - Dent / paintcoat damage - Repair and paint |

**Damage 9:** Roof: Roof - Dent / paintcoat damage - Repair and paint

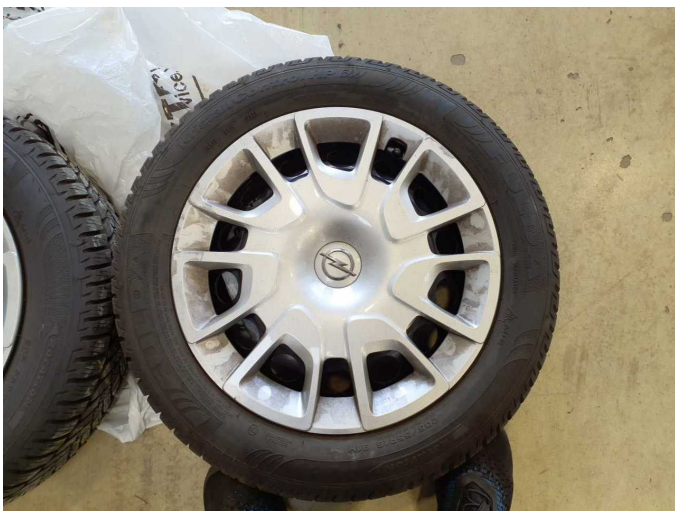
| No. | Component group | Description |
|---|---|---|
| 3 | 2nd wheel set | 1 wheel cover - Scratch(es) - No deduction |

**Wear and tear 3:** 2nd wheel set: 1 wheel cover - Scratch(es) - No deduction

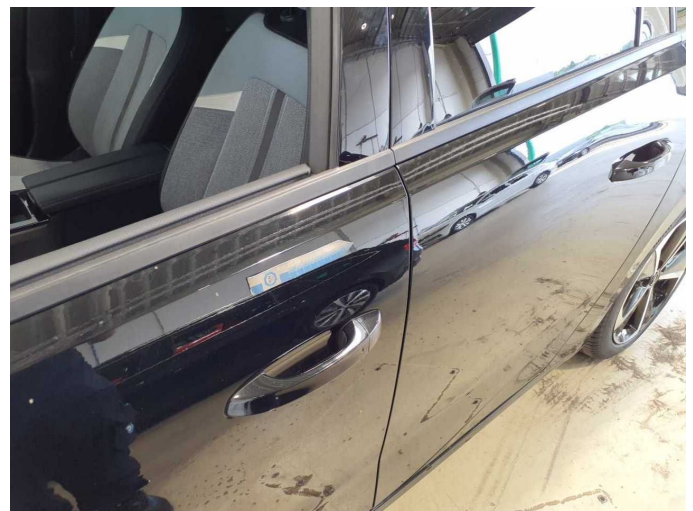
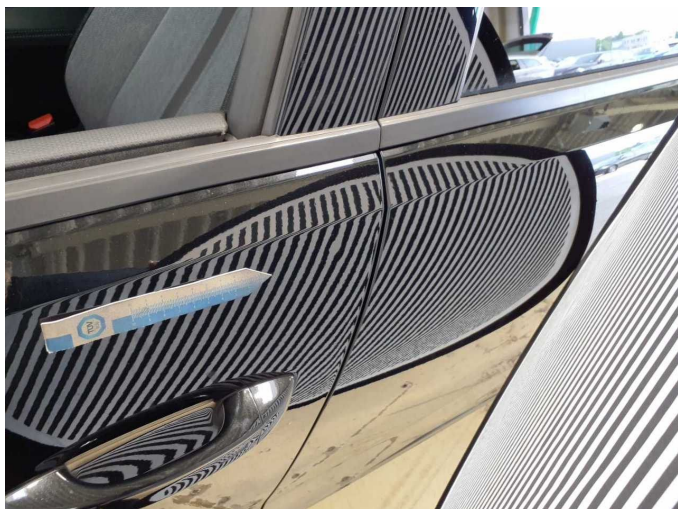
| No. | Component group | Description |
|---|---|---|
| 5 | Door - front left side | Door - dent(s) - No deduction |

**Wear and tear 5:** Door - front left side: Door - dent(s) - No deduction

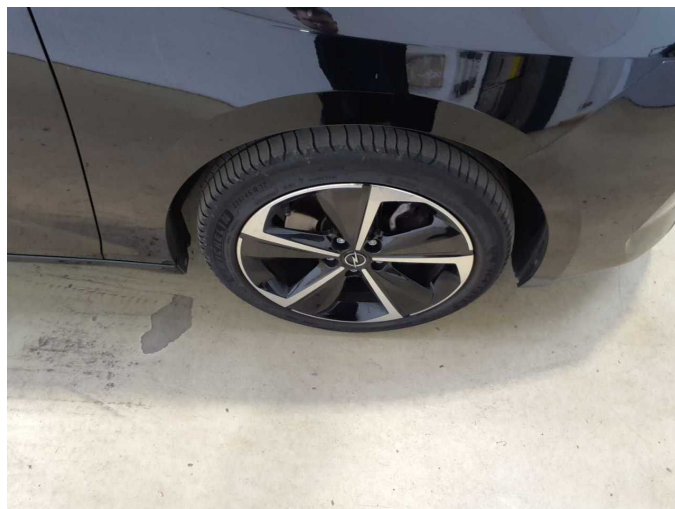
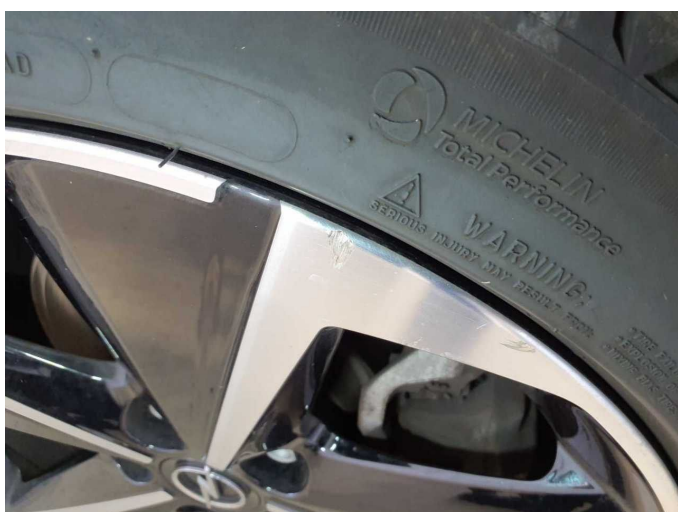
| No. | Component group | Description |
|---|---|---|
| 6 | Wheel / tyres | Alloy rim - front right side - Scratch(es) - No deduction |

**Wear and tear 6:** Wheel / tyres: Alloy rim - front right side - Scratch(es) - No deduction

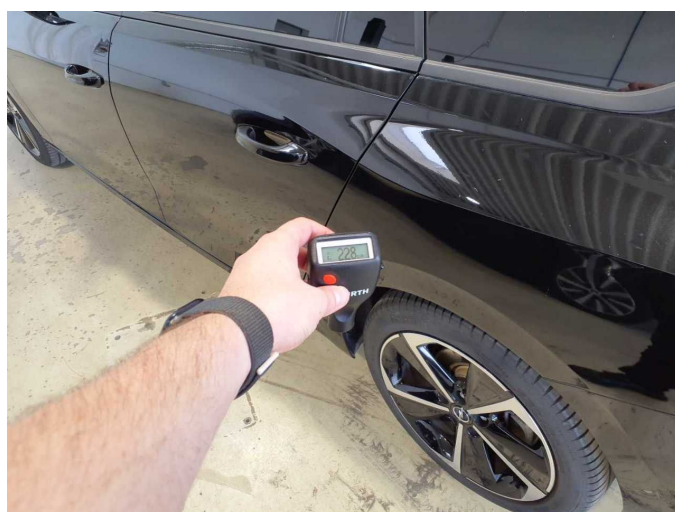
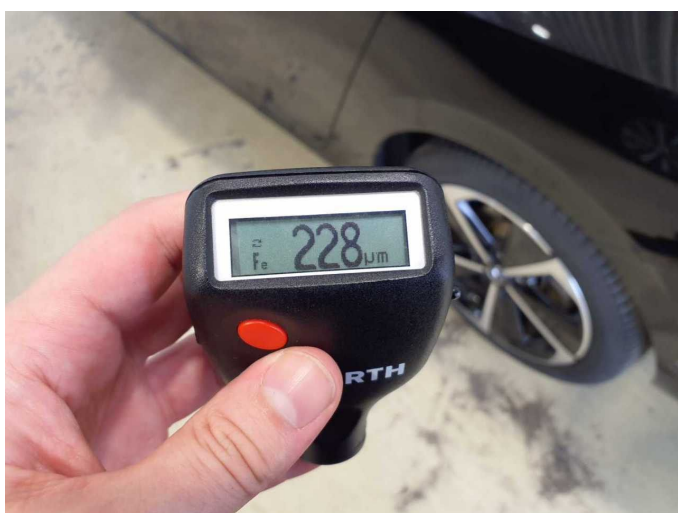
- 1 Side panel - rear left side, Professionally carried out, Invoice of repair done Non-existent
- 2 Door - rear left side, Professionally carried out, Invoice of repair done Non-existent

| Side panel - rear left side | 228 µm | Door - rear left side | 172 µm |

**Repainting 1:** Side panel - rear left side

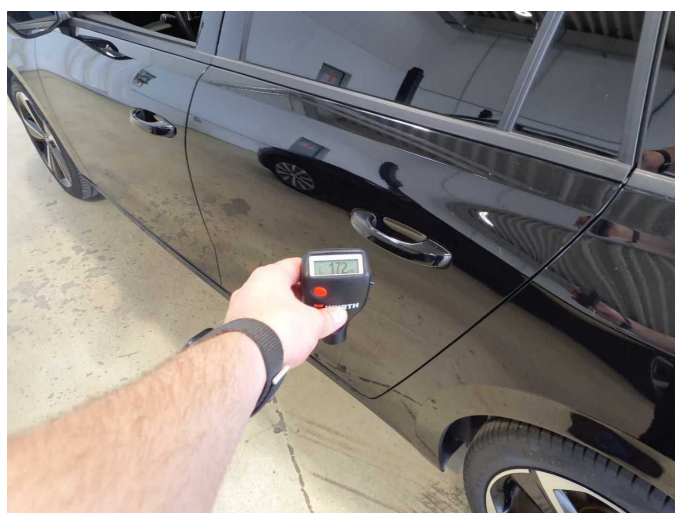
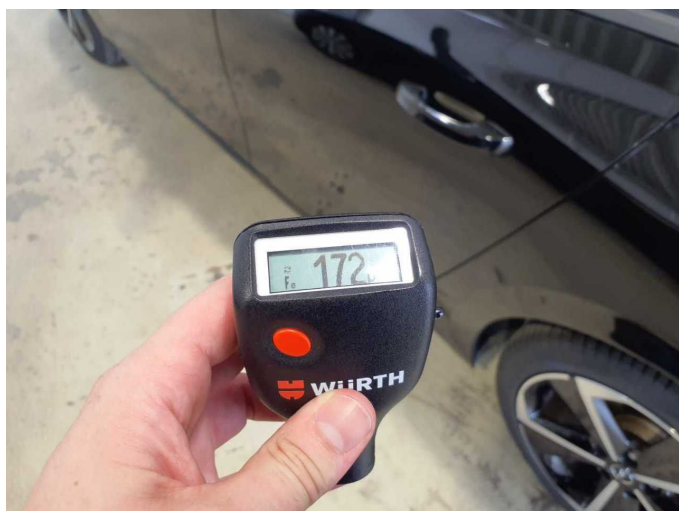
**Repainting 2:** Door - rear left side
