Expertise

Protocol number: 46500023  
Order No. / Reference: 26028681  
Inspection date: 10 Jul 2026

Manufacturer: Mercedes-Benz  
VIN: W1VVLBEZ5T4565415

Model: Vito 116 CDI Lang HA Aut. PRO

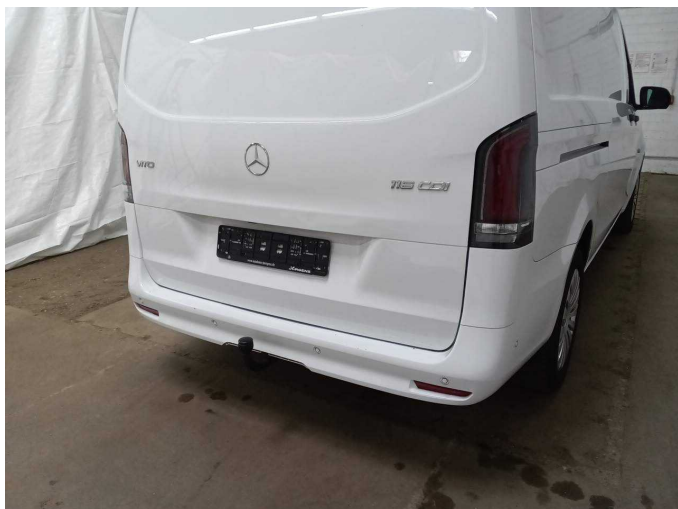
| No. | Component group | Description |
|---|---|---|
| 2 | Rear bumper | Rear bumper - Scratch(es) - Paint |

**Damage 2:** Rear bumper: Rear bumper - Scratch(es) - Paint

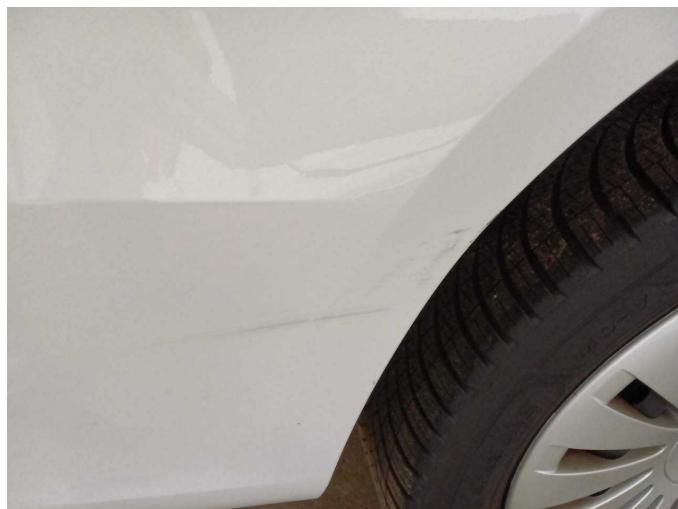
**Damage 2:** Rear bumper: Rear bumper - Scratch(es) - Paint

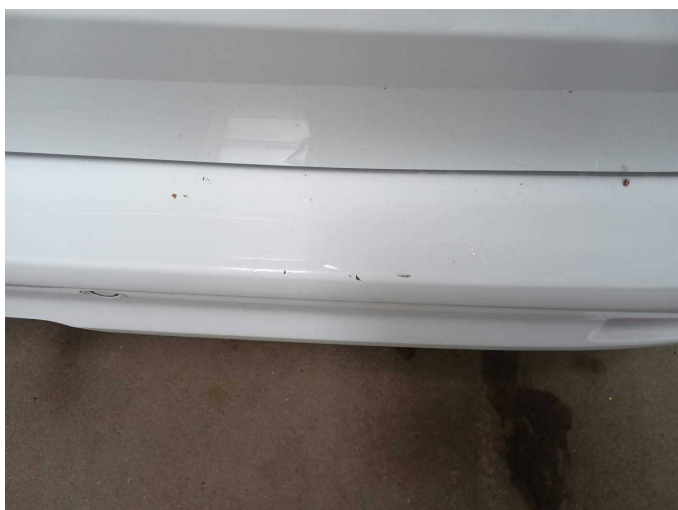
**Damage 2:** Rear bumper: Rear bumper - Scratch(es) - Paint

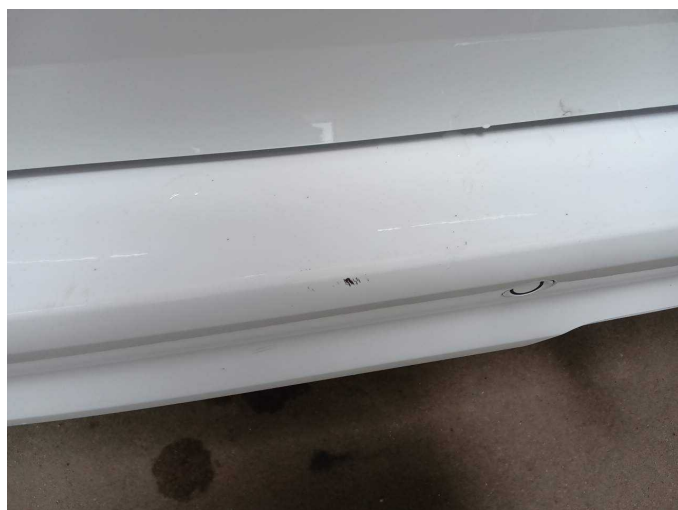
**Damage 2:** Rear bumper: Rear bumper - Scratch(es) - Paint

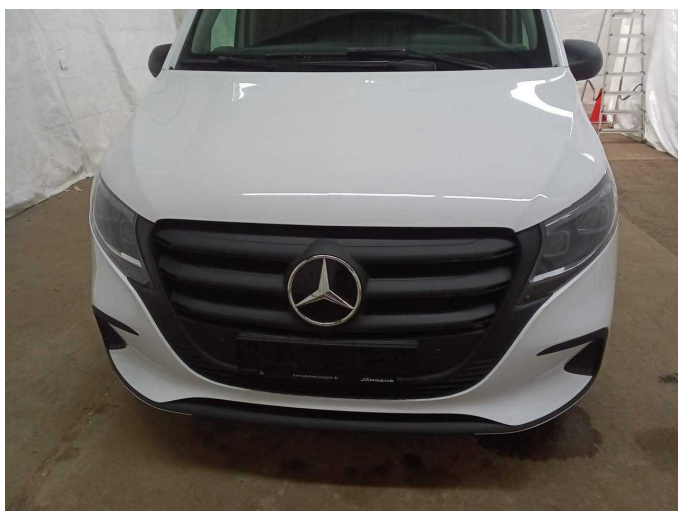
| No. | Component group | Description |
|---|---|---|
| 3 | Front bumper | Front bumper - Scratch(es) - Paint |

**Damage 3:** Front bumper: Front bumper - Scratch(es) - Paint

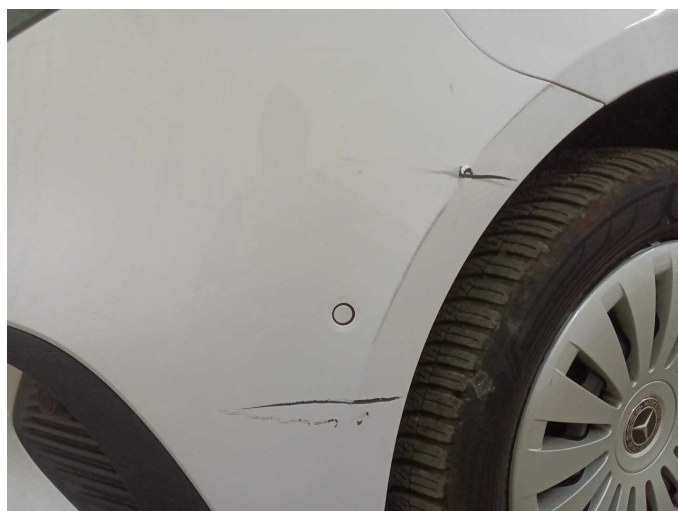
**Damage 3:** Front bumper: Front bumper - Scratch(es) - Paint

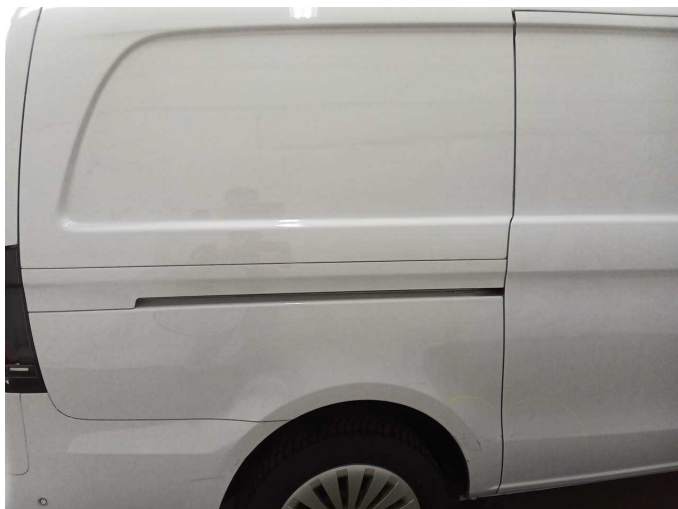
| No. | Component group | Description |
|---|---|---|
| 4 | Side panel - rear right side | Elbow - Dent / paintcoat damage - Repair and paint |

**Damage 4:** Side panel - rear right side: Elbow - Dent / paintcoat damage  
- Repair and paint

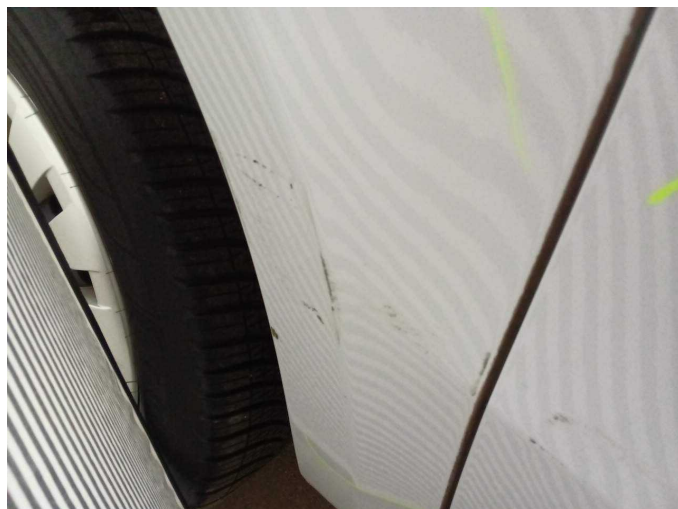
**Damage 4:** Side panel - rear right side: Elbow - Dent / paintcoat damage  
- Repair and paint

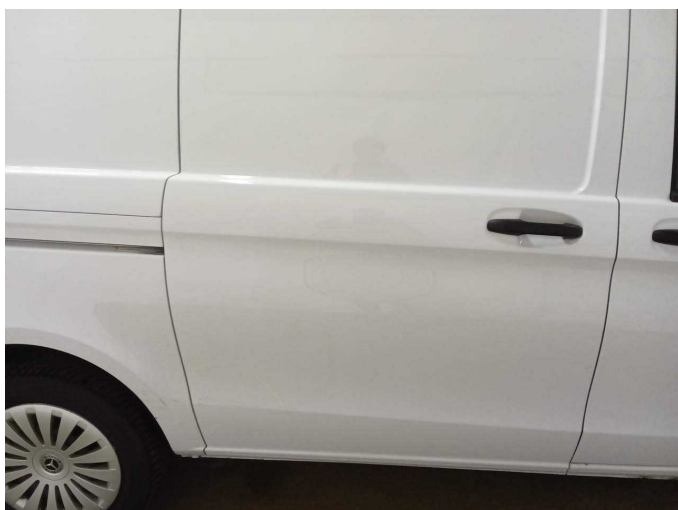
| No. | Component group | Description |
|---|---|---|
| 5 | Sliding door, right | Sliding door - Dent / paintcoat damage - Repair and paint |

**Damage 5:** Sliding door, right: Sliding door - Dent / paintcoat damage -  
Repair and paint

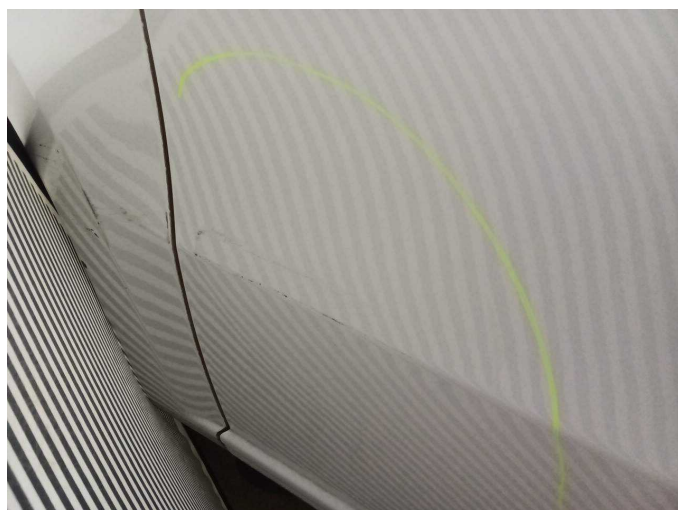
**Damage 5:** Sliding door, right: Sliding door - Dent / paintcoat damage -  
Repair and paint

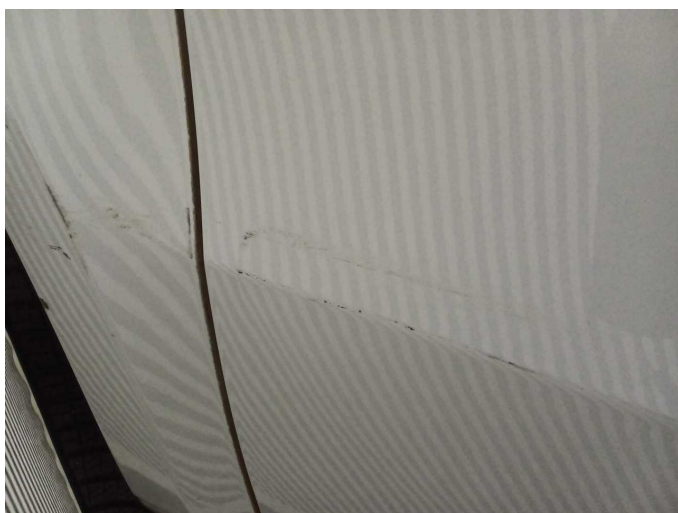
**Damage 5:** Sliding door, right: Sliding door - Dent / paintcoat damage -  
Repair and paint
