Expertise

Protocol number: 45040054
Order No. / Reference: 26292307
Inspection date: 16 Apr 2026

Model: 317 CDI Sprinter Standard HA 9G-TRONIC PRO

VIN: W1V3KBFZXP861604

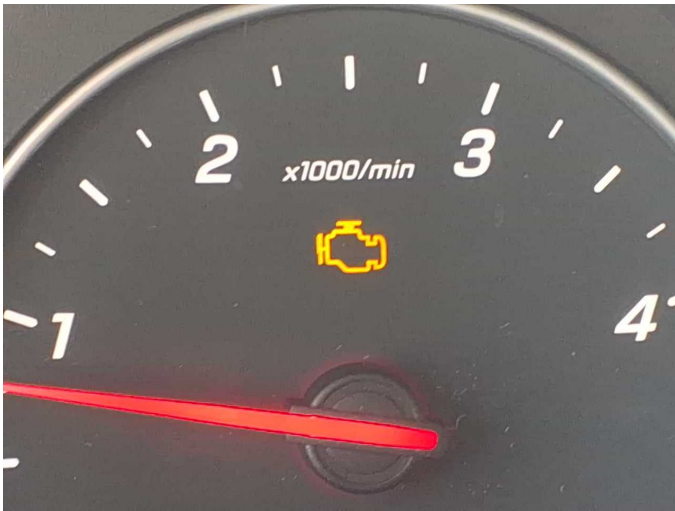
Documents submitted	At the time of the inspection, the vehicle registration certificate Part 2 (title) was available, but the vehicle registration certificate Part 1 (document) was not. (Copy)
VIN comparison	The vehicle identification number (VIN) was read from the vehicle and its conformity with the submitted documents was confirmed by the undersigned during the inspection.
Inspection	The inspection conditions were sufficient for the assessment of the vehicle. No lifting equipment or pit was available for inspecting the vehicle. Therefore, inspection of the vehicle's underside was only possible to a limited extent.
Test drive	No test drive/shunting maneuver was carried out during the inspection of the vehicle.
Engine function test	An engine test run was performed, problem has been detected This is due to the following reason: Motorkontrolleuchte aktiv, Fehlerursache nicht genauer identifizierbar

No.	Component group	Description
1	Instrument panel	Indicator light (Motorkontrolle) - on - Perform diagnosis

Damage 1: Instrument panel: Indicator light (Motorkontrolle) - on - Perform diagnosis

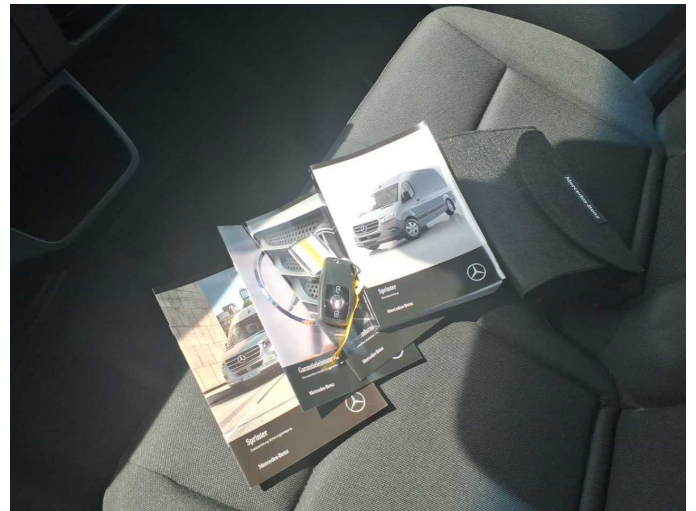
Equipment - Vehicle key

Missing part 1: Equipment: Vehicle key - Missing - Replace
