Expertise

Protocol number: 46652293  
Order No. / Reference: 26597927  
Inspection date: 21 Jul 2026

Manufacturer: Ford

Model: Mustang Mach-E AWD GT

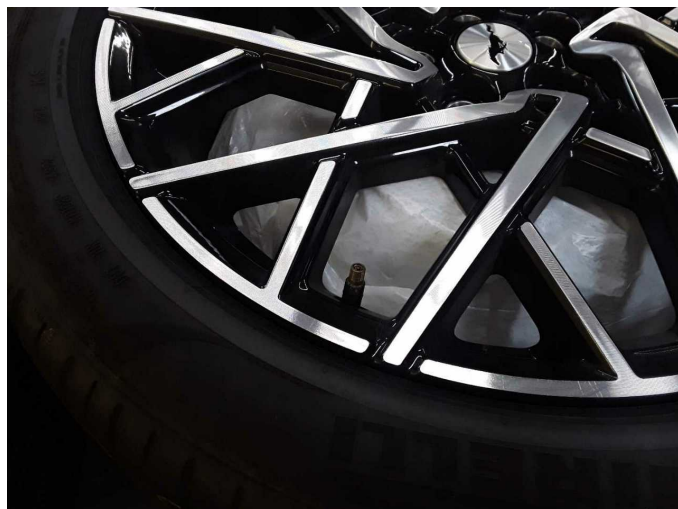
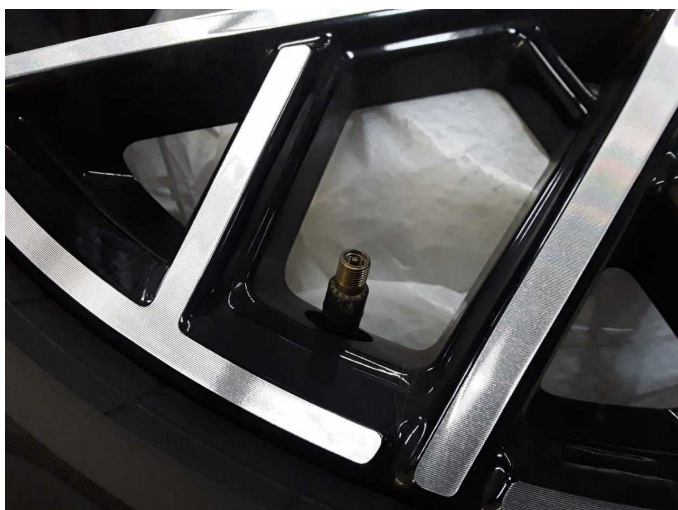
| No. | Component group | Description |
|---|---|---|
| 1 | Wheel / tyres | Valve (Kappe) - Missing - Replace |

**Damage 1:** Wheel / tyres: Valve (Kappe) - Missing - Replace

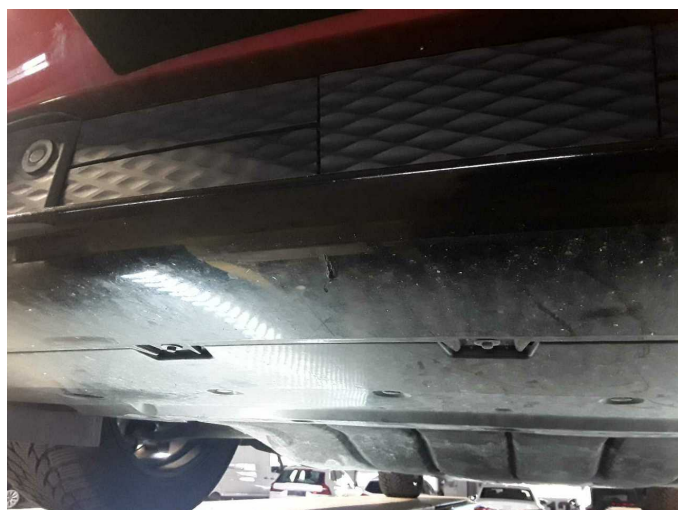
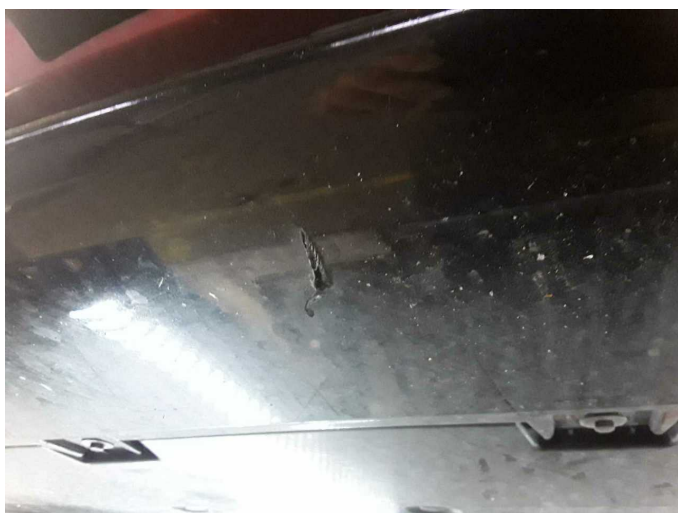
| No. | Component group | Description |
|---|---|---|
| 2 | Front bumper | Spoiler (Windabweiser vorne) - Scratched - Smart repair |

**Damage 2:** Front bumper: Spoiler (Windabweiser vorne) - Scratched - Smart repair

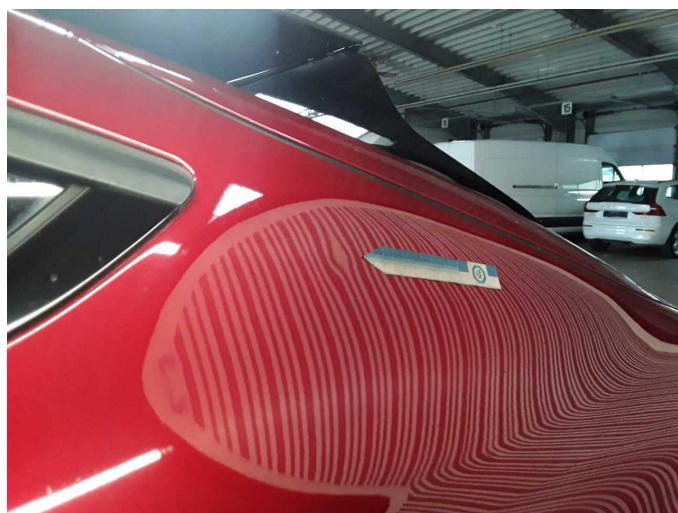
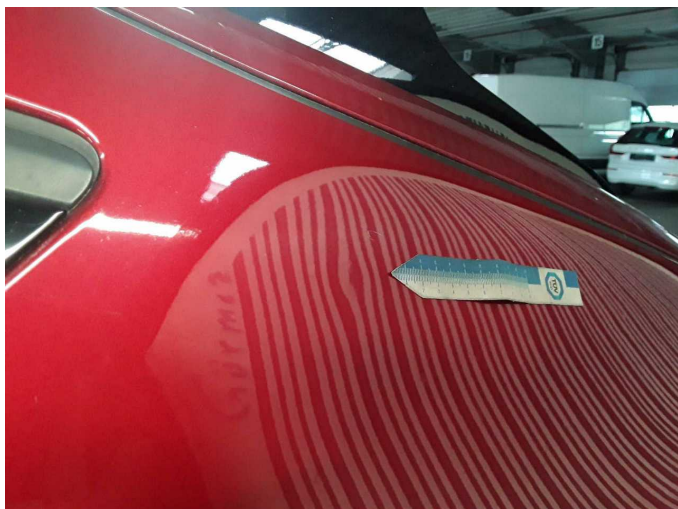
| No. | Component group | Description |
|---|---|---|
| 3 | Side panel - rear left side | Side panel - dent(s) - Smooth repair work |

**Damage 3:** Side panel - rear left side: Side panel - dent(s) - Smooth repair work

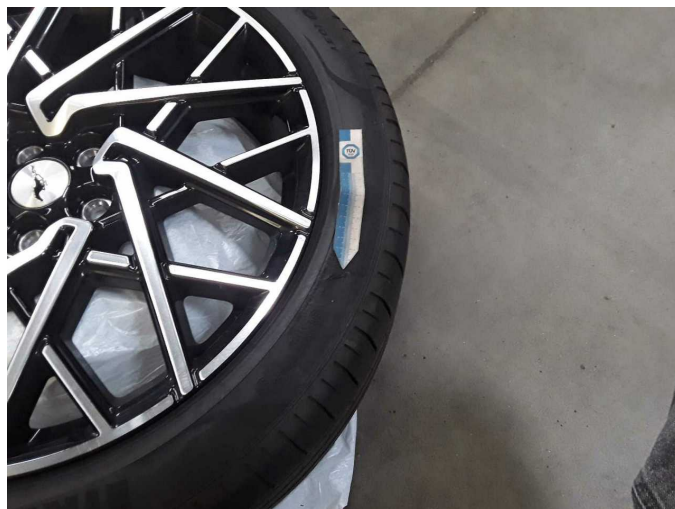
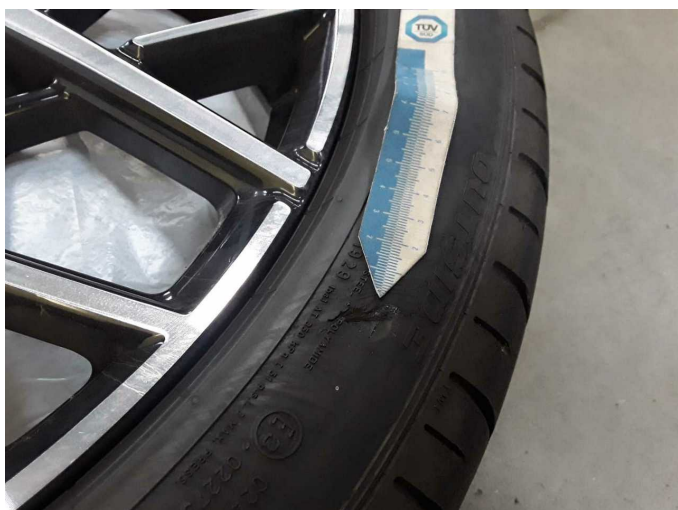
| No. | Component group | Description |
|---|---|---|
| 4 | 2nd wheel set | 1 tyre - Damaged - Replace |

**Damage 4:** 2nd wheel set: 1 tyre - Damaged - Replace

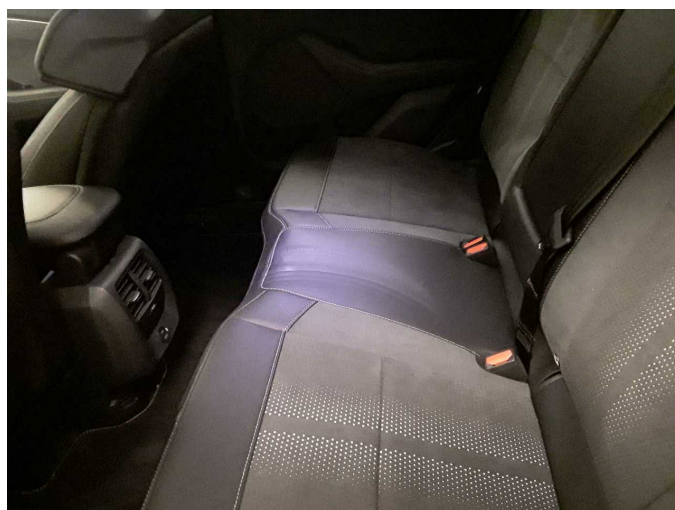
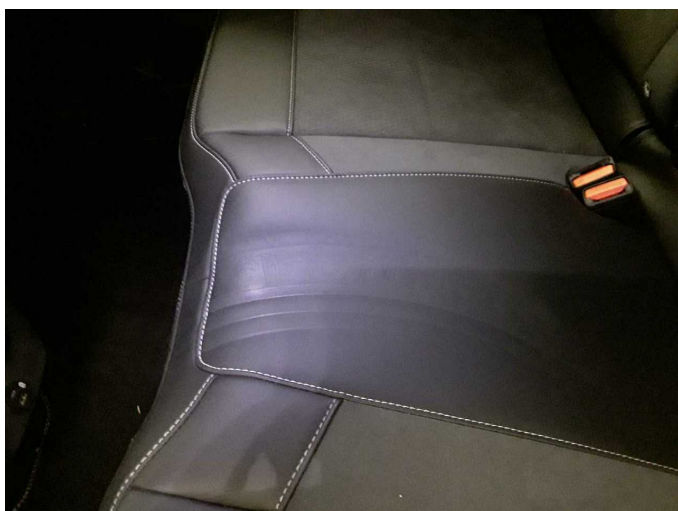
| No. | Component group | Description |
|---|---|---|
| 5 | Seat - rear | Backrest cover - 2nd row (Druckstellen) - Damaged - Loss in value |

**Damage 5:** Seat - rear: Backrest cover - 2nd row (Druckstellen) - Damaged - Loss in value

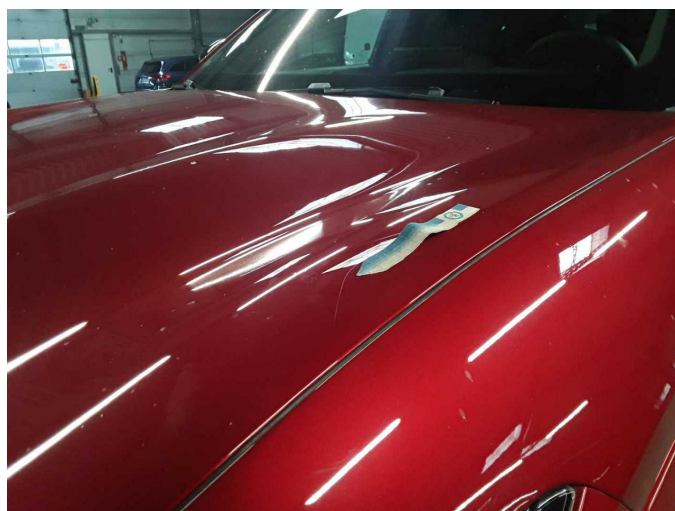
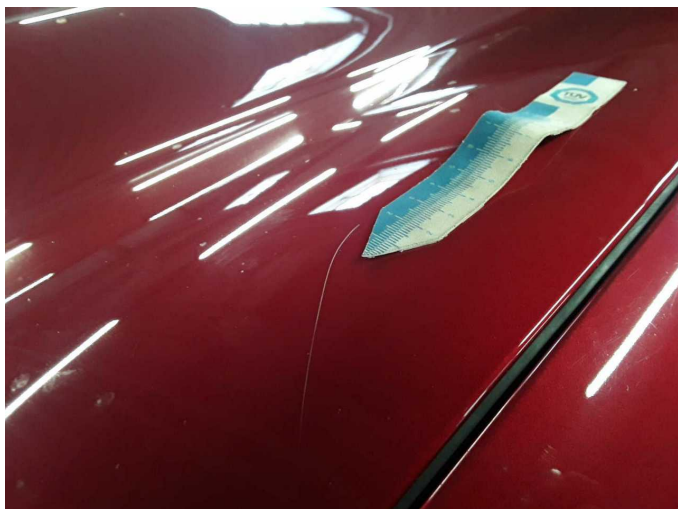
| No. | Component group | Description |
|---|---|---|
| 6 | Bonnet | Bonnet - Scratch(es) - Paint |

**Damage 6:** Bonnet: Bonnet - Scratch(es) - Paint
