Expertise

Protocol number: 46454398  
Order No. / Reference: 26692429  
Inspection date: 9 Jul 2026

Manufacturer: Mercedes-Benz

Model: Vito 119 CDI Extralang HA Aut. PRO

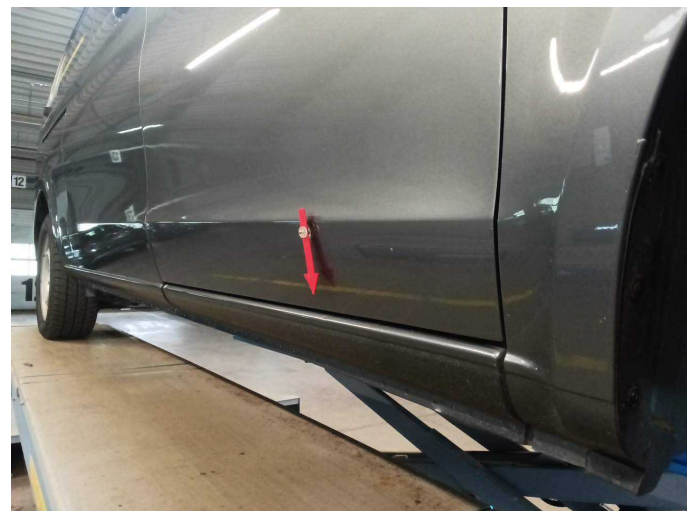
| No. | Component group | Description |
|---|---|---|
| 1 | Sill - right side | Sill - dent(s) - Smooth repair work |

Damage 1: Sill - right side: Sill - dent(s) - Smooth repair work

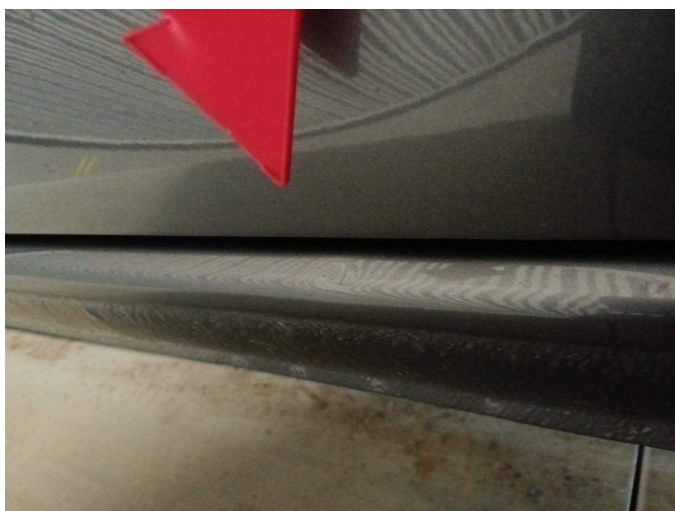
Damage 1: Sill - right side: Sill - dent(s) - Smooth repair work

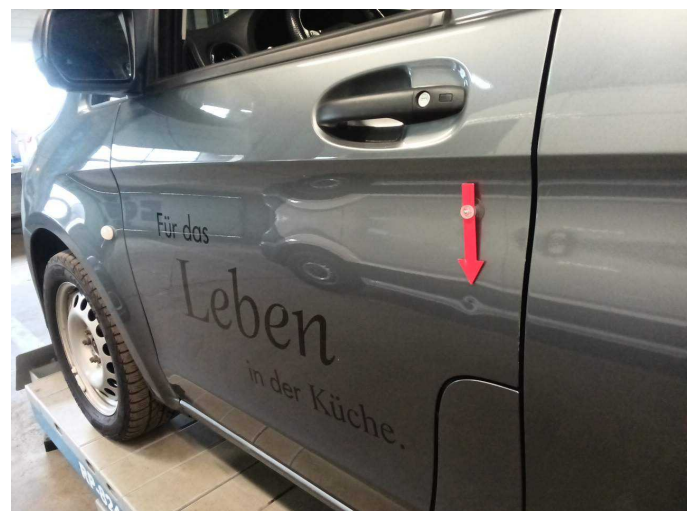
| No. | Component group | Description |
|---|---|---|
| 2 | Door - front left side | Door - dent(s) - Smooth repair work |

Damage 2: Door - front left side: Door - dent(s) - Smooth repair work

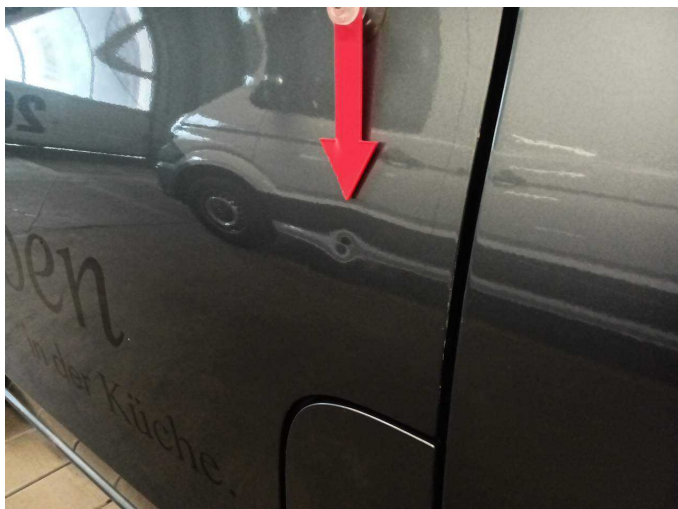
**Damage 2:** Door - front left side: Door - dent(s) - Smooth repair work

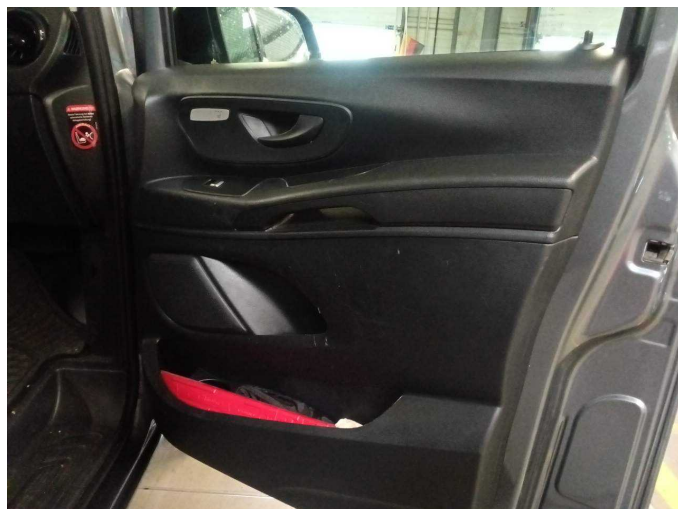
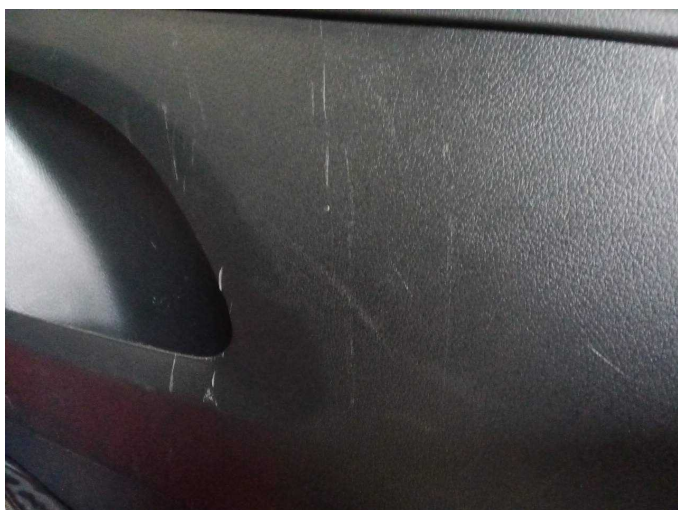
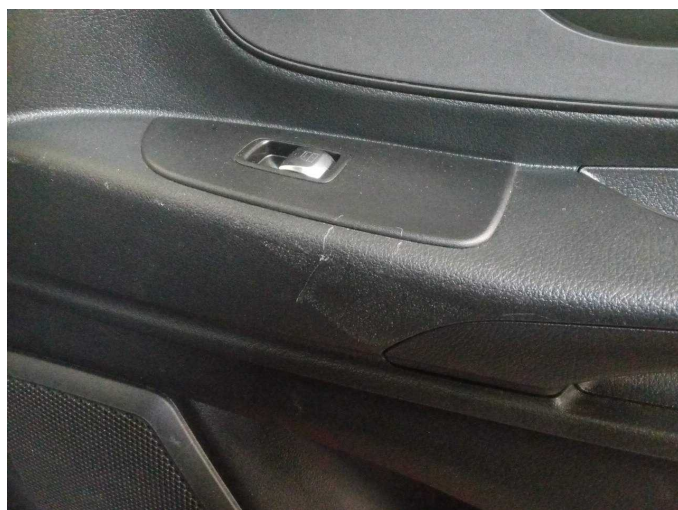
| No. | Component group | Description |
|---|---|---|
| 3 | Trim / covers | Door trim - front right side - Scratch(es) - Smart repair |

**Damage 3:** Trim / covers: Door trim - front right side - Scratch(es) - Smart repair

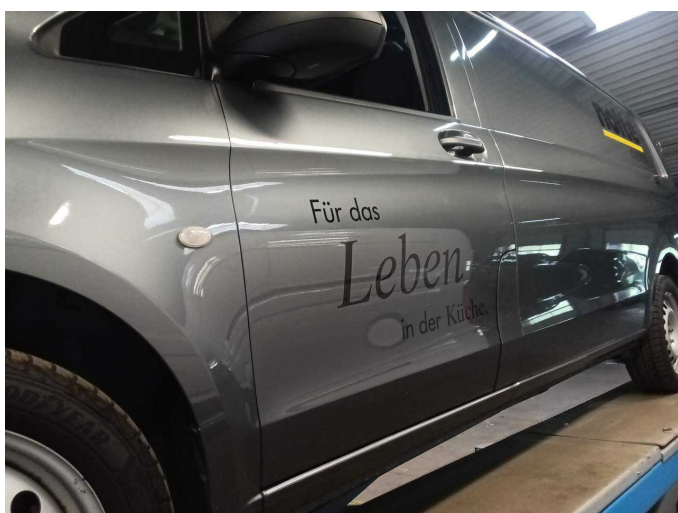
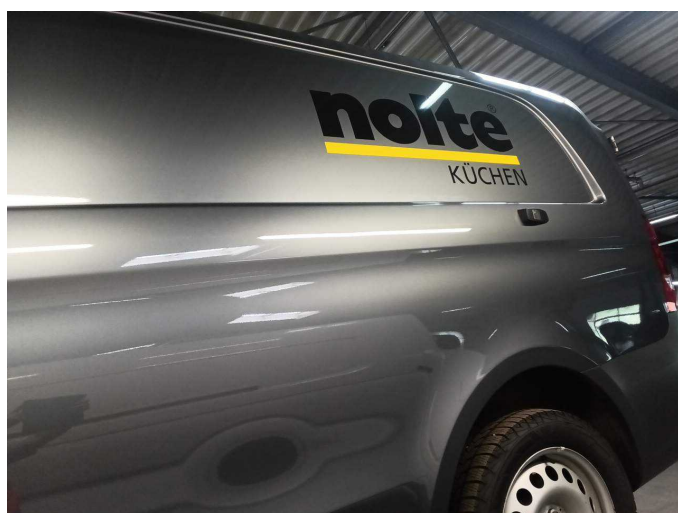
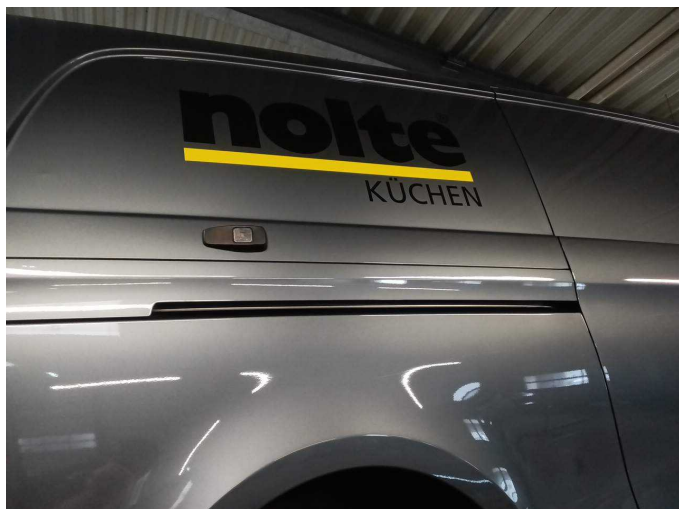
| No. | Component group | Description |
|---|---|---|
| 5 | Body | Body - Glued / labelled - Remove |

**Damage 5:** Body: Body - Glued / labelled - Remove

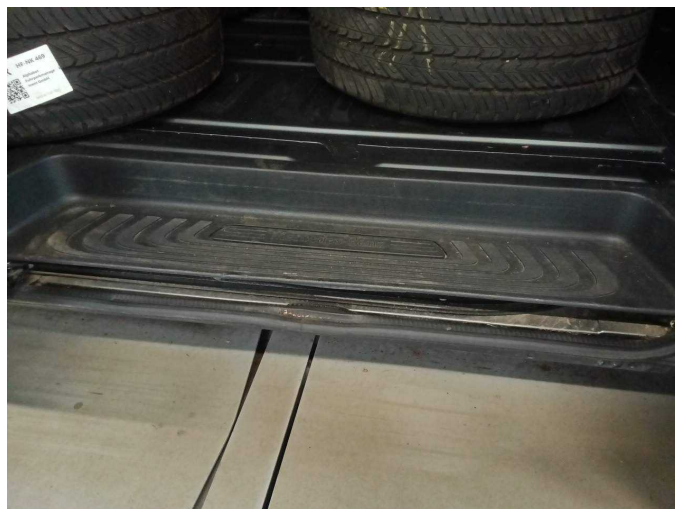
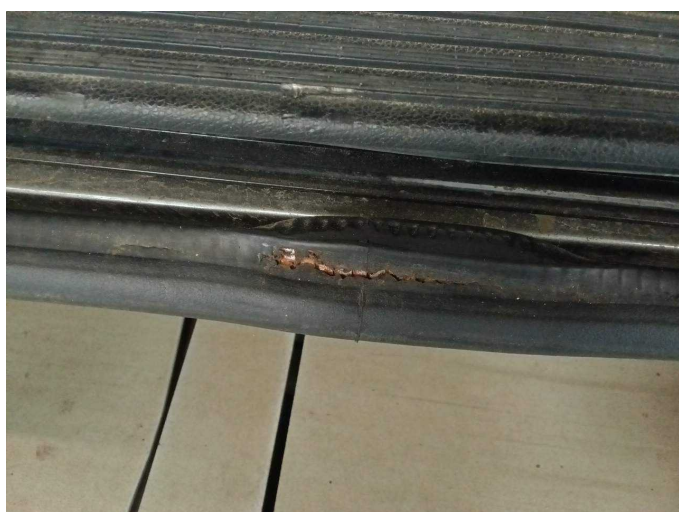
| No. | Component group | Description |
|---|---|---|
| 6 | Sliding door, right | Door seal - Damaged - Replace |

**Damage 6:** Sliding door, right: Door seal - Damaged - Replace

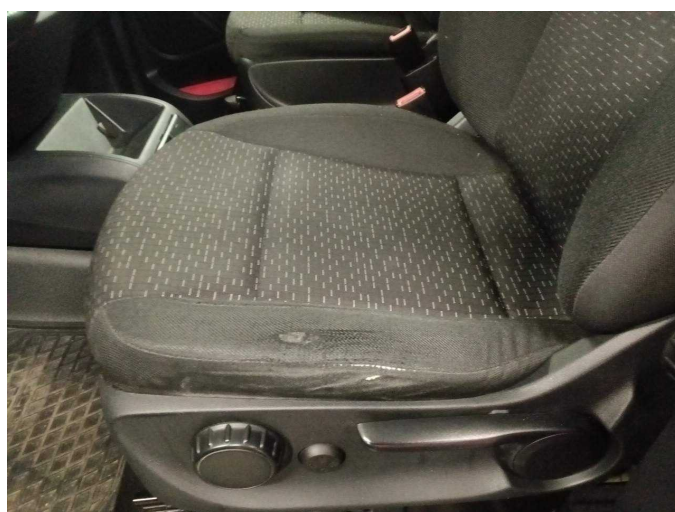
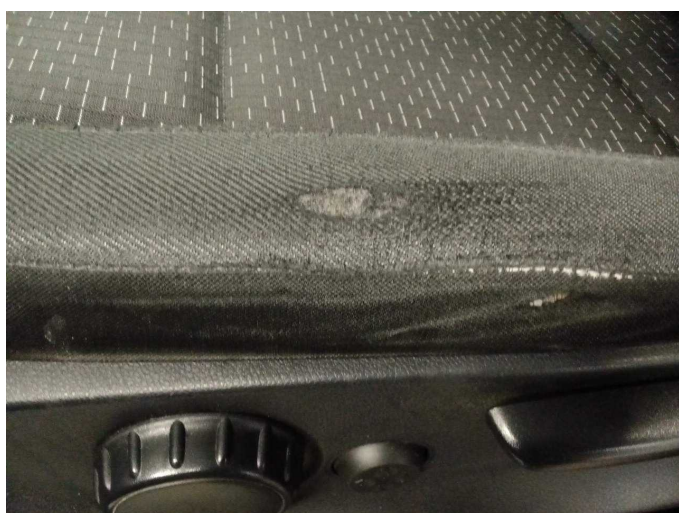
| No. | Component group | Description |
|---|---|---|
| 7 | Seat - front | Seat cover - left side - Damaged - Replace |

**Damage 7:** Seat - front: Seat cover - left side - Damaged - Replace

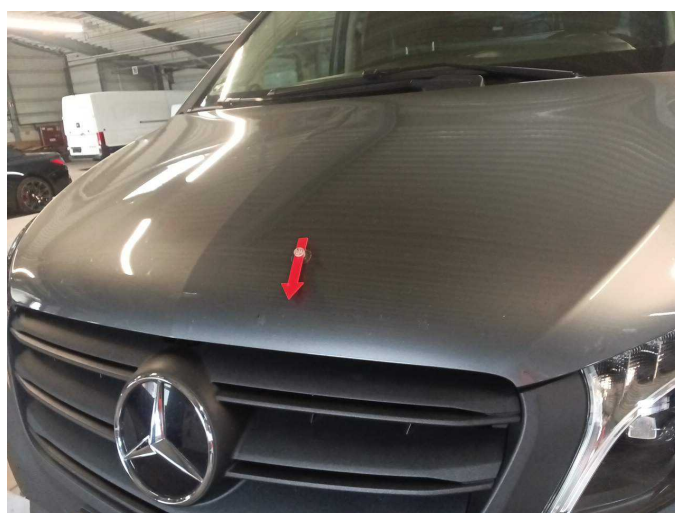
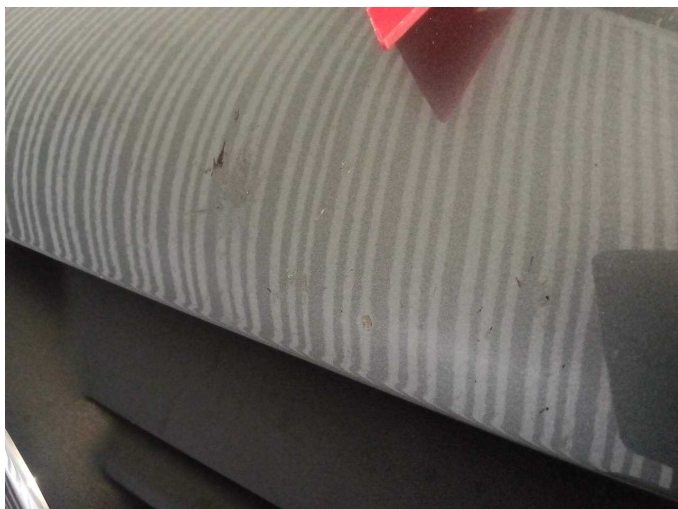
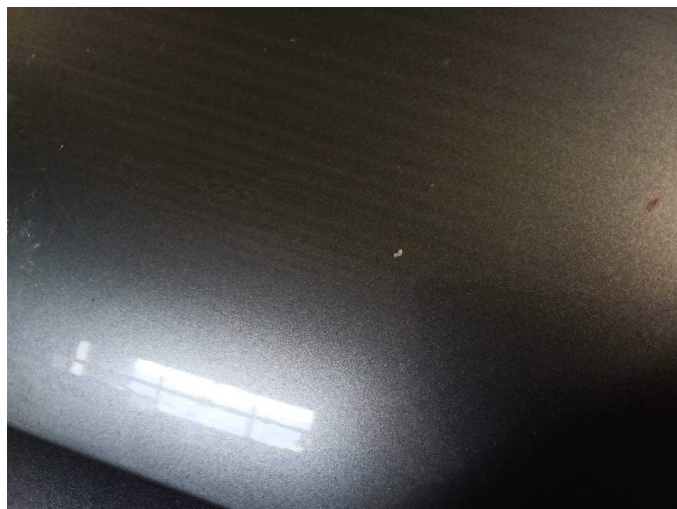
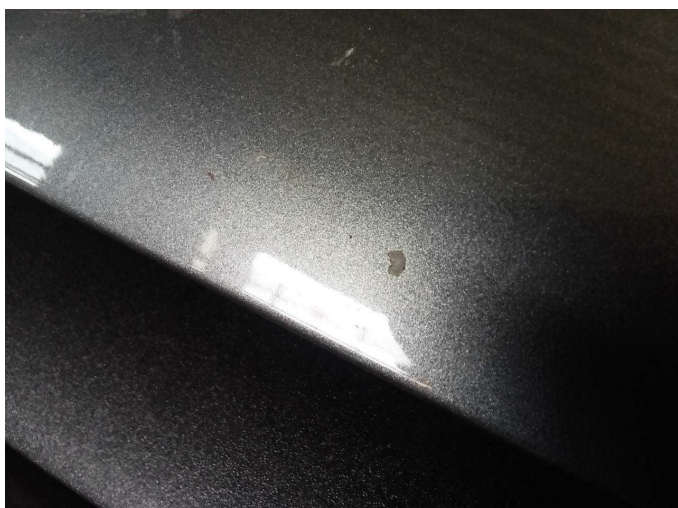
| No. | Component group | Description |
|---|---|---|
| 8 | Bonnet | Bonnet - Dent / paintcoat damage - Repair and paint |

**Damage 8:** Bonnet: Bonnet - Dent / paintcoat damage - Repair and paint

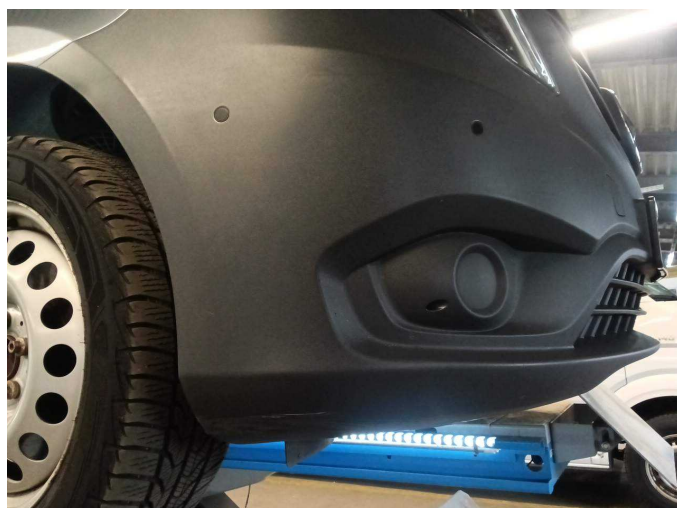
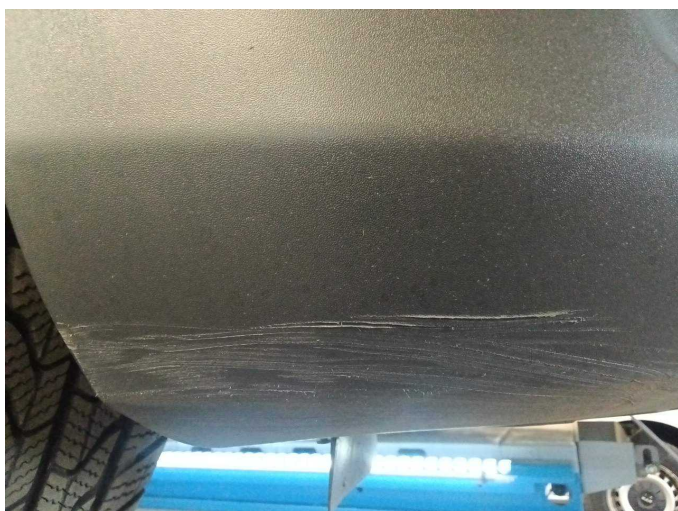
| No. | Component group | Description |
|---|---|---|
| 9 | Front bumper | Front bumper (unpainted) - Scratched - Replace |

**Damage 9:** Front bumper: Front bumper (unpainted) - Scratched - Replace

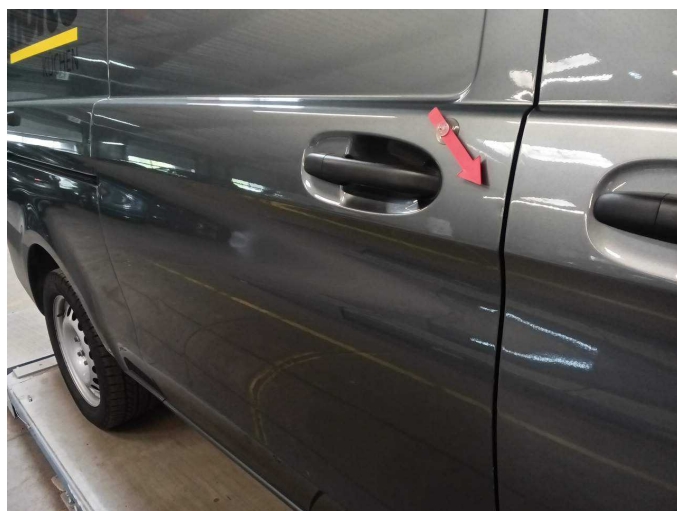
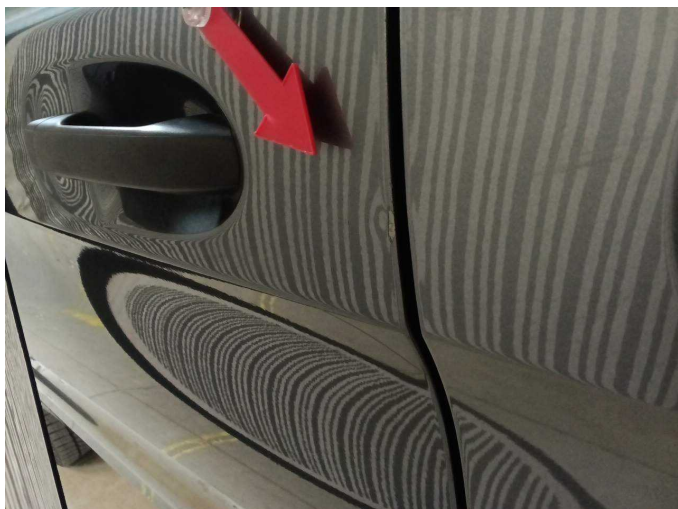
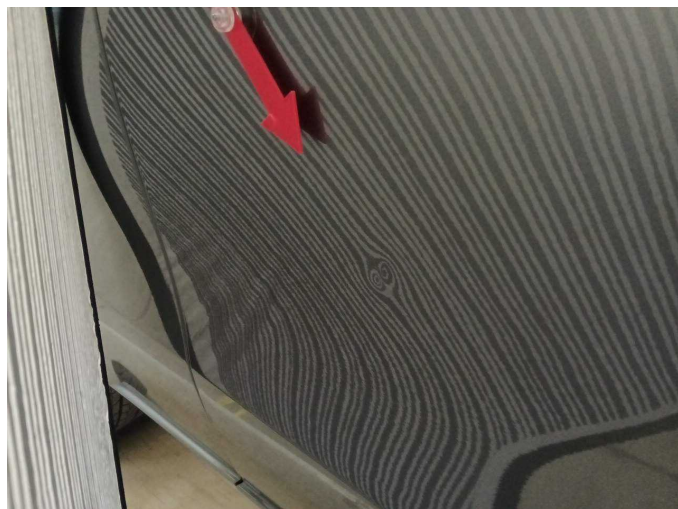
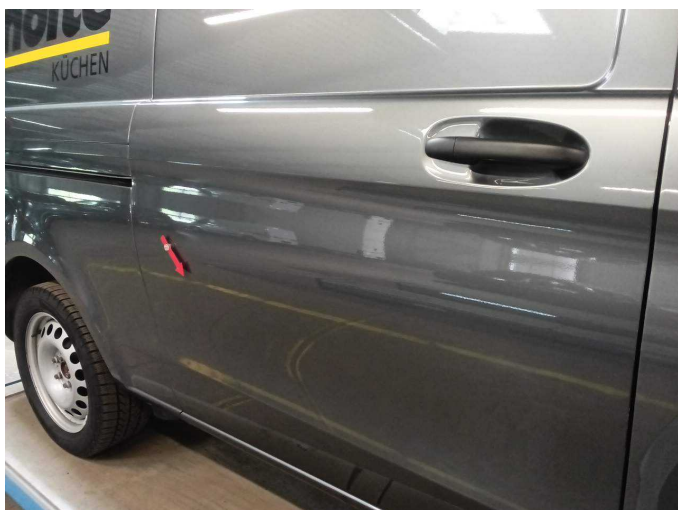
| No. | Component group | Description |
|---|---|---|
| 10 | Sliding door, right | Sliding door - Dent / paintcoat damage - Repair and paint |

**Damage 10:** Sliding door, right: Sliding door - Dent / paintcoat damage - Repair and paint

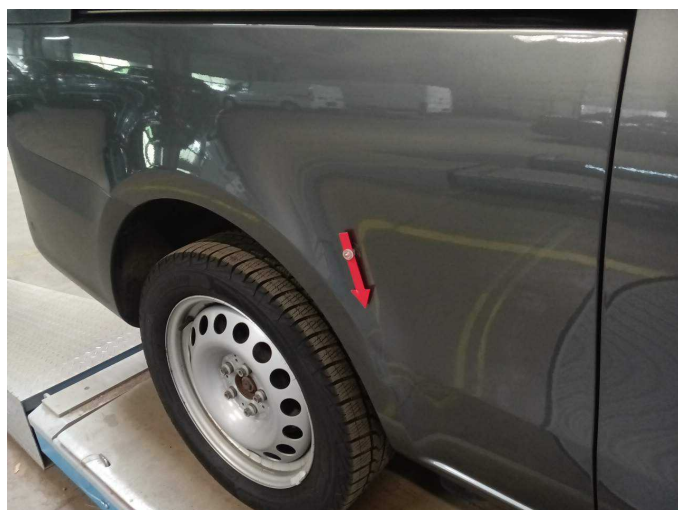
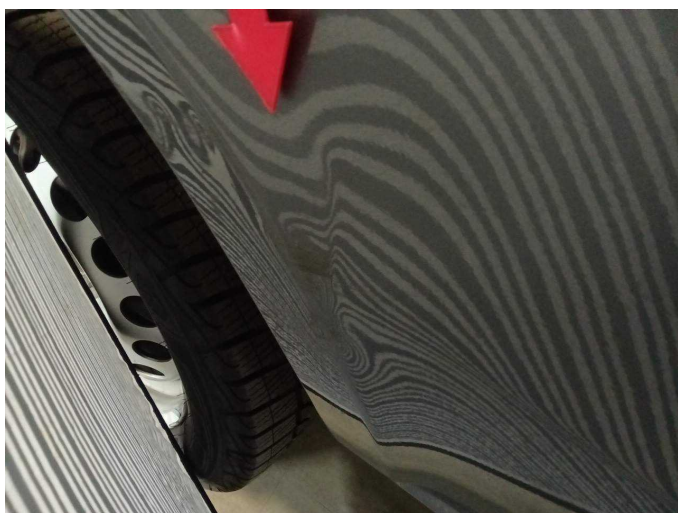
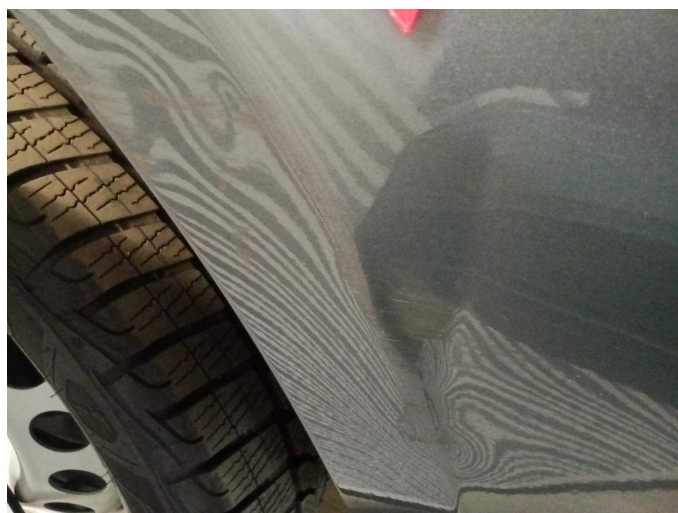
| No. | Component group | Description |
|---|---|---|
| 11 | Side panel - rear right side | Side panel - Dent / paintcoat damage - Repair and paint |

**Damage 11:** Side panel - rear right side: Side panel - Dent / paintcoat damage - Repair and paint

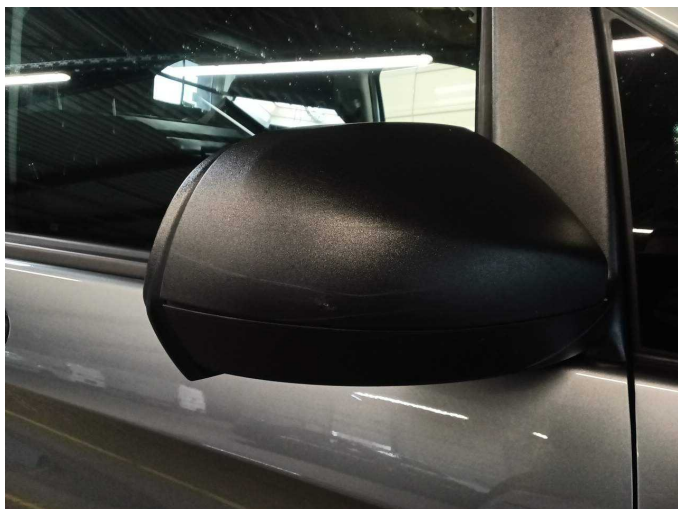
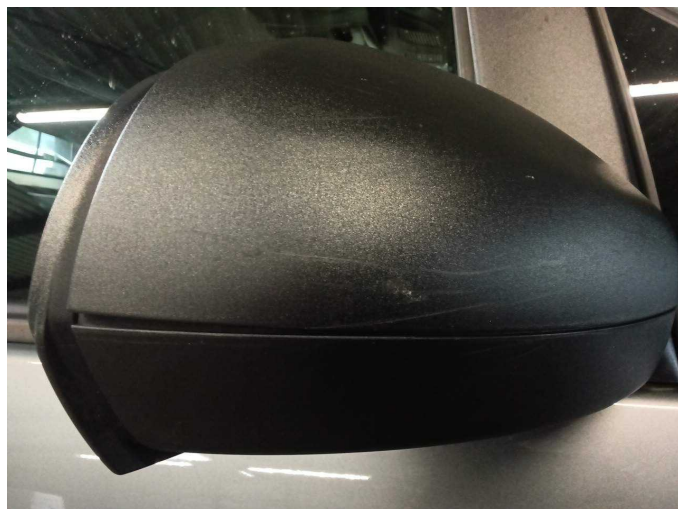
| No. | Component group | Description |
|---|---|---|
| 1 | Wing mirror - right side | Mirror housing - Scratch(es) - No deduction |

**Wear and tear 1:** Wing mirror - right side: Mirror housing - Scratch(es) - No deduction

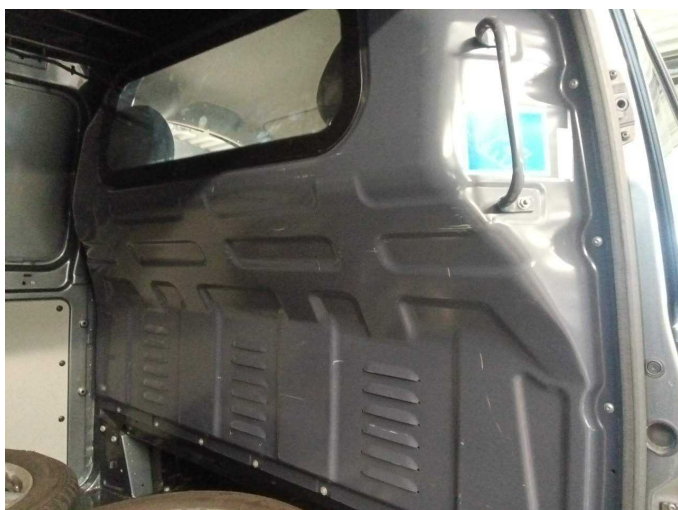
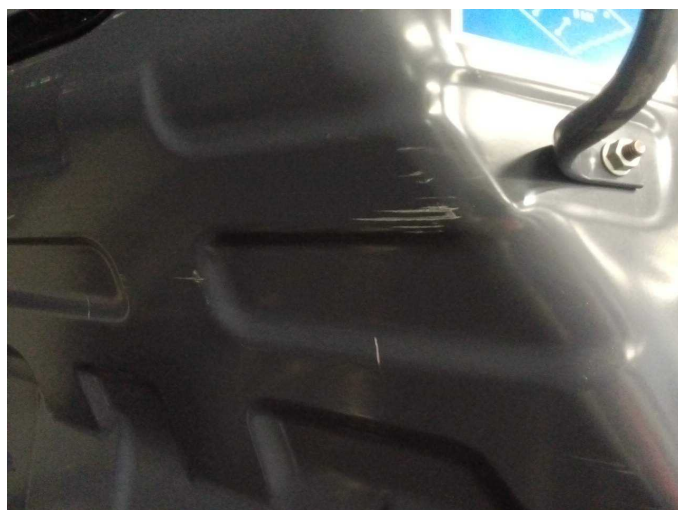
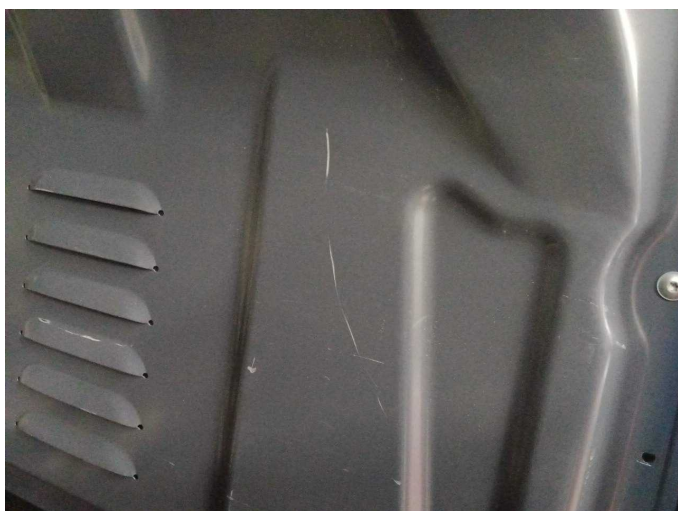
| No. | Component group | Description |
|---|---|---|
| 2 | Interior | Separation net - Scratch(es) - No deduction |

**Wear and tear 2:** Interior: Separation net - Scratch(es) - No deduction

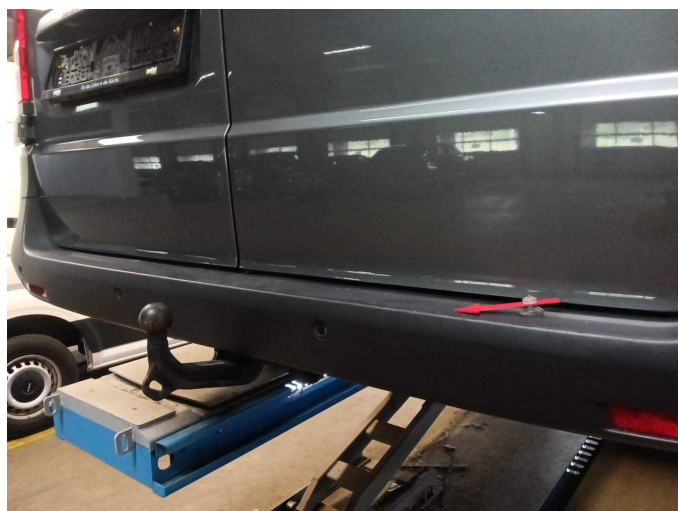
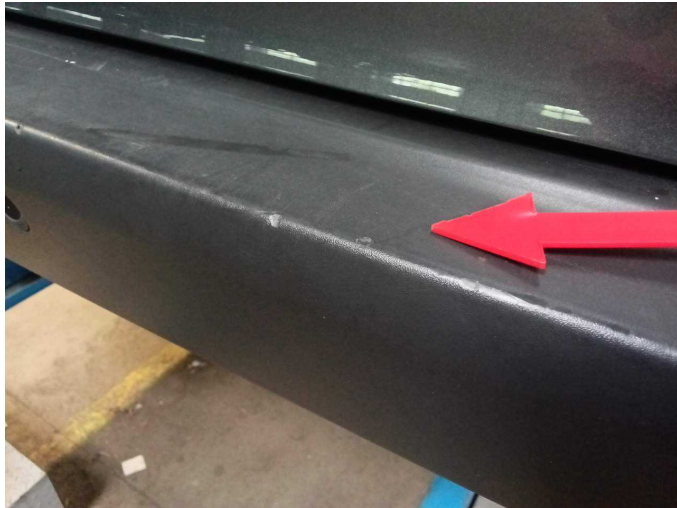
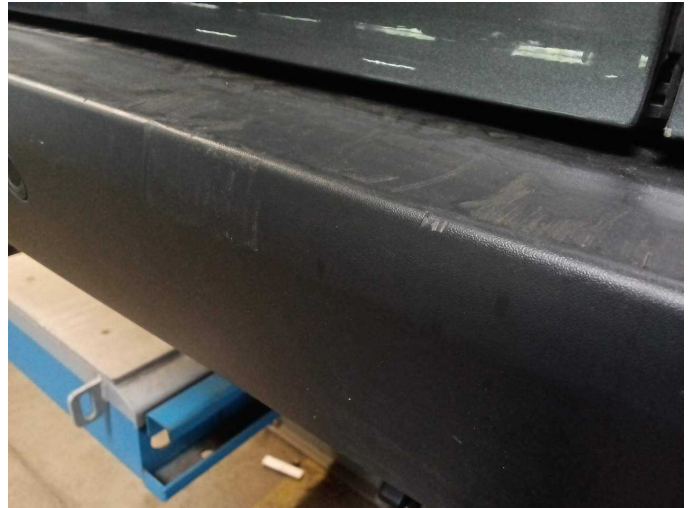
| No. | Component group | Description |
|---|---|---|
| 3 | Rear bumper | Rear bumper (unpainted) - Scratch(es) - No deduction |

**Wear and tear 3:** Rear bumper: Rear bumper (unpainted) - Scratch(es) - No deduction

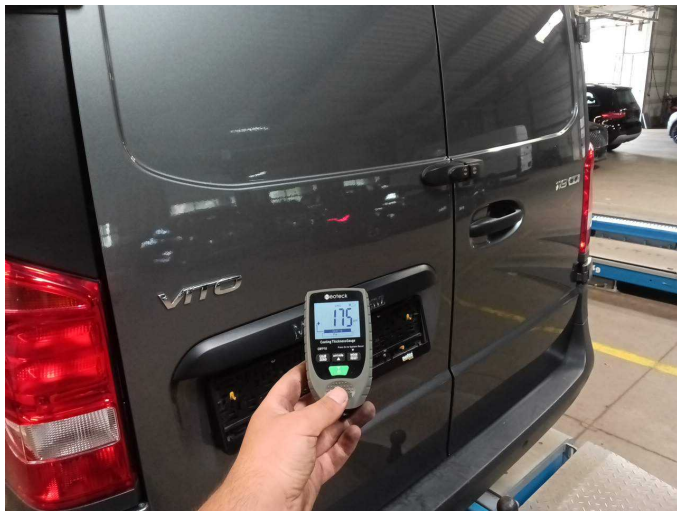
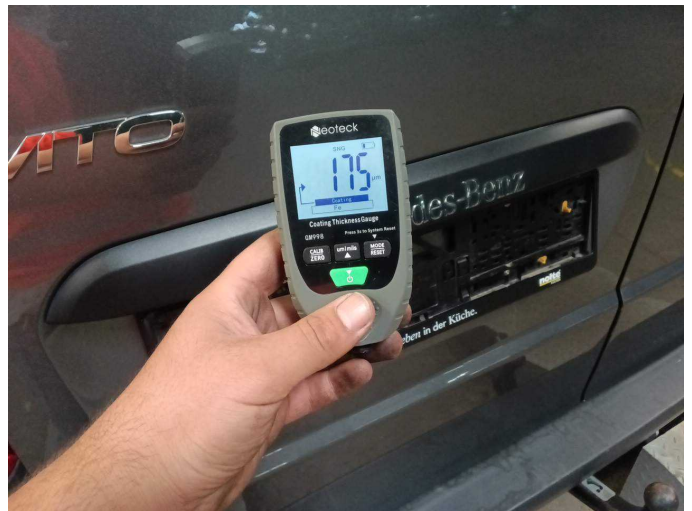
**Boot lid / rear door:** 175 µm

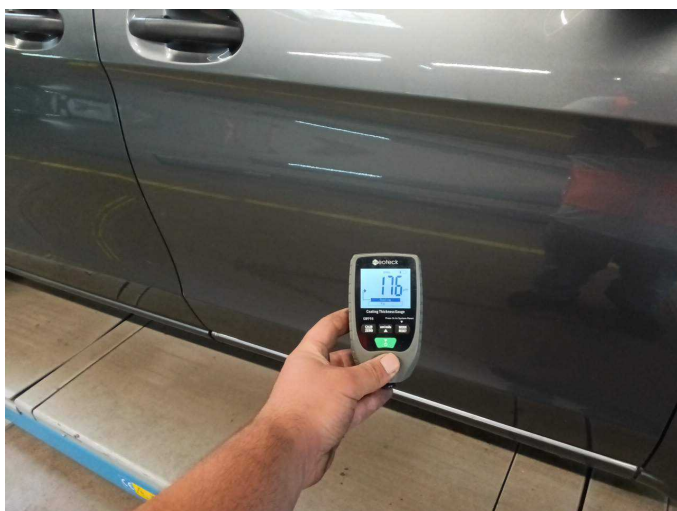
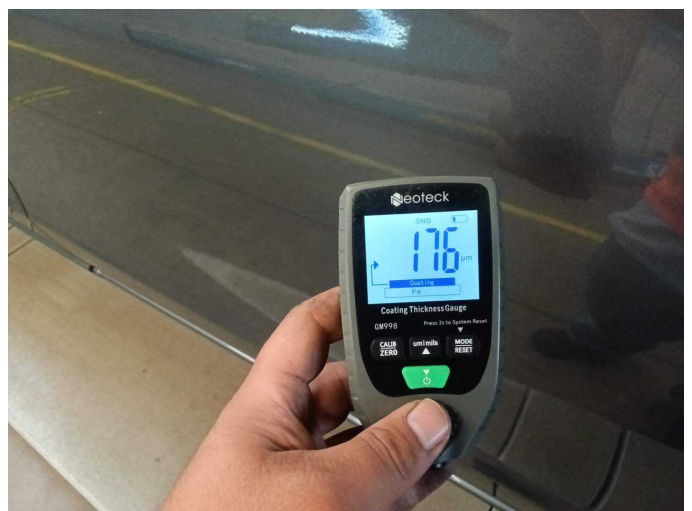
**Door - front right side:** 176 µm
