Expertise

Protocol number: 45946306
Order No. / Reference: 26435684
Inspection date: 11 Jun 2026

Model: Focus Turnier 2.0 EcoBlue Start-Stopp-System Aut.
COOL&CONNECT

VIN: WF0PXXGCHPLS78312

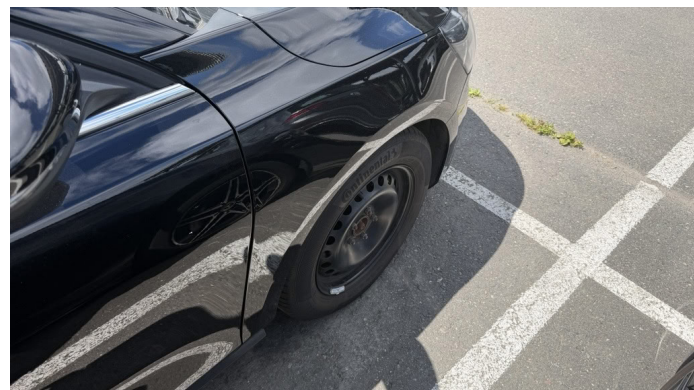
Damage 1: Wheel / tyres: Wheel cover - front right side - Missing - Replace

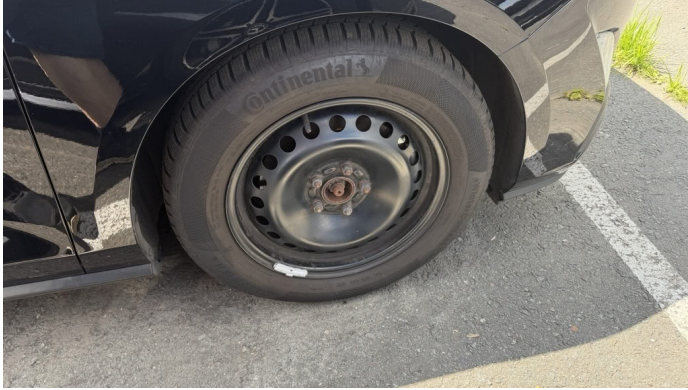
Damage 1: Wheel / tyres: Wheel cover - front right side - Missing - Replace

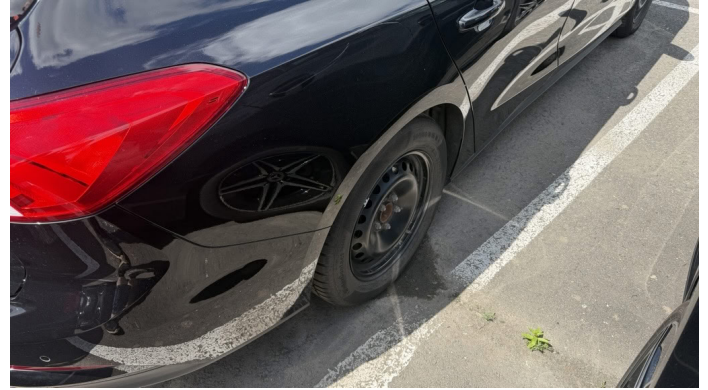
Damage 2: Wheel / tyres: Wheel cover - rear right side - Missing - Replace

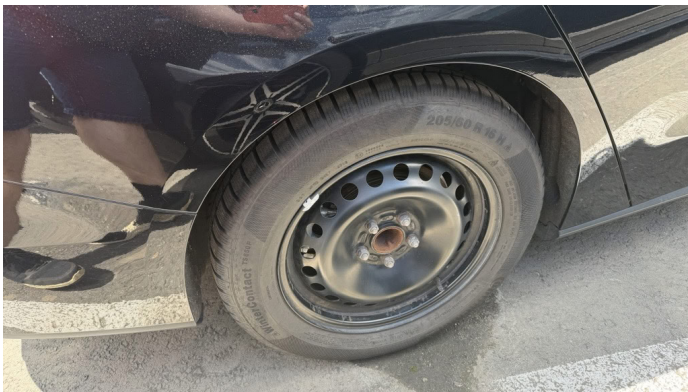
Damage 2: Wheel / tyres: Wheel cover - rear right side - Missing - Replace

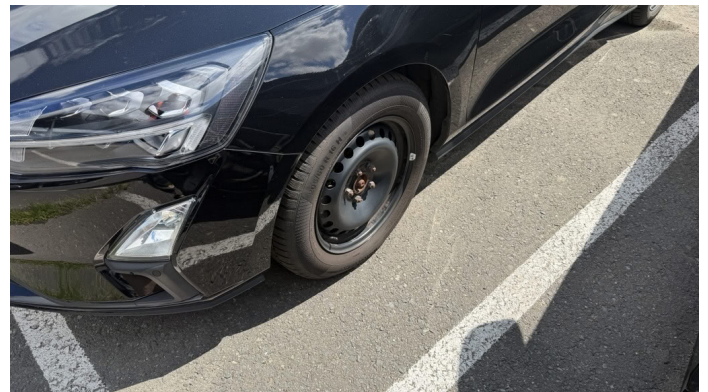
Damage 3: Wheel / tyres: Wheel cover - front left side - Missing - Replace

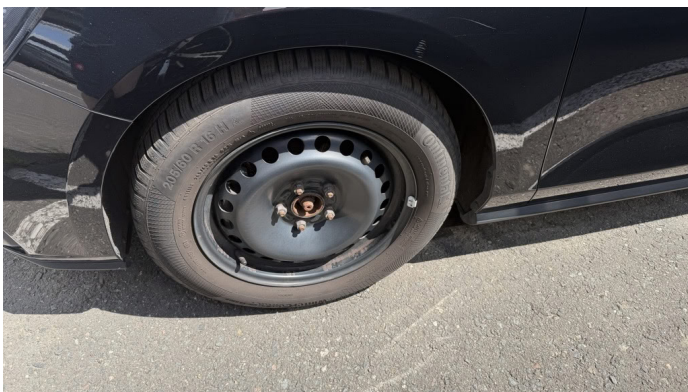
Damage 3: Wheel / tyres: Wheel cover - front left side - Missing - Replace

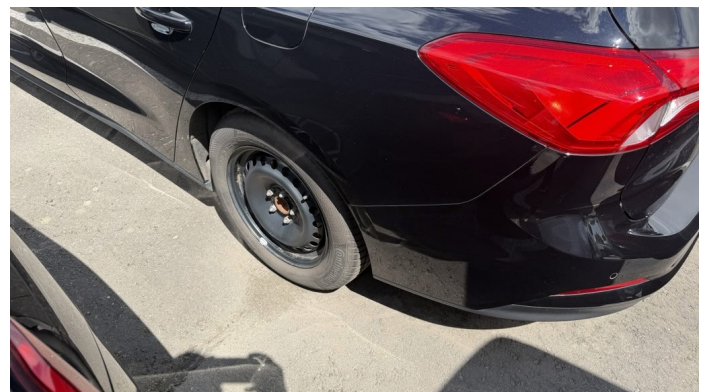
Damage 4: Wheel / tyres: Wheel cover - rear left side - Missing - Replace

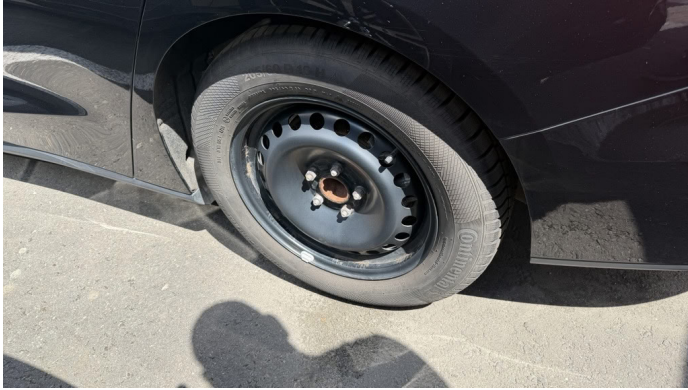
Damage 4: Wheel / tyres: Wheel cover - rear left side - Missing - Replace

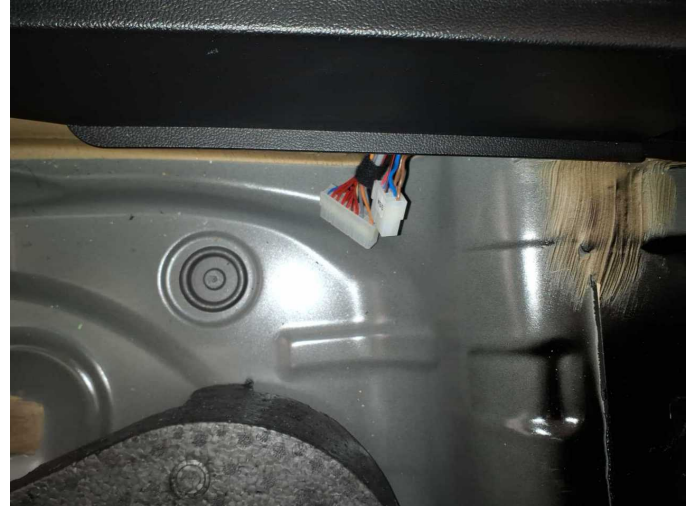
Damage 5: Electrical system: Cable strand (Kabelführung von Frontbereich in Laderaum) - Differs from the original configuration - Remove

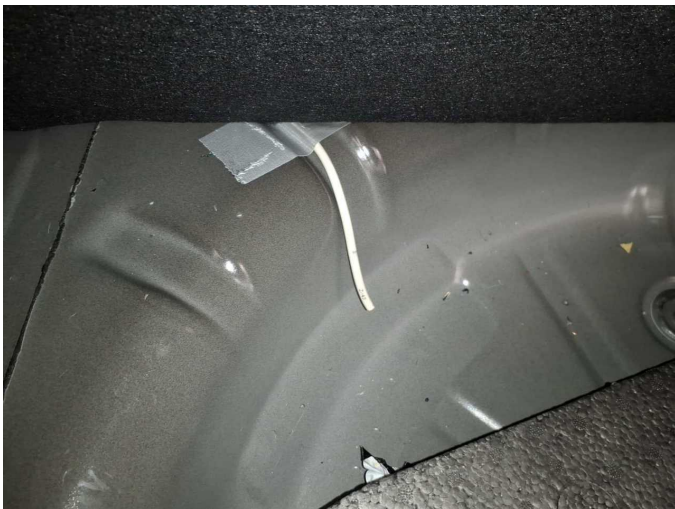
Damage 5: Electrical system: Cable strand (Kabelführung von Frontbereich in Laderaum) - Differs from the original configuration - Remove

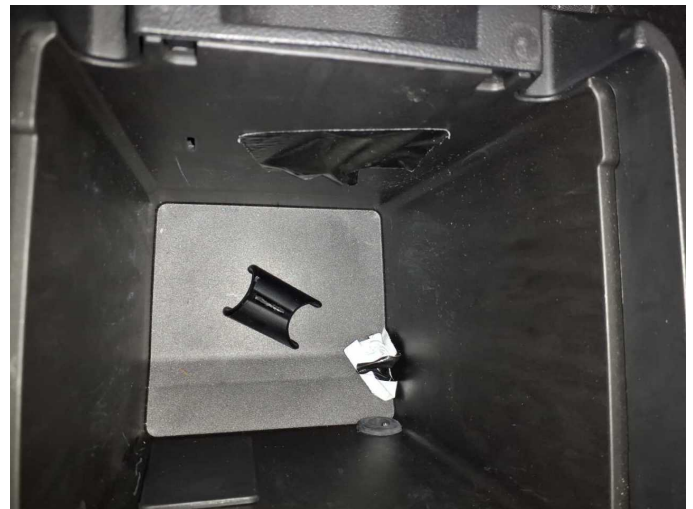
Damage 6: Interior: Arm rest, front (Deckel hinten, Fehlbohrungen) - Differs from the original configuration - Replace

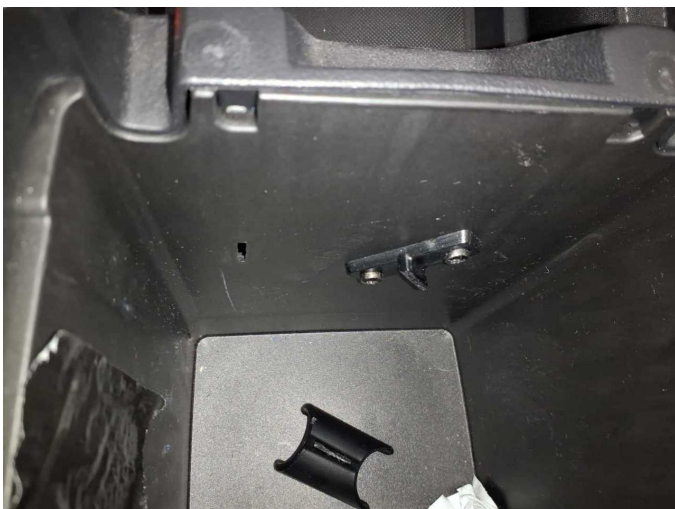
Damage 6: Interior: Arm rest, front (Deckel hinten, Fehlbohrungen) - Differs from the original configuration - Replace

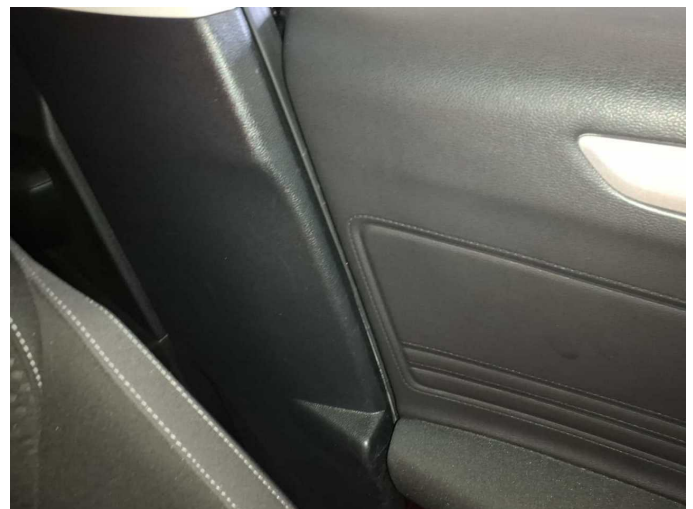
Damage 7: Trim / covers: B-pillar - trim - interior, left side (Fehlbohrungen) - Differs from the original configuration - Replace

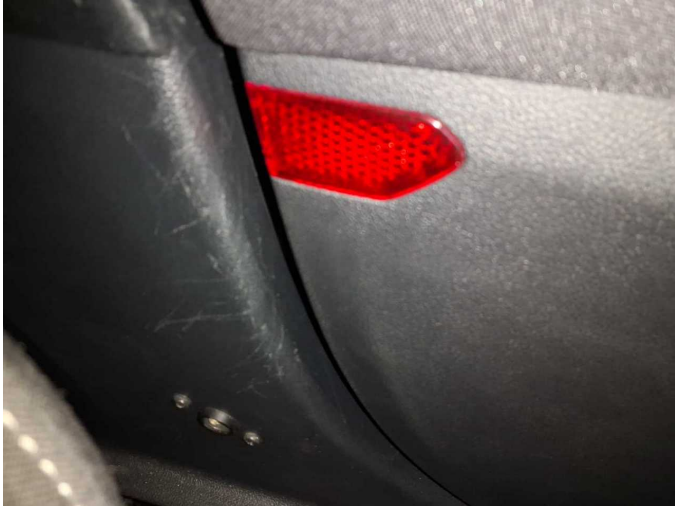
Damage 7: Trim / covers: B-pillar - trim - interior, left side (Fehlbohrungen) - Differs from the original configuration - Replace

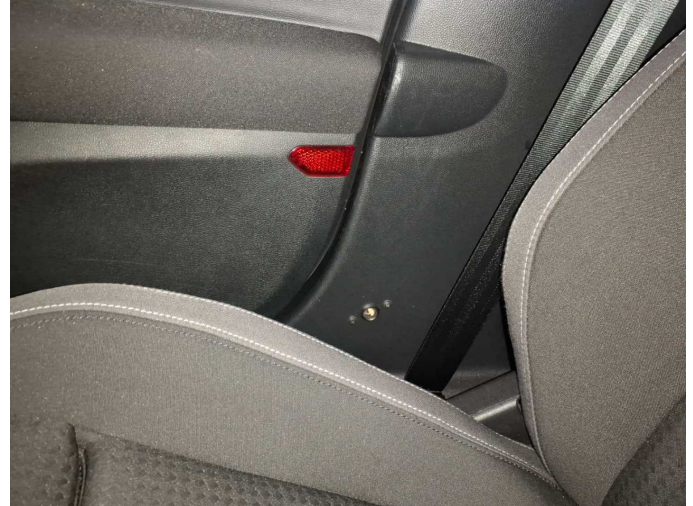
Damage 8: Trim / covers: B-pillar - trim - interior, right side (Fehlbohrungen) - Differs from the original configuration - Replace

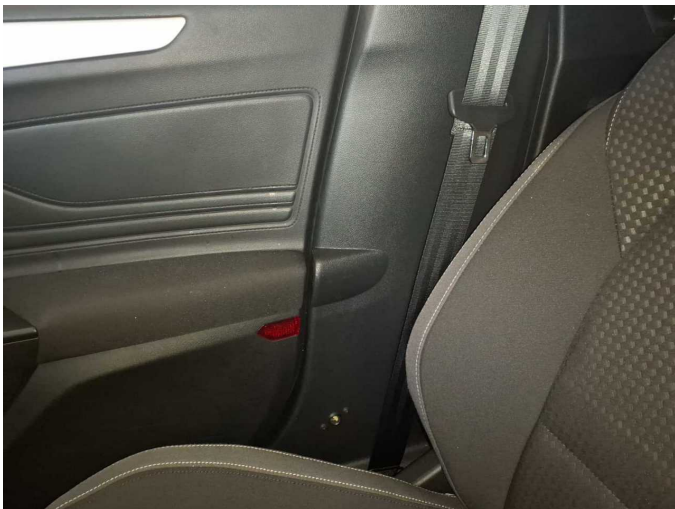
Damage 8: Trim / covers: B-pillar - trim - interior, right side (Fehlbohrungen) - Differs from the original configuration - Replace

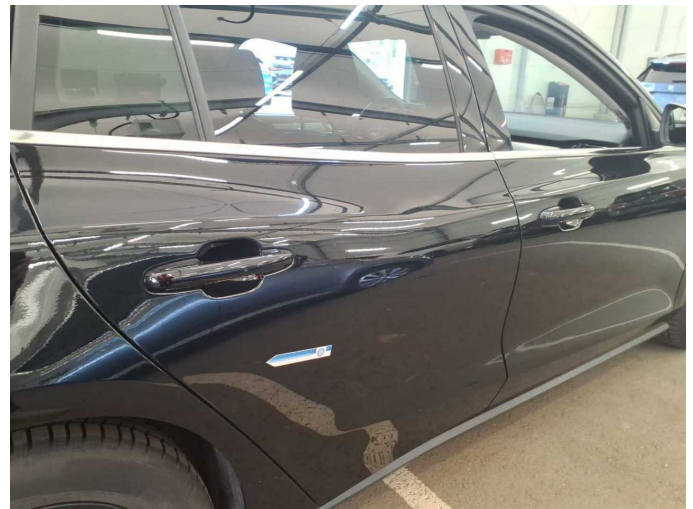
Damage 9: Door - rear right side: Door - Scratch(es) - Smart repair

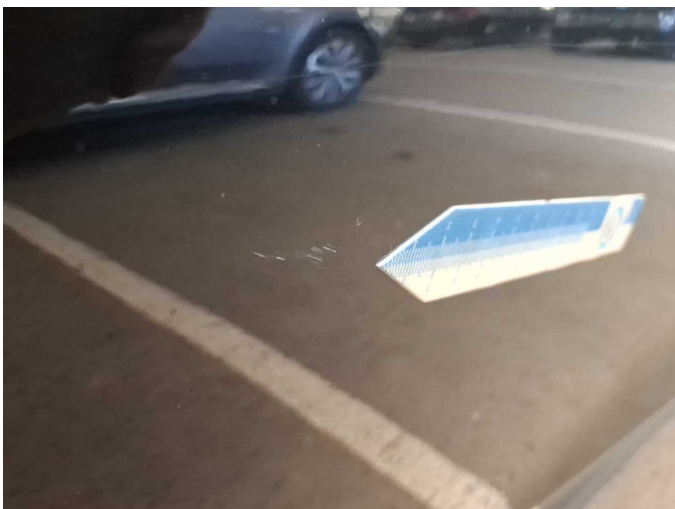
Damage 9: Door - rear right side: Door - Scratch(es) - Smart repair

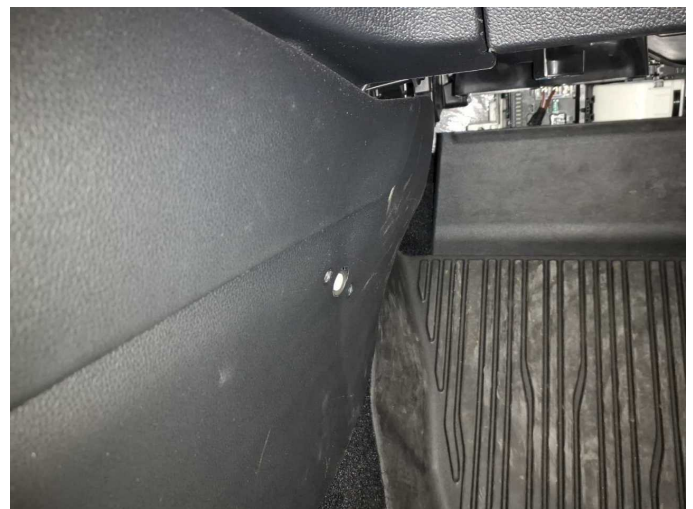
Damage 10: Instrument panel: Centre console - front (Blende Rechts, Fehlbohrungen) - Differs from the original configuration - Replace

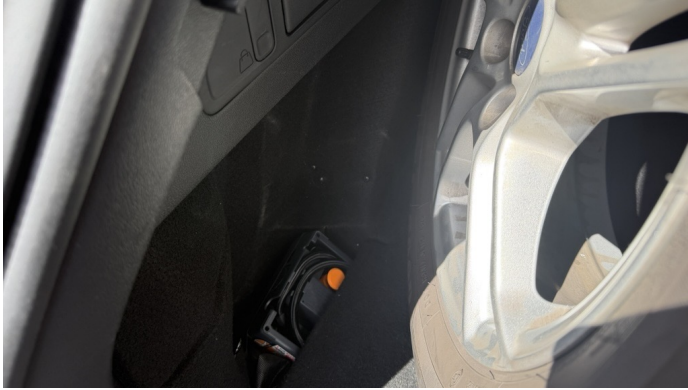
Damage 11: Trim / covers: Cargo area - lining -left side - Differs from the original configuration - Replace

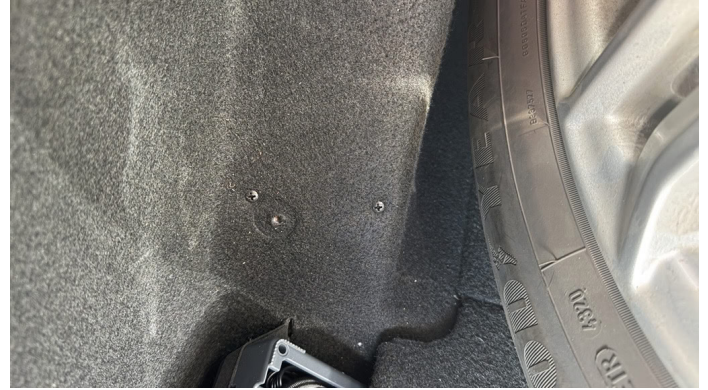
Damage 11: Trim / covers: Cargo area - lining -left side - Differs from the original configuration - Replace

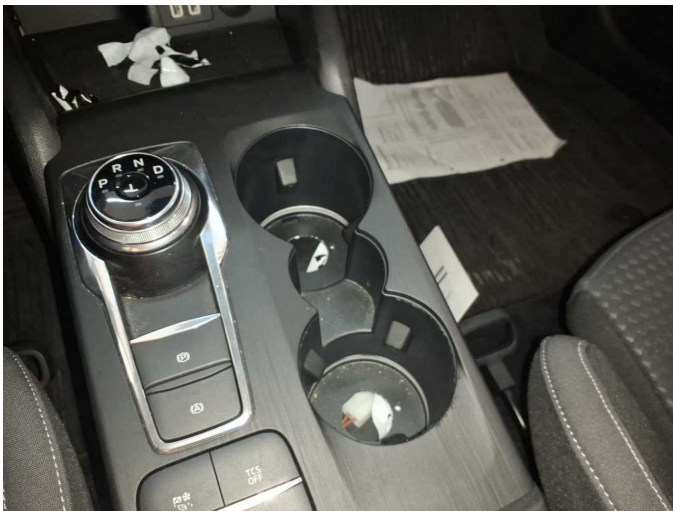
Damage 12: Instrument panel: Centre console - front (Getränkehalter, Fehlbohrungen) - Differs from the original configuration - Replace

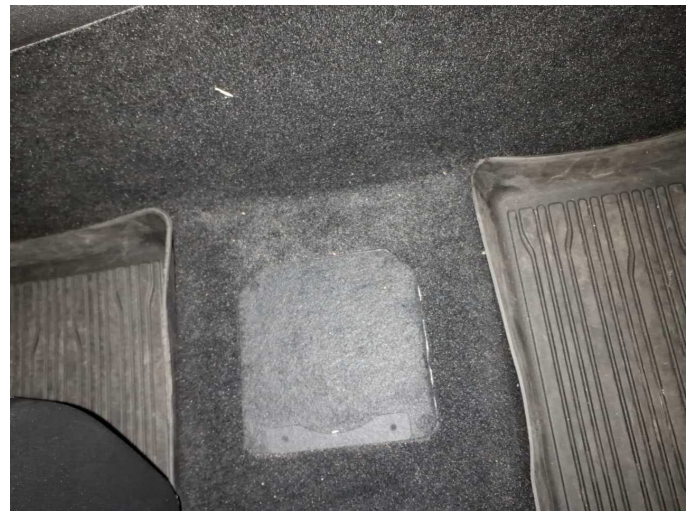
Damage 13: Trim / covers: Carpet - Differs from the original configuration - Replace

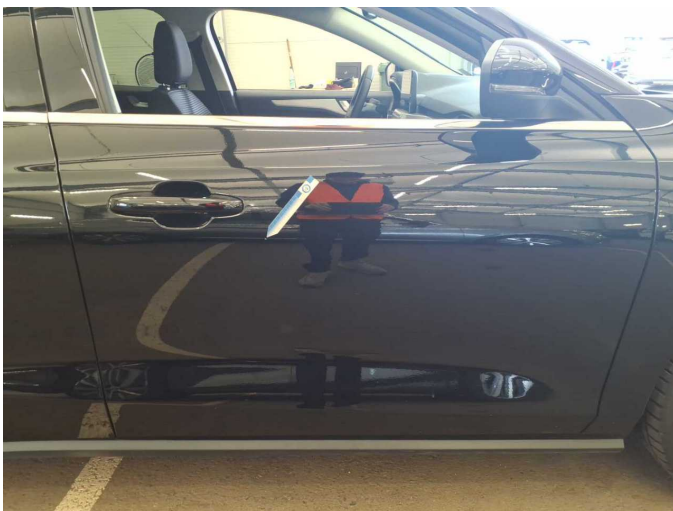
Damage 14: Door - front right side: Door - Scratch(es) - Paint

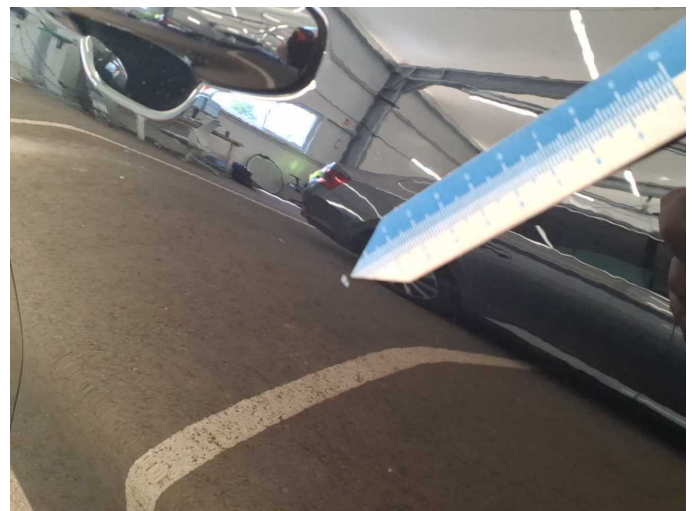
Damage 14: Door - front right side: Door - Scratch(es) - Paint

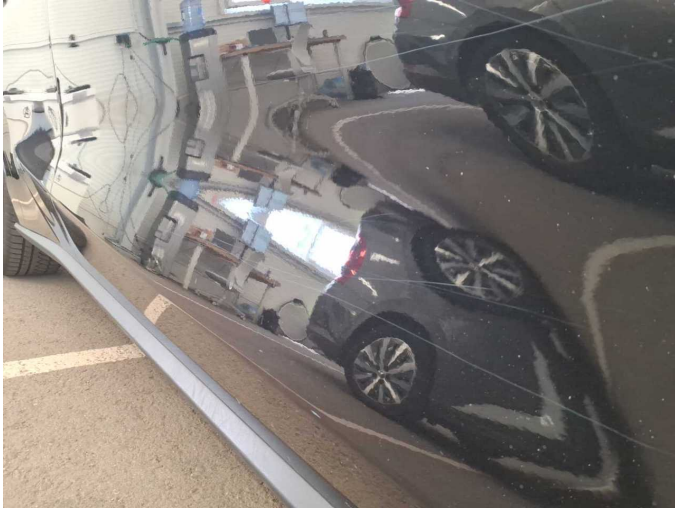
Damage 14: Door - front right side: Door - Scratch(es) - Paint

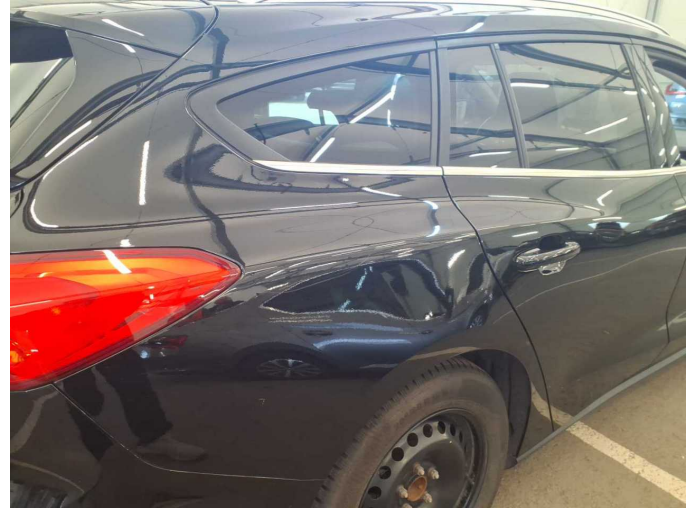
Damage 15: Side panel - rear right side: Side panel - Scratch(es) - Paint

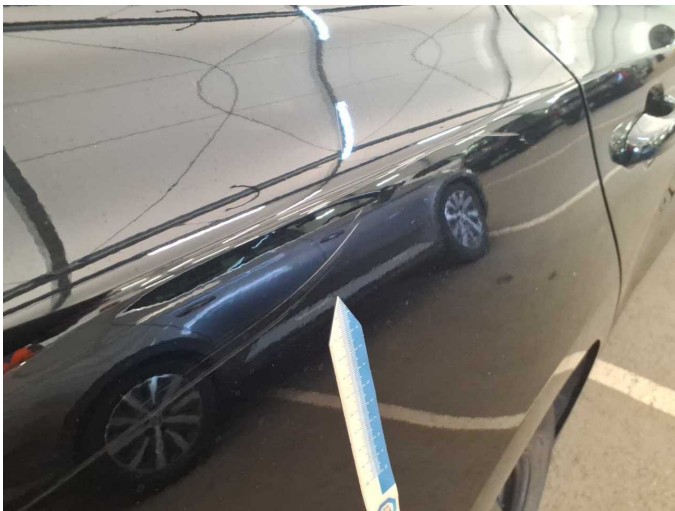
Damage 15: Side panel - rear right side: Side panel - Scratch(es) - Paint

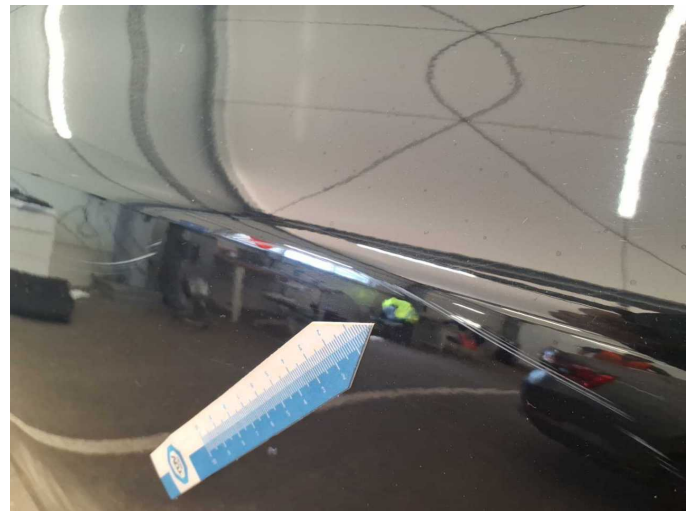
Damage 15: Side panel - rear right side: Side panel - Scratch(es) - Paint
