## IDENTIFICATION VEHICLE

Driver name:  
Make: POLESTAR  
Model / version: 2  
Vin: LPSVSEGEKNL072913  
Plate: 2BWF846  
Mileage: 72820  
SOH:  
First registration: 15/04/2022  
Color: Thunder (met)

## DAMAGES SUMMARY

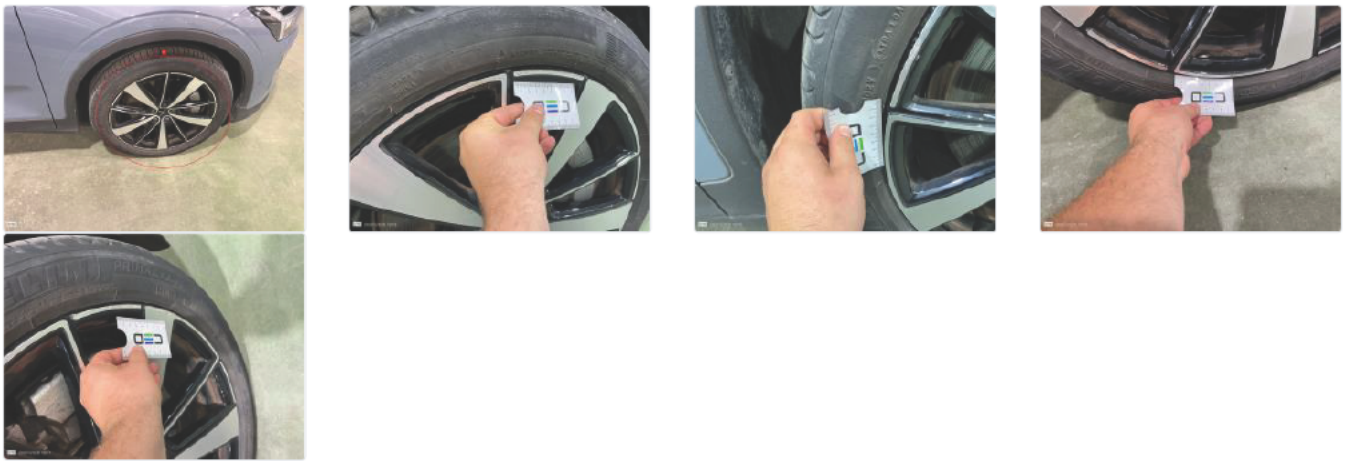
| # | Location | Damage type |
|---|---|---|
| 9 | Alloy rim FR polished | Grooved |

9 - Alloy rim FR polished - Grooved

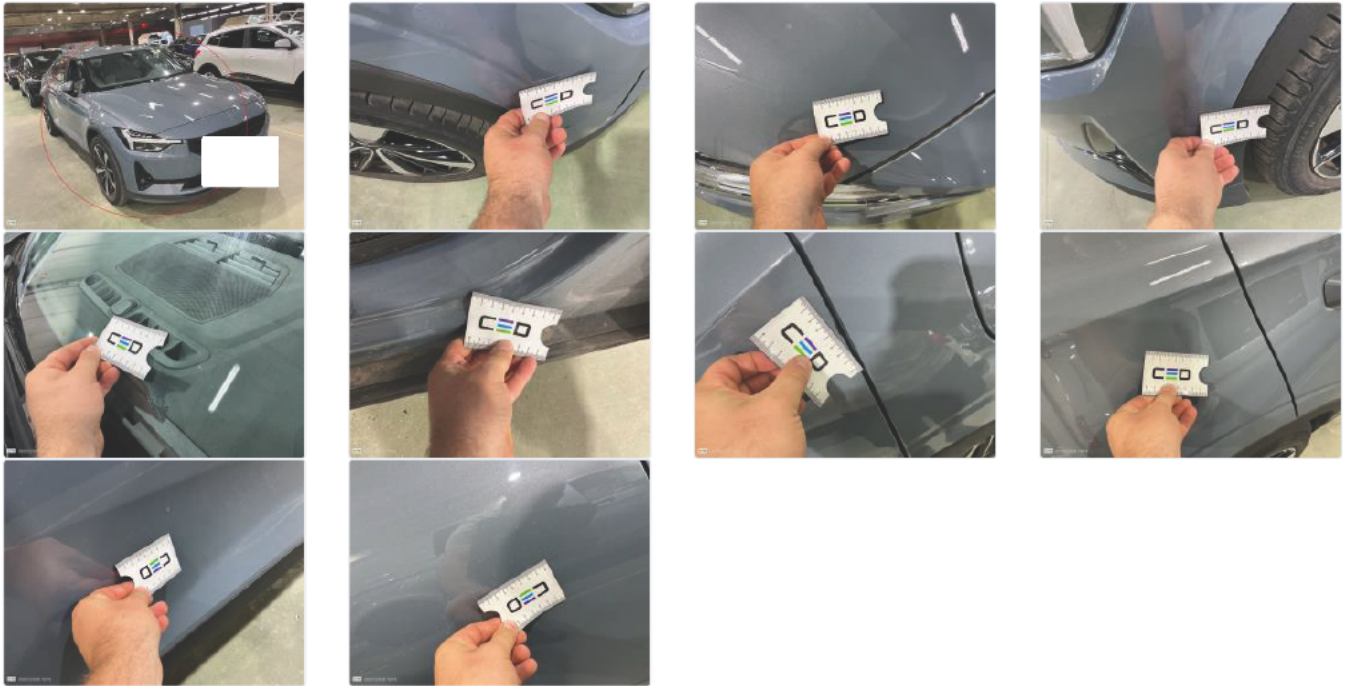
| # | Location | Damage type | Renta® | Repaired | Already invoiced |
|---|---|---|---|---|---|
| 4 | Bodywork | Dent(s) and scratch(es) | ✓ | ✗ | ✗ |

4 - Bodywork - Dent(s) and scratch(es) - Renta®
