## Expertise

Protocol number: 45512544  
Order No. / Reference: 26367000  
Inspection date: 18 May 2026

Manufacturer: Opel

Model: Astra Sports Tourer 1.5 D Automatik Business Edition

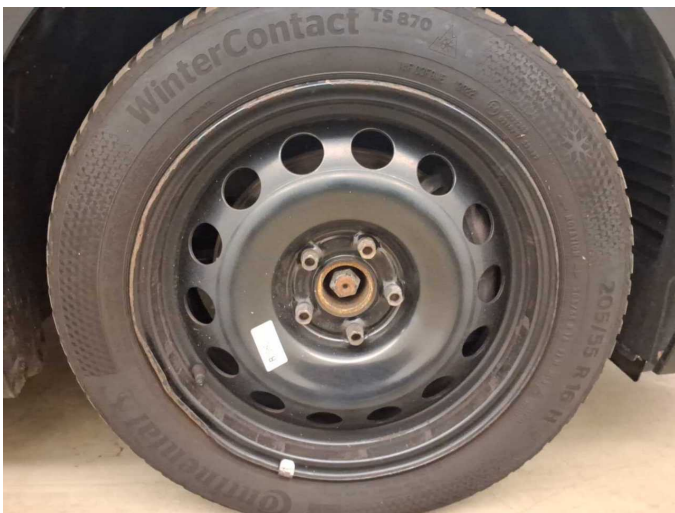
Damage 1: Wheel / tyres: Wheel cover - front right side - Missing - Replace

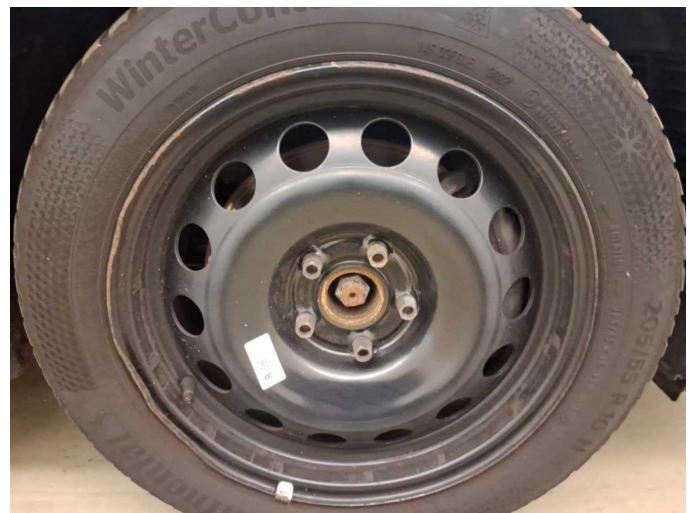
Damage 2: Wheel / tyres: Wheel rim - front right side - Deformed - Replace

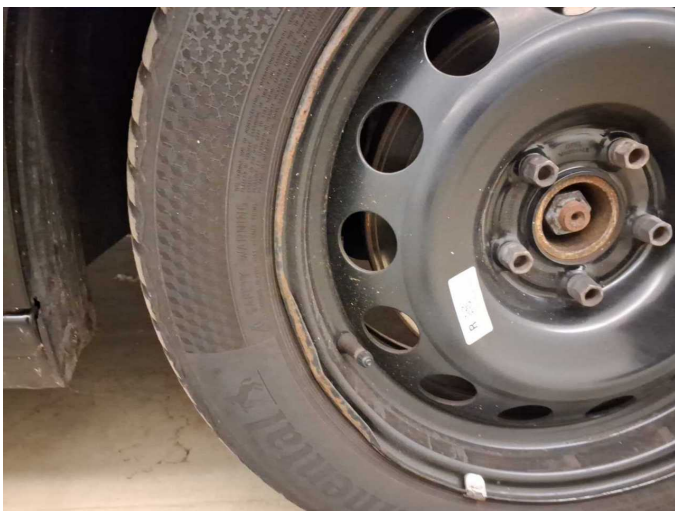
Damage 2: Wheel / tyres: Wheel rim - front right side - Deformed - Replace

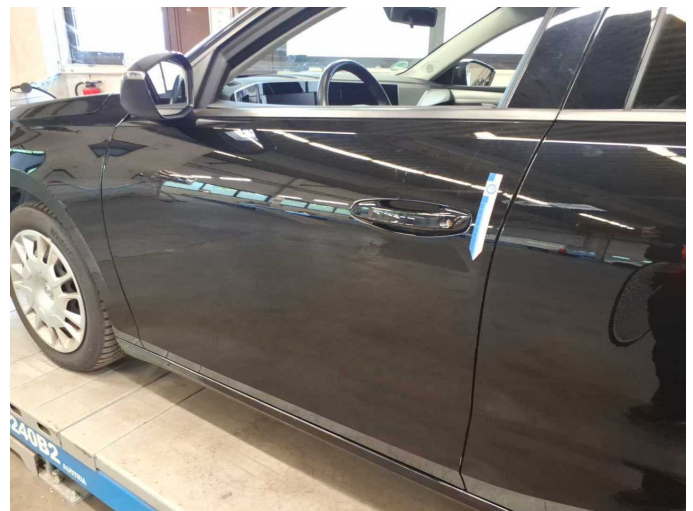
Damage 3: Door - front left side: Door edge - Scratched - Smart repair

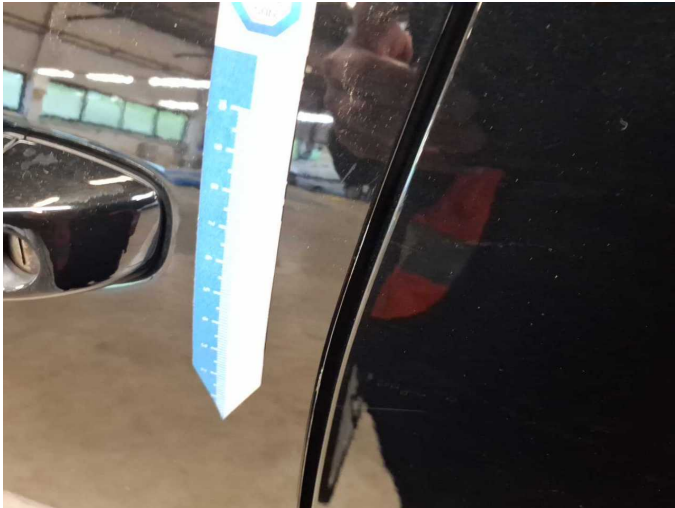
**Damage 3:** Door - front left side: Door edge - Scratched - Smart repair

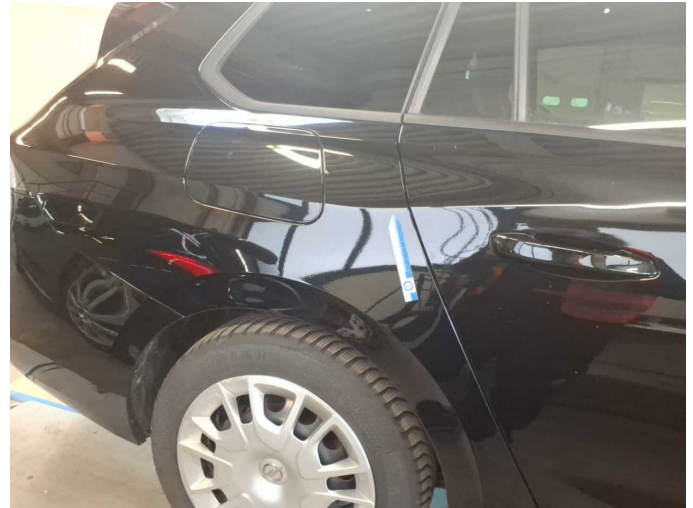
**Damage 4:** Side panel - rear right side: Side panel (Aufpolieren) - Scratch(es) - Smart repair

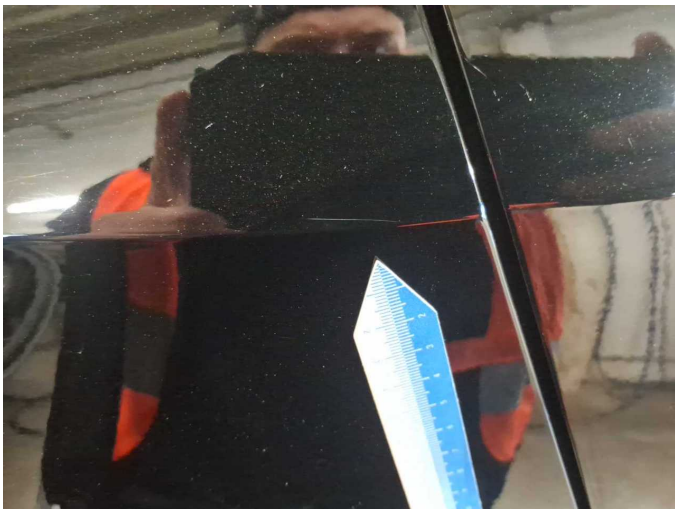
**Damage 4:** Side panel - rear right side: Side panel (Aufpolieren) - Scratch(es) - Smart repair

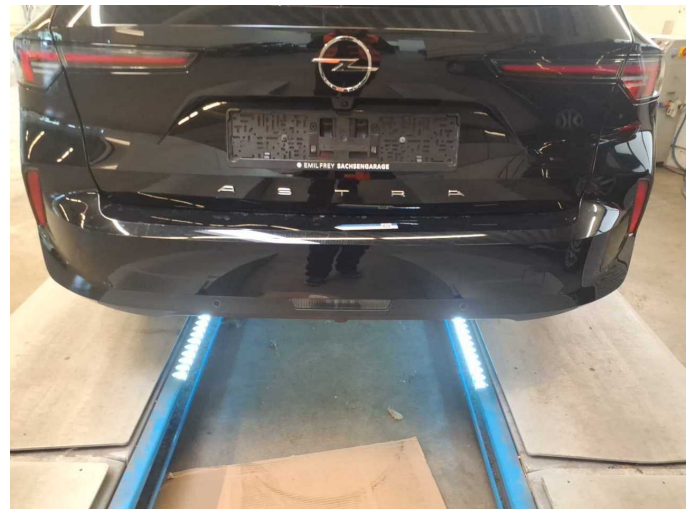
**Damage 5:** Rear bumper: Rear bumper - Scratched - Smart repair

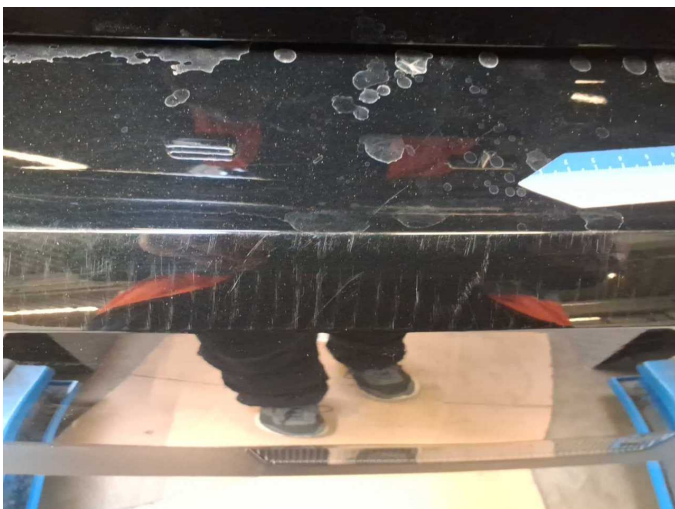
**Damage 5:** Rear bumper: Rear bumper - Scratched - Smart repair

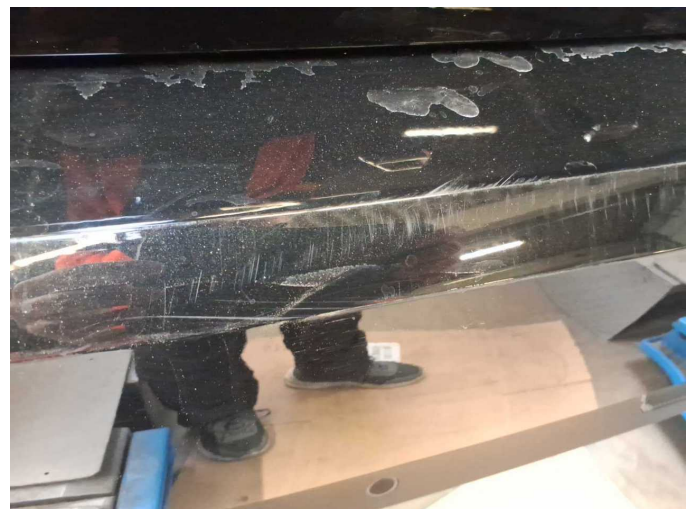
**Damage 5:** Rear bumper: Rear bumper - Scratched - Smart repair

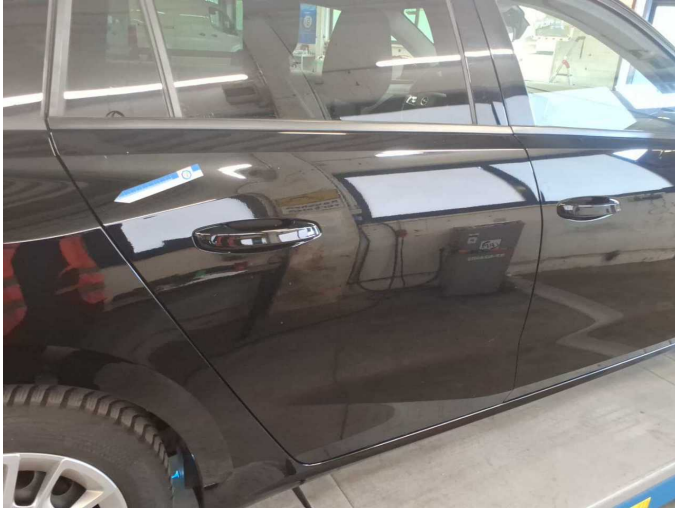
**Damage 6:** Door - rear right side: Door - Scratched - Smart repair

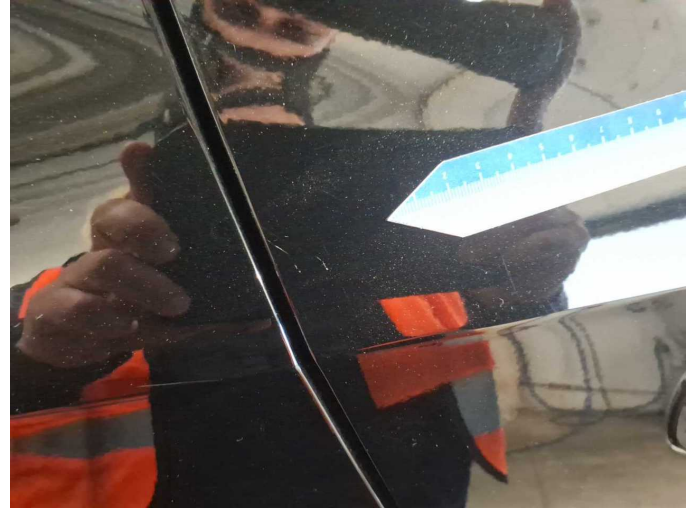
**Damage 6:** Door - rear right side: Door - Scratched - Smart repair

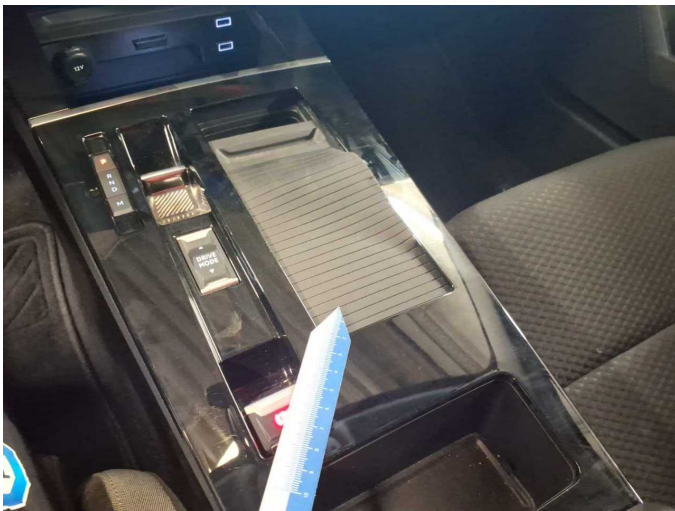
**Damage 7:** Interior: Interior (Abdeckung Becherhalter) - does not comply with manufacturer's specifications - Replace

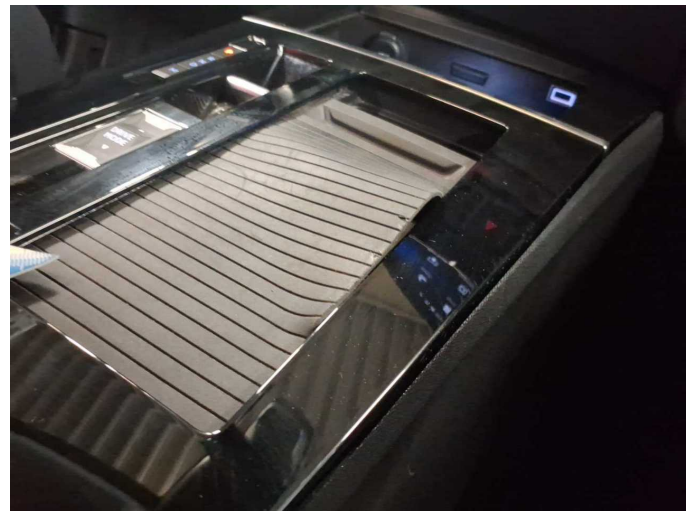
**Damage 7:** Interior: Interior (Abdeckung Becherhalter) - does not comply with manufacturer's specifications - Replace

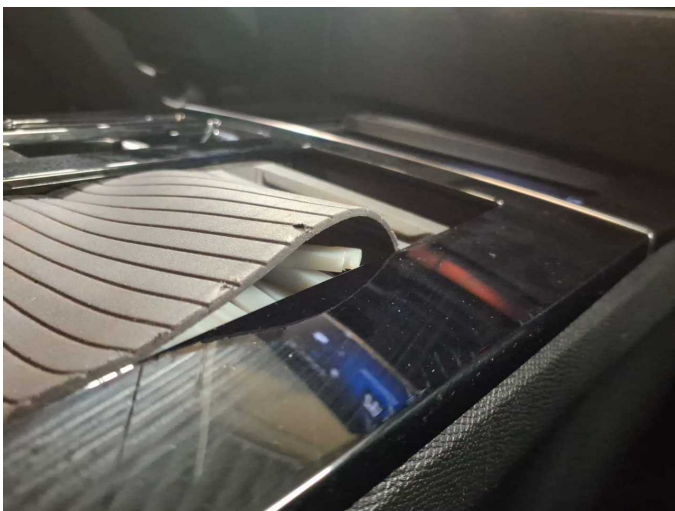
**Damage 7:** Interior: Interior (Abdeckung Becherhalter) - does not comply with manufacturer's specifications - Replace

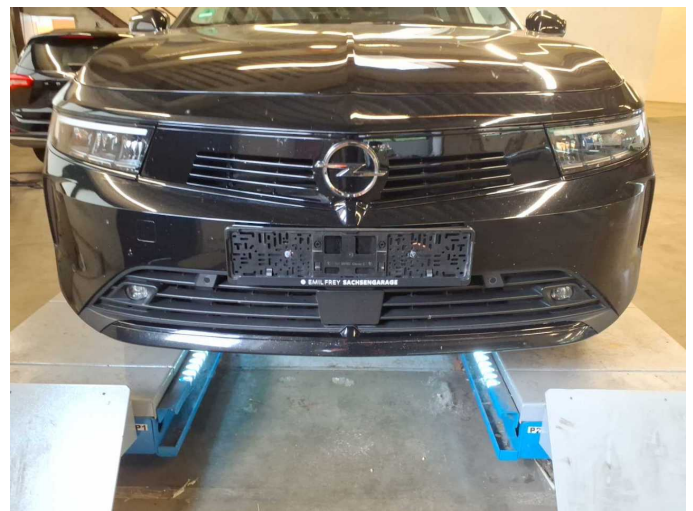
**Wear and tear 1:** Front bumper: Front bumper - Stone chips - No deduction

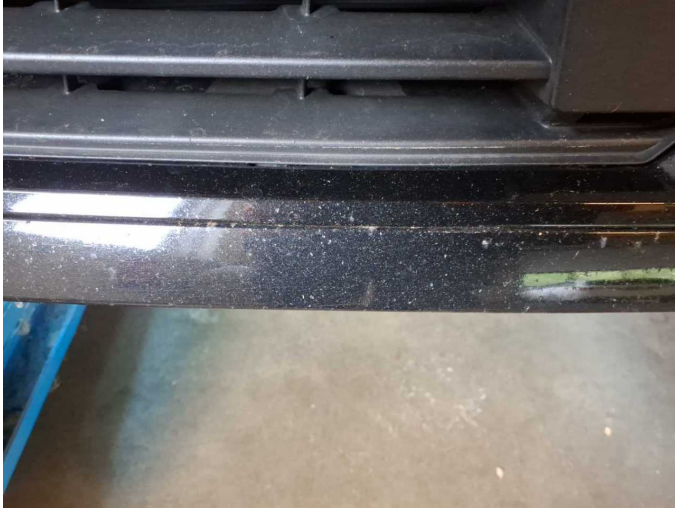
**Wear and tear 1:** Front bumper: Front bumper - Stone chips - No deduction

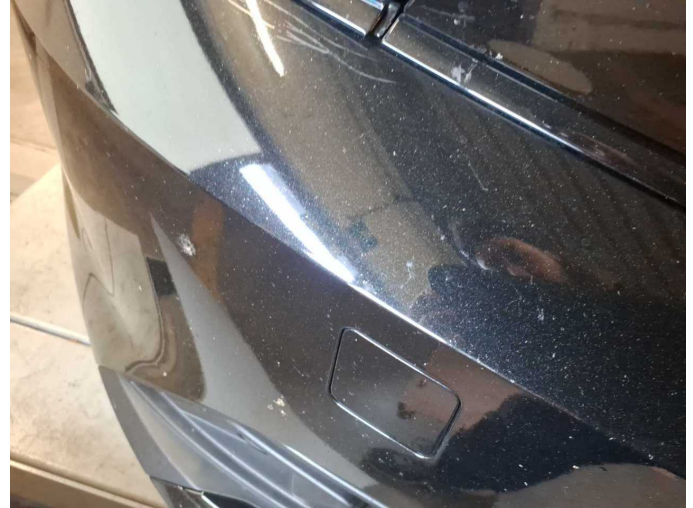
**Wear and tear 1:** Front bumper: Front bumper - Stone chips - No deduction

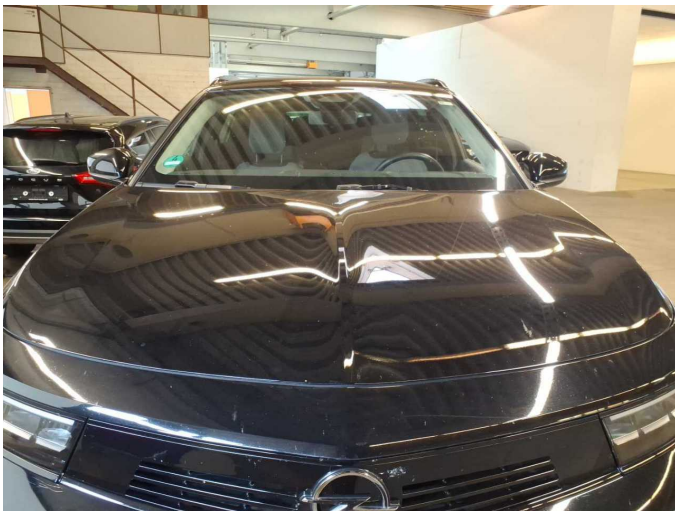
**Wear and tear 2:** Bonnet: Bonnet - Stone chips - No deduction

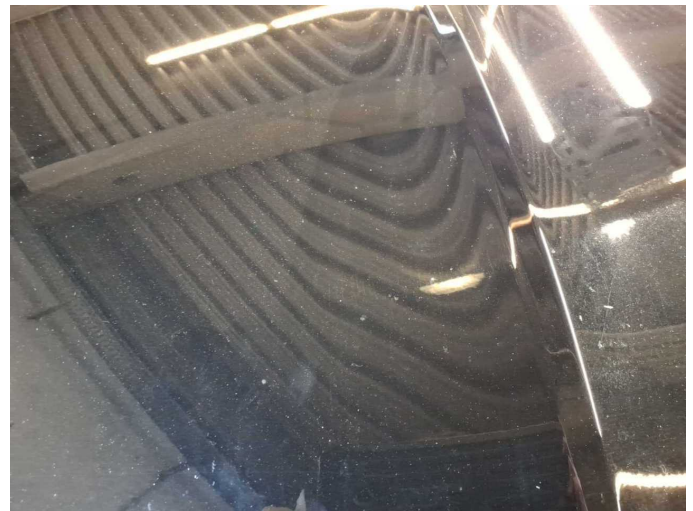
**Wear and tear 2:** Bonnet: Bonnet - Stone chips - No deduction

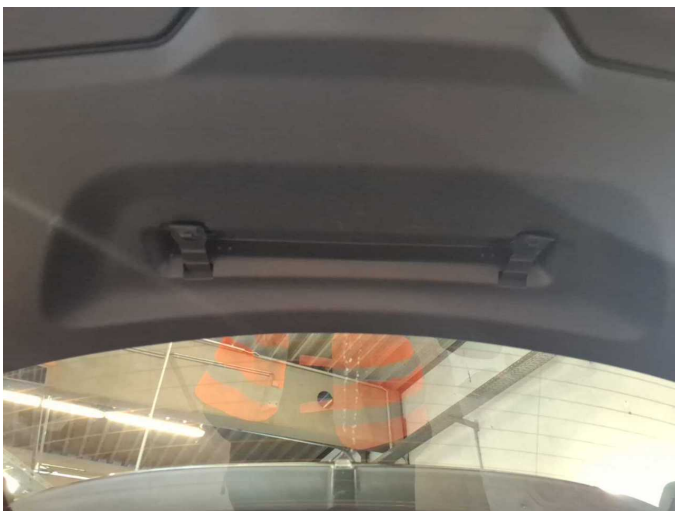
**Missing part 1:** Equipment: Warning triangle - Missing - Replace
