Expertise

Protocol number: 46441298  
Order No. / Reference: 26417497-1  
Inspection date: 22 Jun 2026

Model: Transporter T6.1 2.0 TDI SCR DSG 4MOTION Kasten Kurz

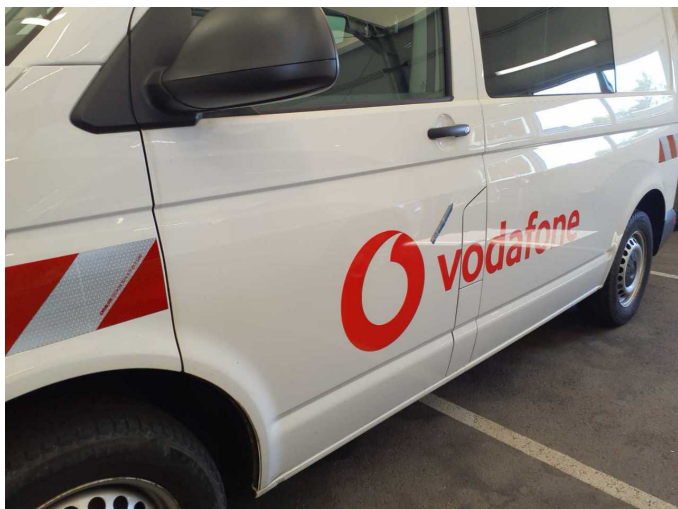
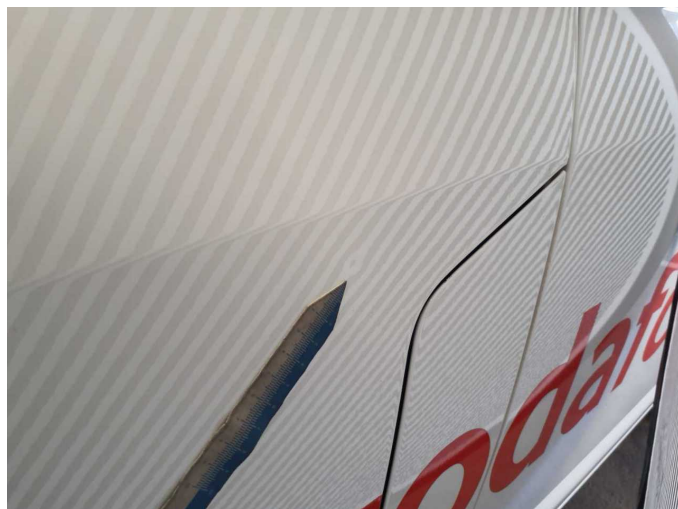
| No. | Component group | Description |
|---|---|---|
| 1 | Door - front left side | Door - dent(s) - Smart repair |

**Damage 1:** Door - front left side: Door - dent(s) - Smart repair

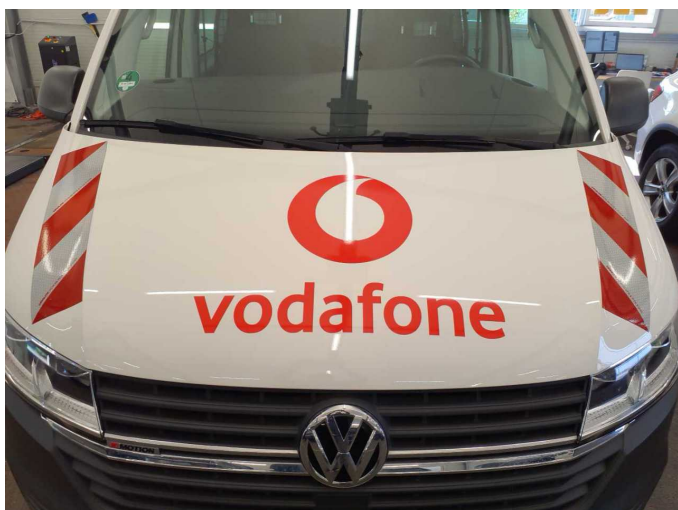
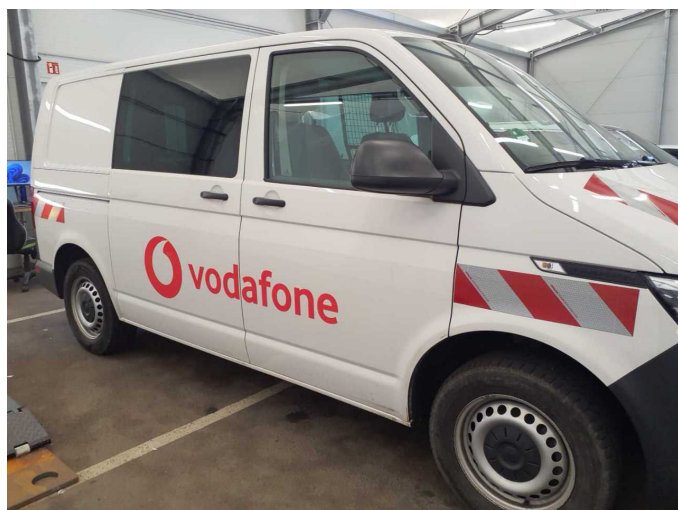
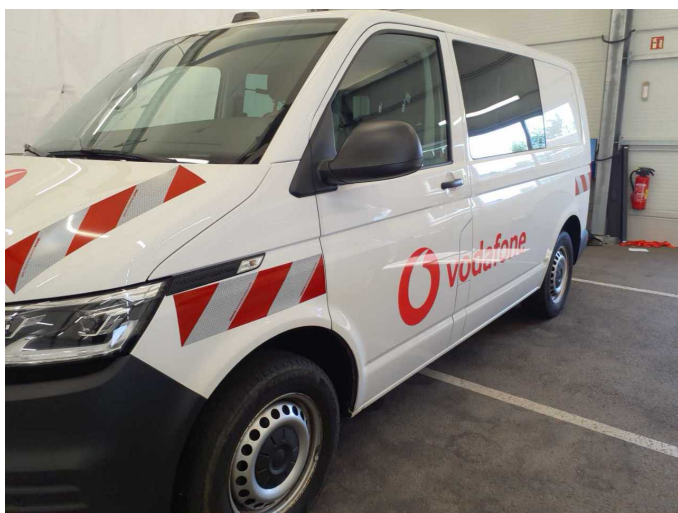
| No. | Component group | Description |
|---|---|---|
| 2 | Body | Body - Glued / labelled - De-glue / neutralise |

**Damage 2:** Body: Body - Glued / labelled - De-glue / neutralise
