## Expertise

Protocol number: 45585933  
Order No. / Reference: 26292872  
Inspection date: 13 May 2026

Model: Vito 116 CDI Extralang HA Aut. PRO

VIN: W1VVLCEZXT4565643

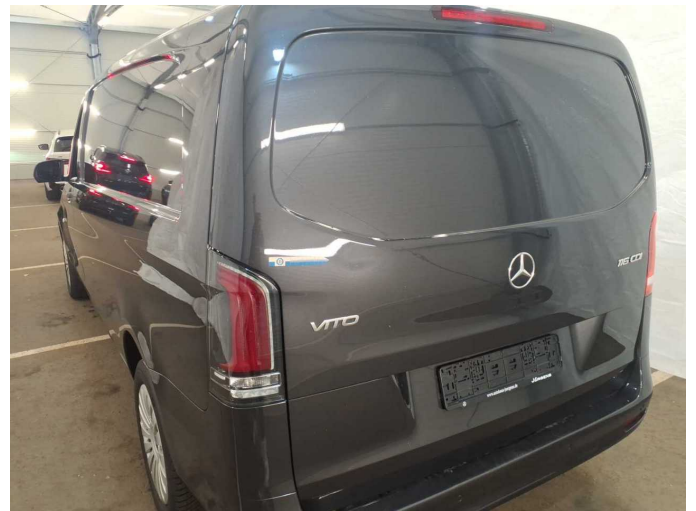
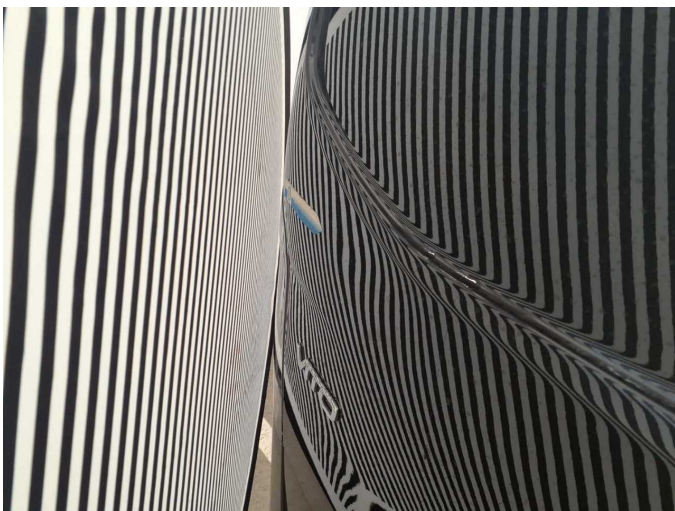
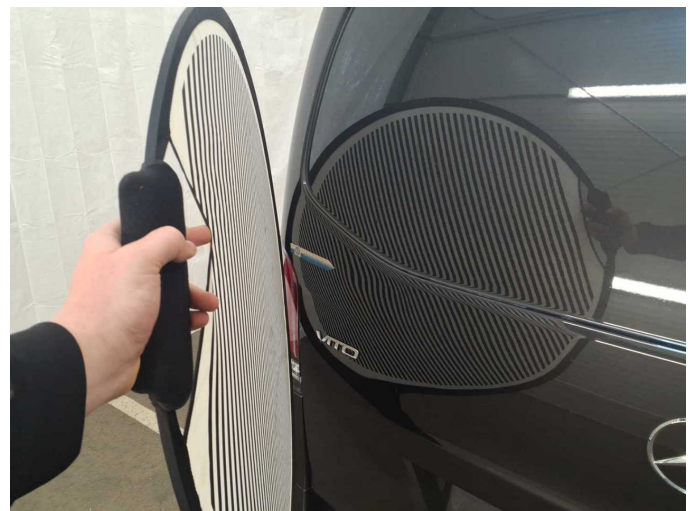
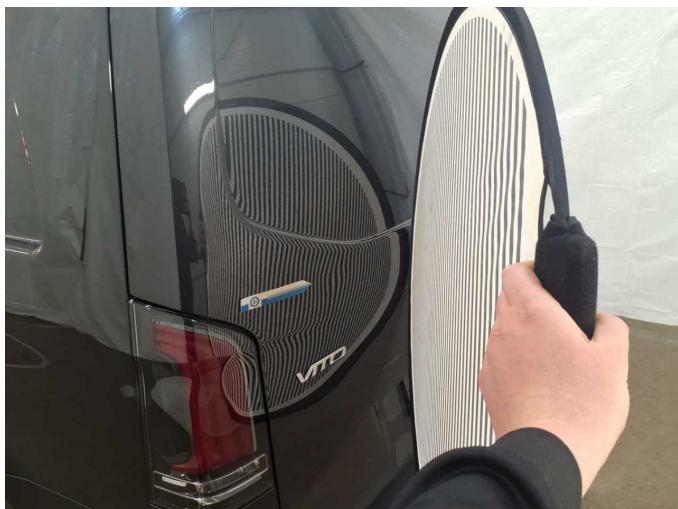
No.	Component group	Description
1	Misc.	Inspection / maintenance - No evidence - No deduction
2	Misc.	Main inspection - No evidence - No deduction
3	Boot lid / rear door	Boot lid - dent(s) - Repair and paint

Damage 3: Boot lid / rear door: Boot lid - dent(s) - Repair and paint

**Damage 3:** Boot lid / rear door: Boot lid - dent(s) - Repair and paint

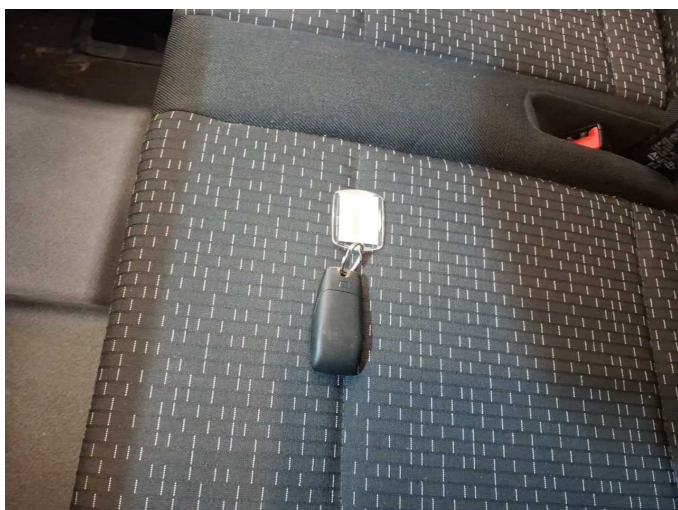
**Missing part 2:** Equipment: Vehicle key - Missing - Replace
