Protocol number: 46266333
Order No. / Reference: 26550343
Inspection date: 29 Jun 2026

Manufacturer: Peugeot

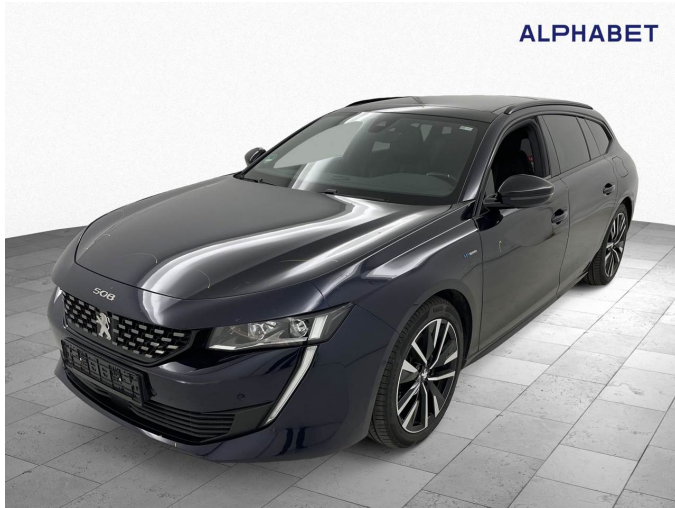
Figure 1: Diagonal front (left)

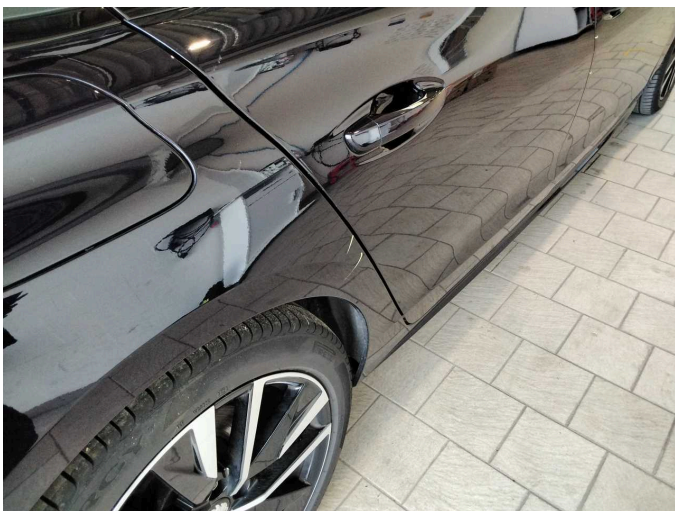
Damage 2: Side panel - rear right side: Side panel - dent(s) - Smooth repair work

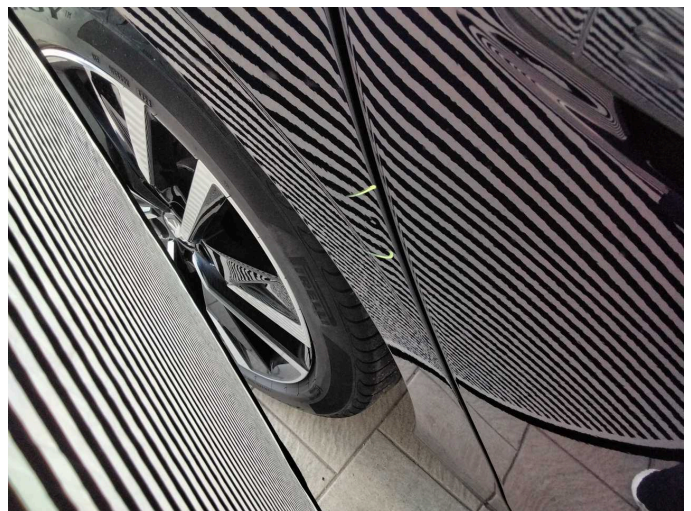
Damage 2: Side panel - rear right side: Side panel - dent(s) - Smooth repair work

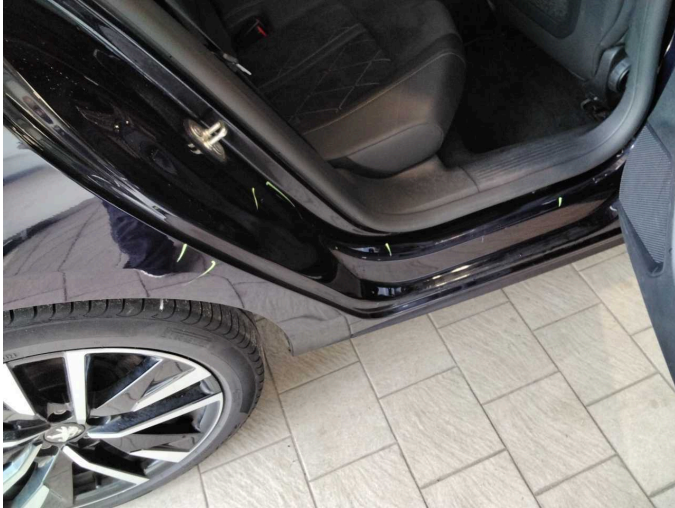
Damage 3: Body: C-pillar - right side - Scratch(es) - Smart repair

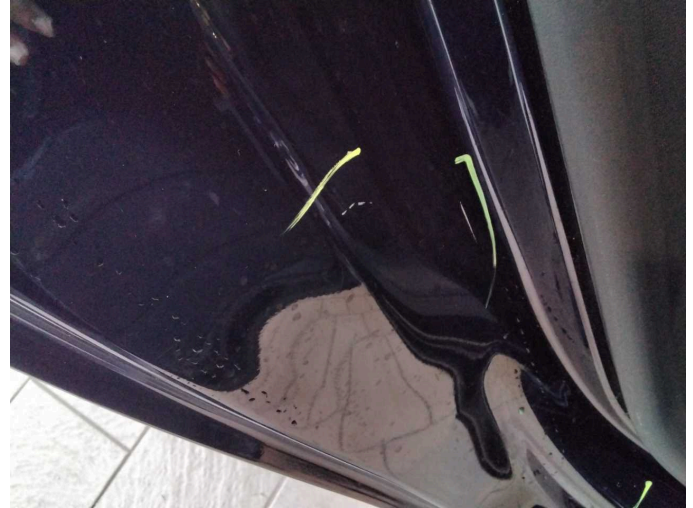
Damage 3: Body: C-pillar - right side - Scratch(es) - Smart repair

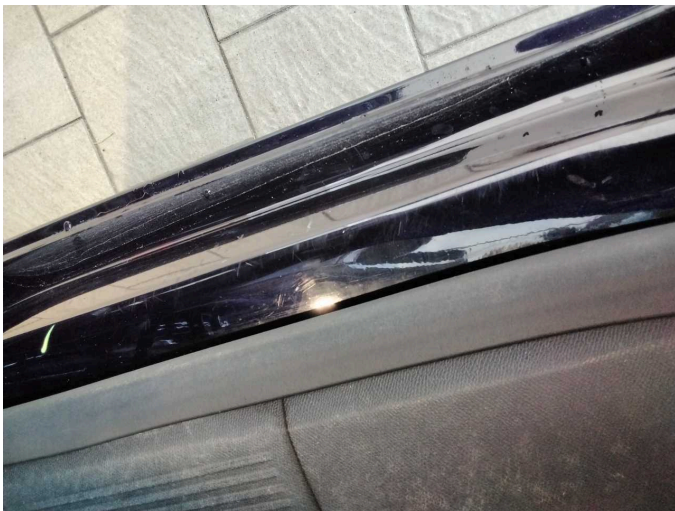
Damage 3: Body: C-pillar - right side - Scratch(es) - Smart repair

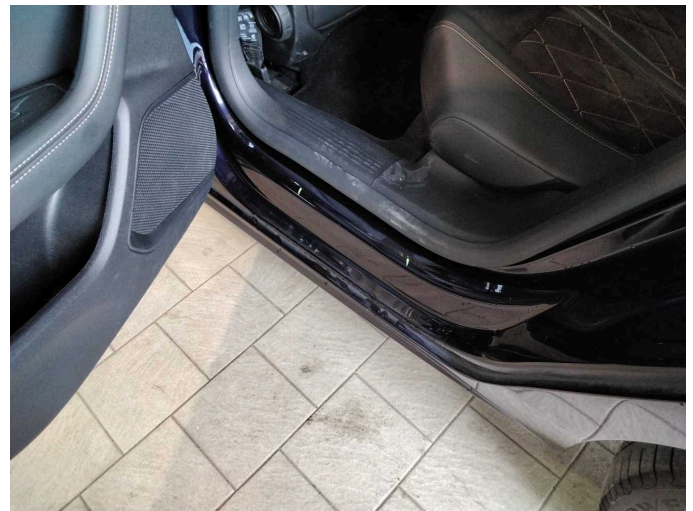
Damage 4: Side panel - rear left side: Sill - Scratch(es) - Smart repair

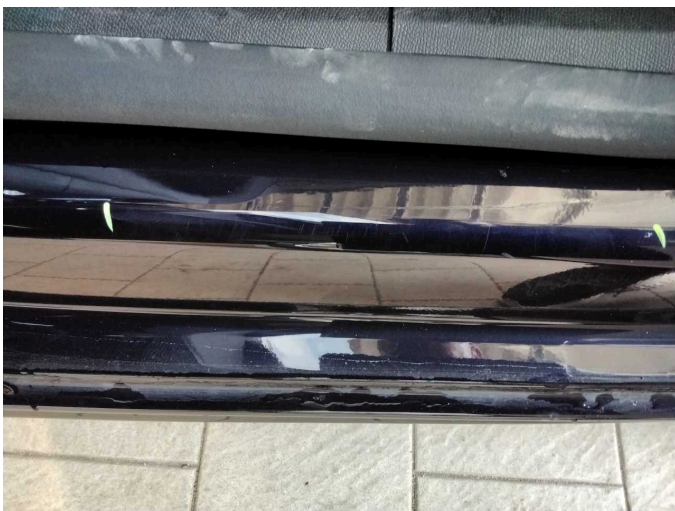
Damage 4: Side panel - rear left side: Sill - Scratch(es) - Smart repair

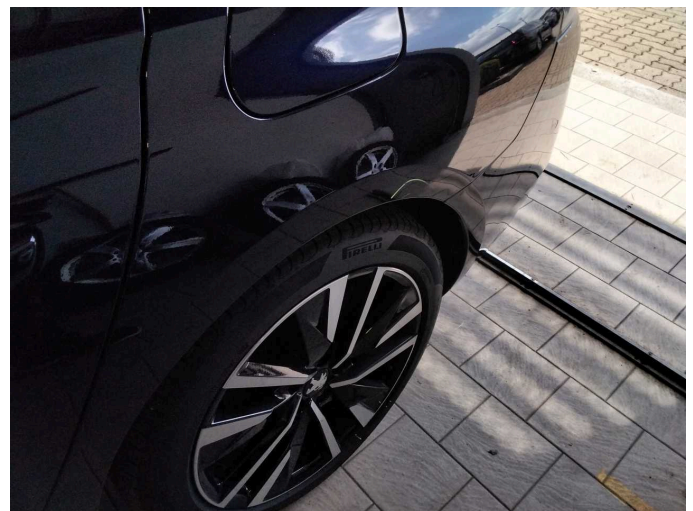
Damage 5: Side panel - rear left side: Side panel - Dent / paintcoat damage - Smart repair

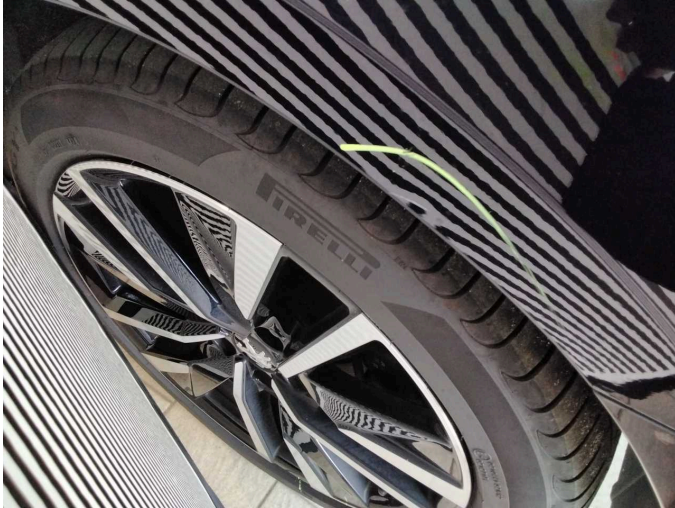
Damage 5: Side panel - rear left side: Side panel - Dent / paintcoat damage - Smart repair

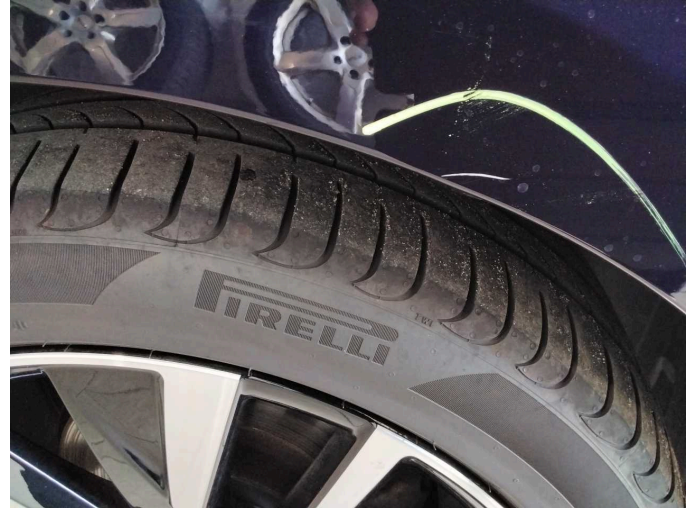
Damage 5: Side panel - rear left side: Side panel - Dent / paintcoat damage - Smart repair

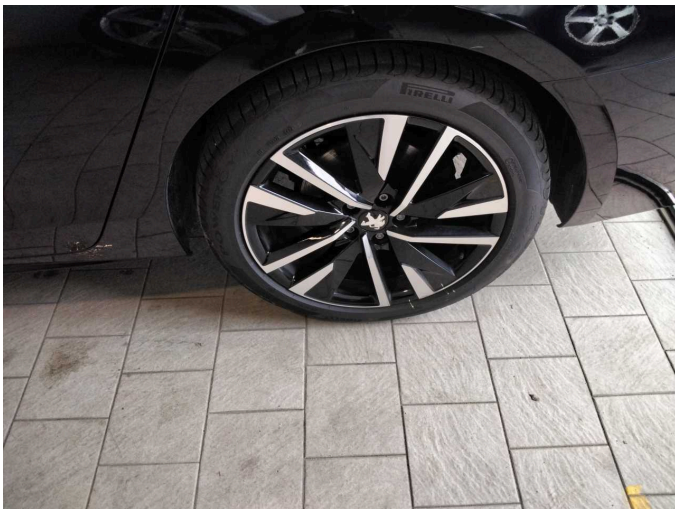
Damage 6: Wheel / tyres: Alloy rim - rear left side - Scratch(es) - Loss in value

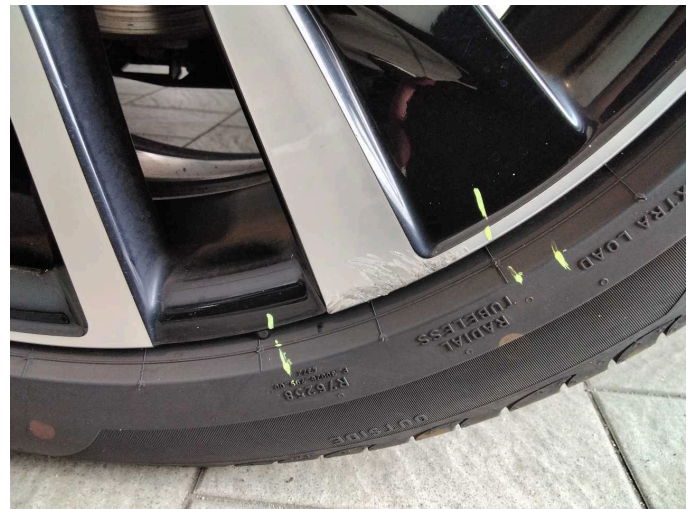
Damage 6: Wheel / tyres: Alloy rim - rear left side - Scratch(es) - Loss in value

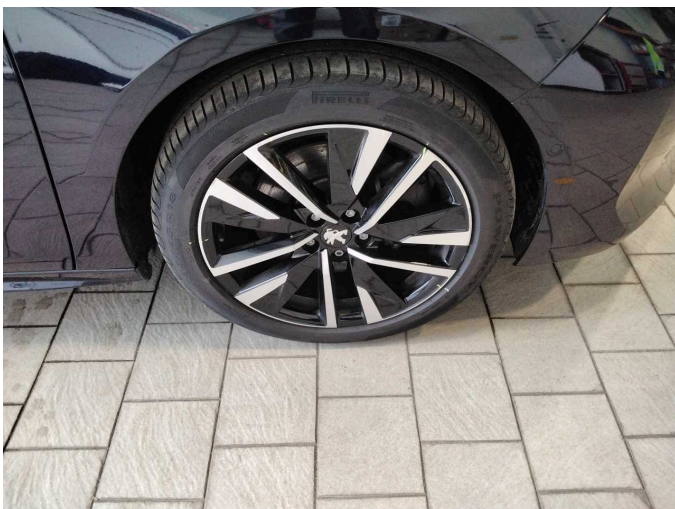
Damage 7: Wheel / tyres: Alloy rim - front right side - Scratch(es) - Loss in value

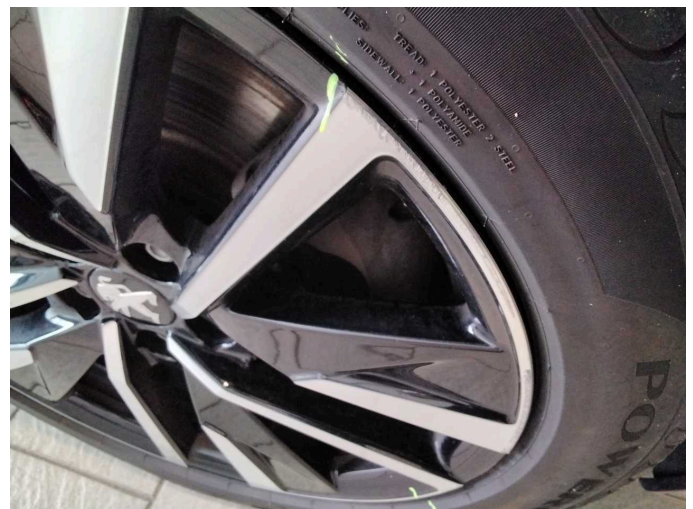
Damage 7: Wheel / tyres: Alloy rim - front right side - Scratch(es) - Loss in value

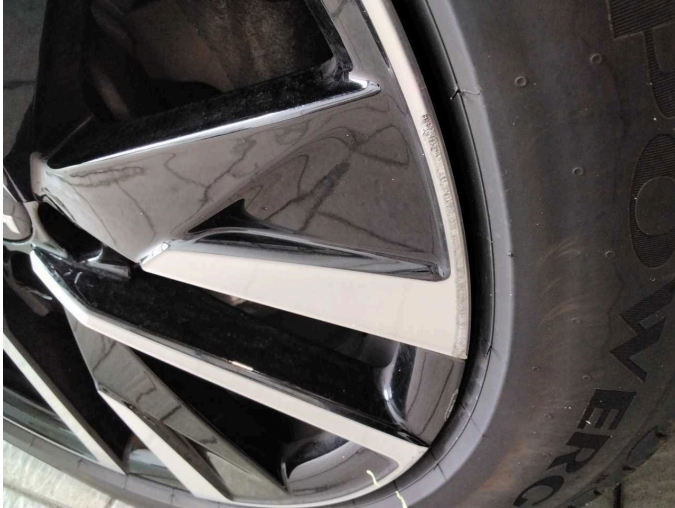
Damage 7: Wheel / tyres: Alloy rim - front right side - Scratch(es) - Loss in value

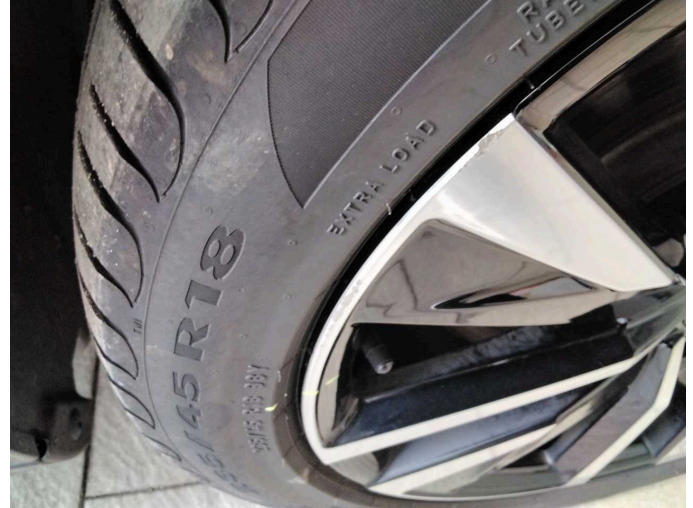
Damage 7: Wheel / tyres: Alloy rim - front right side - Scratch(es) - Loss in value

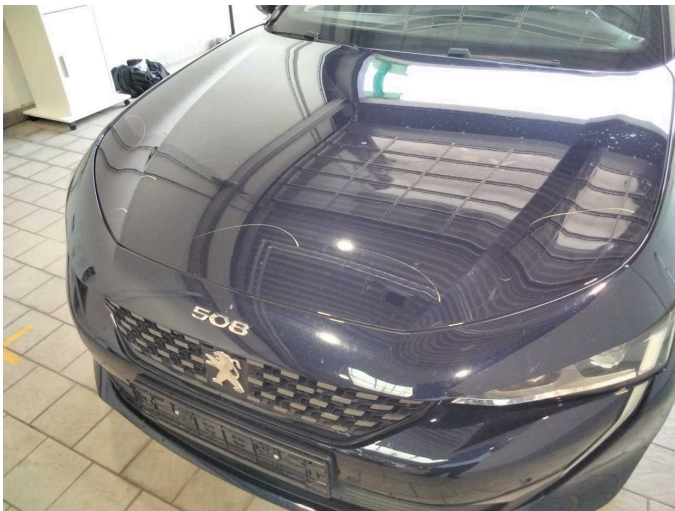
Damage 8: Bonnet: Bonnet - Dent / paintcoat damage - Repair and paint

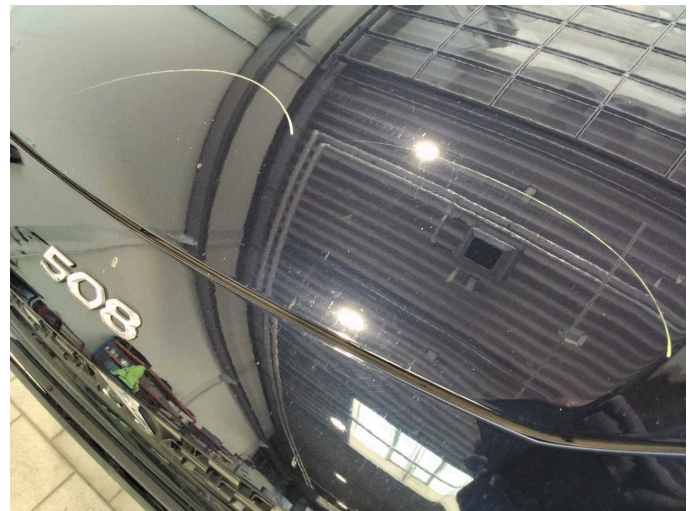
Damage 8: Bonnet: Bonnet - Dent / paintcoat damage - Repair and paint

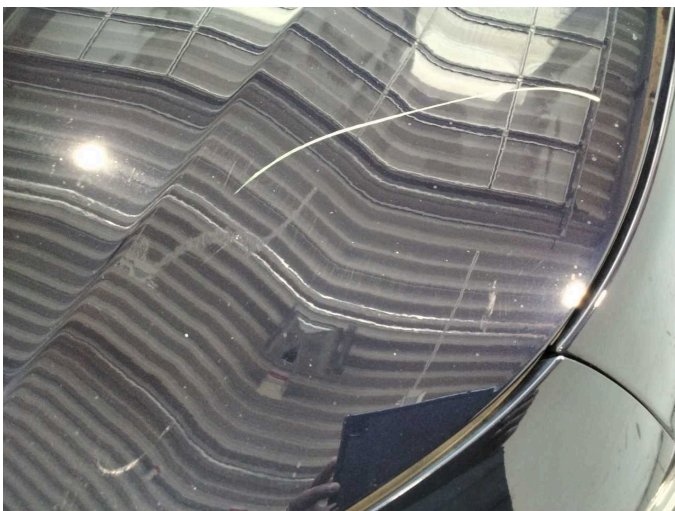
Damage 8: Bonnet: Bonnet - Dent / paintcoat damage - Repair and paint

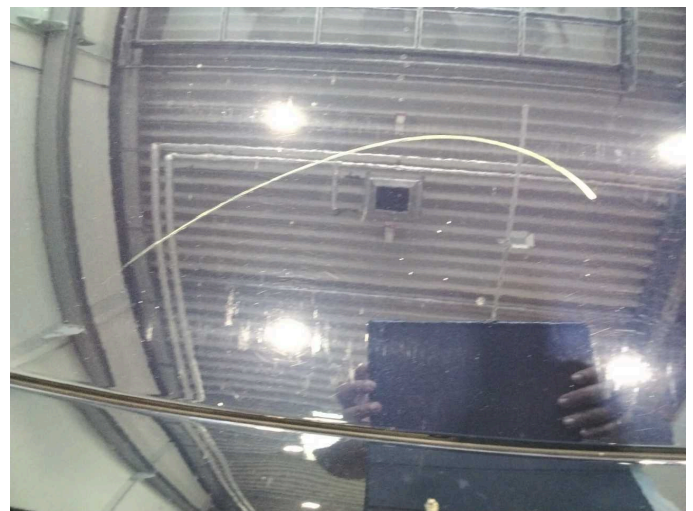
Damage 8: Bonnet: Bonnet - Dent / paintcoat damage - Repair and paint

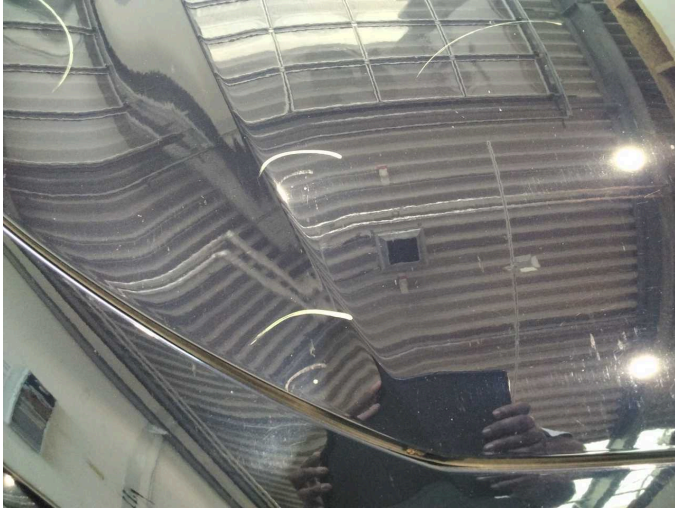
Damage 8: Bonnet: Bonnet - Dent / paintcoat damage - Repair and paint

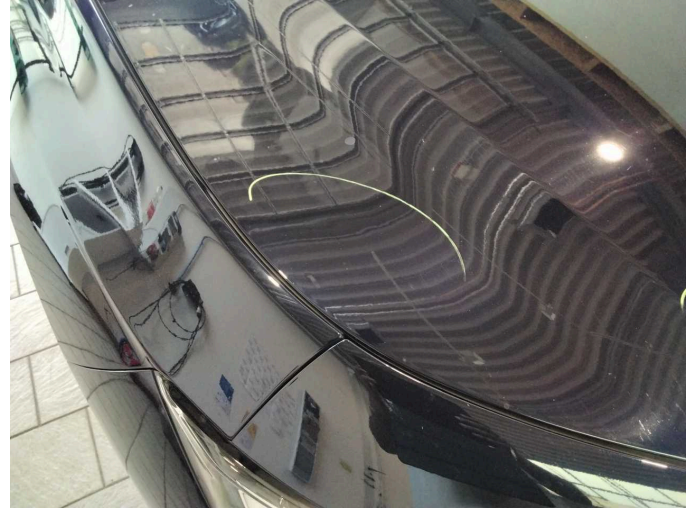
Damage 8: Bonnet: Bonnet - Dent / paintcoat damage - Repair and paint

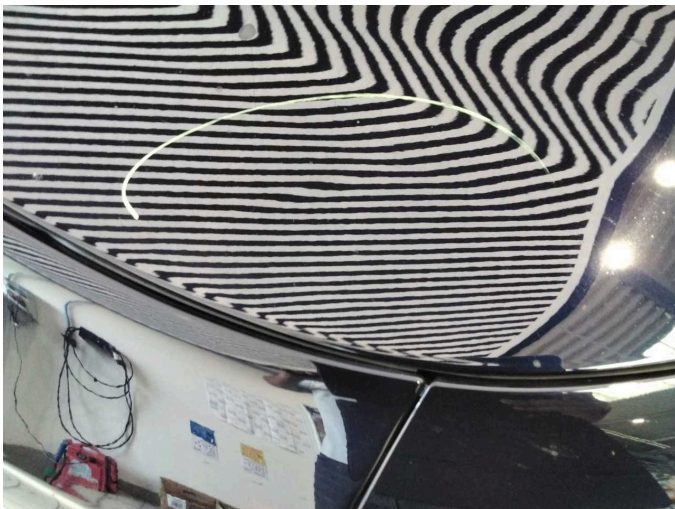
Damage 8: Bonnet: Bonnet - Dent / paintcoat damage - Repair and paint

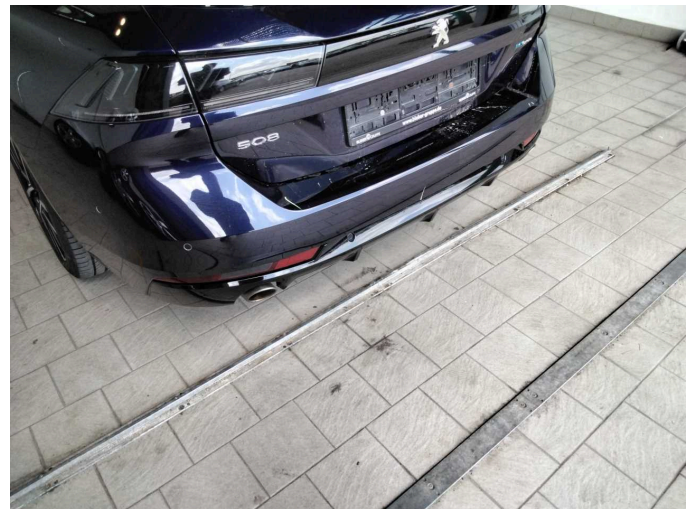
Damage 9: Rear bumper: Rear bumper - Scratch(es) - Paint

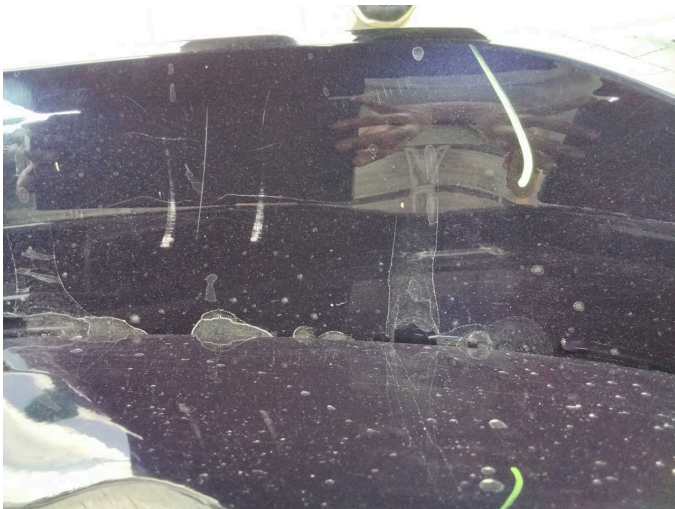
Damage 9: Rear bumper: Rear bumper - Scratch(es) - Paint

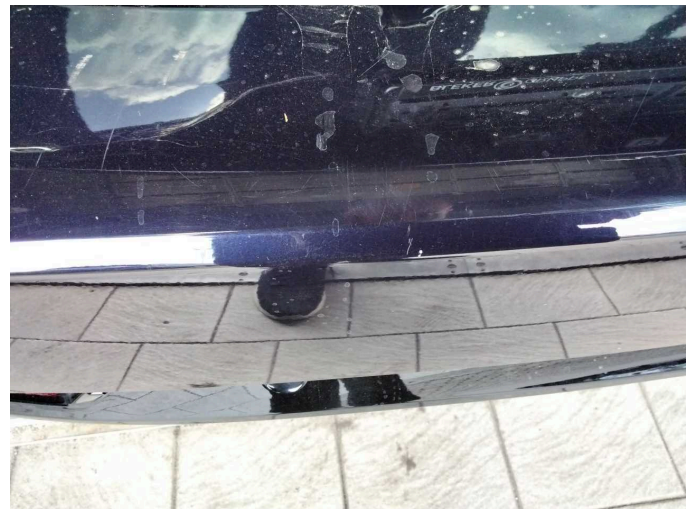
Damage 9: Rear bumper: Rear bumper - Scratch(es) - Paint

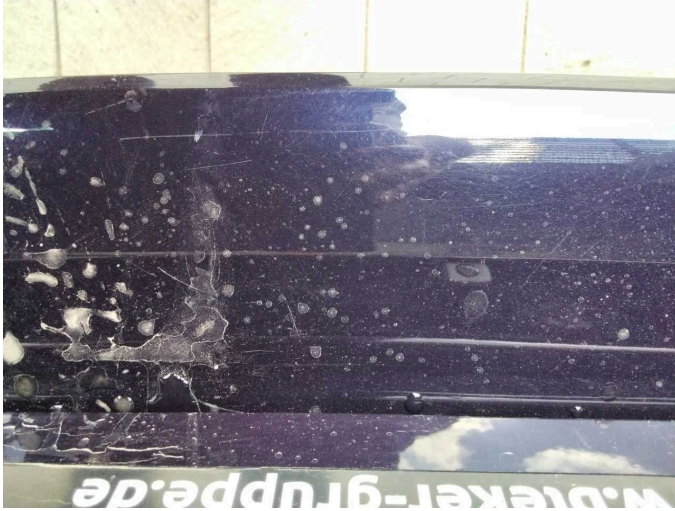
Damage 9: Rear bumper: Rear bumper - Scratch(es) - Paint

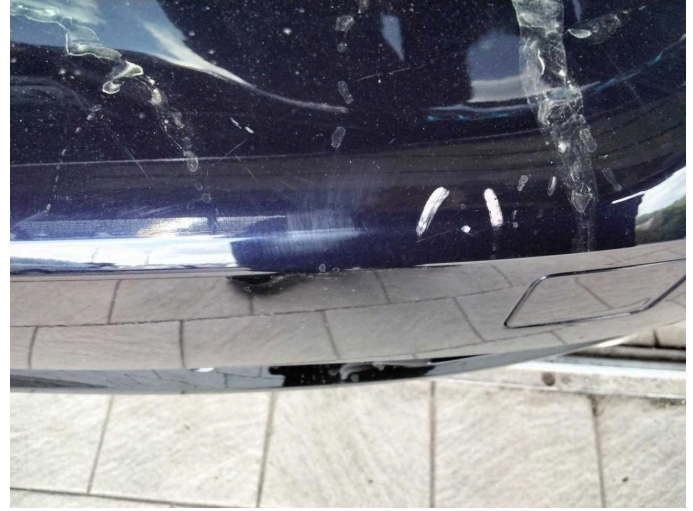
Damage 9: Rear bumper: Rear bumper - Scratch(es) - Paint

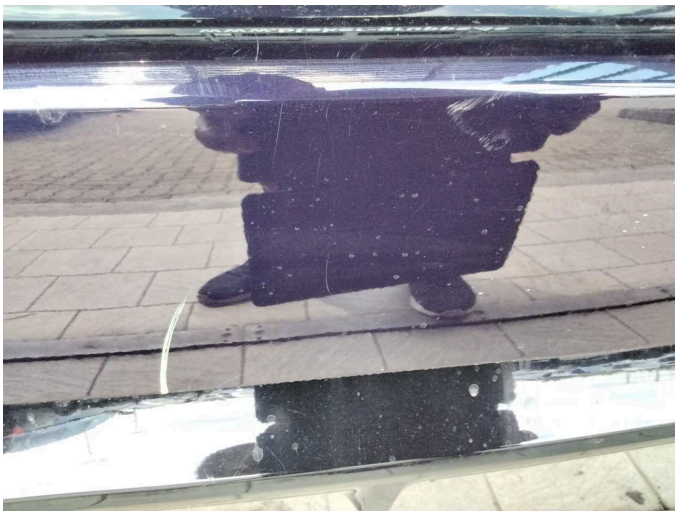
Damage 9: Rear bumper: Rear bumper - Scratch(es) - Paint

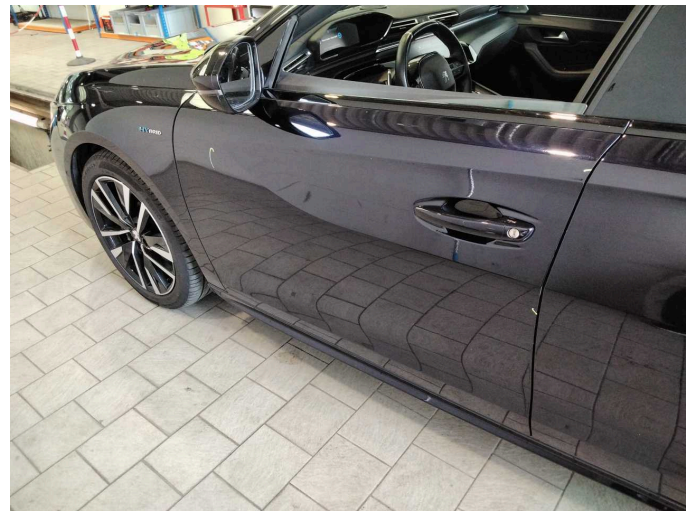
Damage 10: Door - front left side: Door - Dent / paintcoat damage - Repair and paint

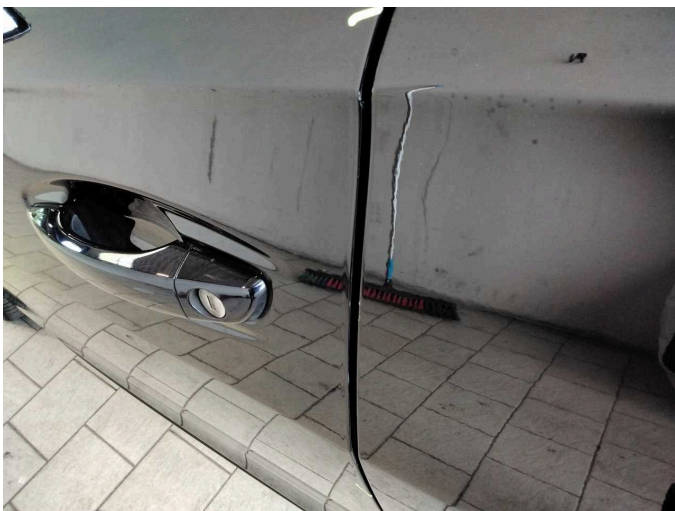
Damage 10: Door - front left side: Door - Dent / paintcoat damage - Repair and paint

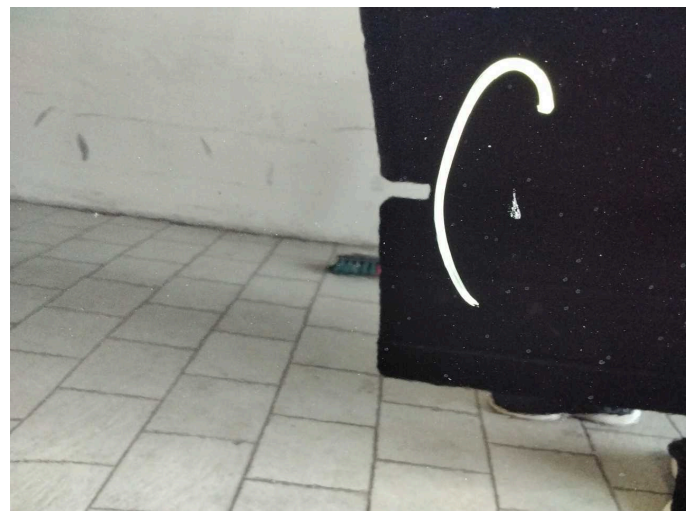
Damage 10: Door - front left side: Door - Dent / paintcoat damage - Repair and paint

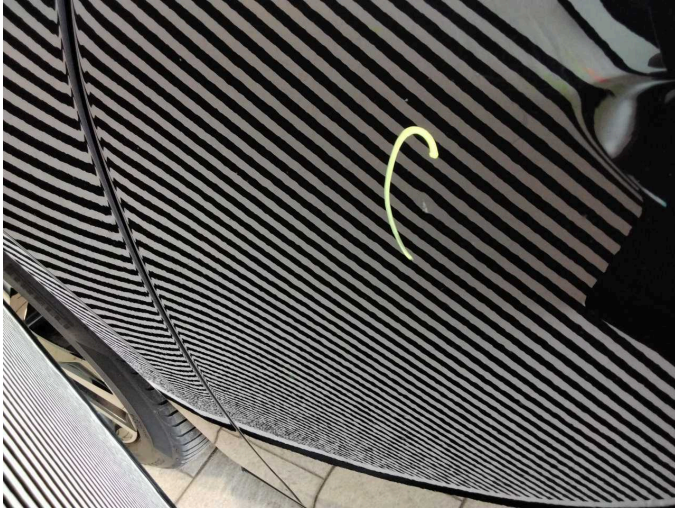
Damage 10: Door - front left side: Door - Dent / paintcoat damage - Repair and paint

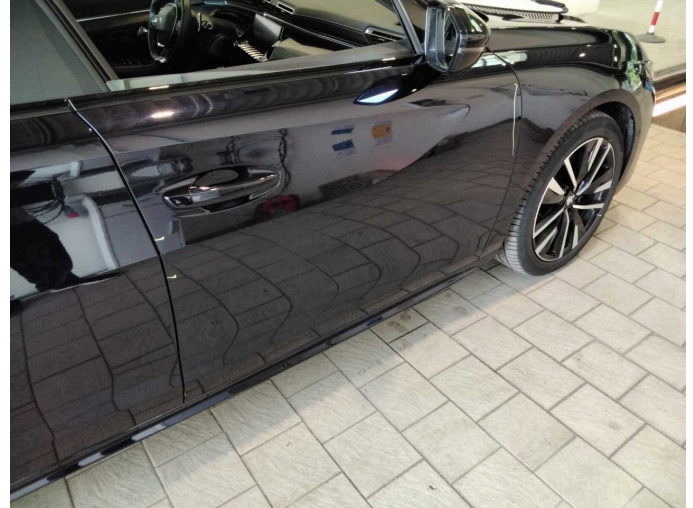
Damage 11: Door - front right side: Door - Dent / paintcoat damage - Repair and paint

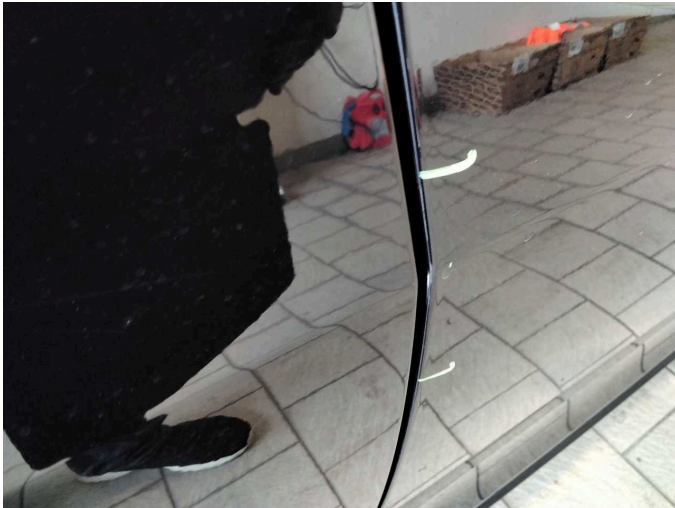
Damage 11: Door - front right side: Door - Dent / paintcoat damage - Repair and paint

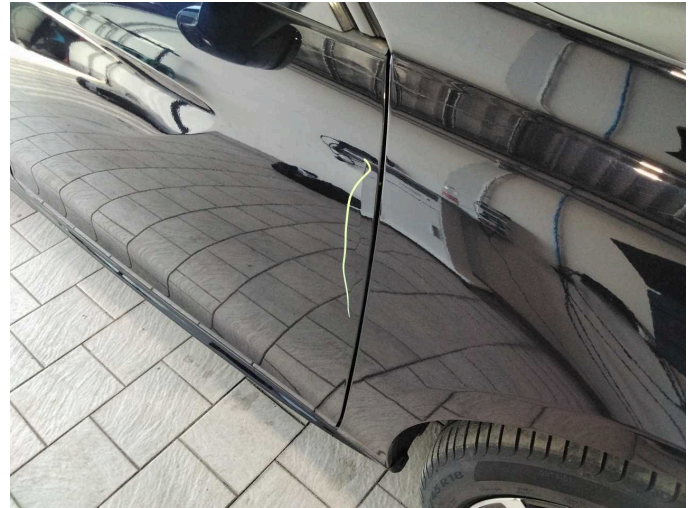
Damage 11: Door - front right side: Door - Dent / paintcoat damage - Repair and paint

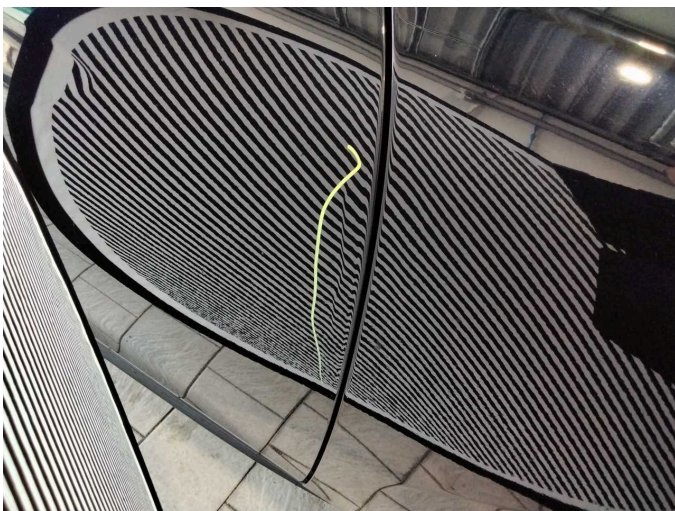
Damage 11: Door - front right side: Door - Dent / paintcoat damage - Repair and paint

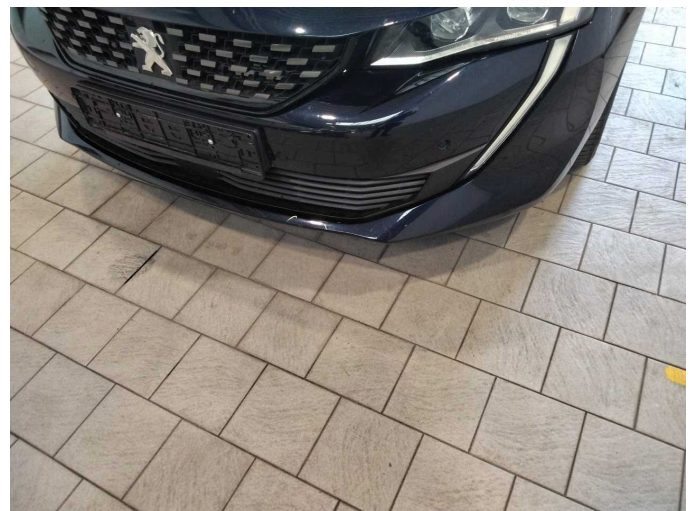
Damage 12: Front bumper: Front bumper - Scratch(es) - Paint

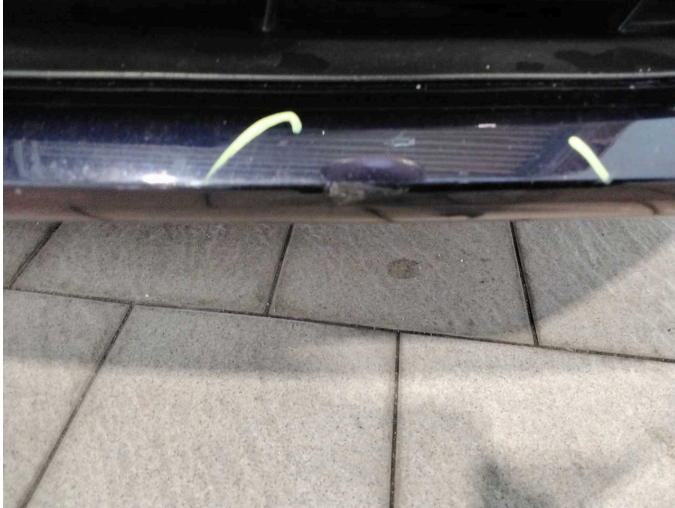
Damage 12: Front bumper: Front bumper - Scratch(es) - Paint

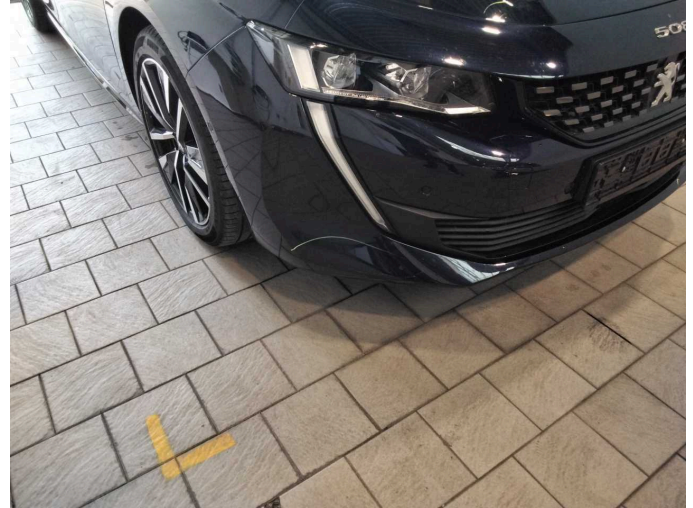
Damage 12: Front bumper: Front bumper - Scratch(es) - Paint

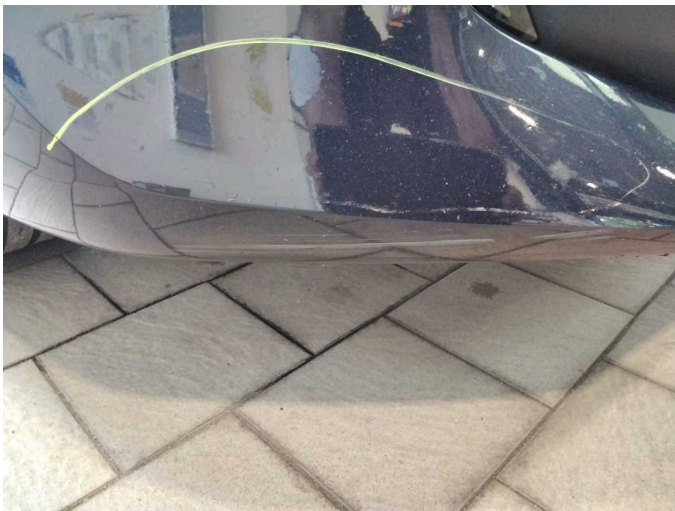
Damage 12: Front bumper: Front bumper - Scratch(es) - Paint

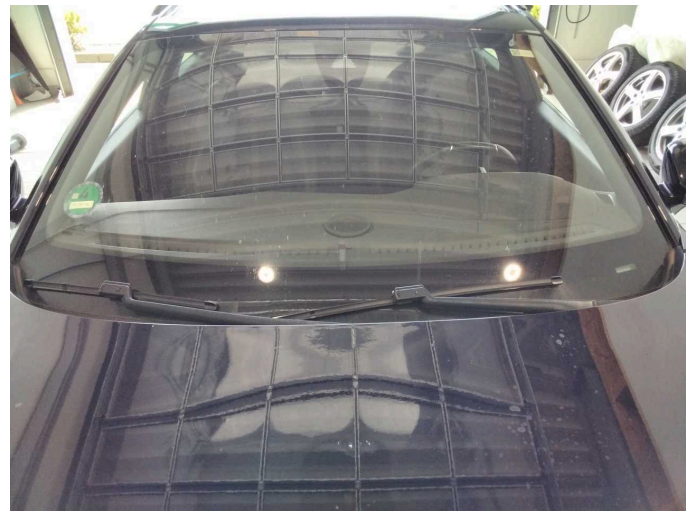
Wear and tear 1: Vehicle glazing: Windscreen - Stone chips - No deduction
