Expertise

Protocol number: 46509548  
Order No. / Reference: 26185346  
Inspection date: 13 Jul 2026

Manufacturer: Mercedes-Benz  
VIN: W1VVLCEZ7T4558892

Model: Vito 116 CDI Extralang HA Aut. PRO

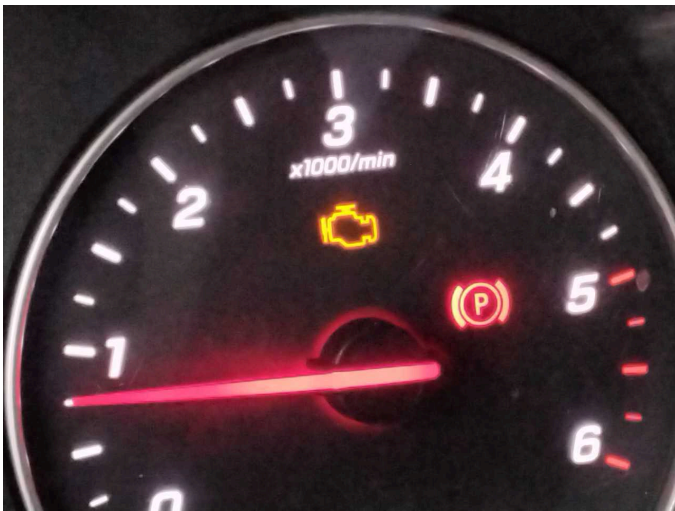
| Engine function test | An engine test run was performed, problem has been detected<br>This is due to the following reason.:<br>Motorkontrolle aktiv |

| No. | Component group | Description |
|---|---|---|
| 1 | Instrument panel | Indicator light (Mkl) - on - Perform diagnosis |

Damage 1: Instrument panel: Indicator light (Mkl) - on - Perform diagnosis

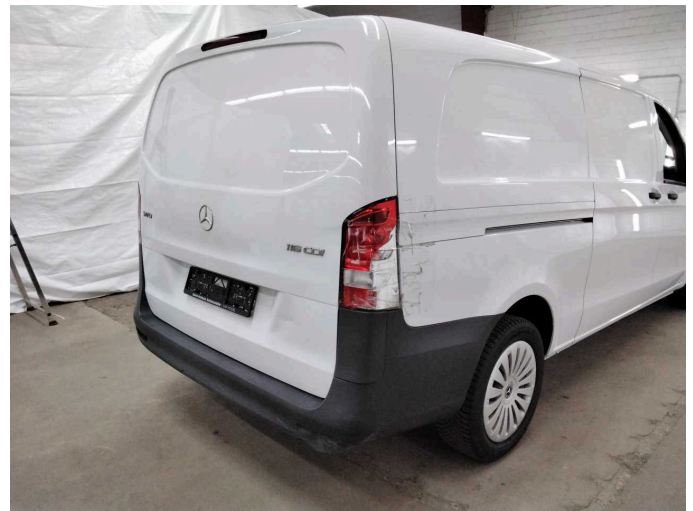
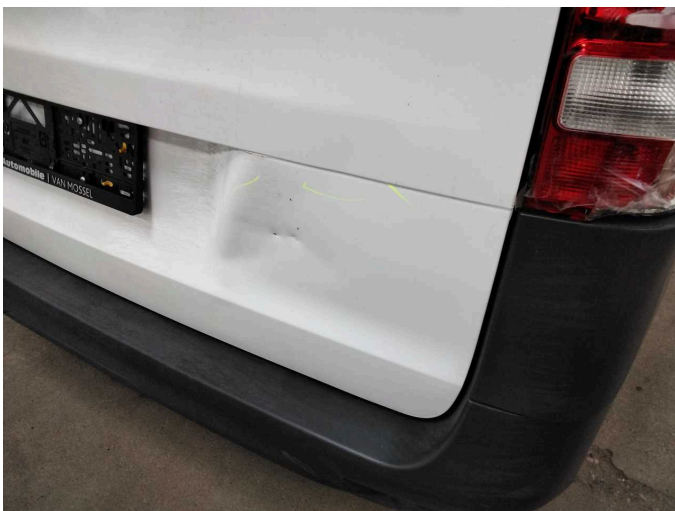
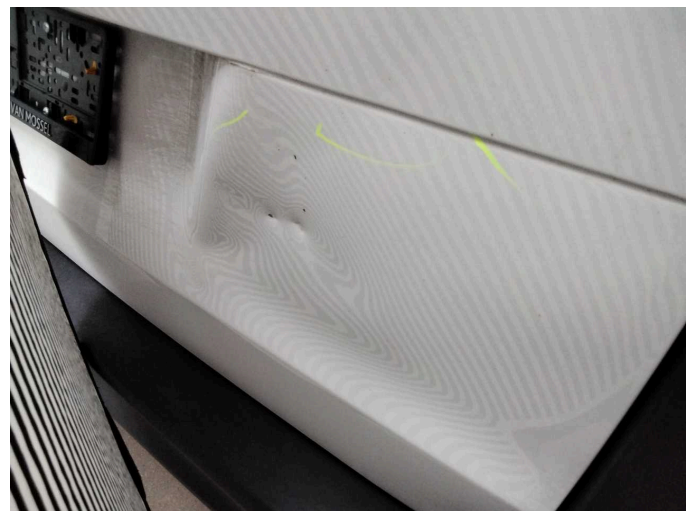
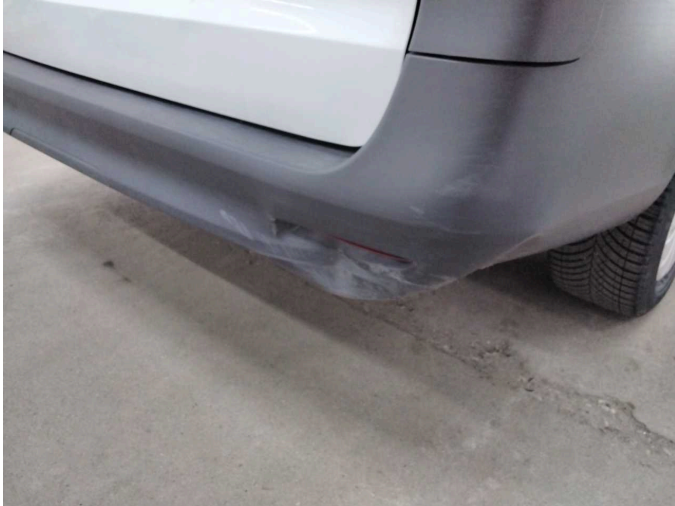
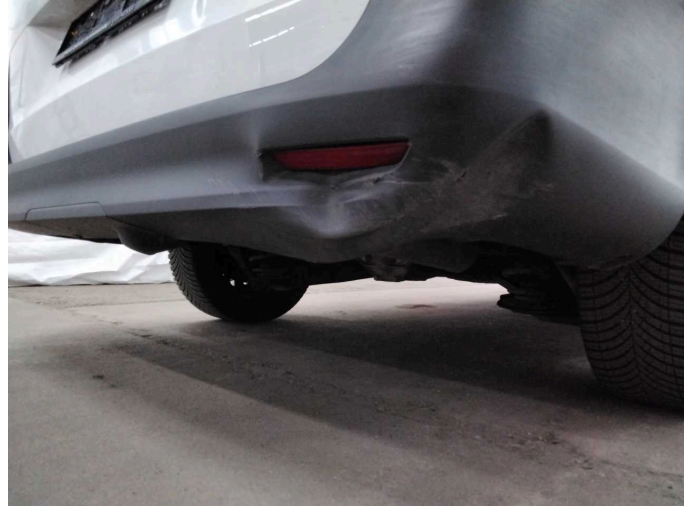
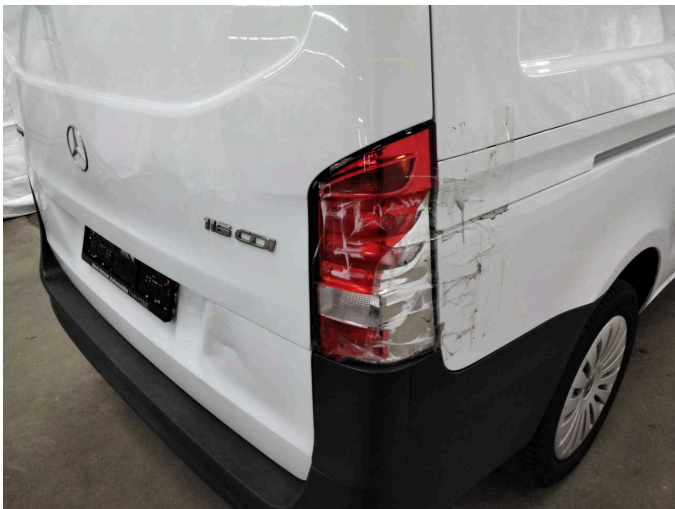
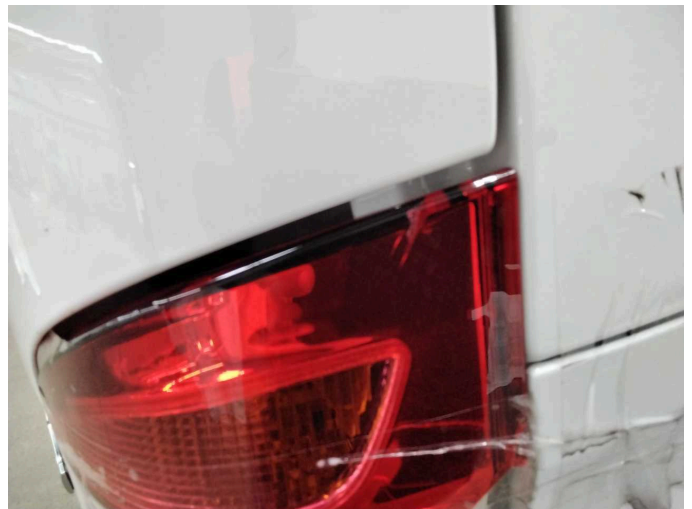
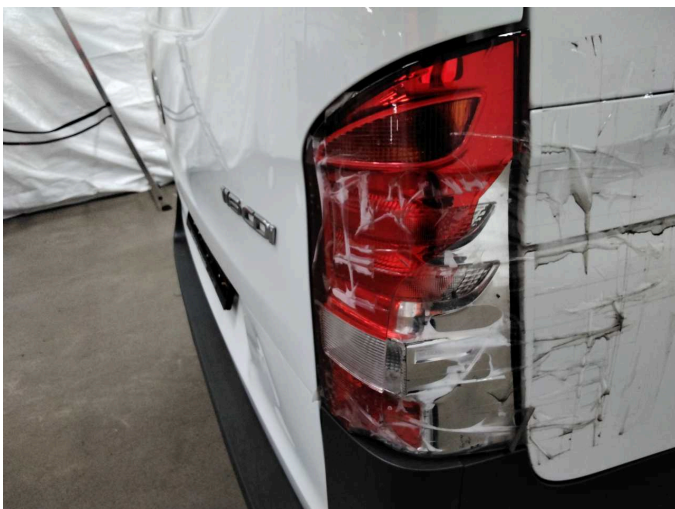
- 1 Rear, Side right

Non-repaired previous damages were found at the vehicle. The necessary repair costs are listed in the expert report or if necessary, are listed in detail in a separately enclosed repair cost calculation.

Das Fahrzeug befand sich zum Besichtigungszeitpunkt in beschädigtem, nicht demontiertem Zustand. Schadenausweitung möglich, Zusatzkosten können entstehen.

Accident 1: Rear, Side right
