## Expertise

Protocol number: 46023893  
Order No. / Reference: 26410573-1  
Inspection date: 18 Jun 2026

Model: Trafic Blue dCi 170 EDC Grand Spaceclass

VIN: VF1JL000971193019

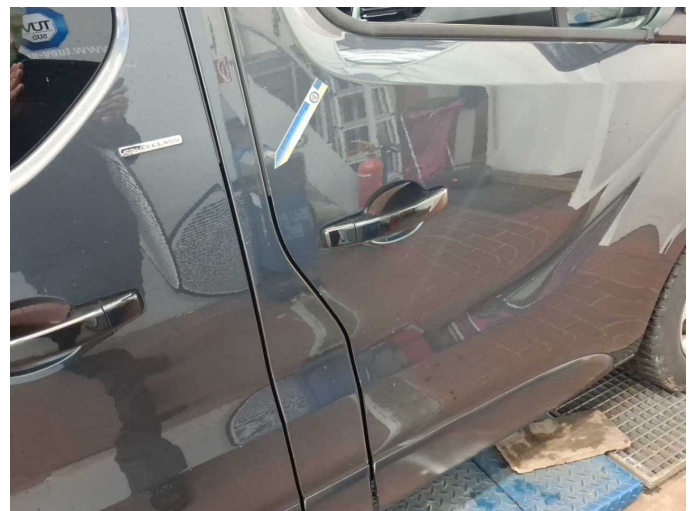
No.	Component group	Description
1	Door - front right side	Door edge - Scratch(es) - Smart repair
2	Door - rear left side	Brightware - lower - Scratch(es) - Smart repair
3	Side panel - rear left side	Side panel (Blende Heckleuchte) - Scratch(es) - Smart repair
4	Side panel - rear left side	Side panel - dent(s) - Repair and paint
5	Door - front left side	Door - Scratch(es) - Paint
6	Door - rear left side	Door (Und kratzer) - dent(s) - Repair and paint

Damage 1: Door - front right side: Door edge - Scratch(es) - Smart repair

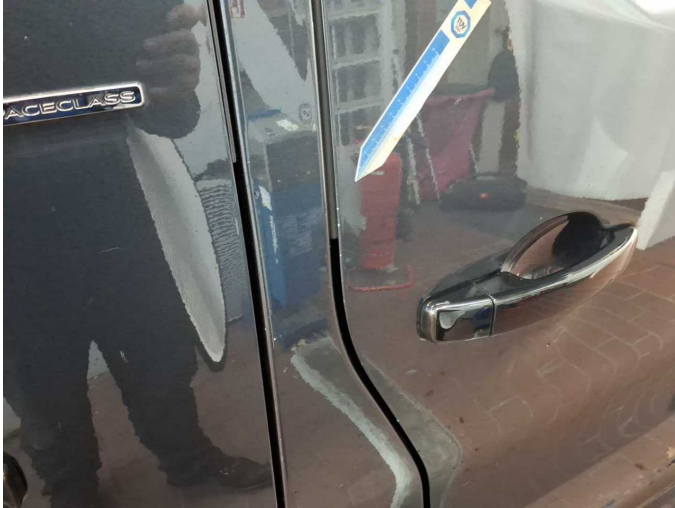
**Damage 1:** Door - front right side: Door edge - Scratch(es) - Smart repair

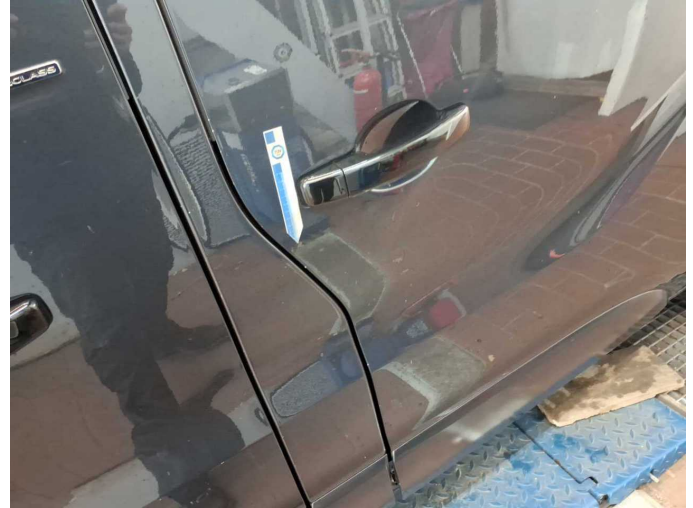
**Damage 1:** Door - front right side: Door edge - Scratch(es) - Smart repair

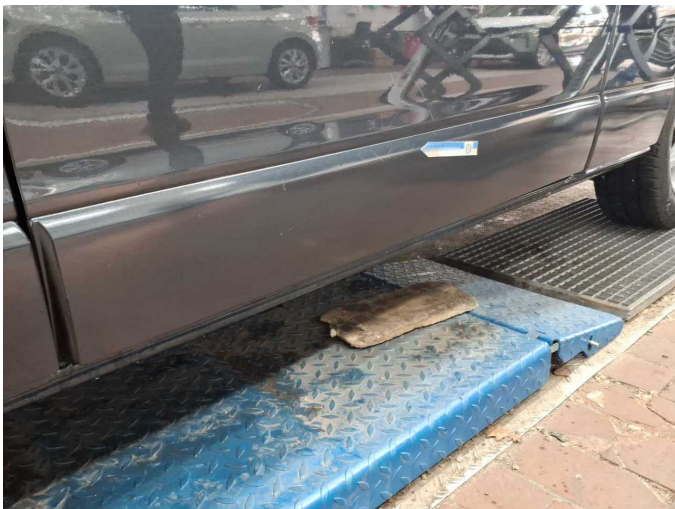
**Damage 2:** Door - rear left side: Brightware - lower - Scratch(es) - Smart repair

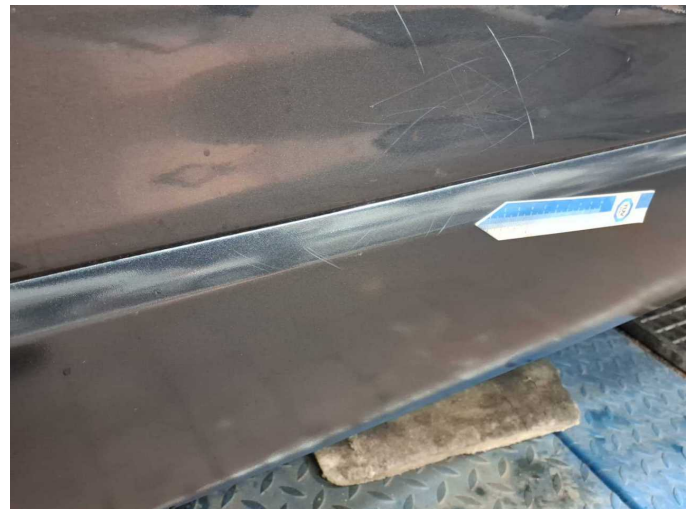
**Damage 2:** Door - rear left side: Brightware - lower - Scratch(es) - Smart repair

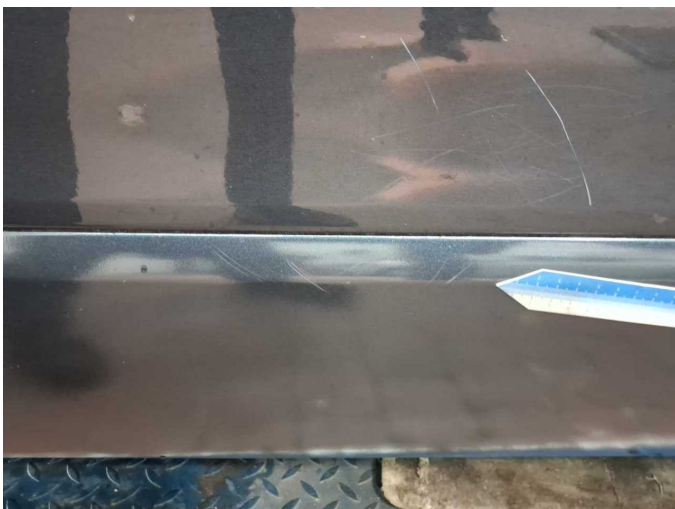
**Damage 2:** Door - rear left side: Brightware - lower - Scratch(es) - Smart repair

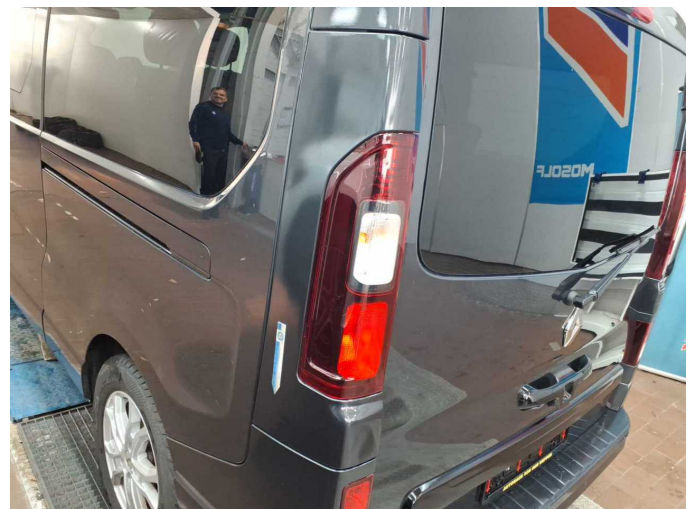
**Damage 3:** Side panel - rear left side: Side panel (Blende Heckleuchte) - Scratch(es) - Smart repair

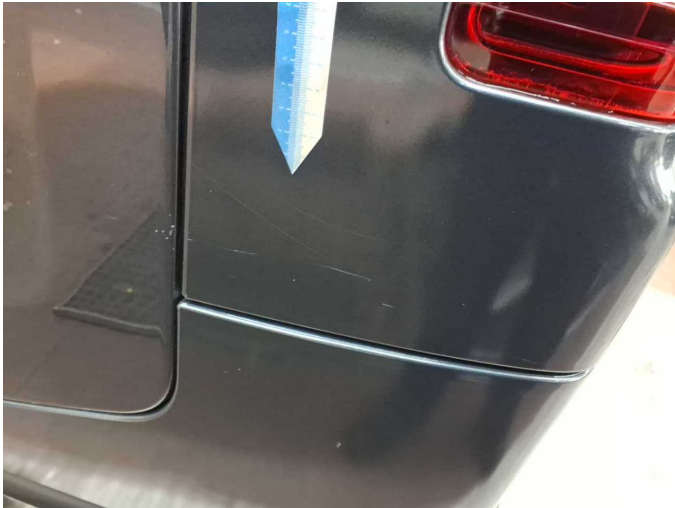
**Damage 3:** Side panel - rear left side: Side panel (Blende Heckleuchte) - Scratch(es) - Smart repair

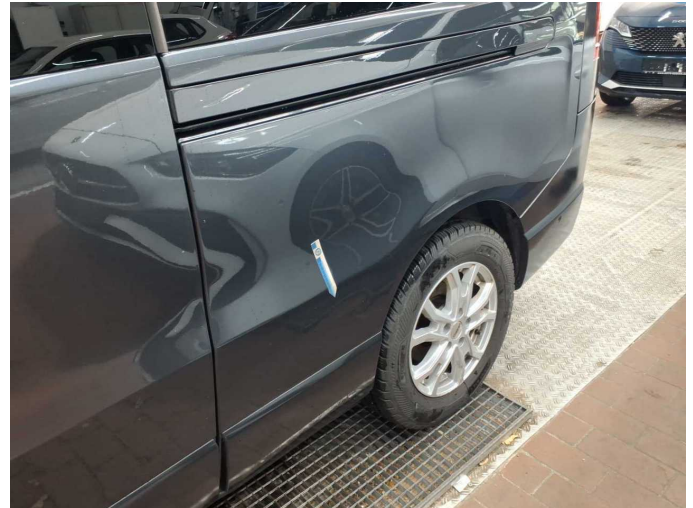
**Damage 4:** Side panel - rear left side: Side panel - dent(s) - Repair and paint

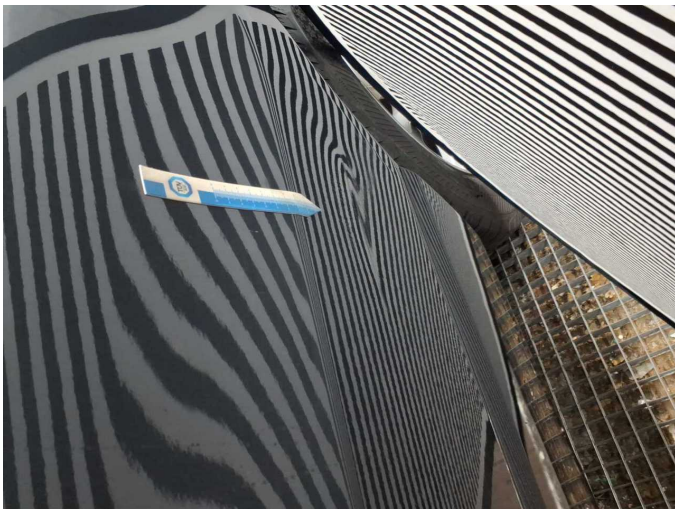
**Damage 4:** Side panel - rear left side: Side panel - dent(s) - Repair and paint

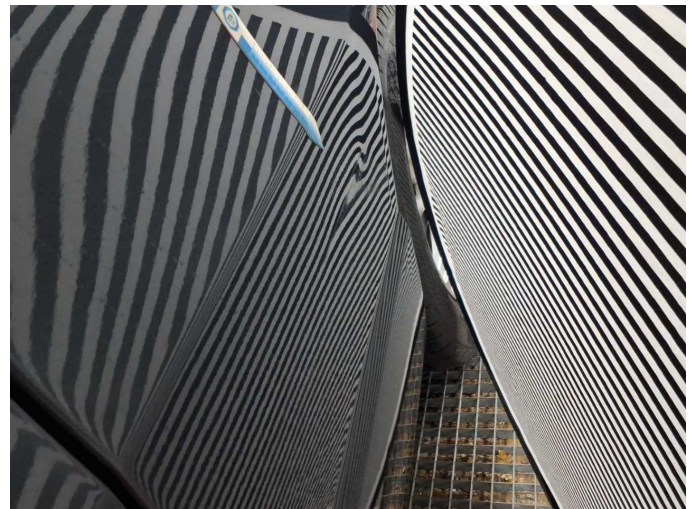
**Damage 4:** Side panel - rear left side: Side panel - dent(s) - Repair and paint

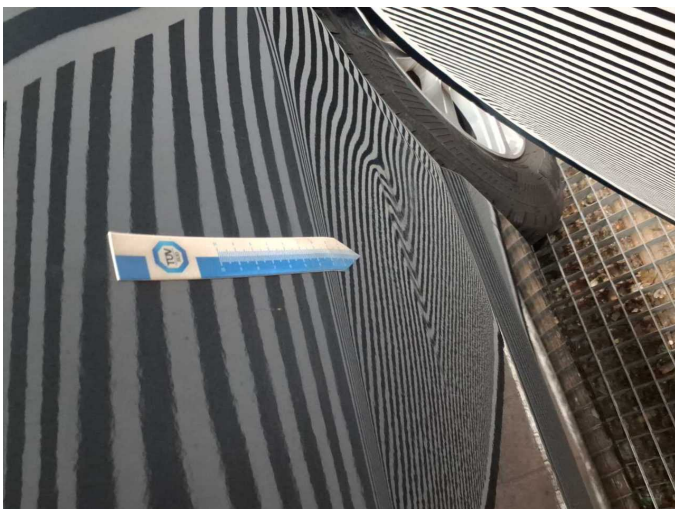
**Damage 4:** Side panel - rear left side: Side panel - dent(s) - Repair and paint

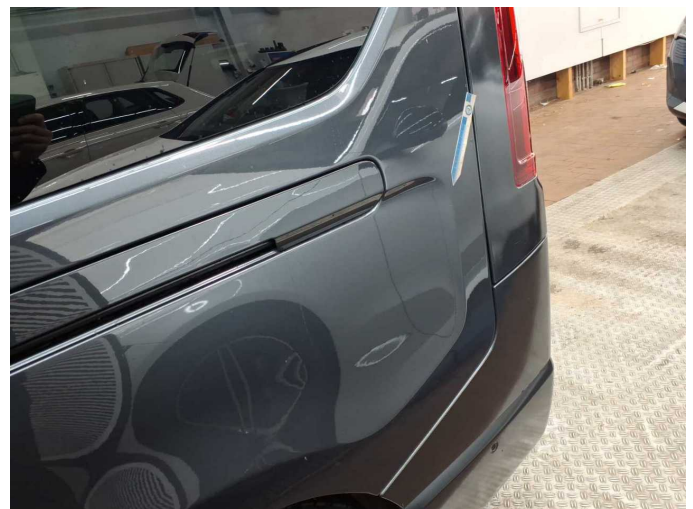
**Damage 4:** Side panel - rear left side: Side panel - dent(s) - Repair and paint

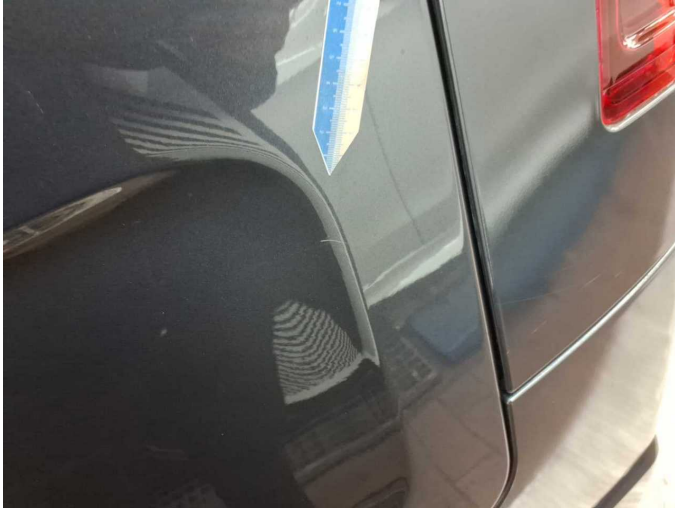
**Damage 4:** Side panel - rear left side: Side panel - dent(s) - Repair and paint

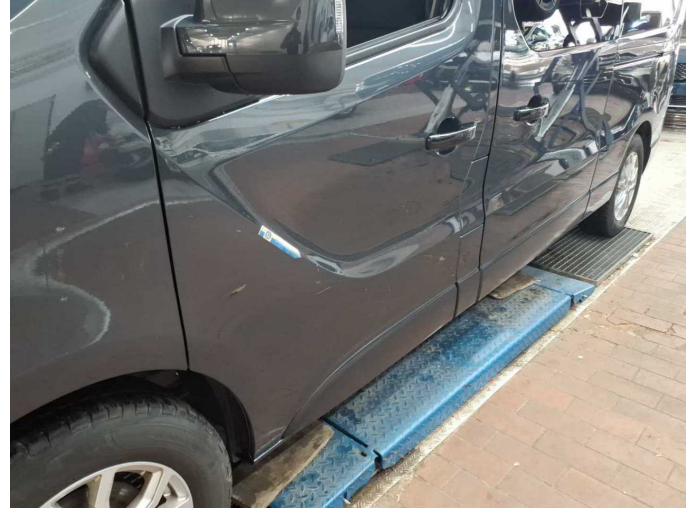
**Damage 5:** Door - front left side: Door - Scratch(es) - Paint

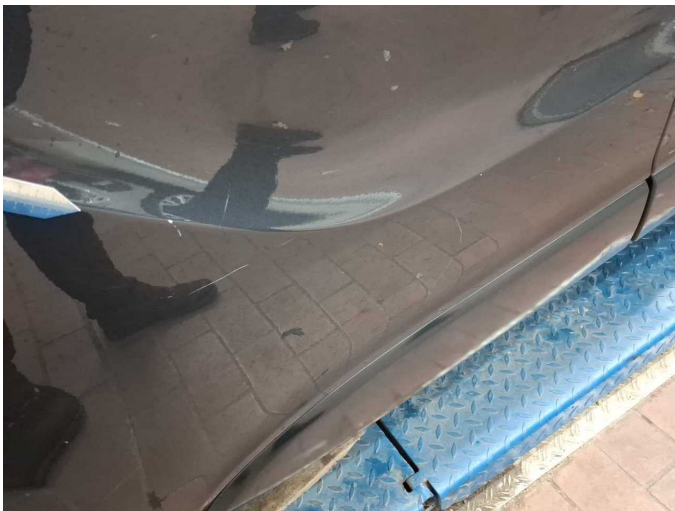
**Damage 5:** Door - front left side: Door - Scratch(es) - Paint

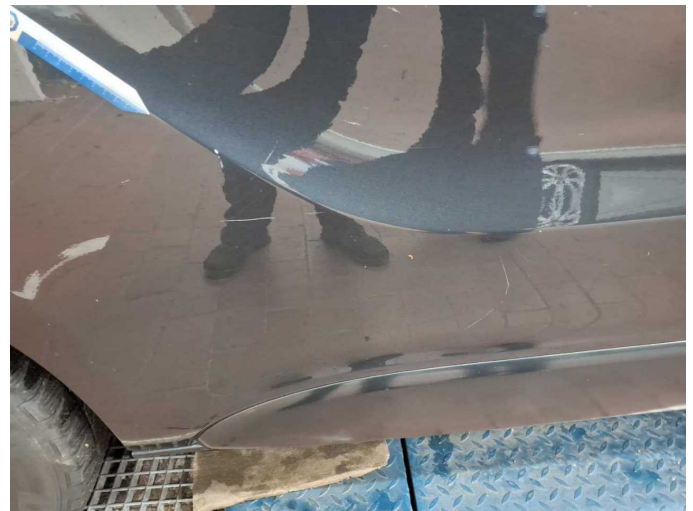
**Damage 5:** Door - front left side: Door - Scratch(es) - Paint

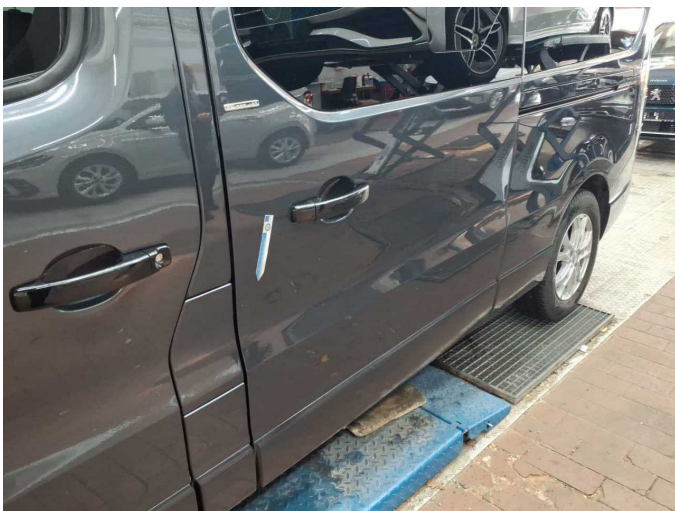
**Damage 6:** Door - rear left side: Door (Und kratzer) - dent(s) - Repair and paint

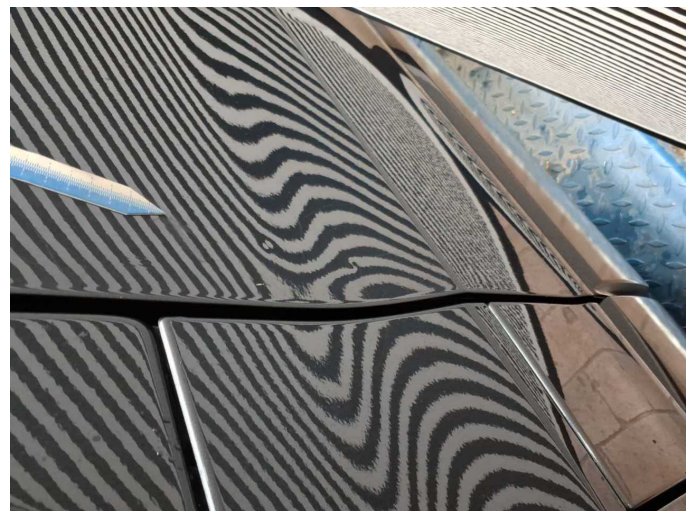
**Damage 6:** Door - rear left side: Door (Und kratzer) - dent(s) - Repair and paint

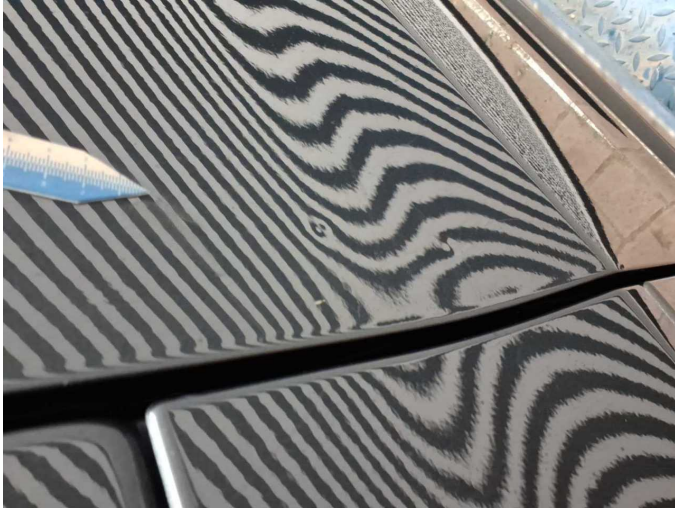
**Damage 6:** Door - rear left side: Door (Und kratzer) - dent(s) - Repair and paint

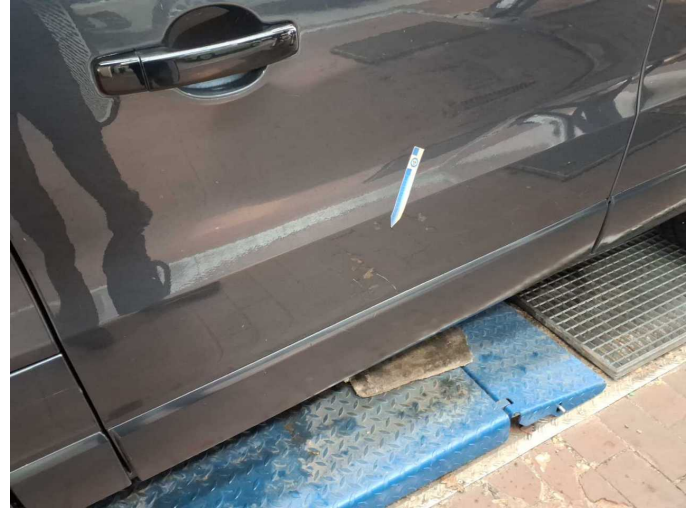
**Damage 6:** Door - rear left side: Door (Und kratzer) - dent(s) - Repair and paint

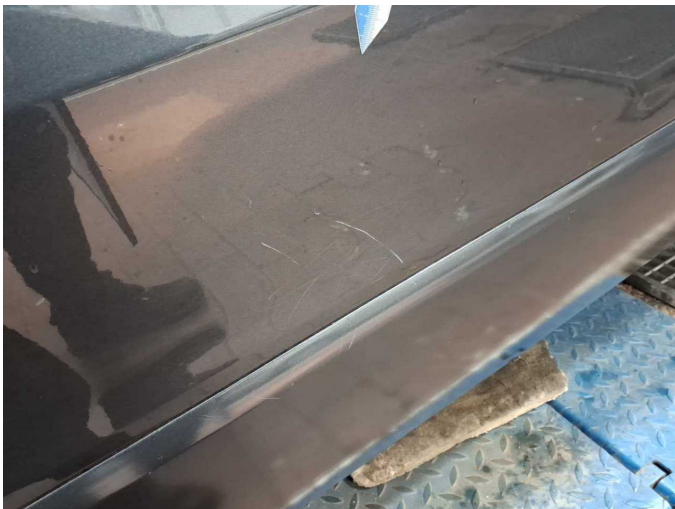
**Damage 6:** Door - rear left side: Door (Und kratzer) - dent(s) - Repair and paint

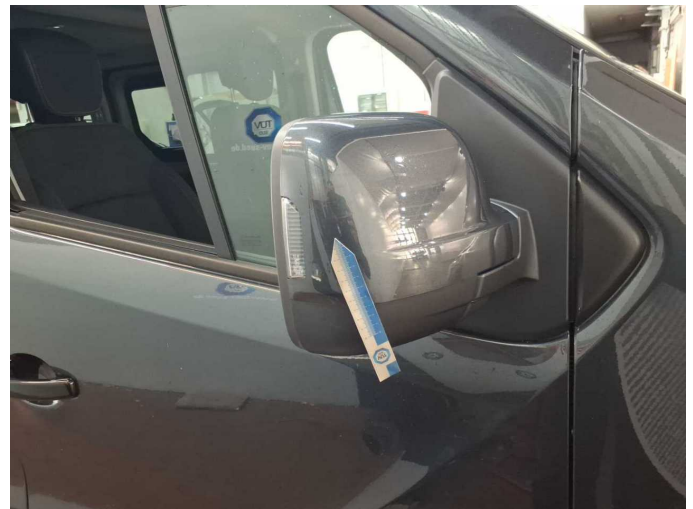
No.	Component group	Description
1	Wing mirror - right side	Cap - Scratch(es) - No deduction

**Wear and tear 1:** Wing mirror - right side: Cap - Scratch(es) - No deduction

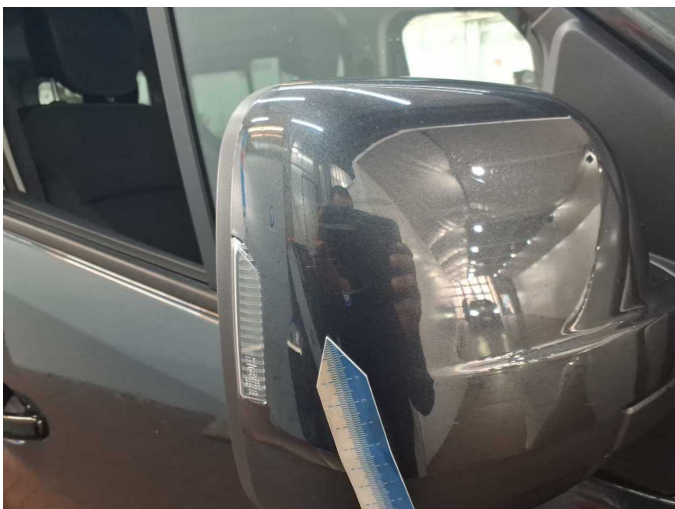
**Wear and tear 1:** Wing mirror - right side: Cap - Scratch(es) - No deduction
