Expertise

Protocol number: 46417624  
Order No. / Reference: 26600880  
Inspection date: 9 Jul 2026

| Manufacturer: Kia | Model: Ceed SW 1.6 CRDi Eco-Dynamics+(48V Mild-Hyb.) DCT7 Spirit |
| VIN: U5YH5819GNL120798 | |

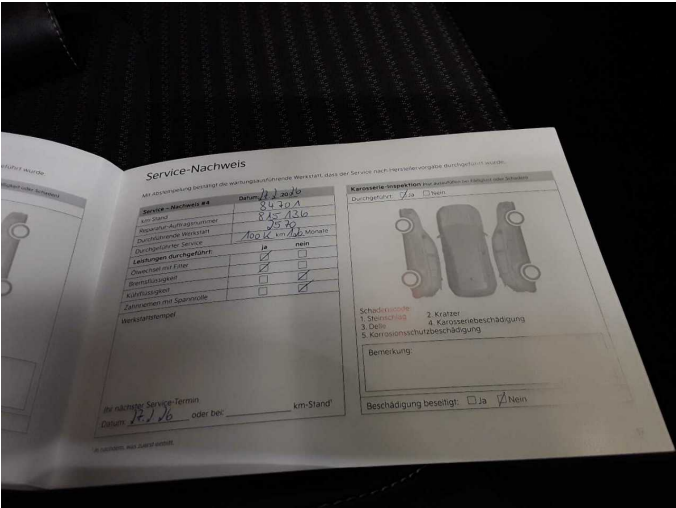
| No. | Component group | Description |
|---|---|---|
| 1 | Documents | Service book (Werkstattstempel fehlt) - Incomplete - No deduction |

Damage 1: Documents: Service book (Werkstattstempel fehlt) - Incomplete - No deduction

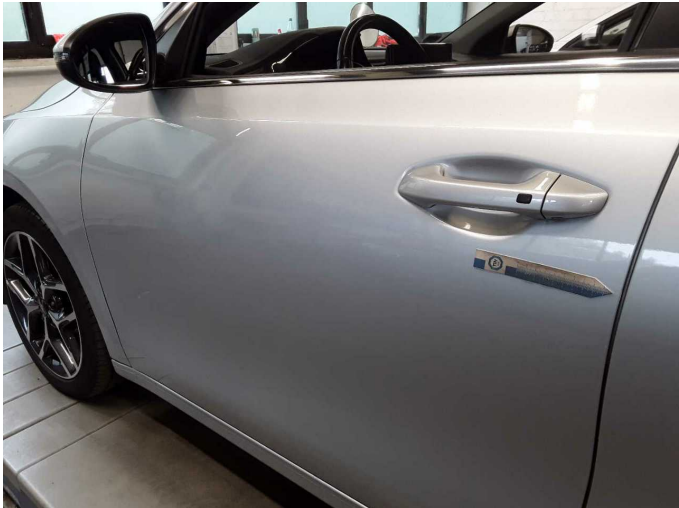
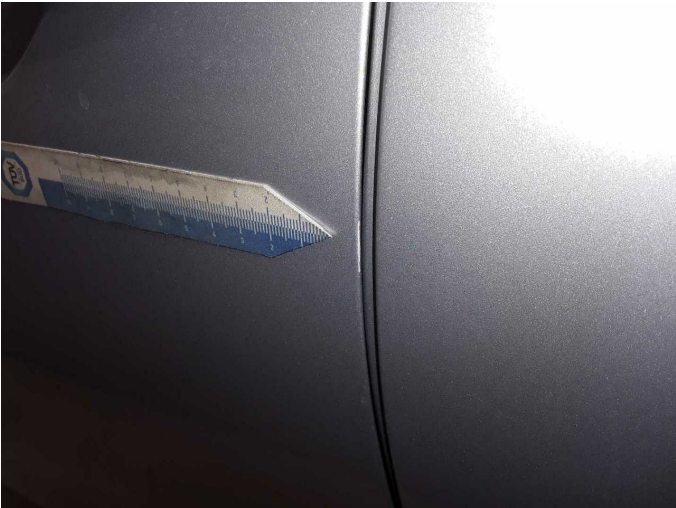
| No. | Component group | Description |
|---|---|---|
| 3 | Door - front left side | Door edge - Scratch(es) - Smart repair |

Damage 3: Door - front left side: Door edge - Scratch(es) - Smart repair

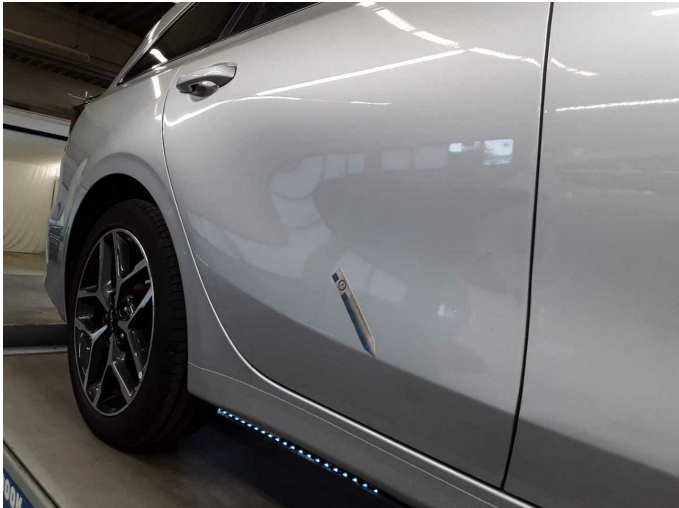
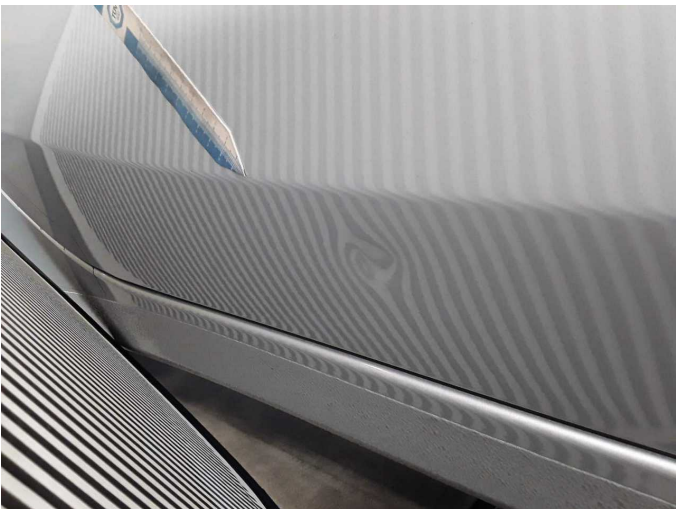
| No. | Component group | Description |
|---|---|---|
| 4 | Door - rear right side | Door - dent(s) - Smooth repair work |

Damage 4: Door - rear right side: Door - dent(s) - Smooth repair work

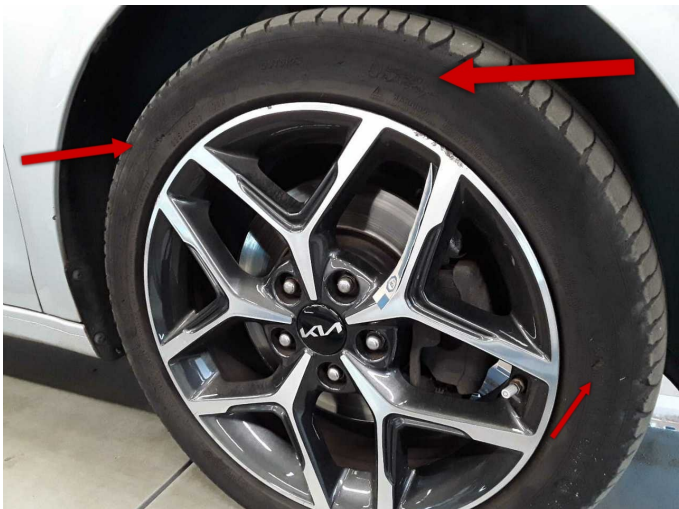
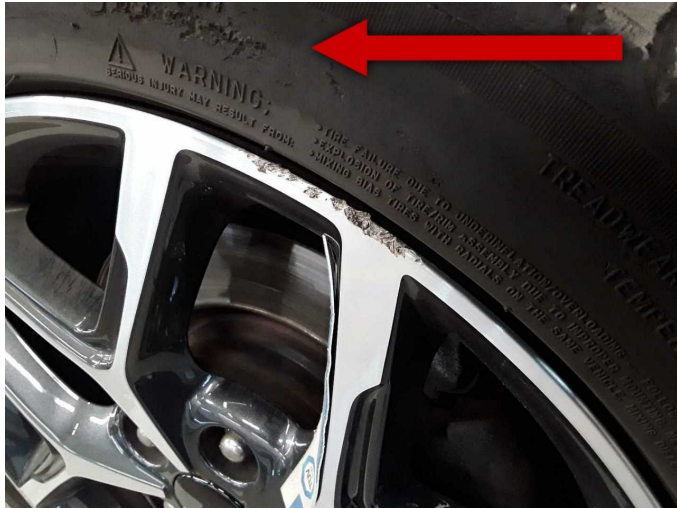
| No. | Component group | Description |
|---|---|---|
| 5 | Wheel / tyres | Tyre - front right side - Porous / cracked - Replace |

Damage 5: Wheel / tyres: Tyre - front right side - Porous / cracked - Replace

**Damage 5:** Wheel / tyres: Tyre - front right side - Porous / cracked - Replace

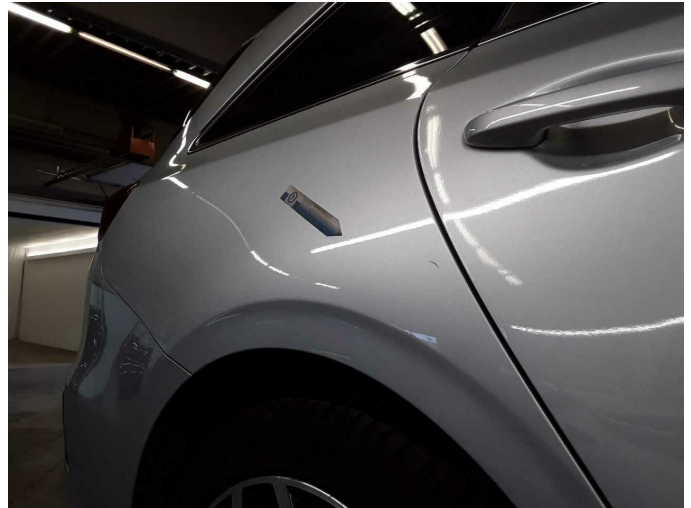
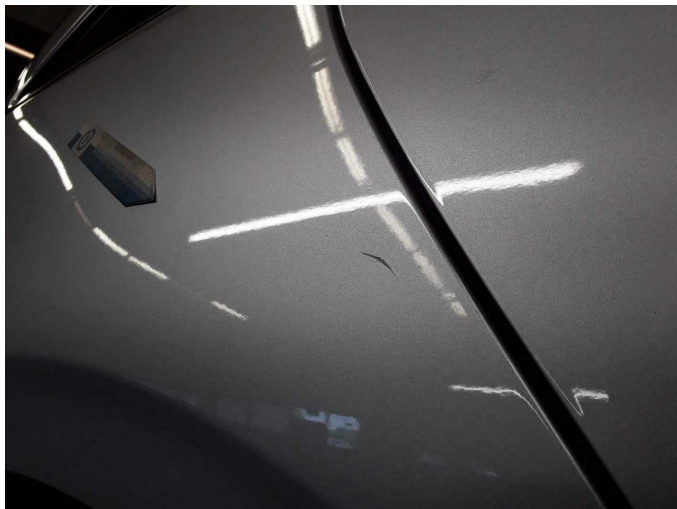
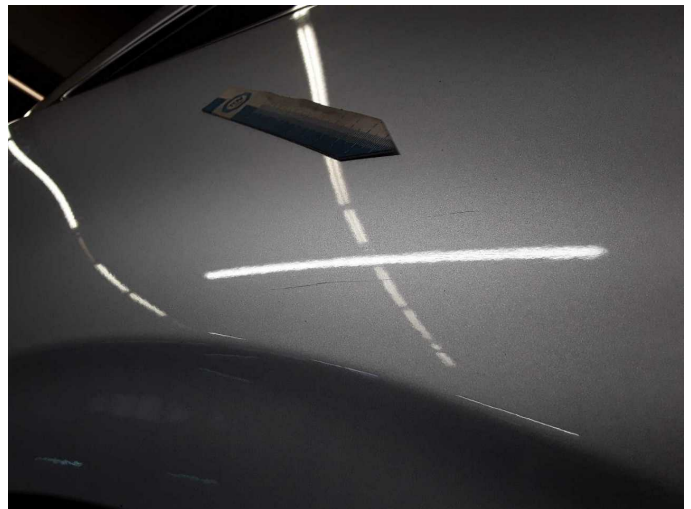
| No. | Component group | Description |
|---|---|---|
| 6 | Side panel - rear right side | Side panel - Scratch(es) - Smart repair |

**Damage 6:** Side panel - rear right side: Side panel - Scratch(es) - Smart repair

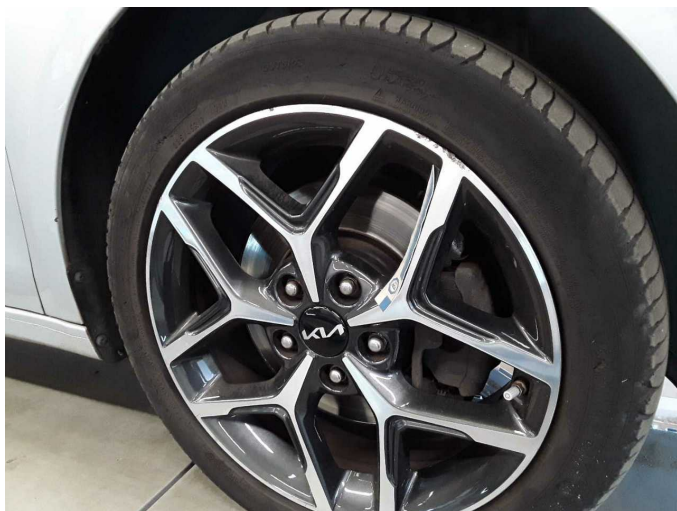
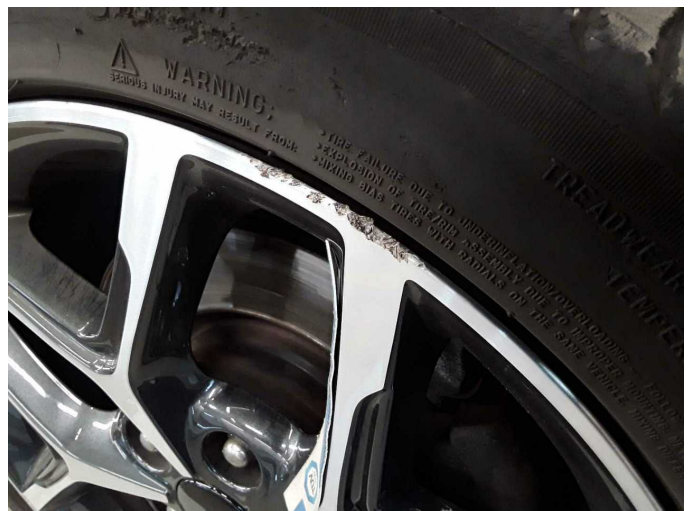
| No. | Component group | Description |
|---|---|---|
| 7 | Wheel / tyres | Alloy rim - front right side - Scratched - Replace |

**Damage 7:** Wheel / tyres: Alloy rim - front right side - Scratched - Replace
