- Vehicle Inspection Report -

Number: 10145603
From: 02.03.2026

Order number: 1002340650
Order completed: 02.03.2026 08:58
Report number: 10145603
VIN: VSSZZZKL3SR057041

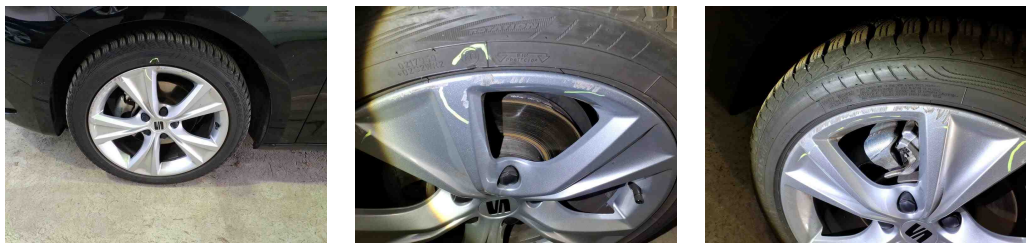
1 - Alloy rim FL - Scratch(es) - Replace
Safety relevant damage

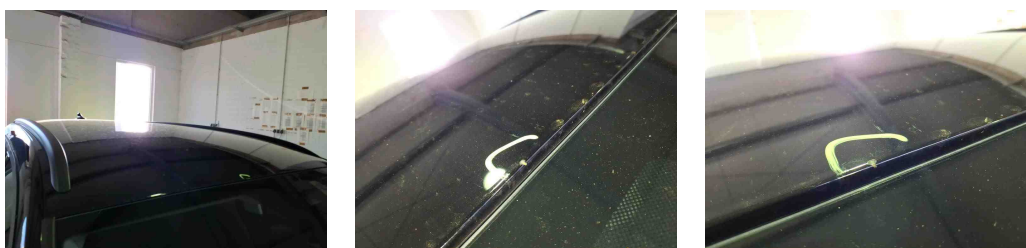
2 - Roof - Rust - Repair and paint (complete)

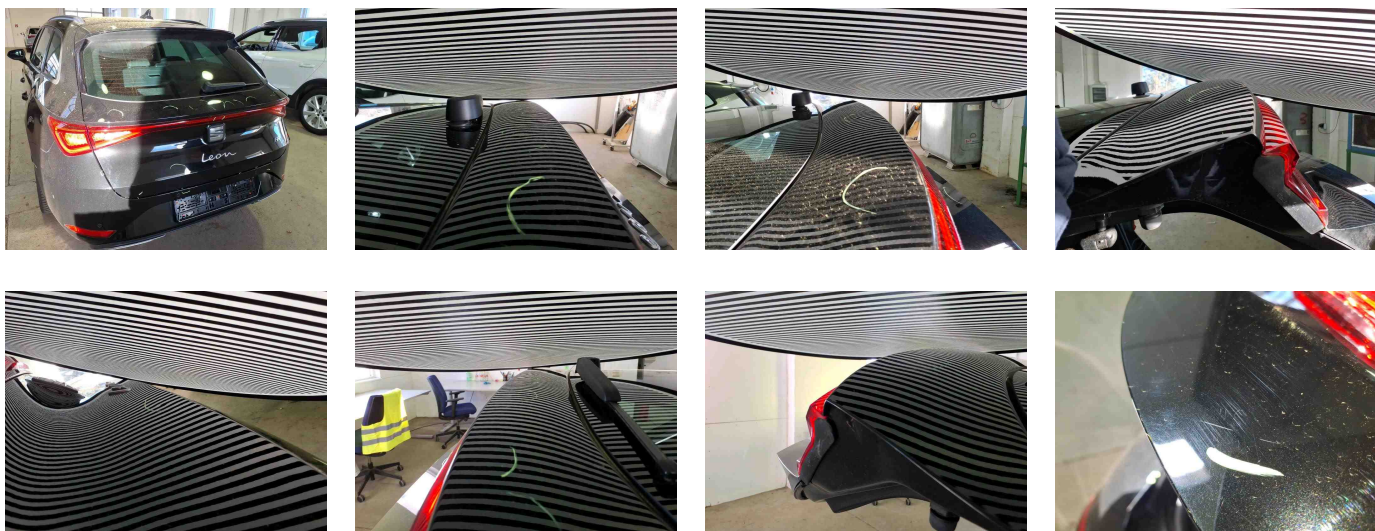
3 - Tailgate / Boot - Dent(s) and scratch(es) - Repair and paint (complete)

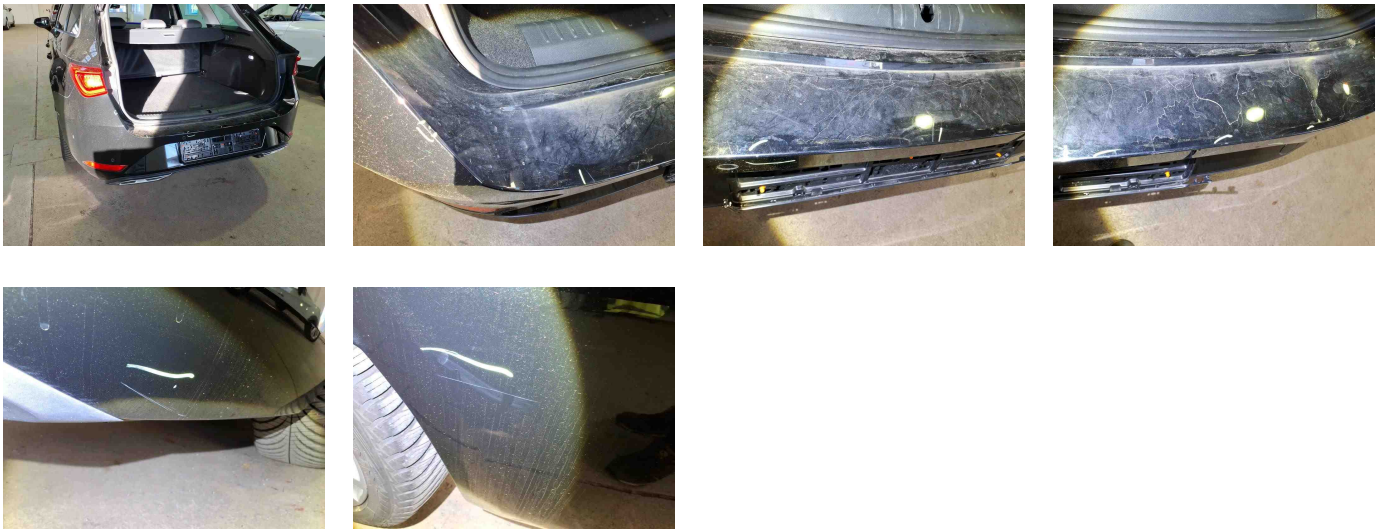
4 - Bumper R - Scratch(es) - Paint

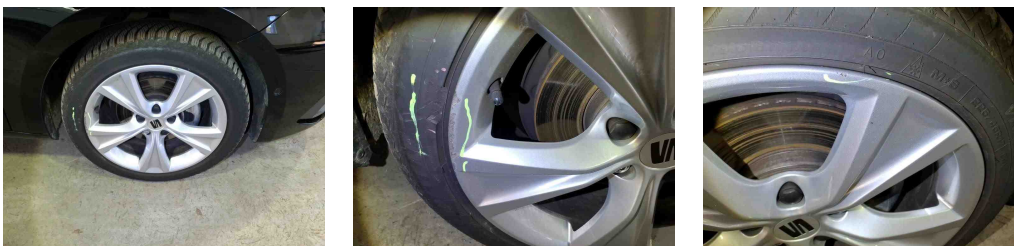
7 - Alloy rim FR - Scratch(es) - Visual depreciation

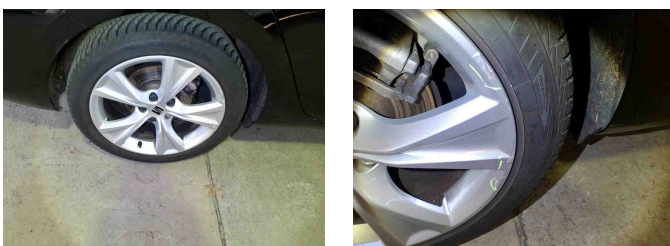
8 - Alloy rim RR - Scratch(es) - Visual depreciation

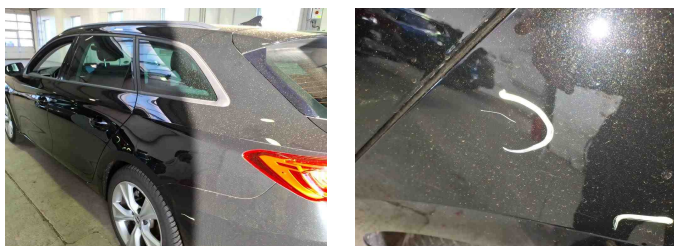
9 - Side wall RL - Scratch(es) - Spot repair

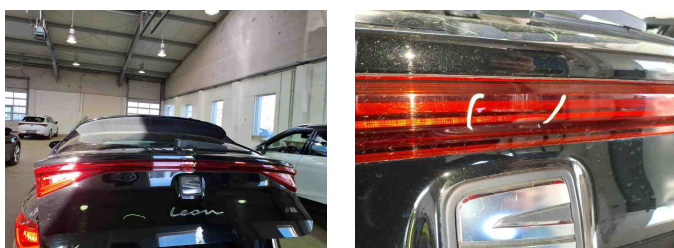
10 - Rear light R tailgate - Scratch(es) - Visual depreciation

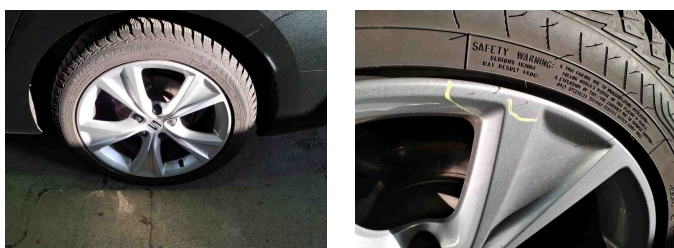
11 - Alloy rim RL - Scratch(es) - Visual depreciation

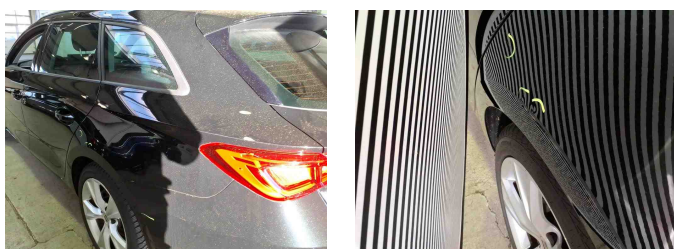
12 - Side wall RL - Dent(s) - Paintless dent repair

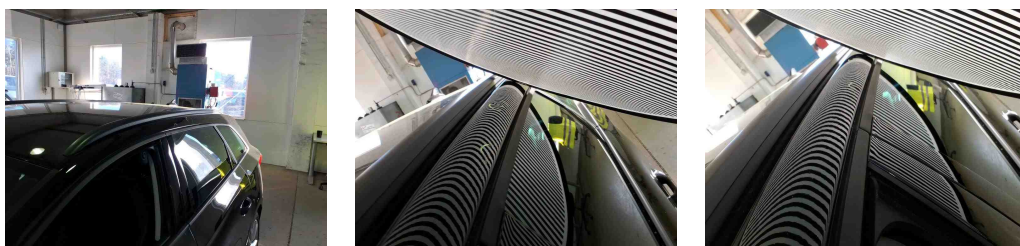
13 - Roof pillar L - Dent(s) - Paintless dent repair
