Expertise

Protocol number: 46510325  
Order No. / Reference: 26185368  
Inspection date: 13 Jul 2026

Manufacturer: Mercedes-Benz

Model: Vito 116 CDI Lang HA Aut. PRO

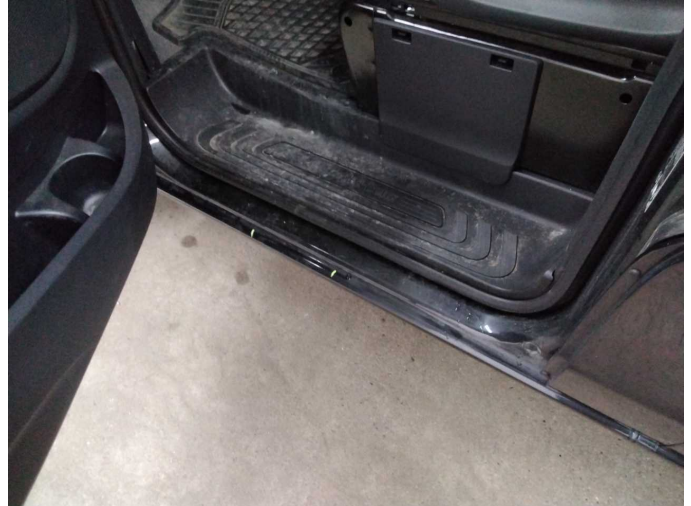
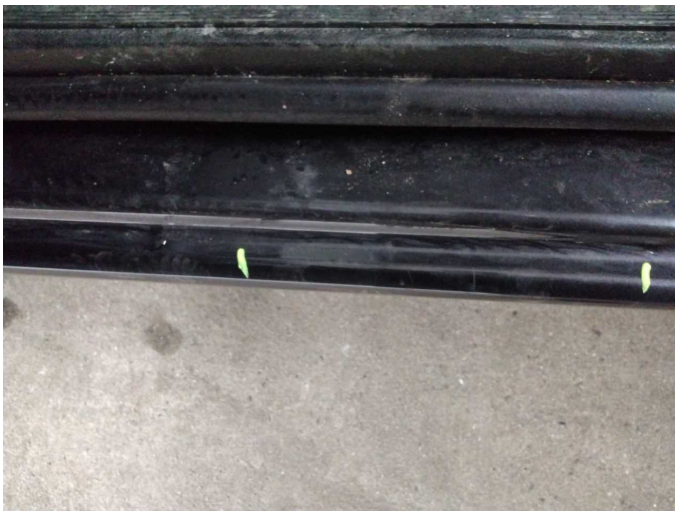
| No. | Component group | Description |
|---|---|---|
| 1 | Sill - left side | Sill - Scratch(es) - Smart repair |

**Damage 1:** Sill - left side: Sill - Scratch(es) - Smart repair

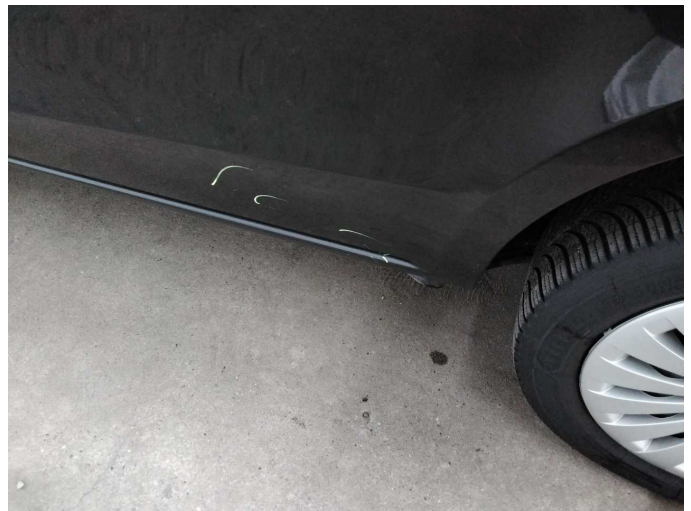
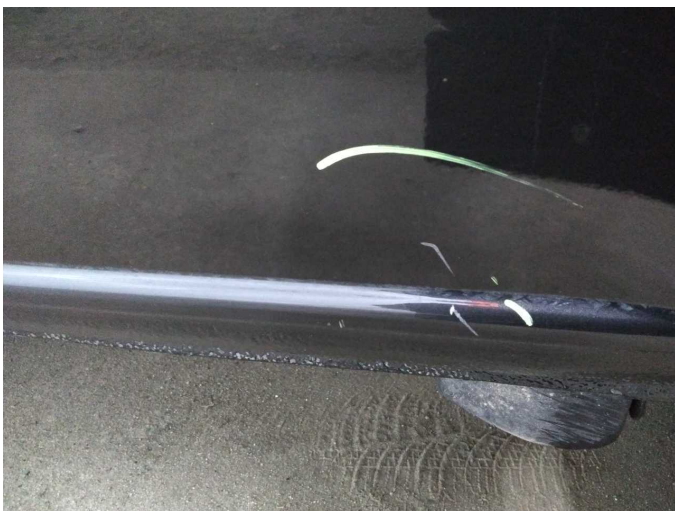
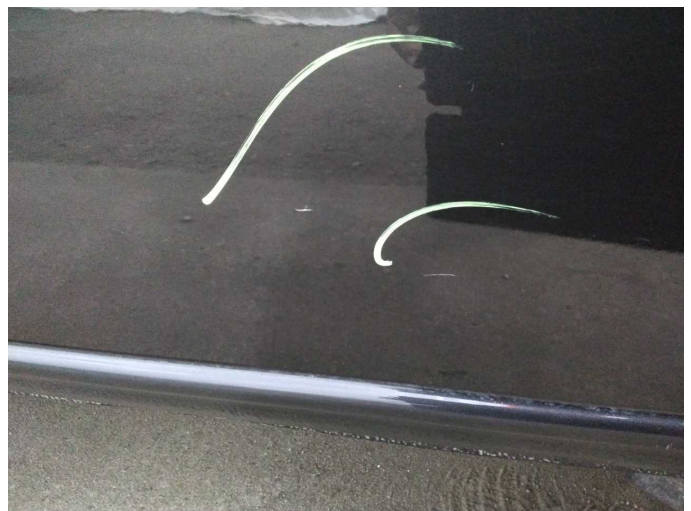
| No. | Component group | Description |
|---|---|---|
| 2 | Side panel - rear left side | Side panel - Scratch(es) - Smart repair |

**Damage 2:** Side panel - rear left side: Side panel - Scratch(es) - Smart repair

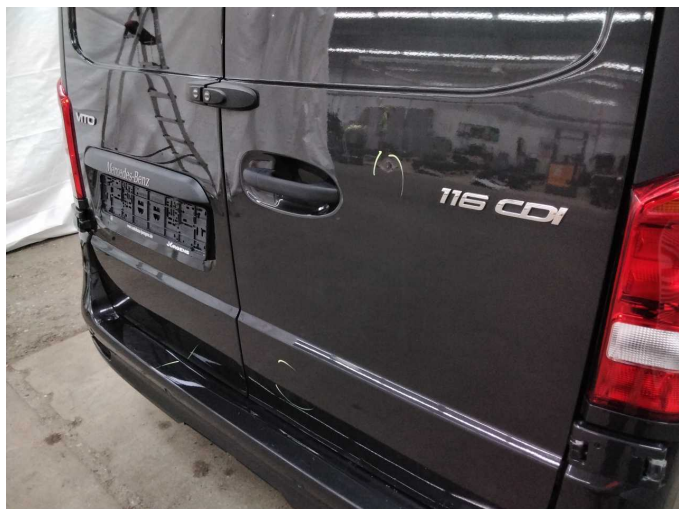
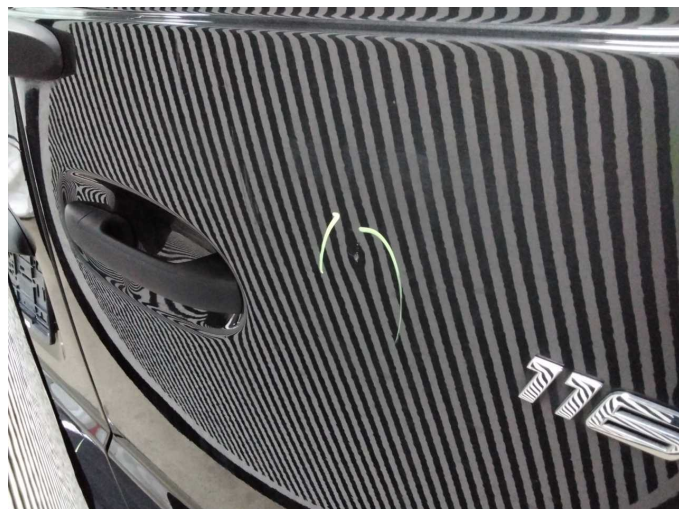
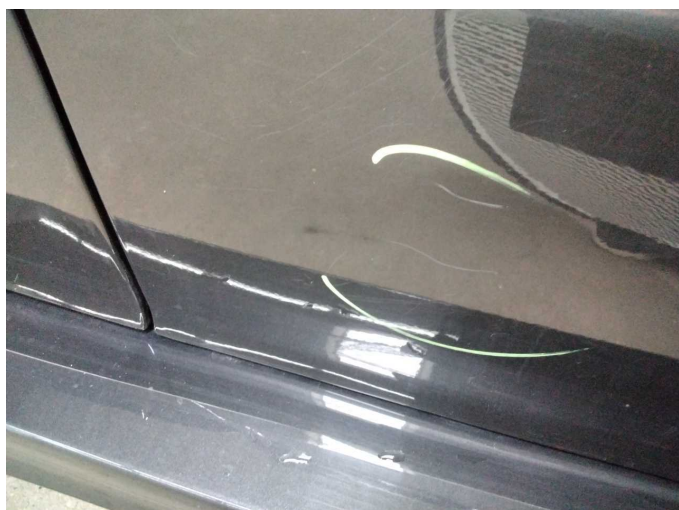
| No. | Component group | Description |
|---|---|---|
| 3 | Boot lid / rear door | Rear door - right side - Dent / paintcoat damage - Smart repair |

**Damage 3:** Boot lid / rear door: Rear door - right side - Dent / paintcoat damage - Smart repair

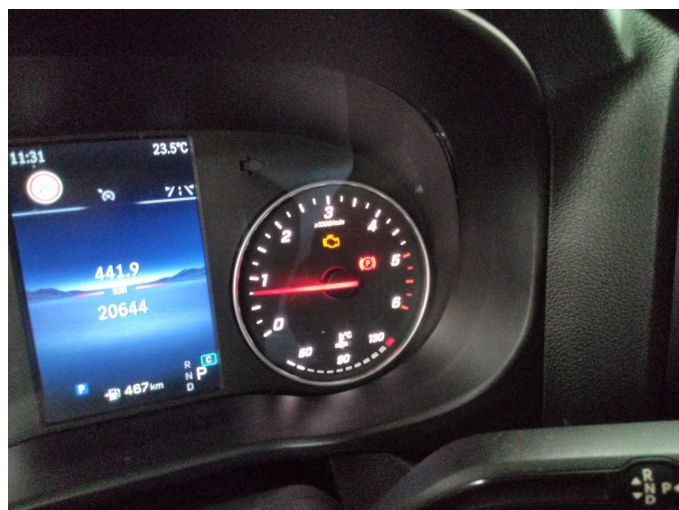
| Engine function test | An engine test run was performed.<br>This is due to the following reason.:<br>Motorkontrolle aktiv |

| No. | Component group | Description |
|---|---|---|
| 4 | Instrument panel | Indicator light (Motorkontrolle) - on - Perform diagnosis |

**Damage 4:** Instrument panel: Indicator light (Motorkontrolle) - on - Perform diagnosis

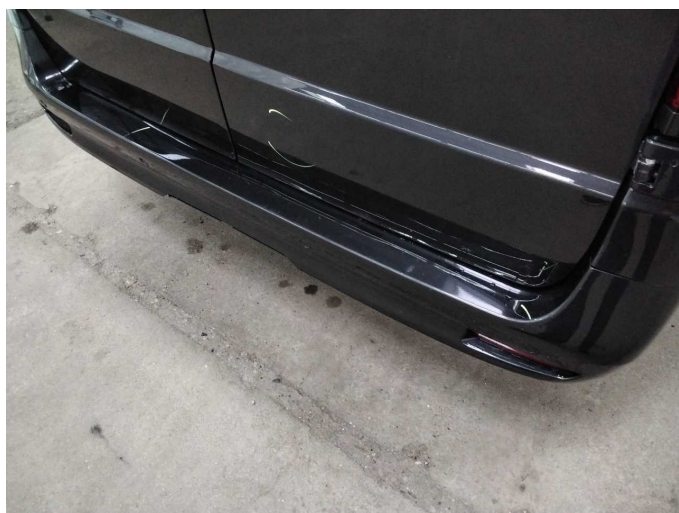
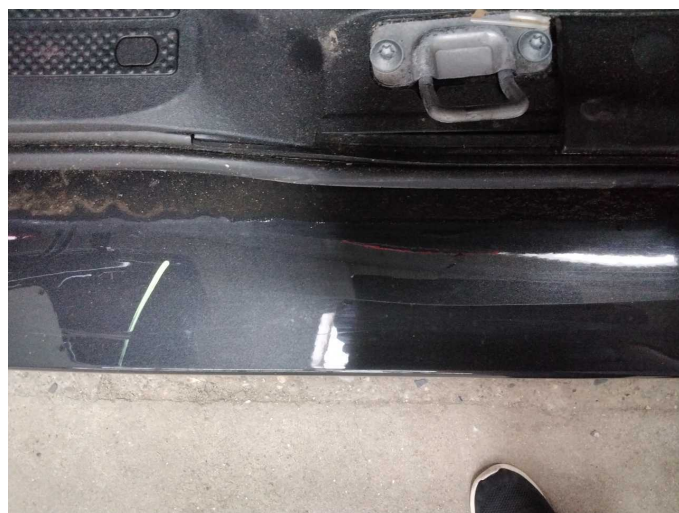
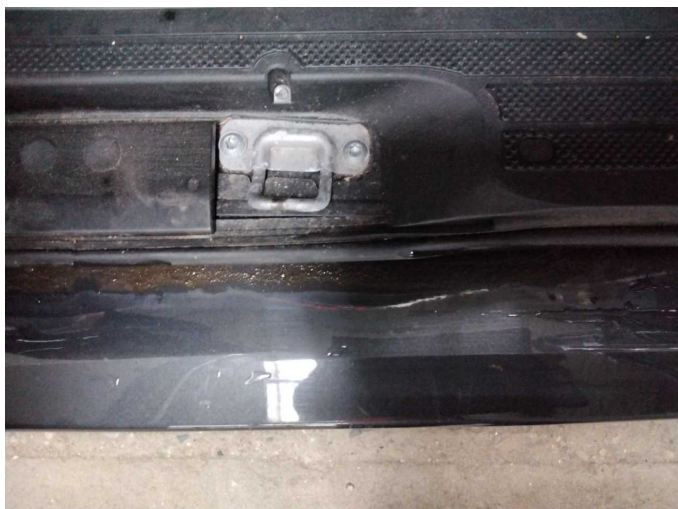
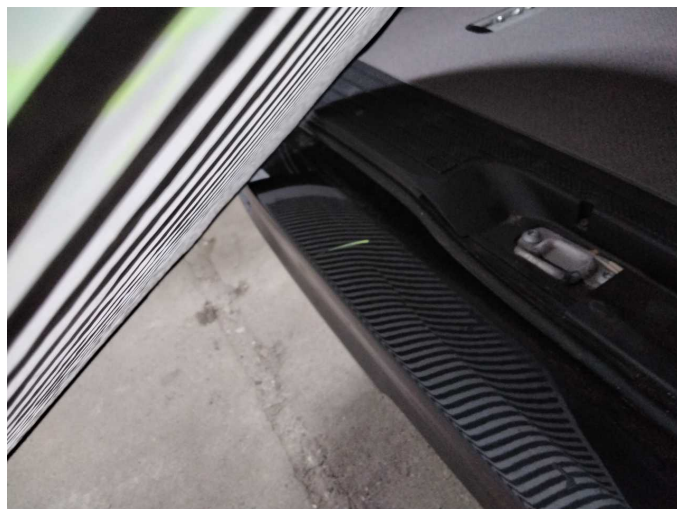
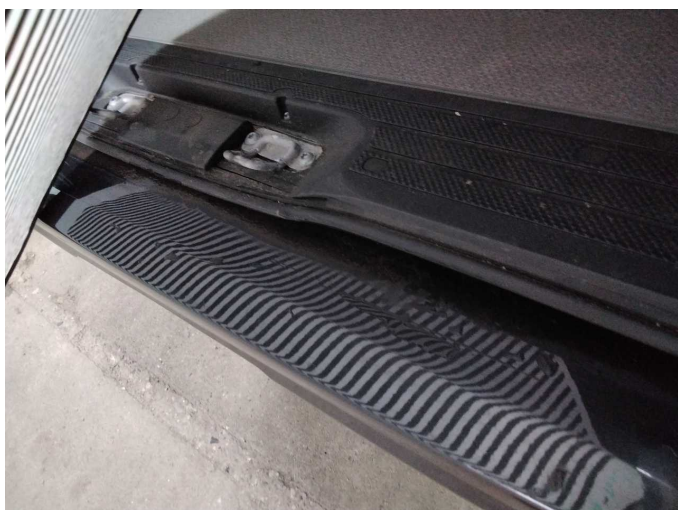
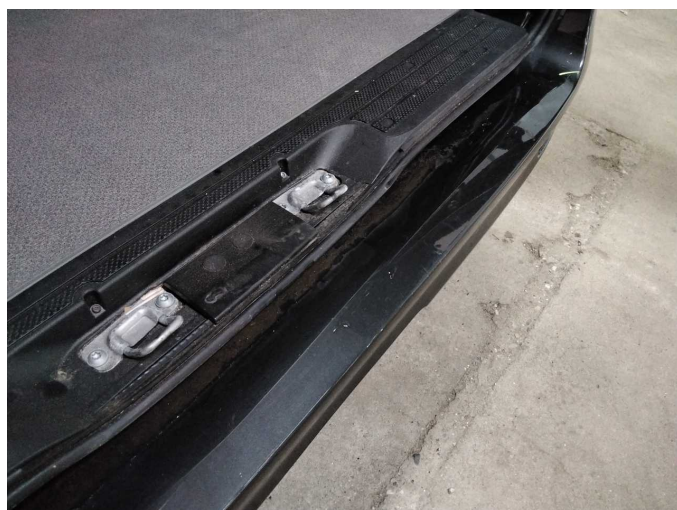
| No. | Component group | Description |
|---|---|---|
| 5 | Rear bumper | Rear bumper (inkl. Träger) - Deformed - Replace |

**Damage 5:** Rear bumper: Rear bumper (inkl. Träger) - Deformed - Replace

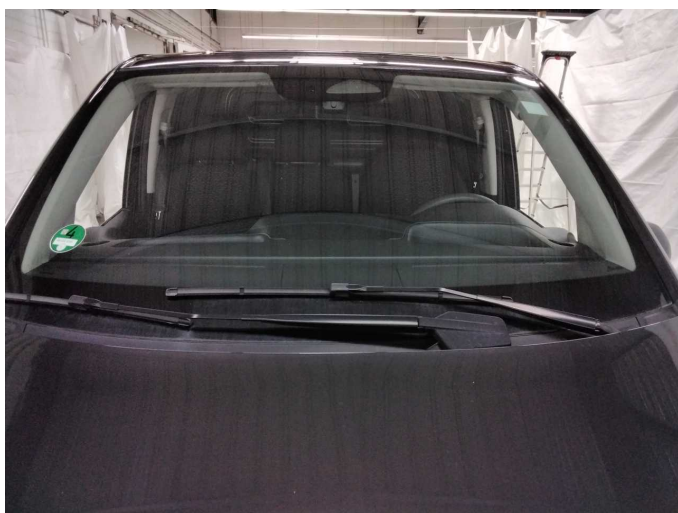
| No. | Component group | Description |
|---|---|---|
| 1 | Vehicle glazing | Windscreen - Stone chips - No deduction |

**Wear and tear 1:** Vehicle glazing: Windscreen - Stone chips - No deduction

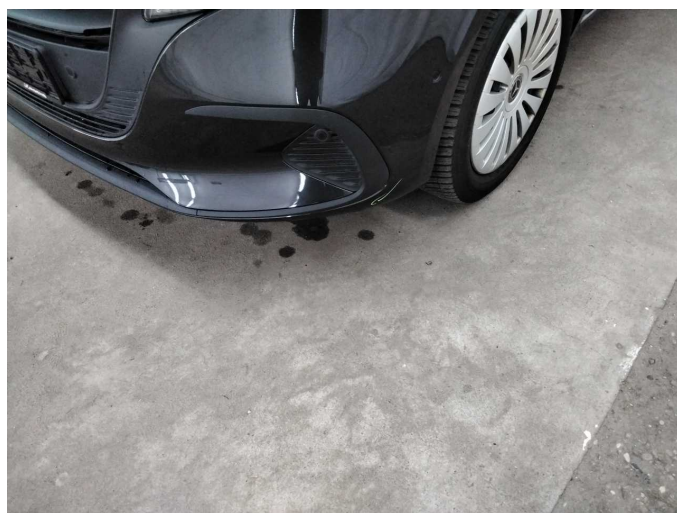
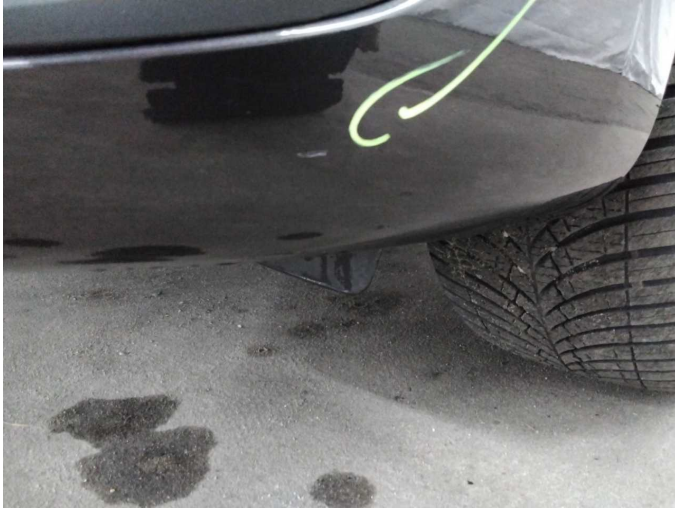
| No. | Component group | Description |
|---|---|---|
| 6 | Front bumper | Front bumper - Scratch(es) - No deduction |

**Wear and tear 6:** Front bumper: Front bumper - Scratch(es) - No deduction

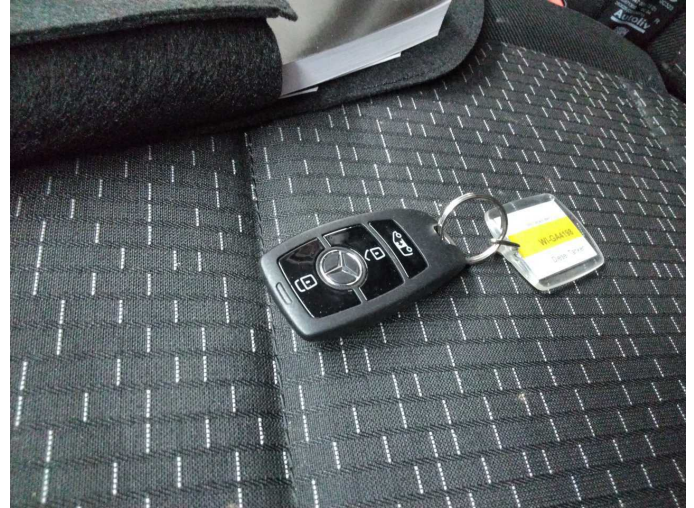
Equipment - Vehicle key

**Missing part 1:** Equipment: Vehicle key - Missing - Replace
