Expertise

Protocol number: 46114796
Order No. / Reference: 26541759
Inspection date: 24 Jun 2026

Model: Octavia Combi 2.0 TDI DSG Sportline

VIN: TMBJJ8NX5PY038633

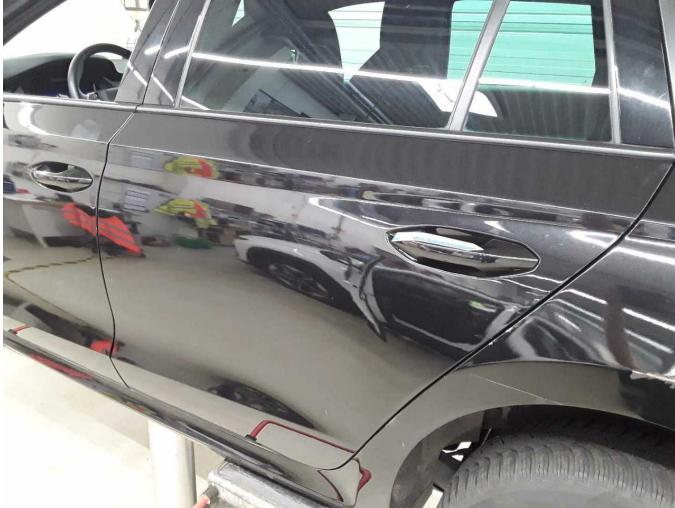
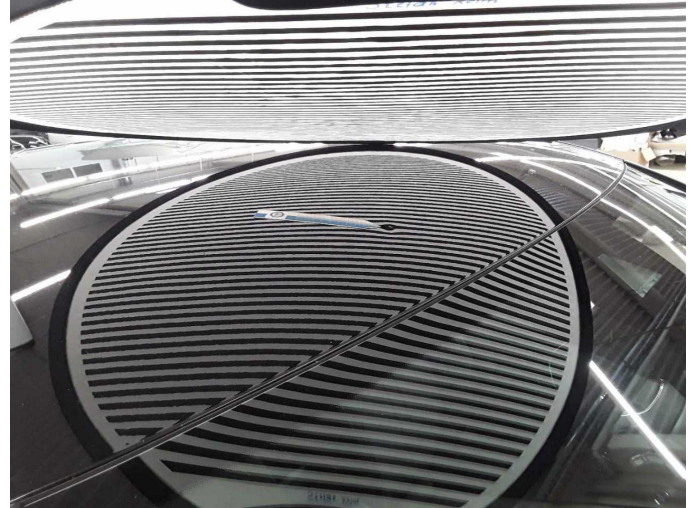
Damage 1: Door - rear left side: Door handle - outside - Scratched - Smart repair

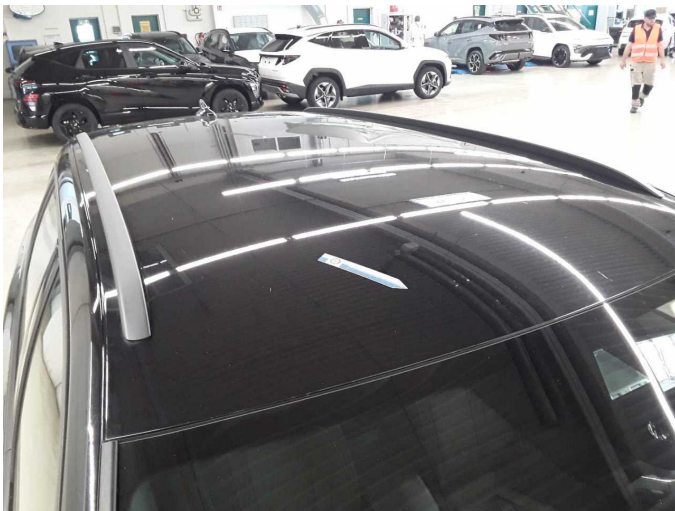
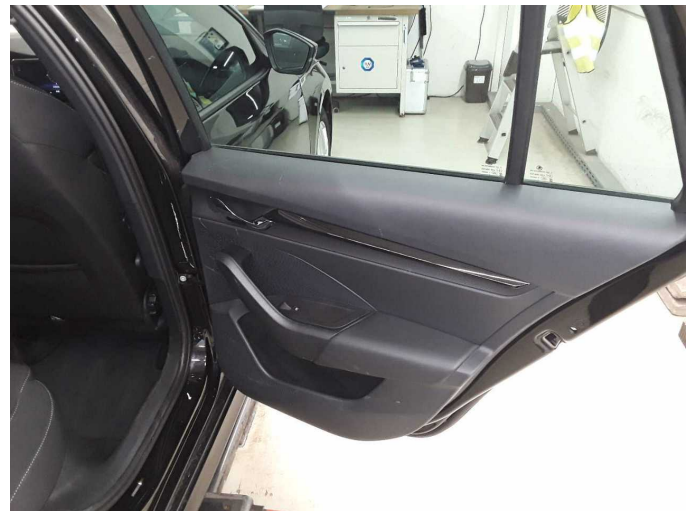
Damage 2: Roof: Roof - dent(s) - Smart repair

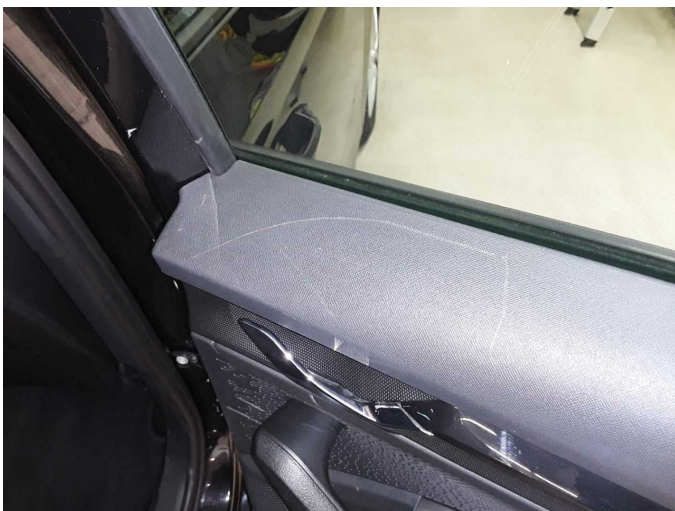
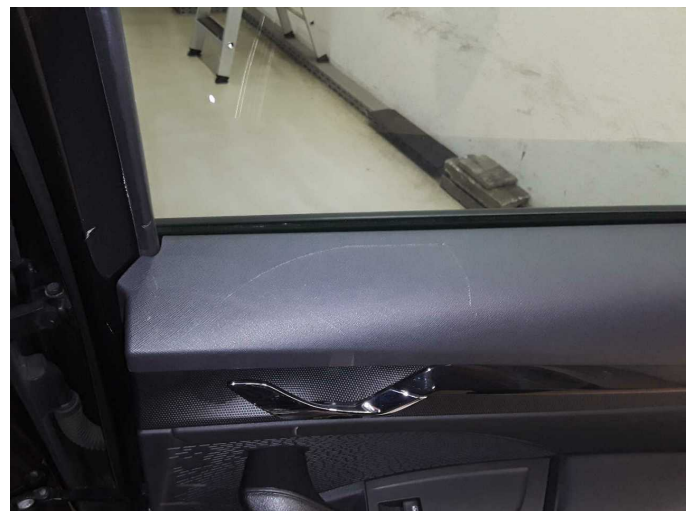
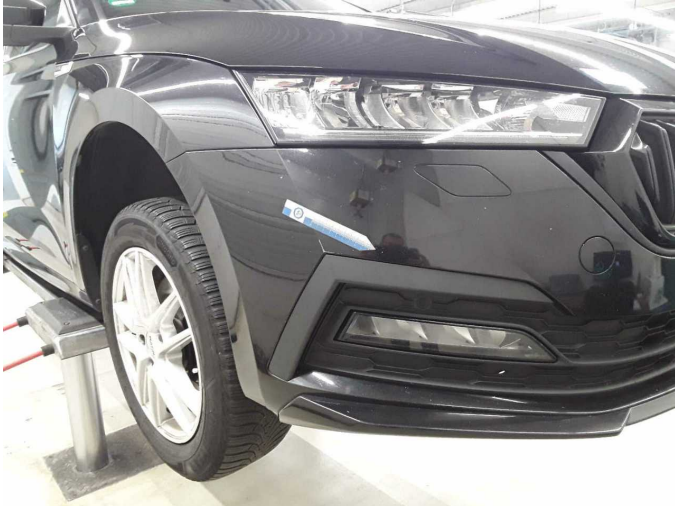
Damage 3: Trim / covers: Door trim - rear right side - Scratch(es) - Loss in value

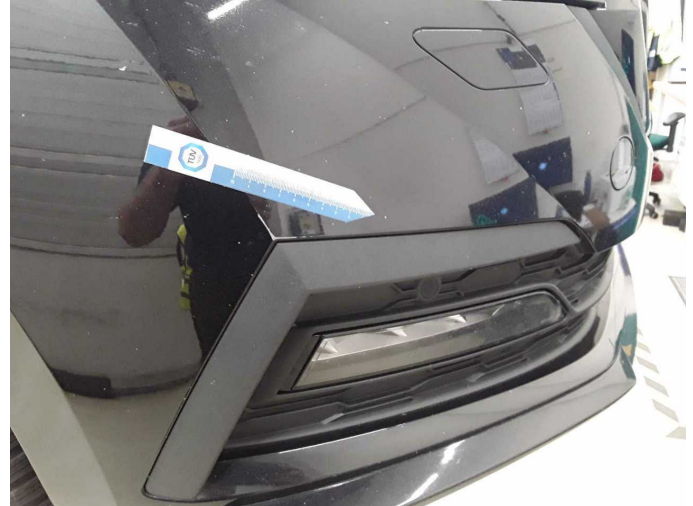
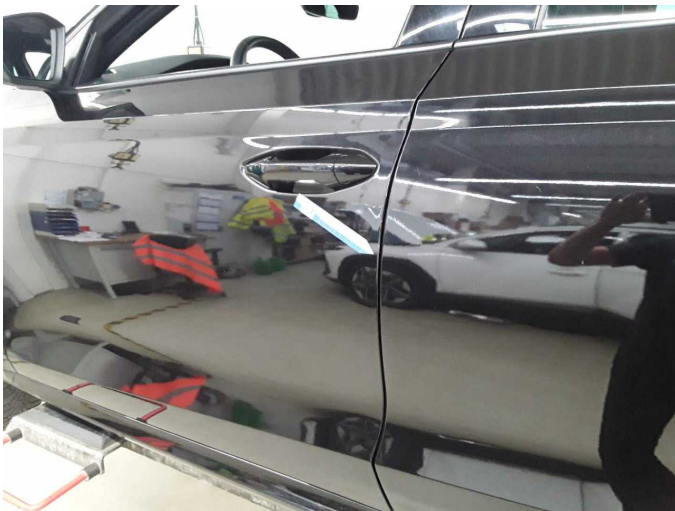
Damage 4: Front bumper: Front bumper - Scratch(es) - Smart repair

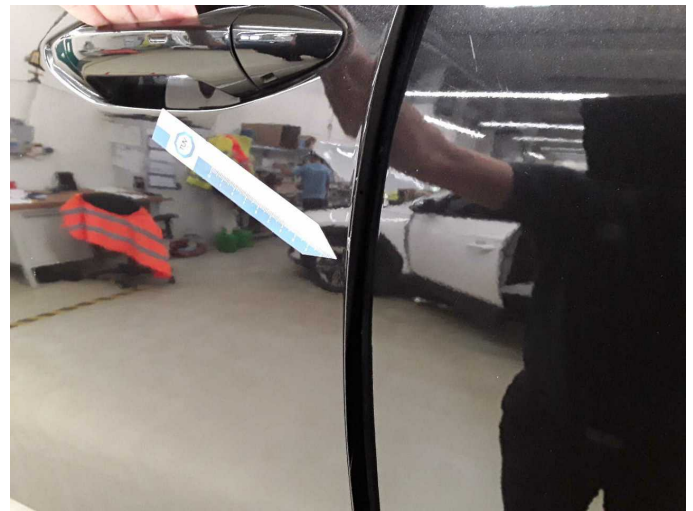
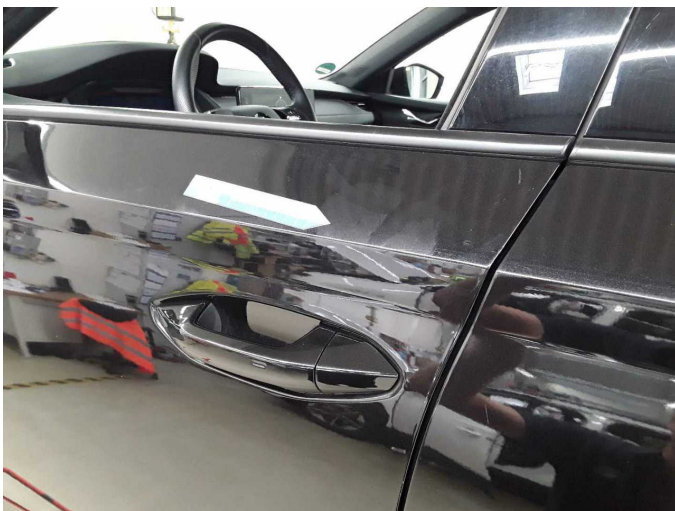
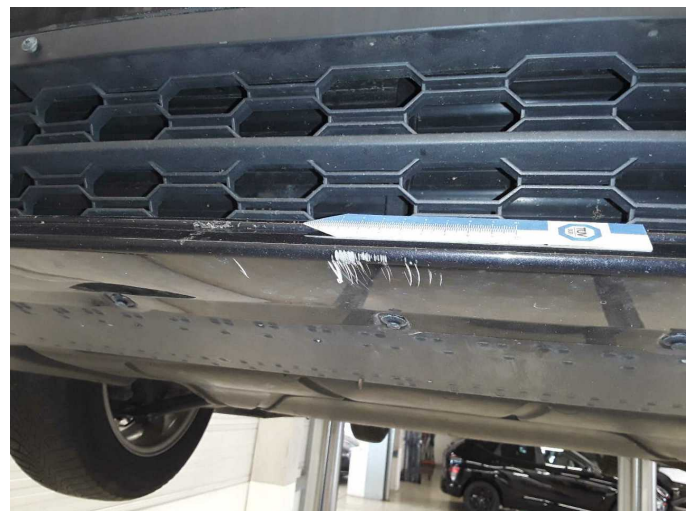
Damage 5: Door - front left side: Door - Scratch(es) - Smart repair

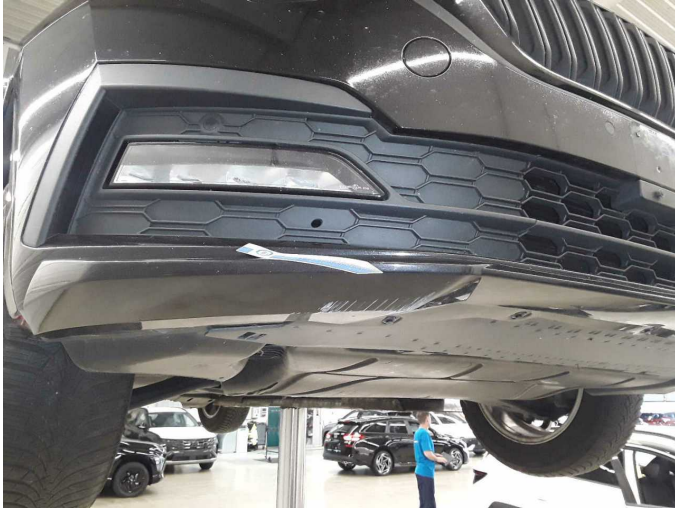
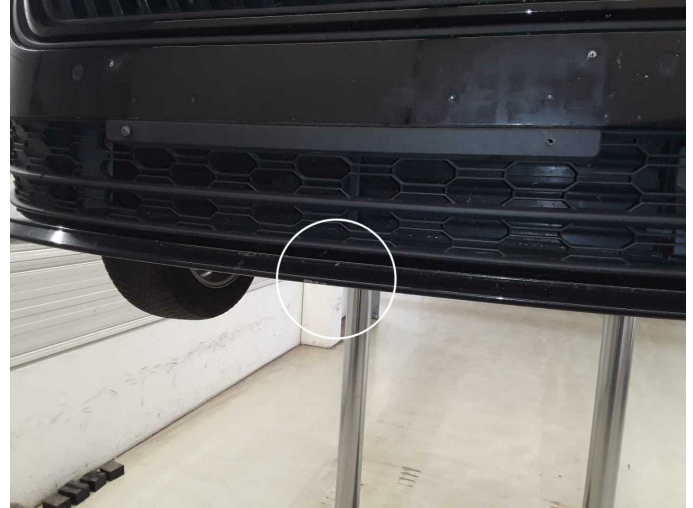
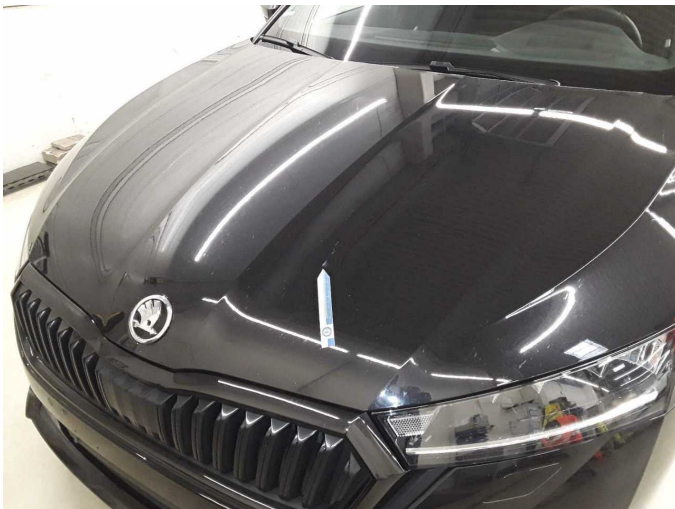
Damage 6: Front bumper: Spoiler - Scratch(es) - Smart repair

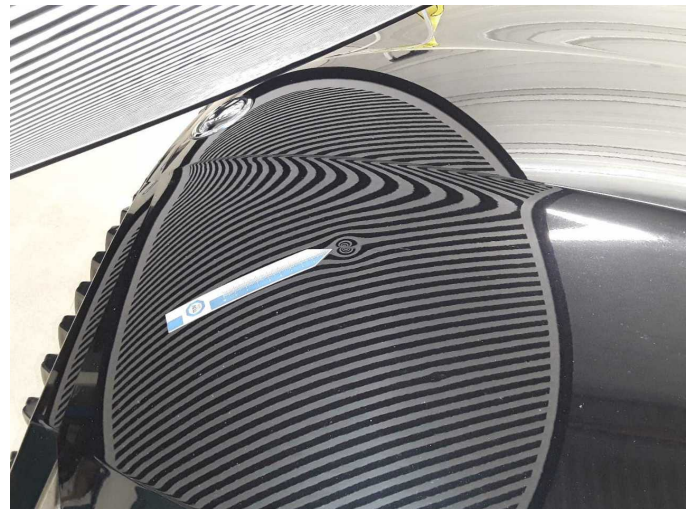
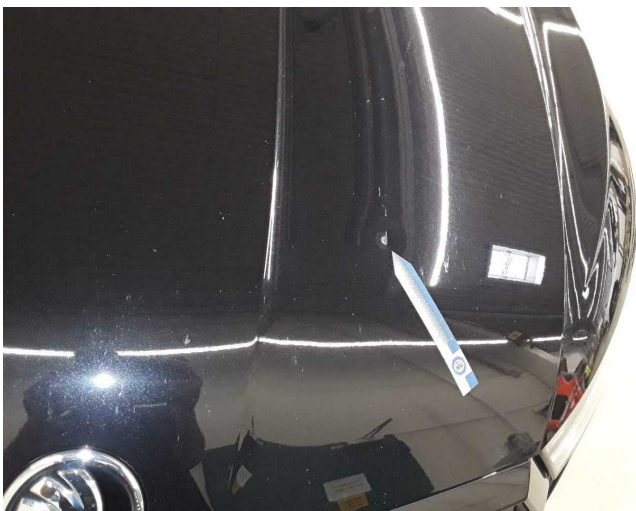
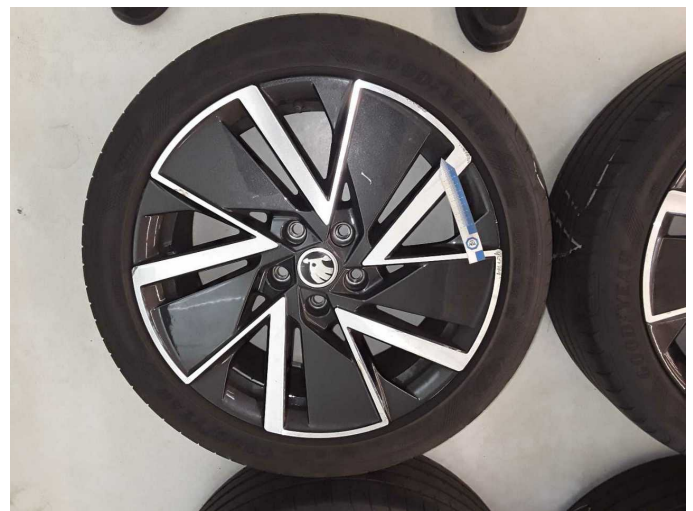
Damage 7: Bonnet: Bonnet - Dent / paintcoat damage - Smart repair

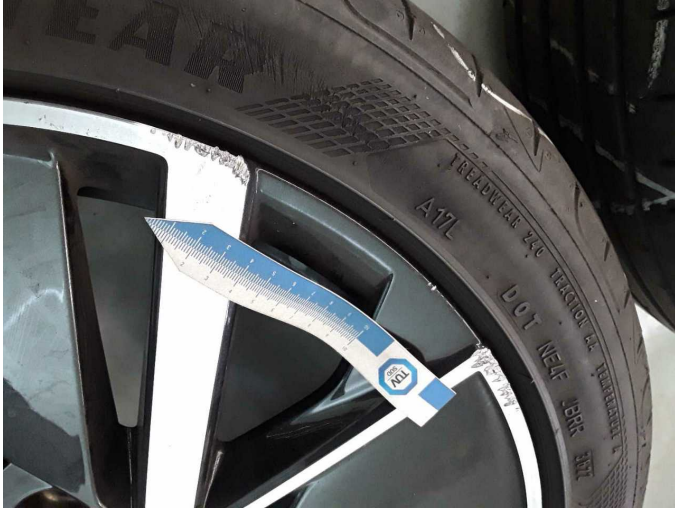
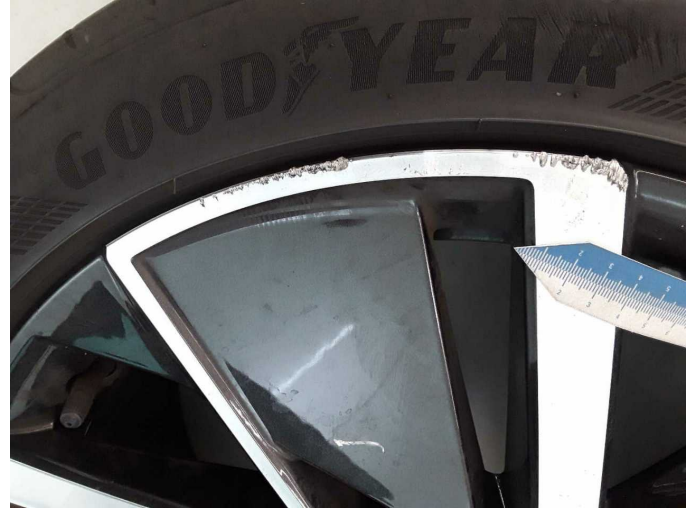
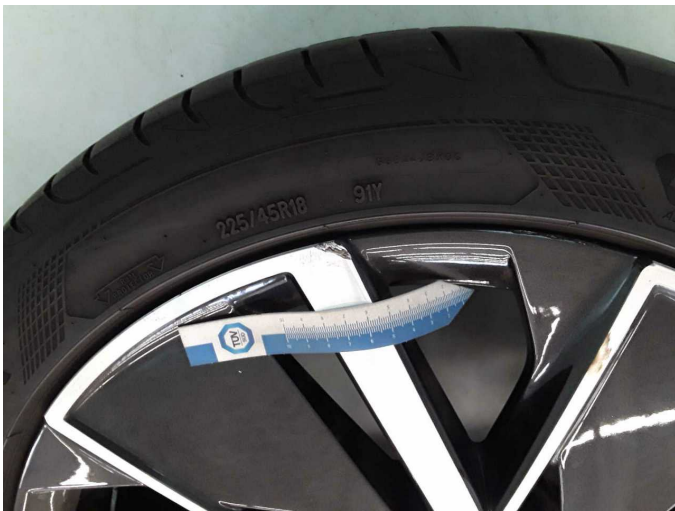
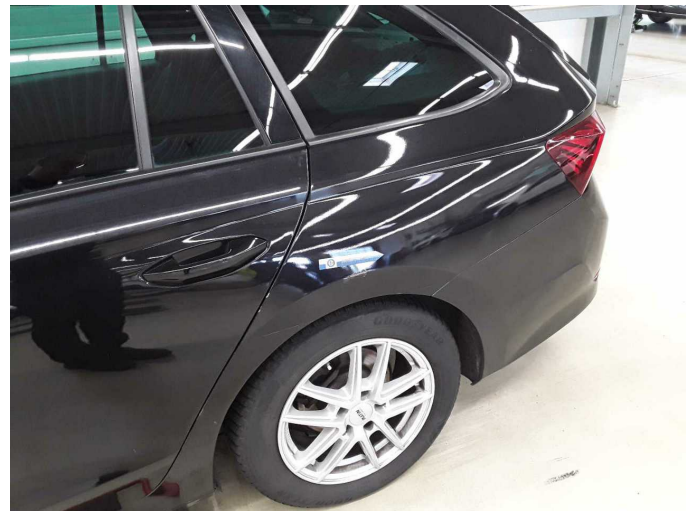
Damage 8: 2nd wheel set: 1 alloy rim - Scratched - Replace

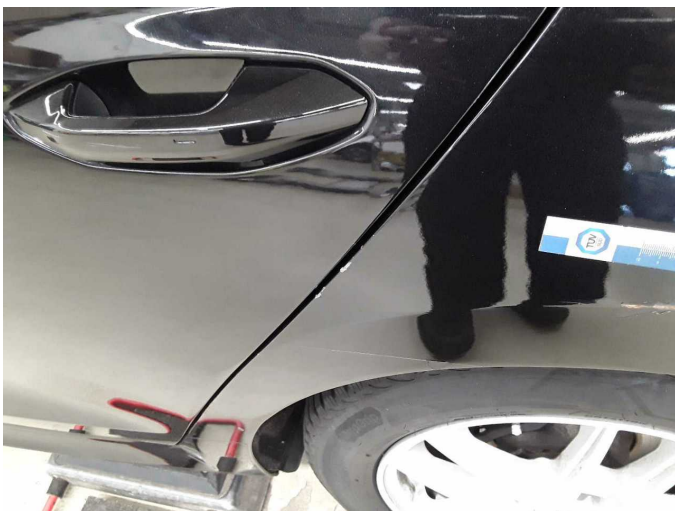
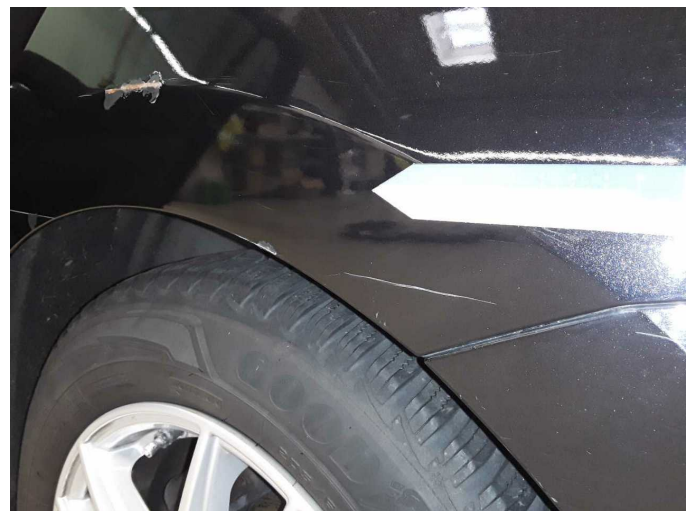
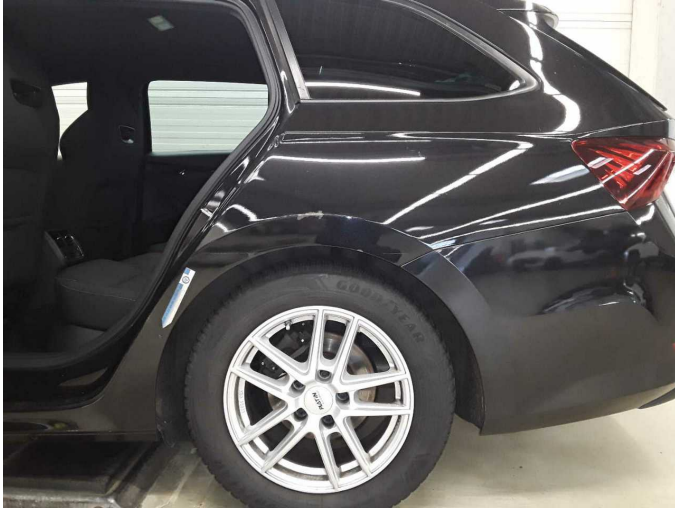
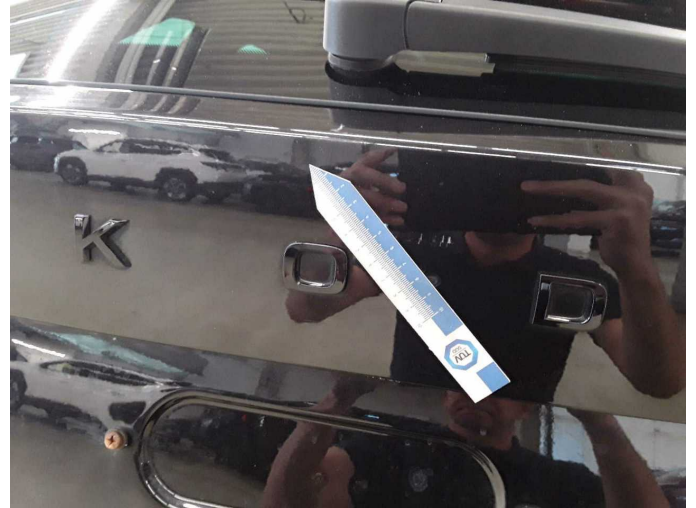
Damage 9: Side panel - rear left side: Side panel - Scratched - Repair and paint

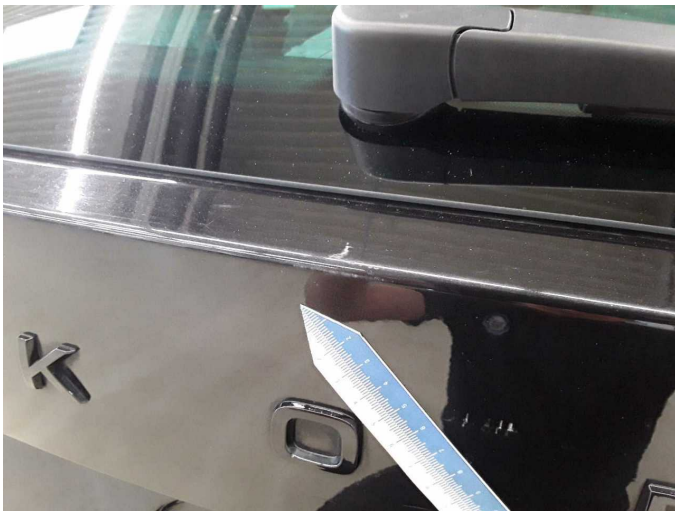
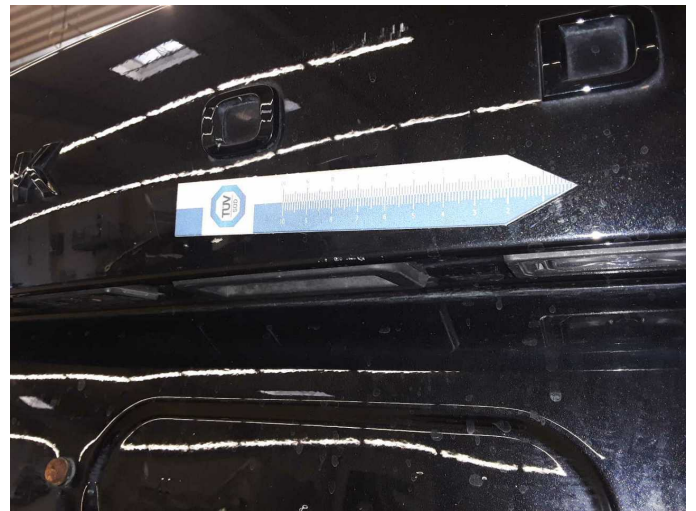
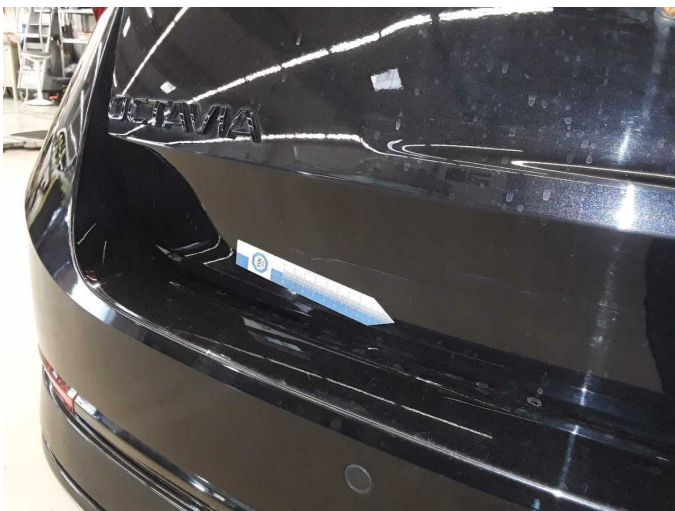
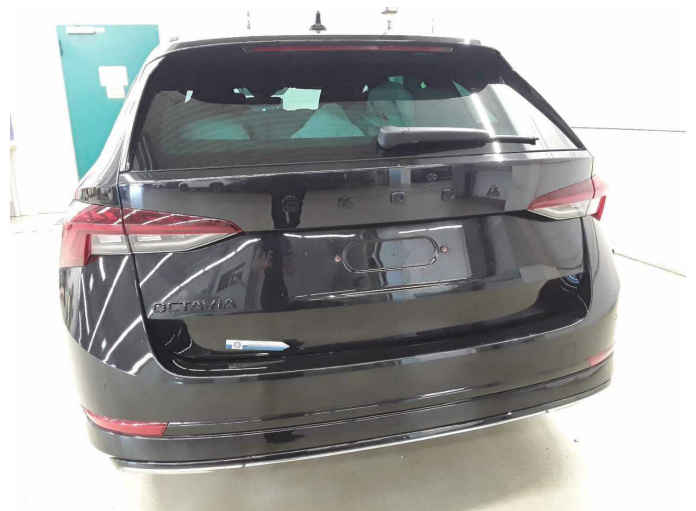
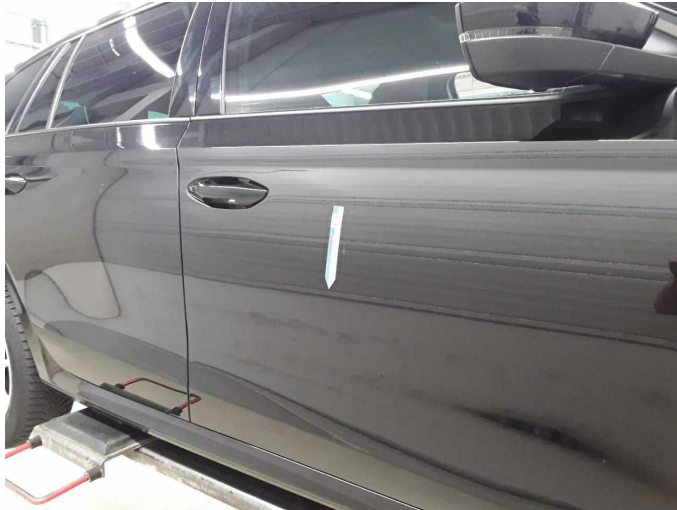
Damage 10: Boot lid / rear door: Boot lid - Scratch(es) - Repair and paint

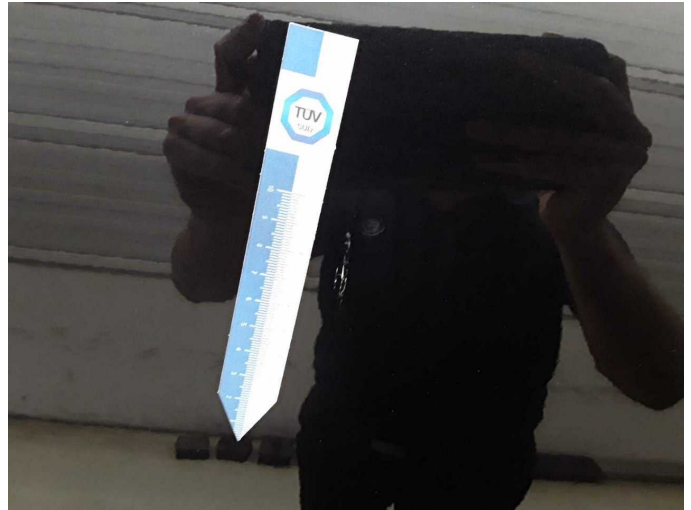
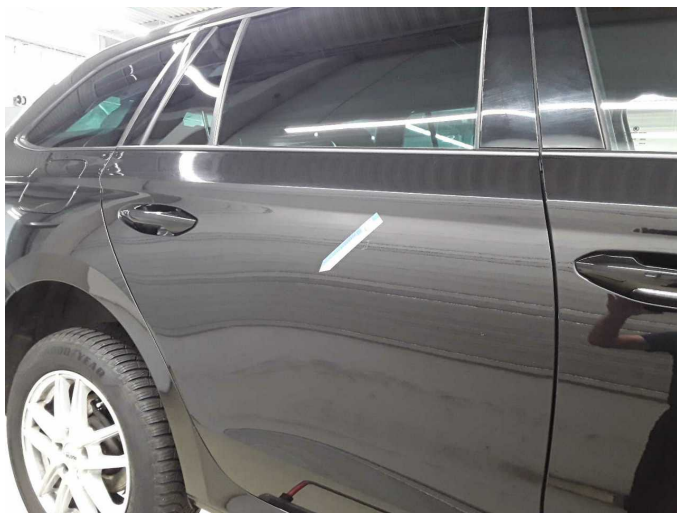
Damage 11: Door - front right side: Door - Scratch(es) - Repair and paint

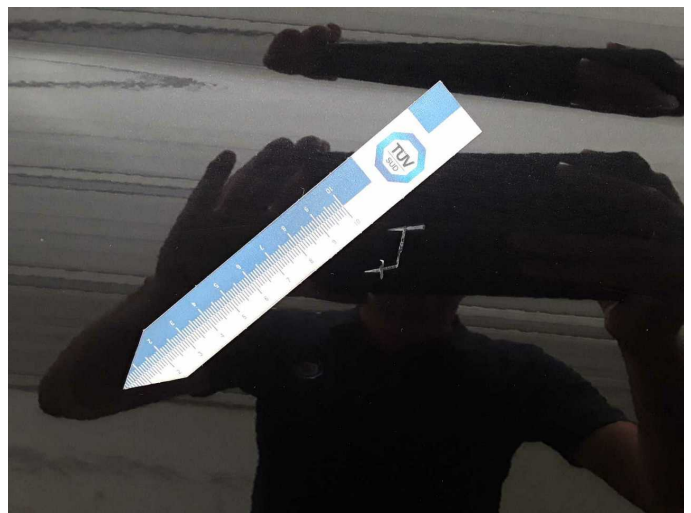
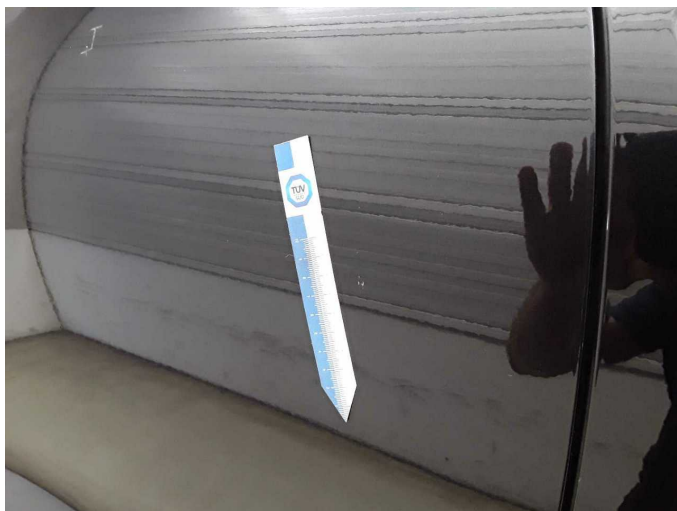
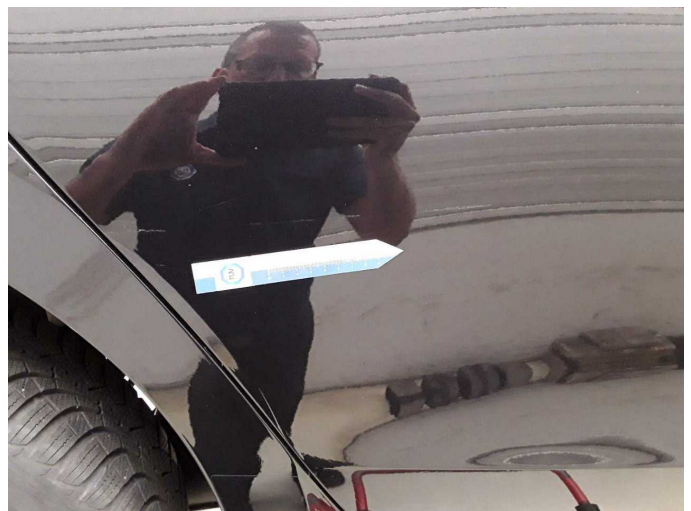
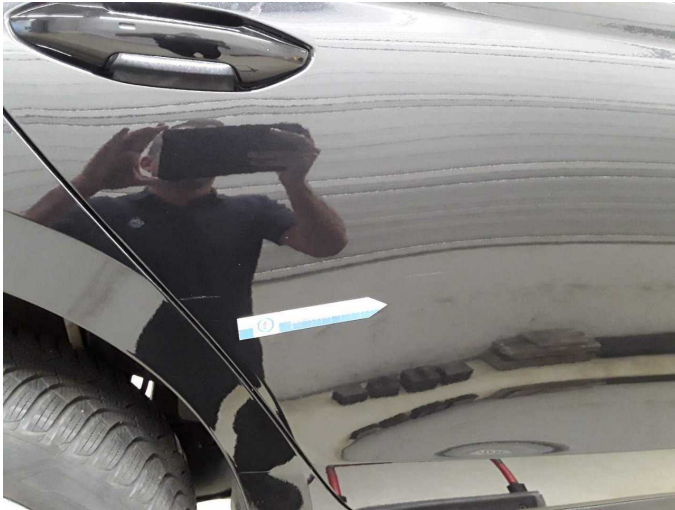
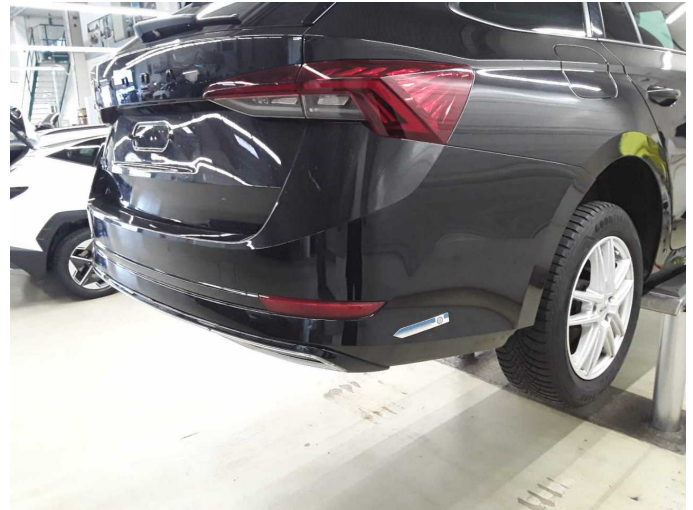
Damage 12: Door - rear right side: Door - Scratch(es) - Repair and paint

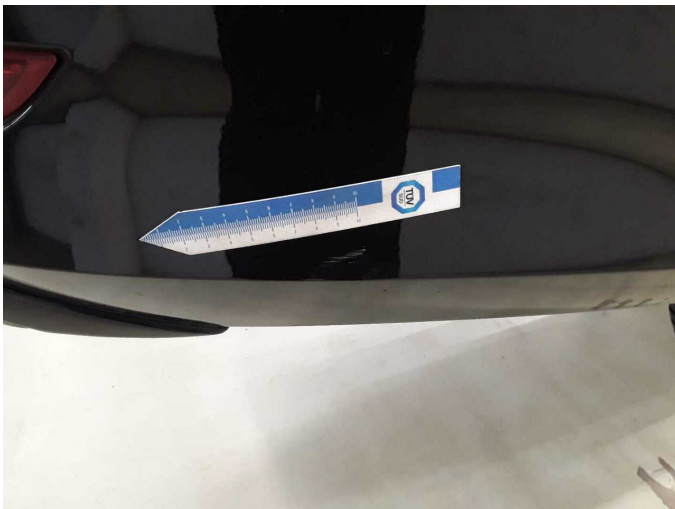
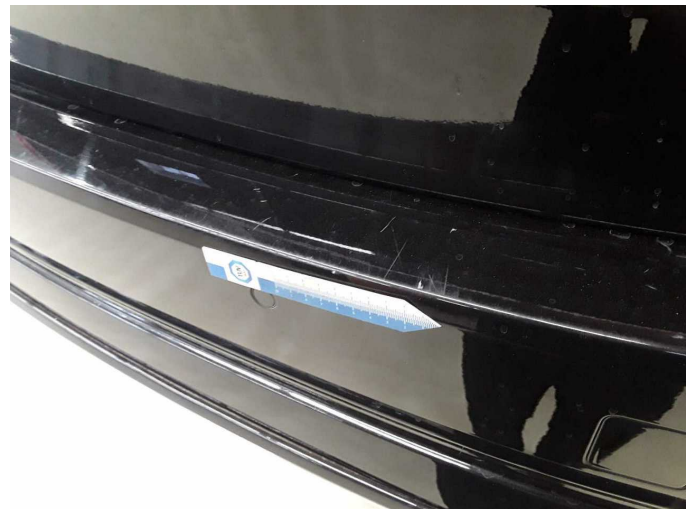
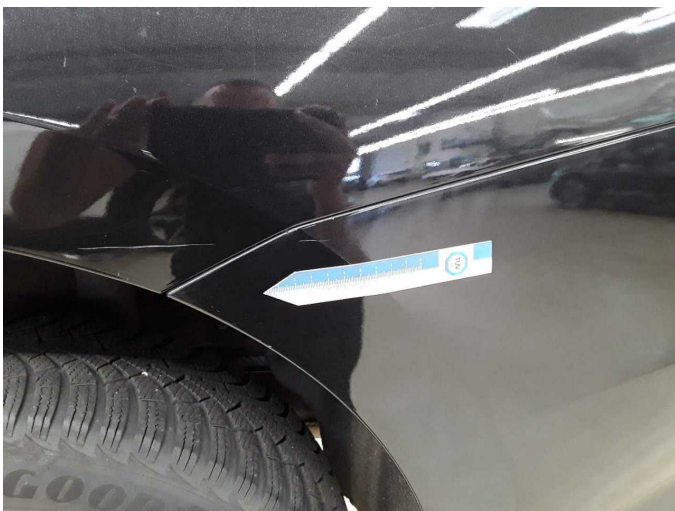
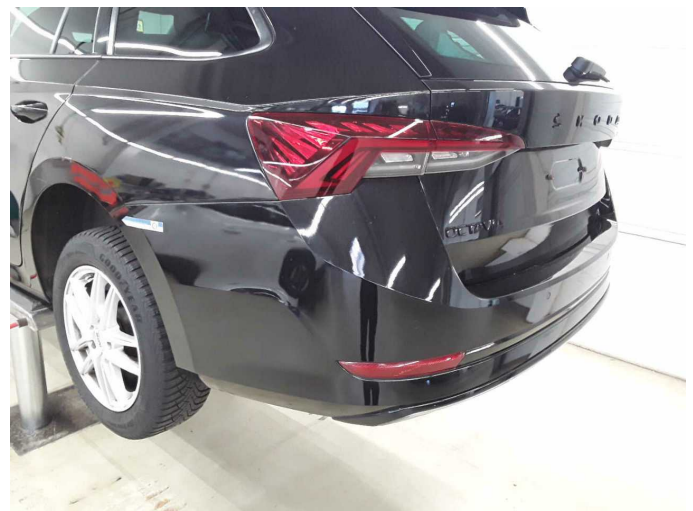
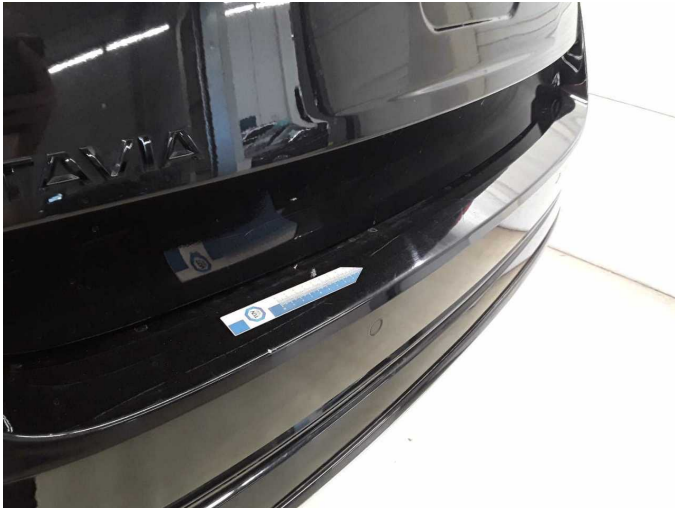
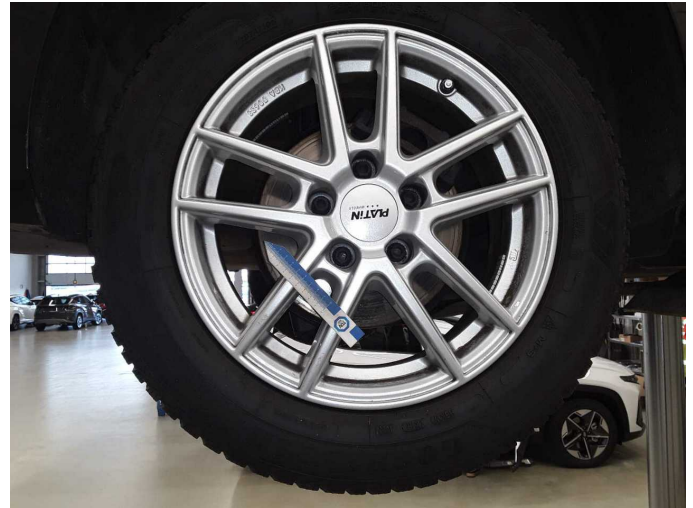
Damage 13: Rear bumper: Rear bumper - Scratch(es) - Repair and paint

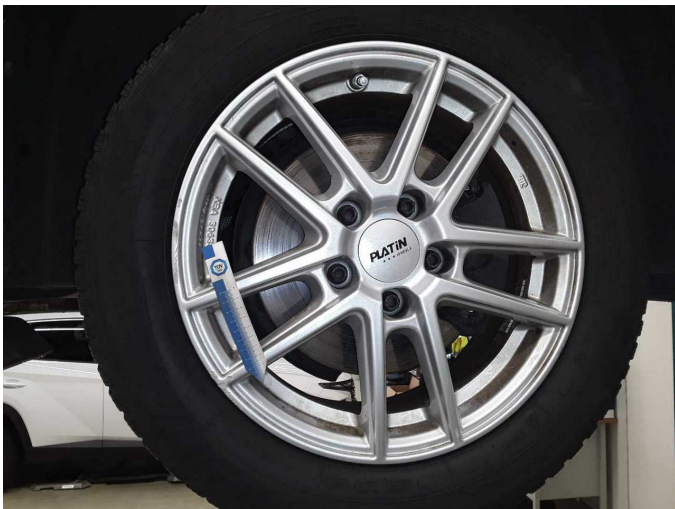
Wear and tear 2: Wheel / tyres: Alloy rim - rear right side - Scratched - No deduction

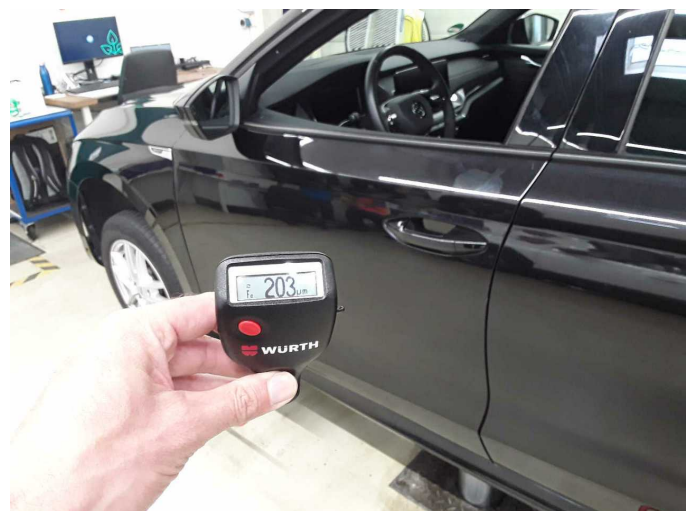
No.	Repainting
1	Side panel - rear left side, Door - front left side, Professionally carried out

Side panel - rear left side: 3,050 μm

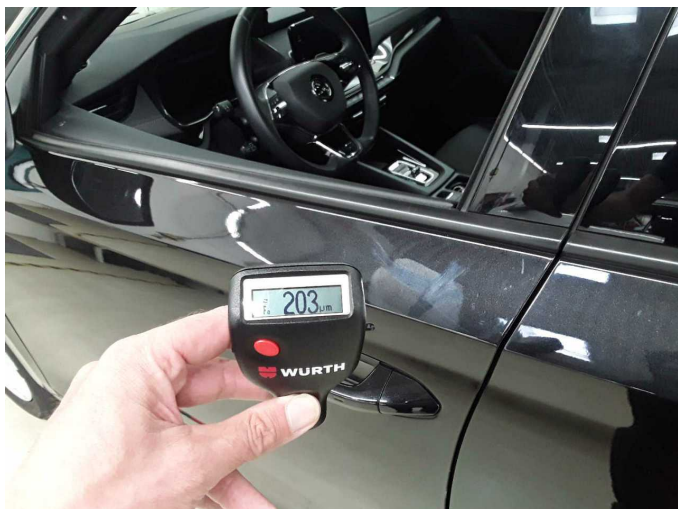
Door - front left side: 203 μm
