## Expertise

Protocol number: 45982517  
Order No. / Reference: 26499407  
Inspection date: 16 Jun 2026

Manufacturer: Peugeot

Model: 2008 BlueHDi 130 EAT8 Allure

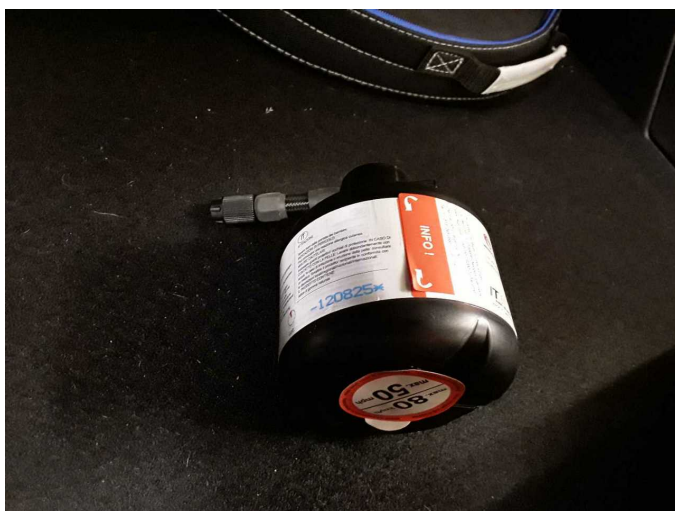
Damage 1: Equipment: Tirefit filler - Expired - Replace

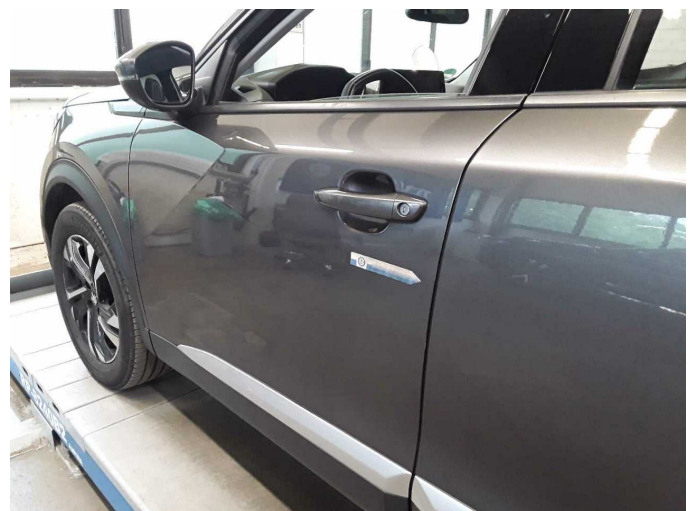
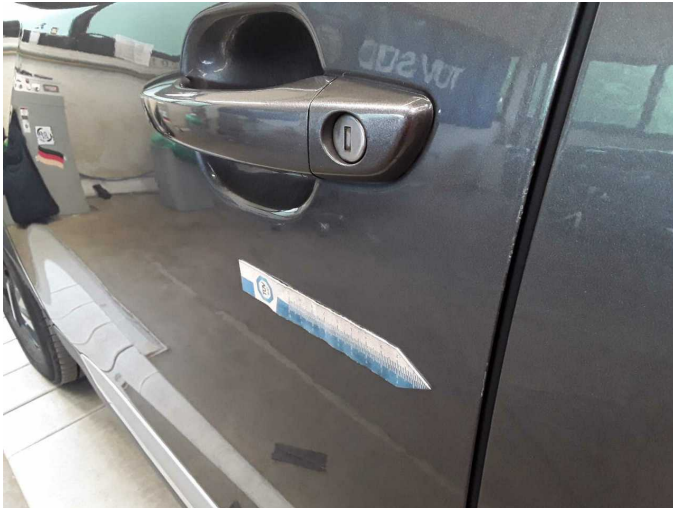
Damage 2: Door - front left side: Door - Scratch(es) - Smart repair

**Damage 2:** Door - front left side: Door - Scratch(es) - Smart repair

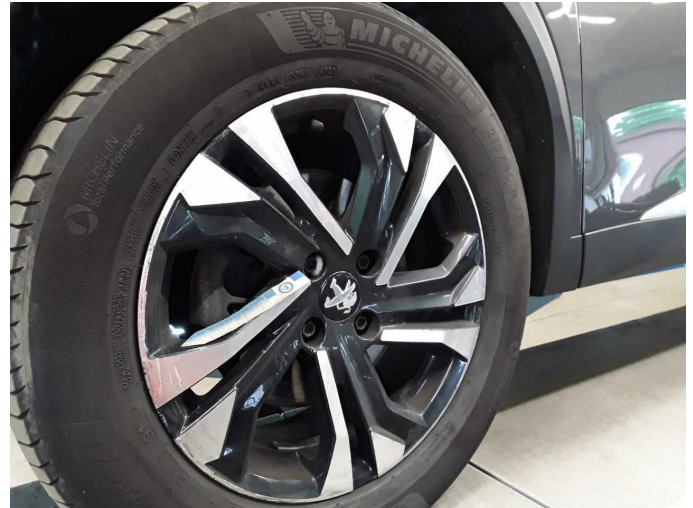
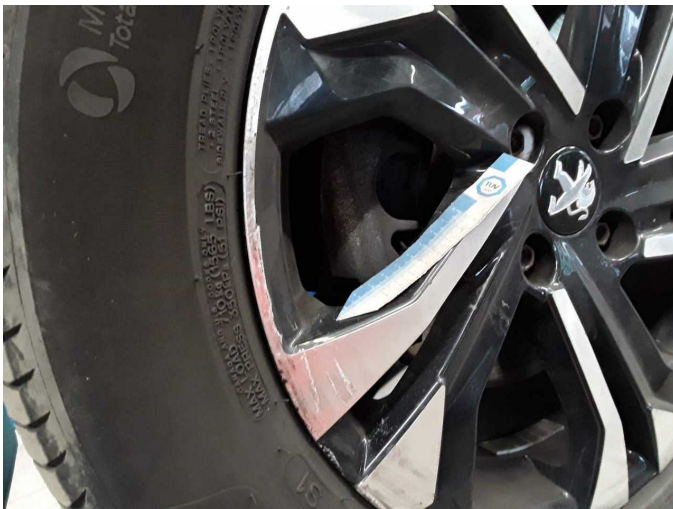
**Damage 3:** Wheel / tyres: Alloy rim - front left side - Scratched - Loss in value

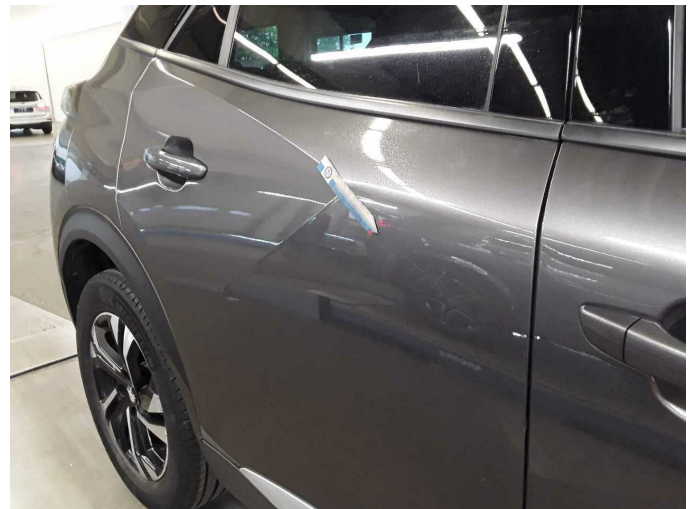
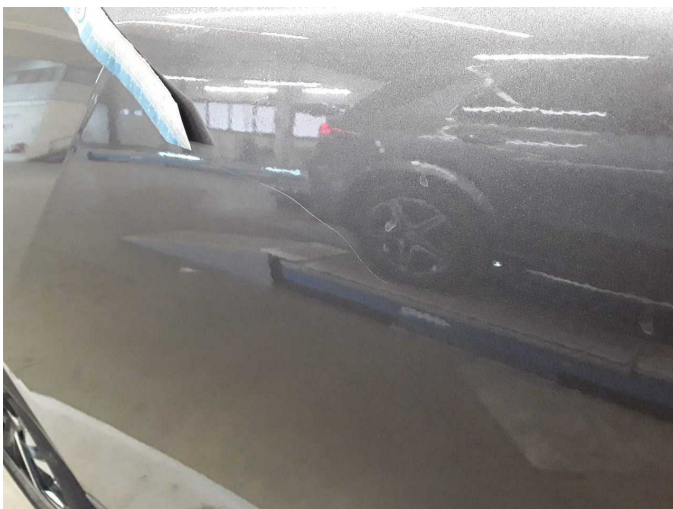
**Damage 4:** Door - rear right side: Door - Scratch(es) - Paint

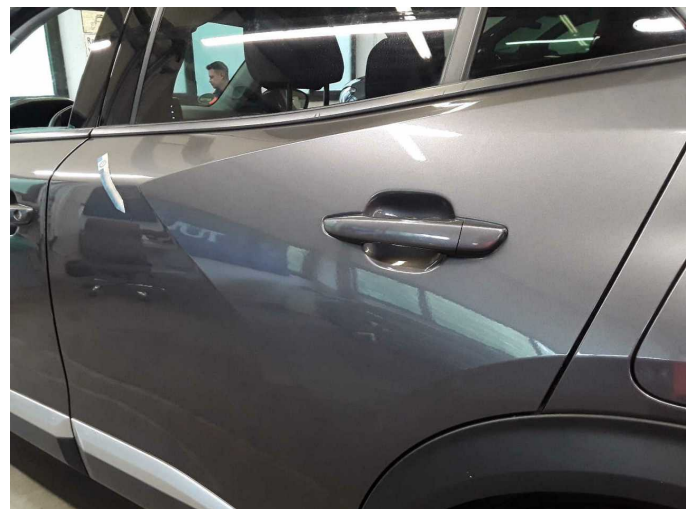
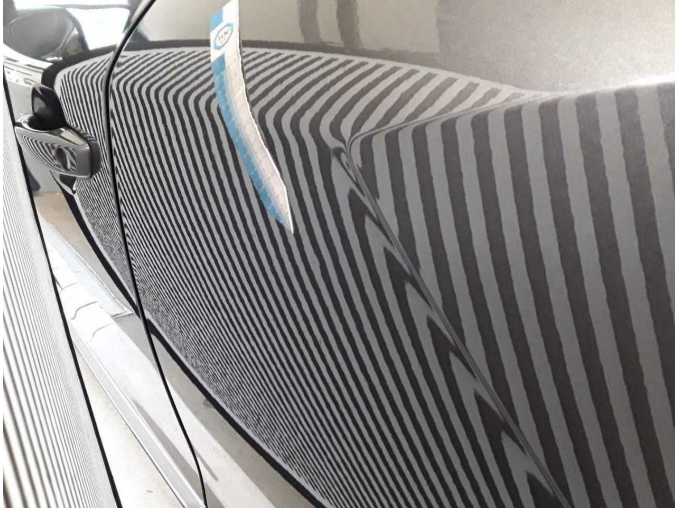
**Damage 5:** Door - rear left side: Door - Dent / paintcoat damage - Paint

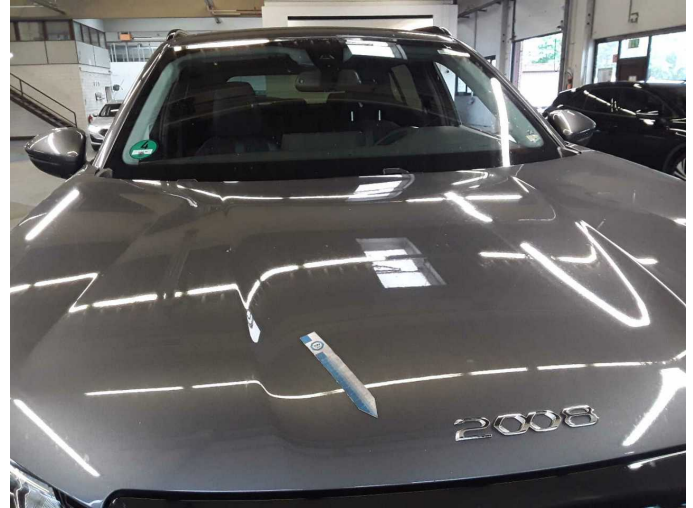
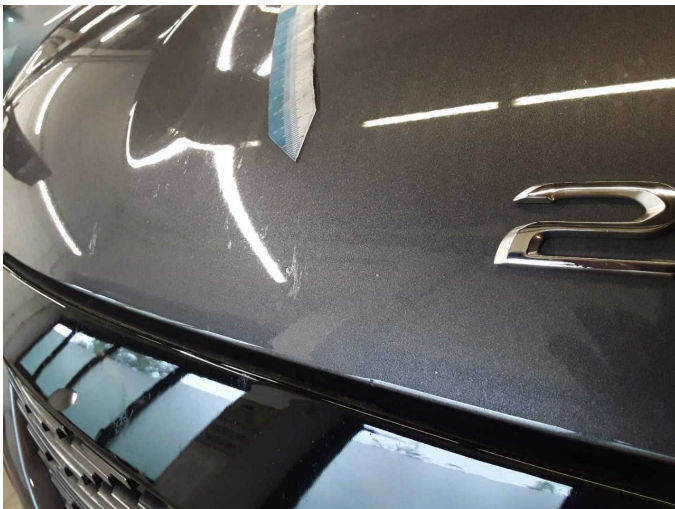
**Wear and tear 1:** Bonnet: Bonnet - Stone chips - No deduction

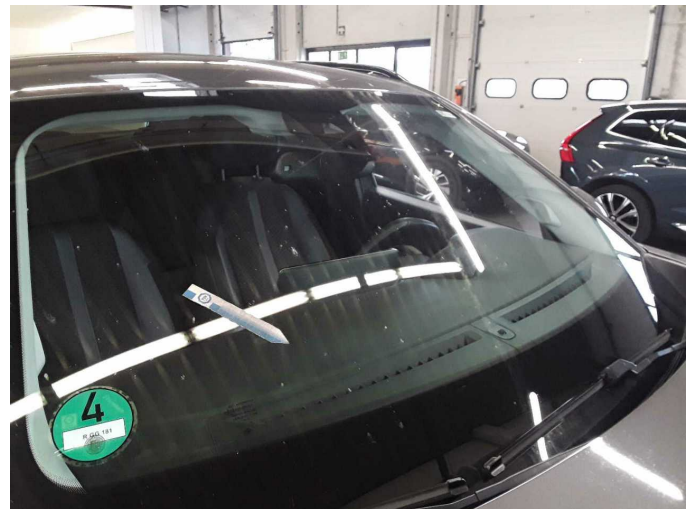
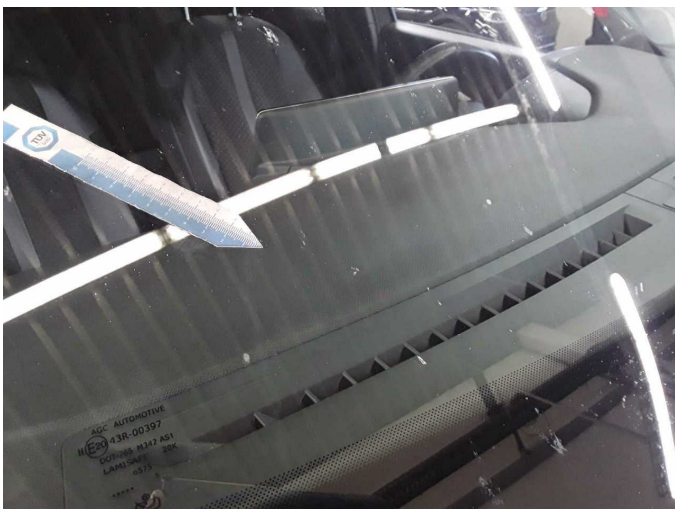
**Wear and tear 2:** Vehicle glazing: Windscreen - Stone chips - No deduction

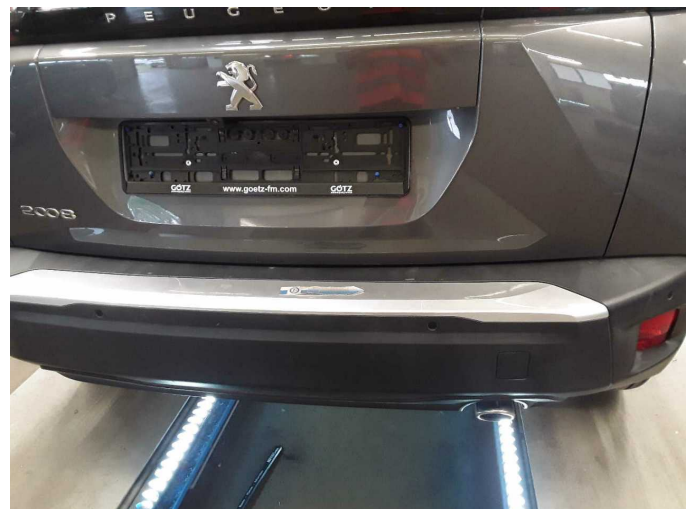
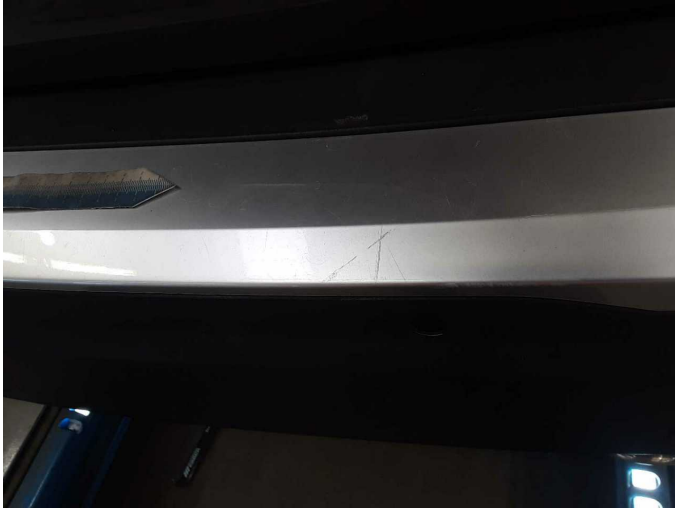
**Wear and tear 3:** Rear bumper: Spoiler - Scratch(es) - No deduction
