Expertise

Protocol number: 46182191  
Order No. / Reference: 26531697  
Inspection date: 24 Jun 2026

Manufacturer: Ford

Model: S-Max 2.0 EcoBlue Aut. ST-LINE

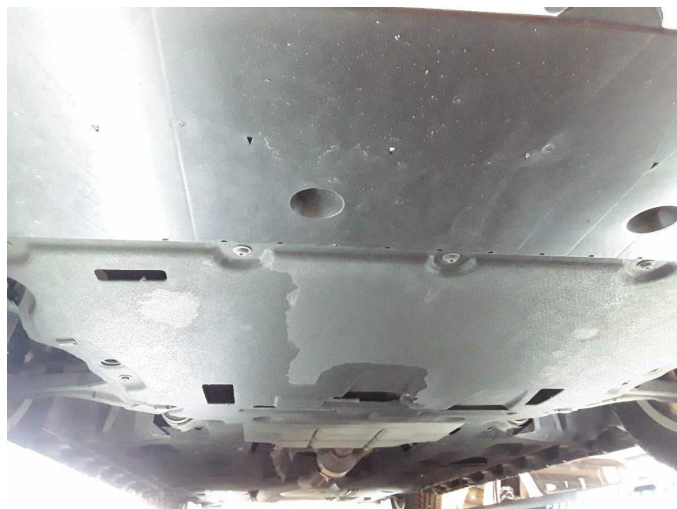
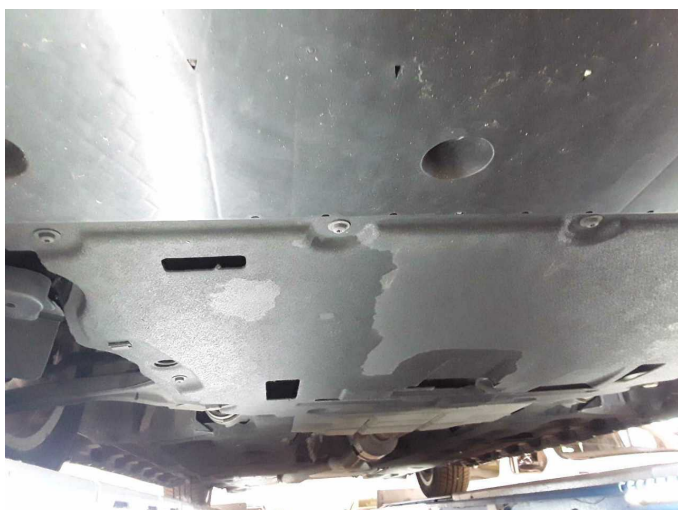
| No. | Component group | Description |
|---|---|---|
| 1 | Engine | Engine - Leaking - Diagnosed and repair if necessary |

**Damage 1:** Engine: Engine - Leaking - Diagnosed and repair if necessary

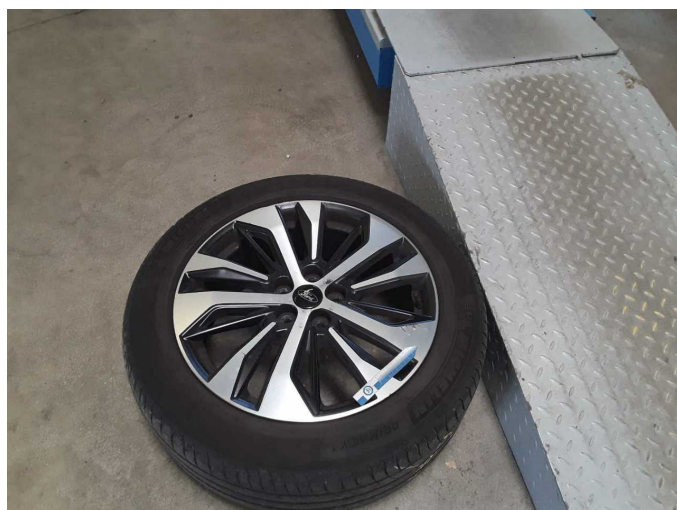
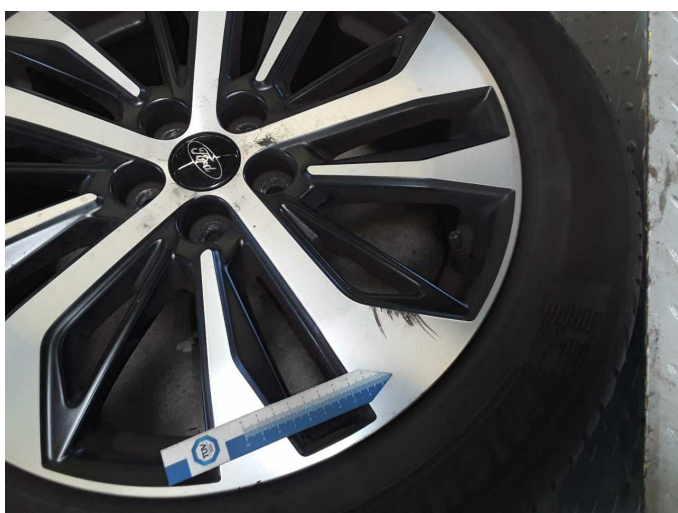
| No. | Component group | Description |
|---|---|---|
| 2 | 2nd wheel set | 1 alloy rim - Scratched - Loss in value |

**Damage 2:** 2nd wheel set: 1 alloy rim - Scratched - Loss in value

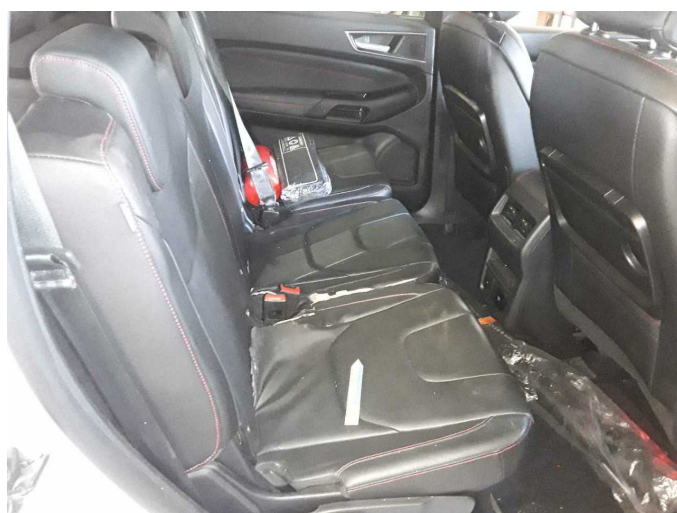
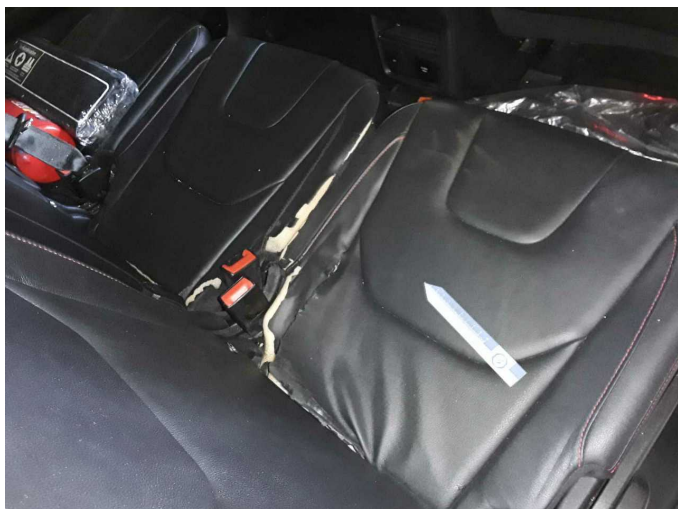
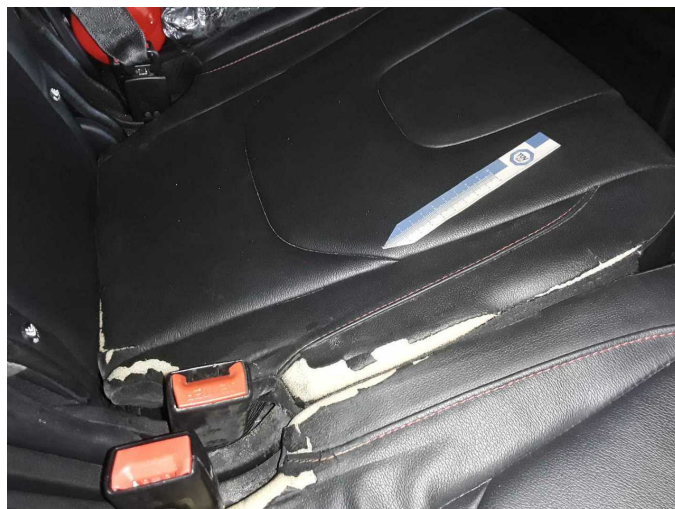
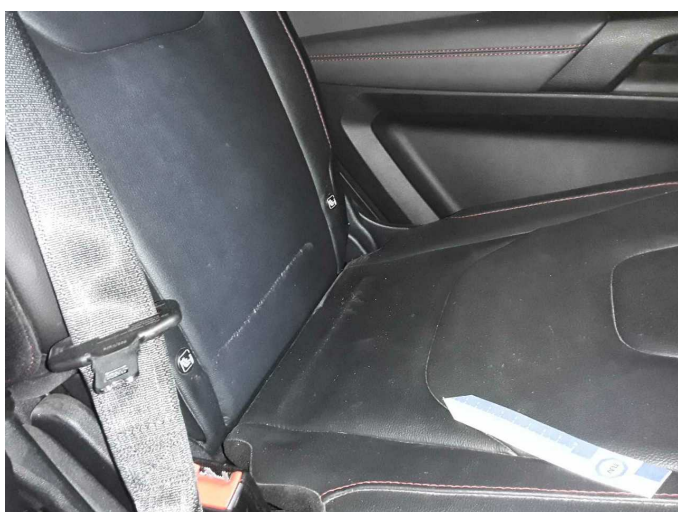
| No. | Component group | Description |
|---|---|---|
| 3 | Seat - rear | Back seat - Damaged - Replace |

**Damage 3:** Seat - rear: Back seat - Damaged - Replace

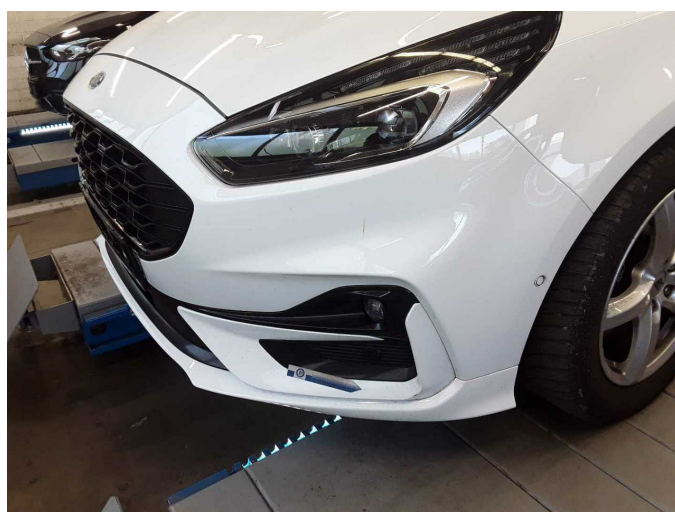
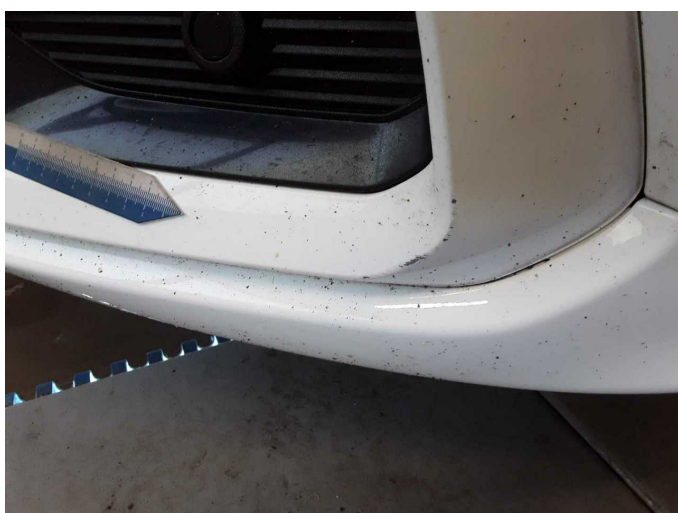
| No. | Component group | Description |
|---|---|---|
| 4 | Front bumper | Front bumper (+ mit Steinschlägen übersät) - Scratch(es) - Paint |

**Damage 4:** Front bumper: Front bumper (+ mit Steinschlägen übersät) - Scratch(es) - Paint

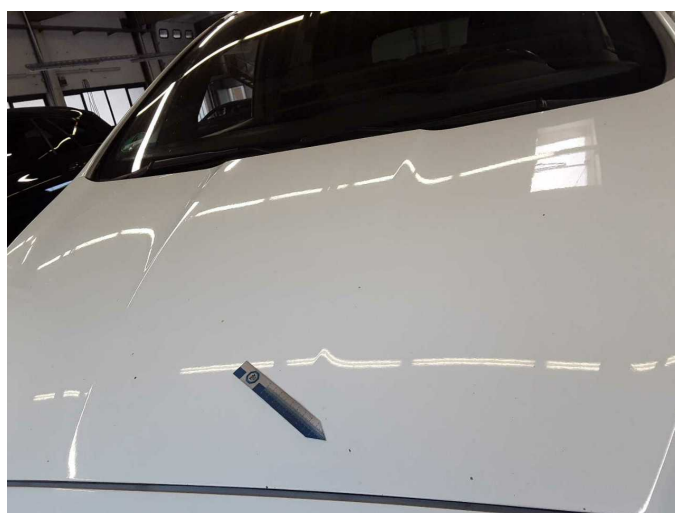
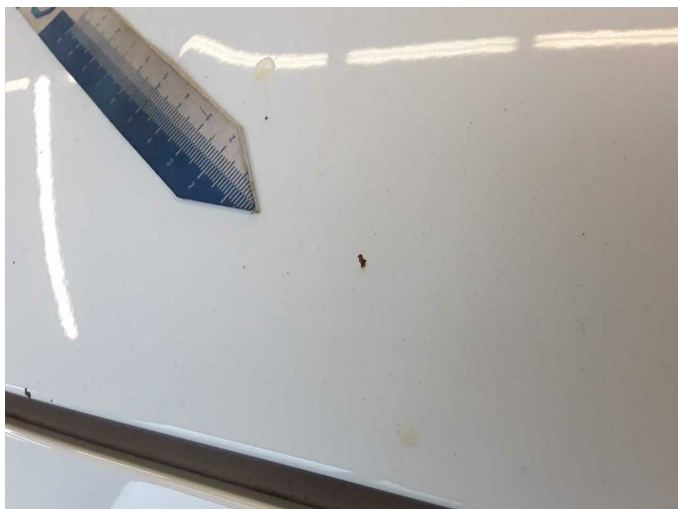
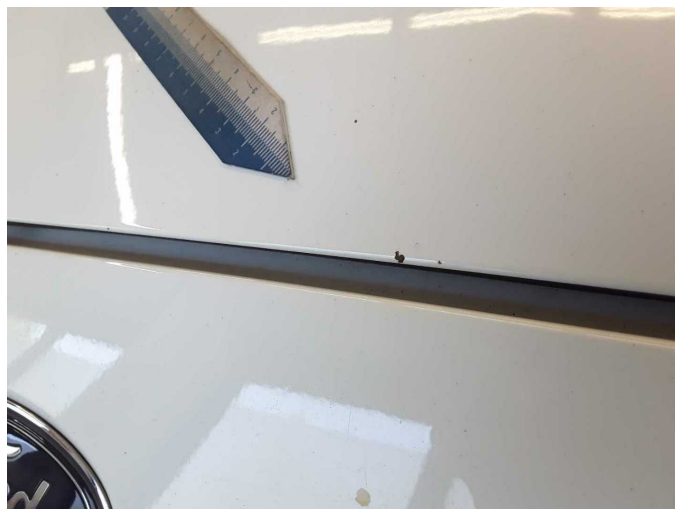
| No. | Component group | Description |
|---|---|---|
| 5 | Bonnet | Bonnet - Corrosion - Repair and paint |

**Damage 5:** Bonnet: Bonnet - Corrosion - Repair and paint

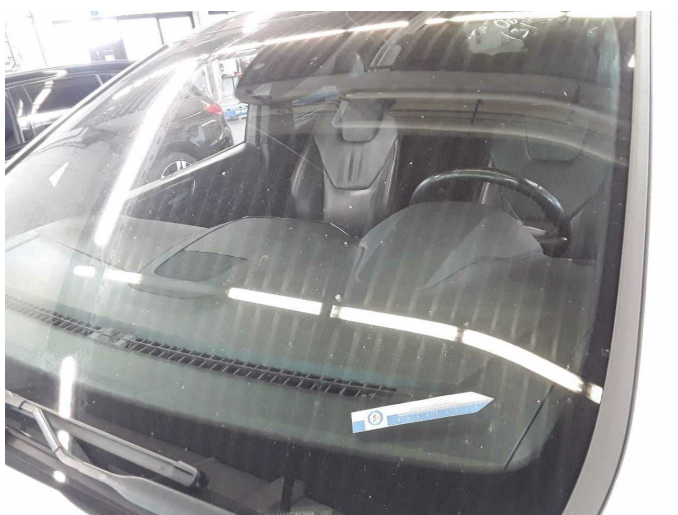
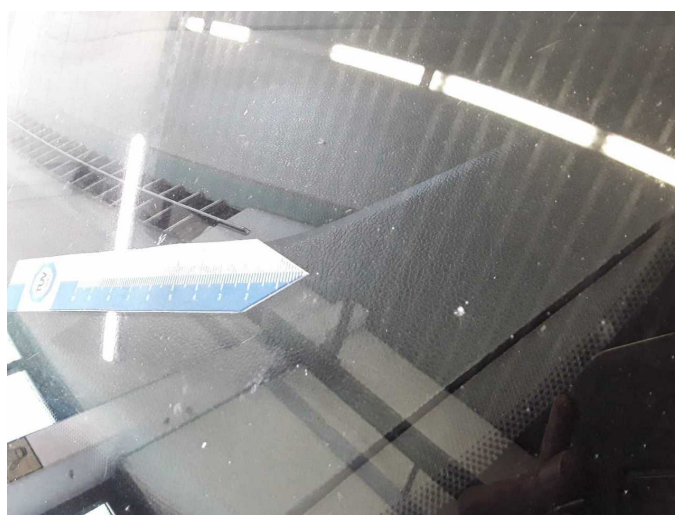
| No. | Component group | Description |
|---|---|---|
| 1 | Vehicle glazing | Windscreen - Stone chips - No deduction |

**Wear and tear 1:** Vehicle glazing: Windscreen - Stone chips - No deduction

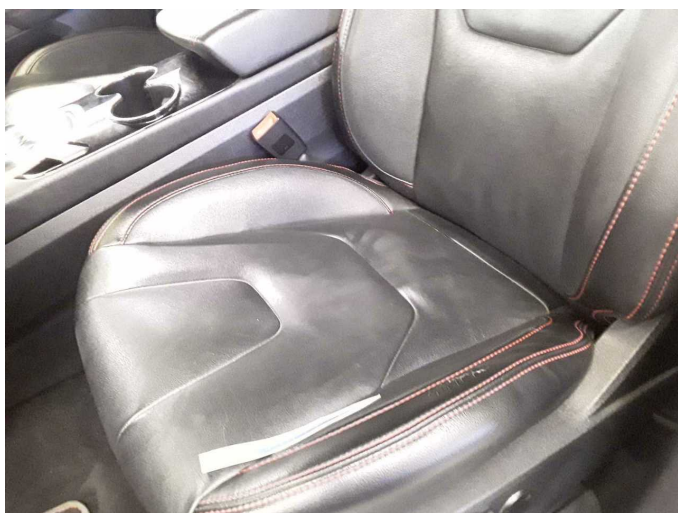
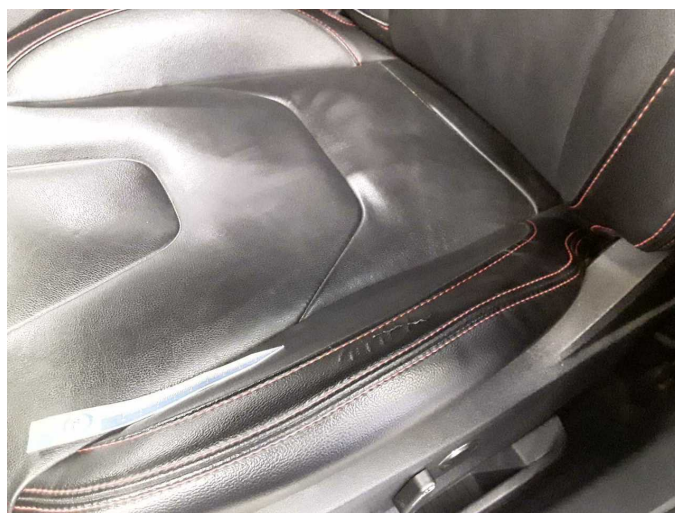
| No. | Component group | Description |
|---|---|---|
| 6 | Seat - front | Seat cover - left side - Broken / torn - No deduction |

**Wear and tear 6:** Seat - front: Seat cover - left side - Broken / torn - No deduction

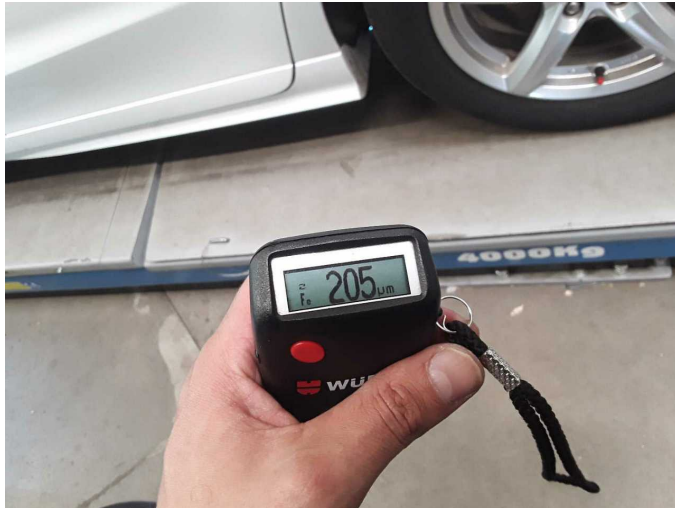
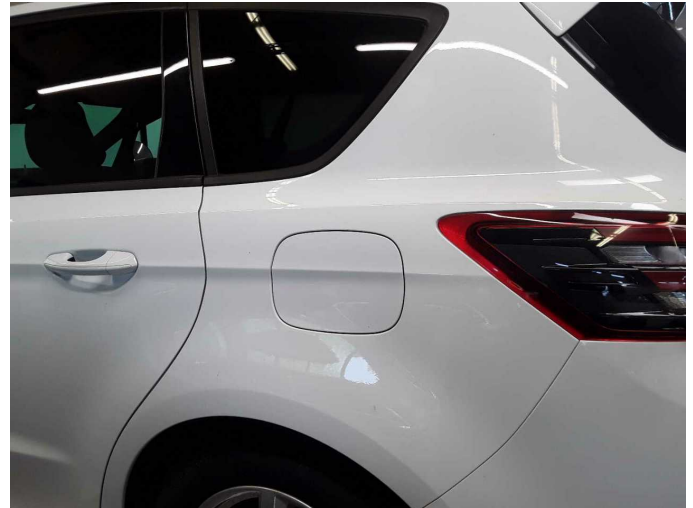
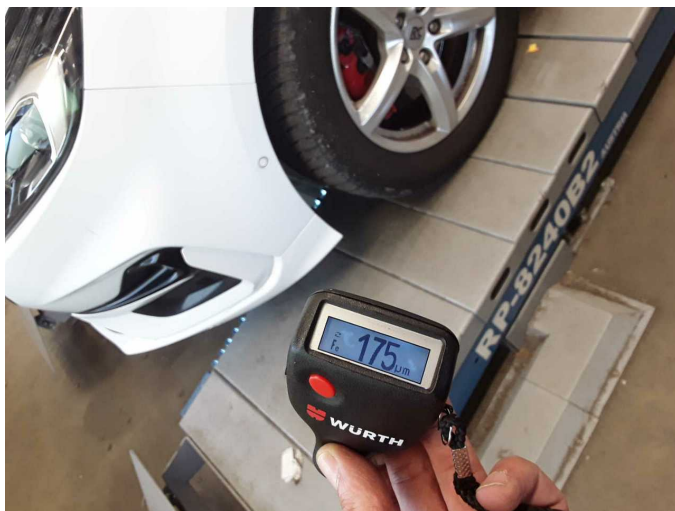
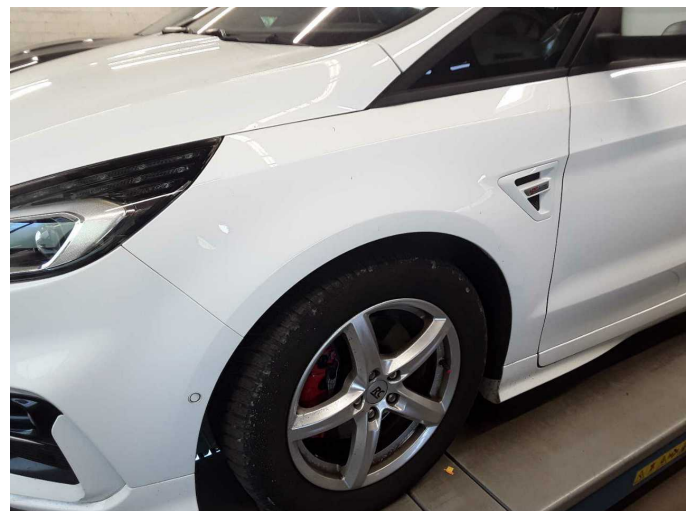
| 1 | Mudguard - left side, Side panel - rear left side, Professionally carried out, Invoice of repair done Non-existent |

| Mudguard - left side | 174 µm | Side panel - rear left side | 205 µm |

**Repainting 1:** Mudguard - left side, Side panel - rear left side
