Expertise

Protocol number: 46265794
Order No. / Reference: 26445620
Inspection date: 30 Jun 2026

Manufacturer: Peugeot

Model: 5008 BlueHDi 130 EAT8 GT

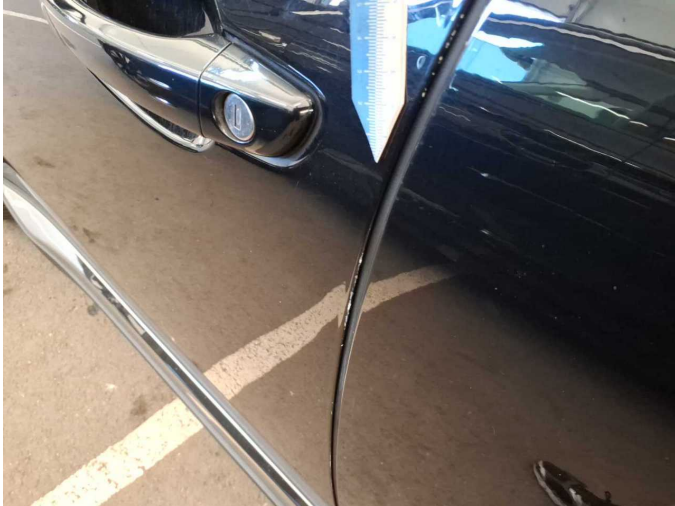
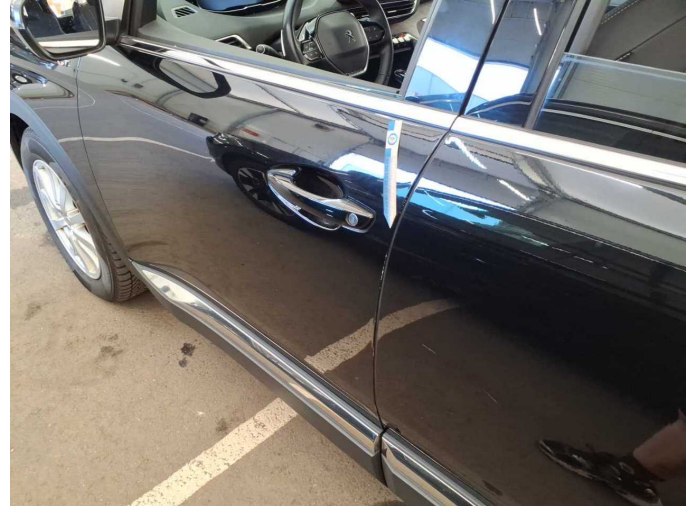
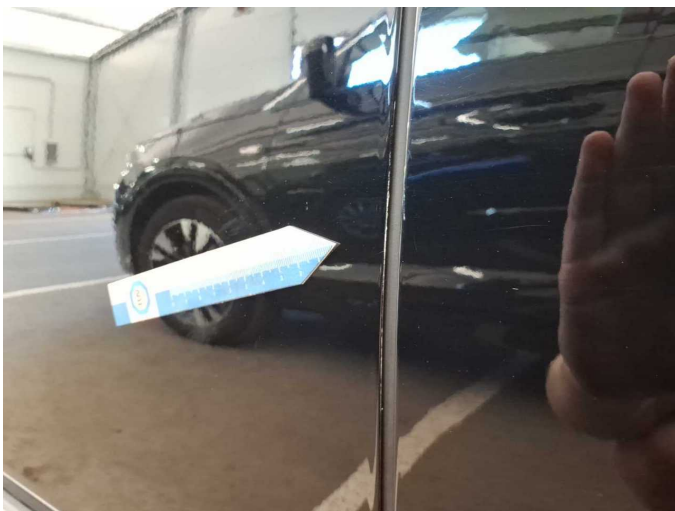
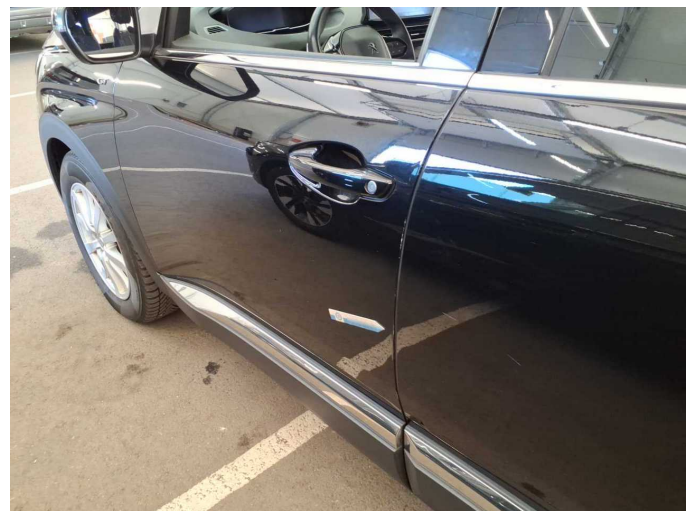
Damage 1: Door - front left side: Door edge - Scratch(es) - Smart repair

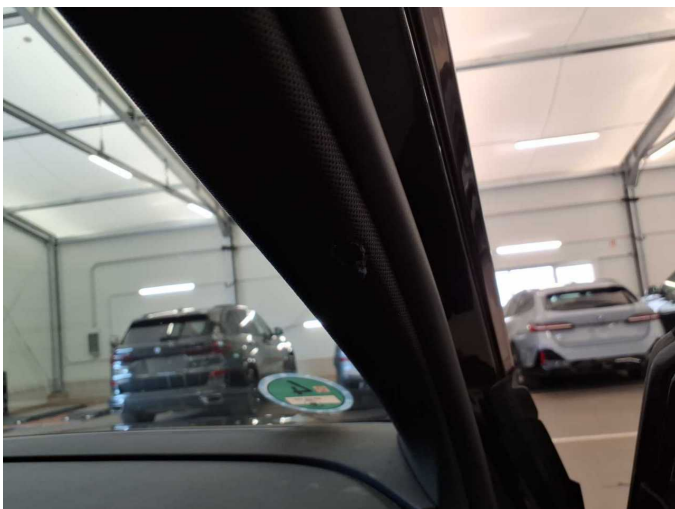
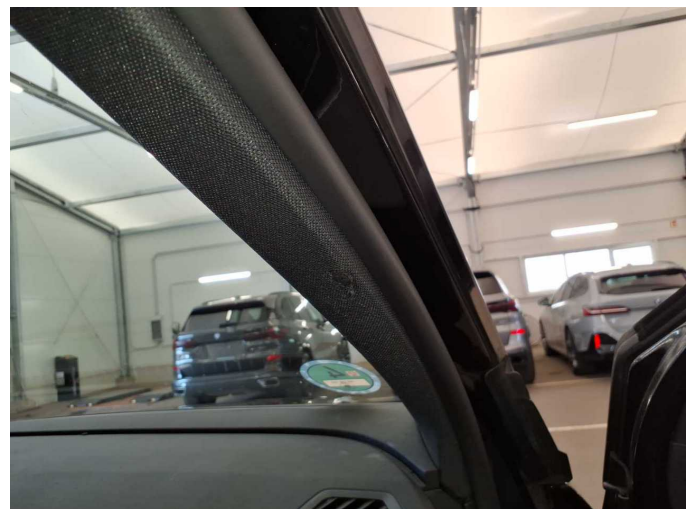
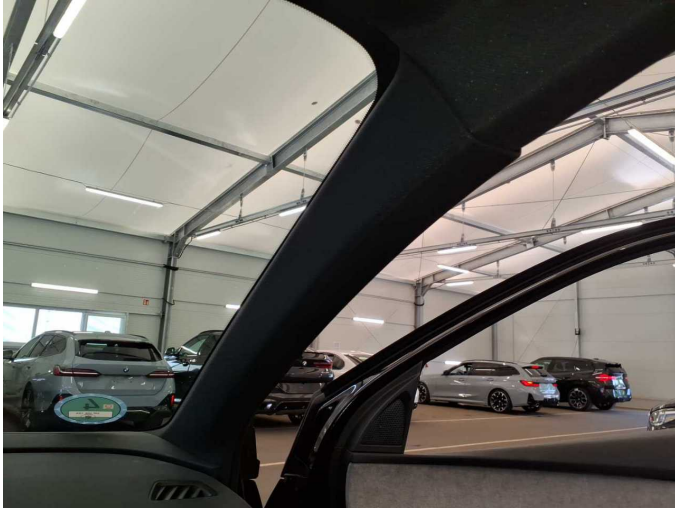
Damage 2: Trim / covers: A-pillar - interior trim - right side - Broken / torn - Replace

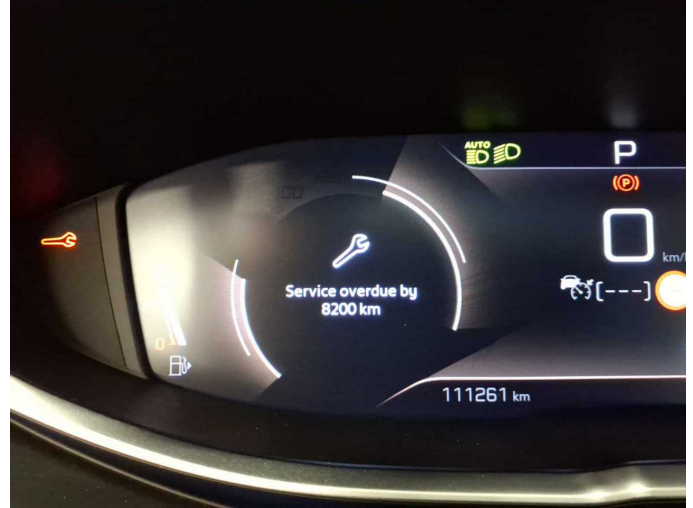
Damage 3: Misc.: Inspection / maintenance - Expired - Perform

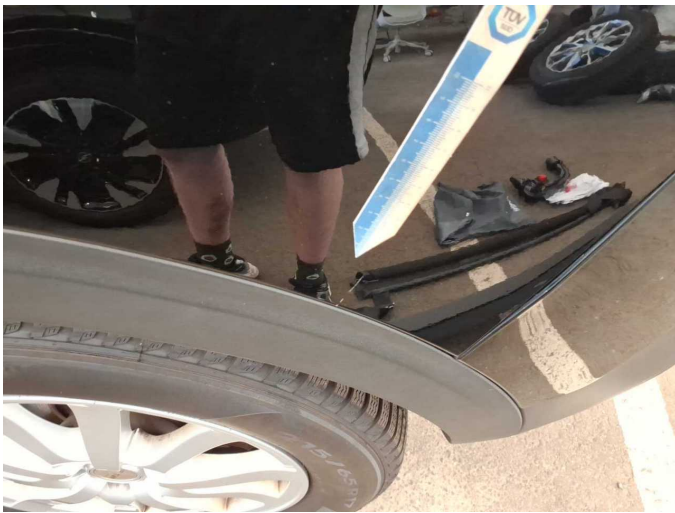
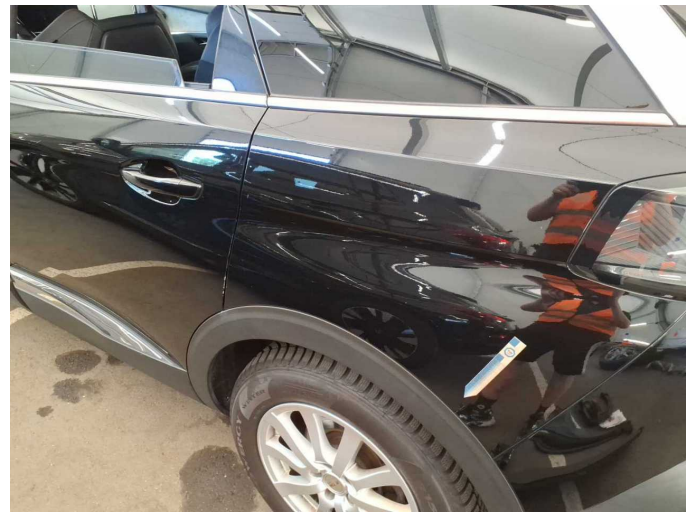
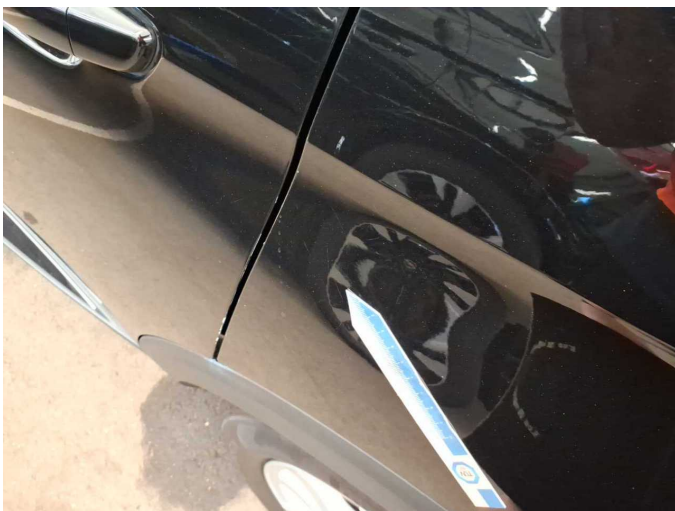
Damage 4: Side panel - rear left side: Side panel - Scratch(es) - Paint

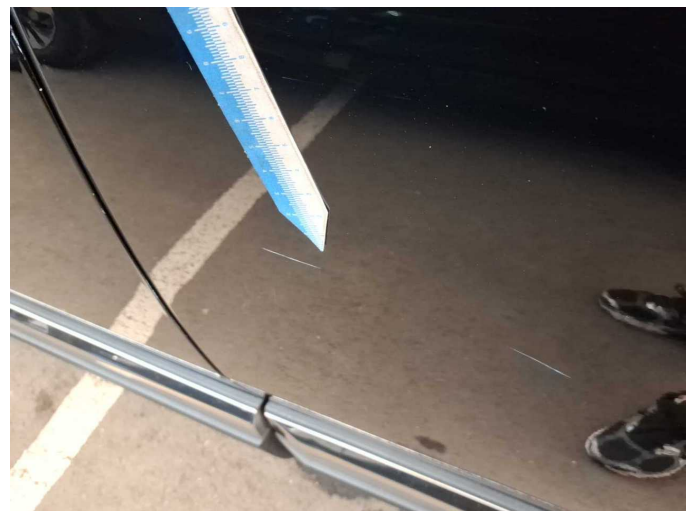
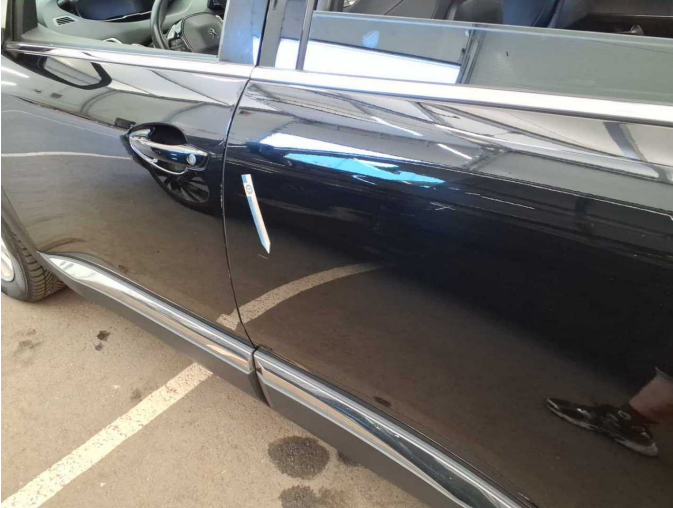
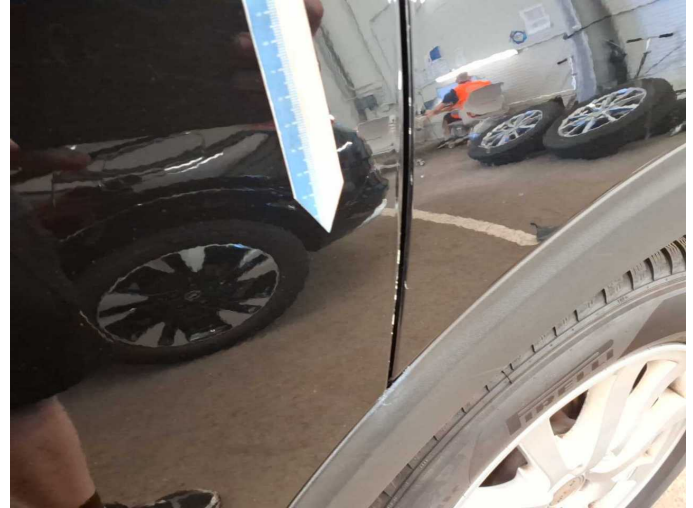
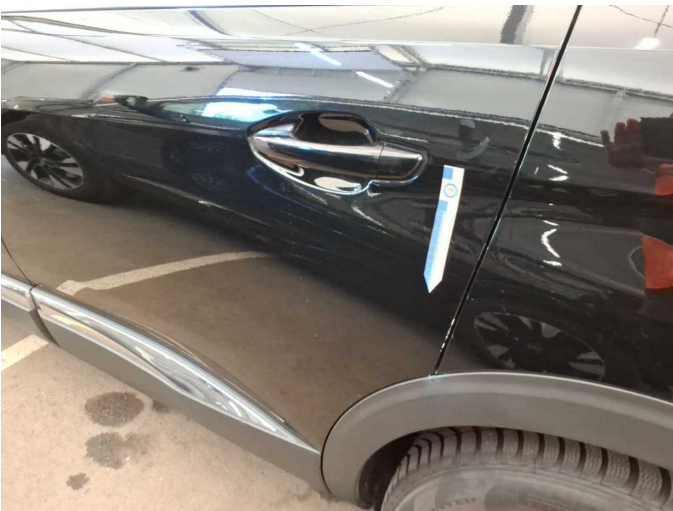
Damage 5: Door - rear left side: Door - Scratch(es) - Paint

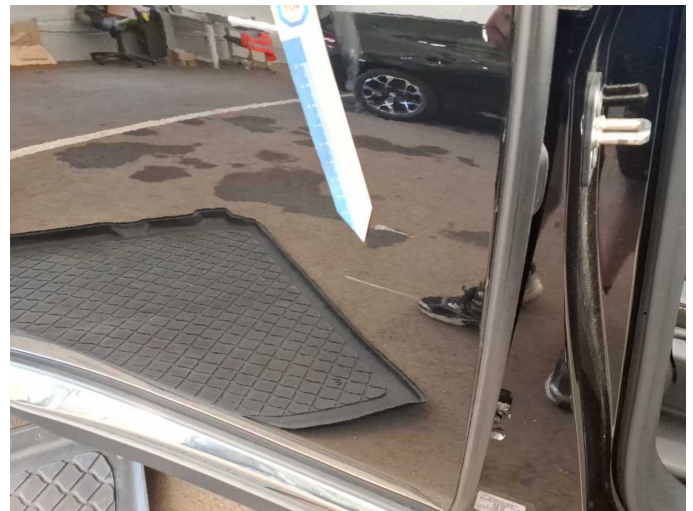
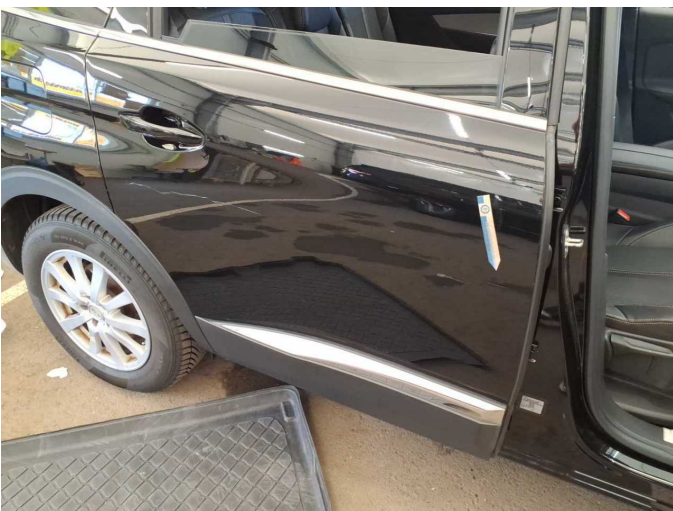
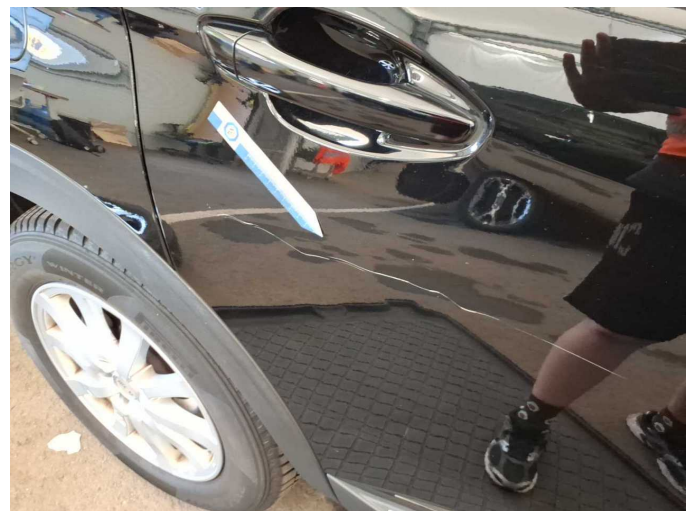
Damage 6: Door - rear right side: Door - Scratch(es) - Paint

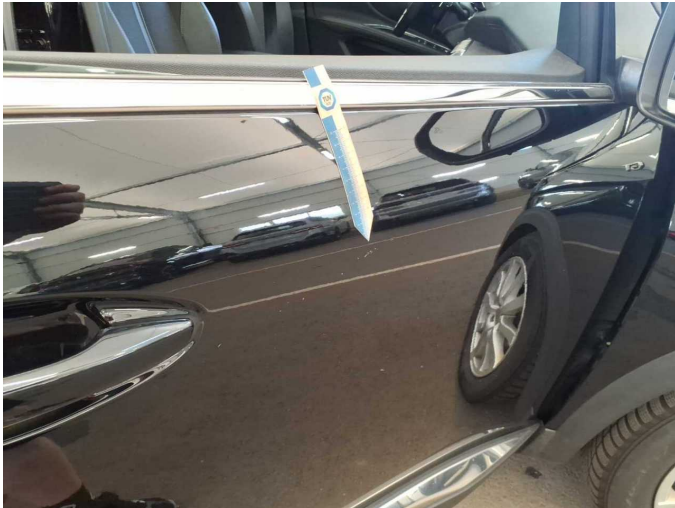
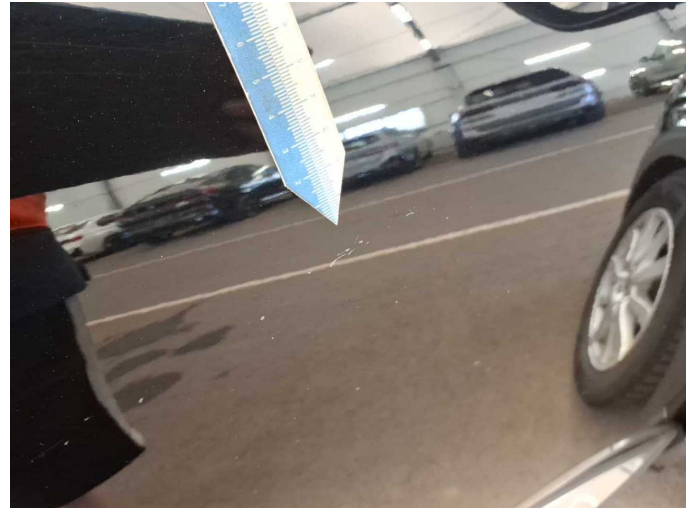
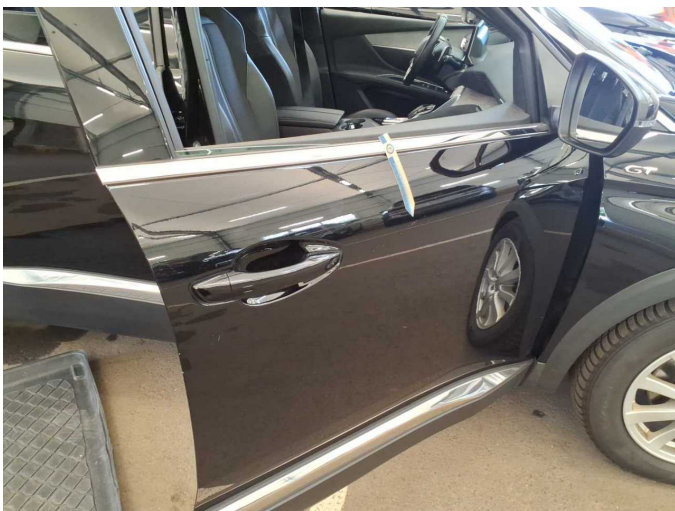
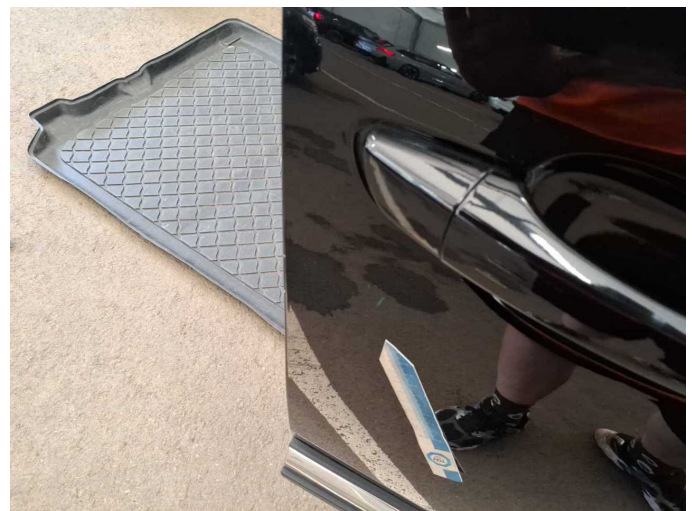
Damage 7: Door - front right side: Door - Scratch(es) - Paint

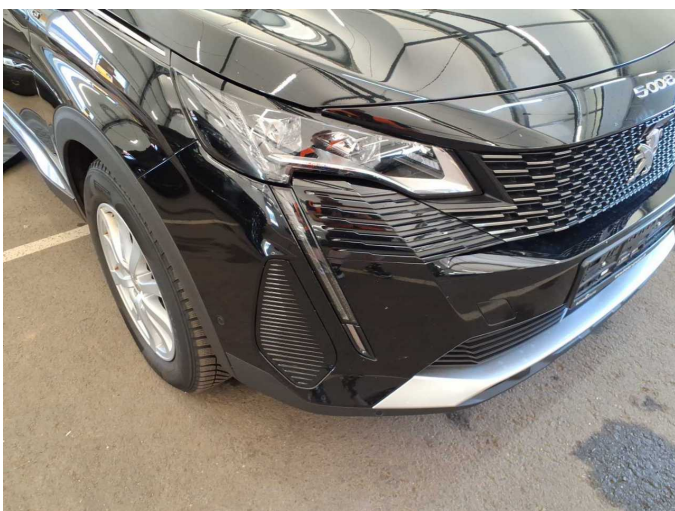
Wear and tear 1: Front bumper: Front bumper - Stone chips - No deduction

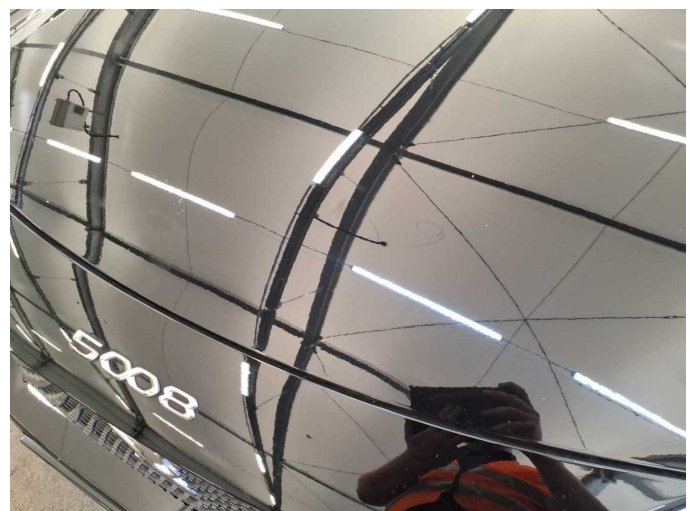
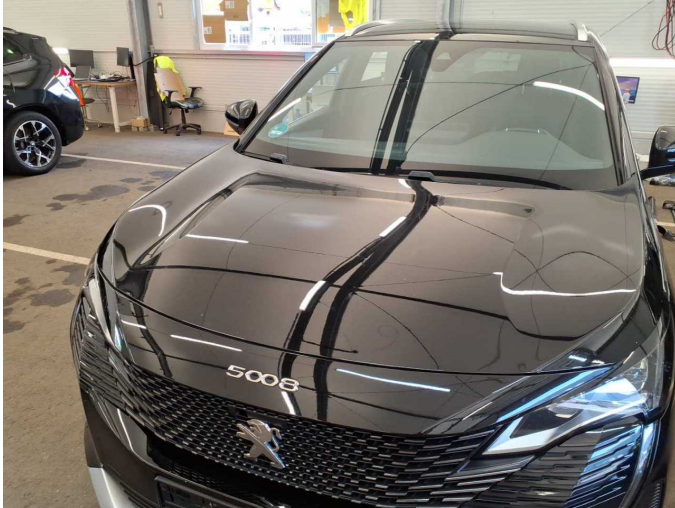
Wear and tear 2: Bonnet: Bonnet - Stone chips - No deduction

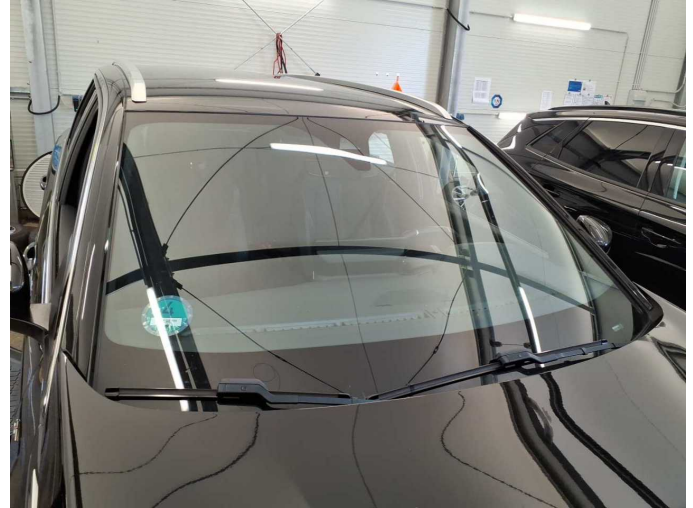
Wear and tear 3: Vehicle glazing: Windscreen - Stone chips - No deduction

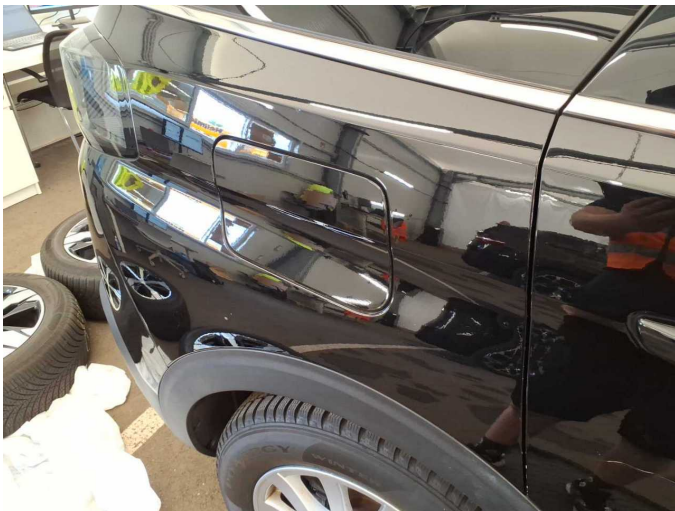
Wear and tear 4: Side panel - rear right side: Side panel - Scratch(es) - No deduction

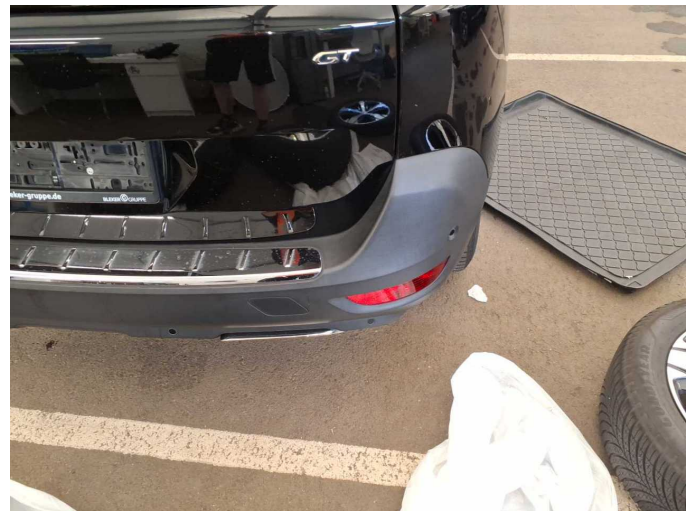
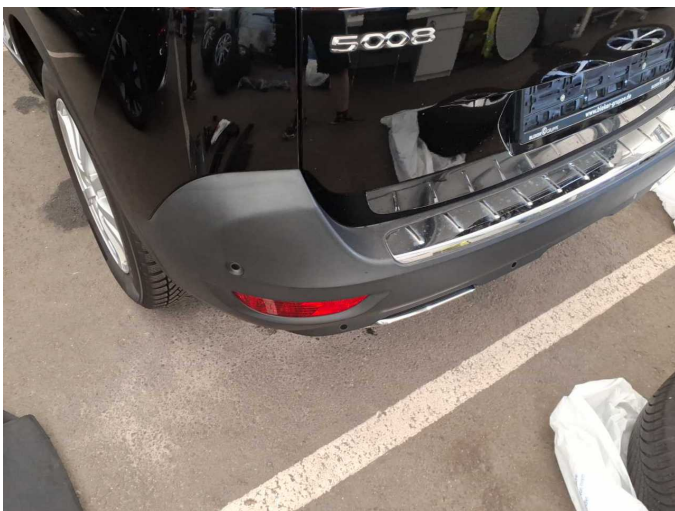
Wear and tear 5: Rear bumper: Rear bumper (unpainted) - Scratch(es) - No deduction
