Expertise

Protocol number: 46294940
Order No. / Reference: MW3041570
Inspection date: 30 Jun 2026

Manufacturer: Renault

Model: Kangoo Maxi Z.E. 33 (mit Batterie)

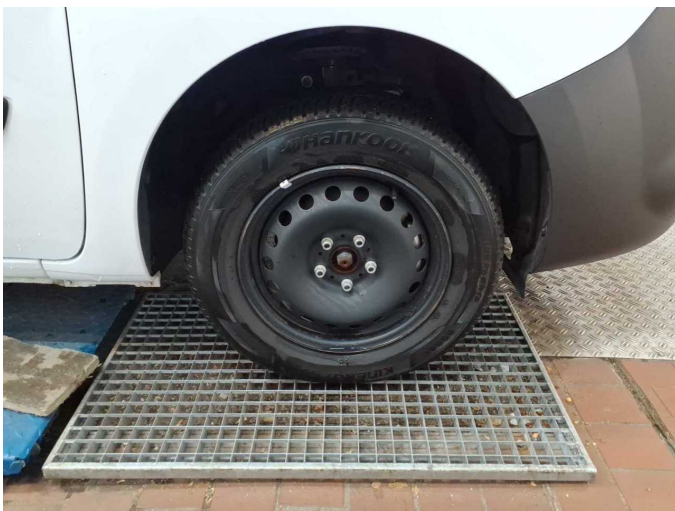
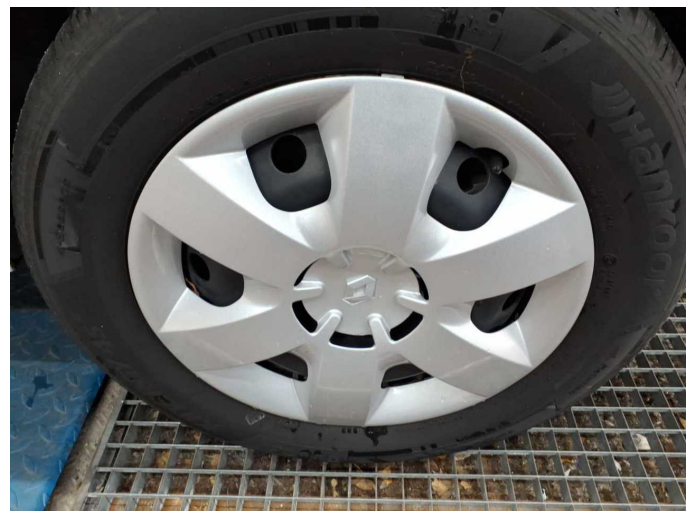
Damage 1: Wheel / tyres: Wheel cover - front right side - Missing - Replace

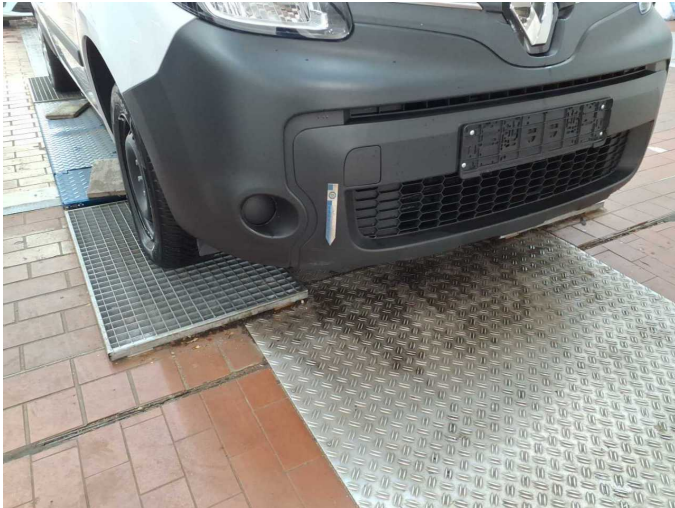
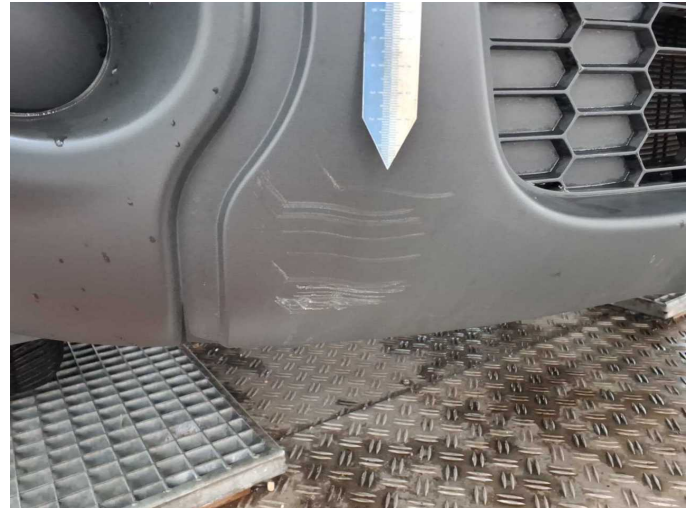
Damage 2: Front bumper: Front bumper (unpainted) - Scratch(es) - Loss in value

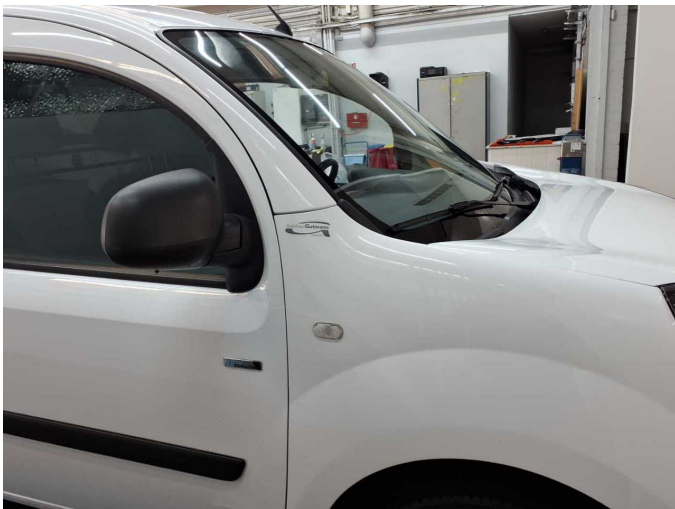
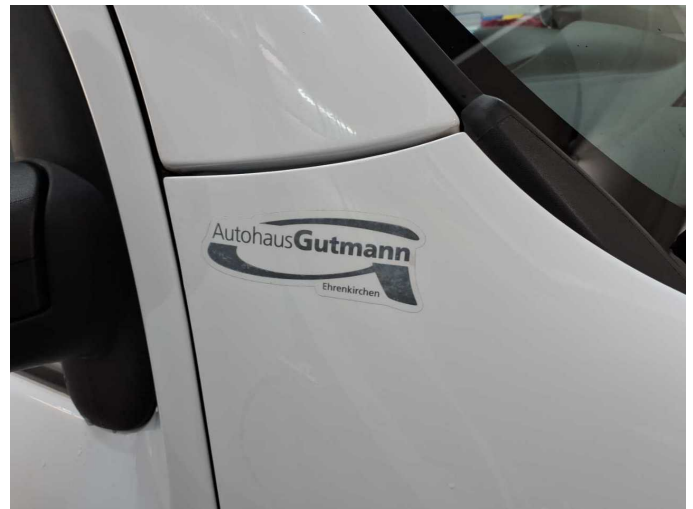
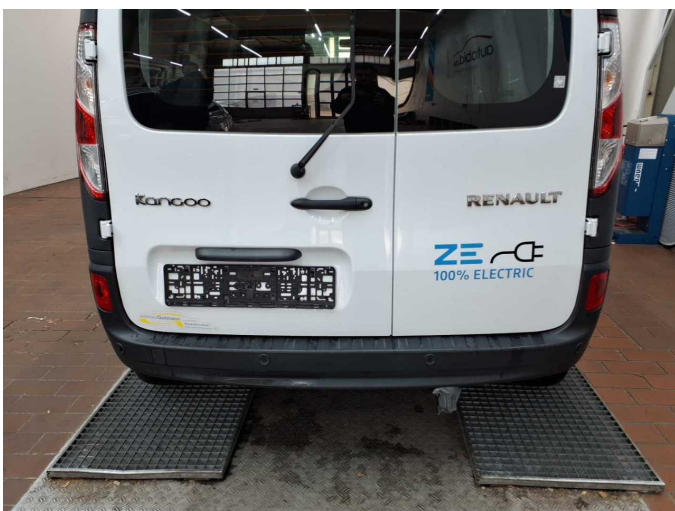
Damage 3: Body: Body - Glued / labelled - De-glug / neutralise

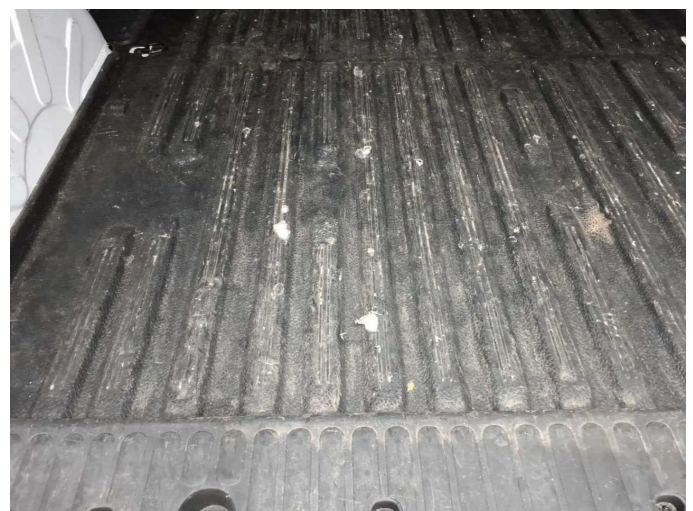
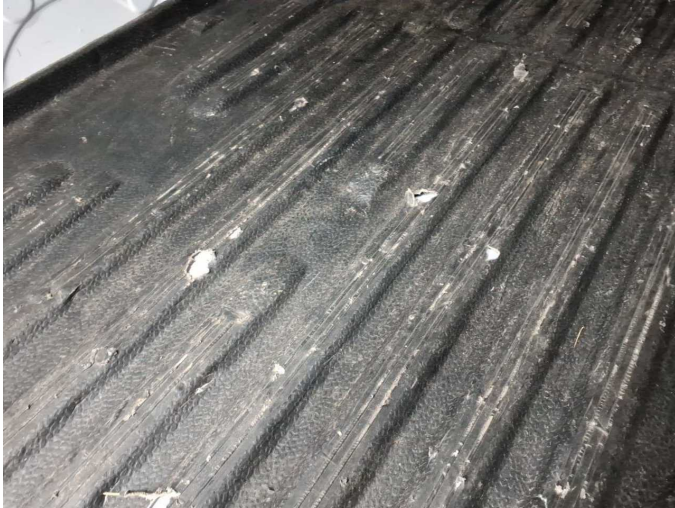
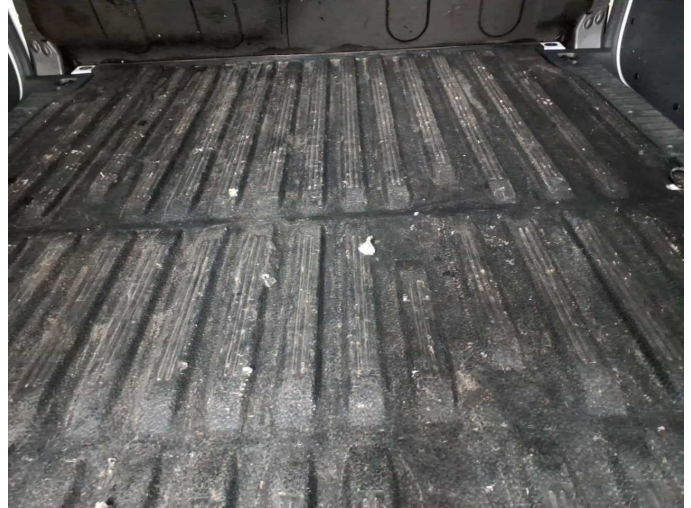
Damage 4: Interior: Cargo area floor - Holes - Loss in value

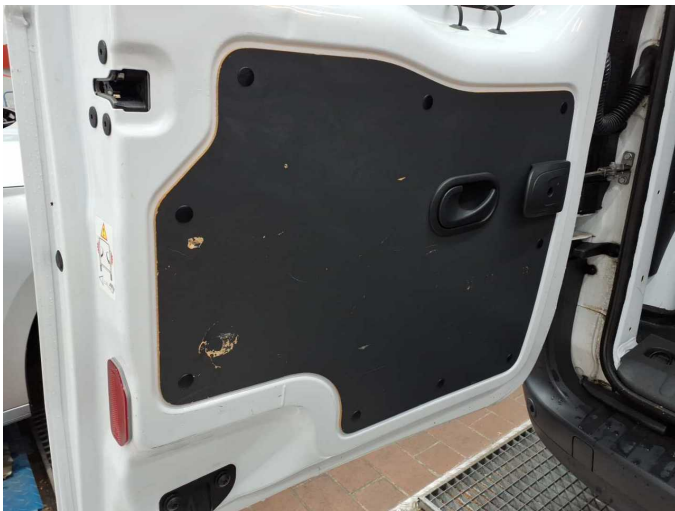
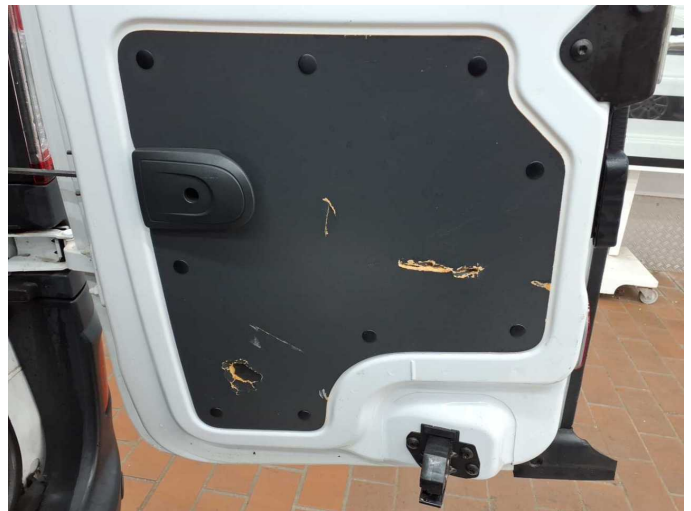
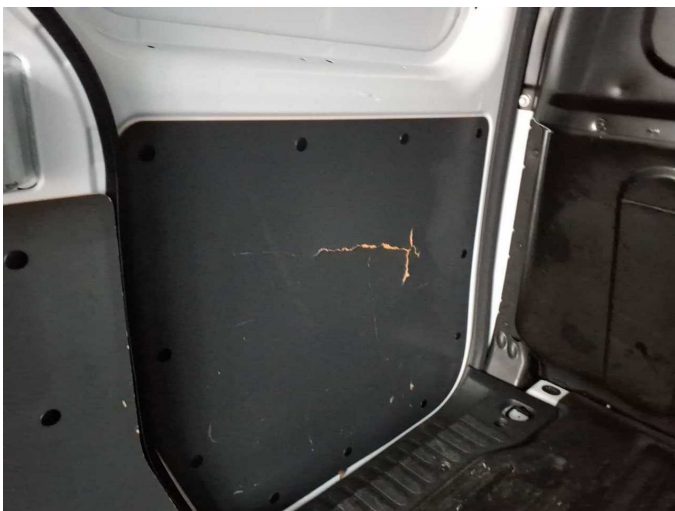
Damage 5: Interior: Interior (Verkleidungen) - Broken / torn - Replace

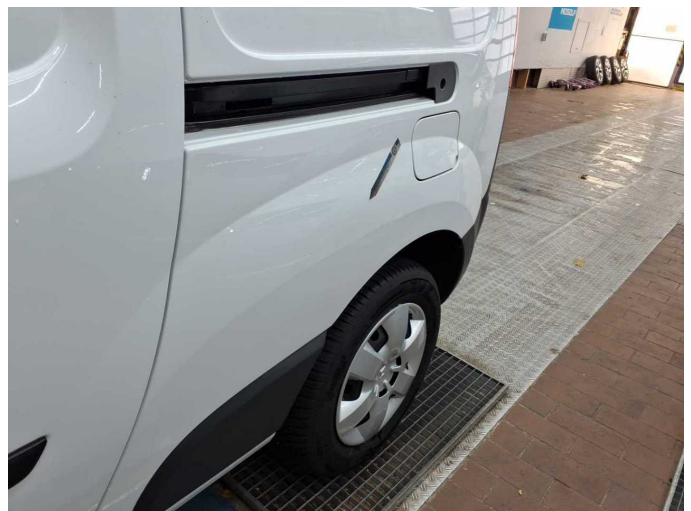
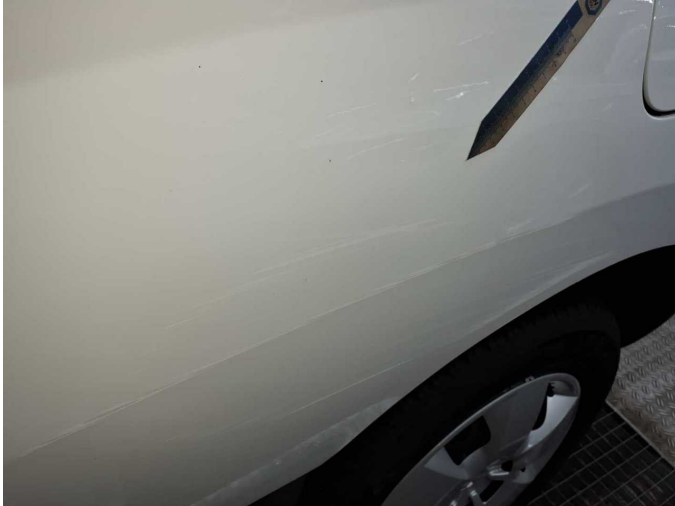
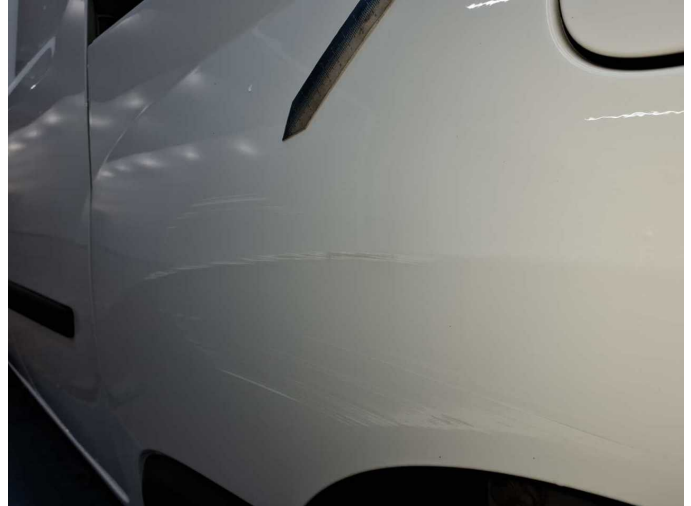
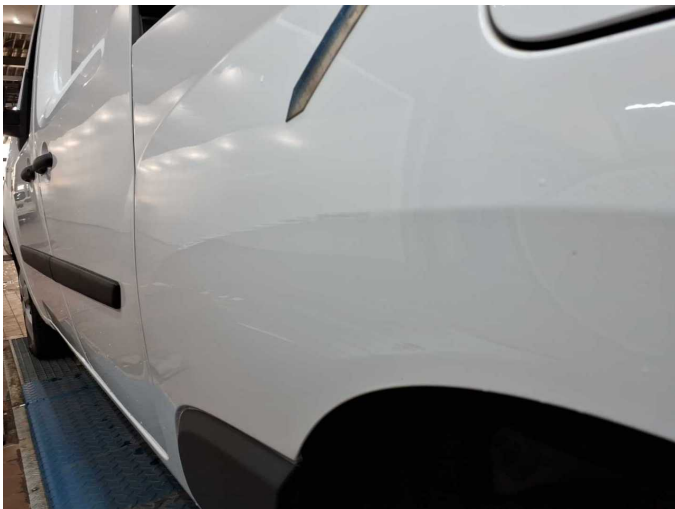
Damage 6: Side panel - rear left side: Side panel - Scratched - Paint

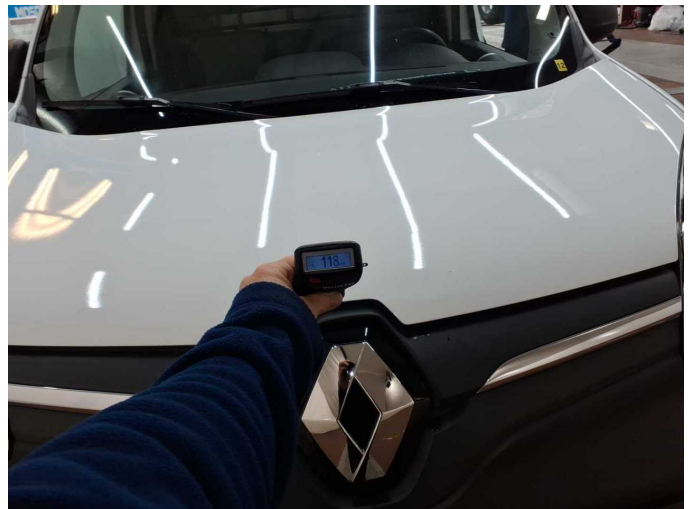
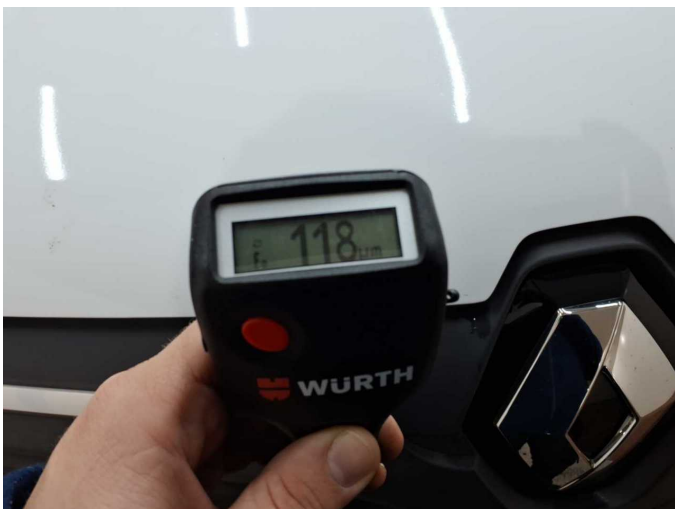
No.	Repainting
1	Bonnet, Professionally carried out, Invoice of repair done Non-existent

Bonnet 180 µm |

Repainting 1: Bonnet
