Expertise

Protocol number: 46356040  
Order No. / Reference: 26550159  
Inspection date: 30 Jun 2026

Manufacturer: Volvo

Model: XC90 T8 AWD Recharge Geartronic Inscription Expression

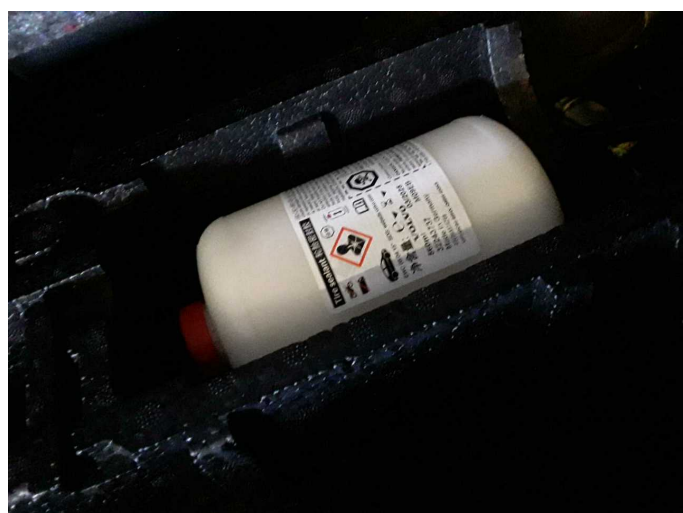
| No. | Component group | Description |
|---|---|---|
| 1 | Equipment | Tirefit filler - Expired - Replace |

Damage 1: Equipment: Tirefit filler - Expired - Replace

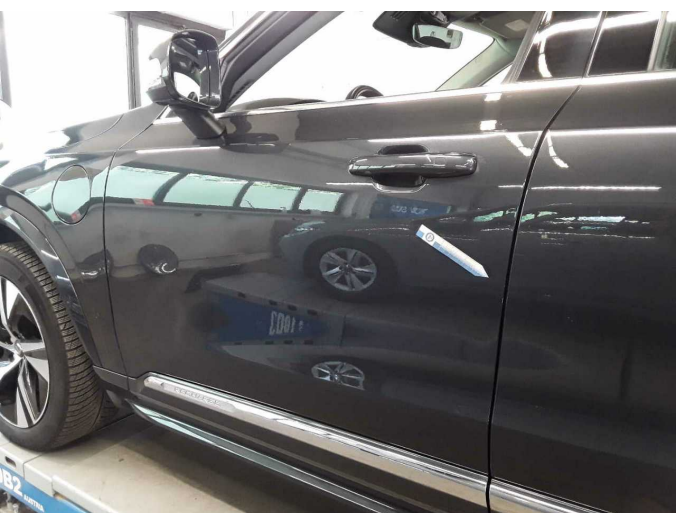
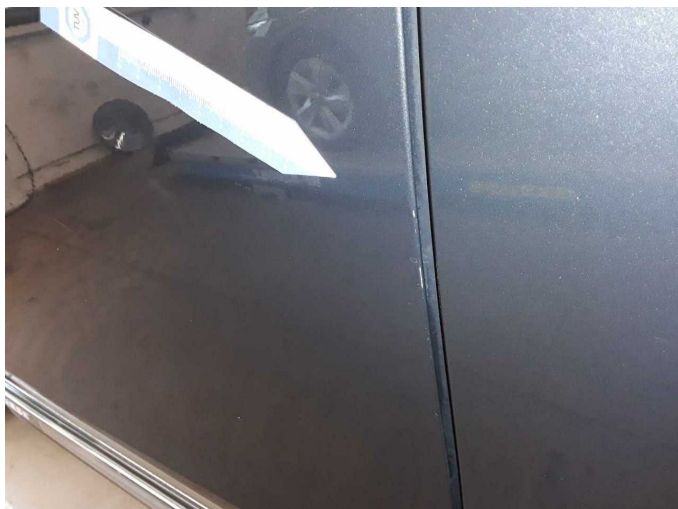
| No. | Component group | Description |
|---|---|---|
| 2 | Door - front left side | Door - Scratch(es) - Smart repair |

Damage 2: Door - front left side: Door - Scratch(es) - Smart repair

**Damage 2:** Door - front left side: Door - Scratch(es) - Smart repair

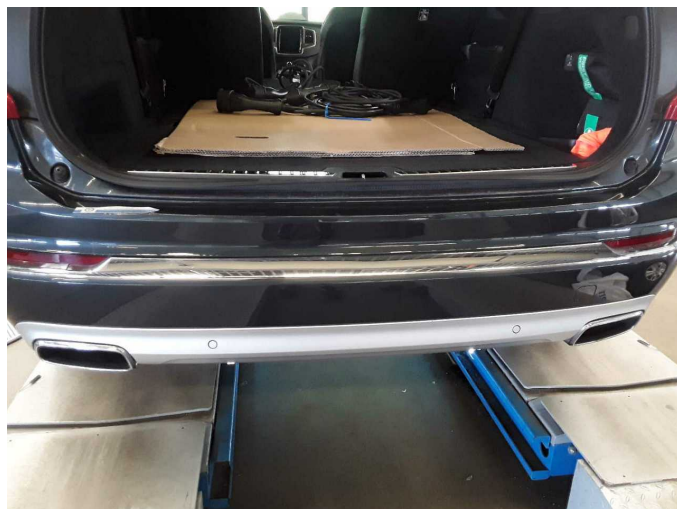
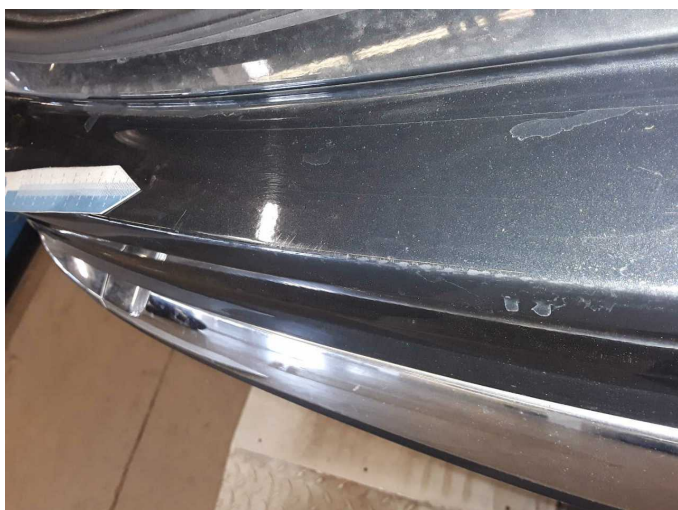
| No. | Component group | Description |
|---|---|---|
| 3 | Rear bumper | Rear bumper - Scratch(es) - Smart repair |

**Damage 3:** Rear bumper: Rear bumper - Scratch(es) - Smart repair

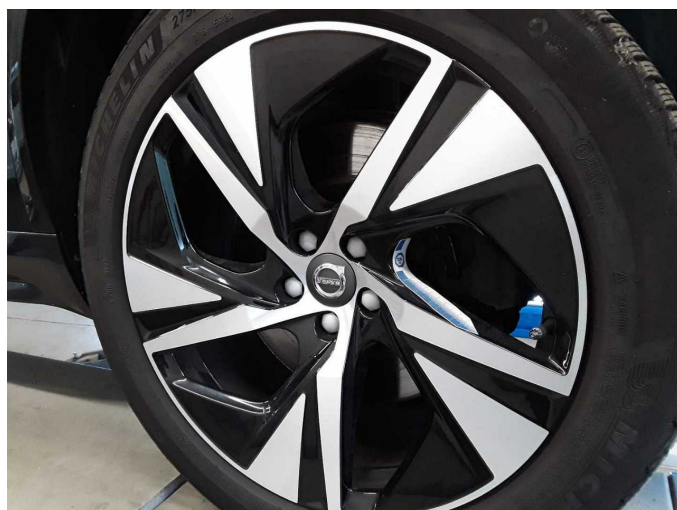
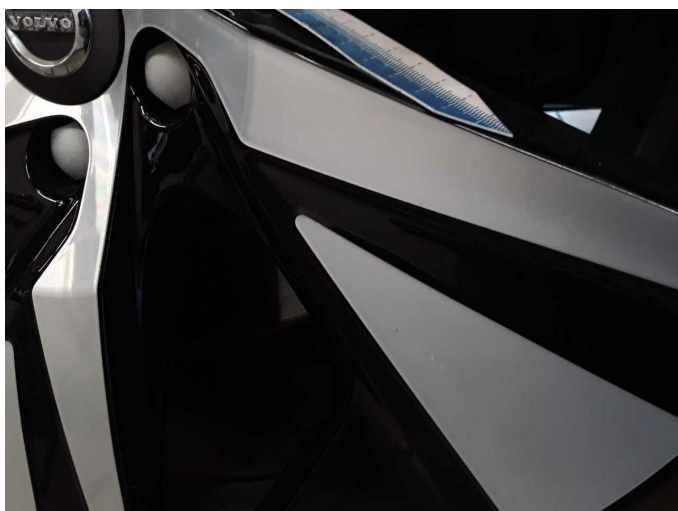
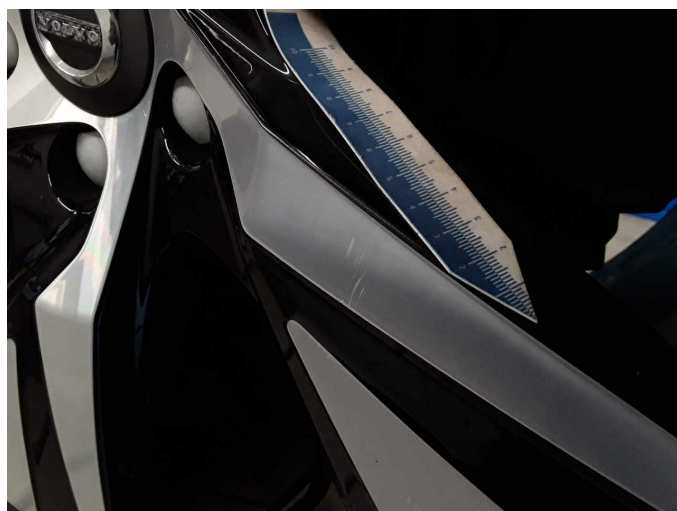
| No. | Component group | Description |
|---|---|---|
| 5 | Wheel / tyres | Alloy rim - front right side - Scratch(es) - Loss in value |

**Damage 5:** Wheel / tyres: Alloy rim - front right side - Scratch(es) - Loss in value

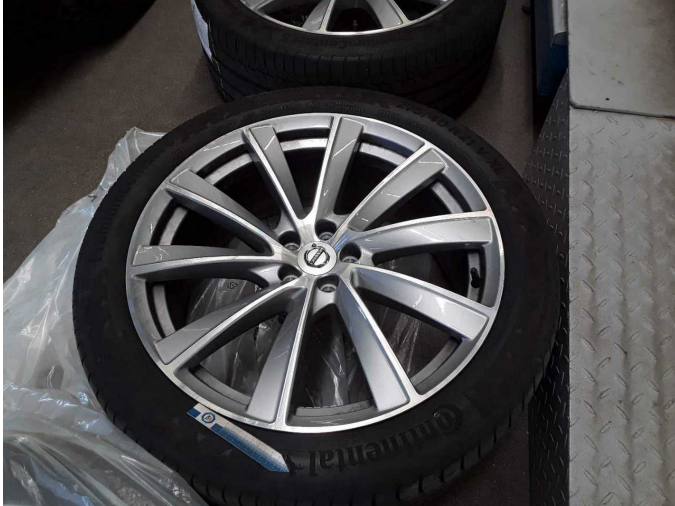
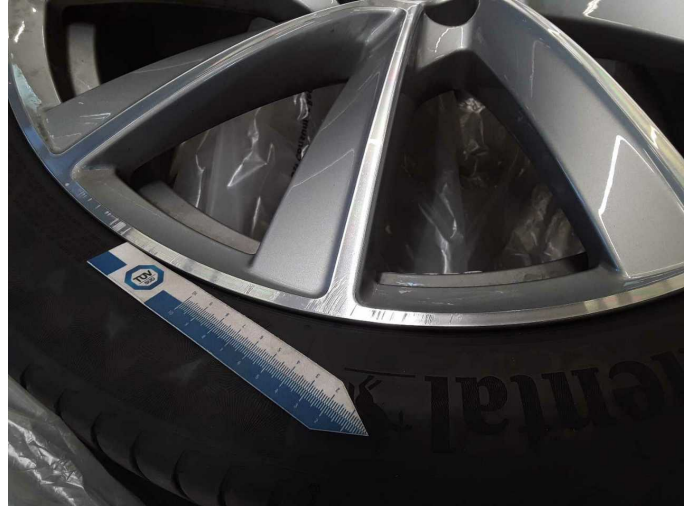
| No. | Component group | Description |
|---|---|---|
| 6 | 2nd wheel set | 1 alloy rim - Scratched - Loss in value |

**Damage 6:** 2nd wheel set: 1 alloy rim - Scratched - Loss in value

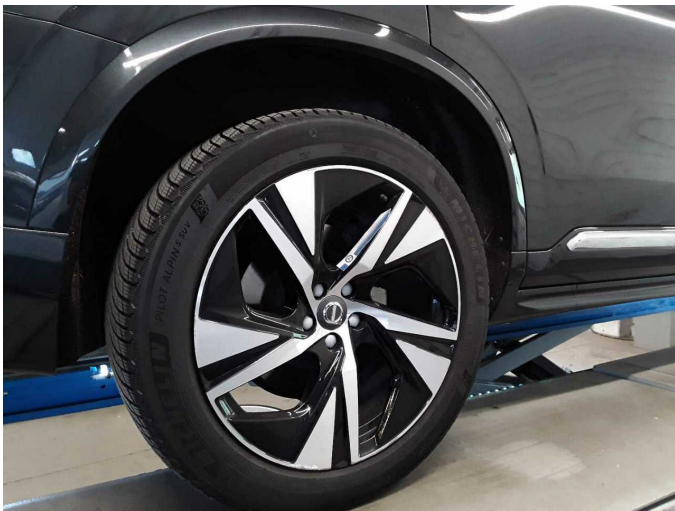
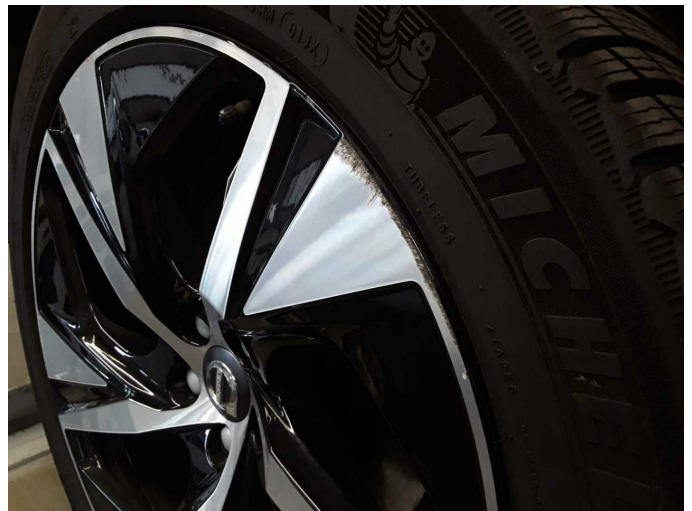
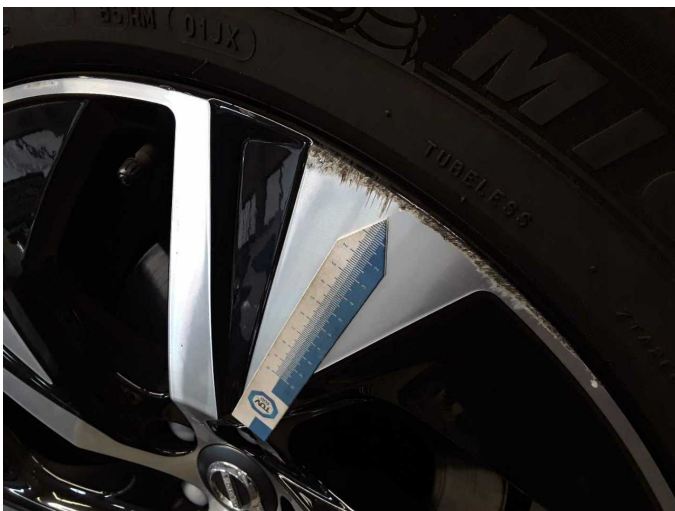
| No. | Component group | Description |
|---|---|---|
| 7 | Wheel / tyres | Alloy rim - rear right side - Scratched - Loss in value |

**Damage 7:** Wheel / tyres: Alloy rim - rear right side - Scratched - Loss in value

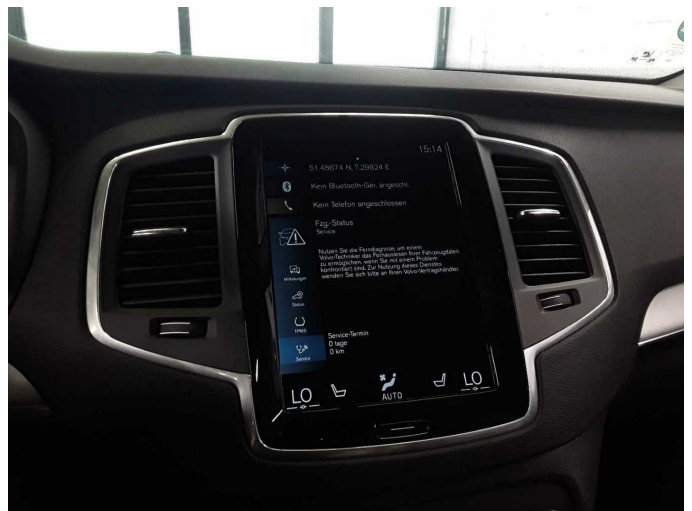
| No. | Component group | Description |
|---|---|---|
| 8 | Misc. | Inspection / maintenance - Due - Perform |

**Damage 8:** Misc.: Inspection / maintenance - Due - Perform

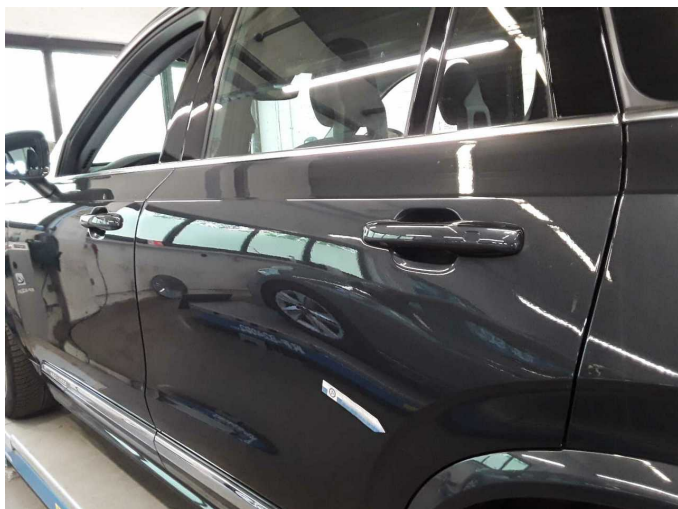
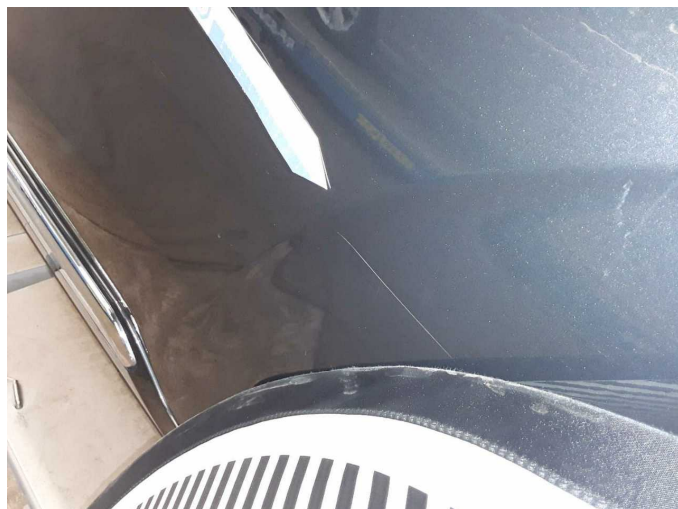
| No. | Component group | Description |
|---|---|---|
| 9 | Door - rear left side | Door - Scratch(es) - Paint |

**Damage 9:** Door - rear left side: Door - Scratch(es) - Paint

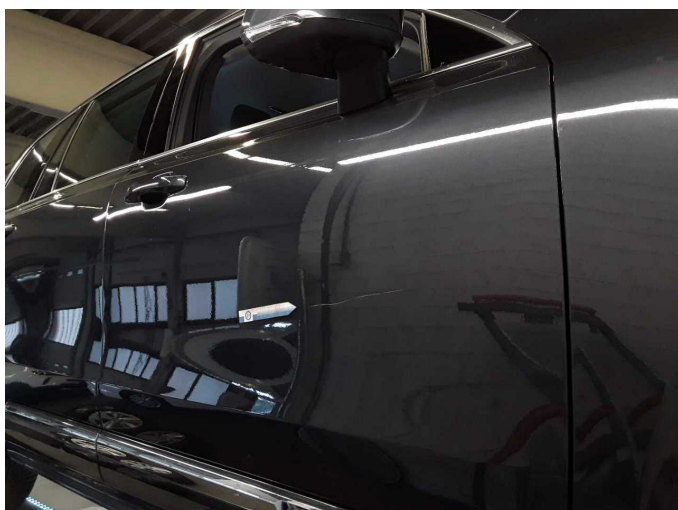
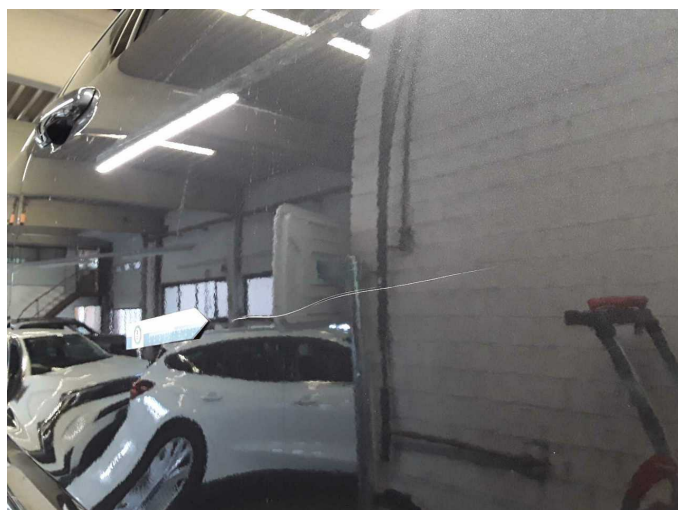
| No. | Component group | Description |
|---|---|---|
| 10 | Door - front right side | Door - Scratch(es) - Paint |

**Damage 10:** Door - front right side: Door - Scratch(es) - Paint

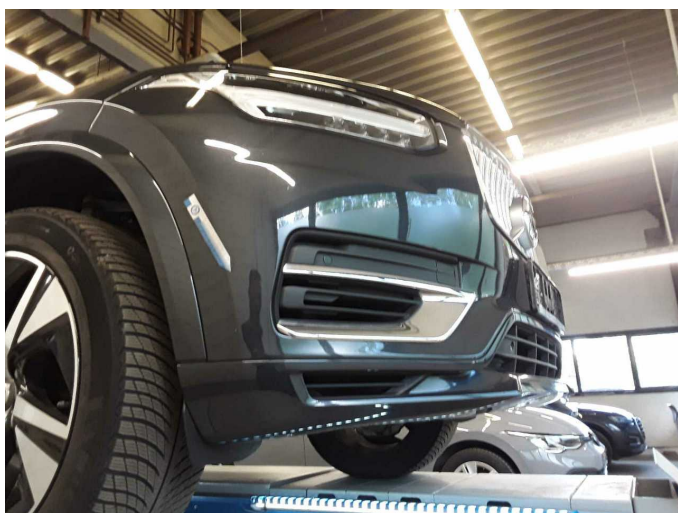
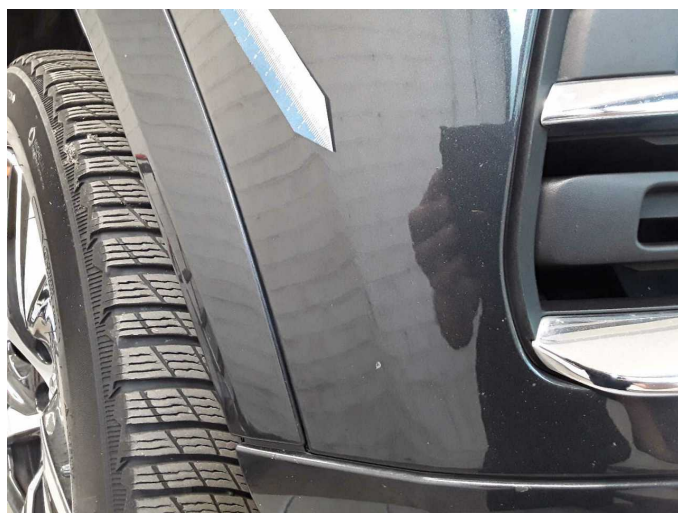
| No. | Component group | Description |
|---|---|---|
| 1 | Front bumper | Front bumper - Stone chips - No deduction |

**Wear and tear 1:** Front bumper: Front bumper - Stone chips - No deduction

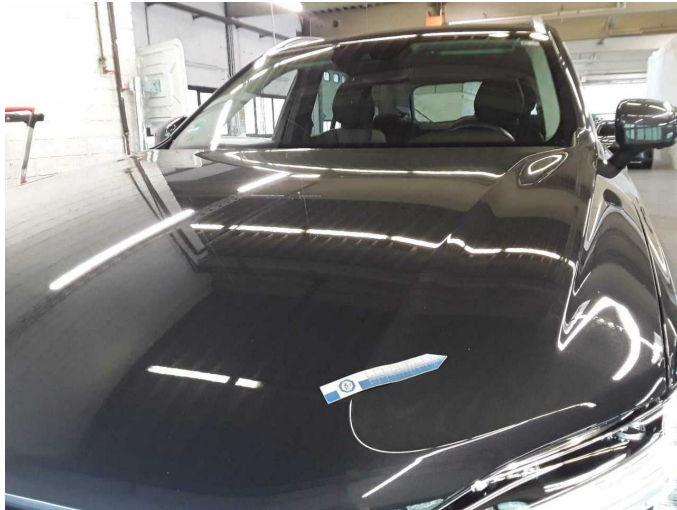
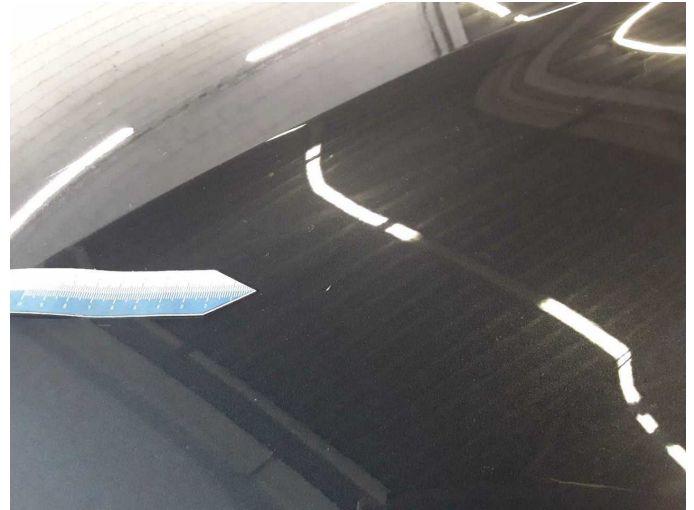
| No. | Component group | Description |
|---|---|---|
| 2 | Bonnet | Bonnet - Stone chips - No deduction |

**Wear and tear 2:** Bonnet: Bonnet - Stone chips - No deduction
