## Expertise

Protocol number: 46292724  
Order No. / Reference: 26512448  
Inspection date: 1 Jul 2026

Manufacturer: Ford

Model: Mondeo Turnier 2.0 EcoBlue Titanium

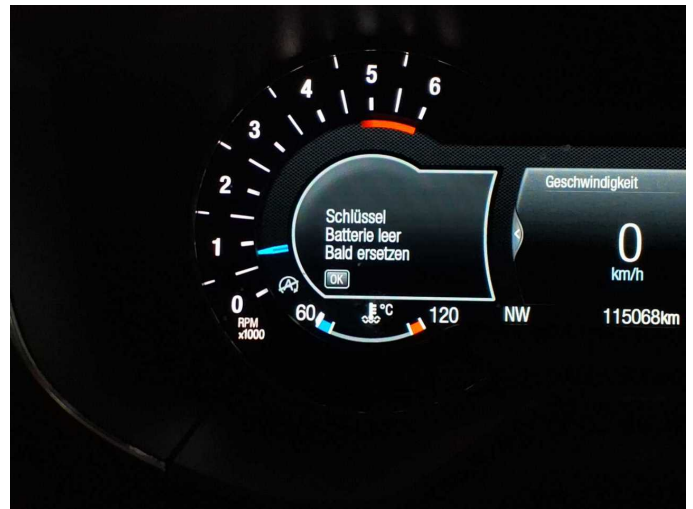
Damage 1: Equipment: Vehicle key (Batterie) - Empty - Replace

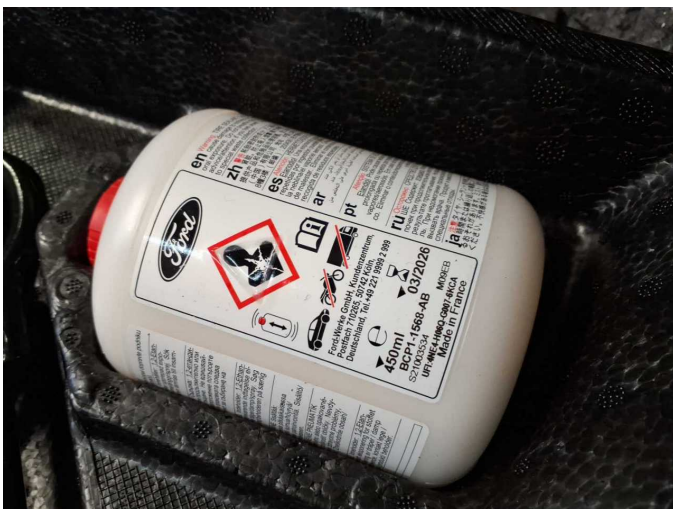
Damage 2: Equipment: Tirefit filler - Expired - Replace

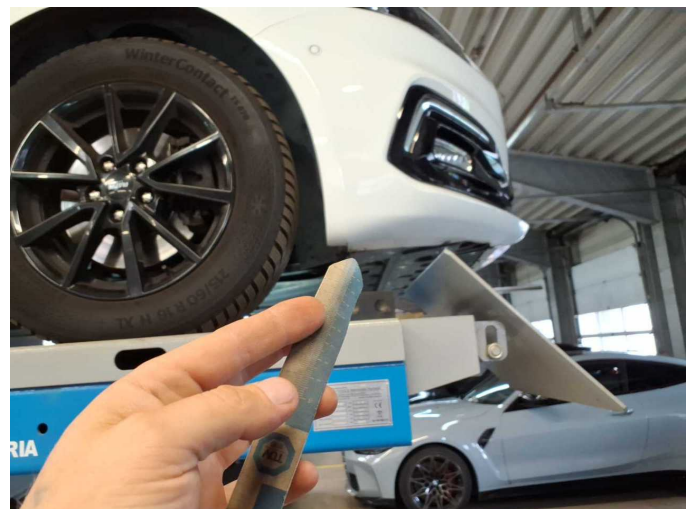
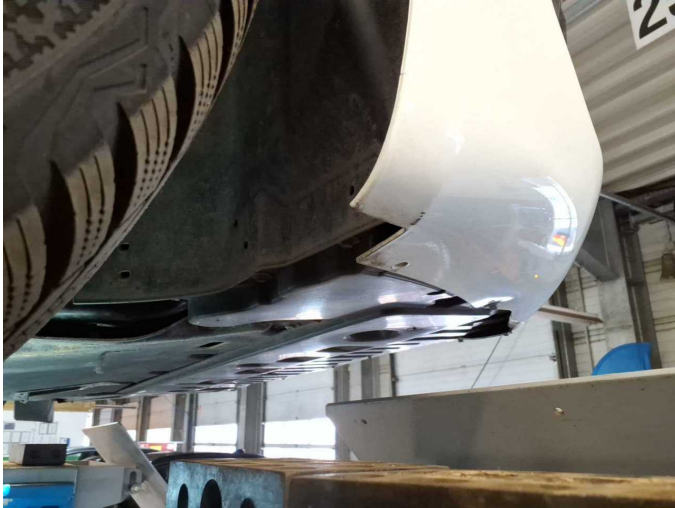
Damage 3: Mudguard - right side: Mud flap (Schmutzabweiser) - Missing - Replace

**Damage 3:** Mudguard - right side: Mud flap (Schmutzabweiser) - Missing - Replace

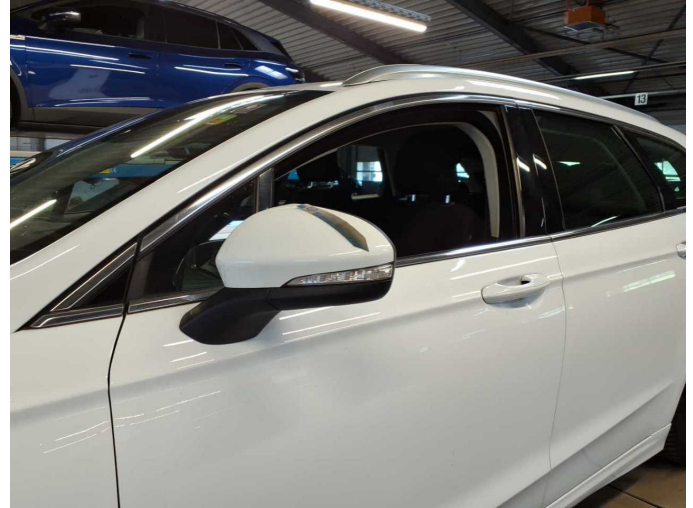
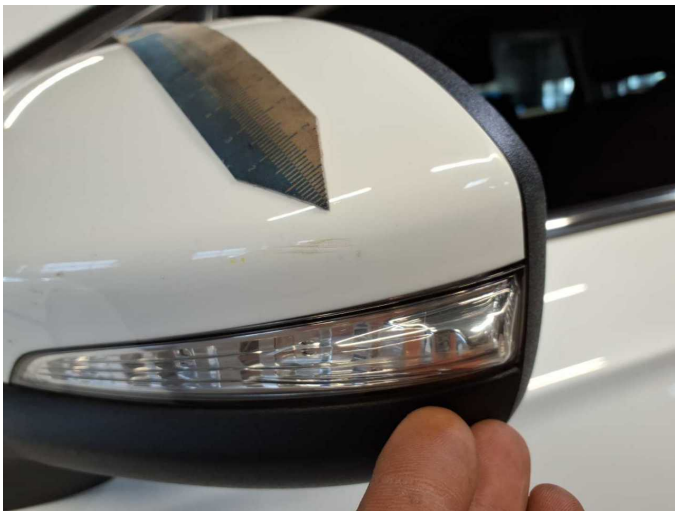
**Damage 4:** Wing mirror - left side: Cap - Scratch(es) - Smart repair

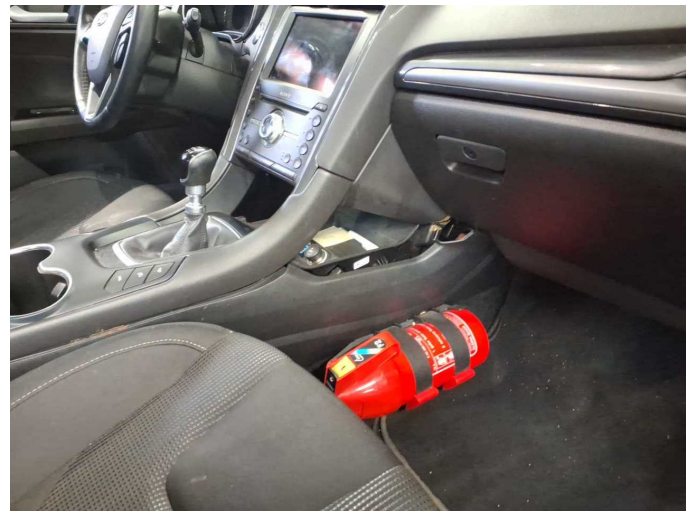
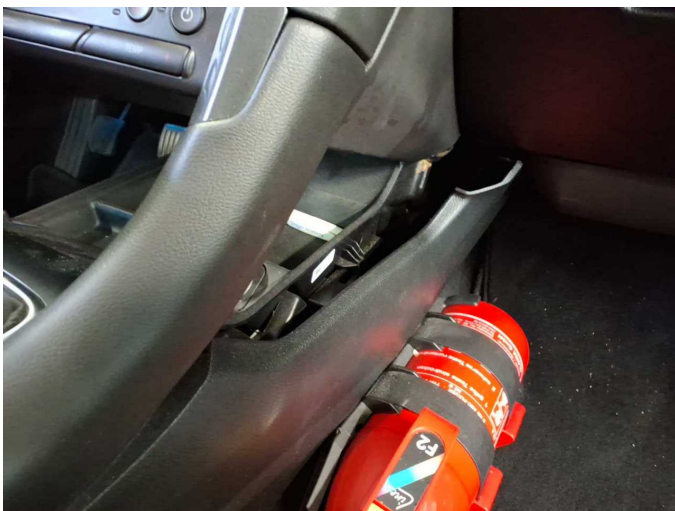
**Damage 5:** Instrument panel: Centre console - front (Abdeckung rechts, evtl. erneuern) - Loose - Un- / install

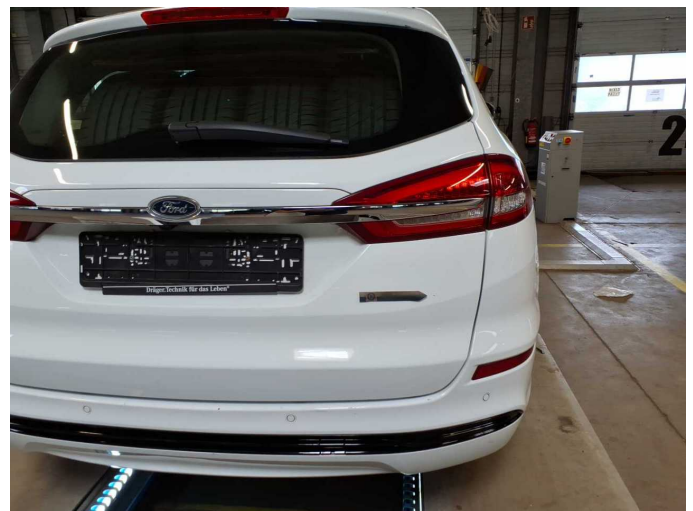
**Damage 6:** Boot lid / rear door: Boot lid - Scratch(es) - Smart repair

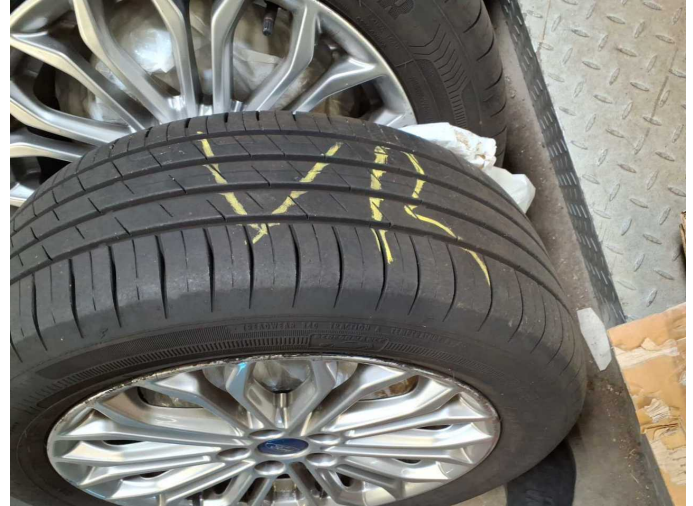
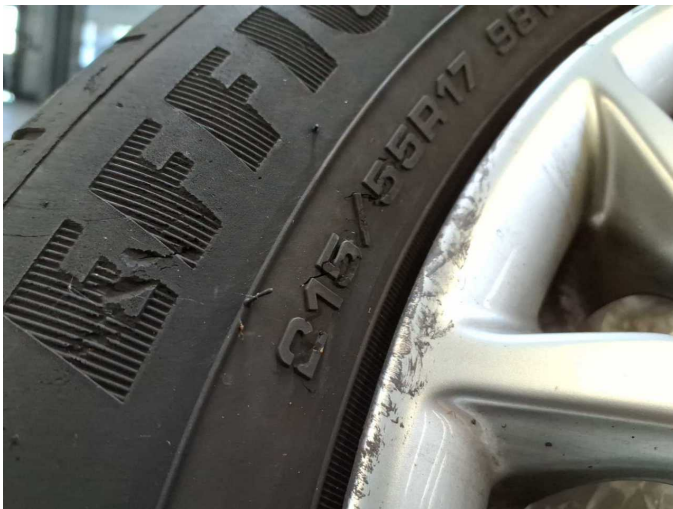
**Damage 7:** 2nd wheel set: 1 tyre (Flanke) - Damaged - Replace

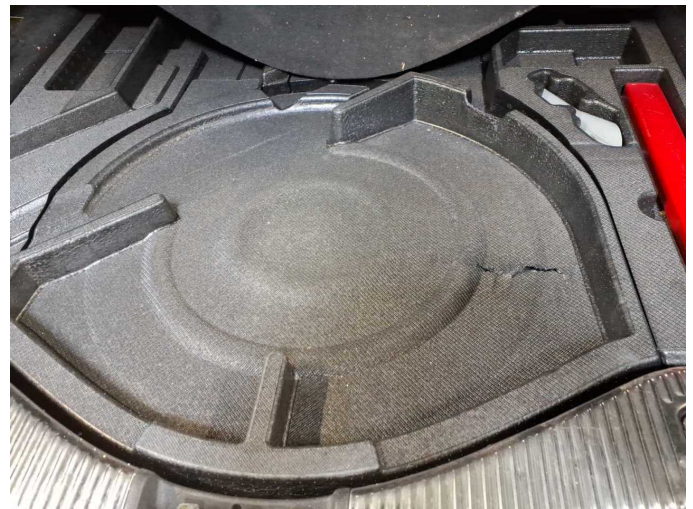
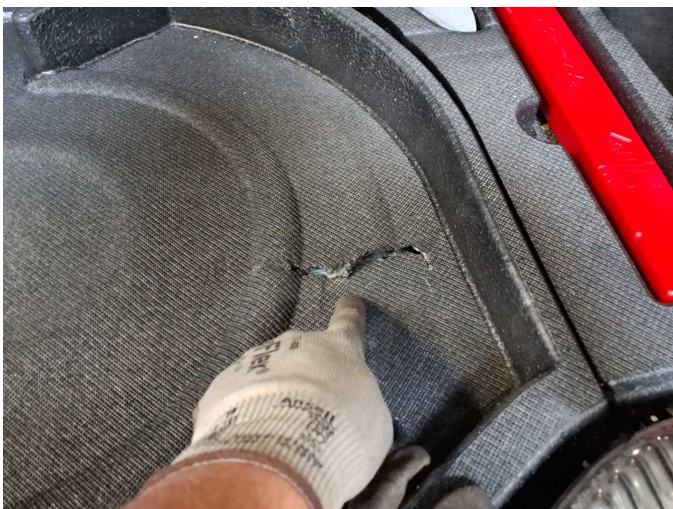
**Damage 8:** Interior: Cargo area floor (Abdeckung) - Broken / torn - Replace

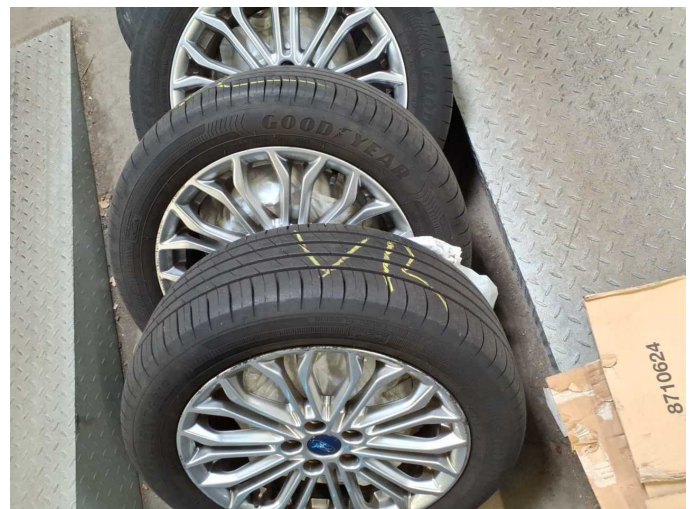
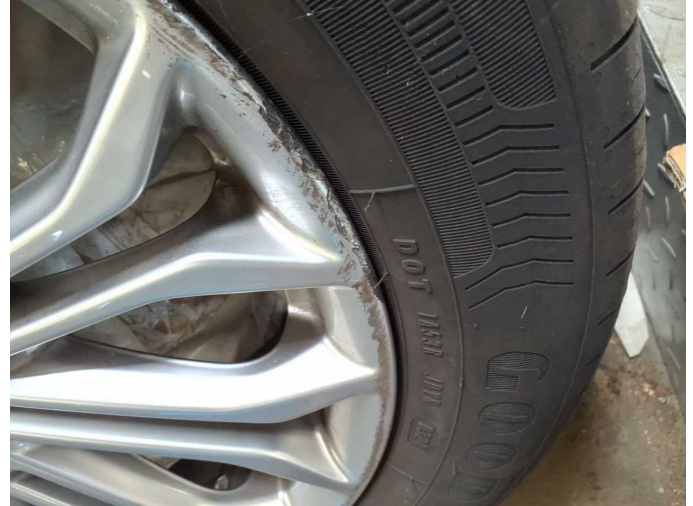
**Damage 9:** 2nd wheel set: 1 alloy rim - Scratched - Loss in value

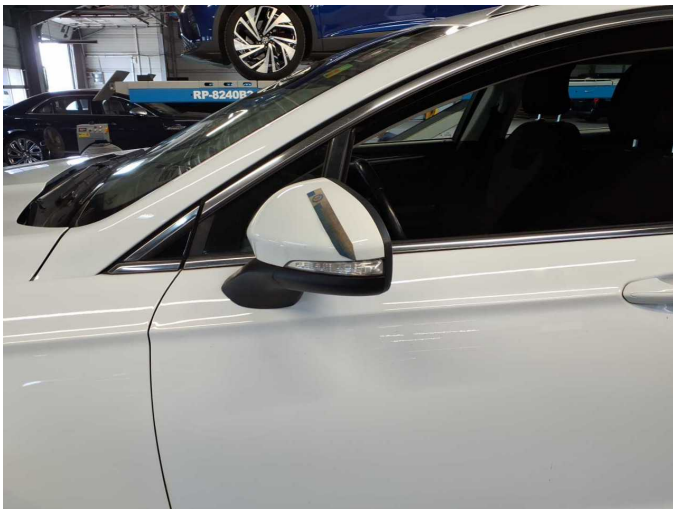
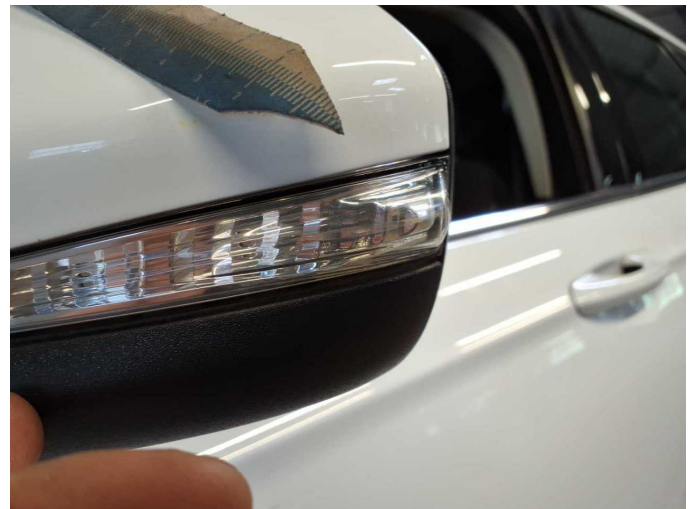
**Damage 10:** Indicator - front: Mirror - left side (Materialabtrag) - Scratch(es) - Replace

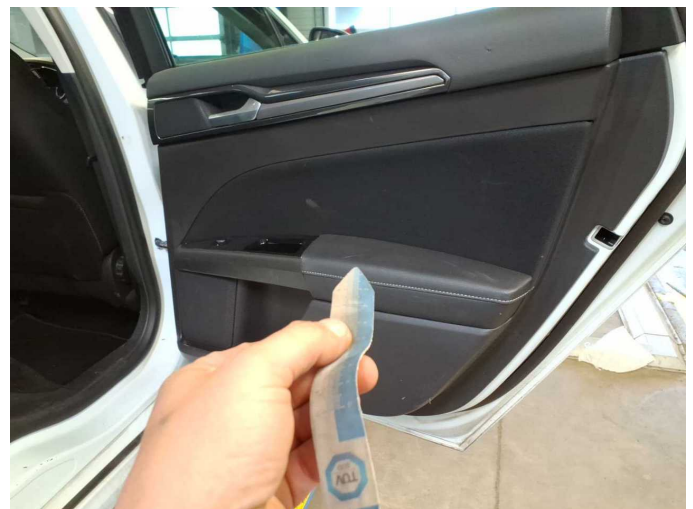
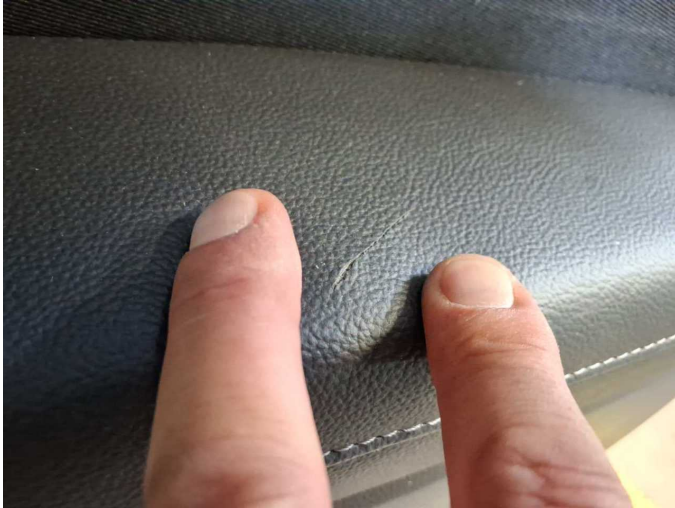
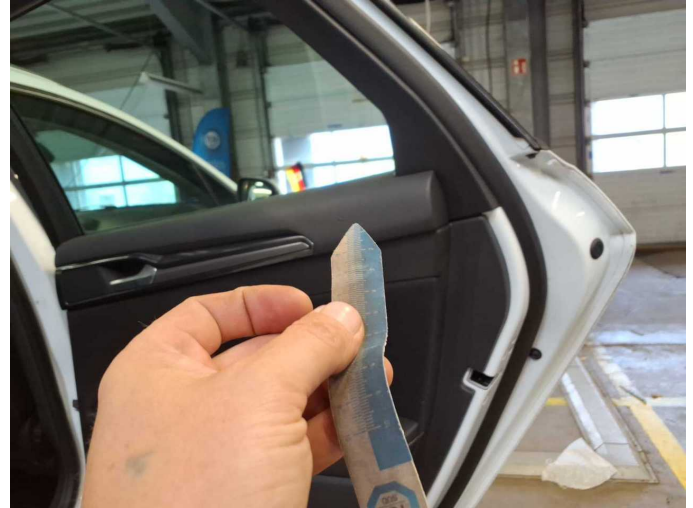
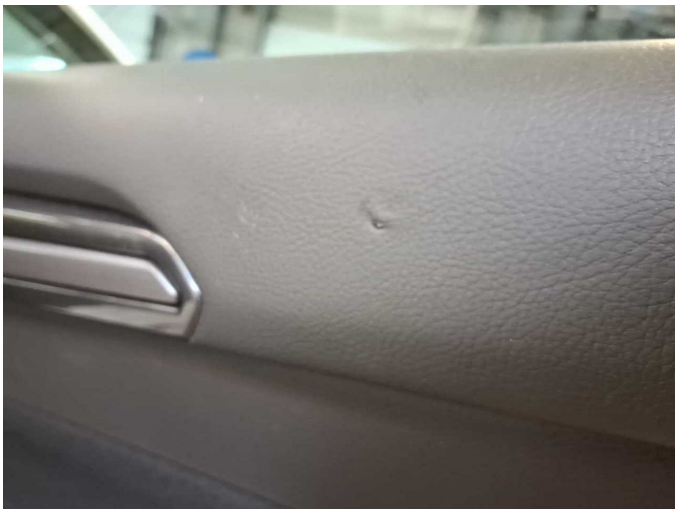
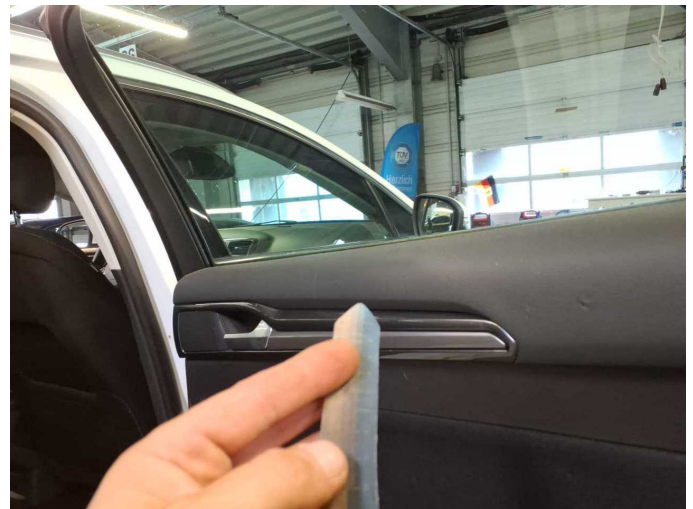
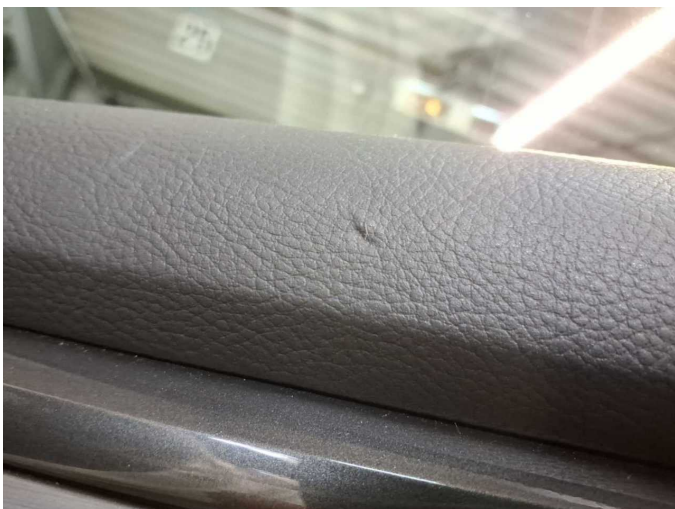
**Damage 11:** Trim / covers: Door trim - rear right side - Damaged - Smart repair

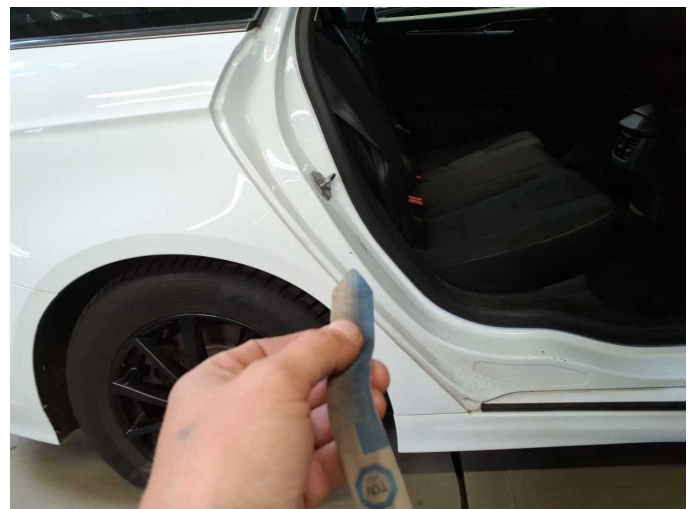
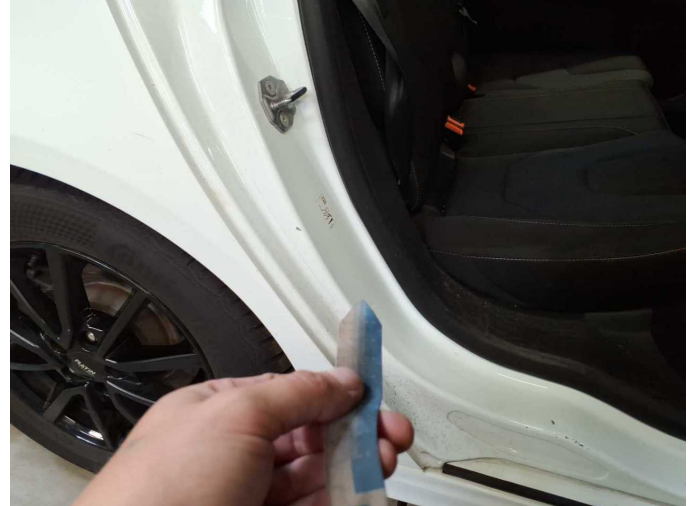
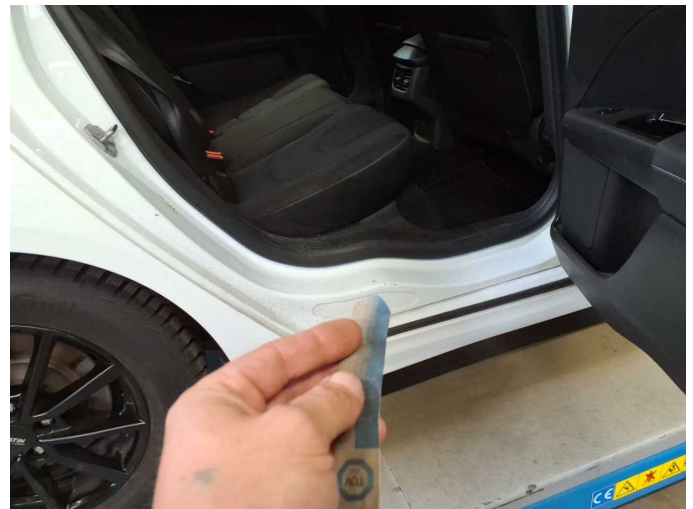
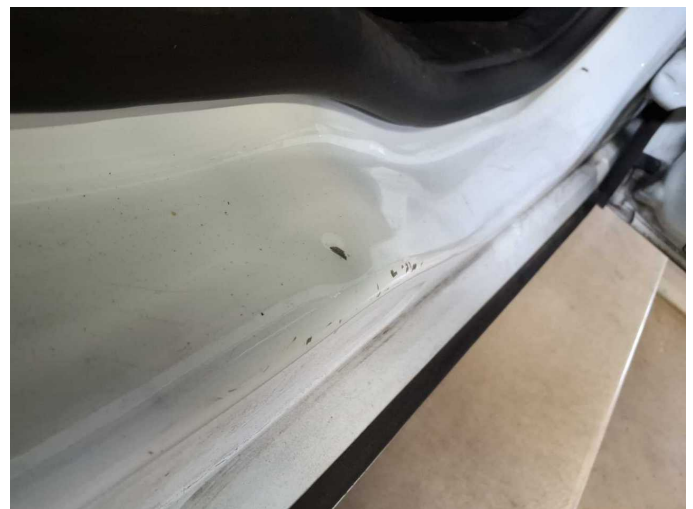
**Damage 12:** Side panel - rear right side: Sill - Dent / paintcoat damage - Smart repair

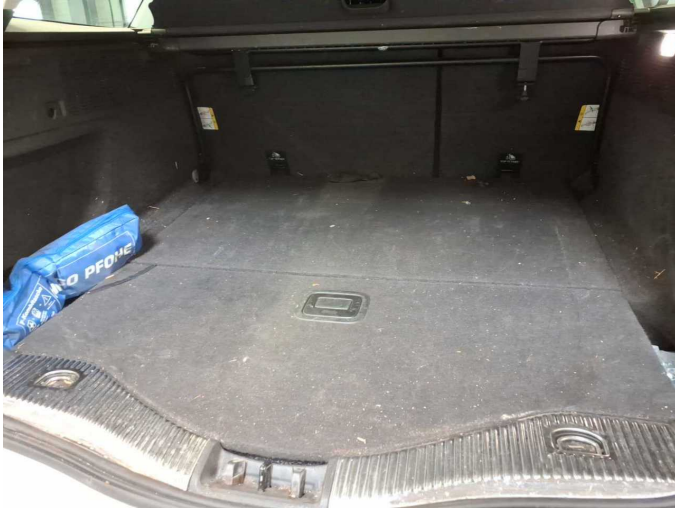
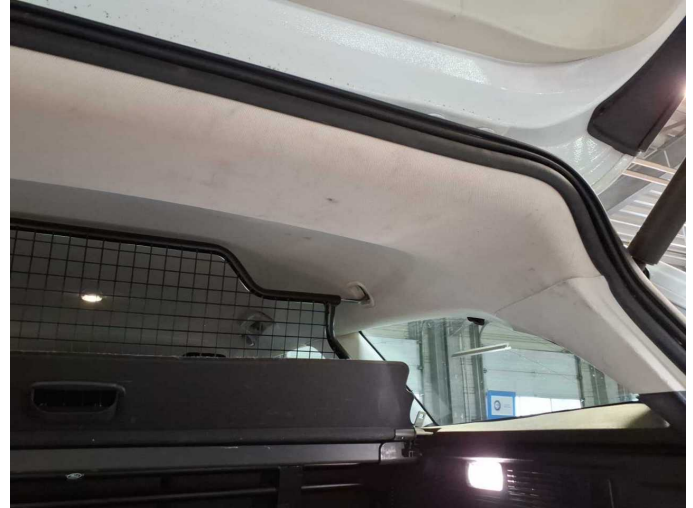
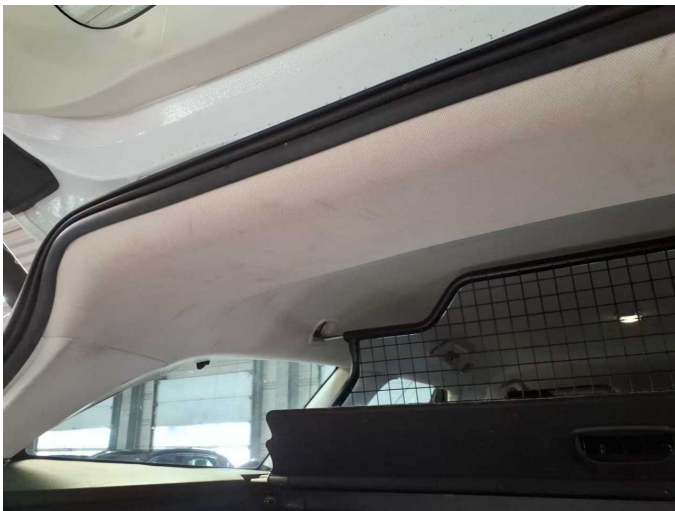
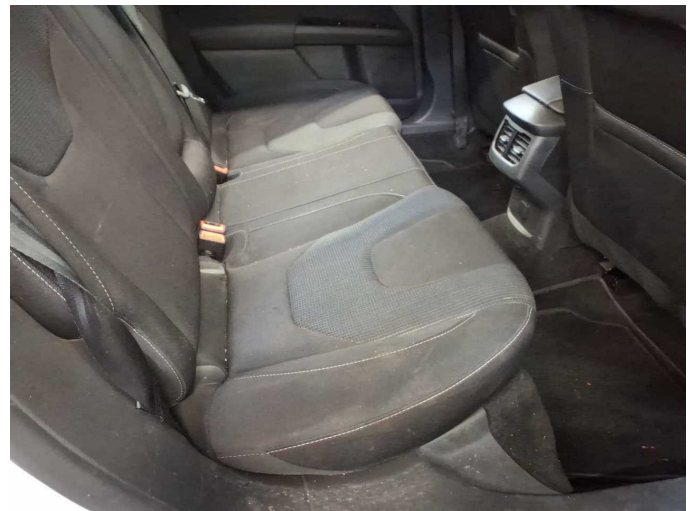
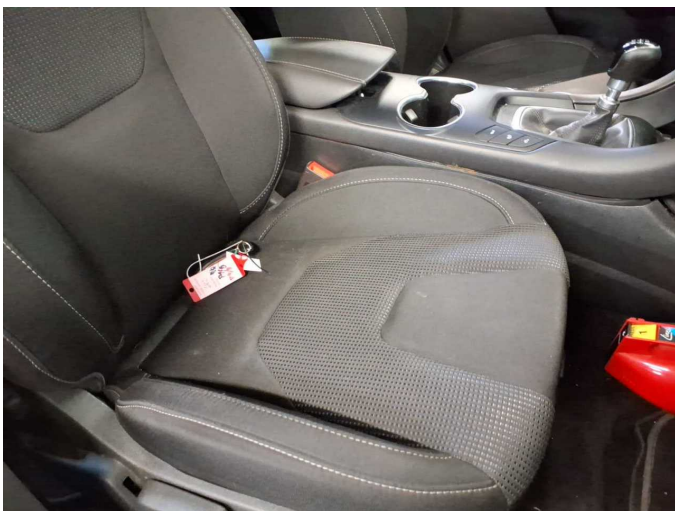
**Damage 13:** Interior: Interior - Soiled - Clean

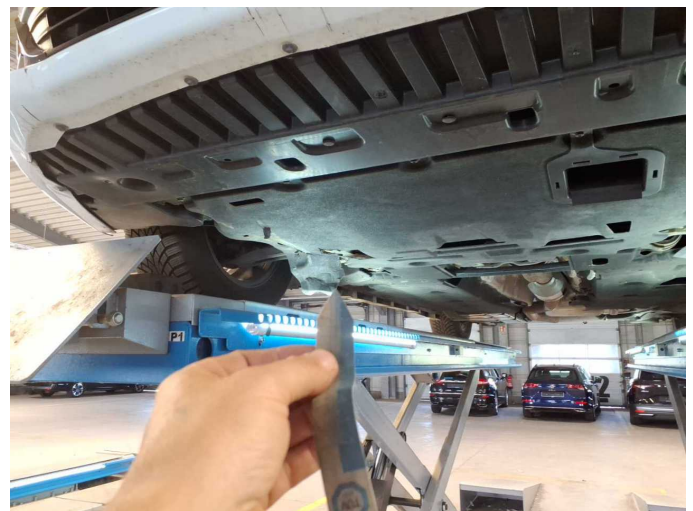
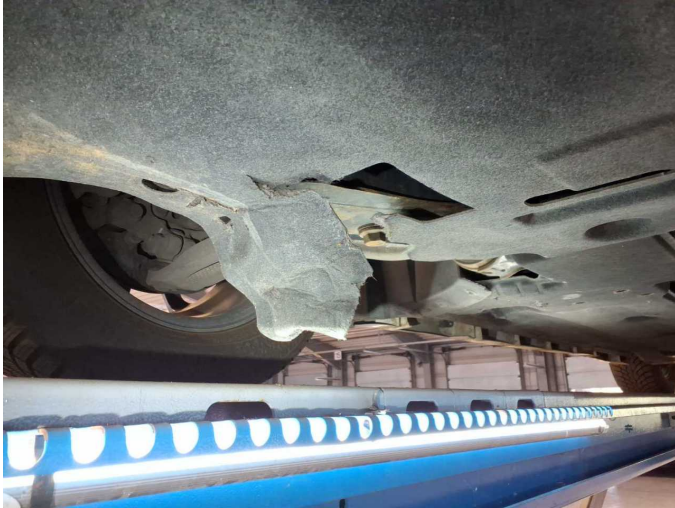
**Damage 14:** Engine: Engine cowling - lower - Broken / torn - Replace

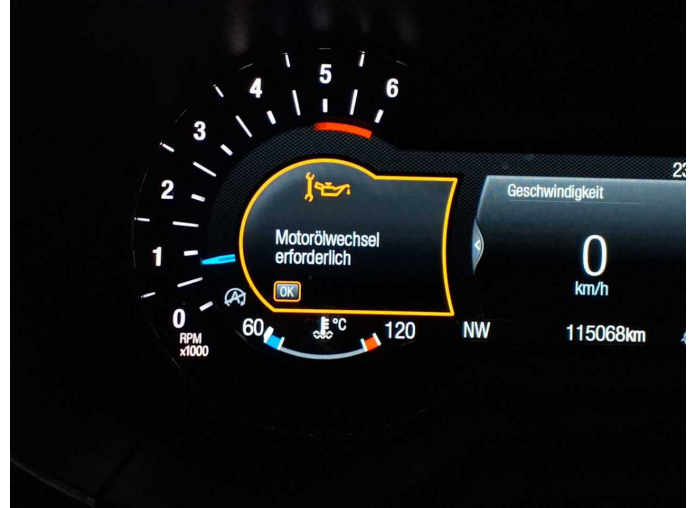
**Damage 15:** Misc.: Inspection / maintenance - Due - Perform

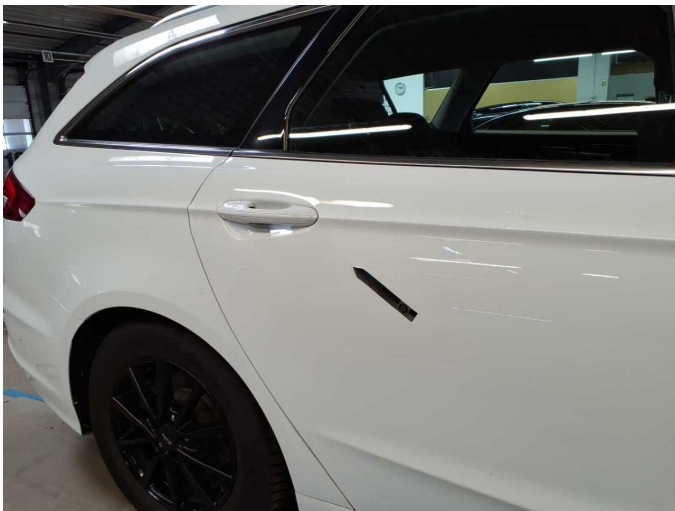
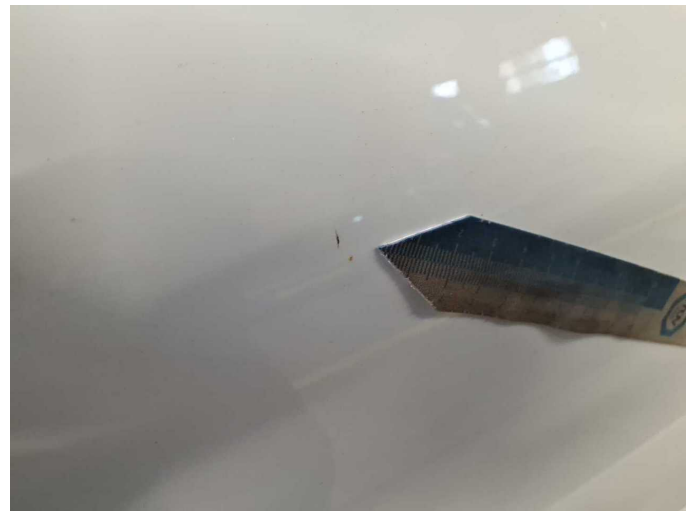
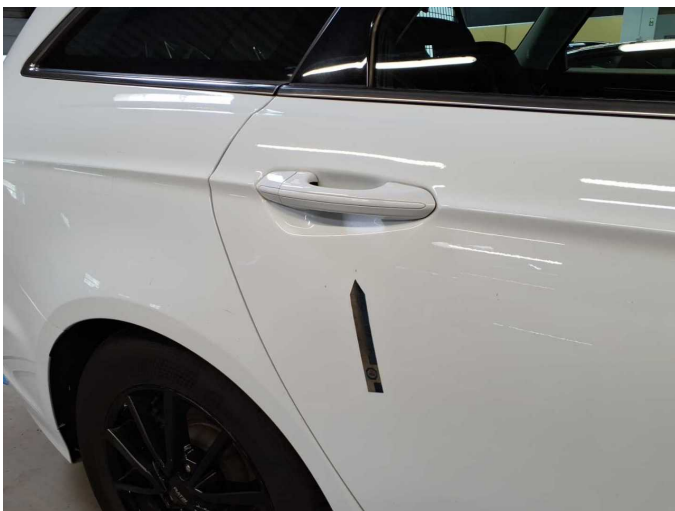
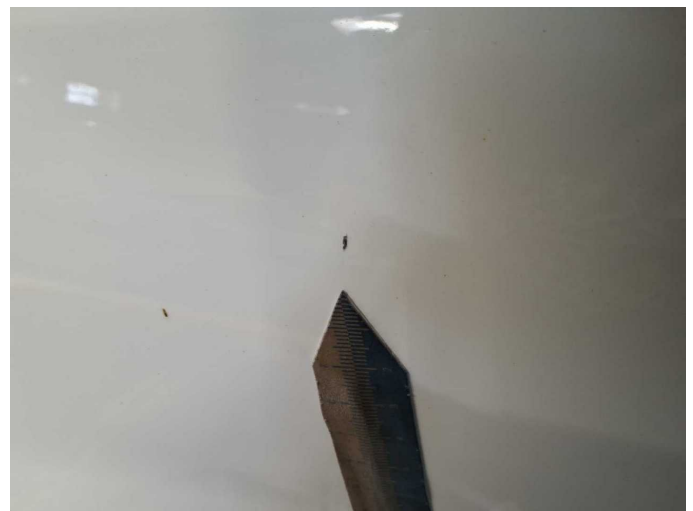
**Damage 16:** Door - rear right side: Door - Scratch(es) - Paint

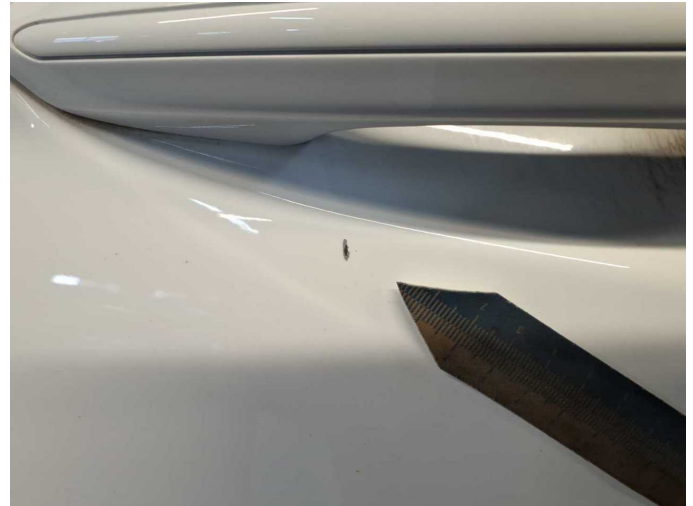
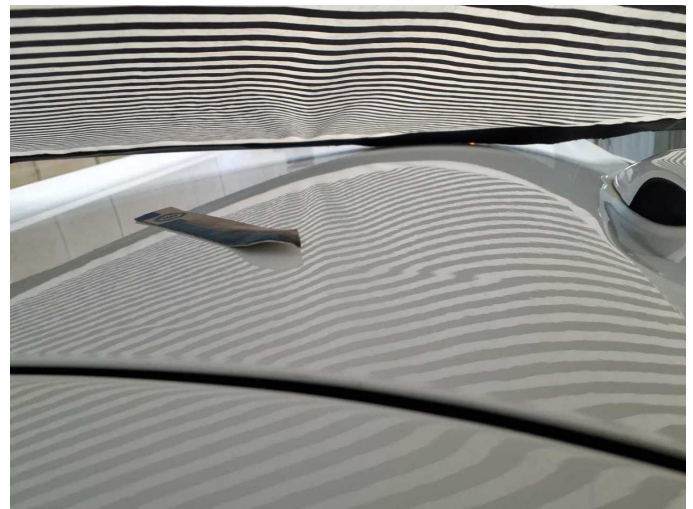
**Damage 17:** Door - front left side: Door - Dent / paintcoat damage - Repair and paint

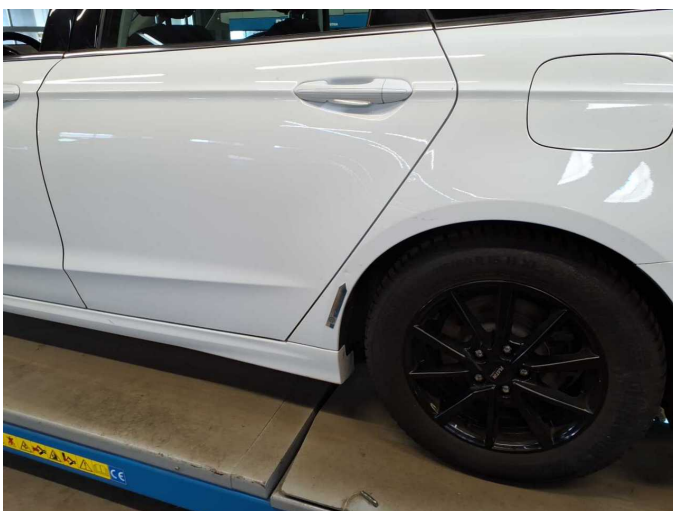
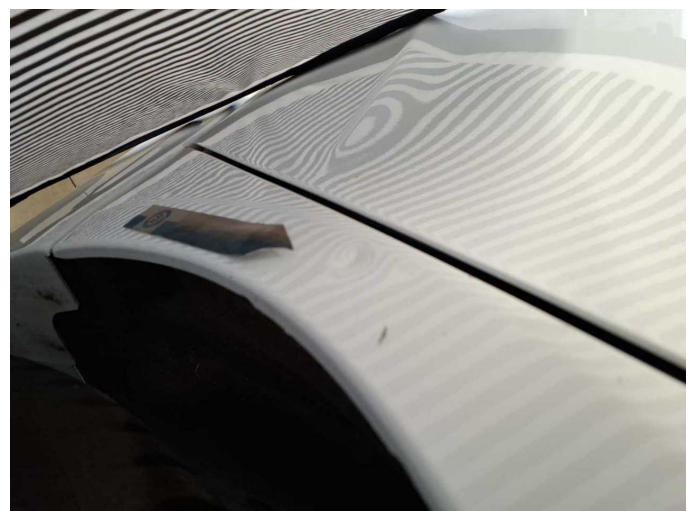
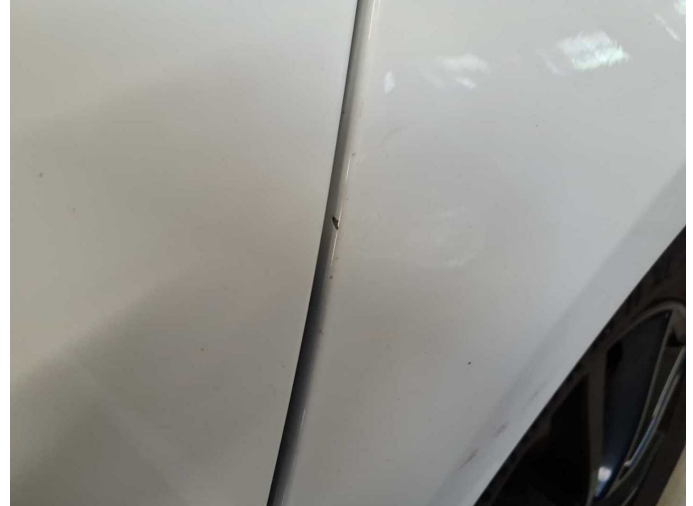
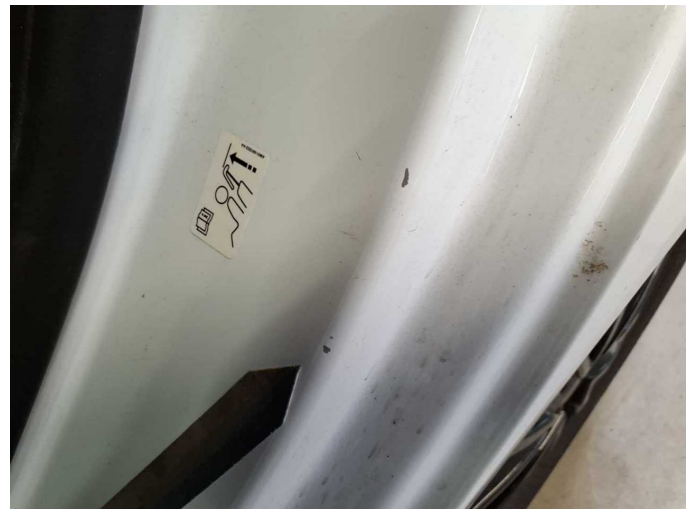
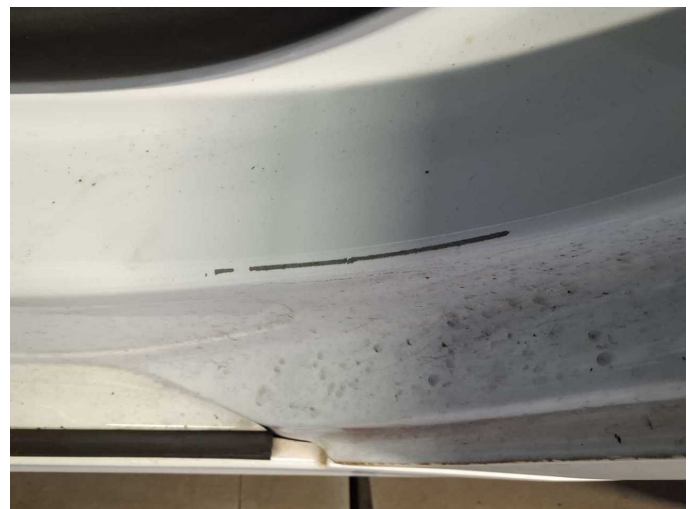
**Damage 18:** Side panel - rear left side: Side panel - Dent / paintcoat damage - Repair and paint

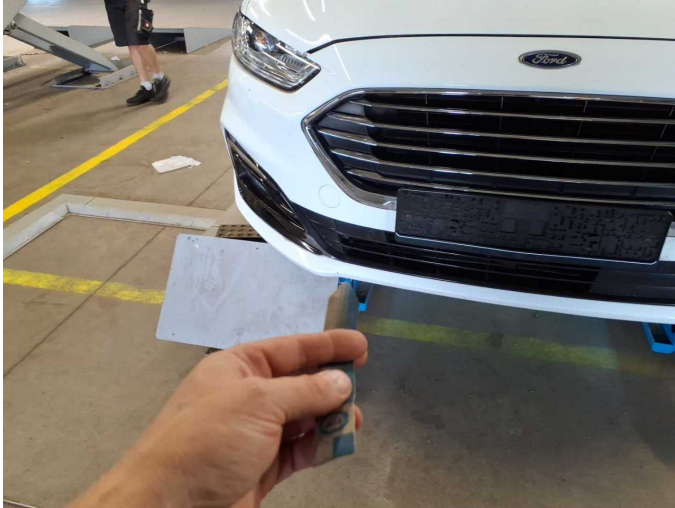
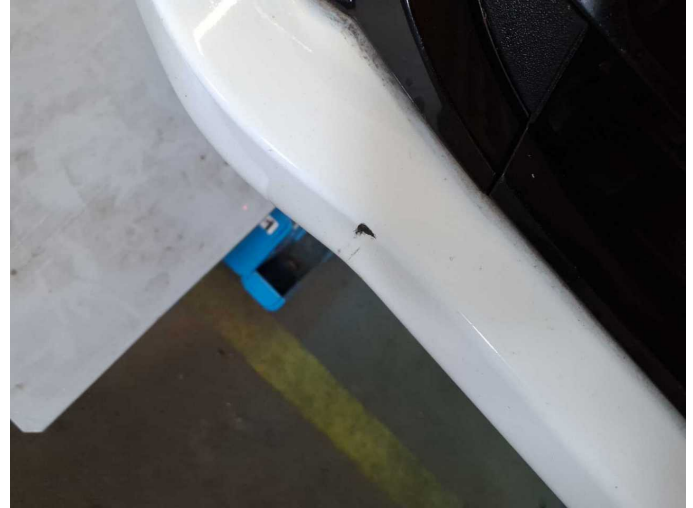
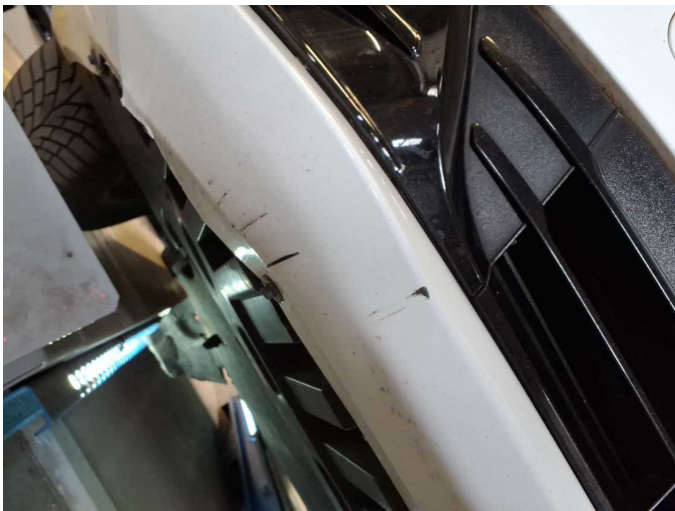
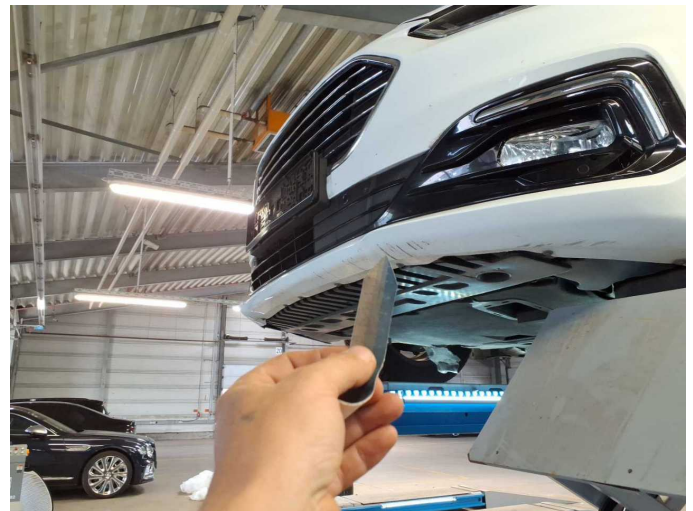
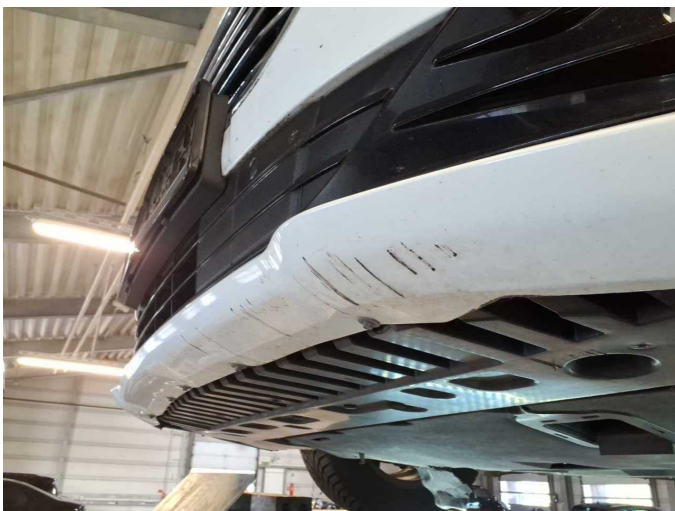
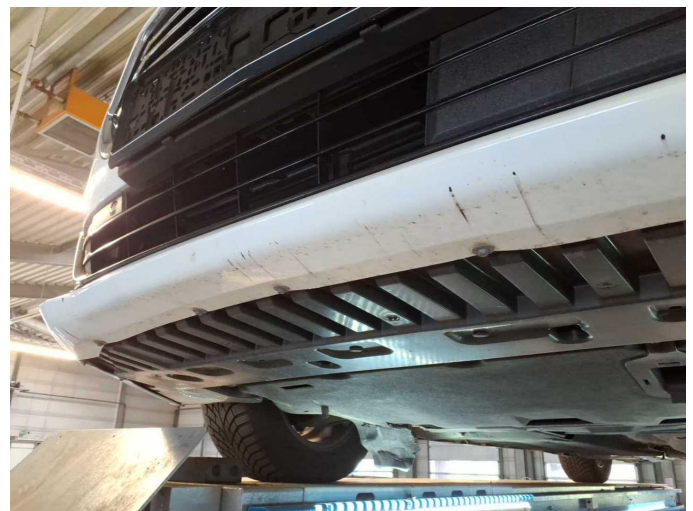
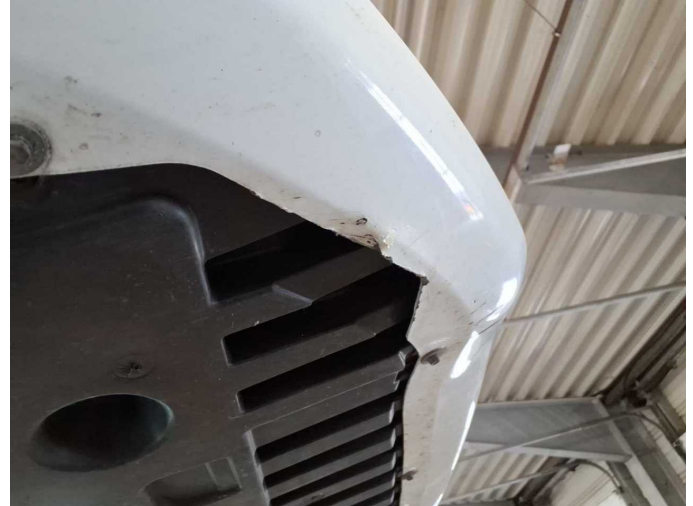
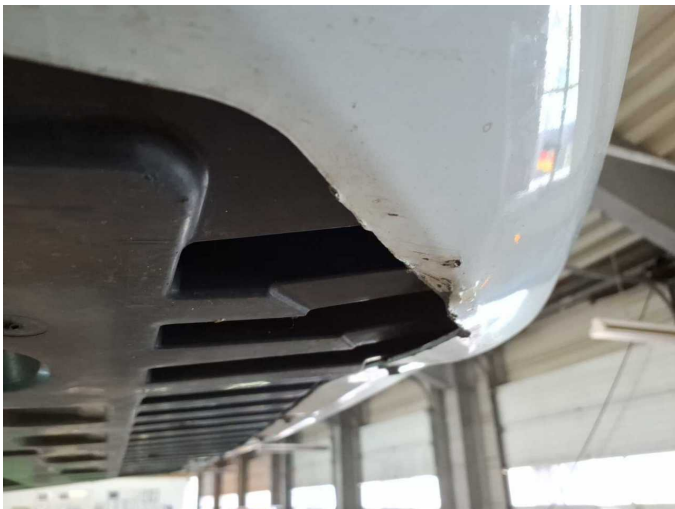
**Damage 19:** Front bumper: Front bumper (Verformt) - Scratched - Repair and paint

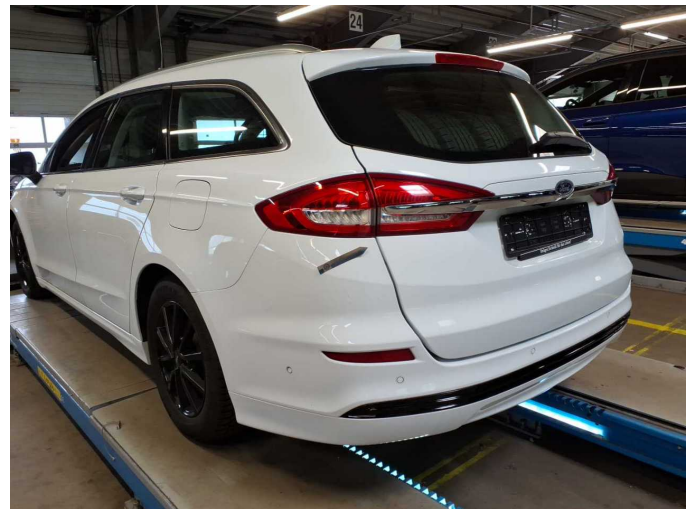
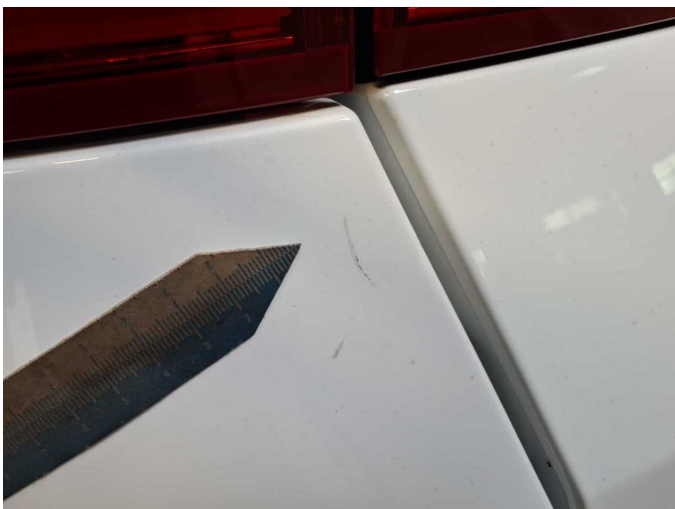
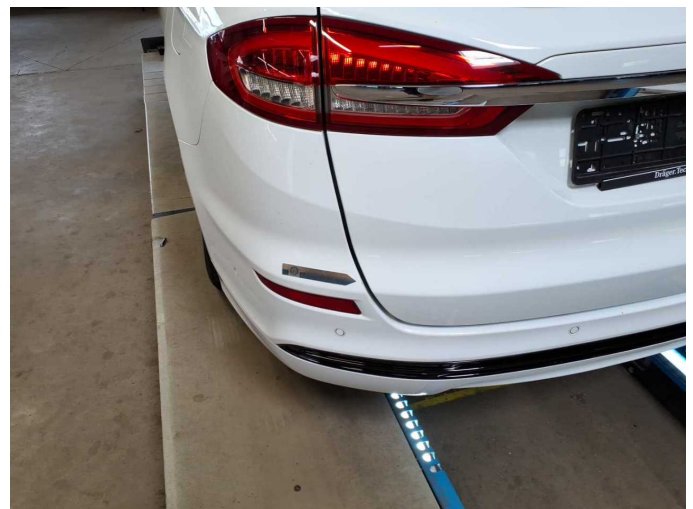
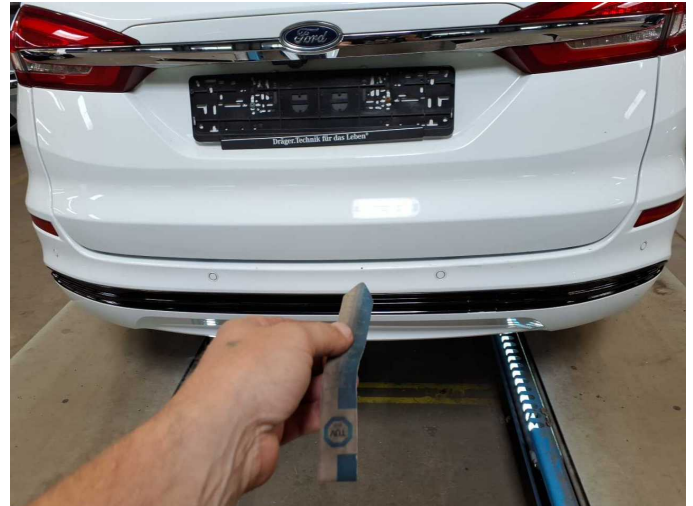
**Damage 20:** Rear bumper: Rear bumper - Scratched - Paint
