## Expertise

Protocol number: 46292724  
Order No. / Reference: 26512448  
Inspection date: 1 Jul 2026

Manufacturer: Ford

Model: Mondeo Turnier 2.0 EcoBlue Titanium

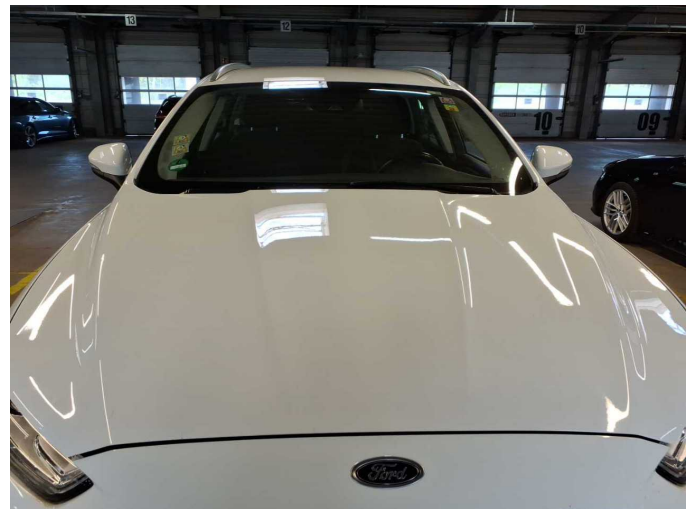
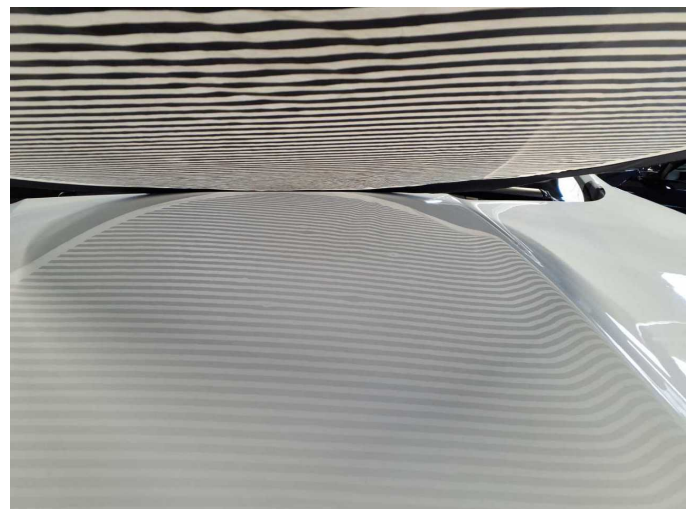
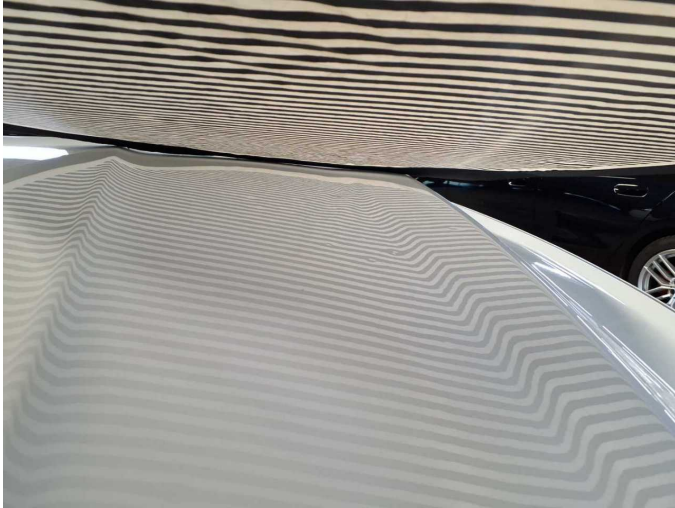
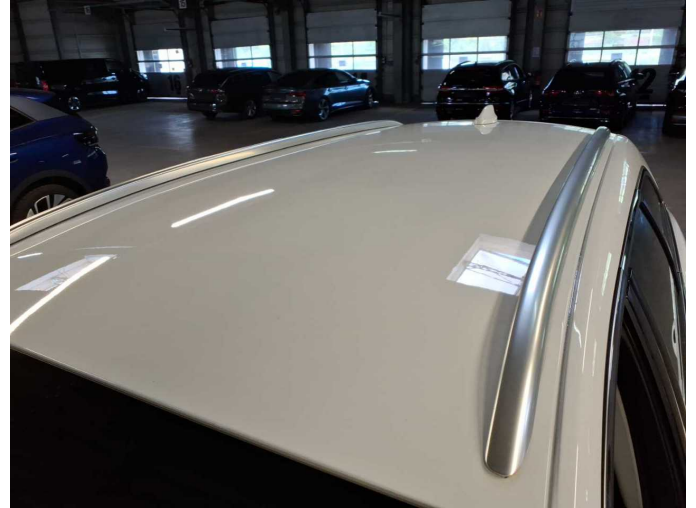
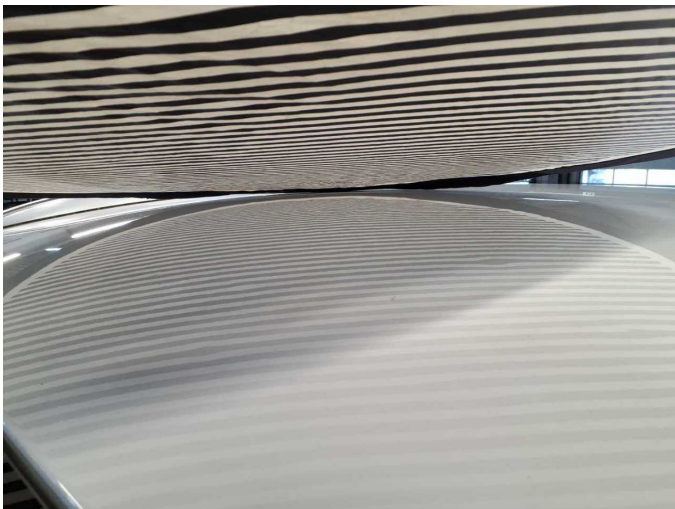
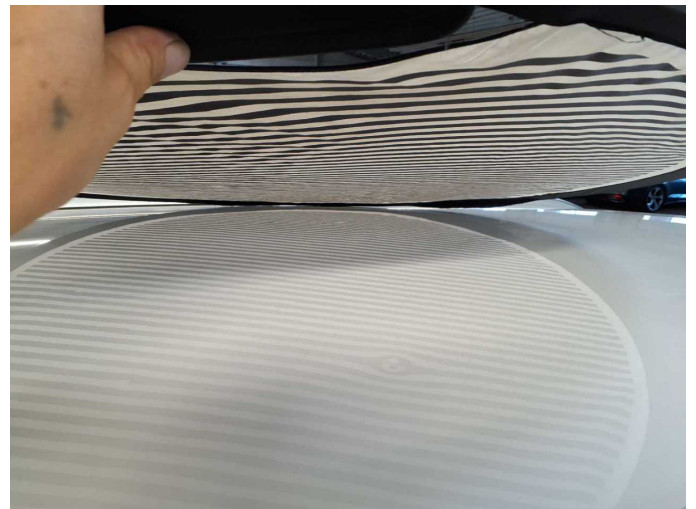
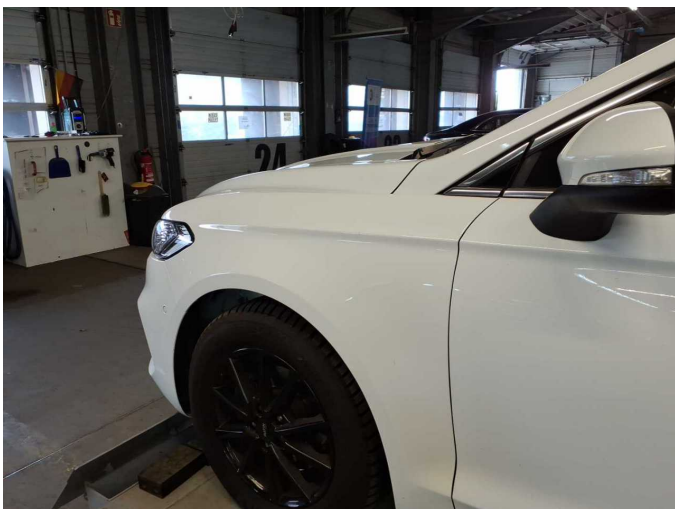
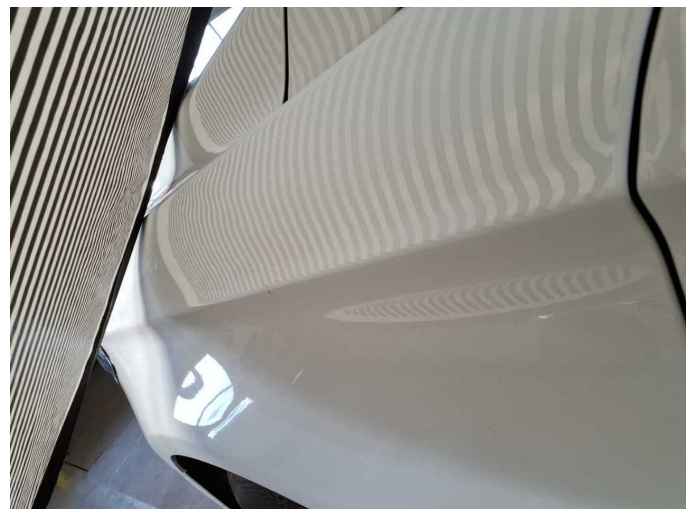
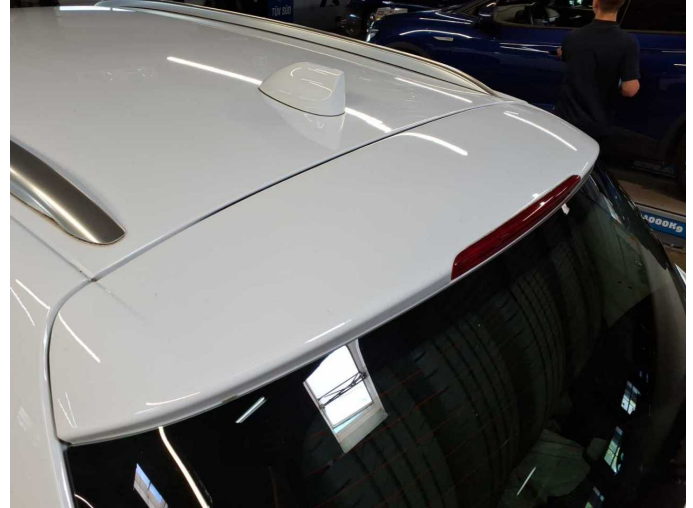
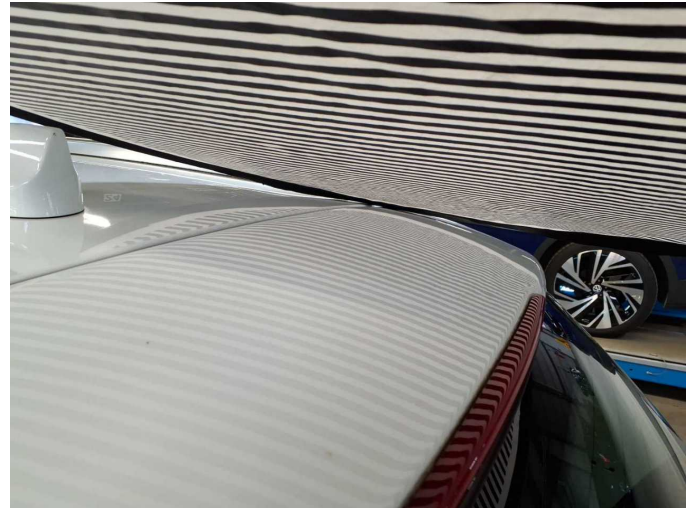
**Damage 21:** Body: Body (+ Motorhaube Lackschaden) - Damage by hail - Smooth repair work

**Damage 21:** Body: Body (+ Motorhaube Lackschaden) - Damage by hail  
- Smooth repair work

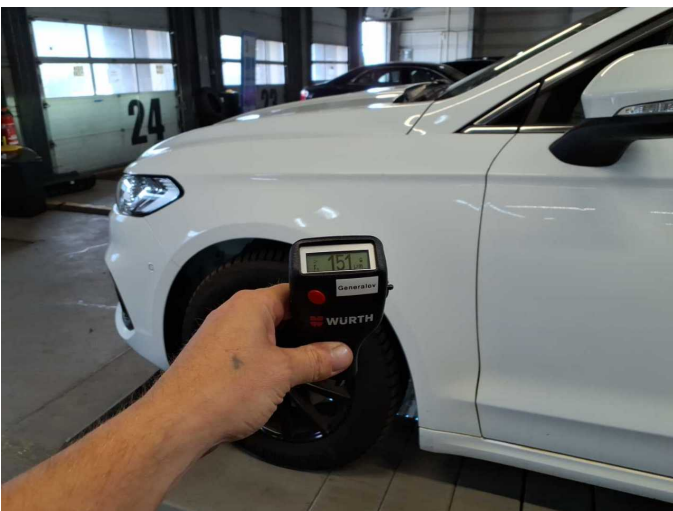
No.	Repainting
1	Mudguard - left side, Professionally carried out, Invoice of repair done Non-existent

Mudguard - left side	151 µm
----------------------	--------

**Repainting 1:** Mudguard - left side
