Expertise

Protocol number: 46750649  
Order No. / Reference: 26628879  
Inspection date: 28 Jul 2026

Manufacturer: Opel

Model: Zafira Life 2.0 D L Aut. Elegance

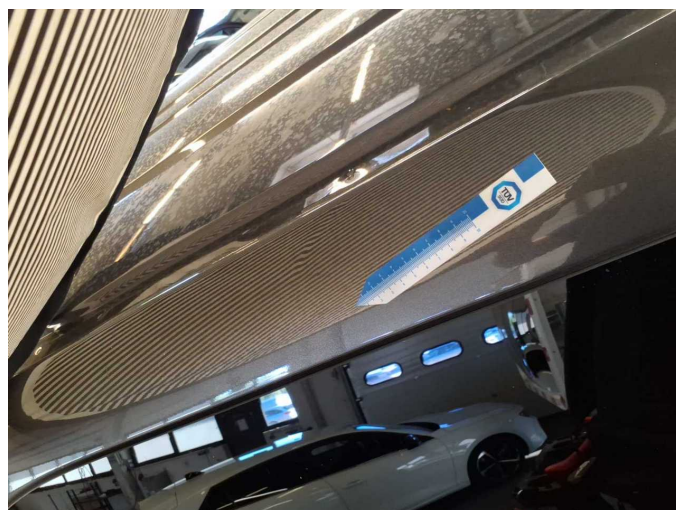
| No. | Component group | Description |
|---|---|---|
| 1 | Roof | Roof rail - right side - dent(s) - Smooth repair work |

Damage 1: Roof: Roof rail - right side - dent(s) - Smooth repair work

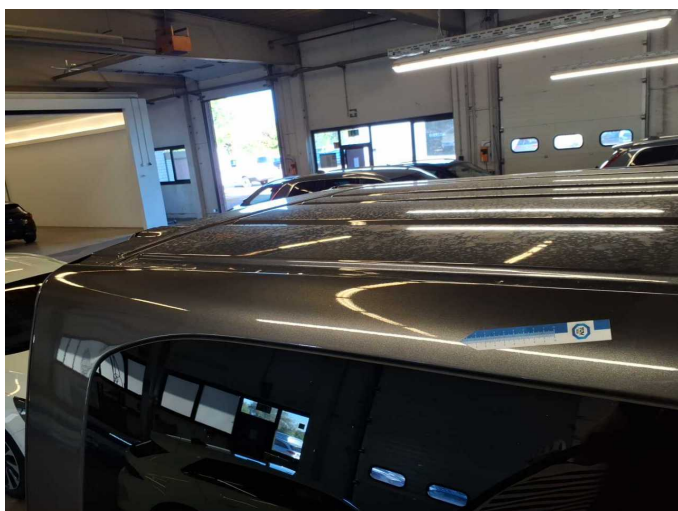
Damage 1: Roof: Roof rail - right side - dent(s) - Smooth repair work

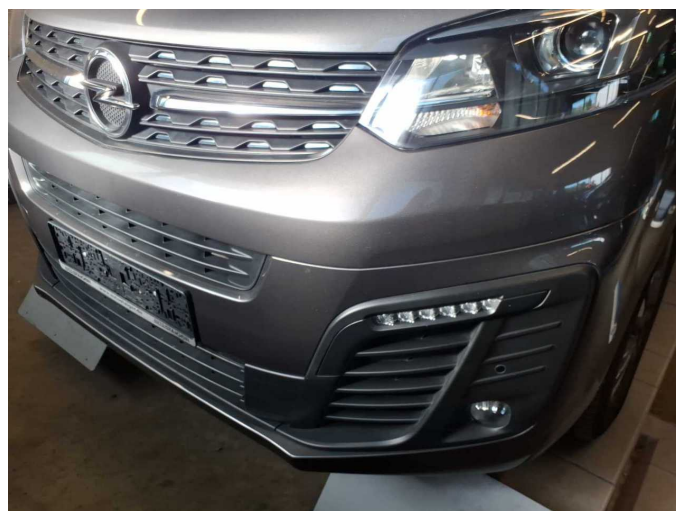
| No. | Component group | Description |
|---|---|---|
| 2 | Front bumper | Front bumper - Scratched - Smart repair |

Damage 2: Front bumper: Front bumper - Scratched - Smart repair

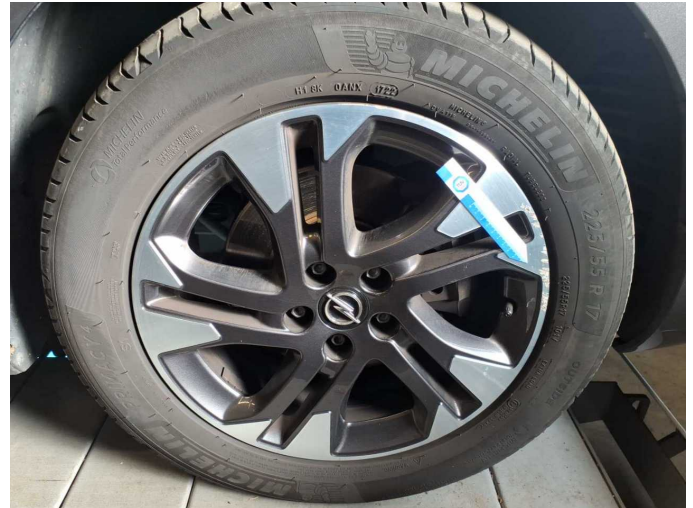
| No. | Component group | Description |
|---|---|---|
| 3 | Wheel / tyres | Alloy rim - front right side (Materialabtrag) - Scratched - Replace |

**Damage 3:** Wheel / tyres: Alloy rim - front right side (Materialabtrag) - Scratched - Replace

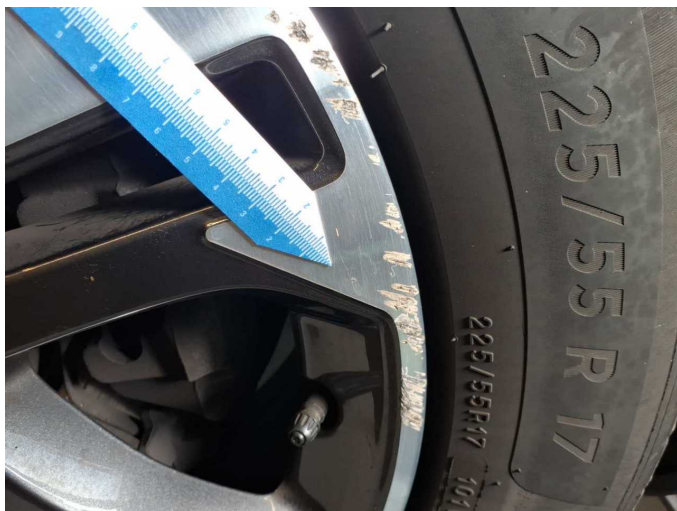
**Damage 3:** Wheel / tyres: Alloy rim - front right side (Materialabtrag) - Scratched - Replace

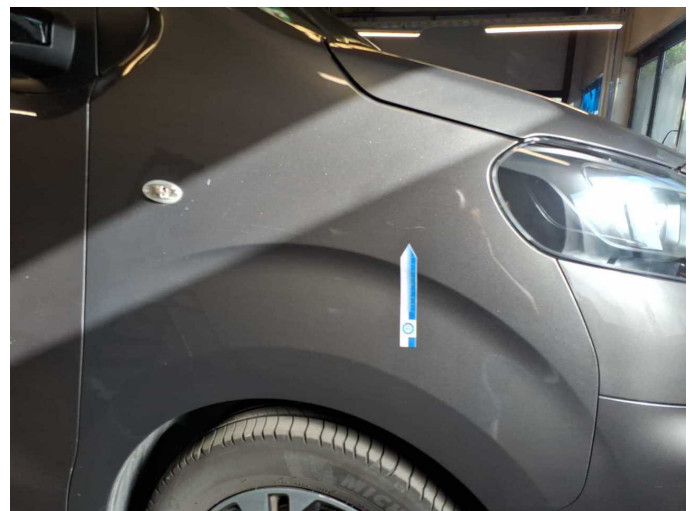
| No. | Component group | Description |
|---|---|---|
| 4 | Mudguard - right side | Mudguard - right side - Scratch(es) - Paint |

**Damage 4:** Mudguard - right side: Mudguard - right side - Scratch(es) - Paint

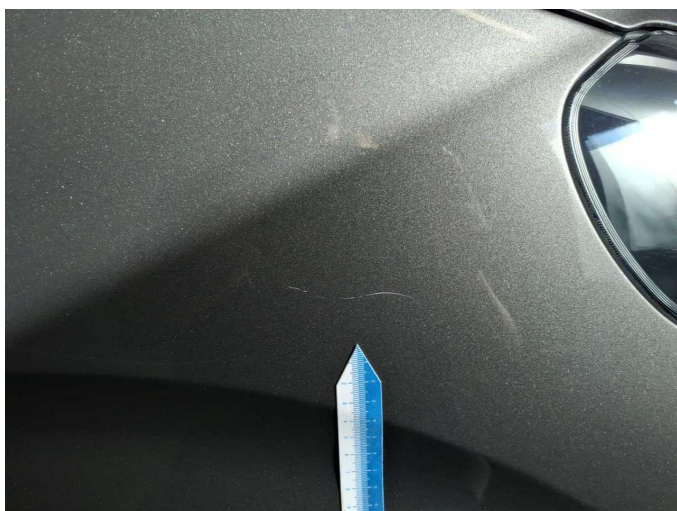
**Damage 4:** Mudguard - right side: Mudguard - right side - Scratch(es) - Paint

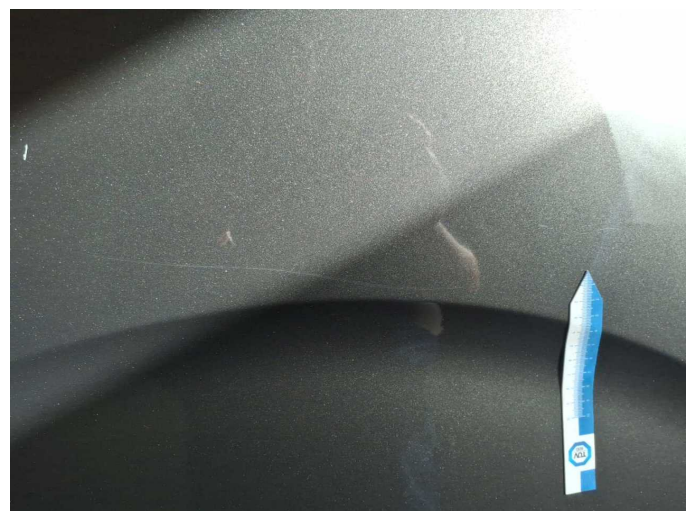
**Damage 4:** Mudguard - right side: Mudguard - right side - Scratch(es) - Paint

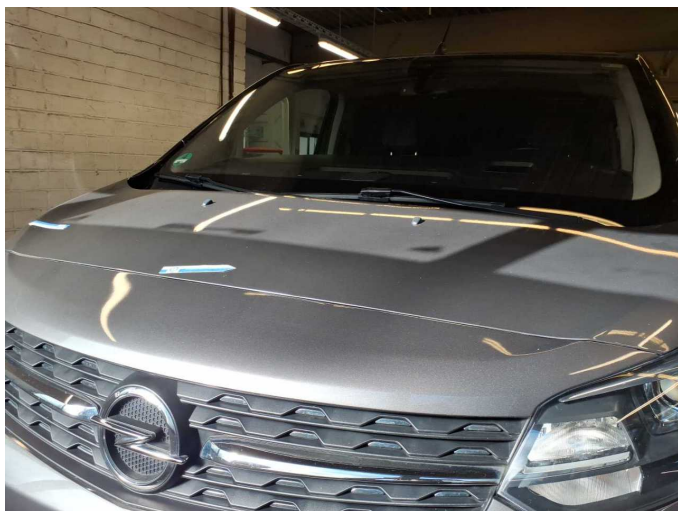
| No. | Component group | Description |
|---|---|---|
| 5 | Bonnet | Bonnet - Scratched - Paint |

**Damage 5:** Bonnet: Bonnet - Scratched - Paint

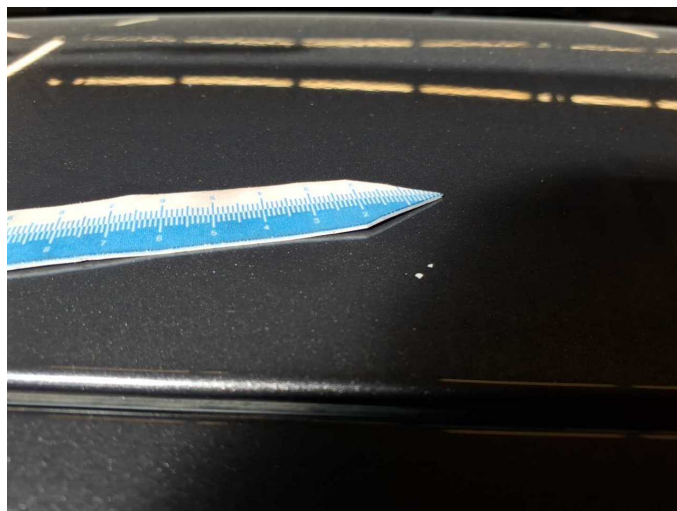
**Damage 5:** Bonnet: Bonnet - Scratched - Paint

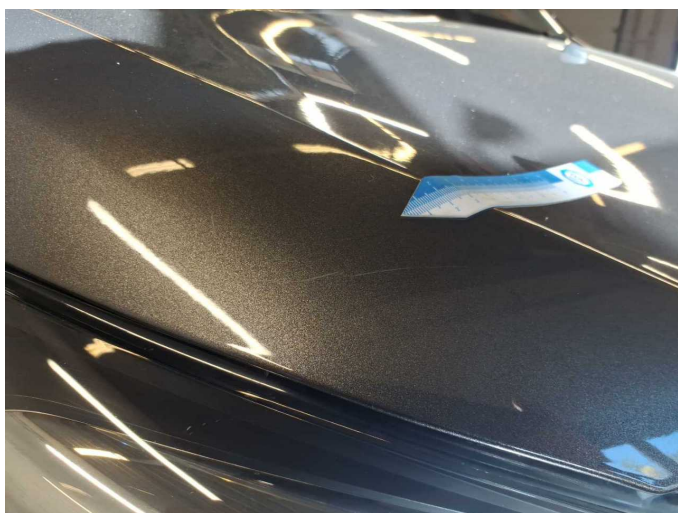
**Damage 5:** Bonnet: Bonnet - Scratched - Paint

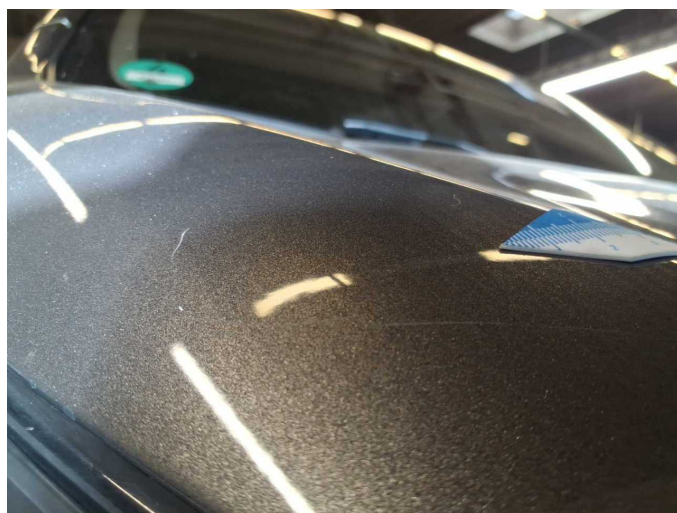
**Damage 5:** Bonnet: Bonnet - Scratched - Paint

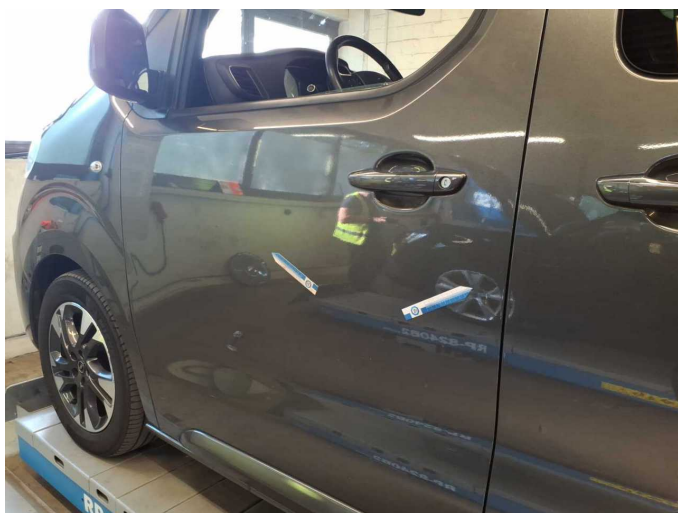
| No. | Component group | Description |
|---|---|---|
| 6 | Door - front left side | Door - Scratched - Paint |

**Damage 6:** Door - front left side: Door - Scratched - Paint

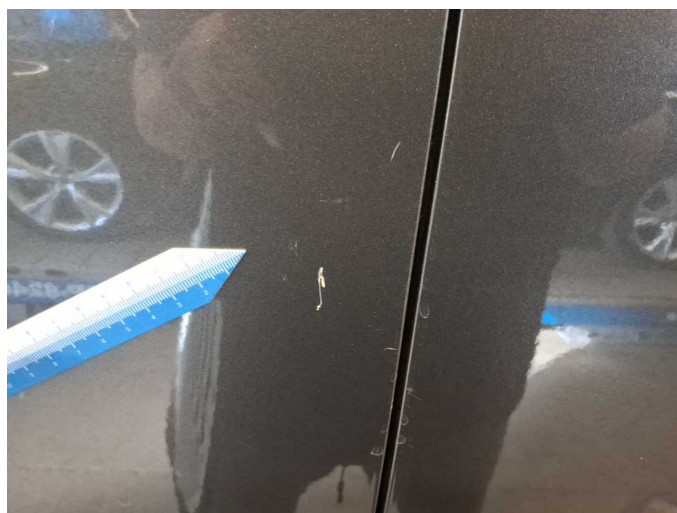
**Damage 6:** Door - front left side: Door - Scratched - Paint

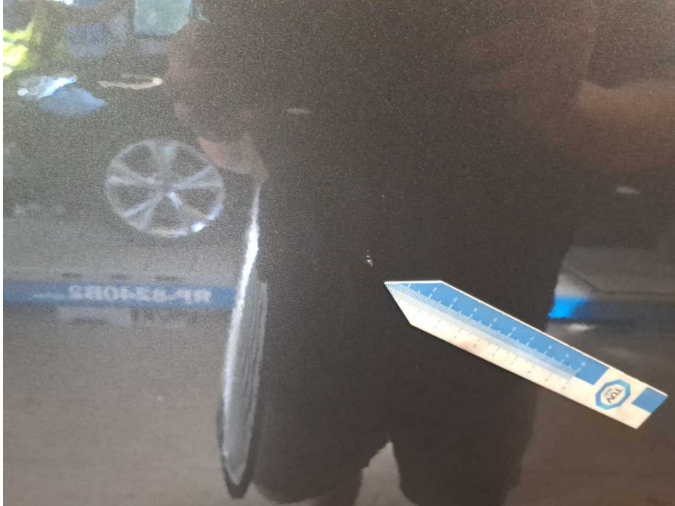
**Damage 6:** Door - front left side: Door - Scratched - Paint

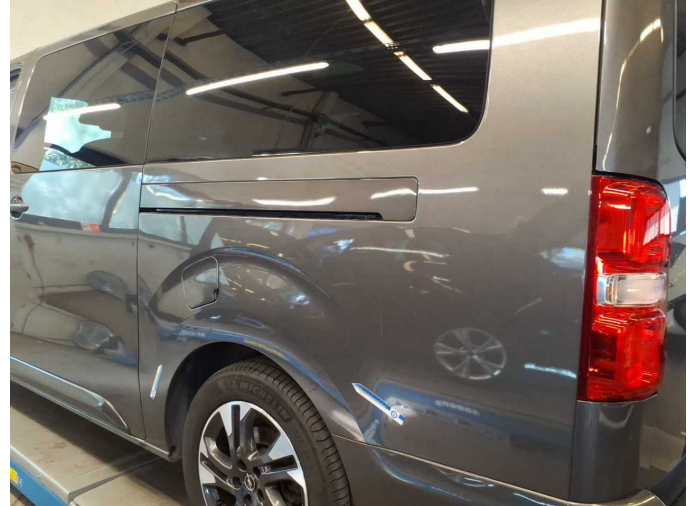
| No. | Component group | Description |
|---|---|---|
| 7 | Side panel - rear left side | Side panel - Dent / paintcoat damage - Repair and paint |

**Damage 7:** Side panel - rear left side: Side panel - Dent / paintcoat damage - Repair and paint

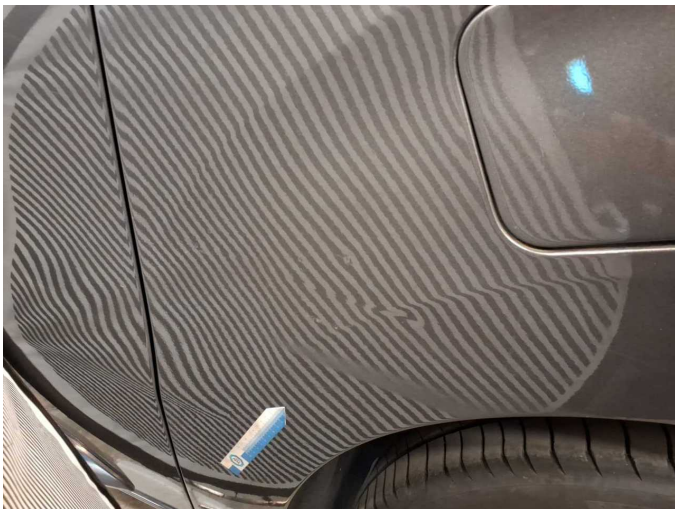
**Damage 7:** Side panel - rear left side: Side panel - Dent / paintcoat damage - Repair and paint

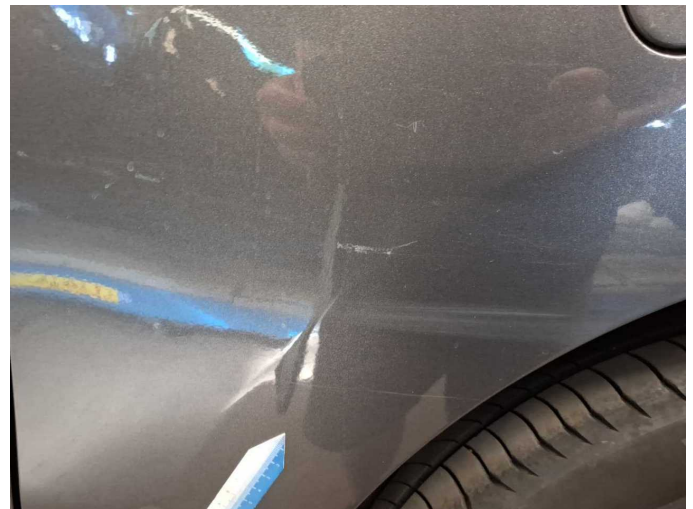
**Damage 7:** Side panel - rear left side: Side panel - Dent / paintcoat damage - Repair and paint

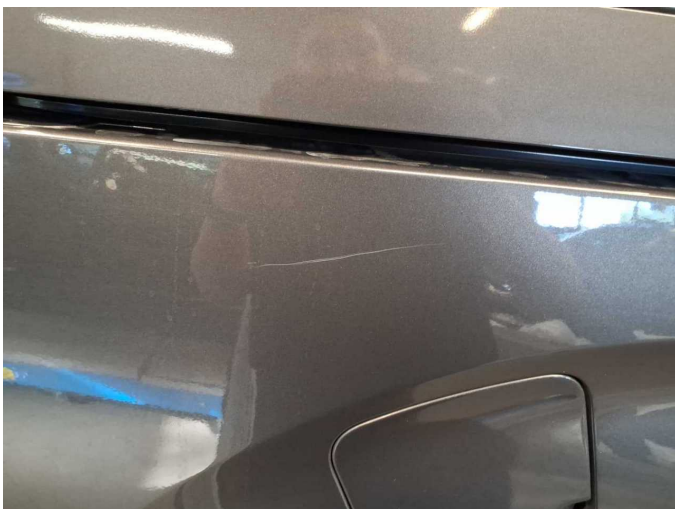
**Damage 7:** Side panel - rear left side: Side panel - Dent / paintcoat damage - Repair and paint

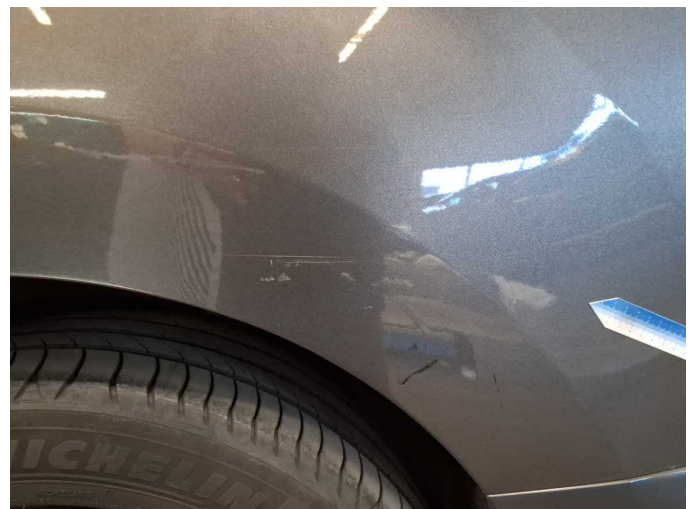
**Damage 7:** Side panel - rear left side: Side panel - Dent / paintcoat damage - Repair and paint

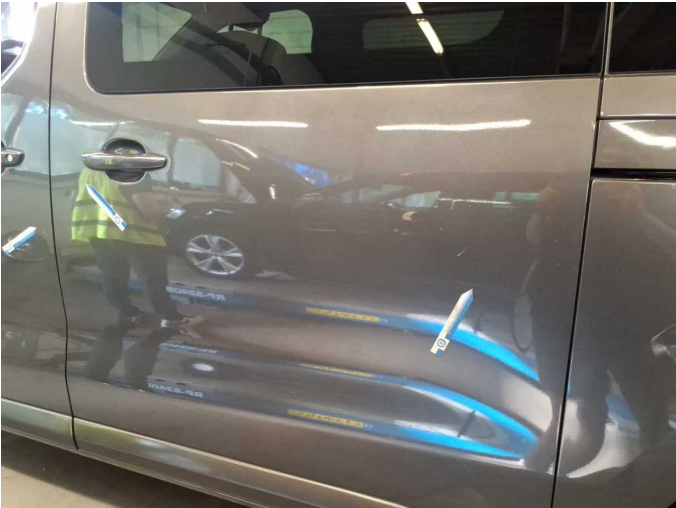
| No. | Component group | Description |
|---|---|---|
| 8 | Sliding door - left side | Sliding door with glass panel - Scratched - Paint |

**Damage 8:** Sliding door - left side: Sliding door with glass panel - Scratched - Paint

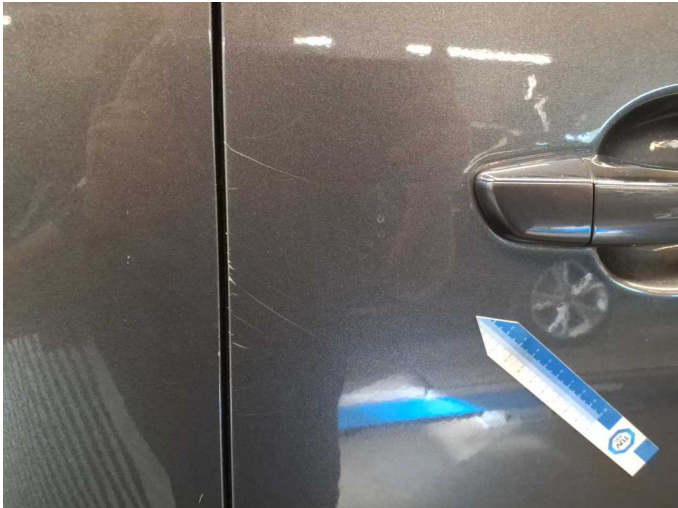
**Damage 8:** Sliding door - left side: Sliding door with glass panel - Scratched - Paint

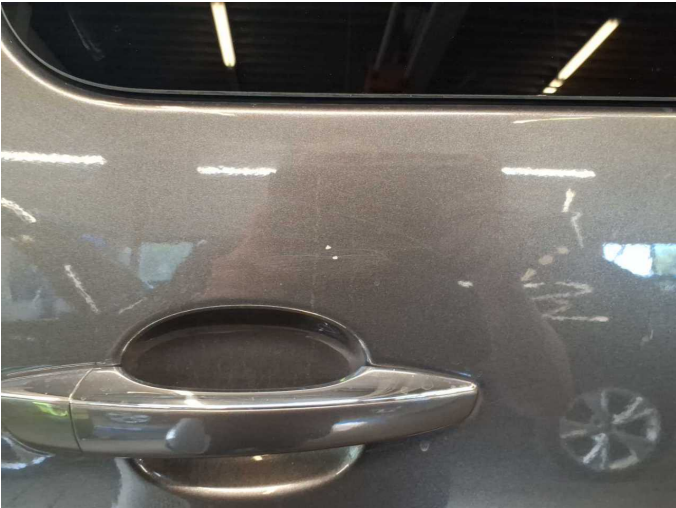
**Damage 8:** Sliding door - left side: Sliding door with glass panel - Scratched - Paint

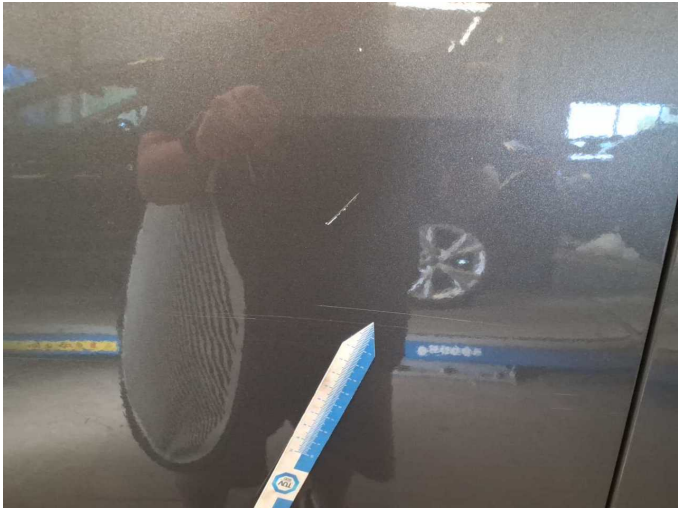
**Damage 8:** Sliding door - left side: Sliding door with glass panel - Scratched - Paint

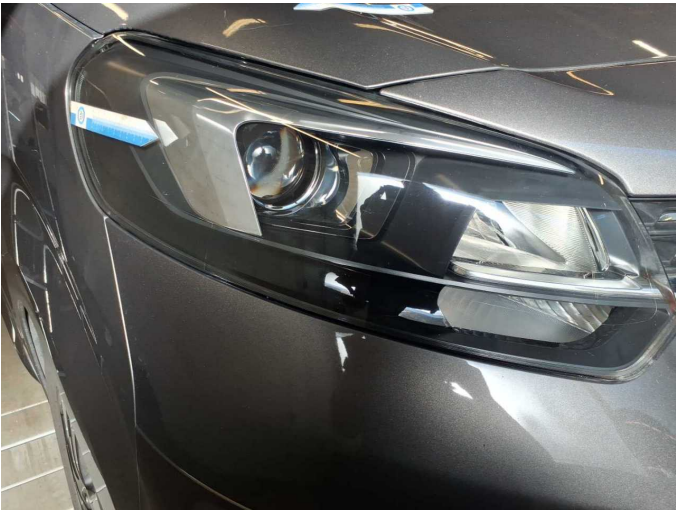
| No. | Component group | Description |
|---|---|---|
| 1 | Headlight | Headlight - right side - Scratch(es) - No deduction |

**Wear and tear 1:** Headlight: Headlight - right side - Scratch(es) - No deduction

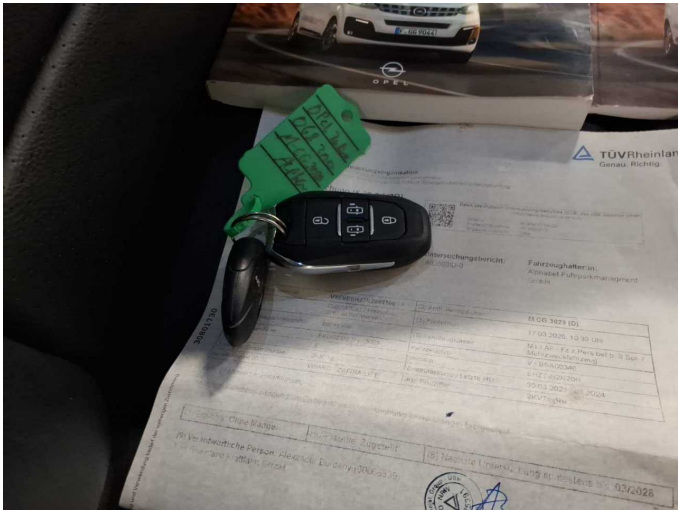
Equipment - Vehicle key

**Missing part 1:** Equipment: Vehicle key - Missing - Replace

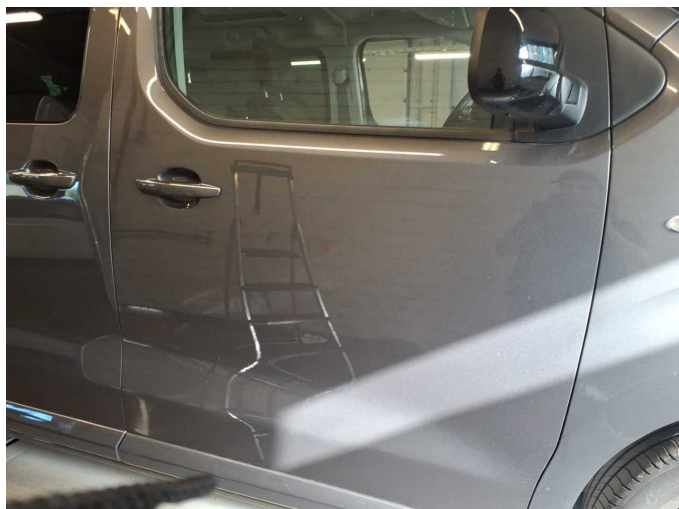
| 1 | Roof, Door - rear right side, Door - front right side |

| Roof | 155 µm | Door - rear right side | 176 µm |

**Repainting 1:** Roof, Door - rear right side, Door - front right side

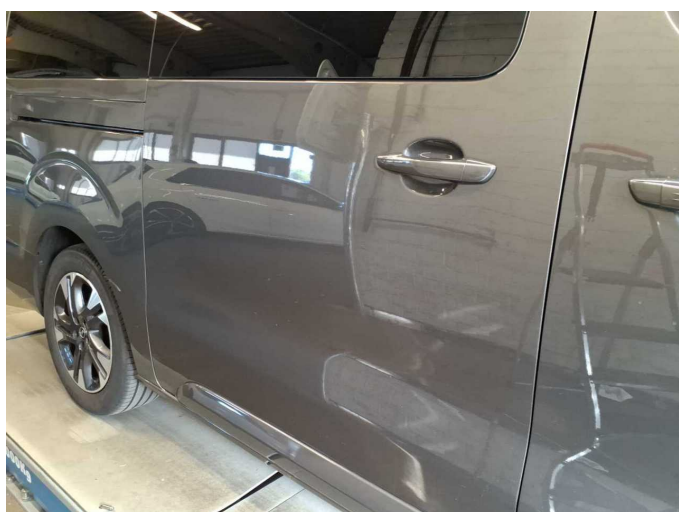
**Repainting 1:** Roof, Door - rear right side, Door - front right side

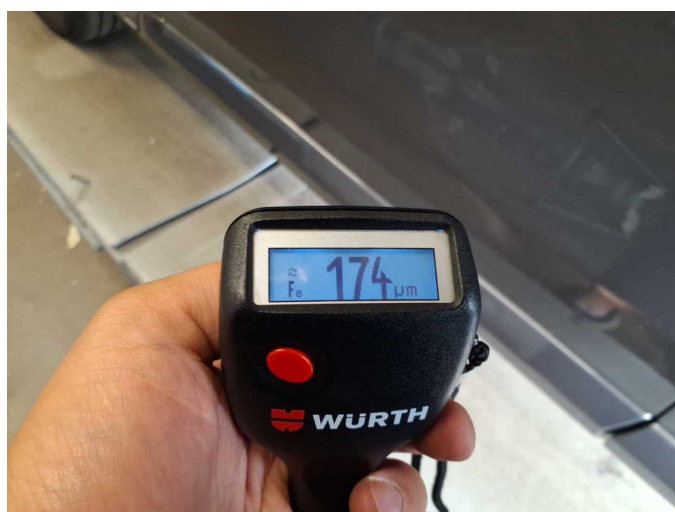
**Repainting 1:** Roof, Door - rear right side, Door - front right side

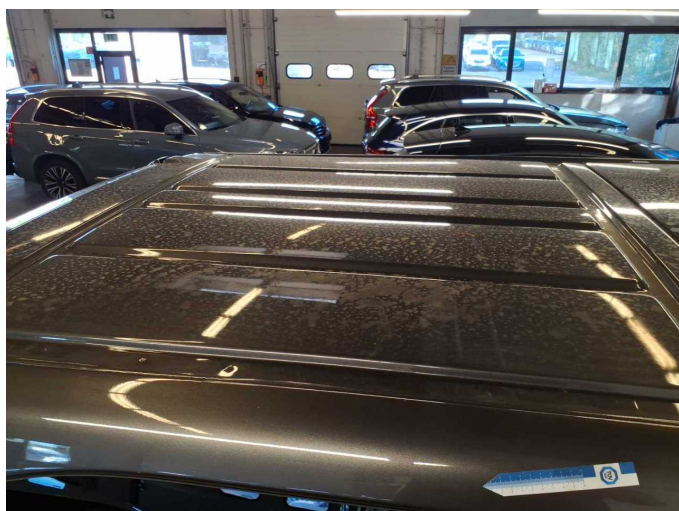
**Repainting 1:** Roof, Door - rear right side, Door - front right side

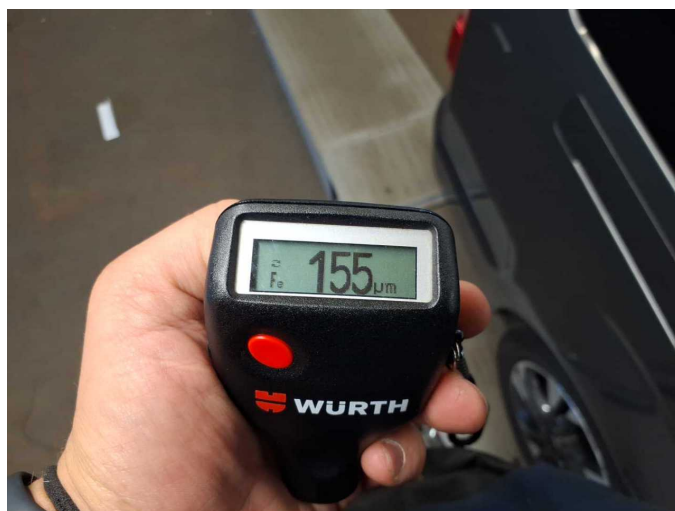
**Repainting 1:** Roof, Door - rear right side, Door - front right side
