Expertise

Protocol number: 46840805  
Order No. / Reference: 26780144  
Inspection date: 3 Aug 2026

Manufacturer: Hyundai

Model: KONA EV Prime

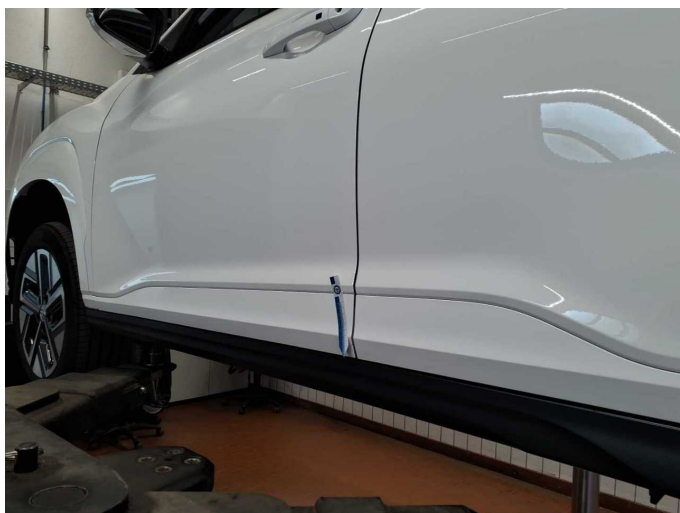
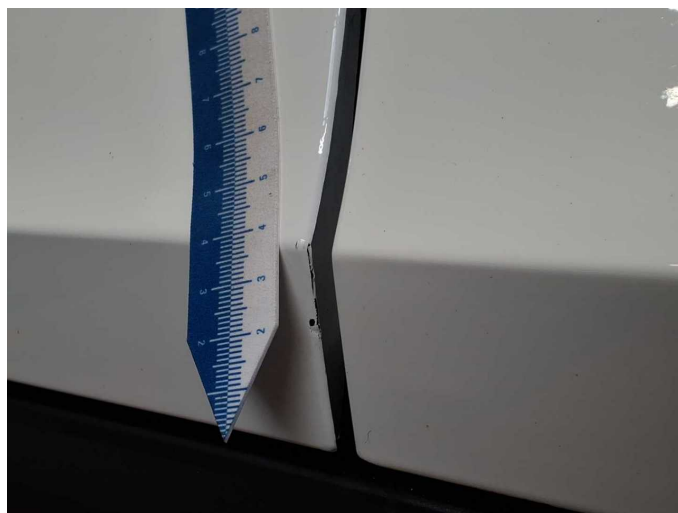
| No. | Component group | Description |
|---|---|---|
| 1 | Door - front left side | Brightware - lower - Scratch(es) - Smart repair |

**Damage 1:** Door - front left side: Brightware - lower - Scratch(es) - Smart repair

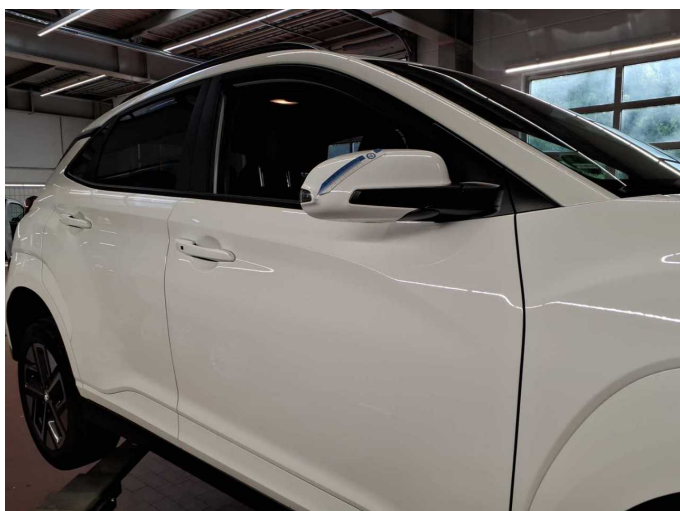
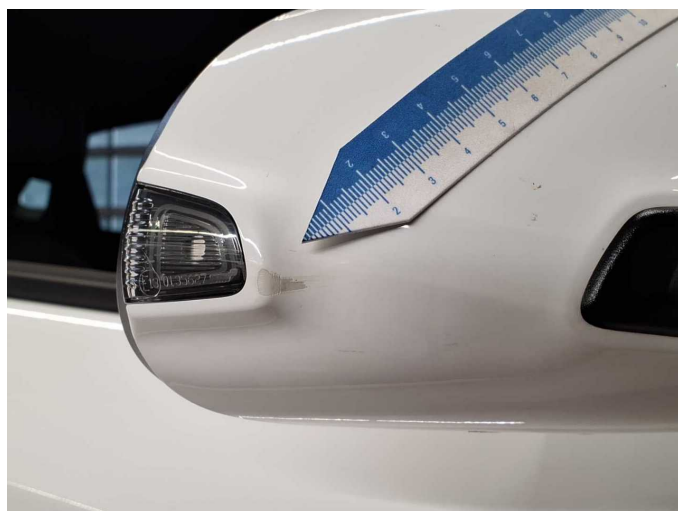
| No. | Component group | Description |
|---|---|---|
| 2 | Wing mirror - right side | Cap - Scratch(es) - Smart repair |

**Damage 2:** Wing mirror - right side: Cap - Scratch(es) - Smart repair

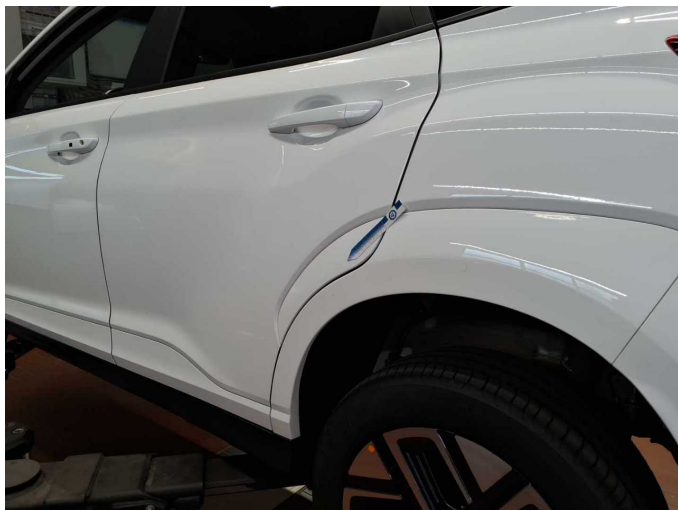
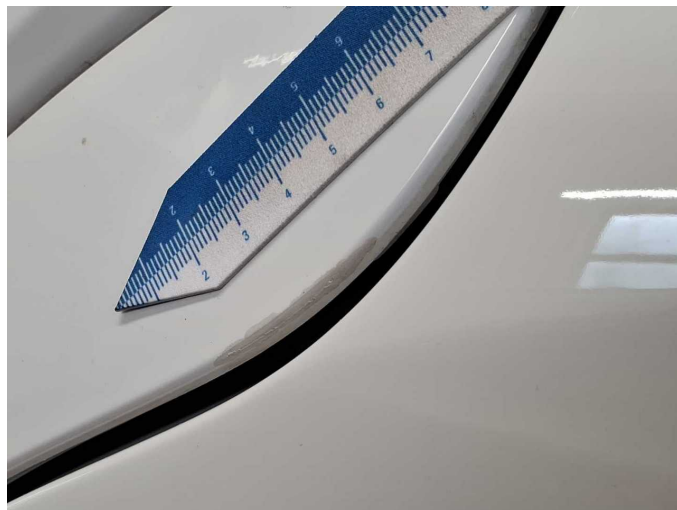
| No. | Component group | Description |
|---|---|---|
| 3 | Door - rear left side | Brightware - lower - Scratch(es) - Smart repair |

**Damage 3:** Door - rear left side: Brightware - lower - Scratch(es) - Smart repair

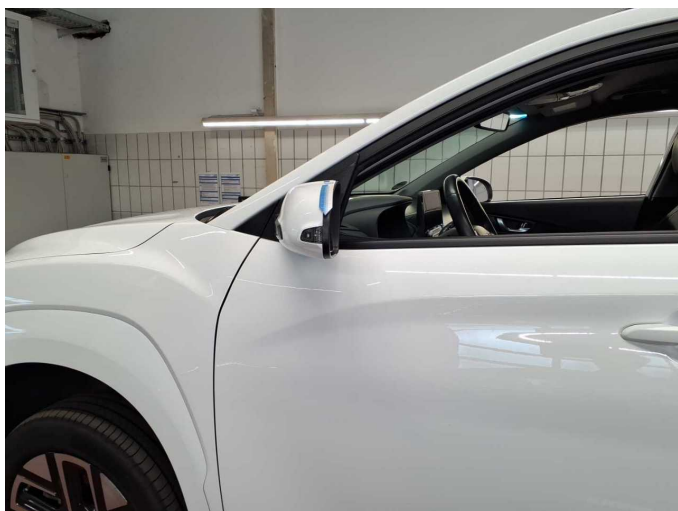
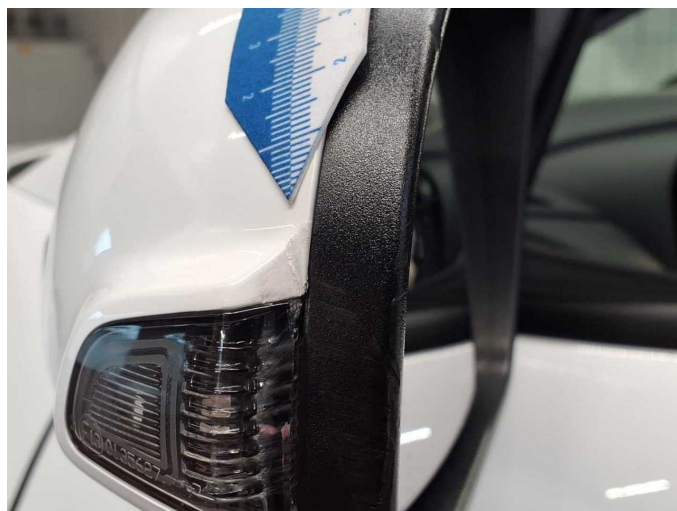
| No. | Component group | Description |
|---|---|---|
| 4 | Wing mirror - left side | Cap - Scratch(es) - Smart repair |

**Damage 4:** Wing mirror - left side: Cap - Scratch(es) - Smart repair

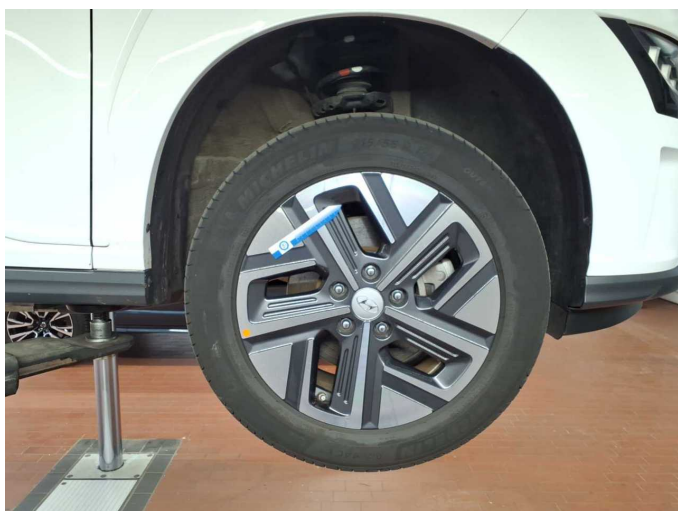
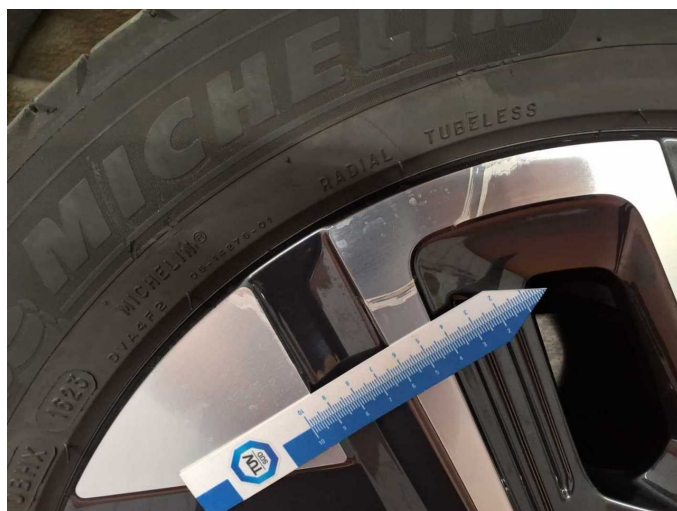
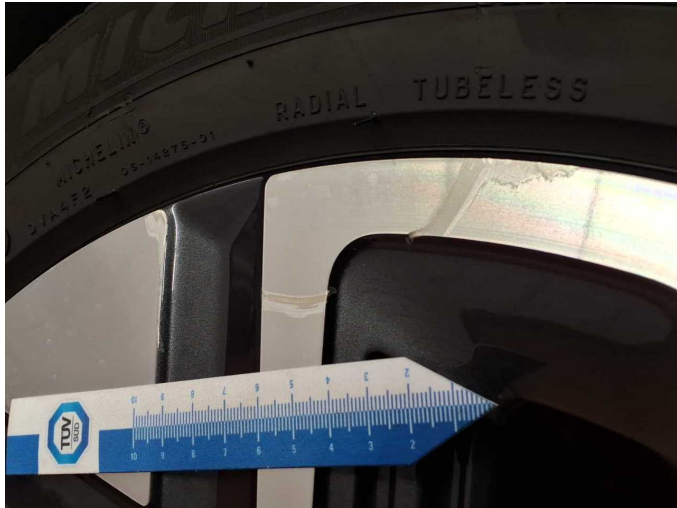
| No. | Component group | Description |
|---|---|---|
| 5 | Wheel / tyres | Alloy rim - front right side - Scratched - Loss in value |

**Damage 5:** Wheel / tyres: Alloy rim - front right side - Scratched - Loss in value

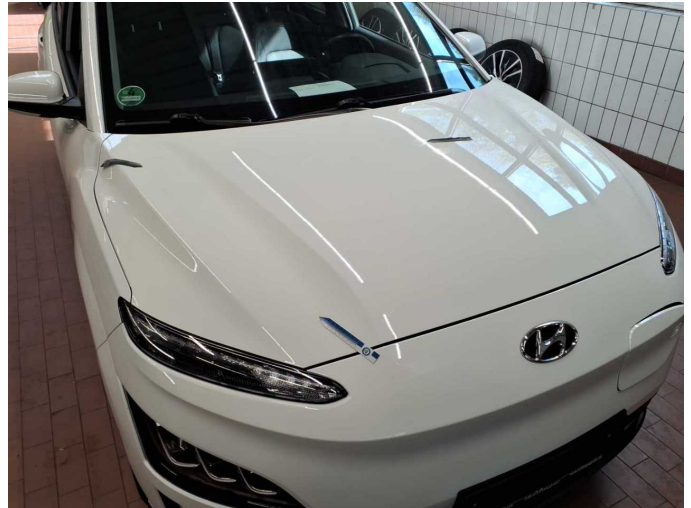
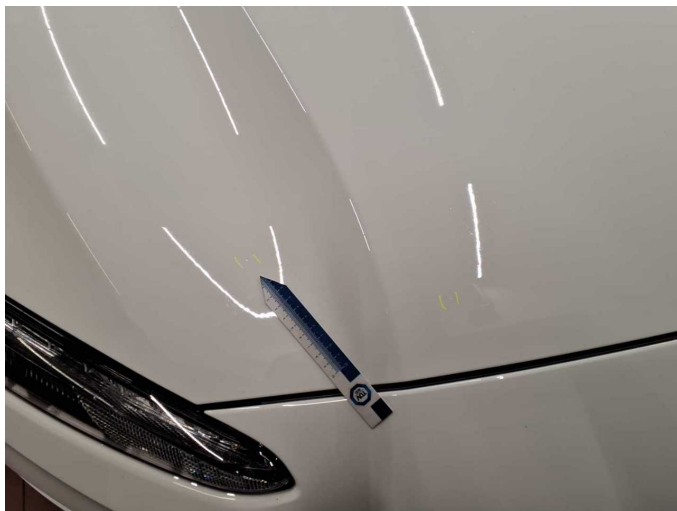
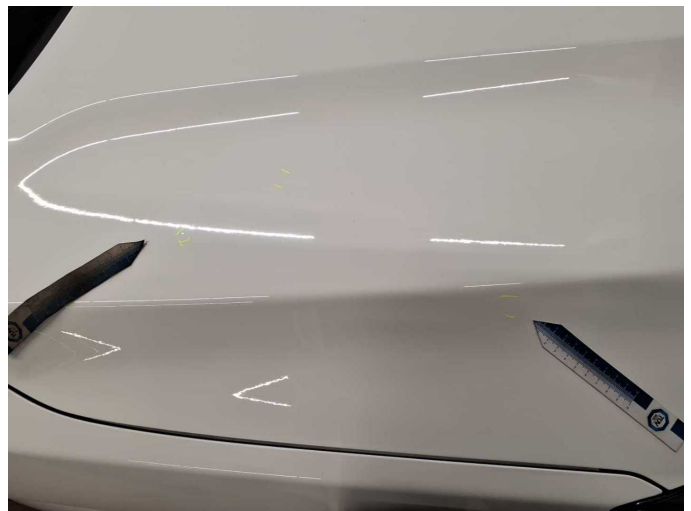
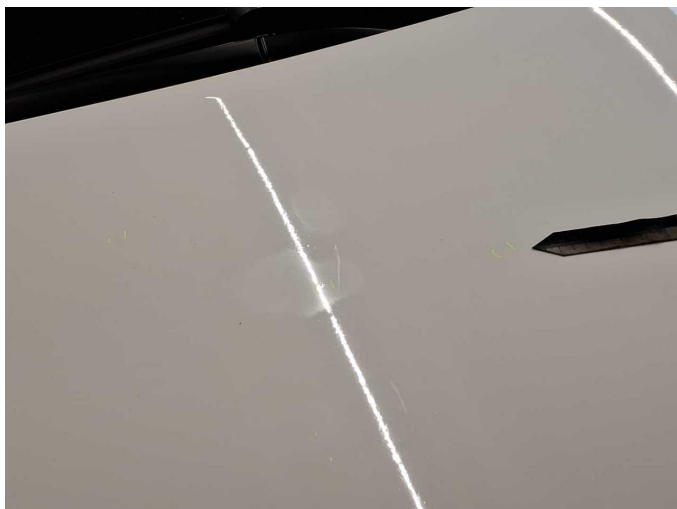
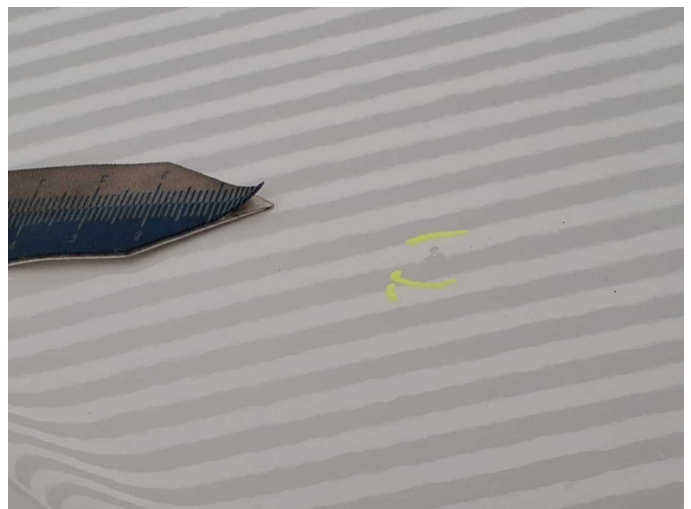
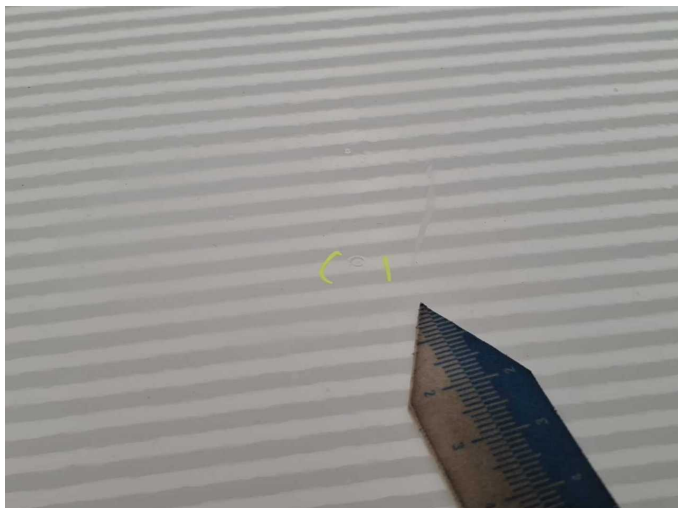
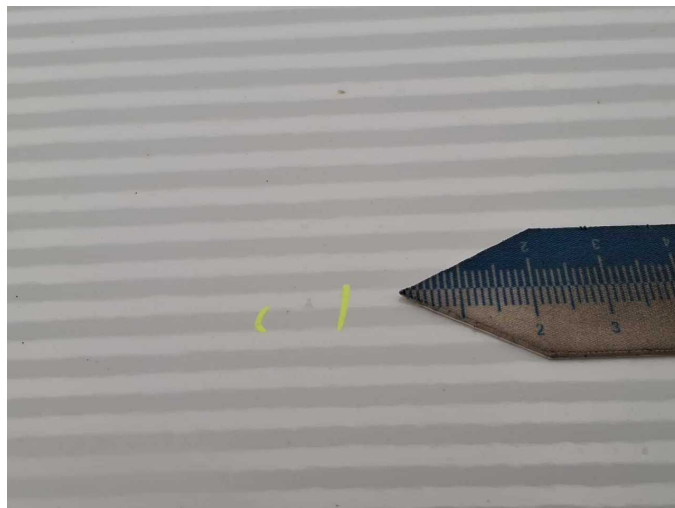
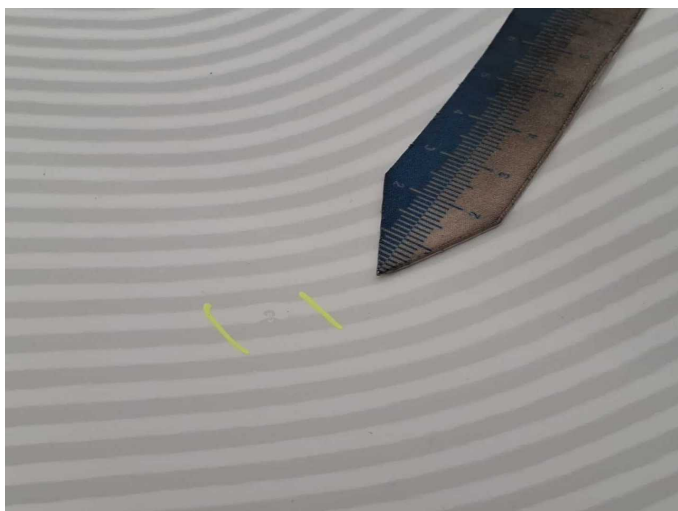
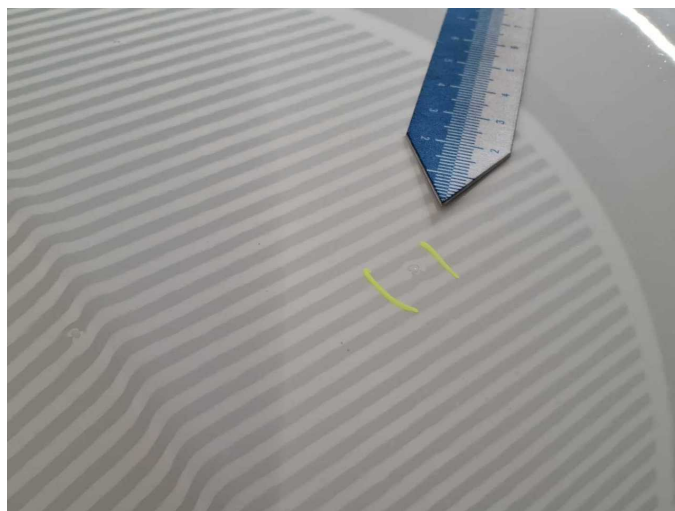
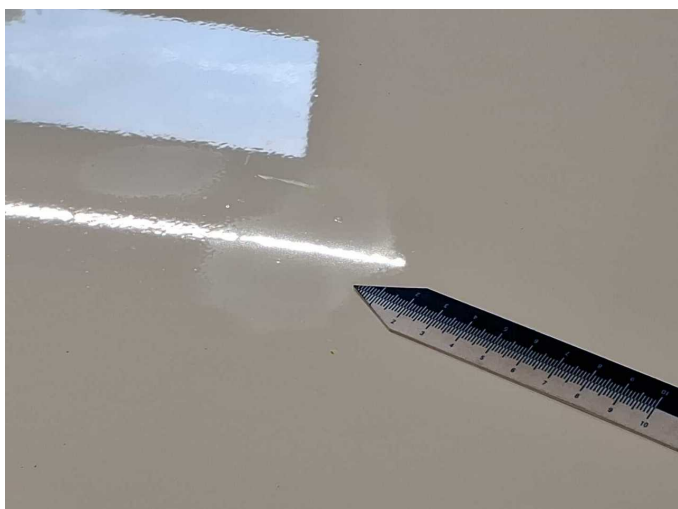
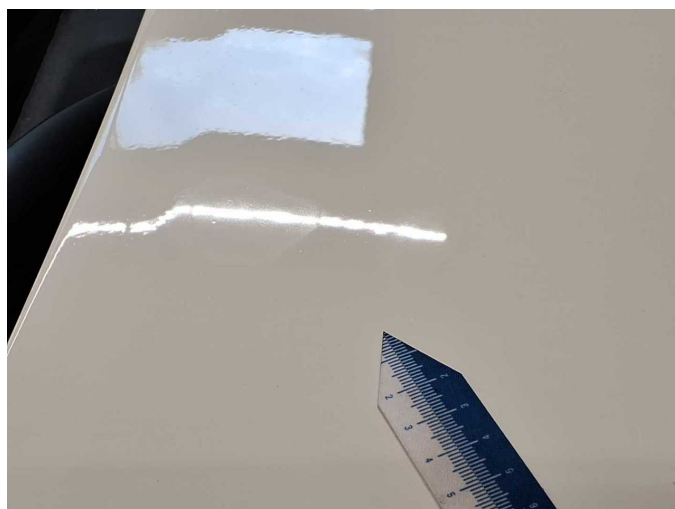
| No. | Component group | Description |
|---|---|---|
| 6 | Bonnet | Bonnet (Lackeinschlüsse) - Unprofessionally repaired - Paint |

**Damage 6:** Bonnet: Bonnet (Lackeinschlüsse) - Unprofessionally repaired - Paint

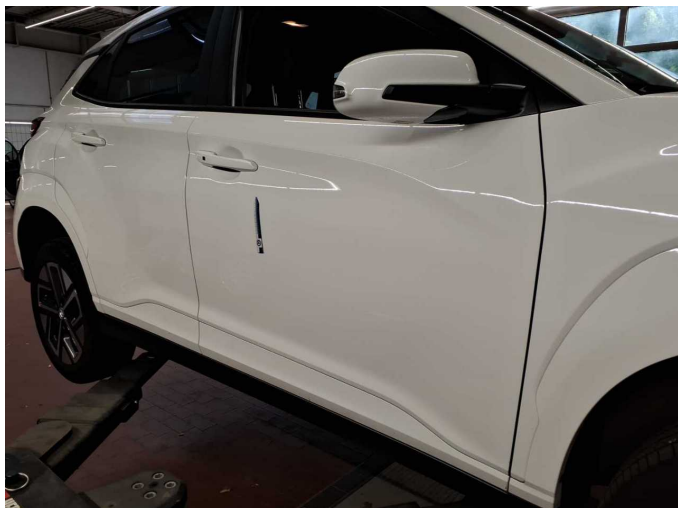
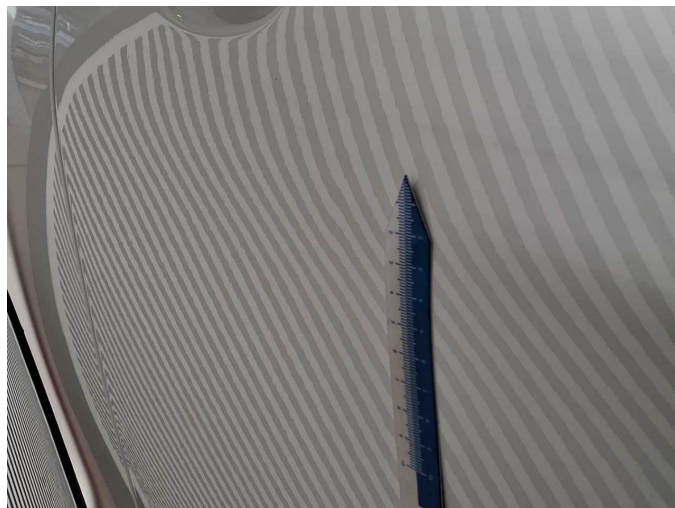
| No. | Component group | Description |
|---|---|---|
| 2 | Door - front right side | Door - dent(s) - No deduction |

**Wear and tear 2:** Door - front right side: Door - dent(s) - No deduction

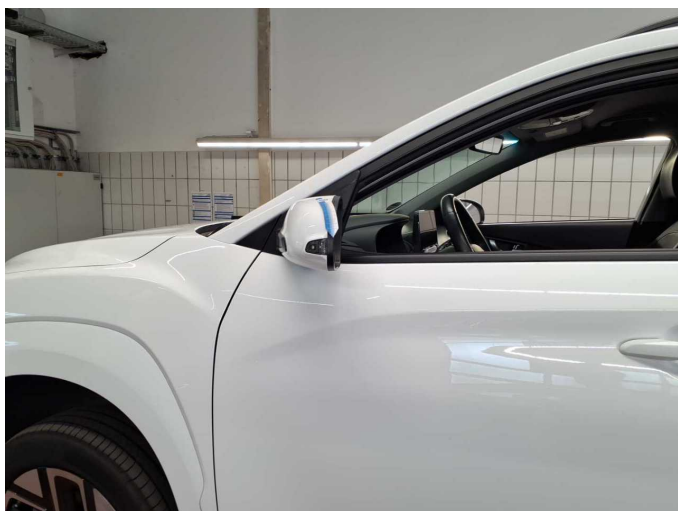
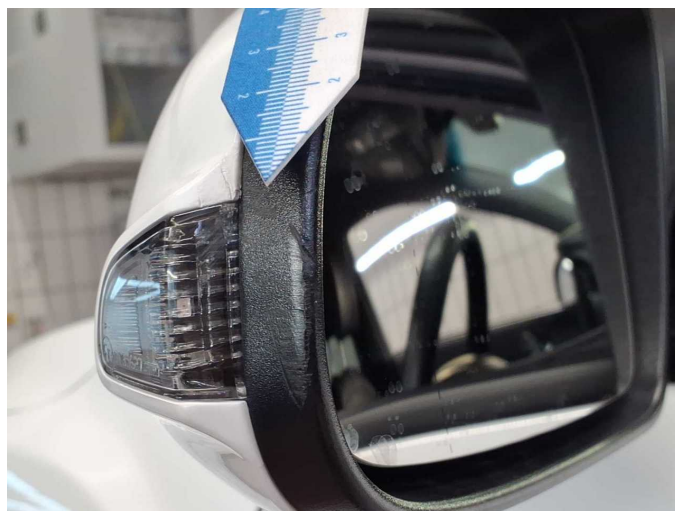
| No. | Component group | Description |
|---|---|---|
| 4 | Wing mirror - left side | Mirror housing - Scratch(es) - No deduction |

**Wear and tear 4:** Wing mirror - left side: Mirror housing - Scratch(es) - No deduction

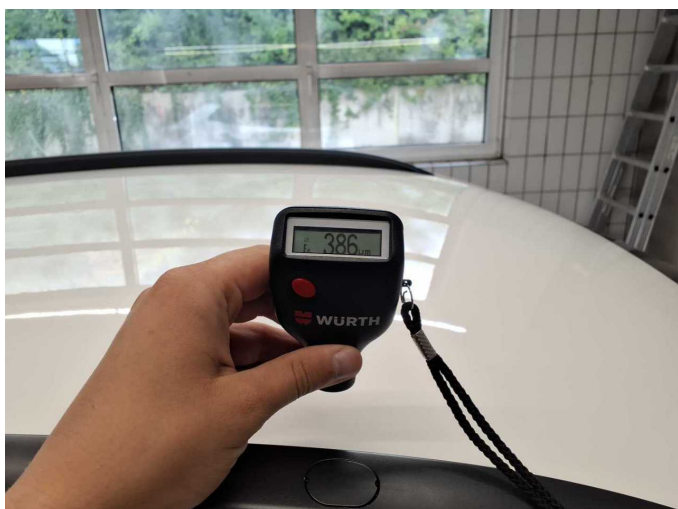
**Repainting 1:** Roof

| Roof | 386 µm | Boot lid / rear door | 246 µm |

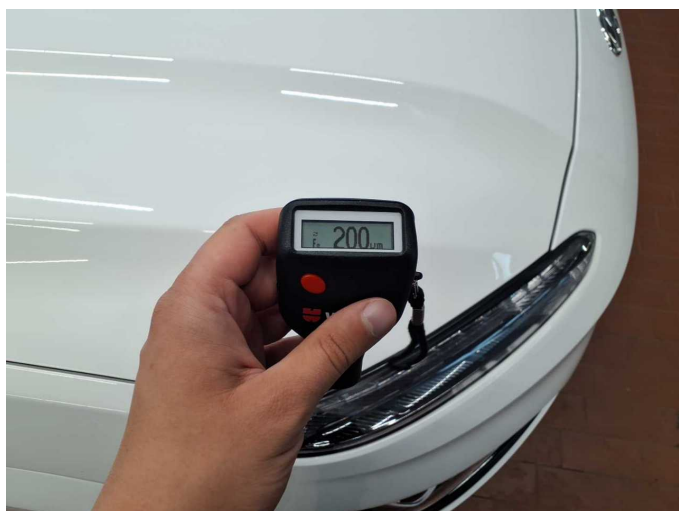
**Repainting 3: Bonnet**

| Bonnet | 200 µm | | |
