Expertise

Protocol number: 46029792
Order No. / Reference: 26471309
Inspection date: 17 Jun 2026

Model: Mondeo Turnier 2.0 Ti-VCT Hybrid ST-Line

VIN: WF0FXXWPCCHNS70408

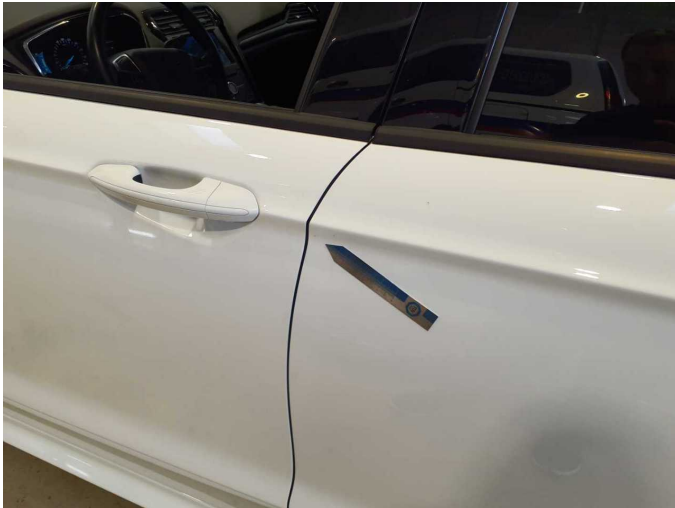
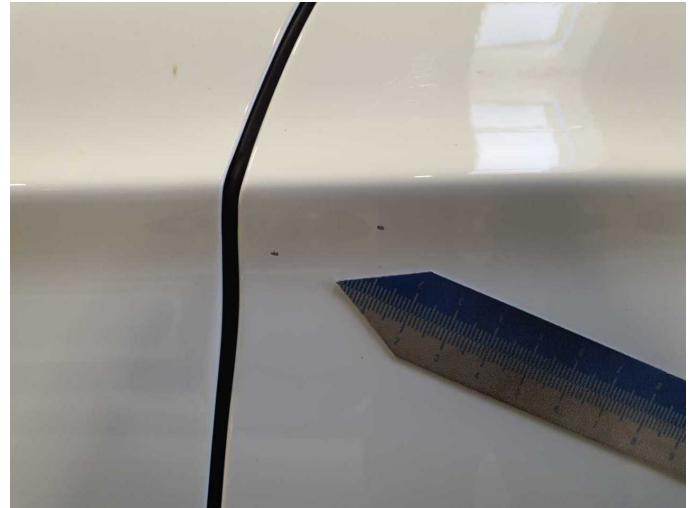
Damage 2: Door - rear left side: Door - Scratch(es) - Smart repair

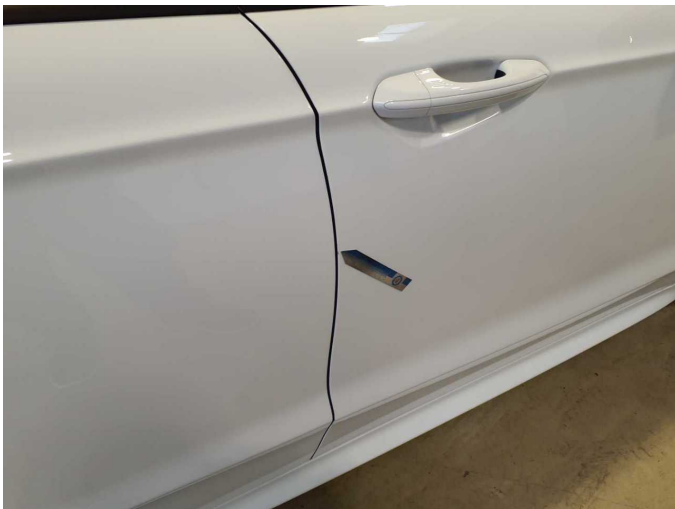
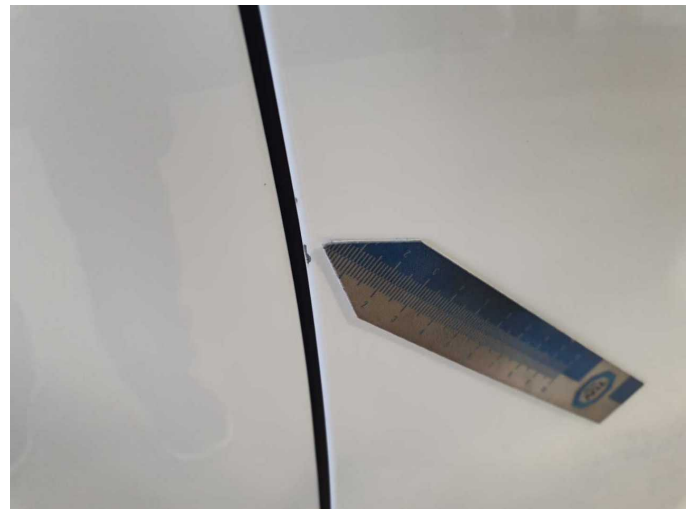
Damage 3: Door - front right side: Door edge - Scratched - Smart repair

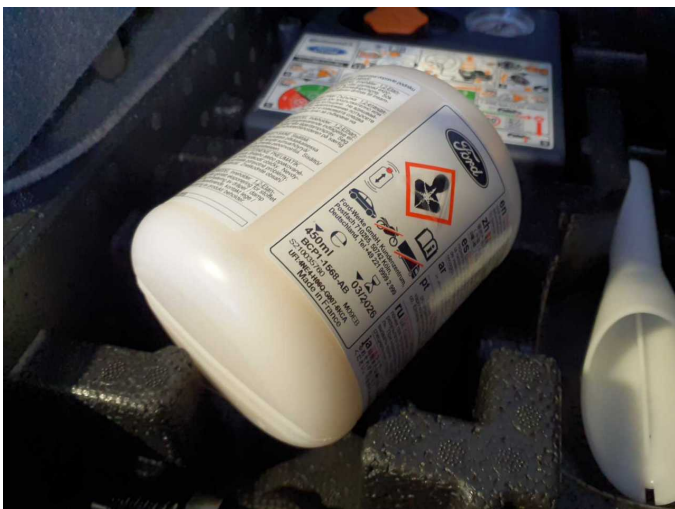
Damage 4: Equipment: Tirefit filler - Expired - Replace

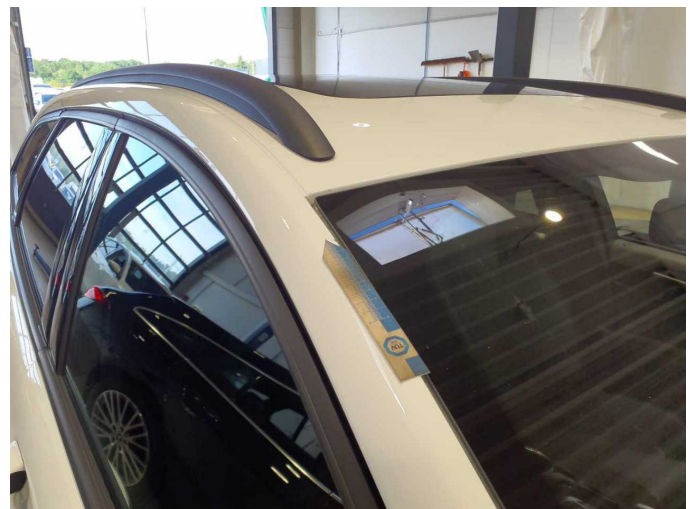
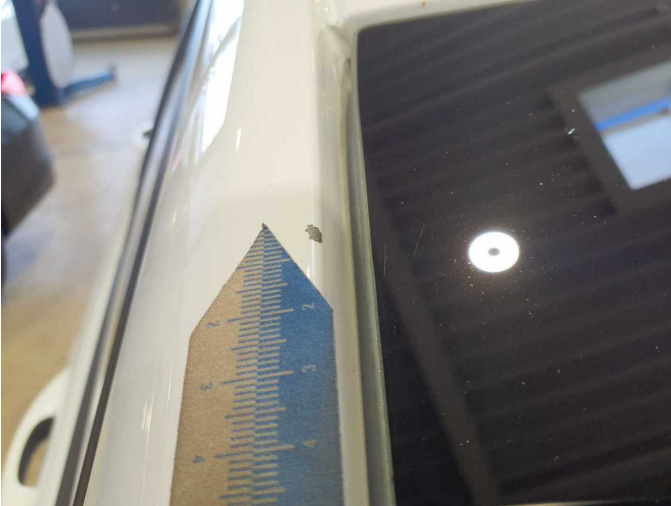
Damage 5: Body: A-pillar - right side - Stone chips - Smart repair

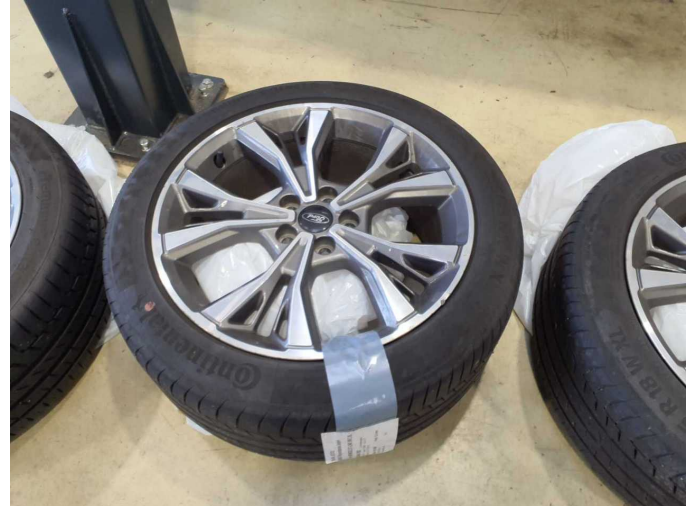
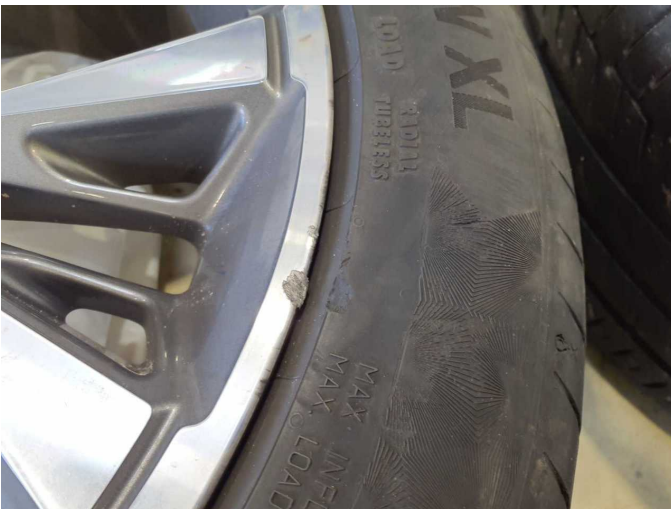
Damage 6: 2nd wheel set: 1 tyre - Damaged - Replace

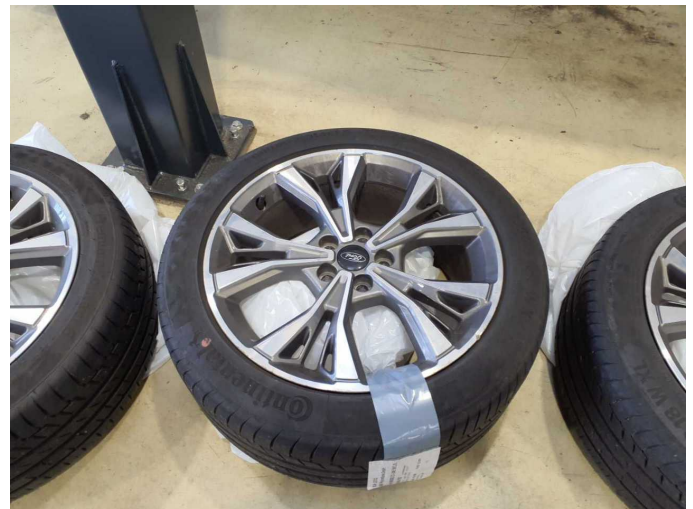
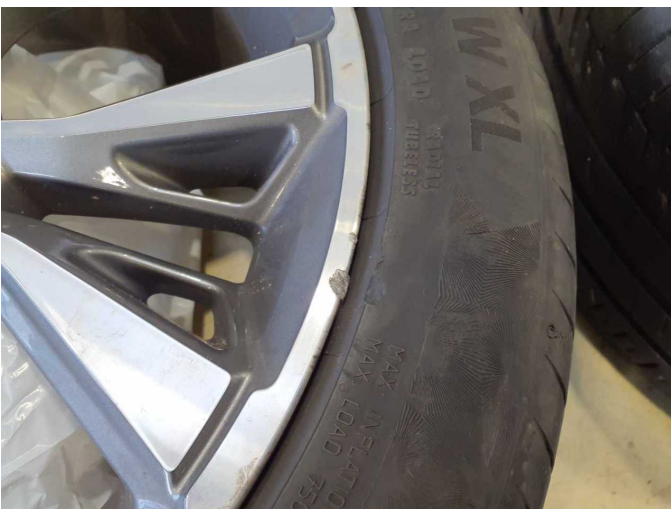
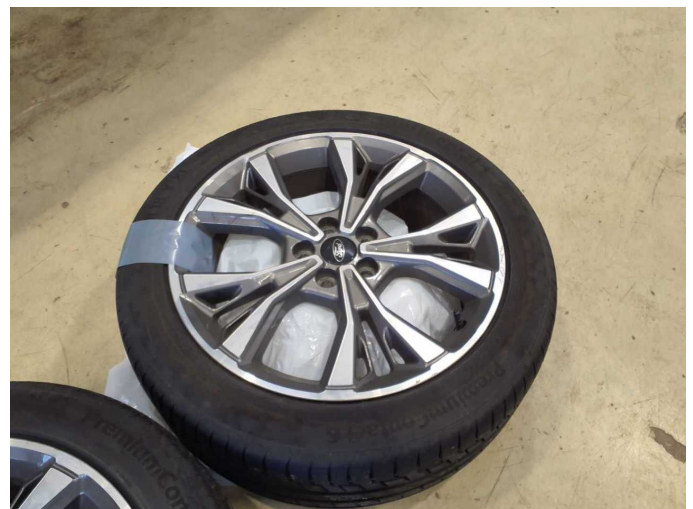
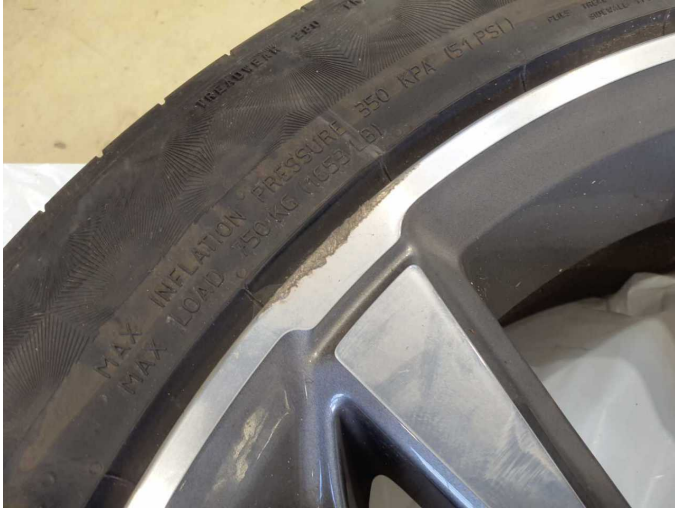
Damage 7: 2nd wheel set: 2 alloy rims - Scratched - Loss in value

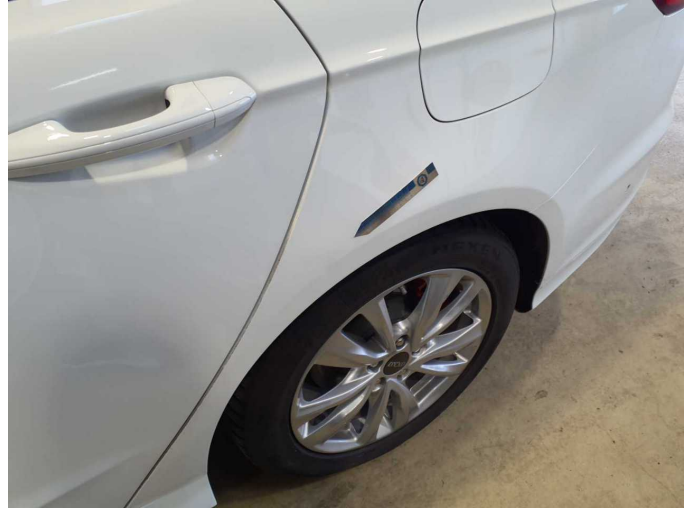
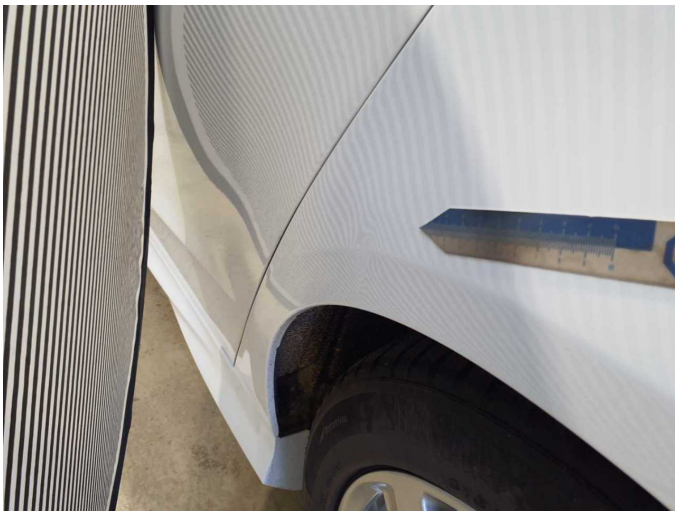
Damage 8: Side panel - rear left side: Side panel - dent(s) - Repair and paint

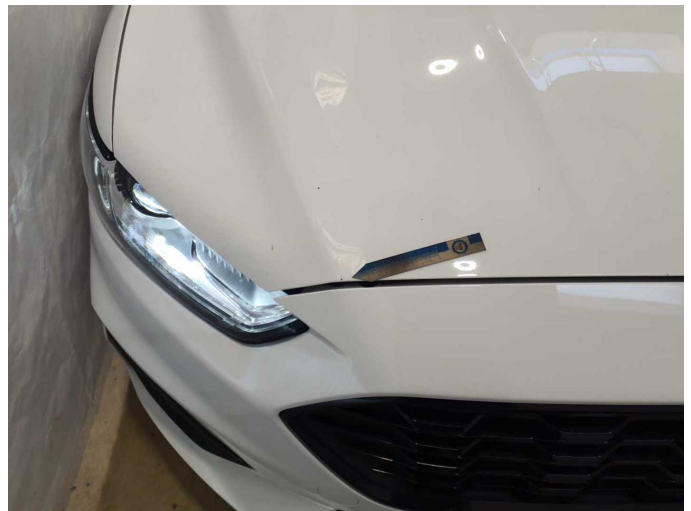
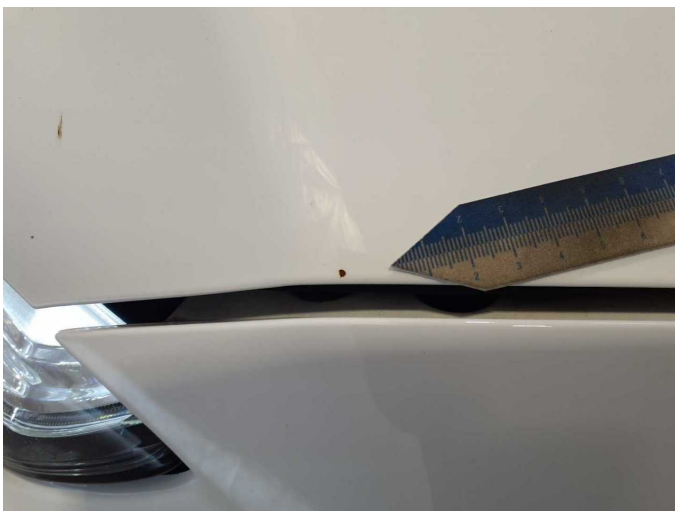
Damage 9: Bonnet: Bonnet - Corrosion - Repair and paint
